## Gas Protection - Validation Record Sheet

**This Record sheet is only applicable to block and beam floor slabs for Characteristic Situation 2 gas protection systems**

Plot 29, Block 10

**For Residential Development at New Church Street, Radcliffe.**

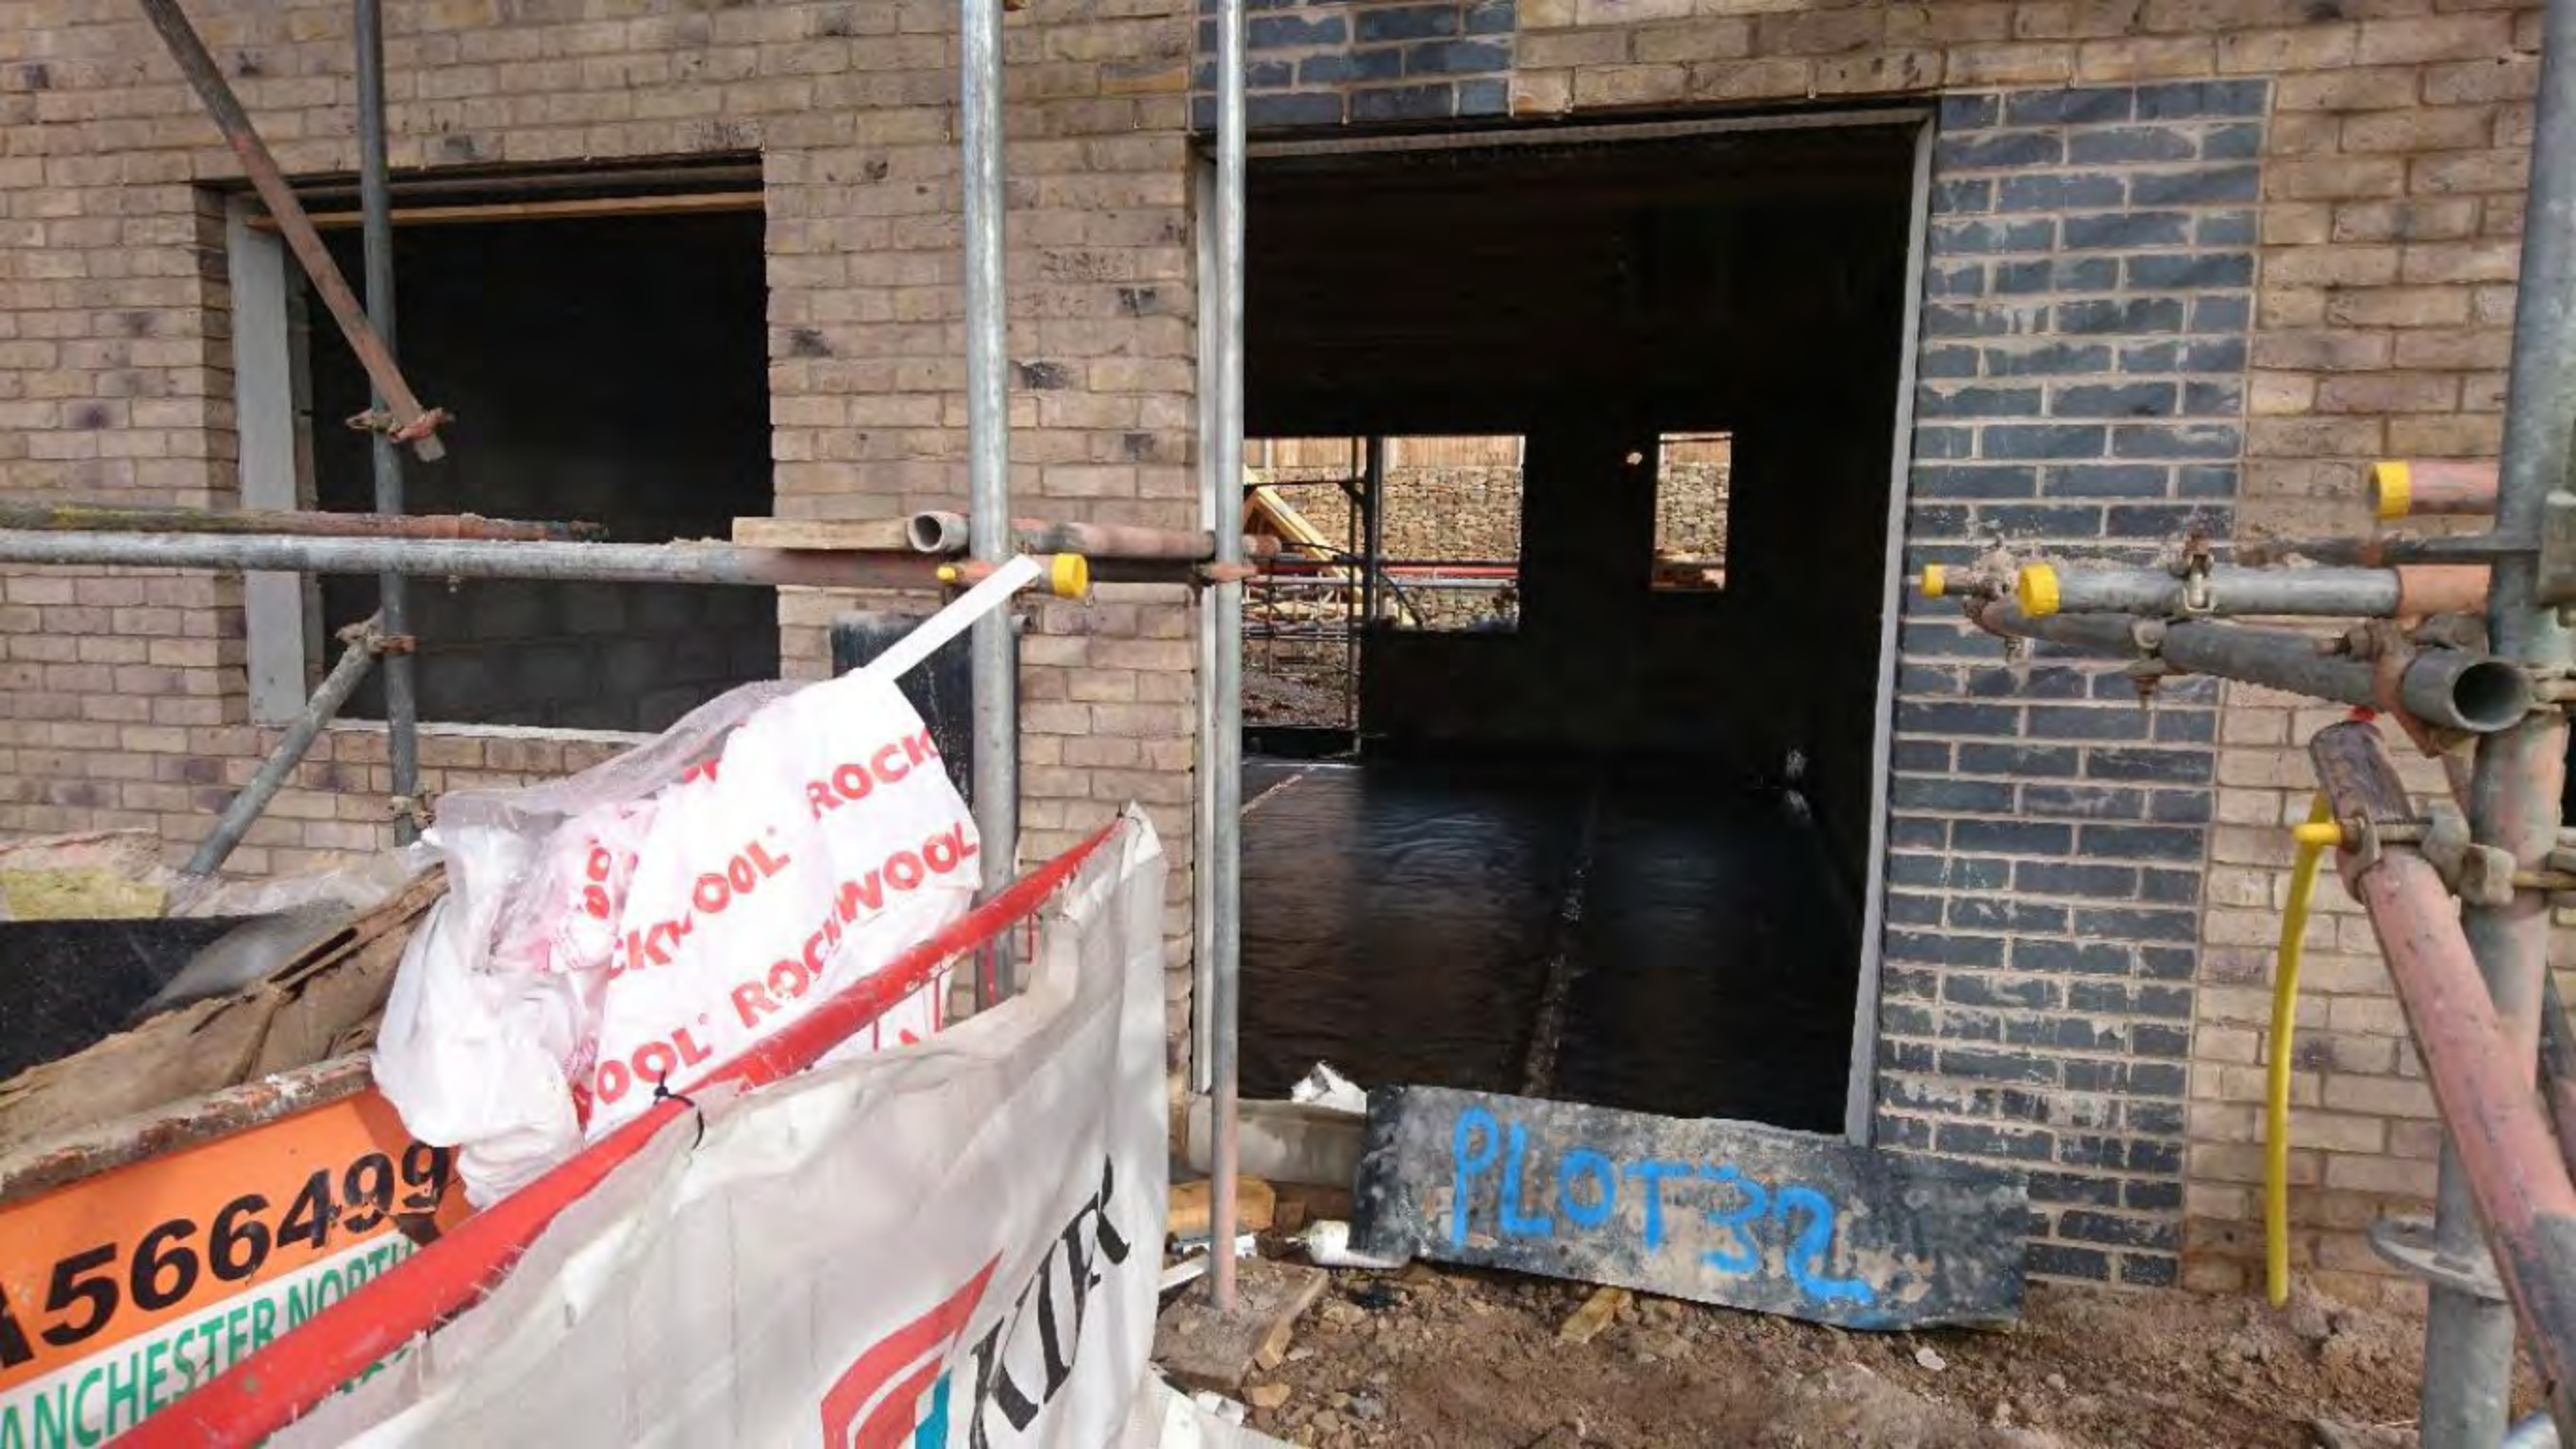
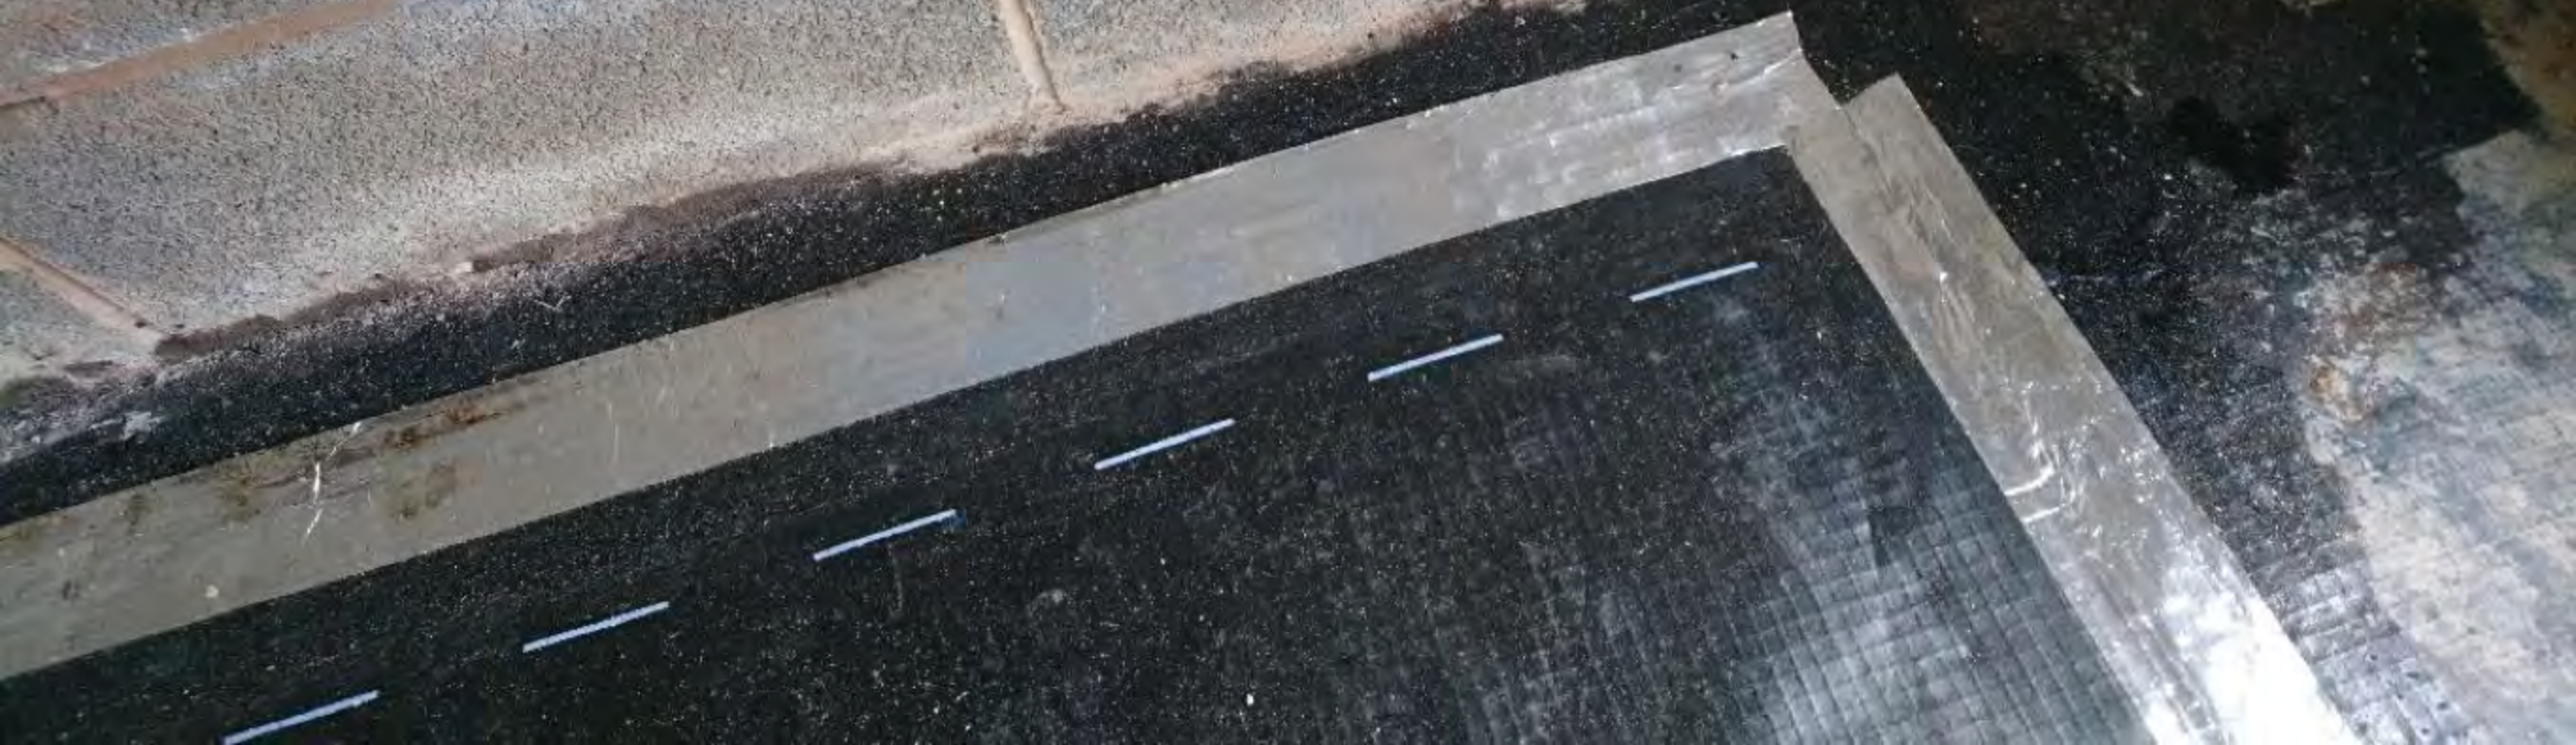
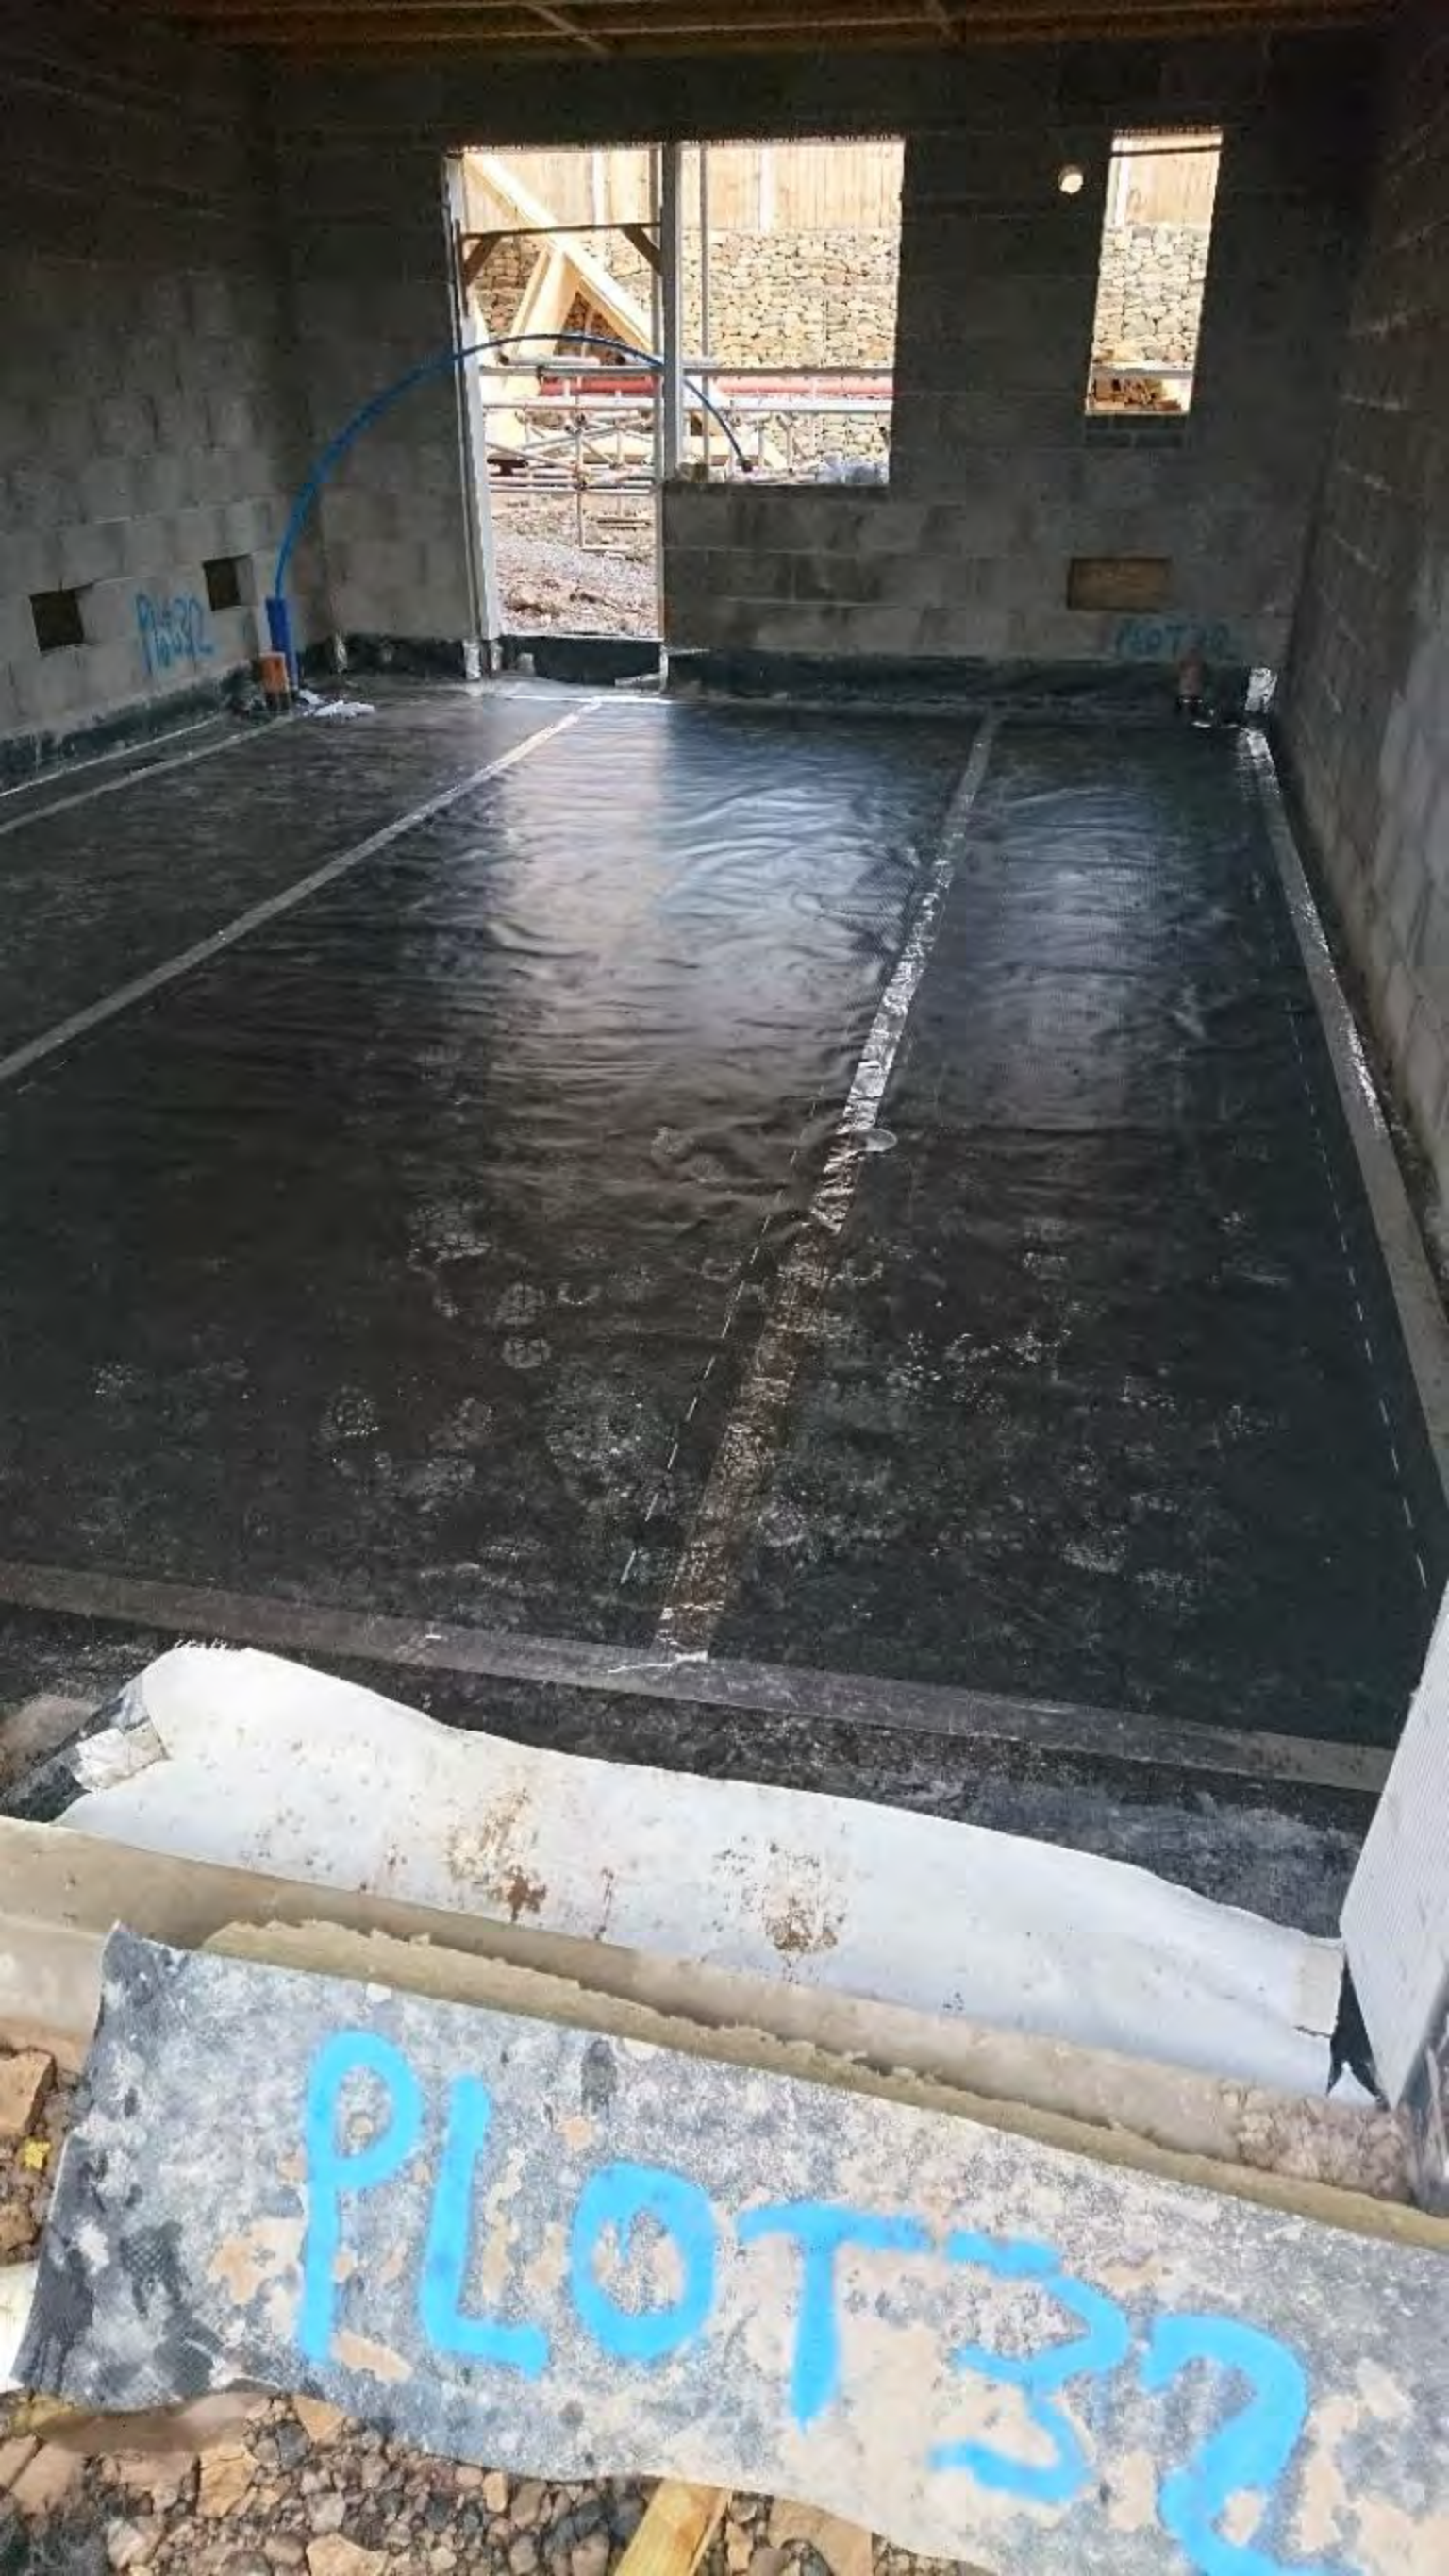
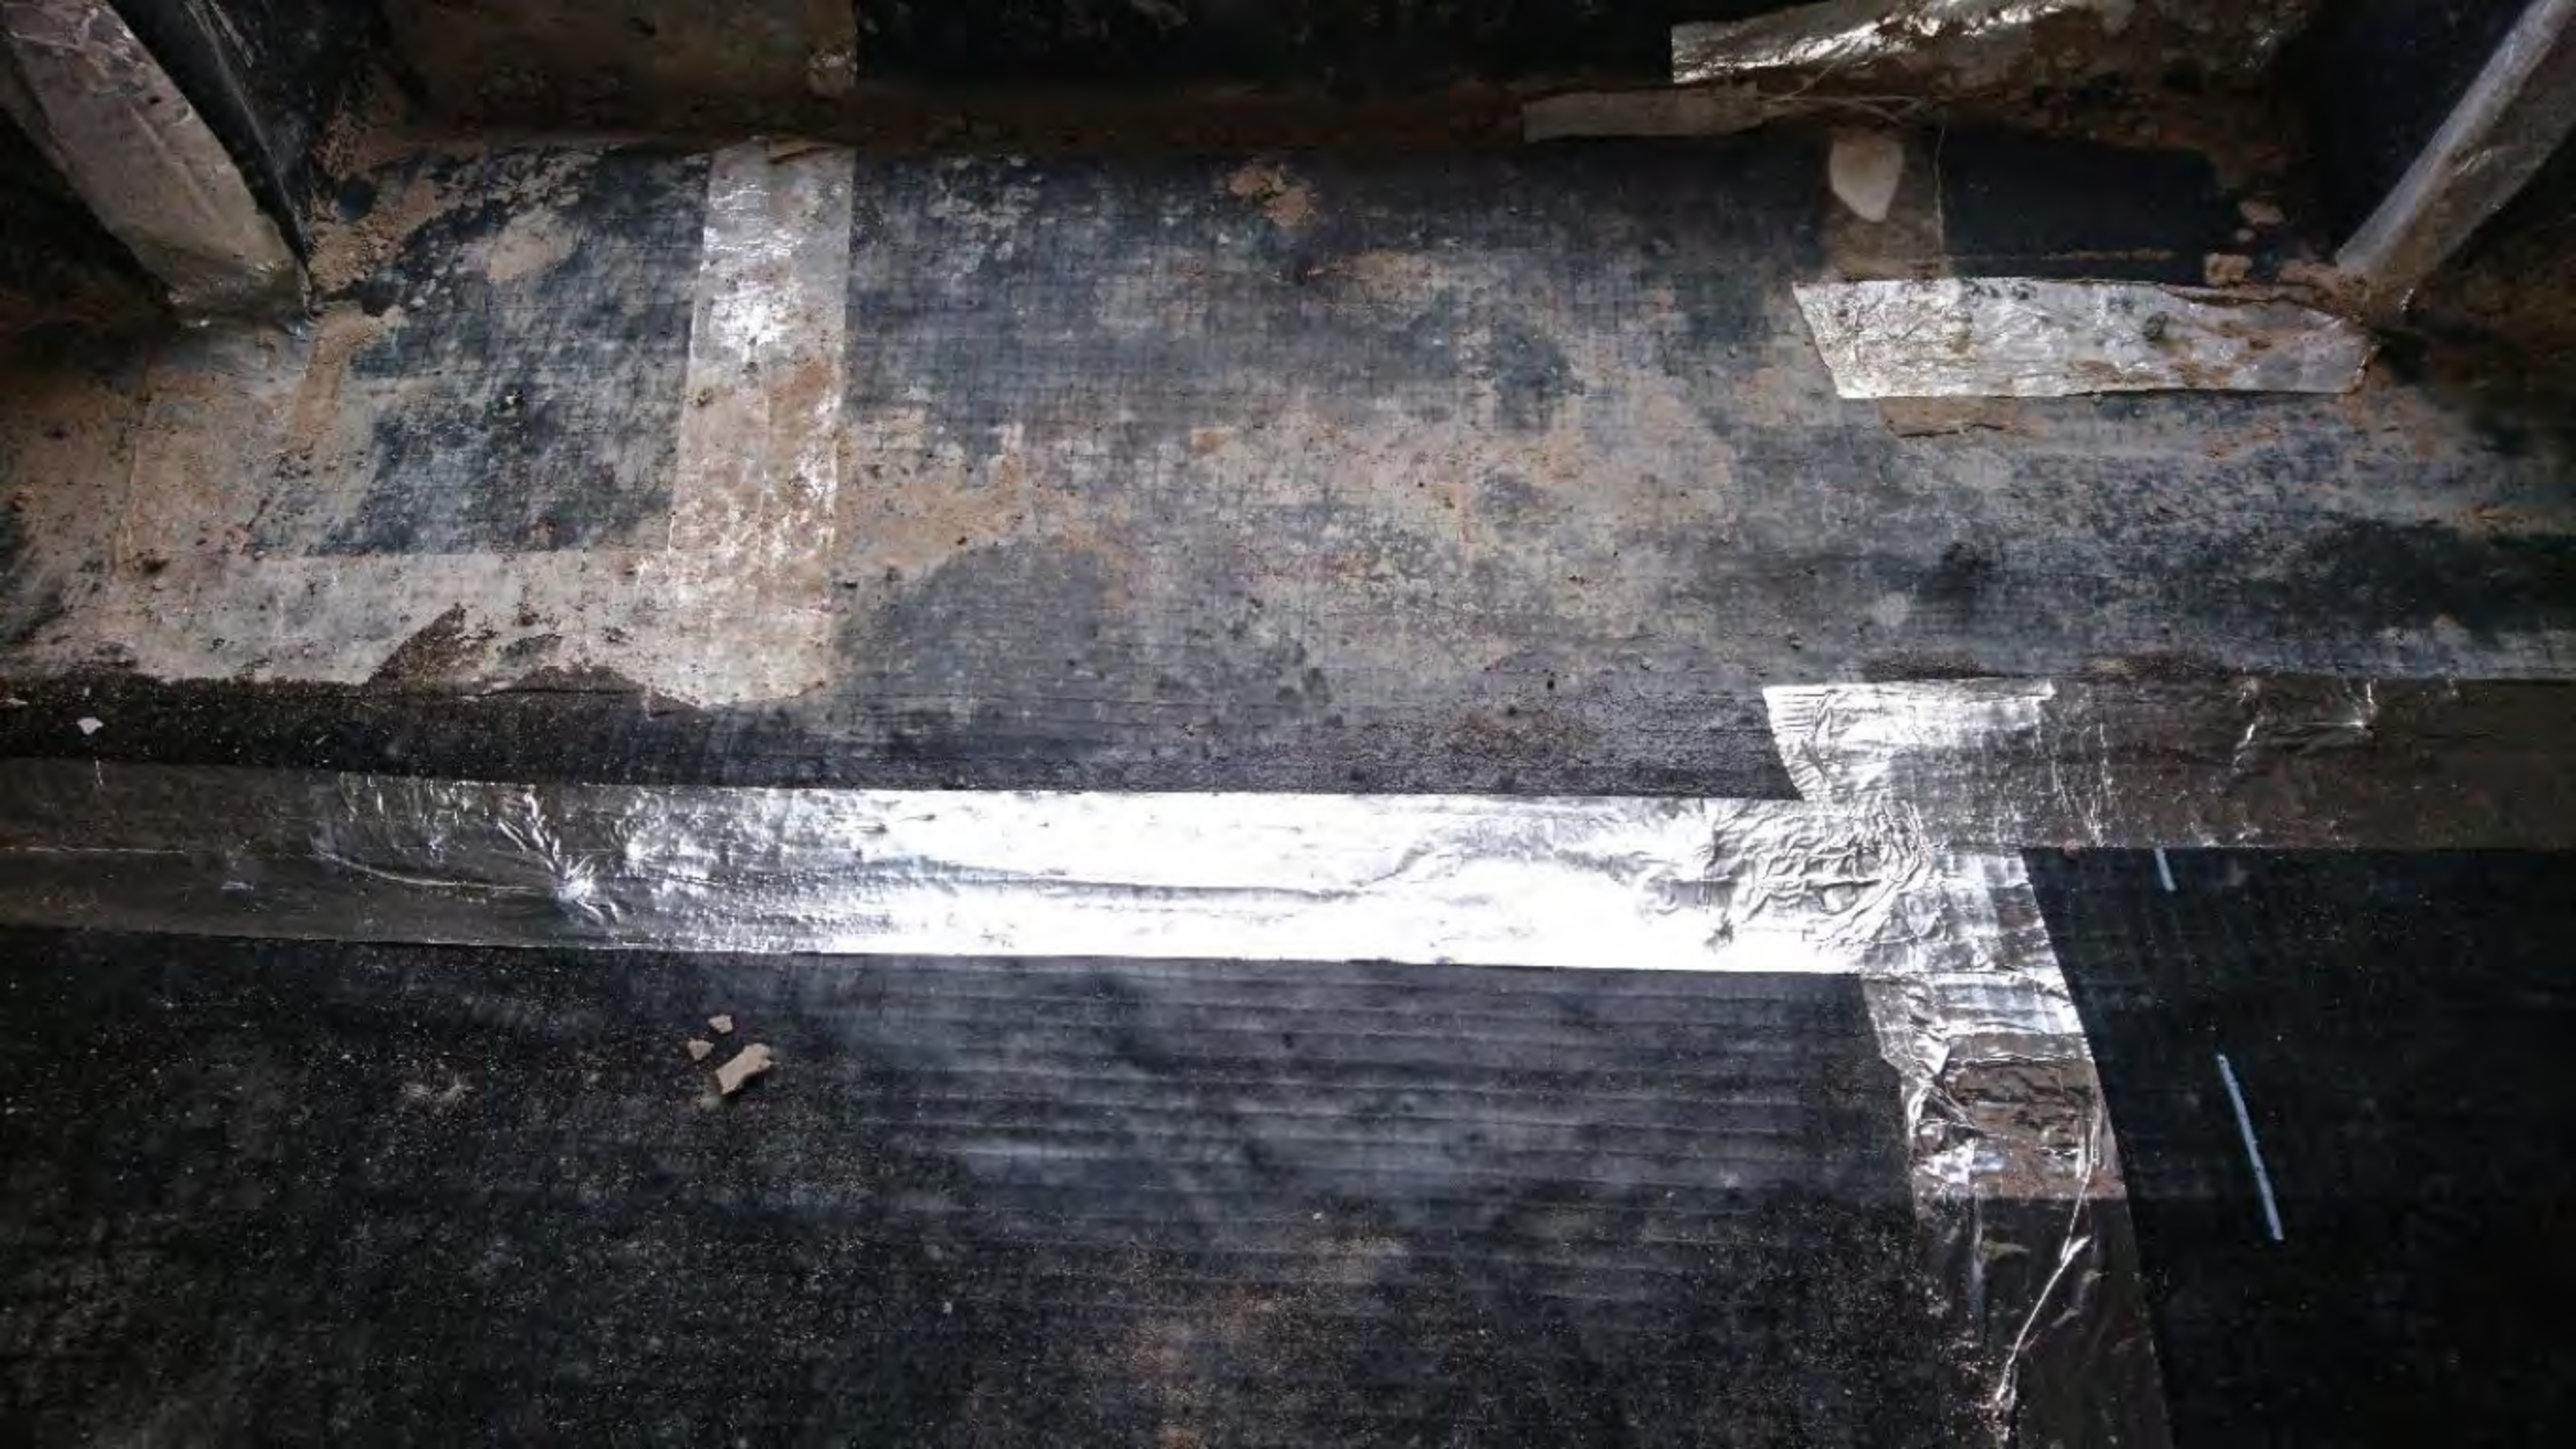
PLOT 32

| 2.2 | Condition of sub-grade & underside of gas membrane | GOOD QUALITY, BRUSHED FLOOR, TAPE APPLIED WELL AND SEALED | | | | | |
| 2.4 | Gas membrane condition and coverage | GOOD SEALED ON ALL FOUR SIDES | | | | | |
| 2.7 | Condition of joints/seals | GOOD – OVERLAP VISIBLE | | | | | |
| 2.8 | Number and condition of service entry seals | GOOD, TAPE CHECKED, ALL JUBILEE CLIPS VISIBLE – 3 N. TOP HATS | | | | | |
