## Gas Protection - Validation Record Sheet

**This Record sheet is only applicable to block and beam floor slabs for Characteristic Situation 2 gas protection systems**

Plot 29, Block 10

**For Residential Development at New Church Street, Radcliffe.**

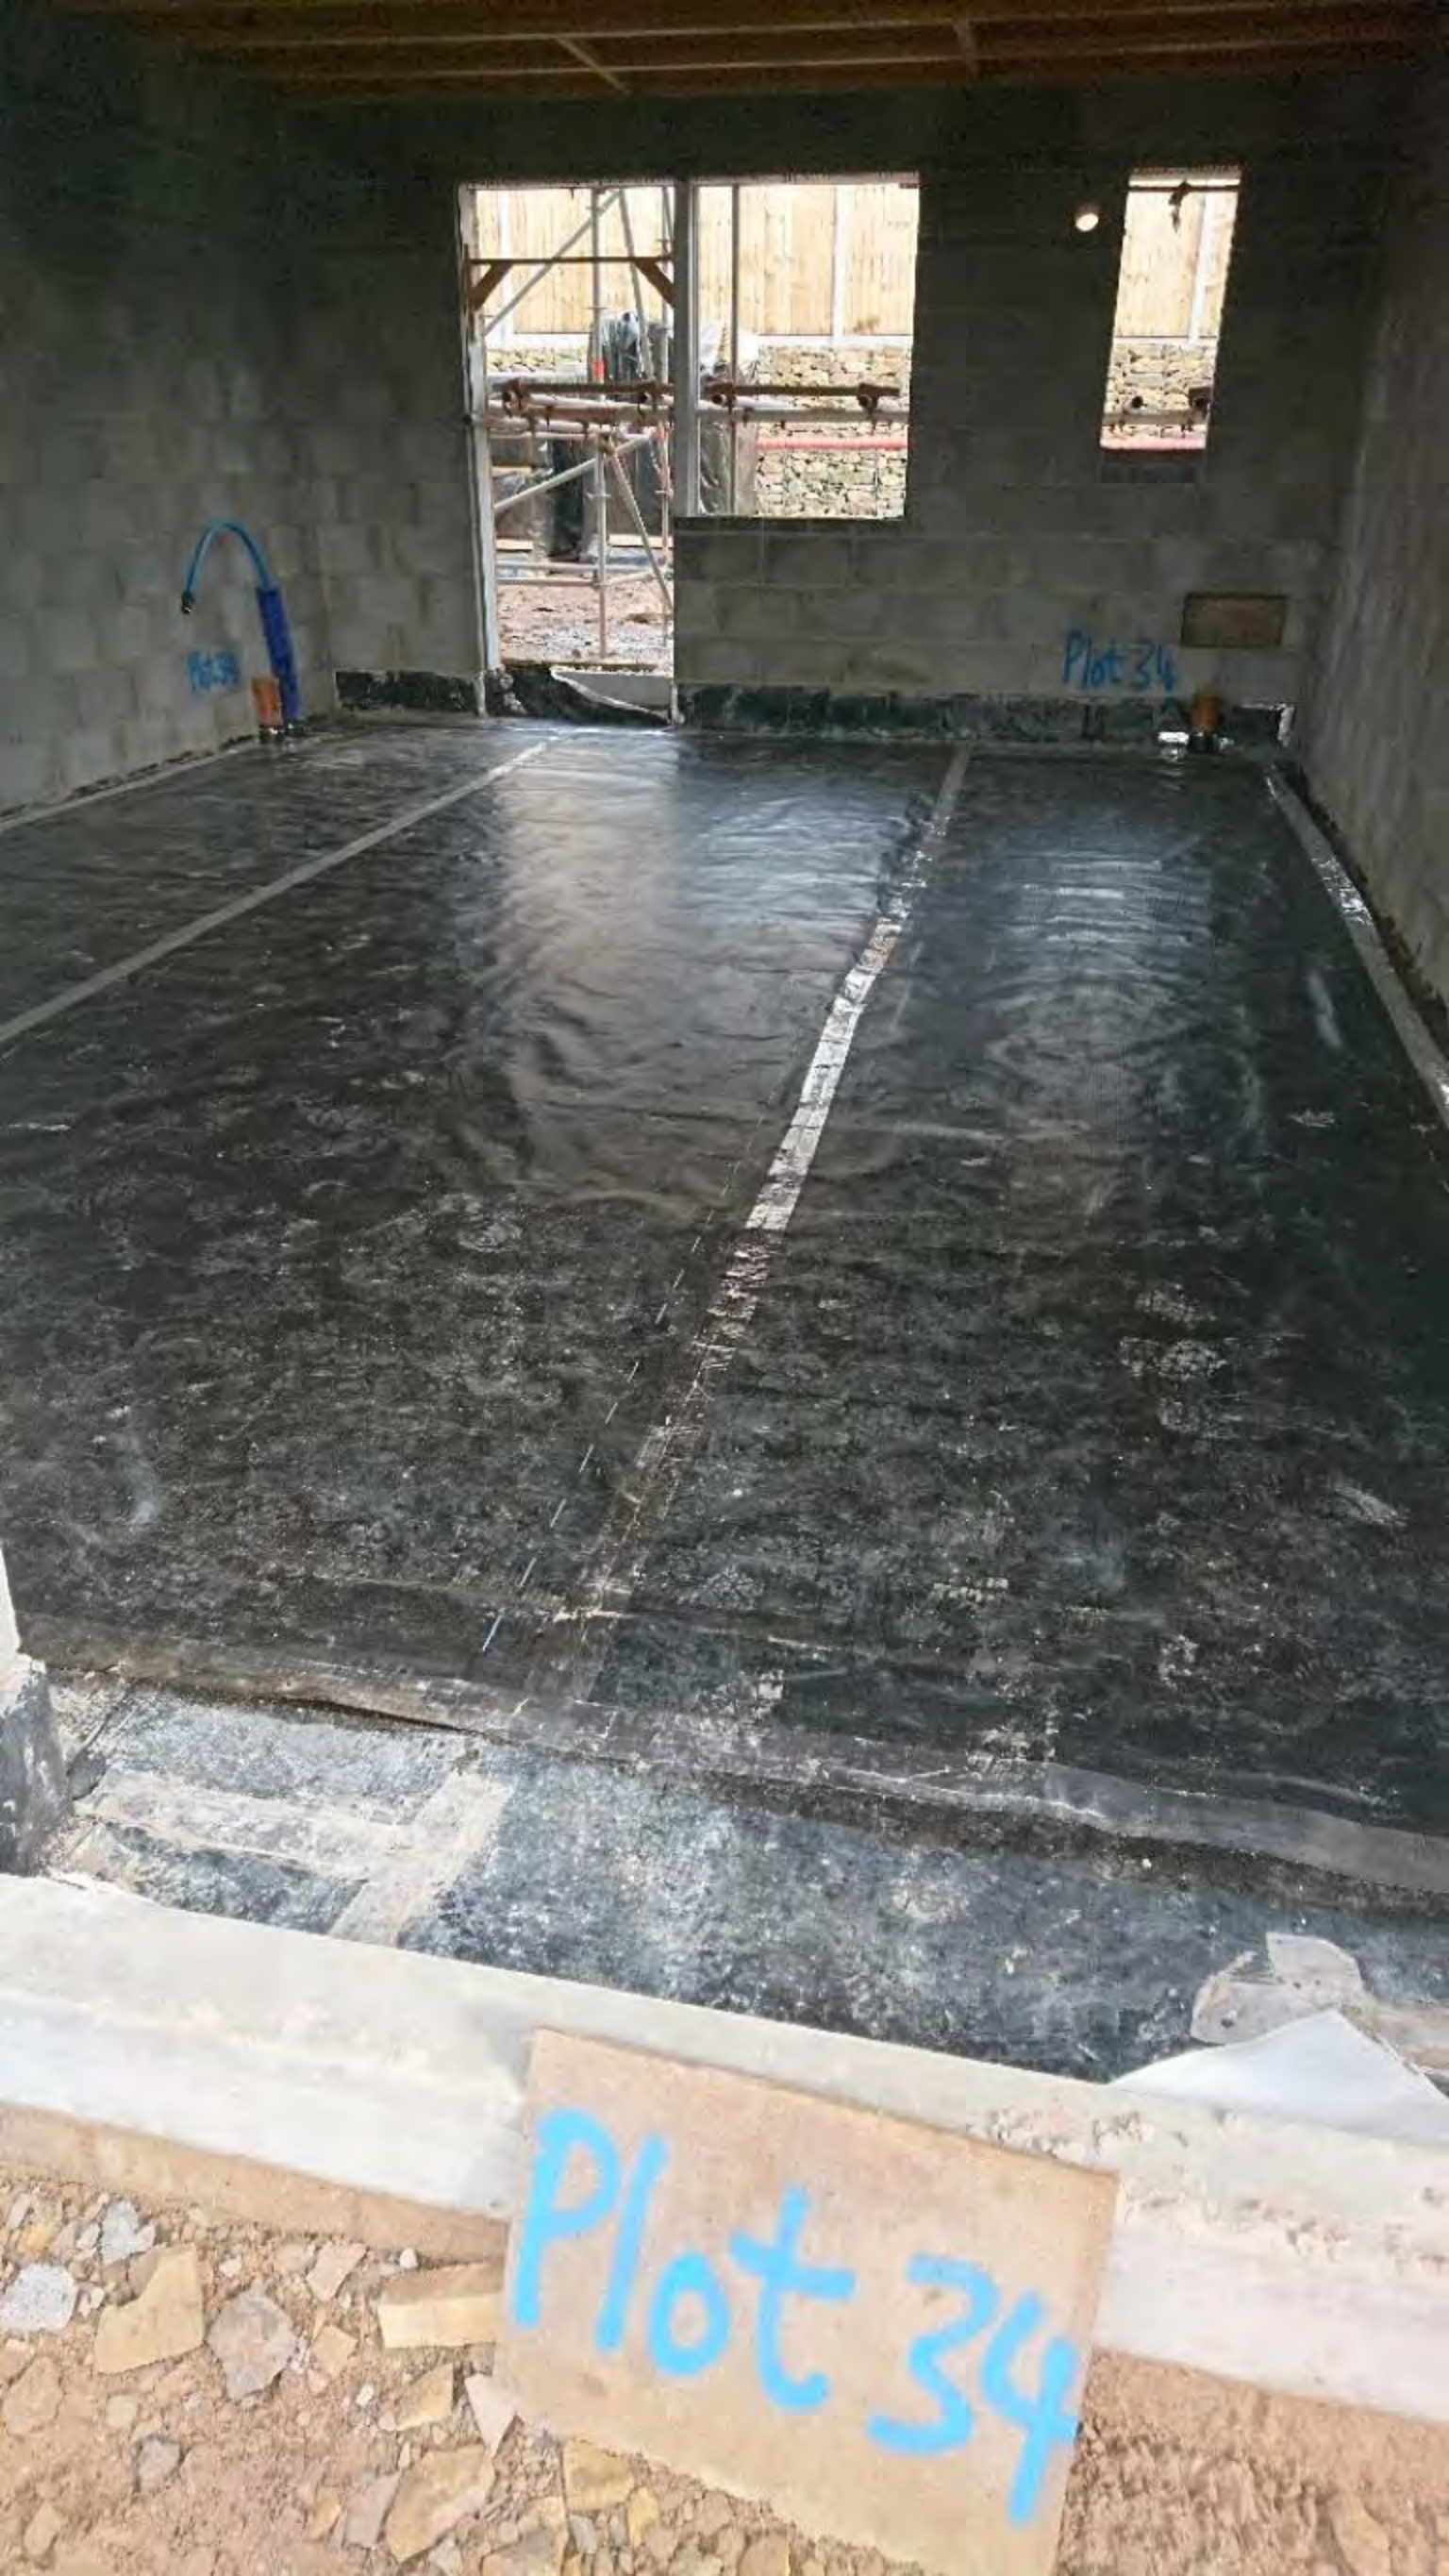
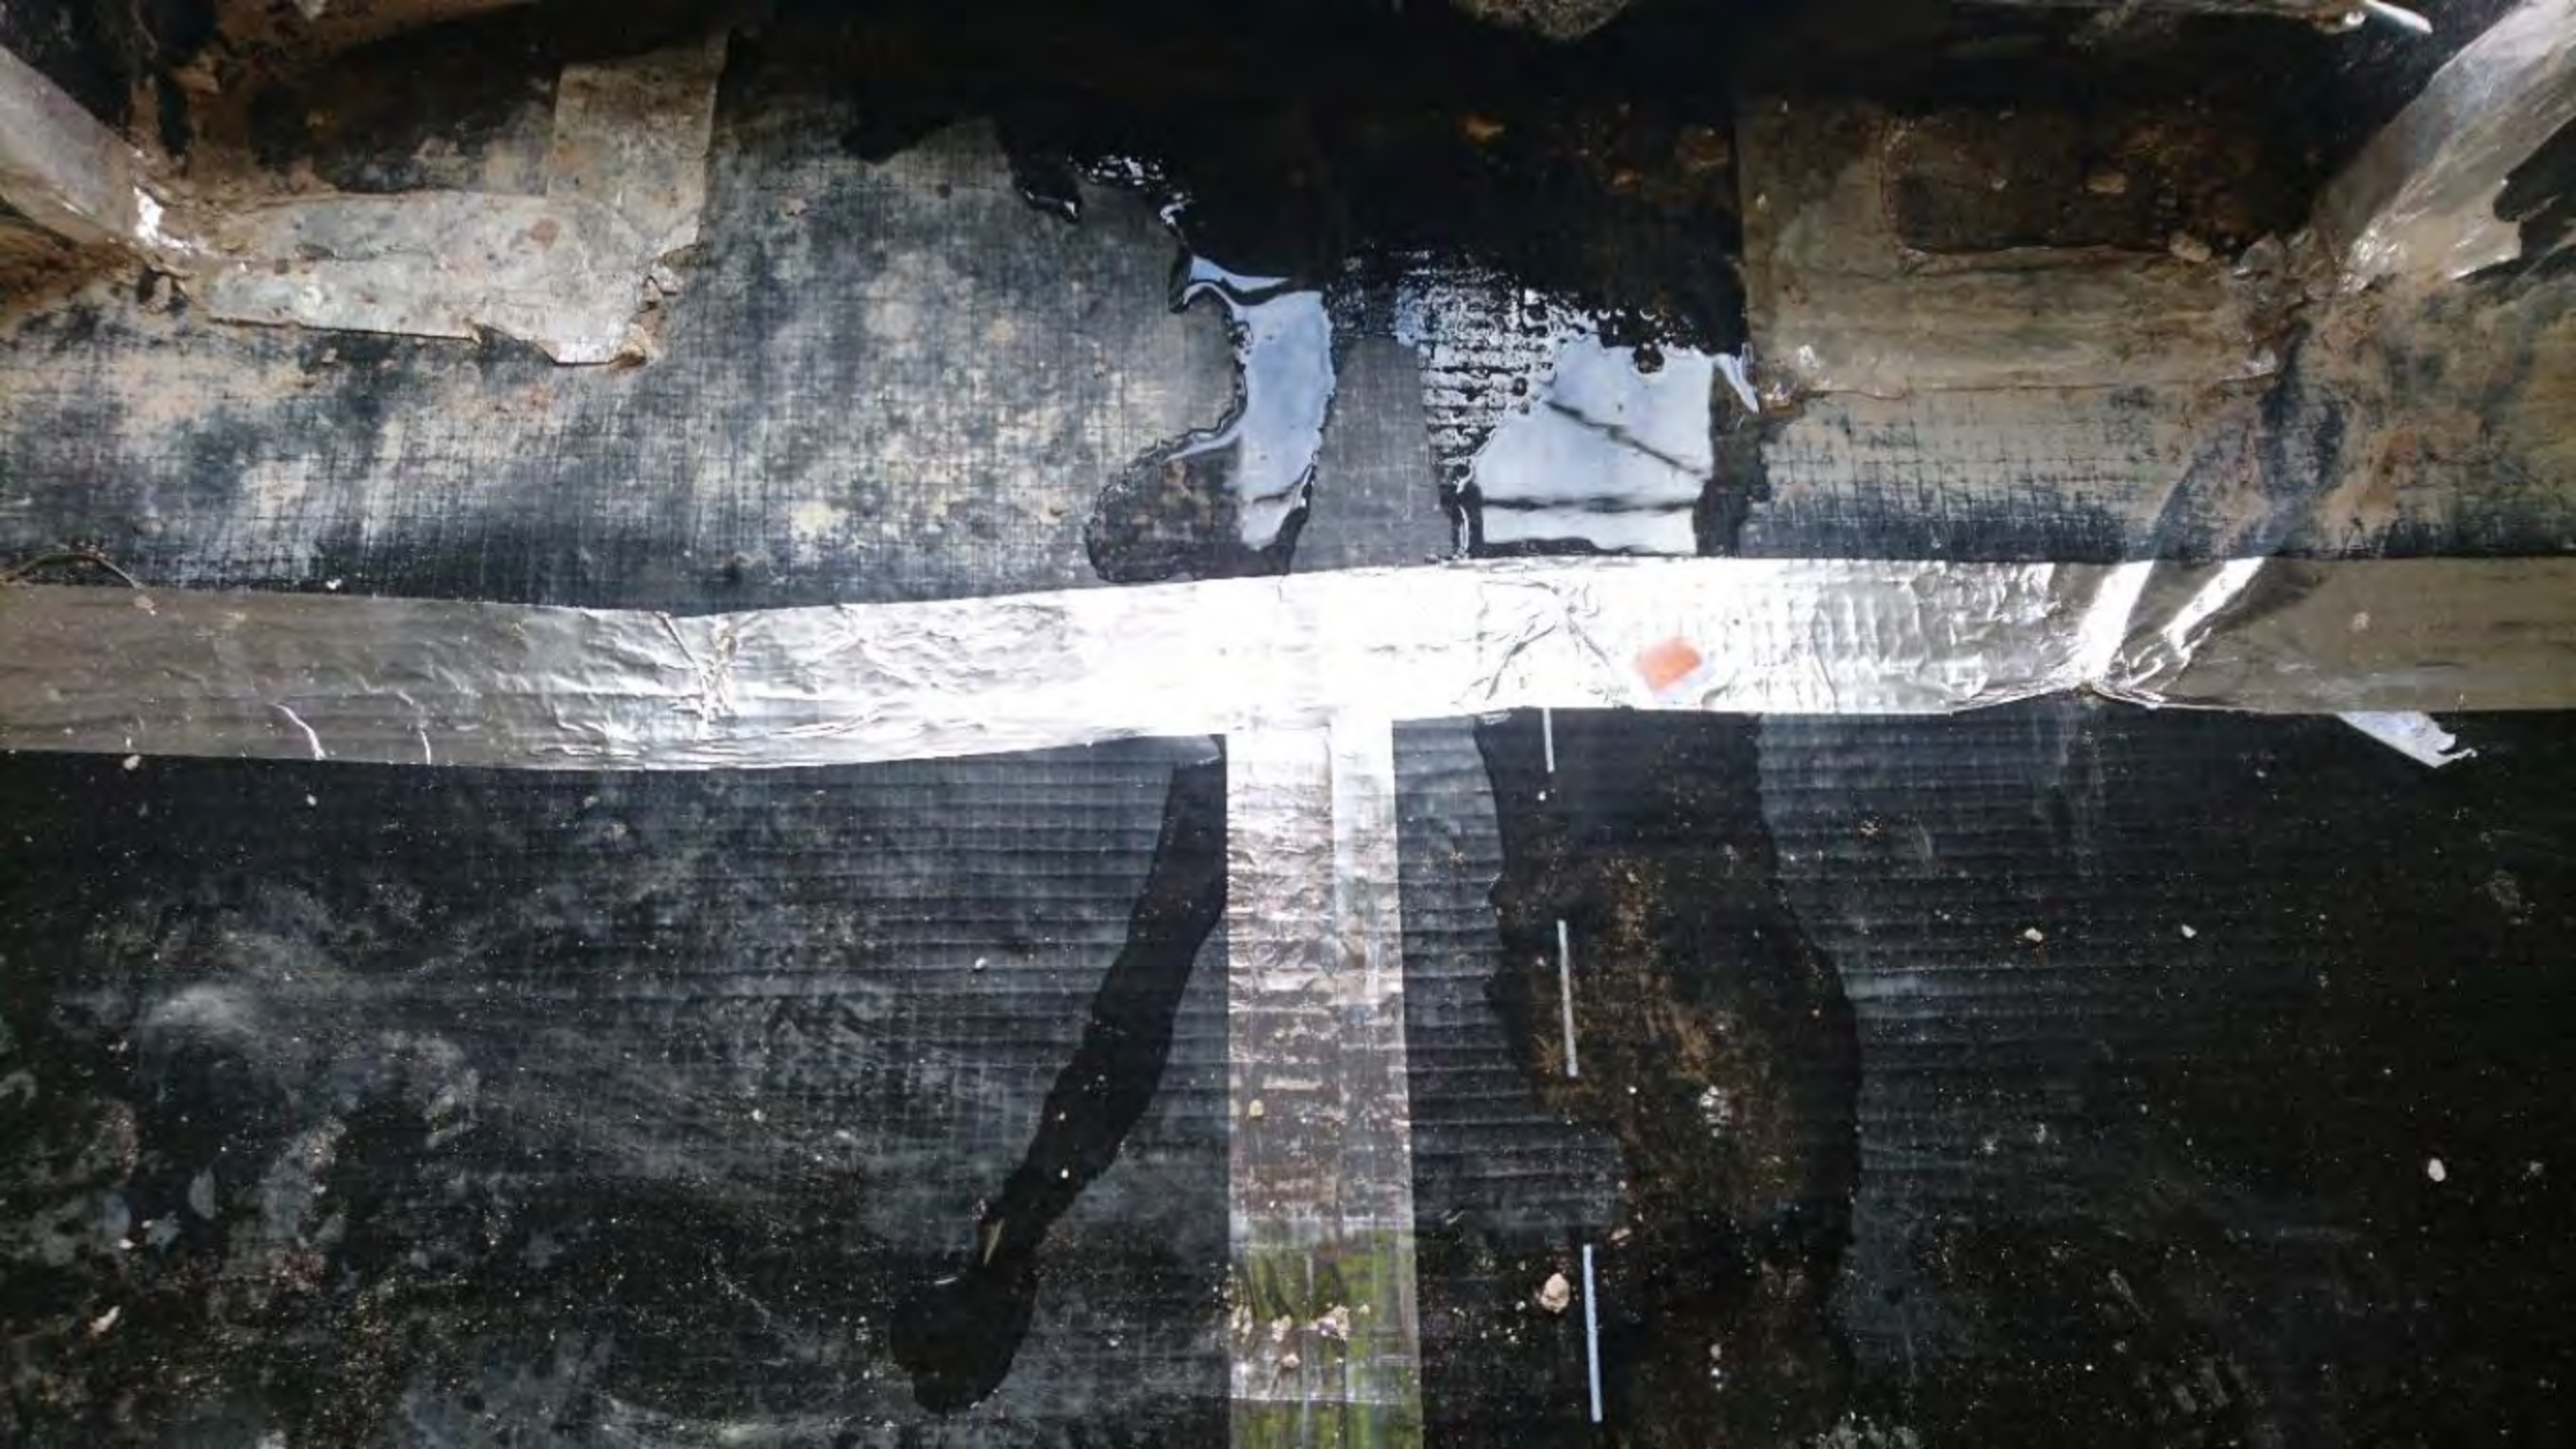
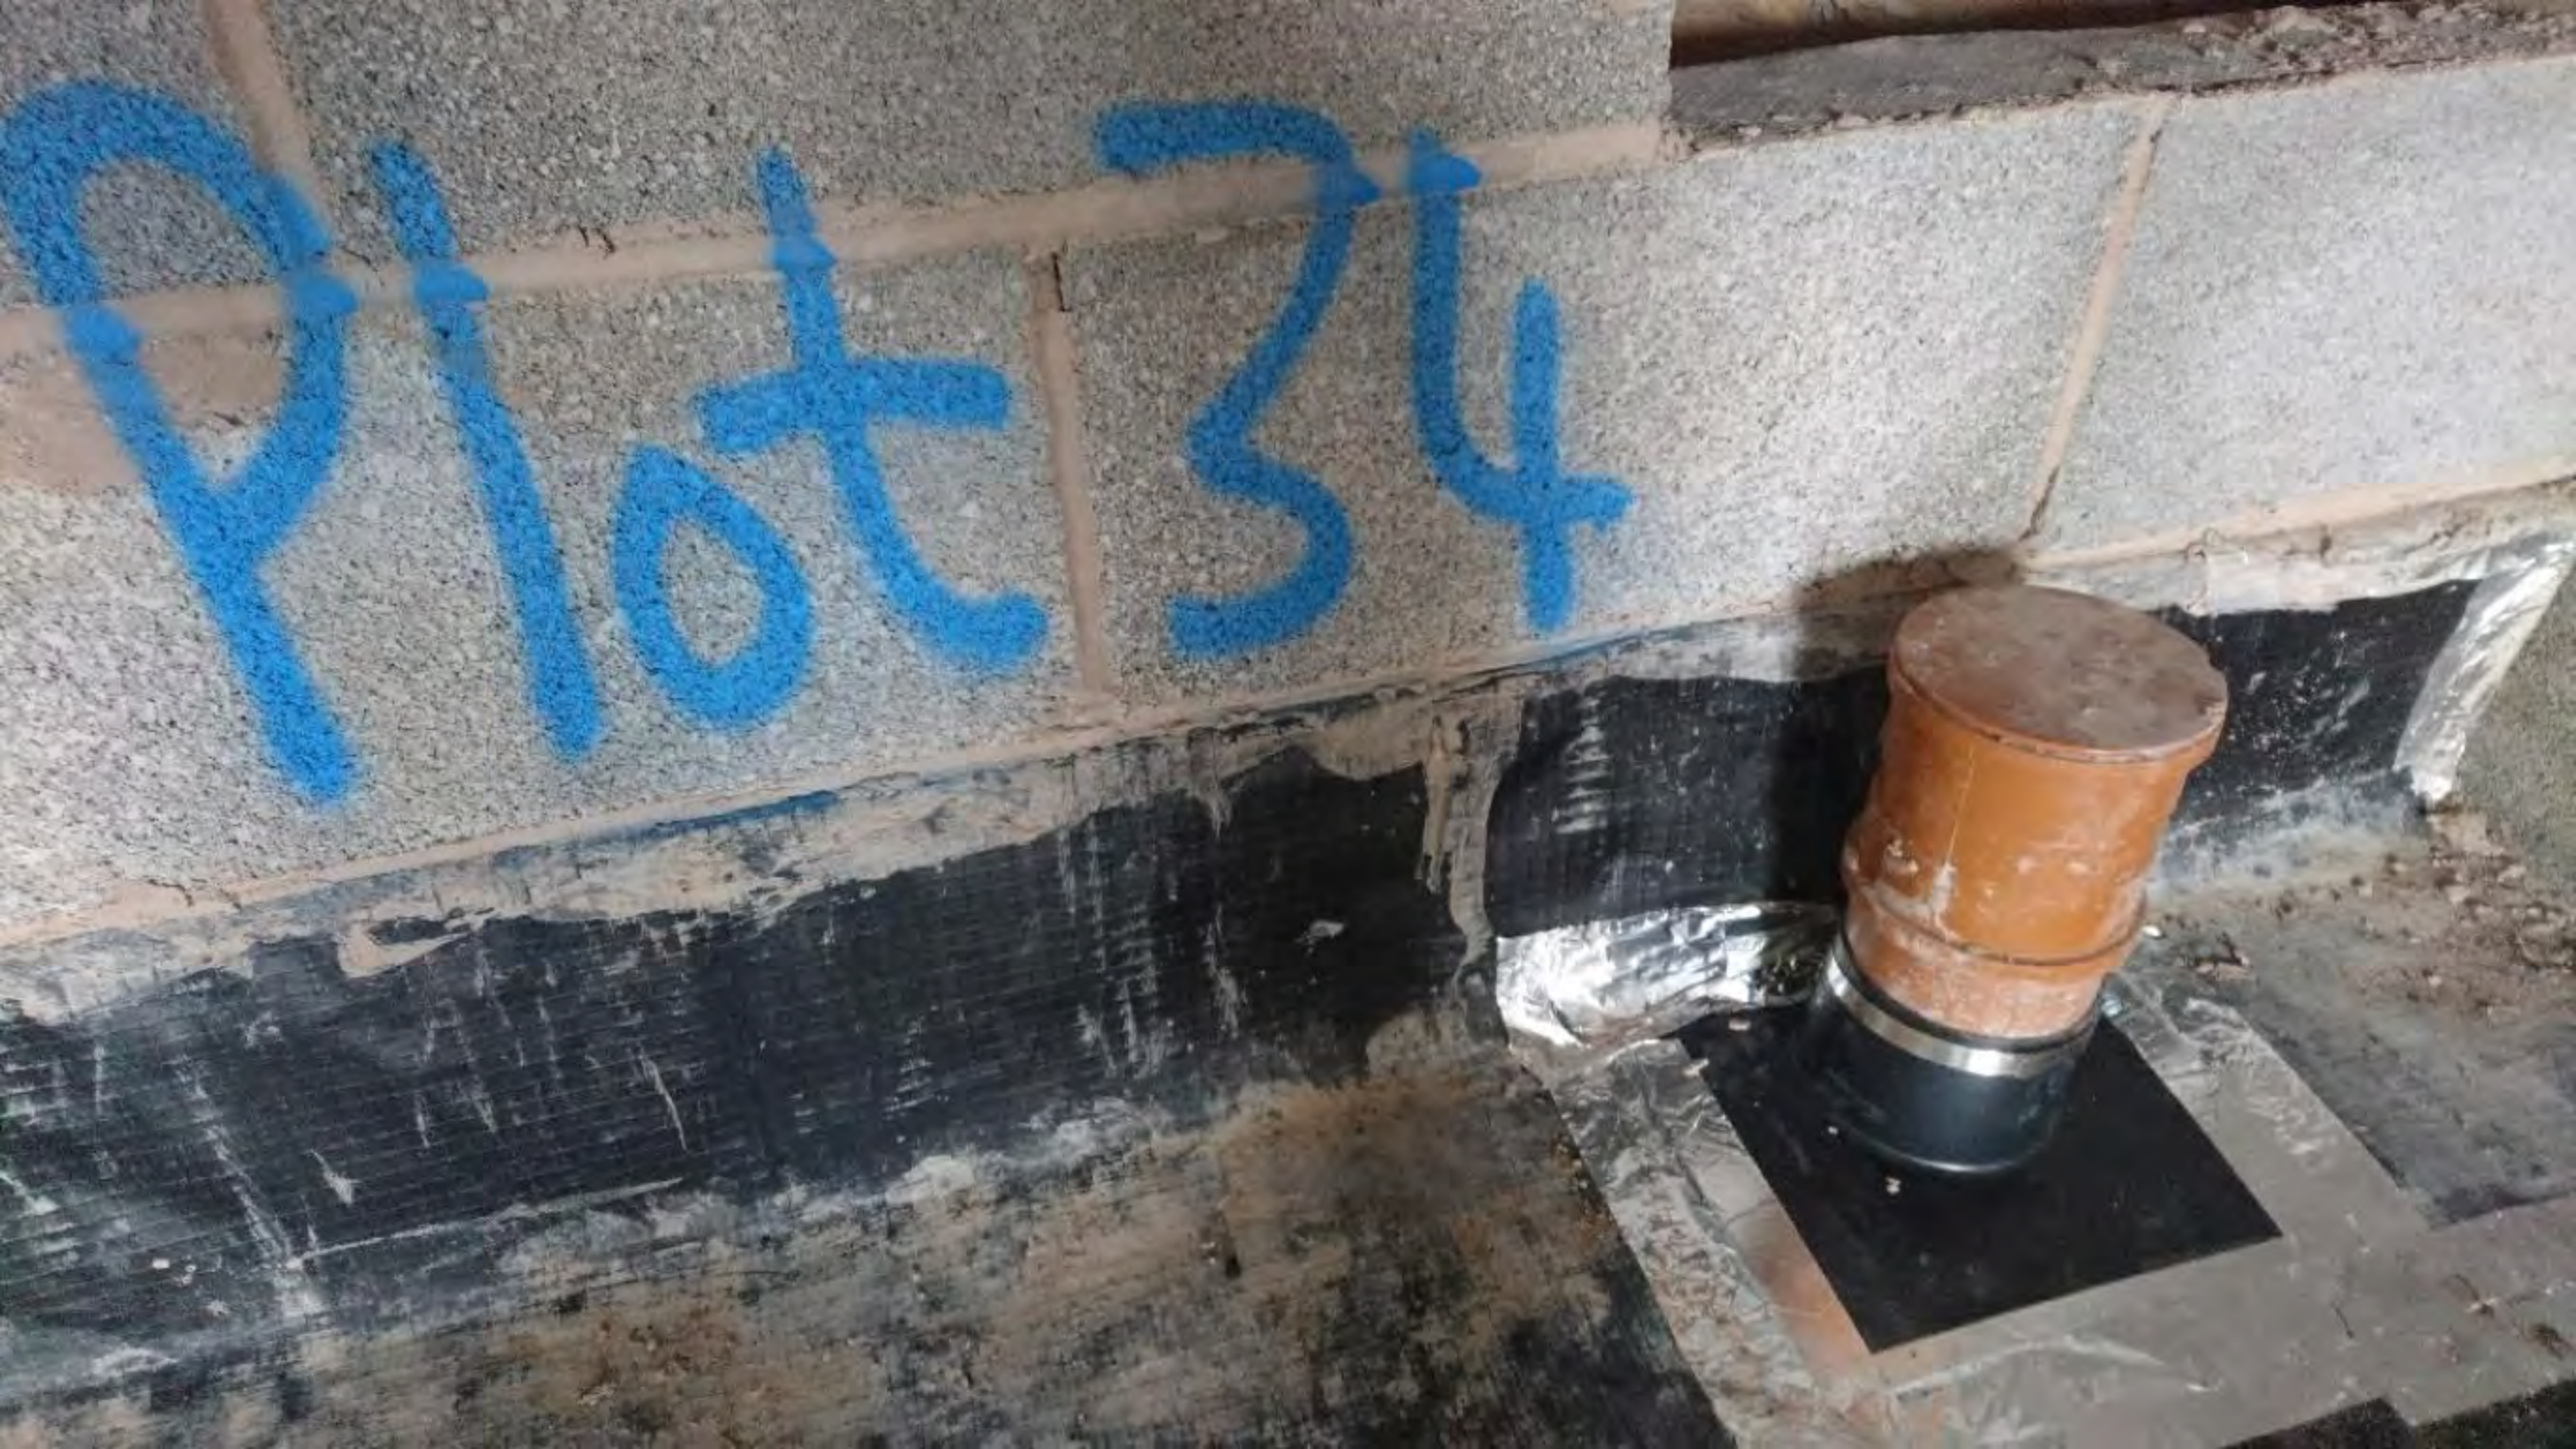
Plot 34

| 2.2 | Condition of sub-grade & underside of gas membrane | GOOD, FLOOR BRUSHED AND TAPES APPLIED WELL AND SEALED | | | | | |
| 2.4 | Gas membrane condition and coverage | GOOD, SEALED ON ALL SIDES | | | | | |
| 2.7 | Condition of joints/seals | GOOD, OVERLAPS VISIBLE | | | | | |
| 2.8 | Number and condition of service entry seals | ALL GOOD, 3 NO TOP HATS WITH SUBILEE CLIPS. TAPES CHECKED. | | | | | |
