## Gas Protection - Validation Record Sheet

**This Record sheet is only applicable to block and beam floor slabs for Characteristic Situation 2 gas protection systems**

Plot 29, Block 10

**For Residential Development at New Church Street, Radcliffe.**

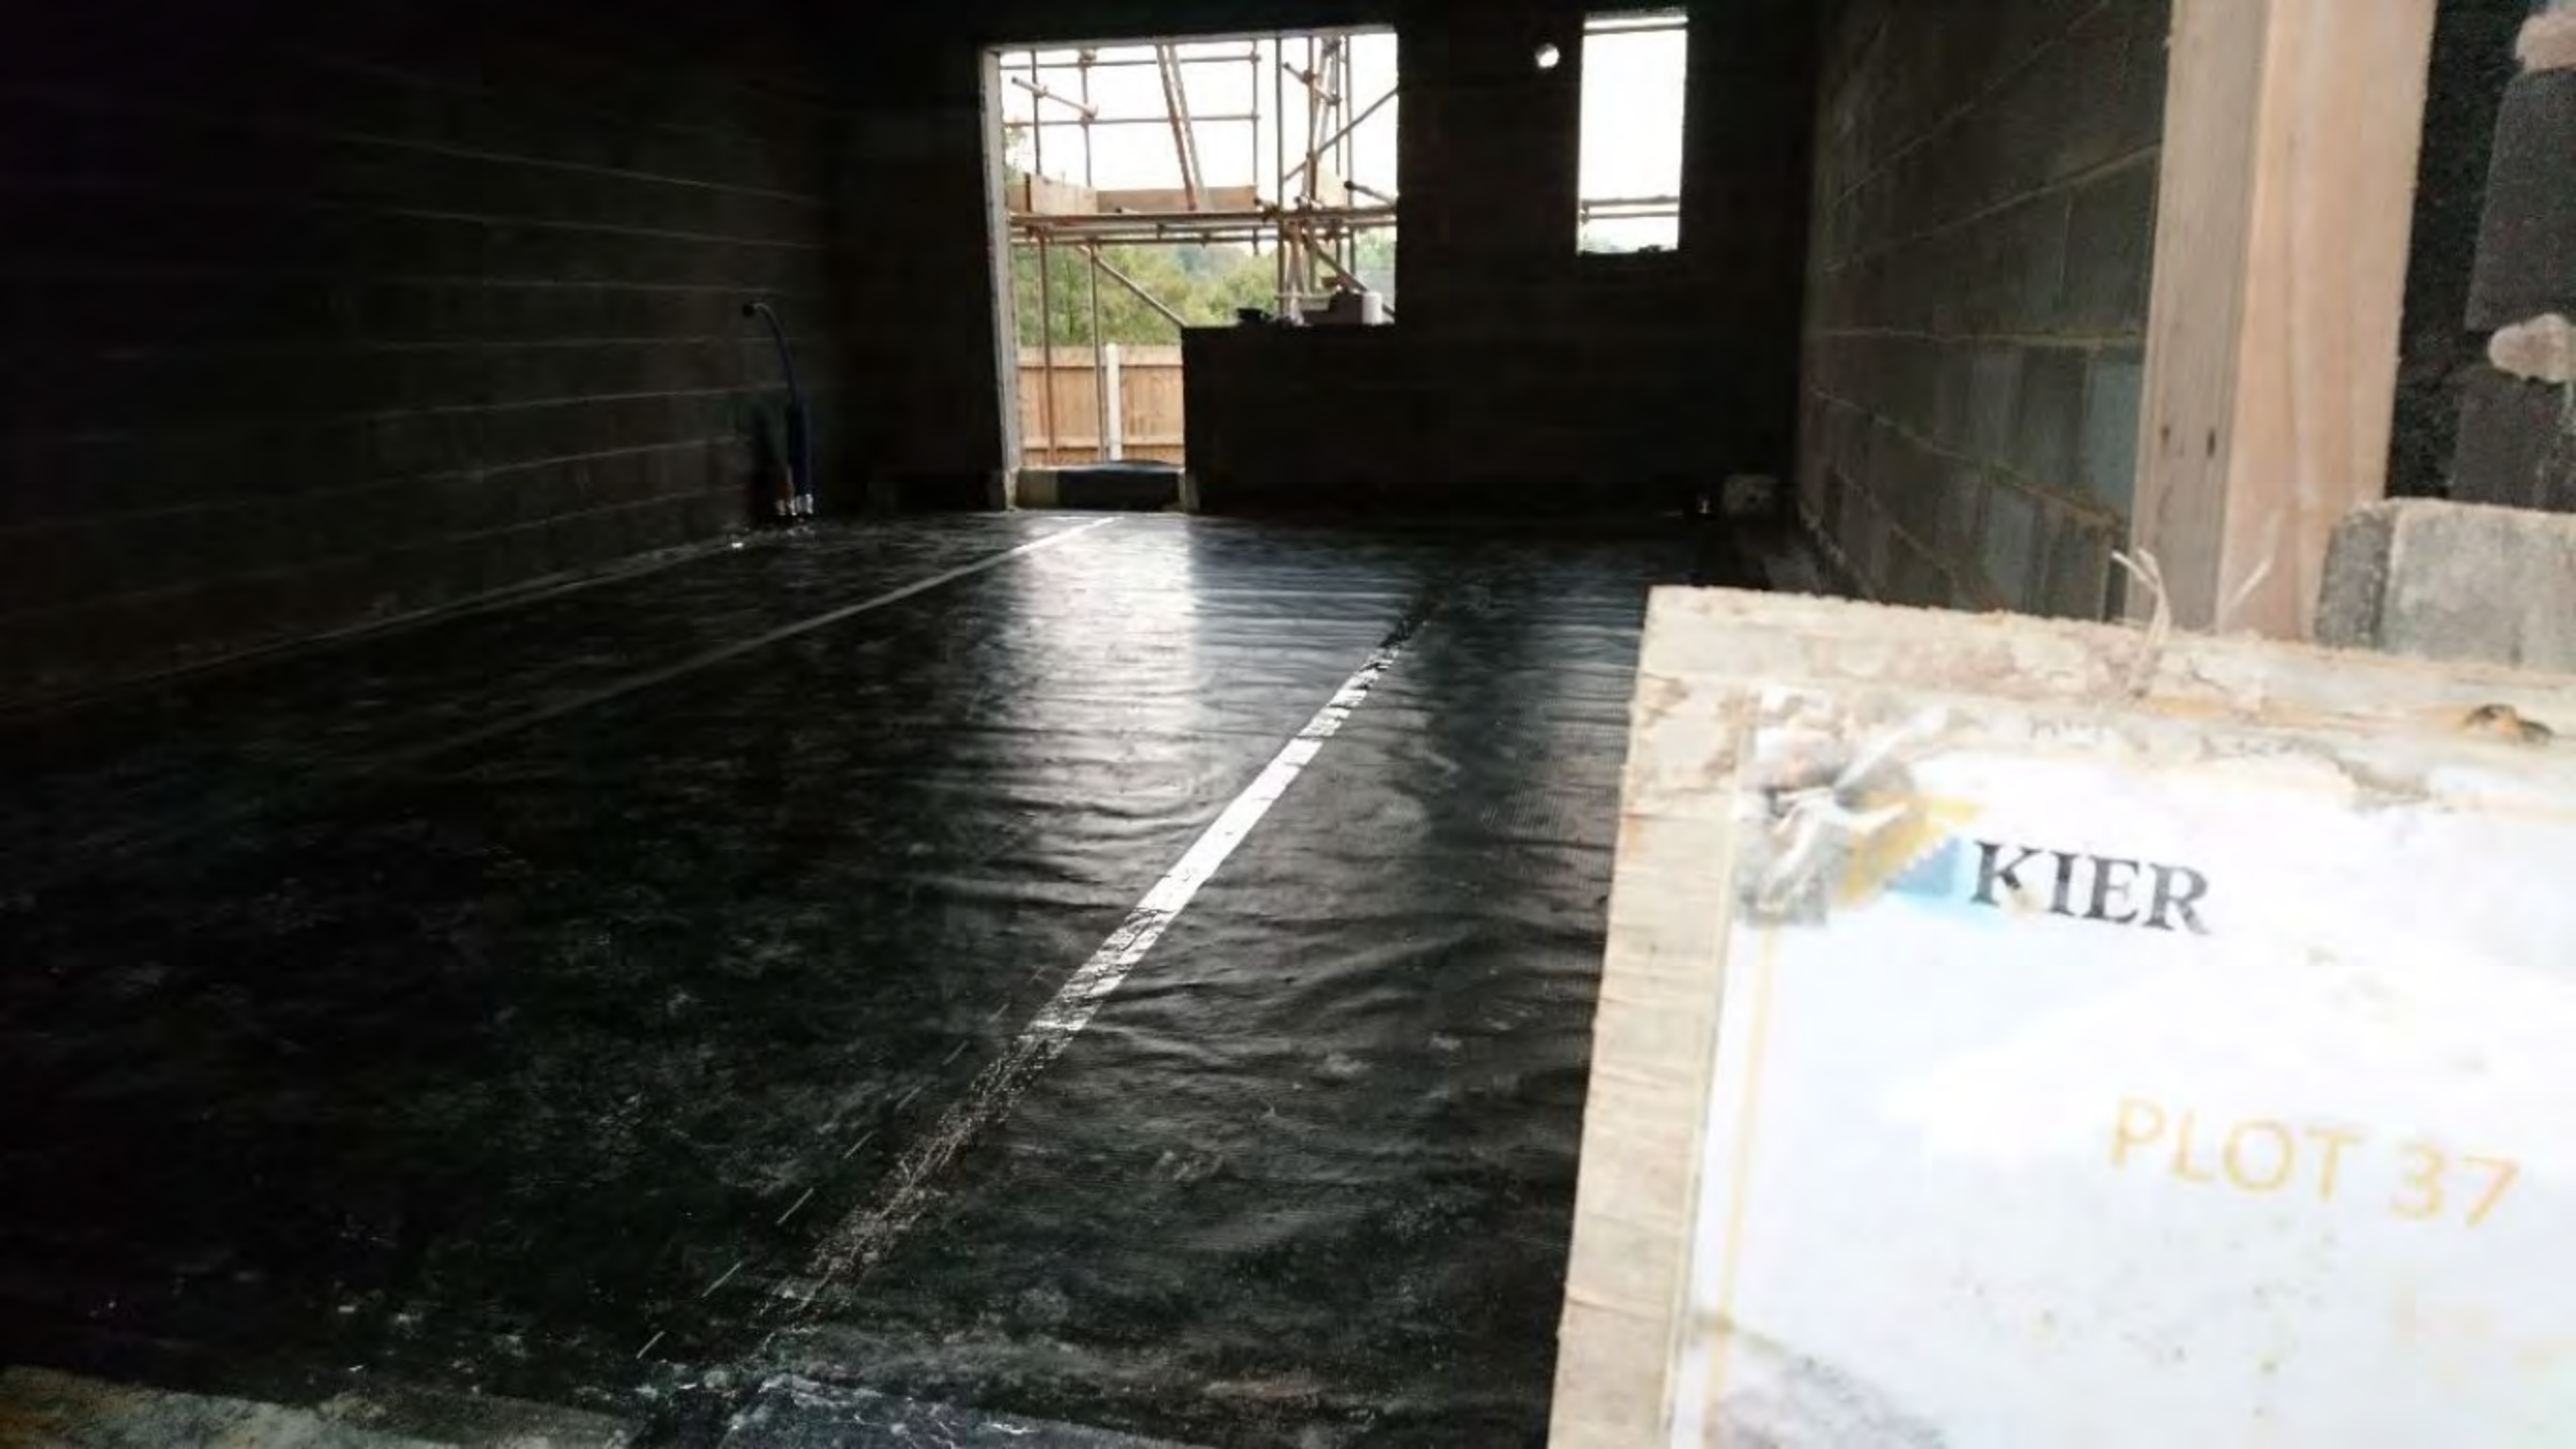
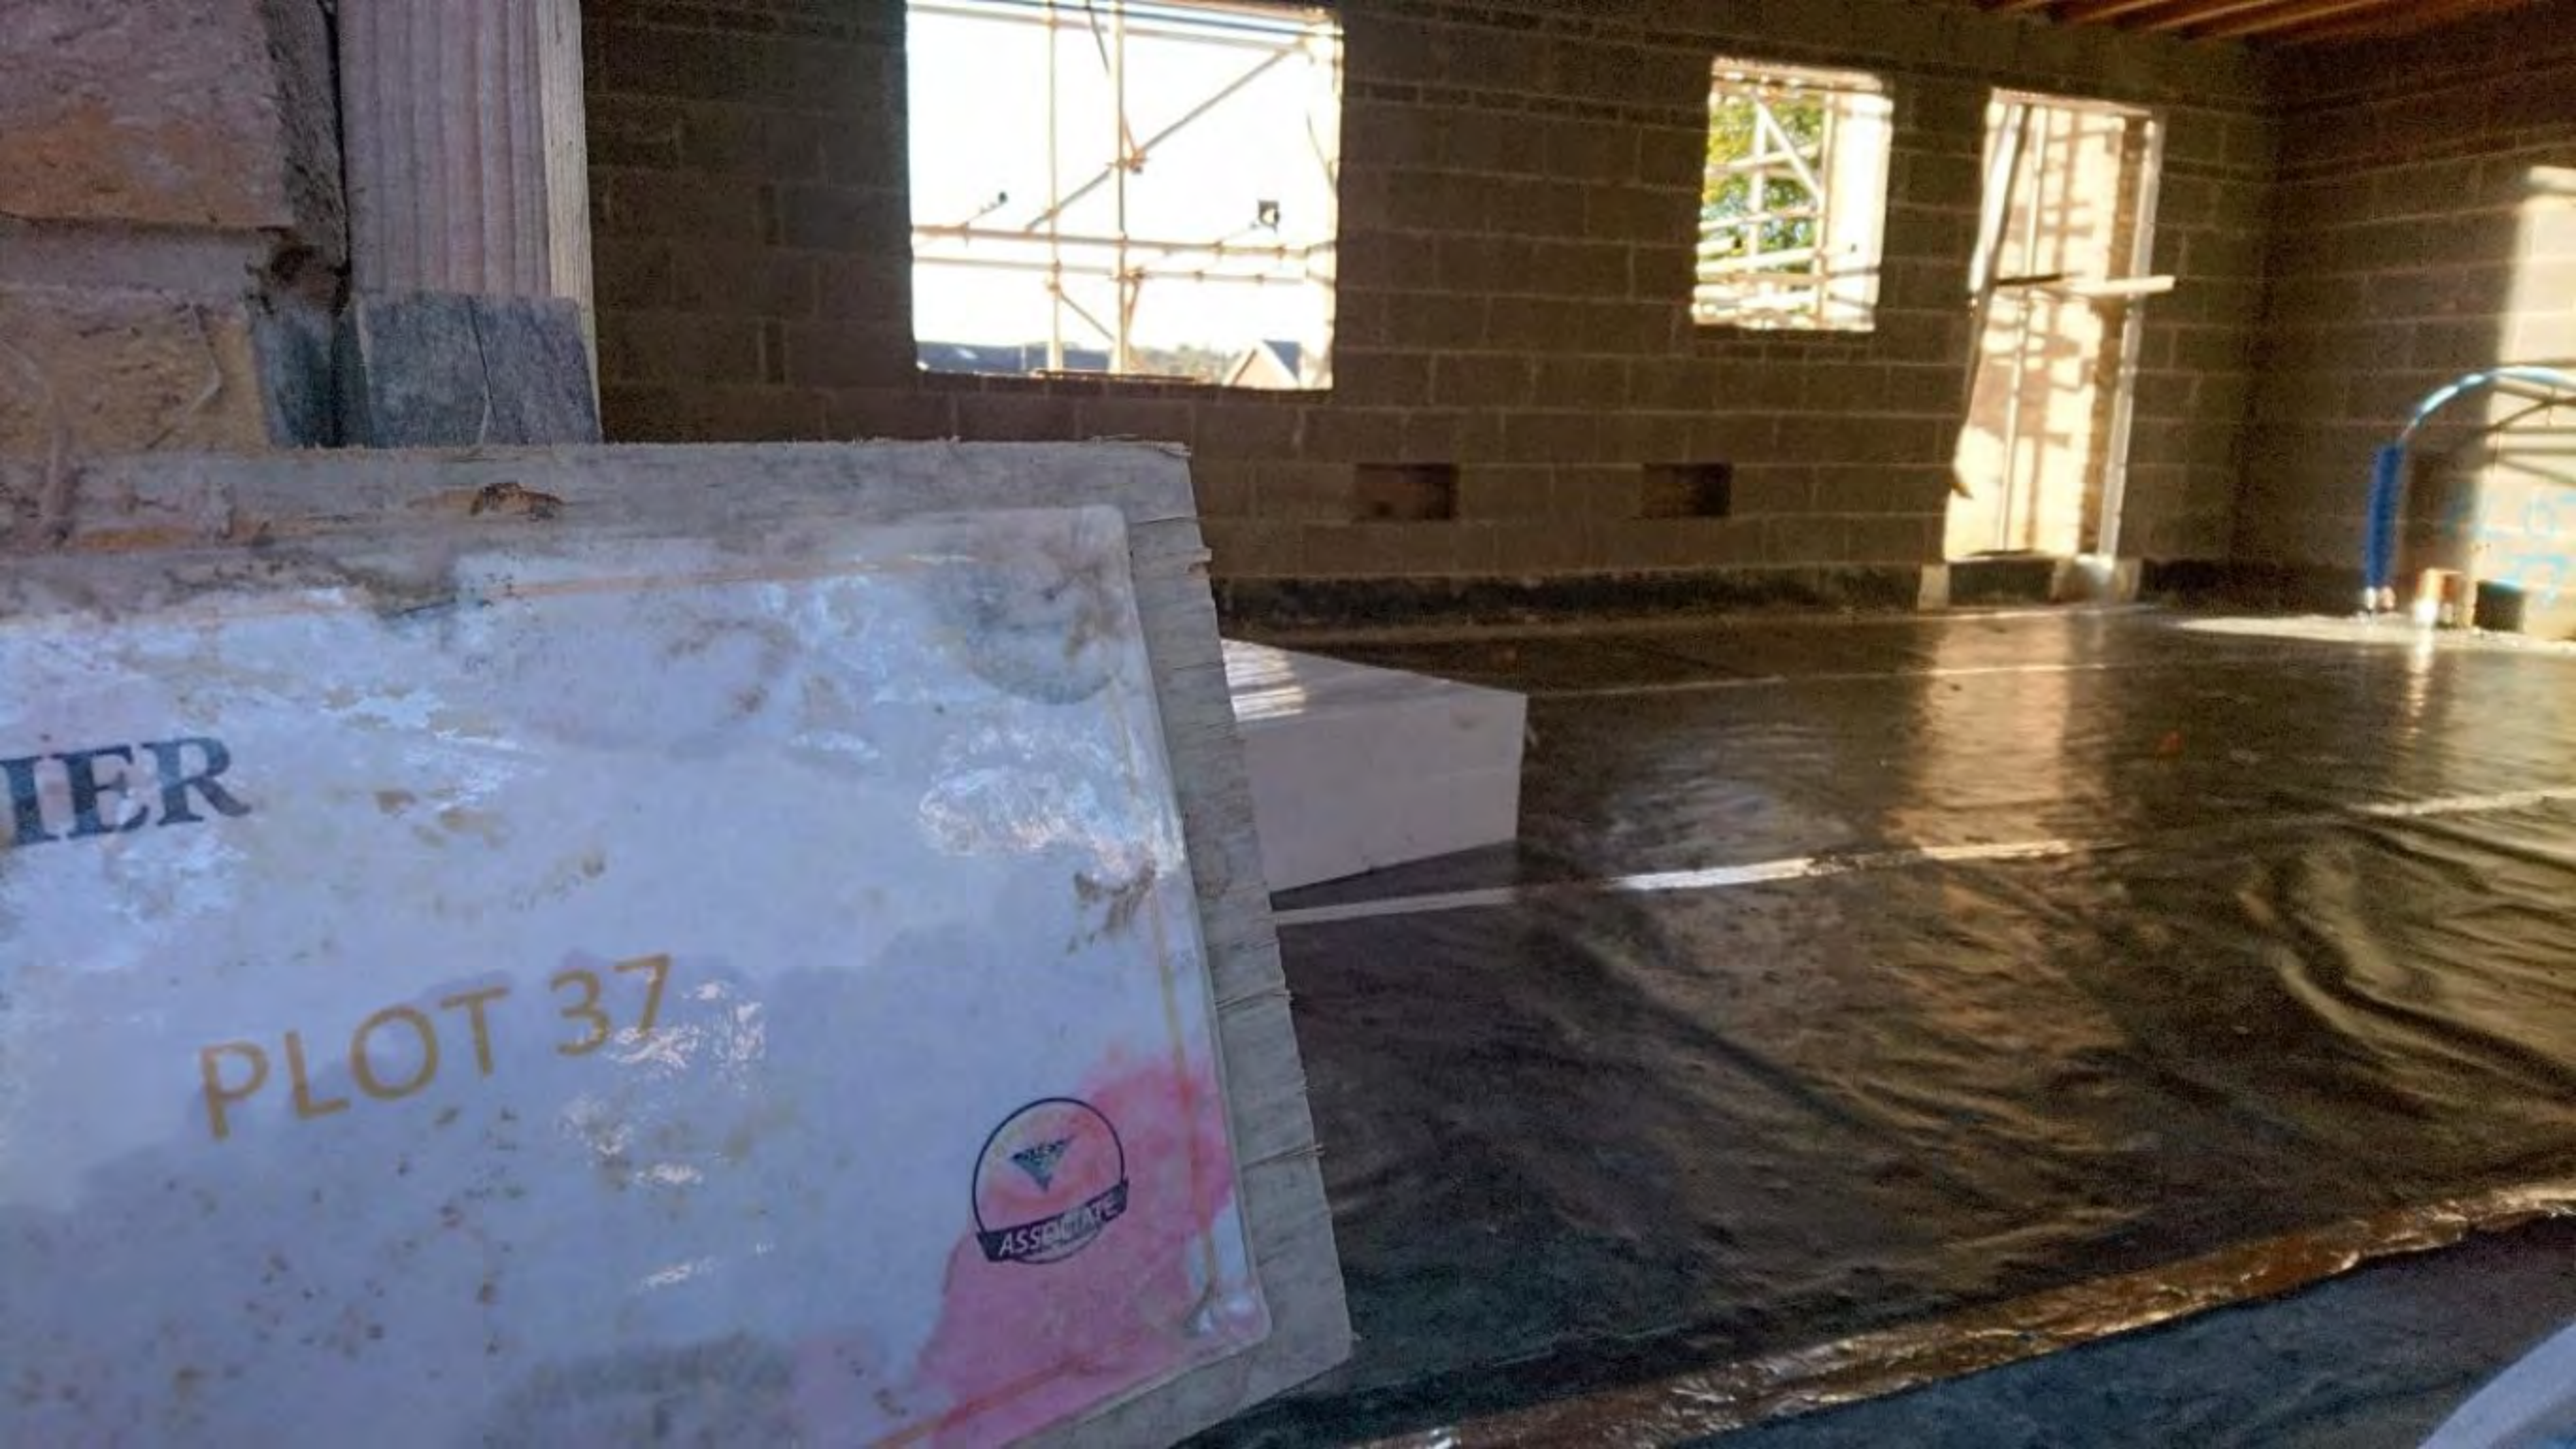
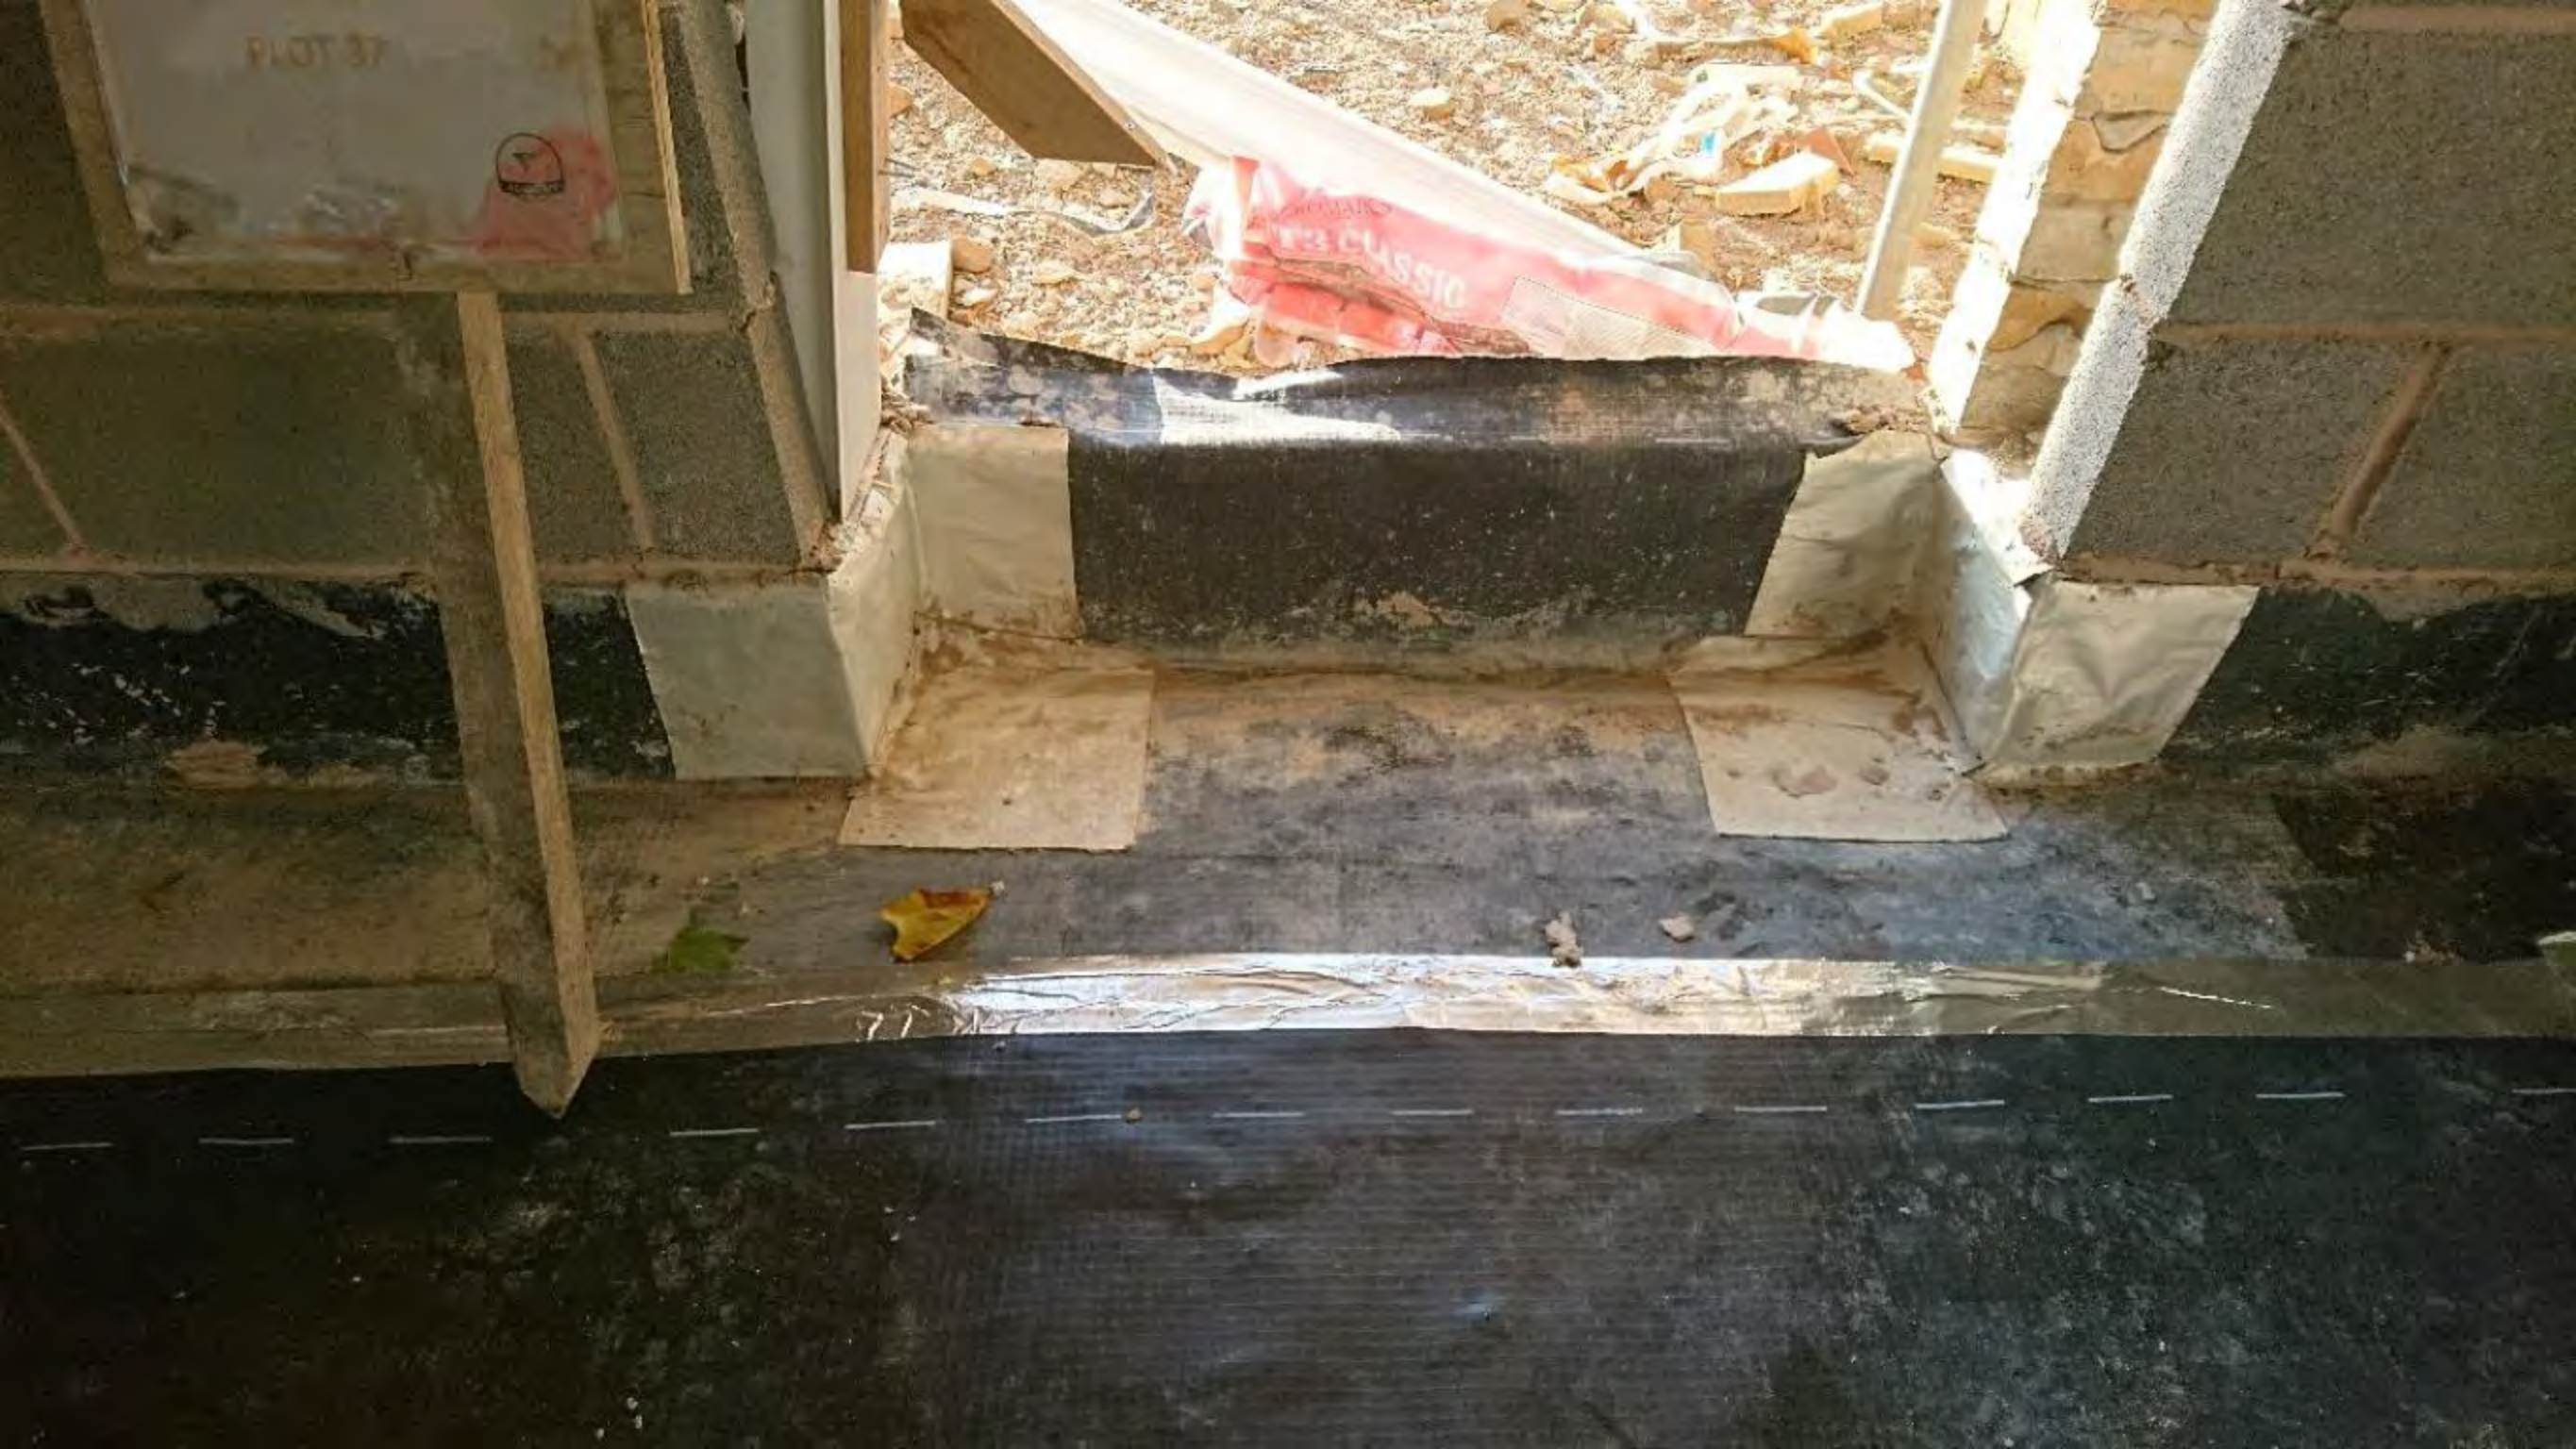
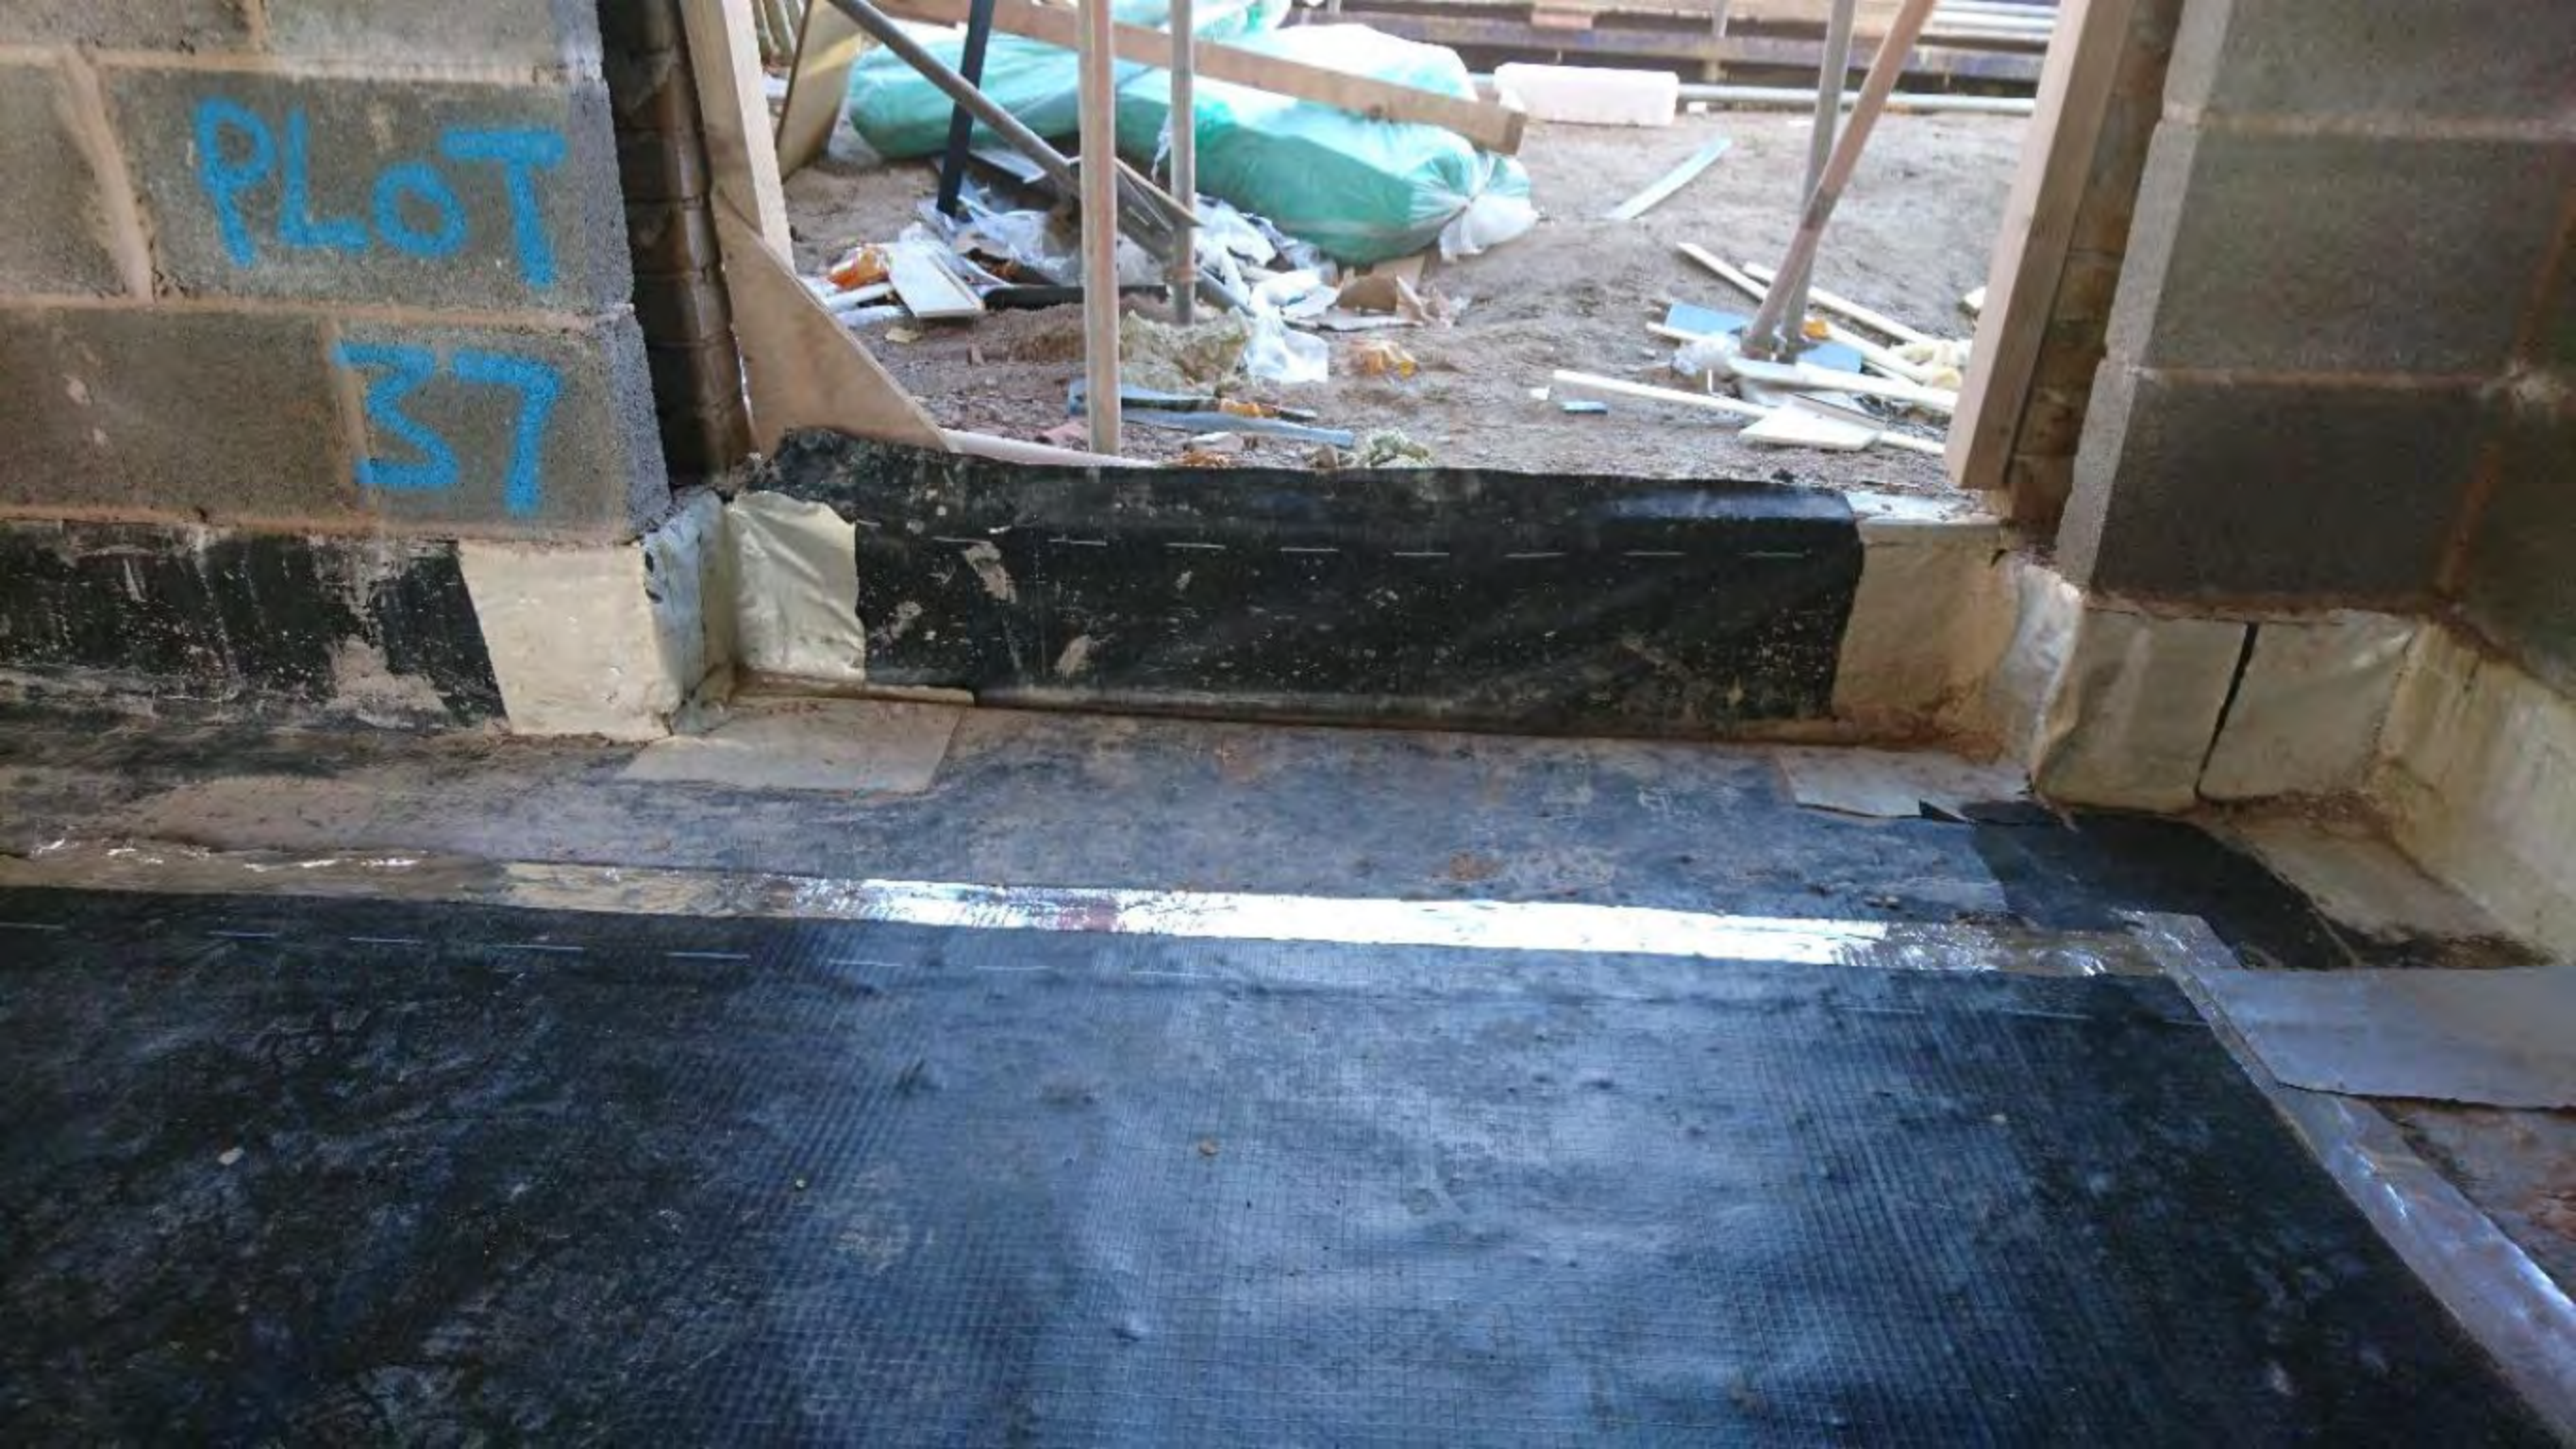
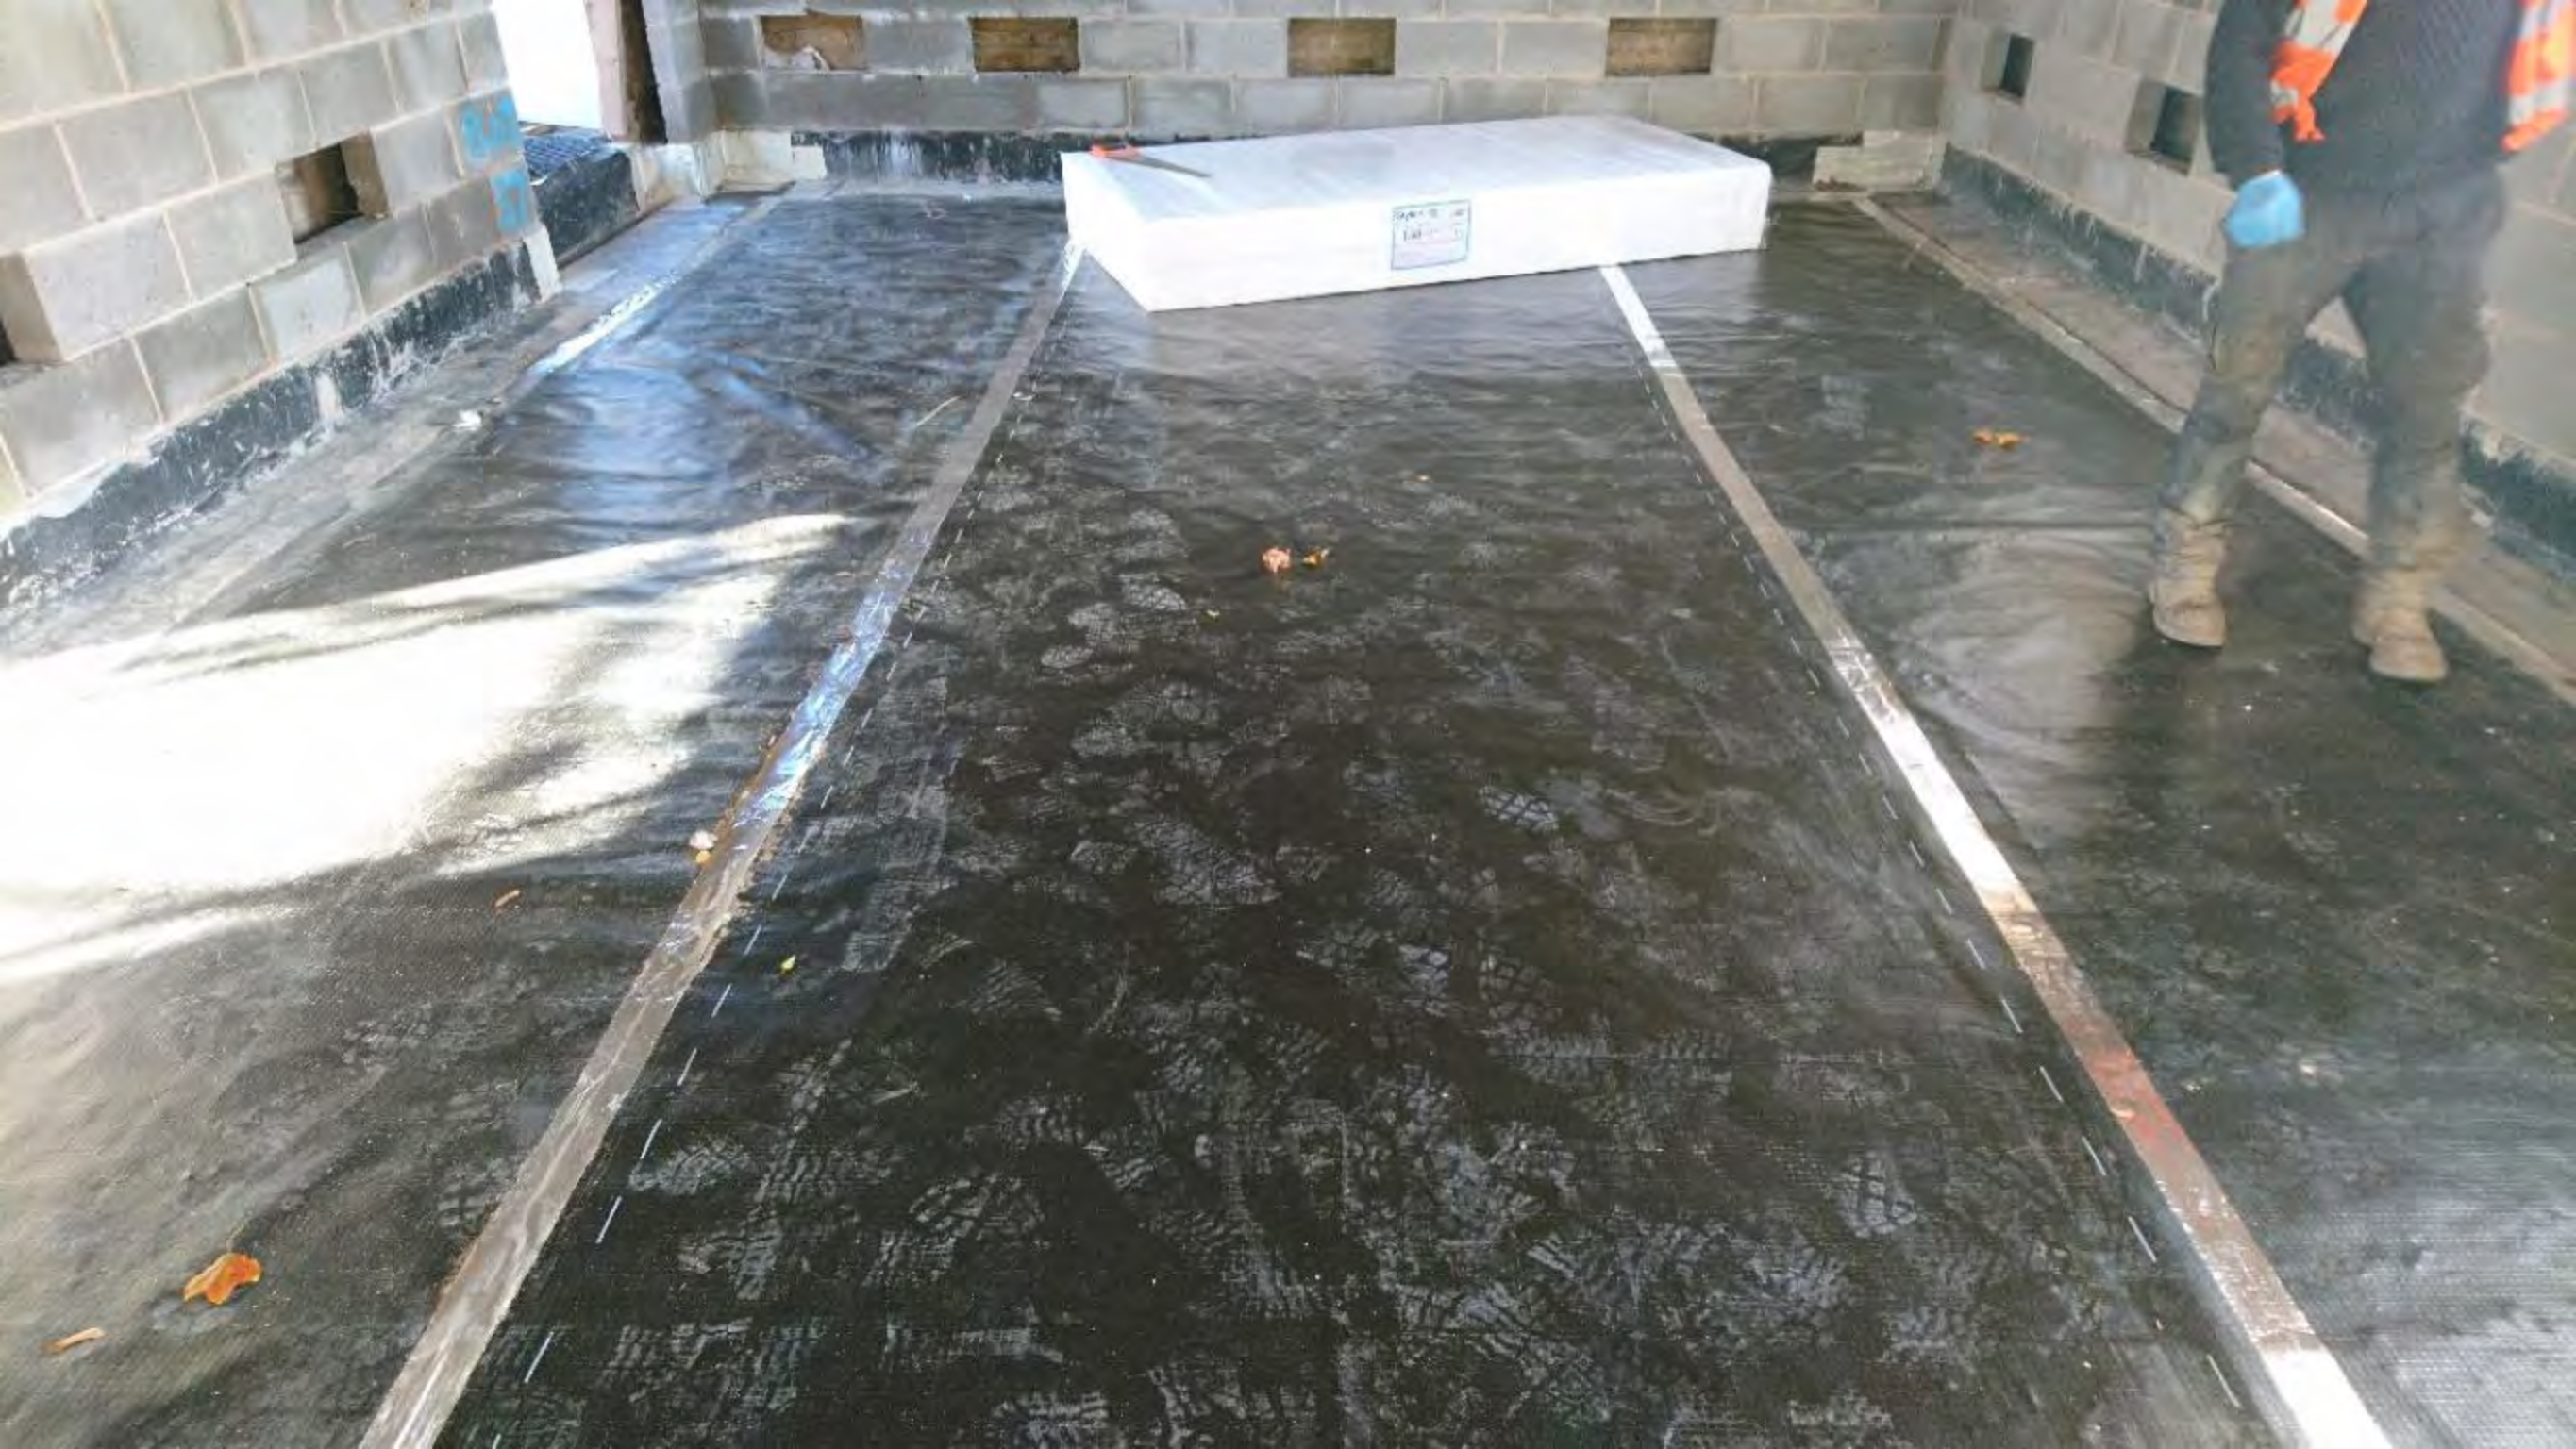
PLOT 37

| 2.2 | Condition of sub-grade & underside of gas membrane | FLOOR BRUSHED AND ALL TAPES APPLIED WELL SEALED TO A GOOD QUALITY | | | | | |
| 2.4 | Gas membrane condition and coverage | SEALED ON ALL FOUR SIDES – ALL GOOD | | | | | |
| 2.7 | Condition of joints/seals | VISIBLE OVERLAPS, ALL GOOD | | | | | |
| 2.8 | Number and condition of service entry seals | 3 NO TOPHATS FITTED WITH JUBILEE CLIPS, TAPES CHECKED, ALL OK | | | | | |
| 2.10 | Repairs or Corrections: | 1 NO REPAIR BY FRONT DOOR. USED 300mm WIDE RADBAR SIA DETAIL STRIP x 20m | | | | | |
