## Gas Protection - Validation Record Sheet

**This Record sheet is only applicable to block and beam floor slabs for Characteristic Situation 2 gas protection systems**

Plot 29, Block 10

**For Residential Development at New Church Street, Radcliffe.**

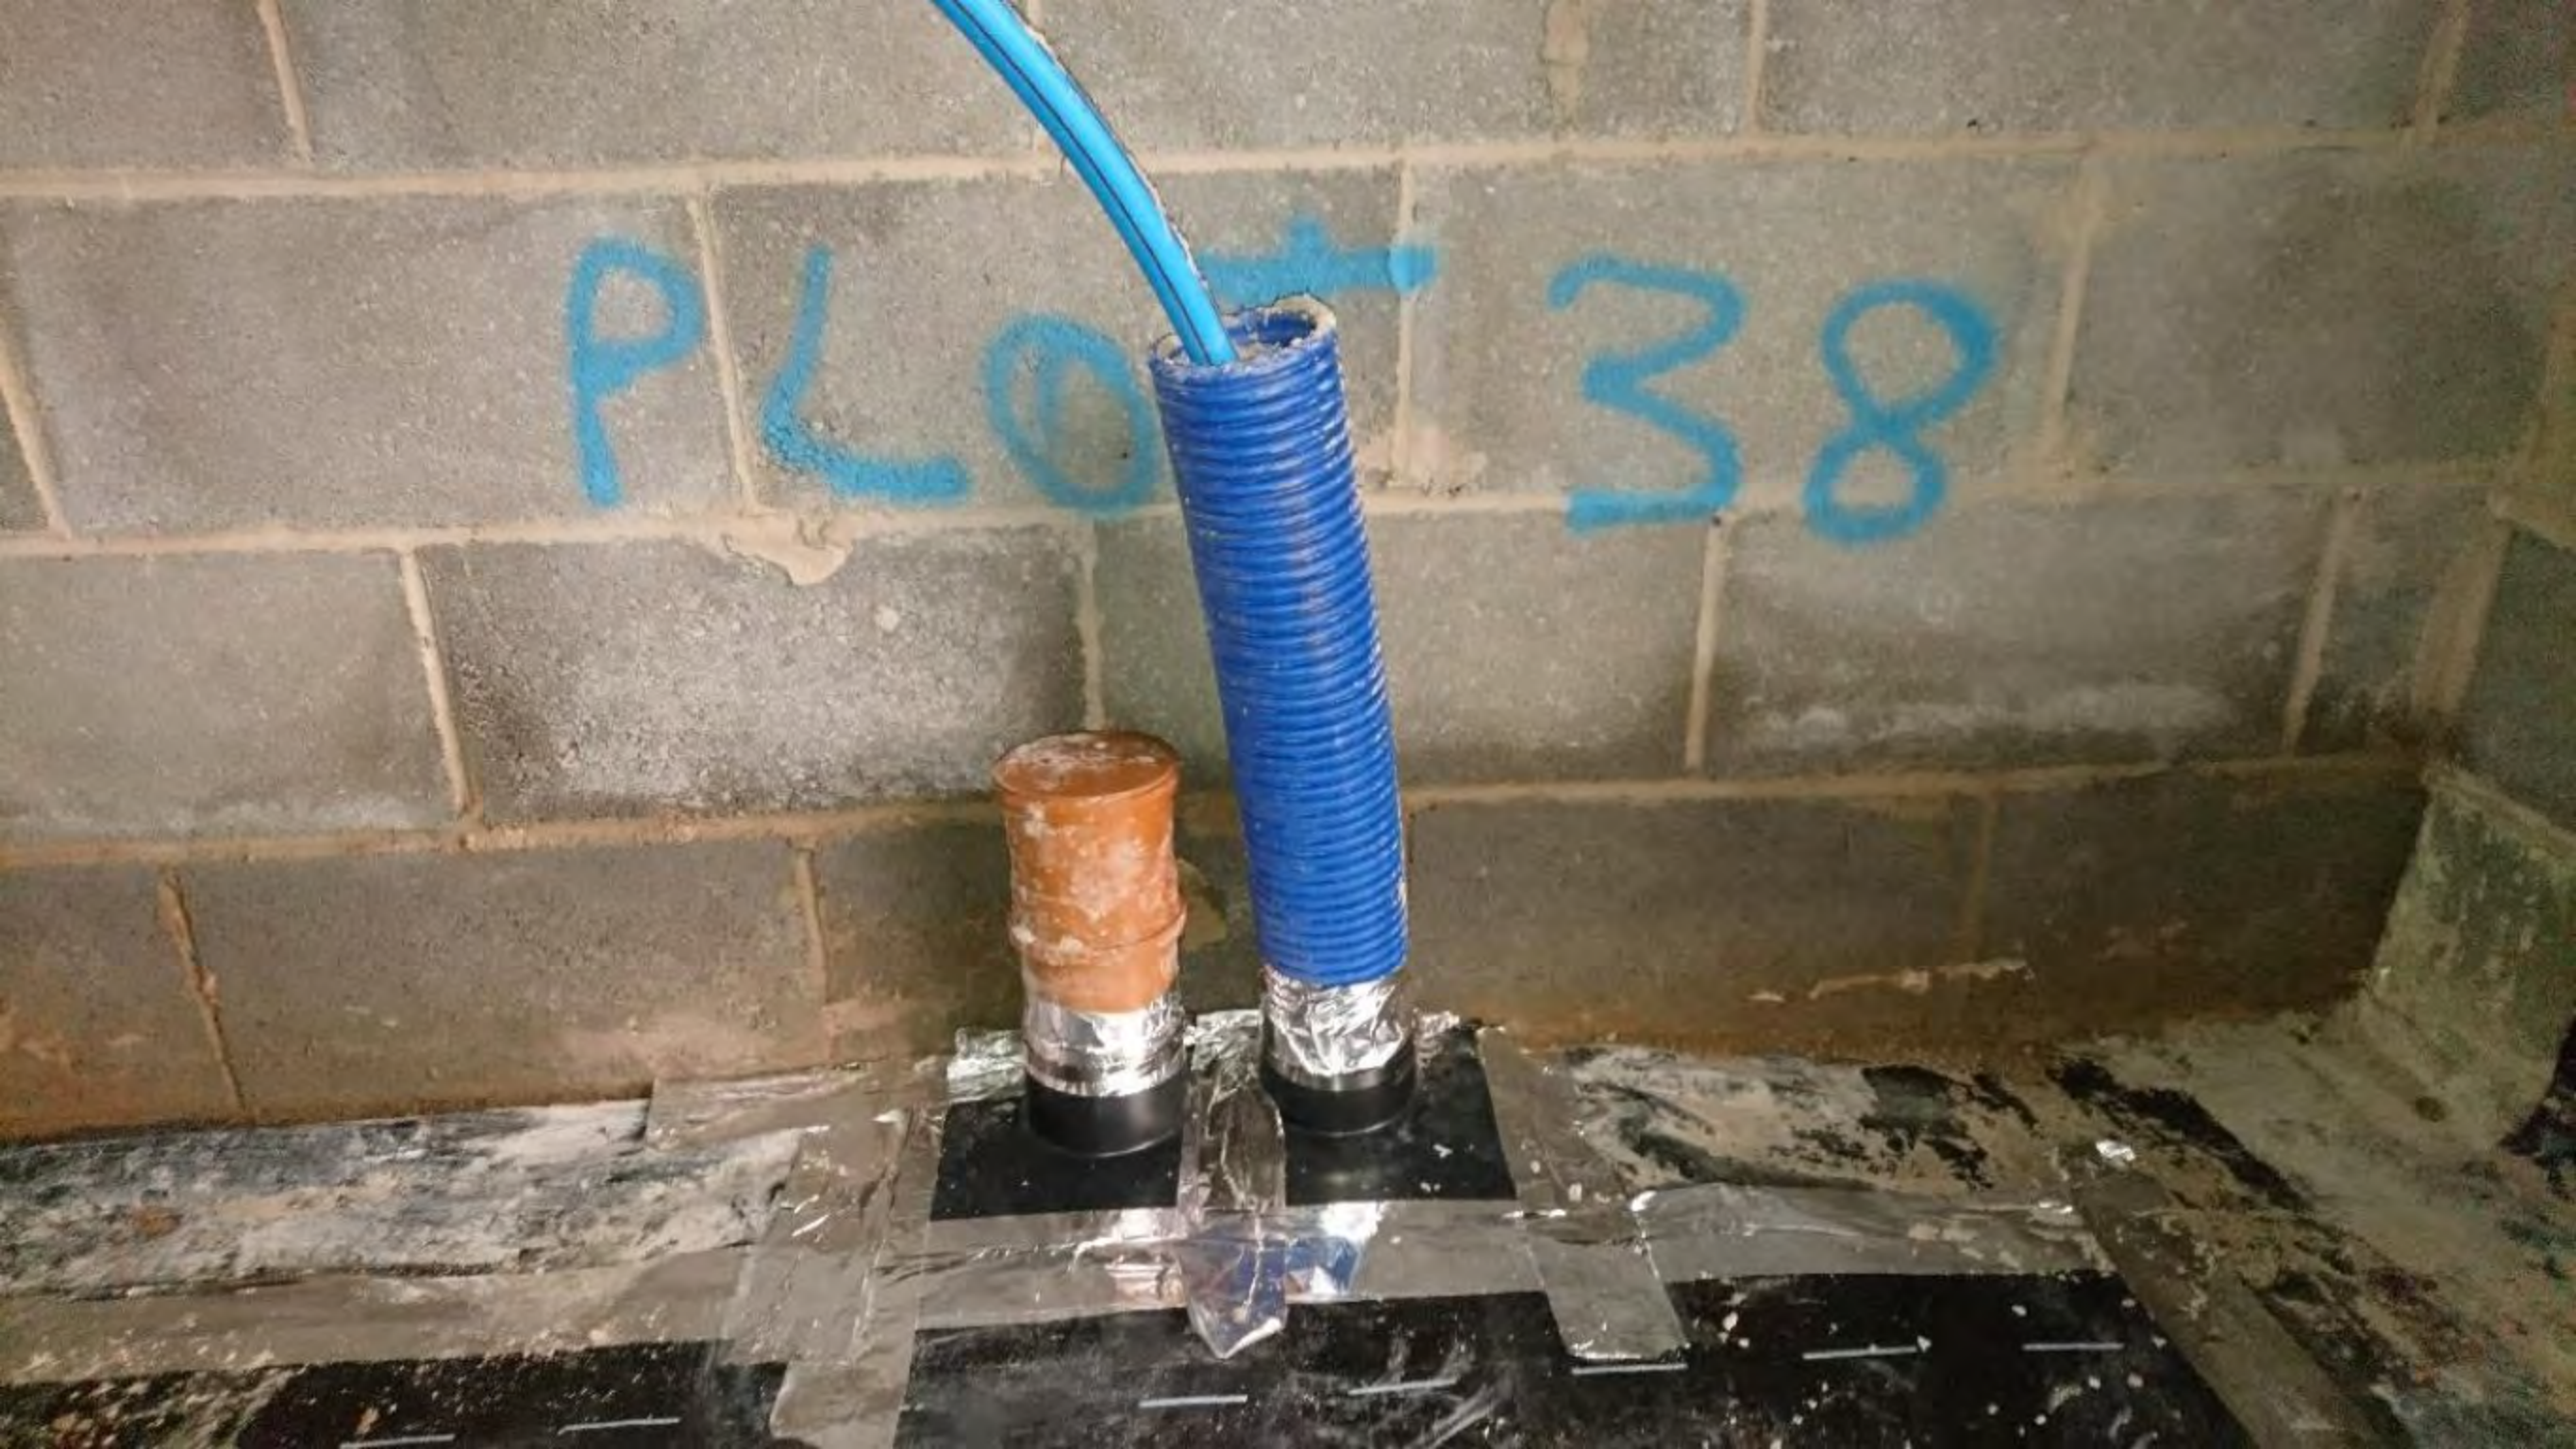
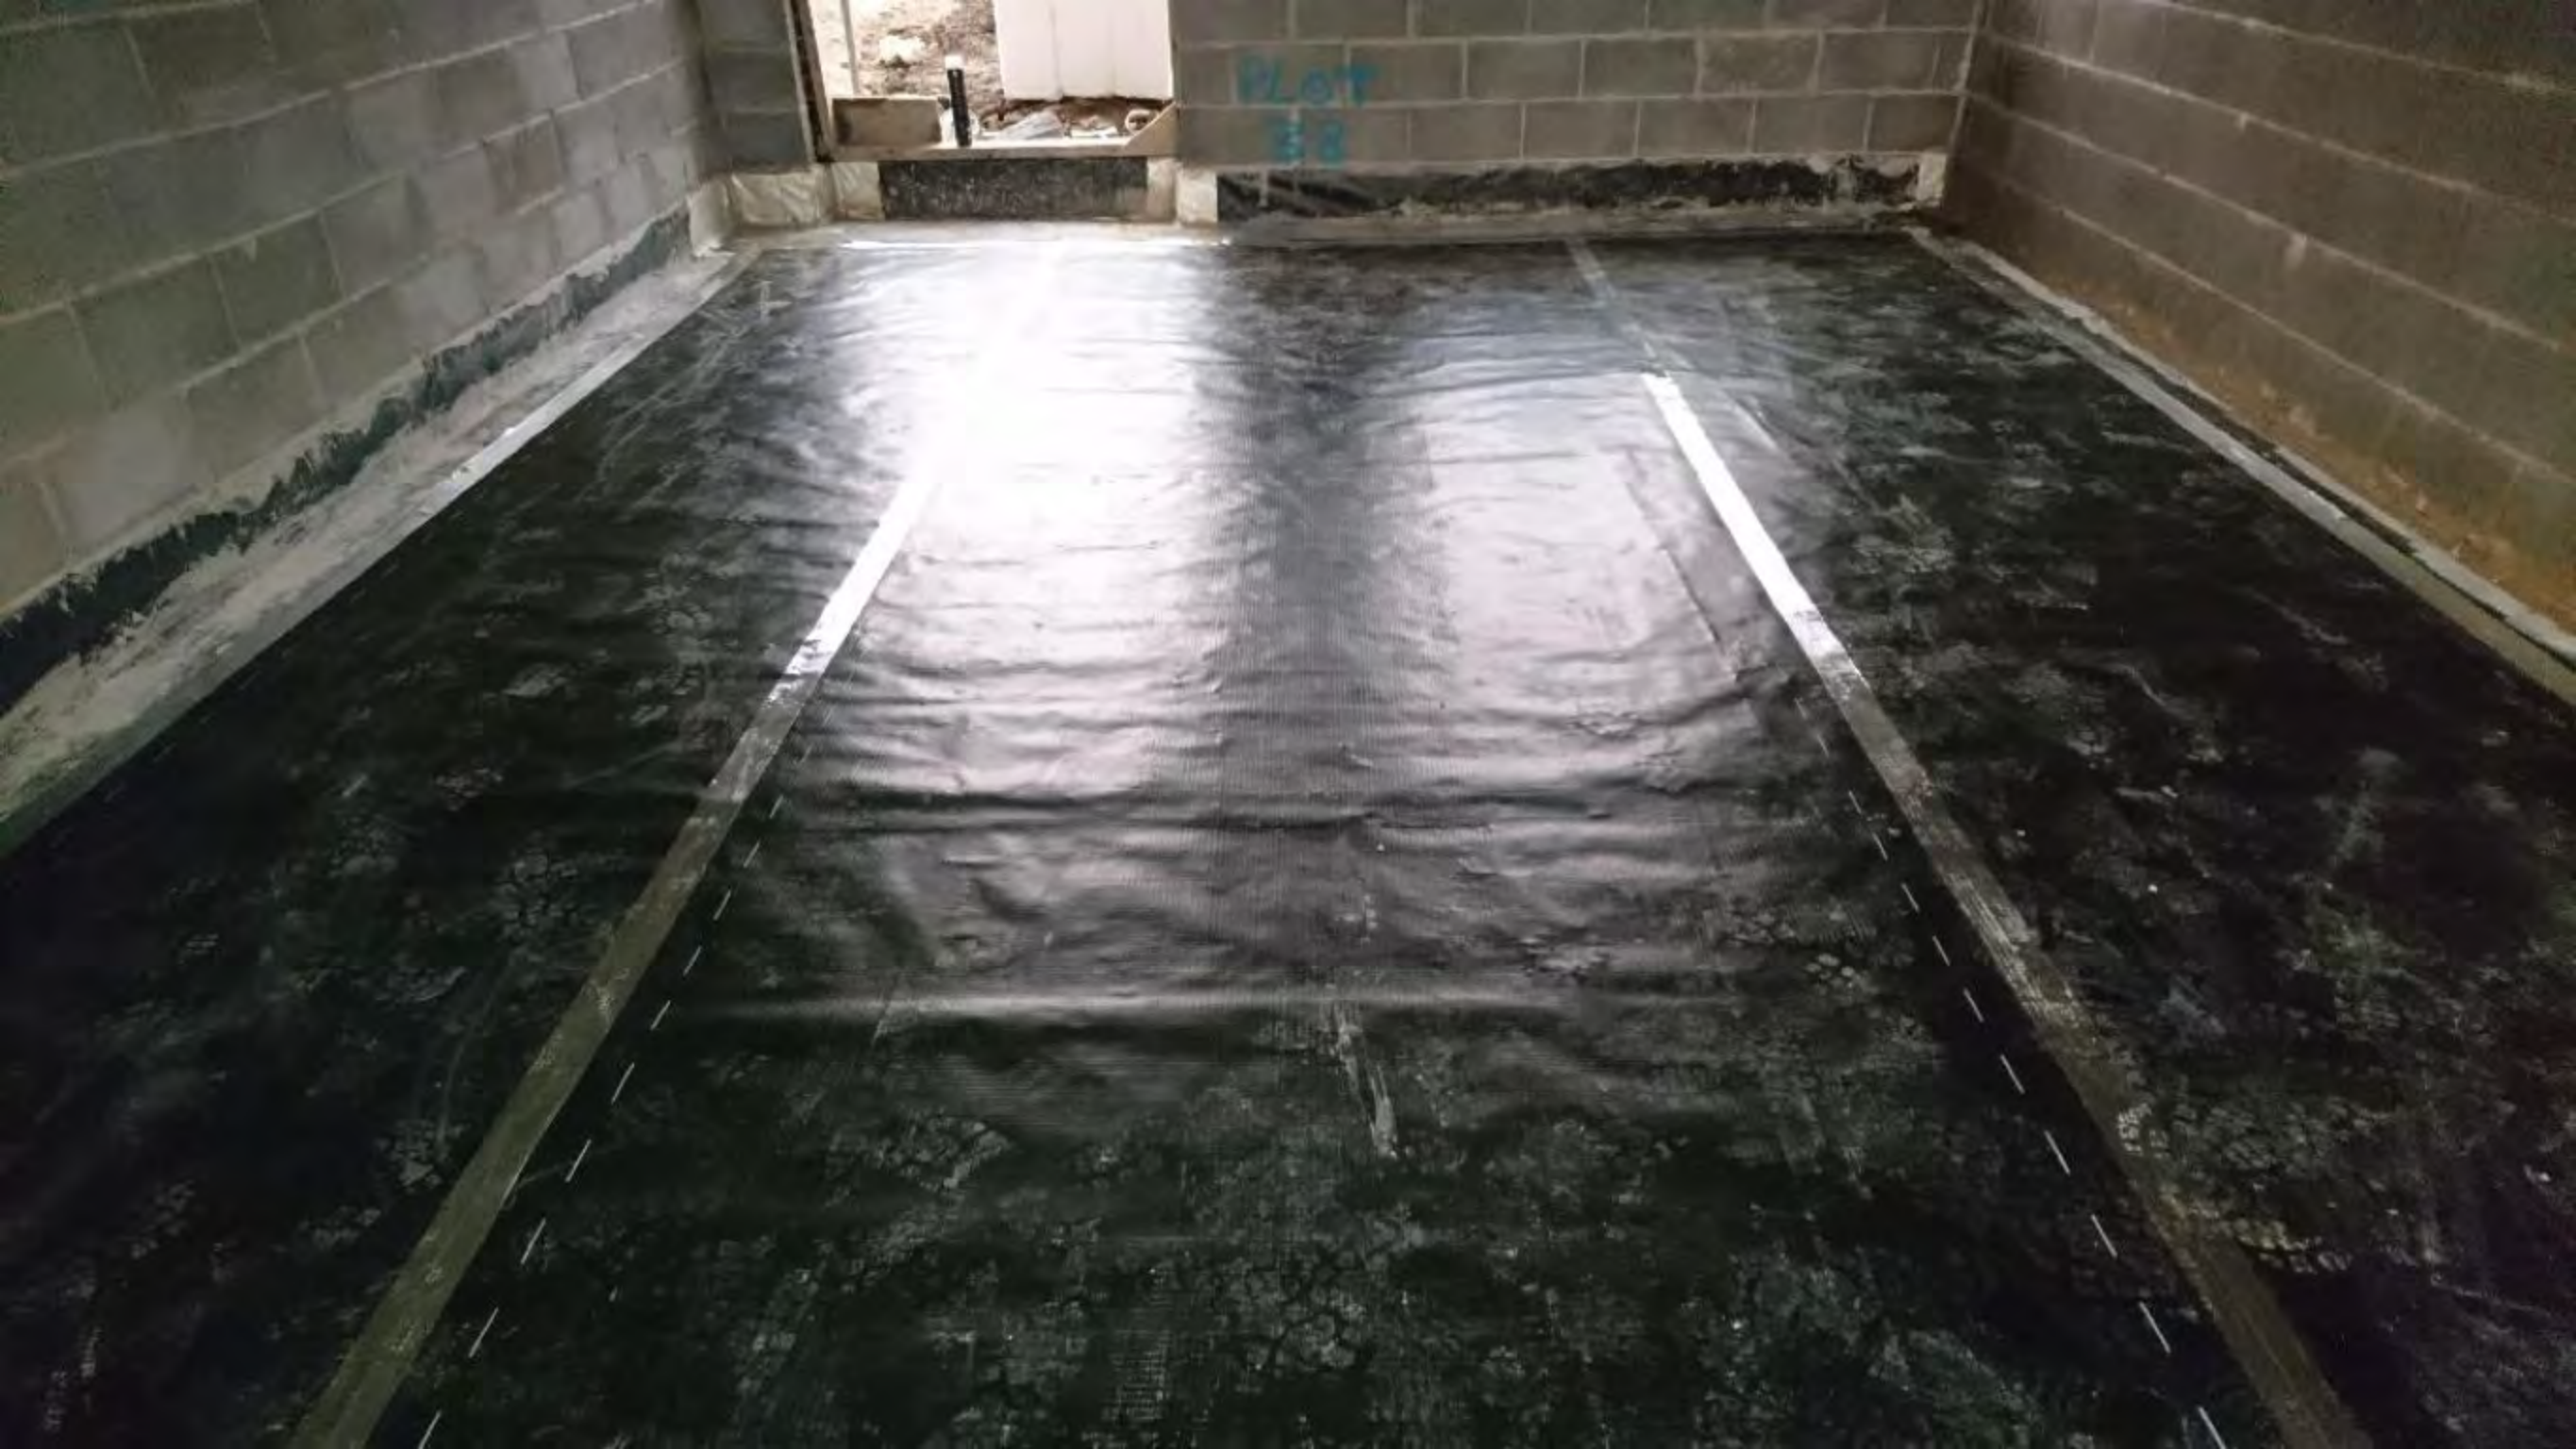
PLOT  
38

| 2.2 | Condition of sub-grade & underside of gas membrane | SEALED TO A GOOD QUALITY, TAPES APPLIED WELL. FLOOR SWEEP CLEAN | | | | | |
| 2.4 | Gas membrane condition and coverage | ALL OK, SEALED ON ALL FOUR SIDES | | | | | |
| 2.7 | Condition of joints/seals | ALL GOOD, VISIBLE OVERLAPS | | | | | |
| 2.8 | Number and condition of service entry seals | 3 NO TOPHATS WITH SUBILEE CLIPS - ALL TAPED UP TO A GOOD STANDARD | | | | | |

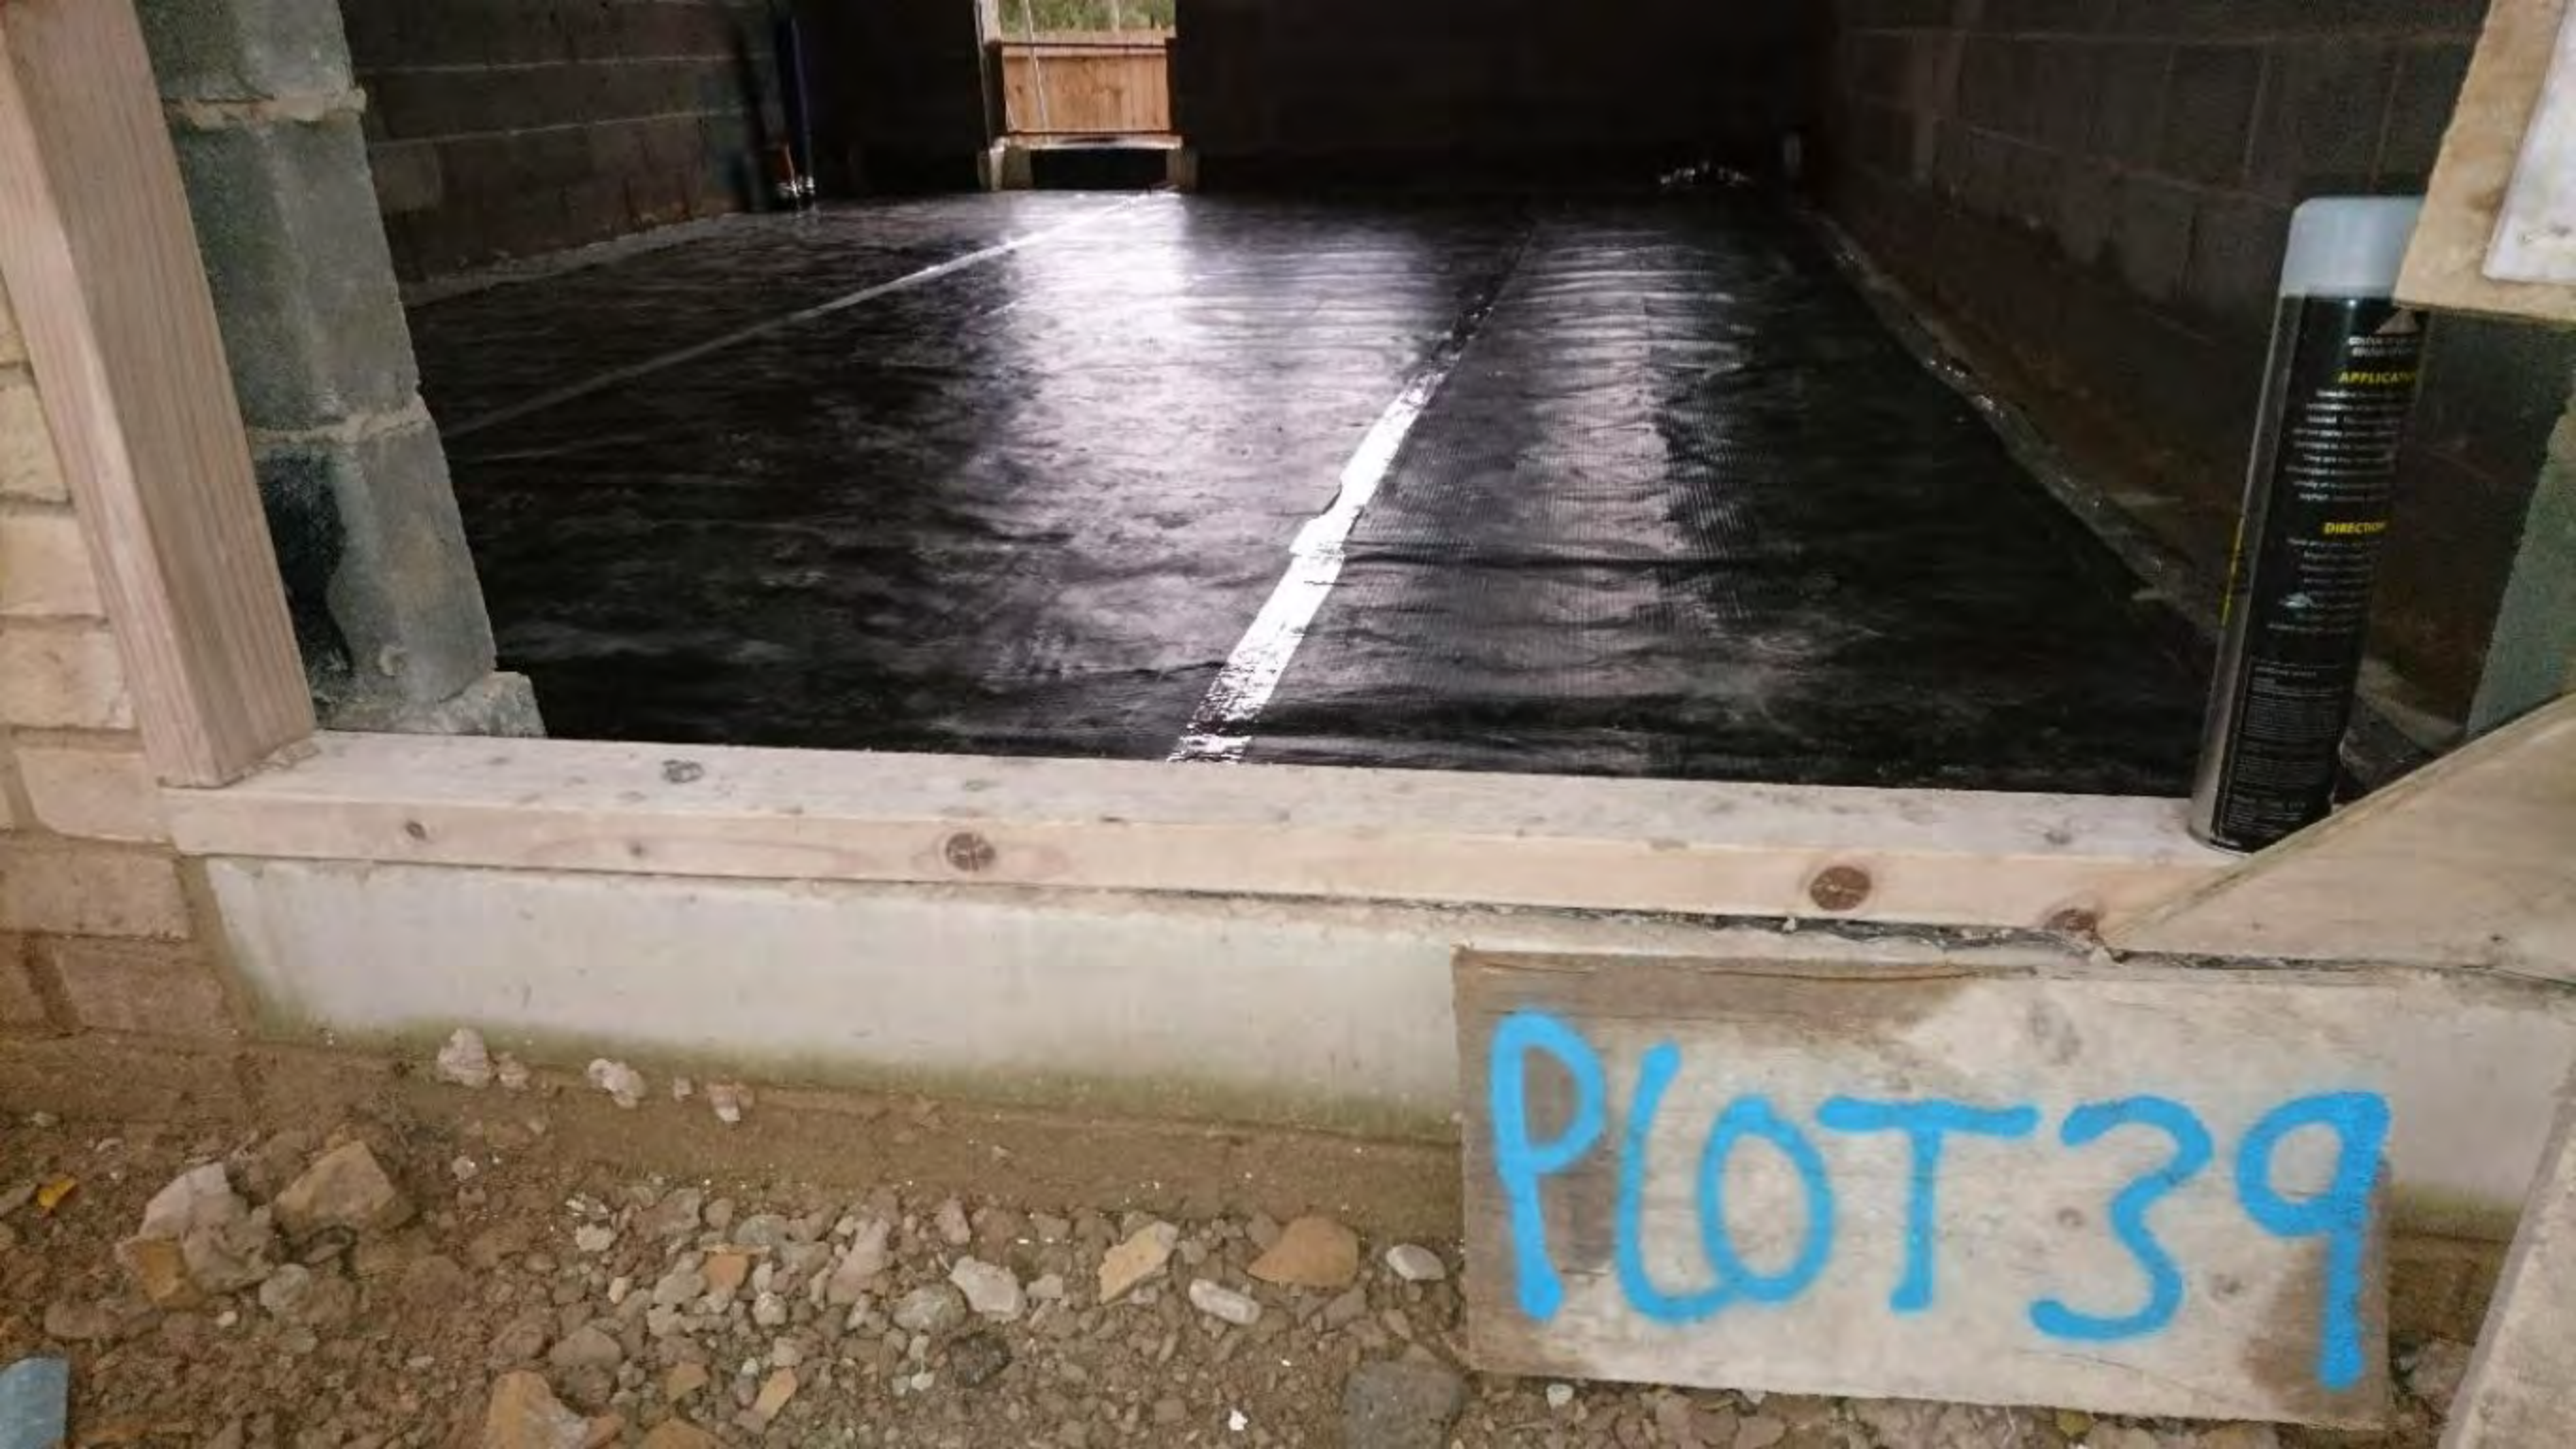
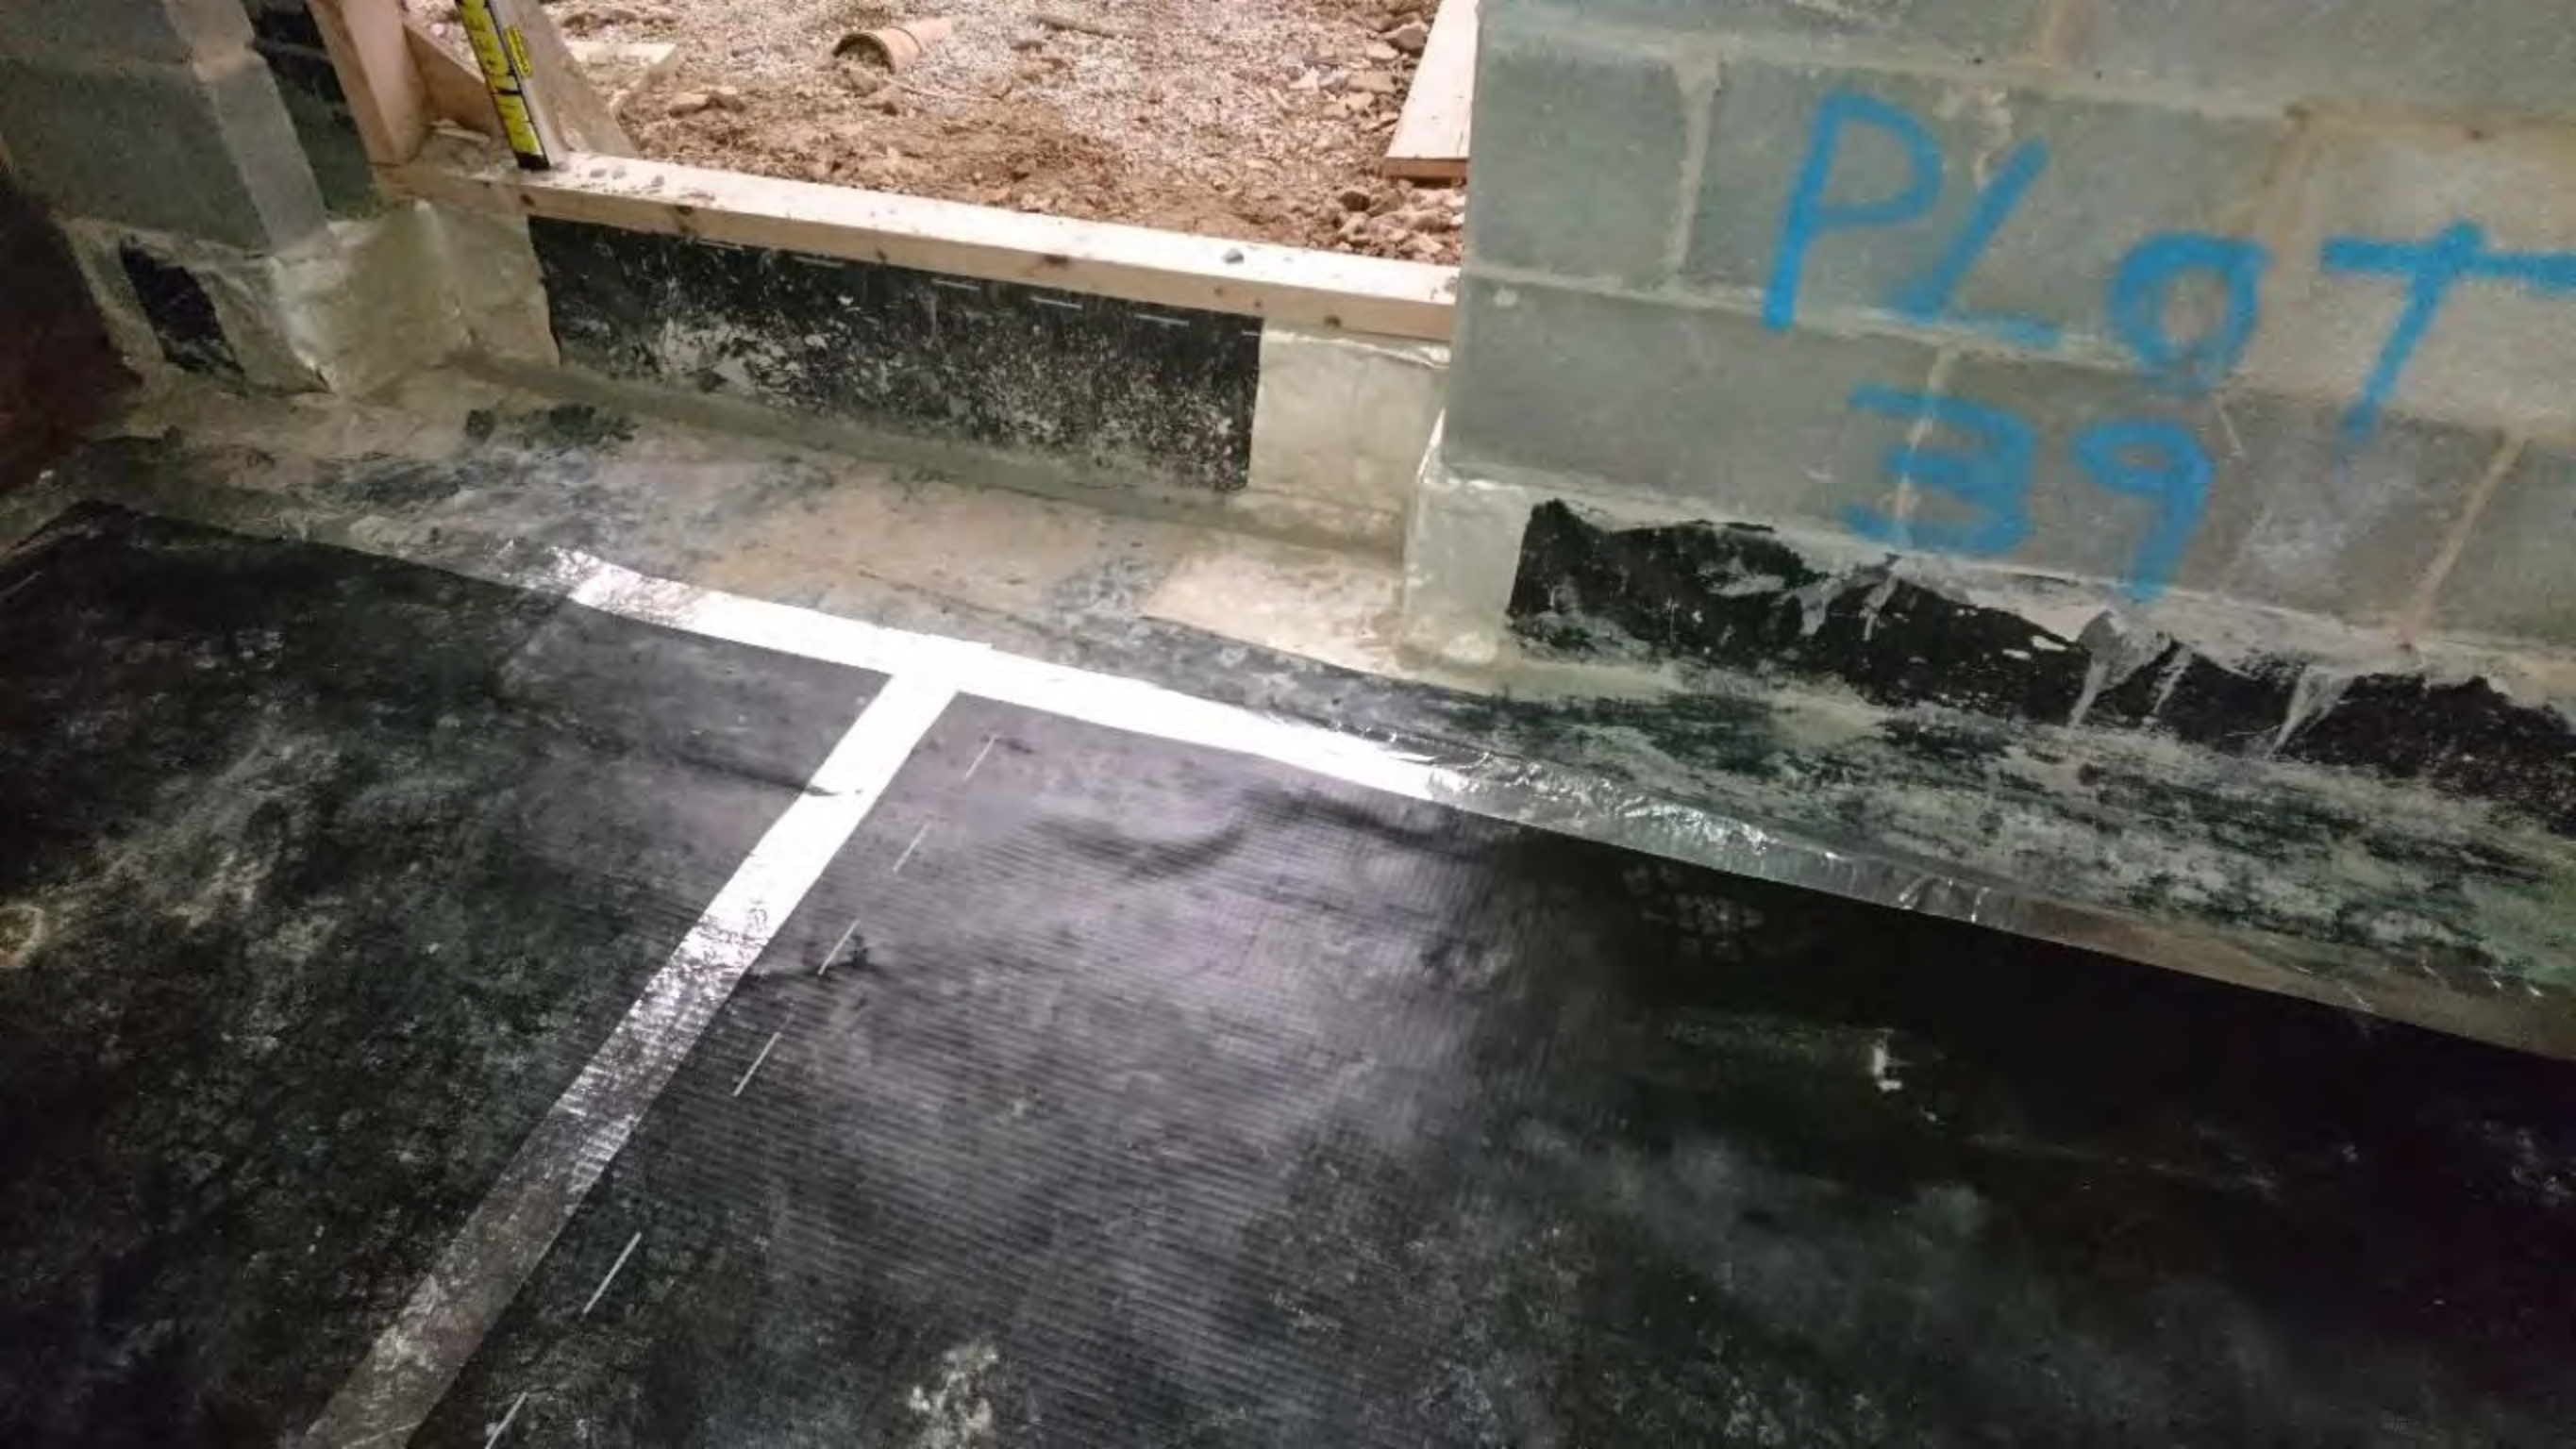
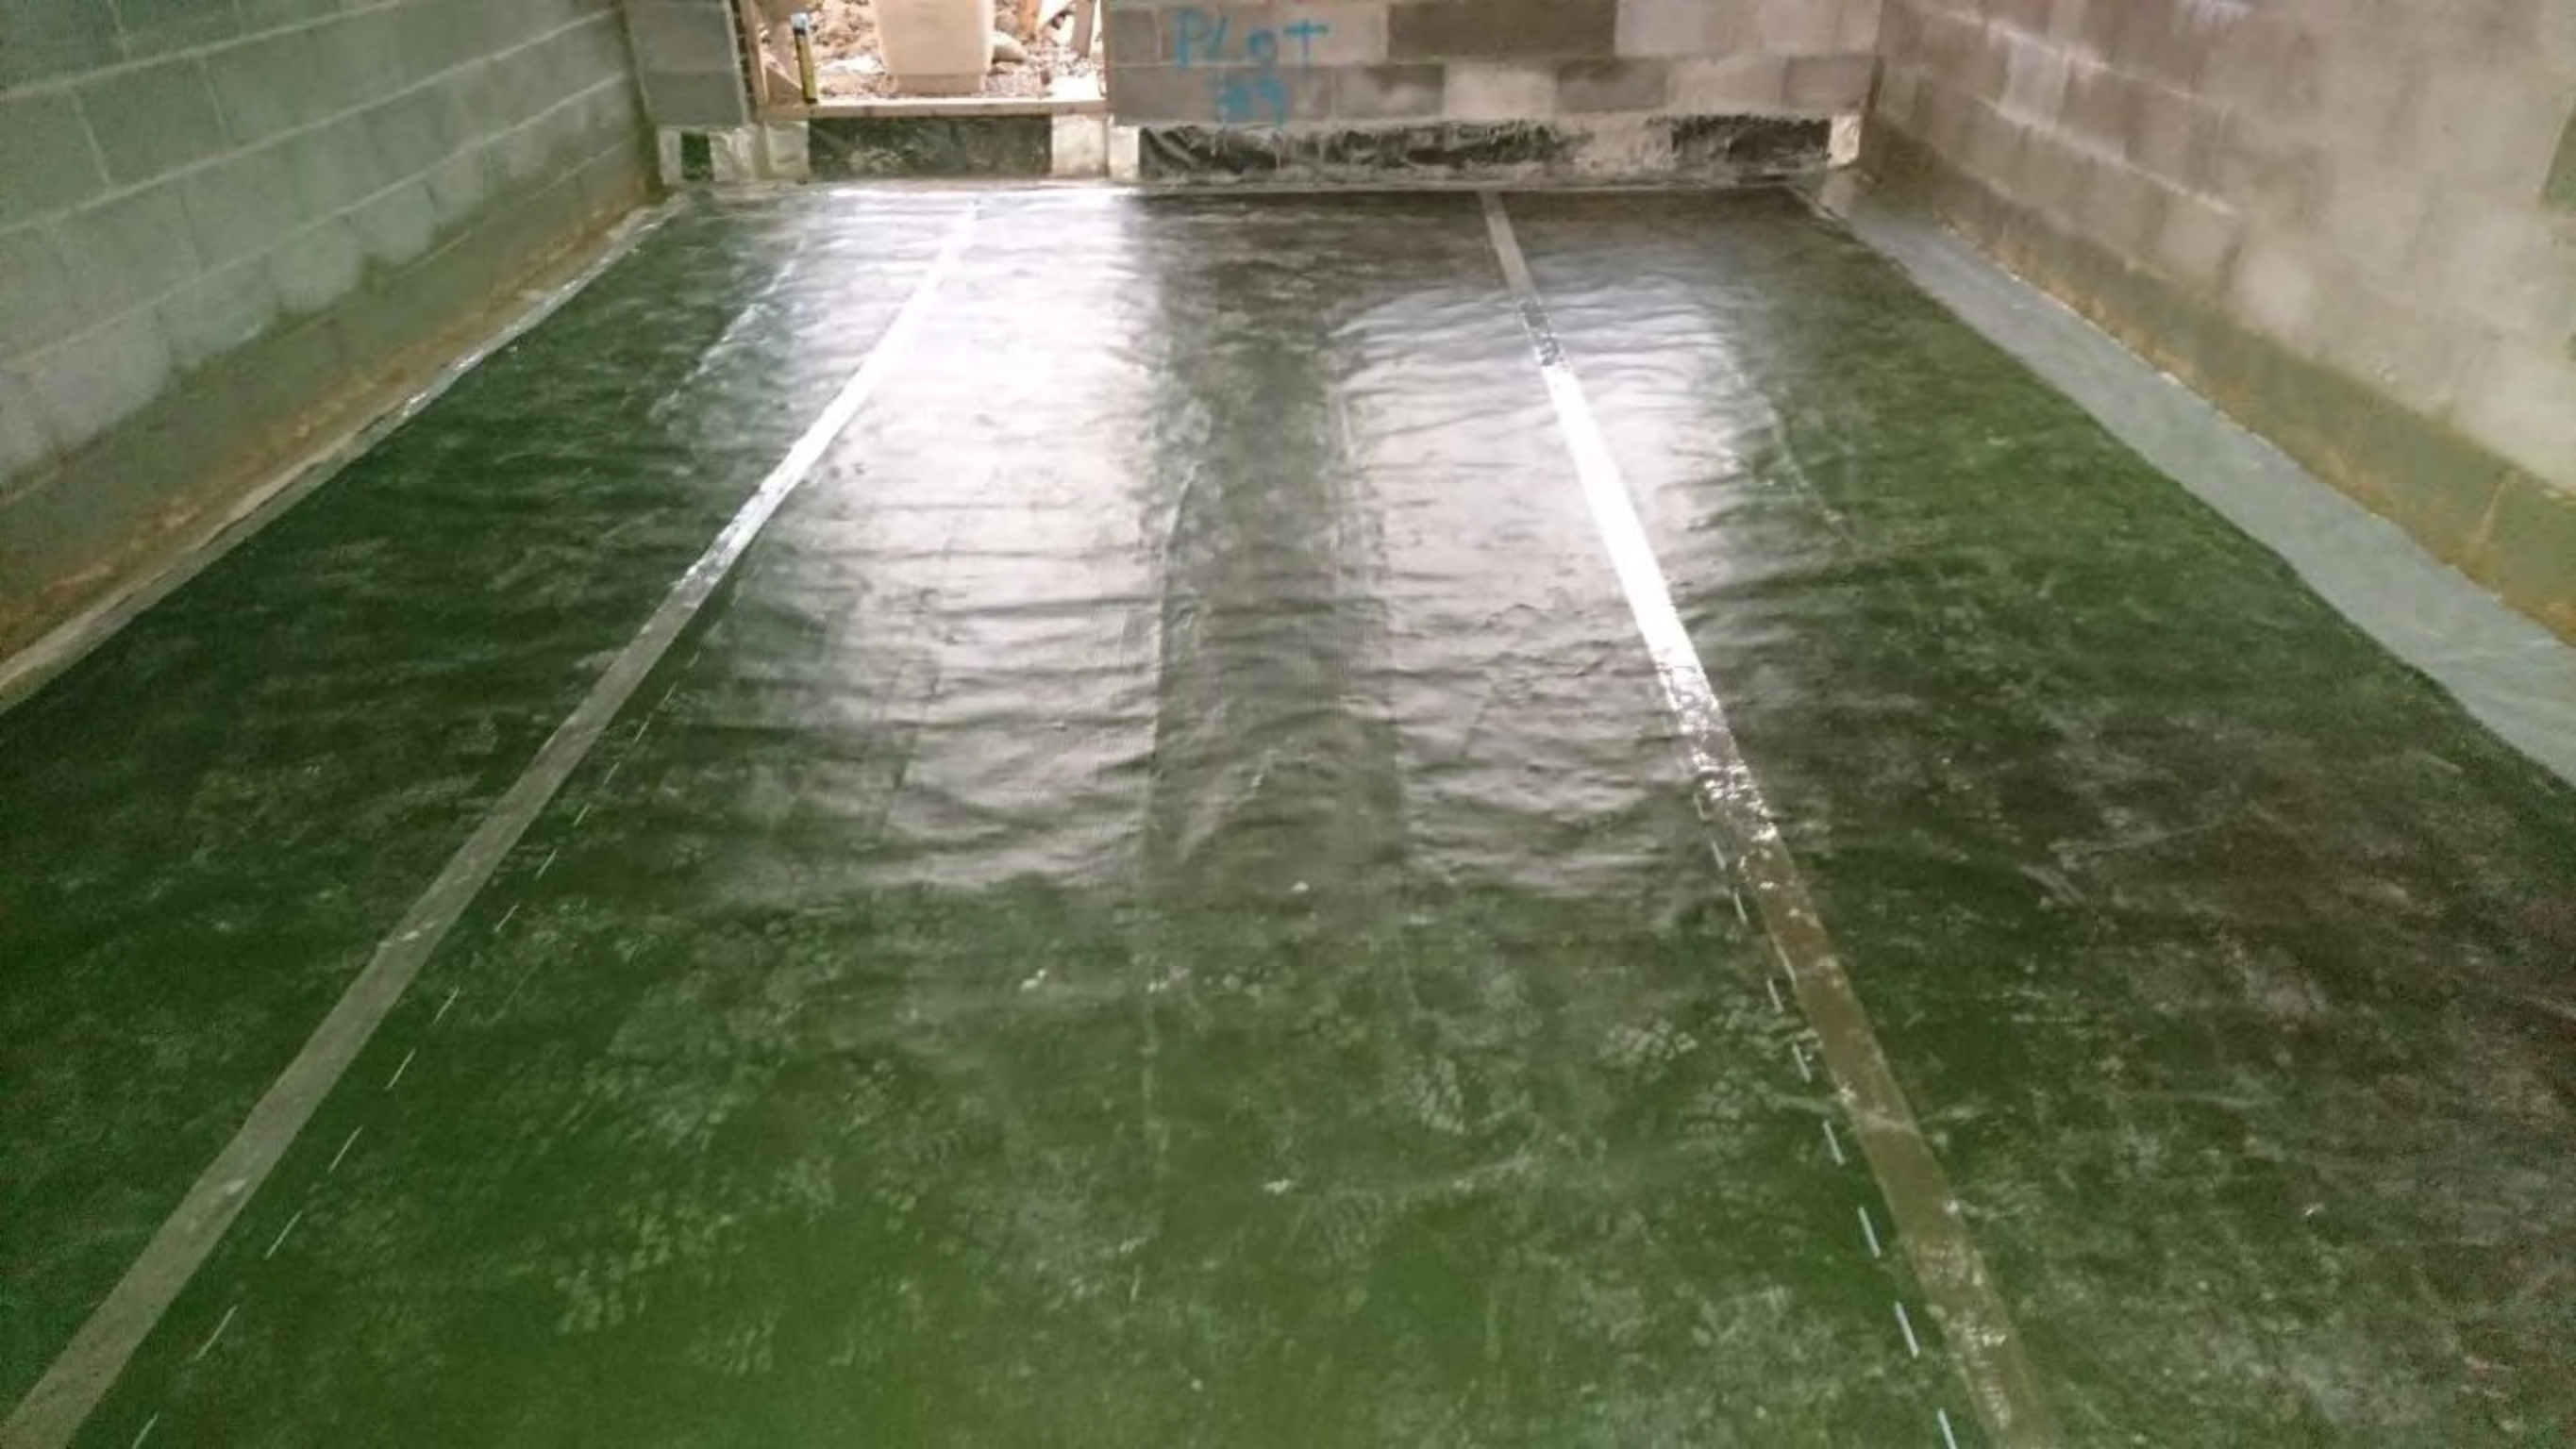
PLOT 39

| 2.2 | Condition of sub-grade & underside of gas membrane | SEALED TO A GOOD QUALITY AND FLOOR SWEEP CLEAN. TAPES APPLIED WELL | | | | | |
| 2.4 | Gas membrane condition and coverage | ALL OK, SEALED ON ALL FOUR SIDES | | | | | |
| 2.7 | Condition of joints/seals | ALL GOOD, VISIBLE OVERLAPS | | | | | |
| 2.8 | Number and condition of service entry seals | 3 NO. TOPHATS FITTED WITH SUBILEE CLIPS, TAPES CHECKED, ALL OK. | | | | | |
| 2.10 | Repairs or Corrections: | 2 PUNCTURES - REPAIRED USING 300x20mm RADBAR S/A DETAIL STRIP | | | | | |
