## Gas Protection - Validation Record Sheet

**This Record sheet is only applicable to block and beam floor slabs for Characteristic Situation 2 gas protection systems**

Plot 29, Block 10

**For Residential Development at New Church Street, Radcliffe.**

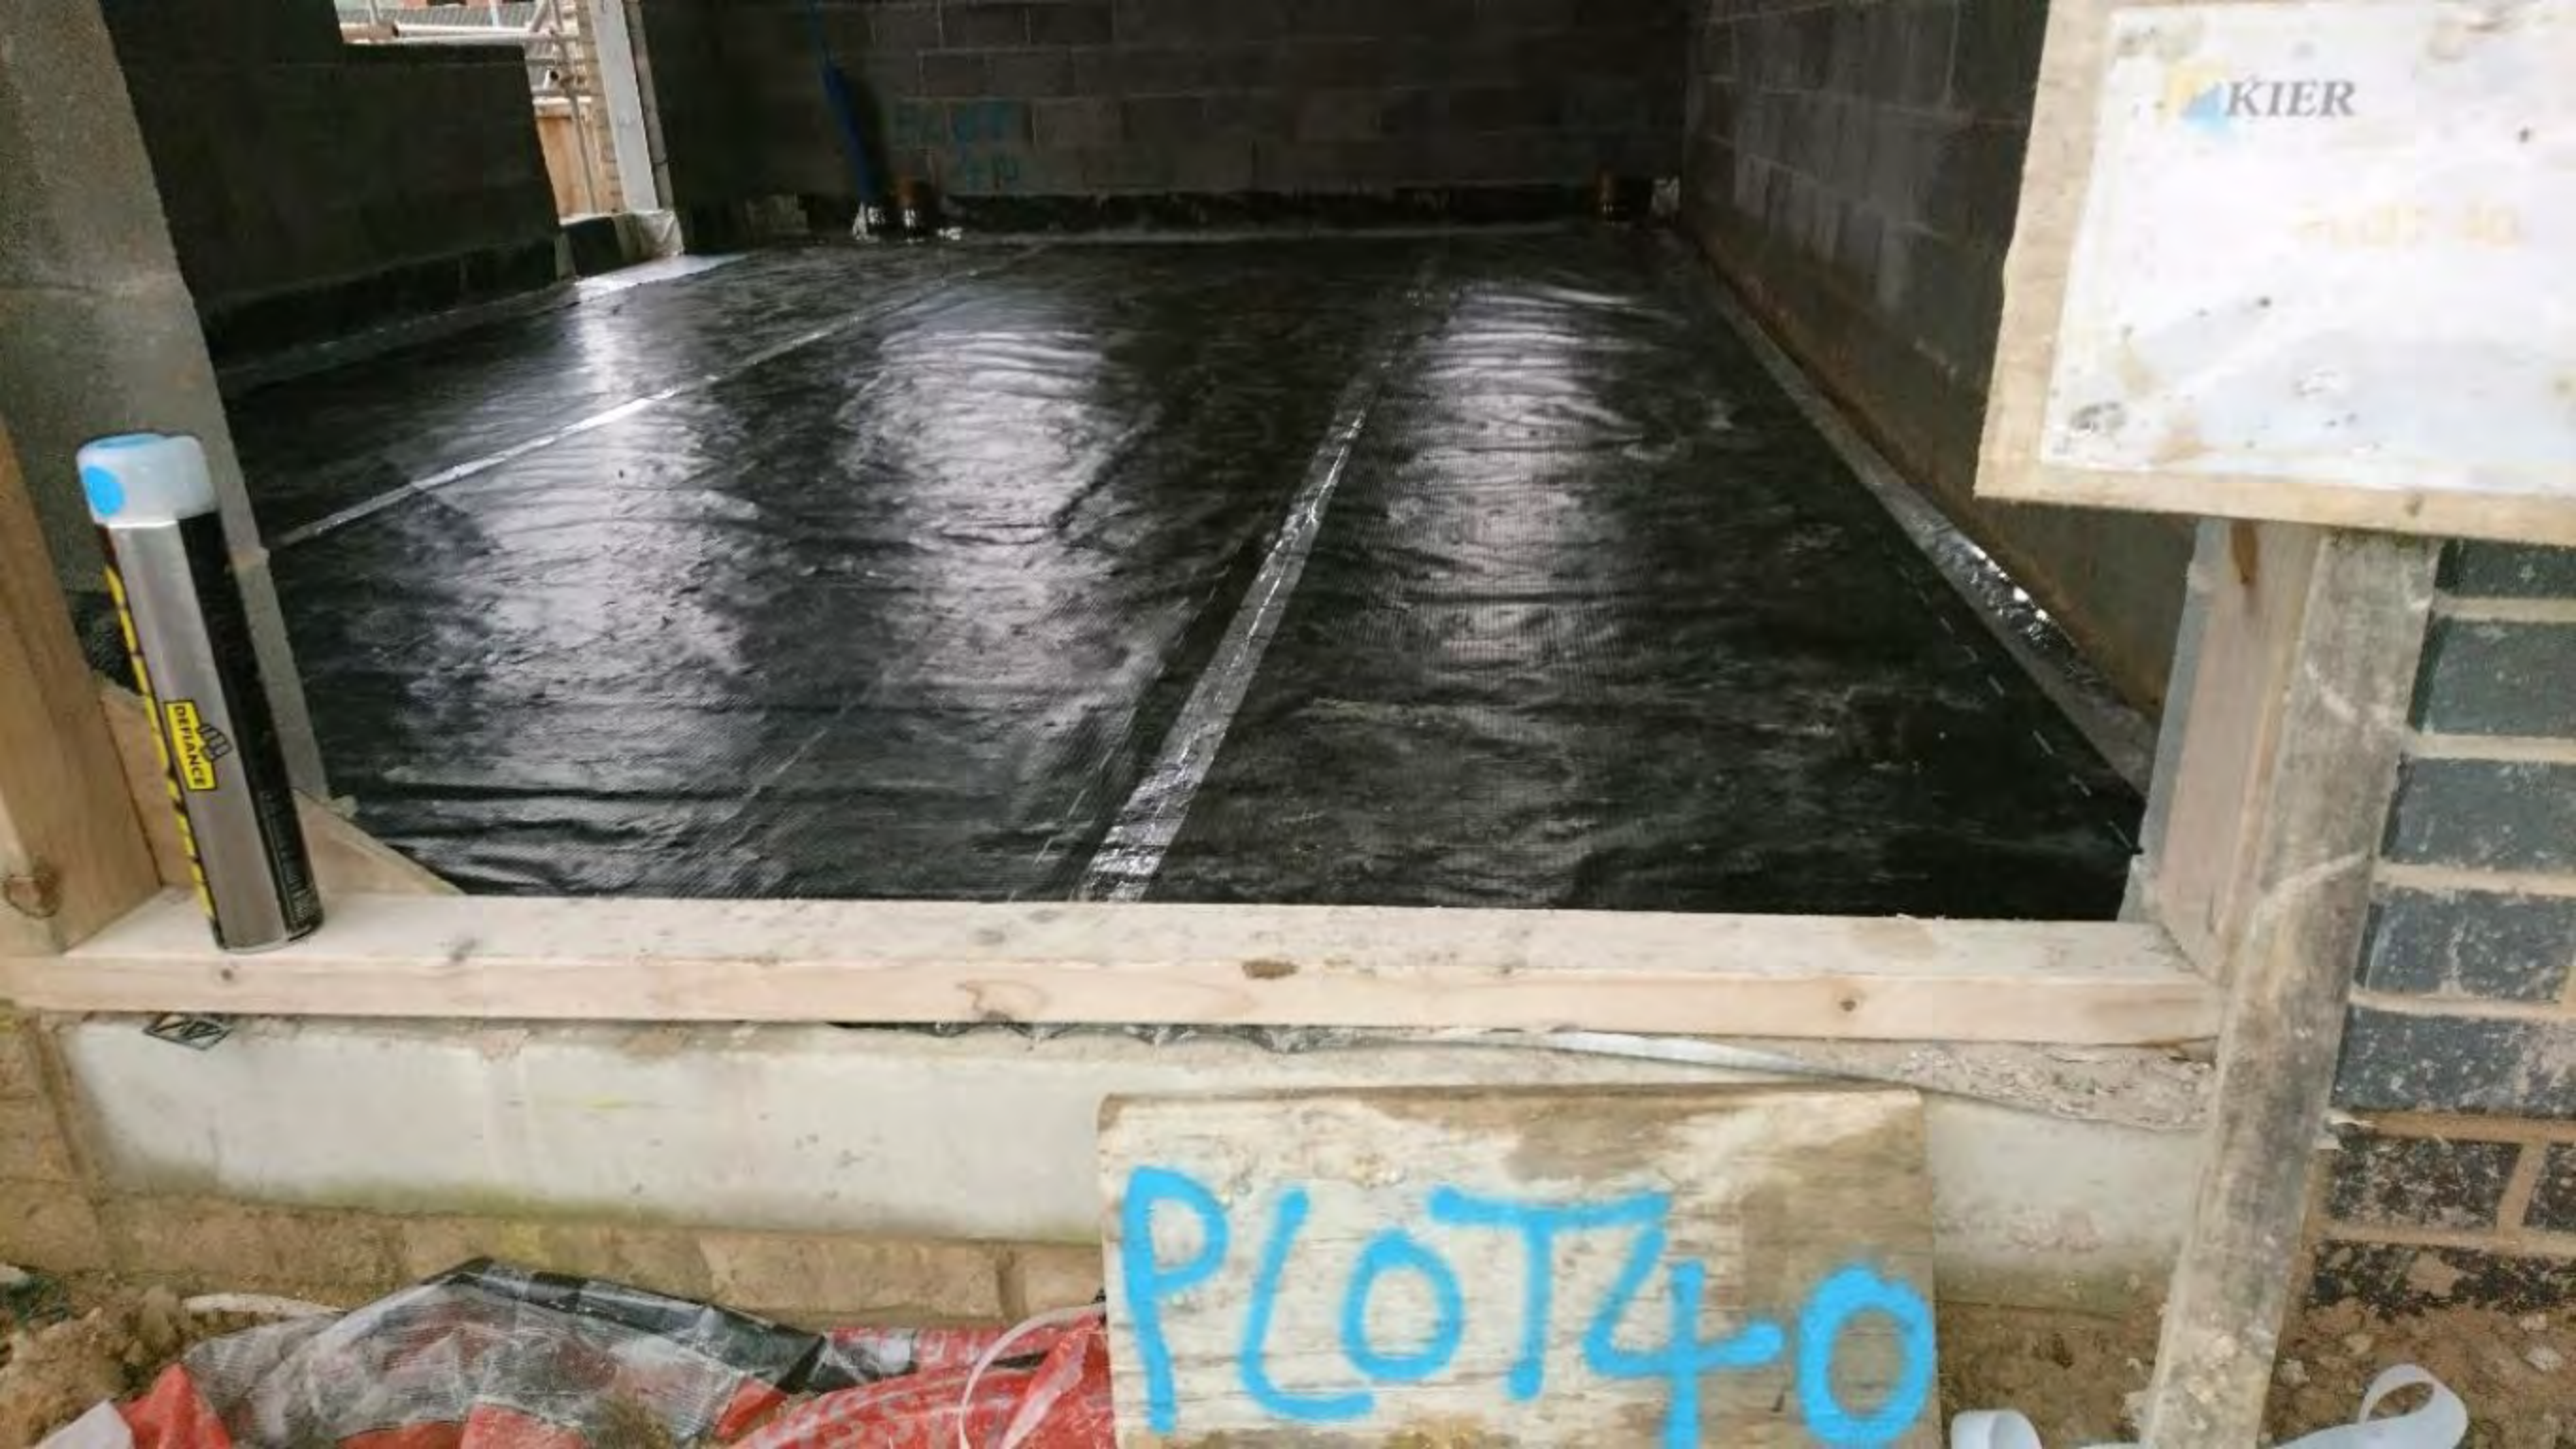
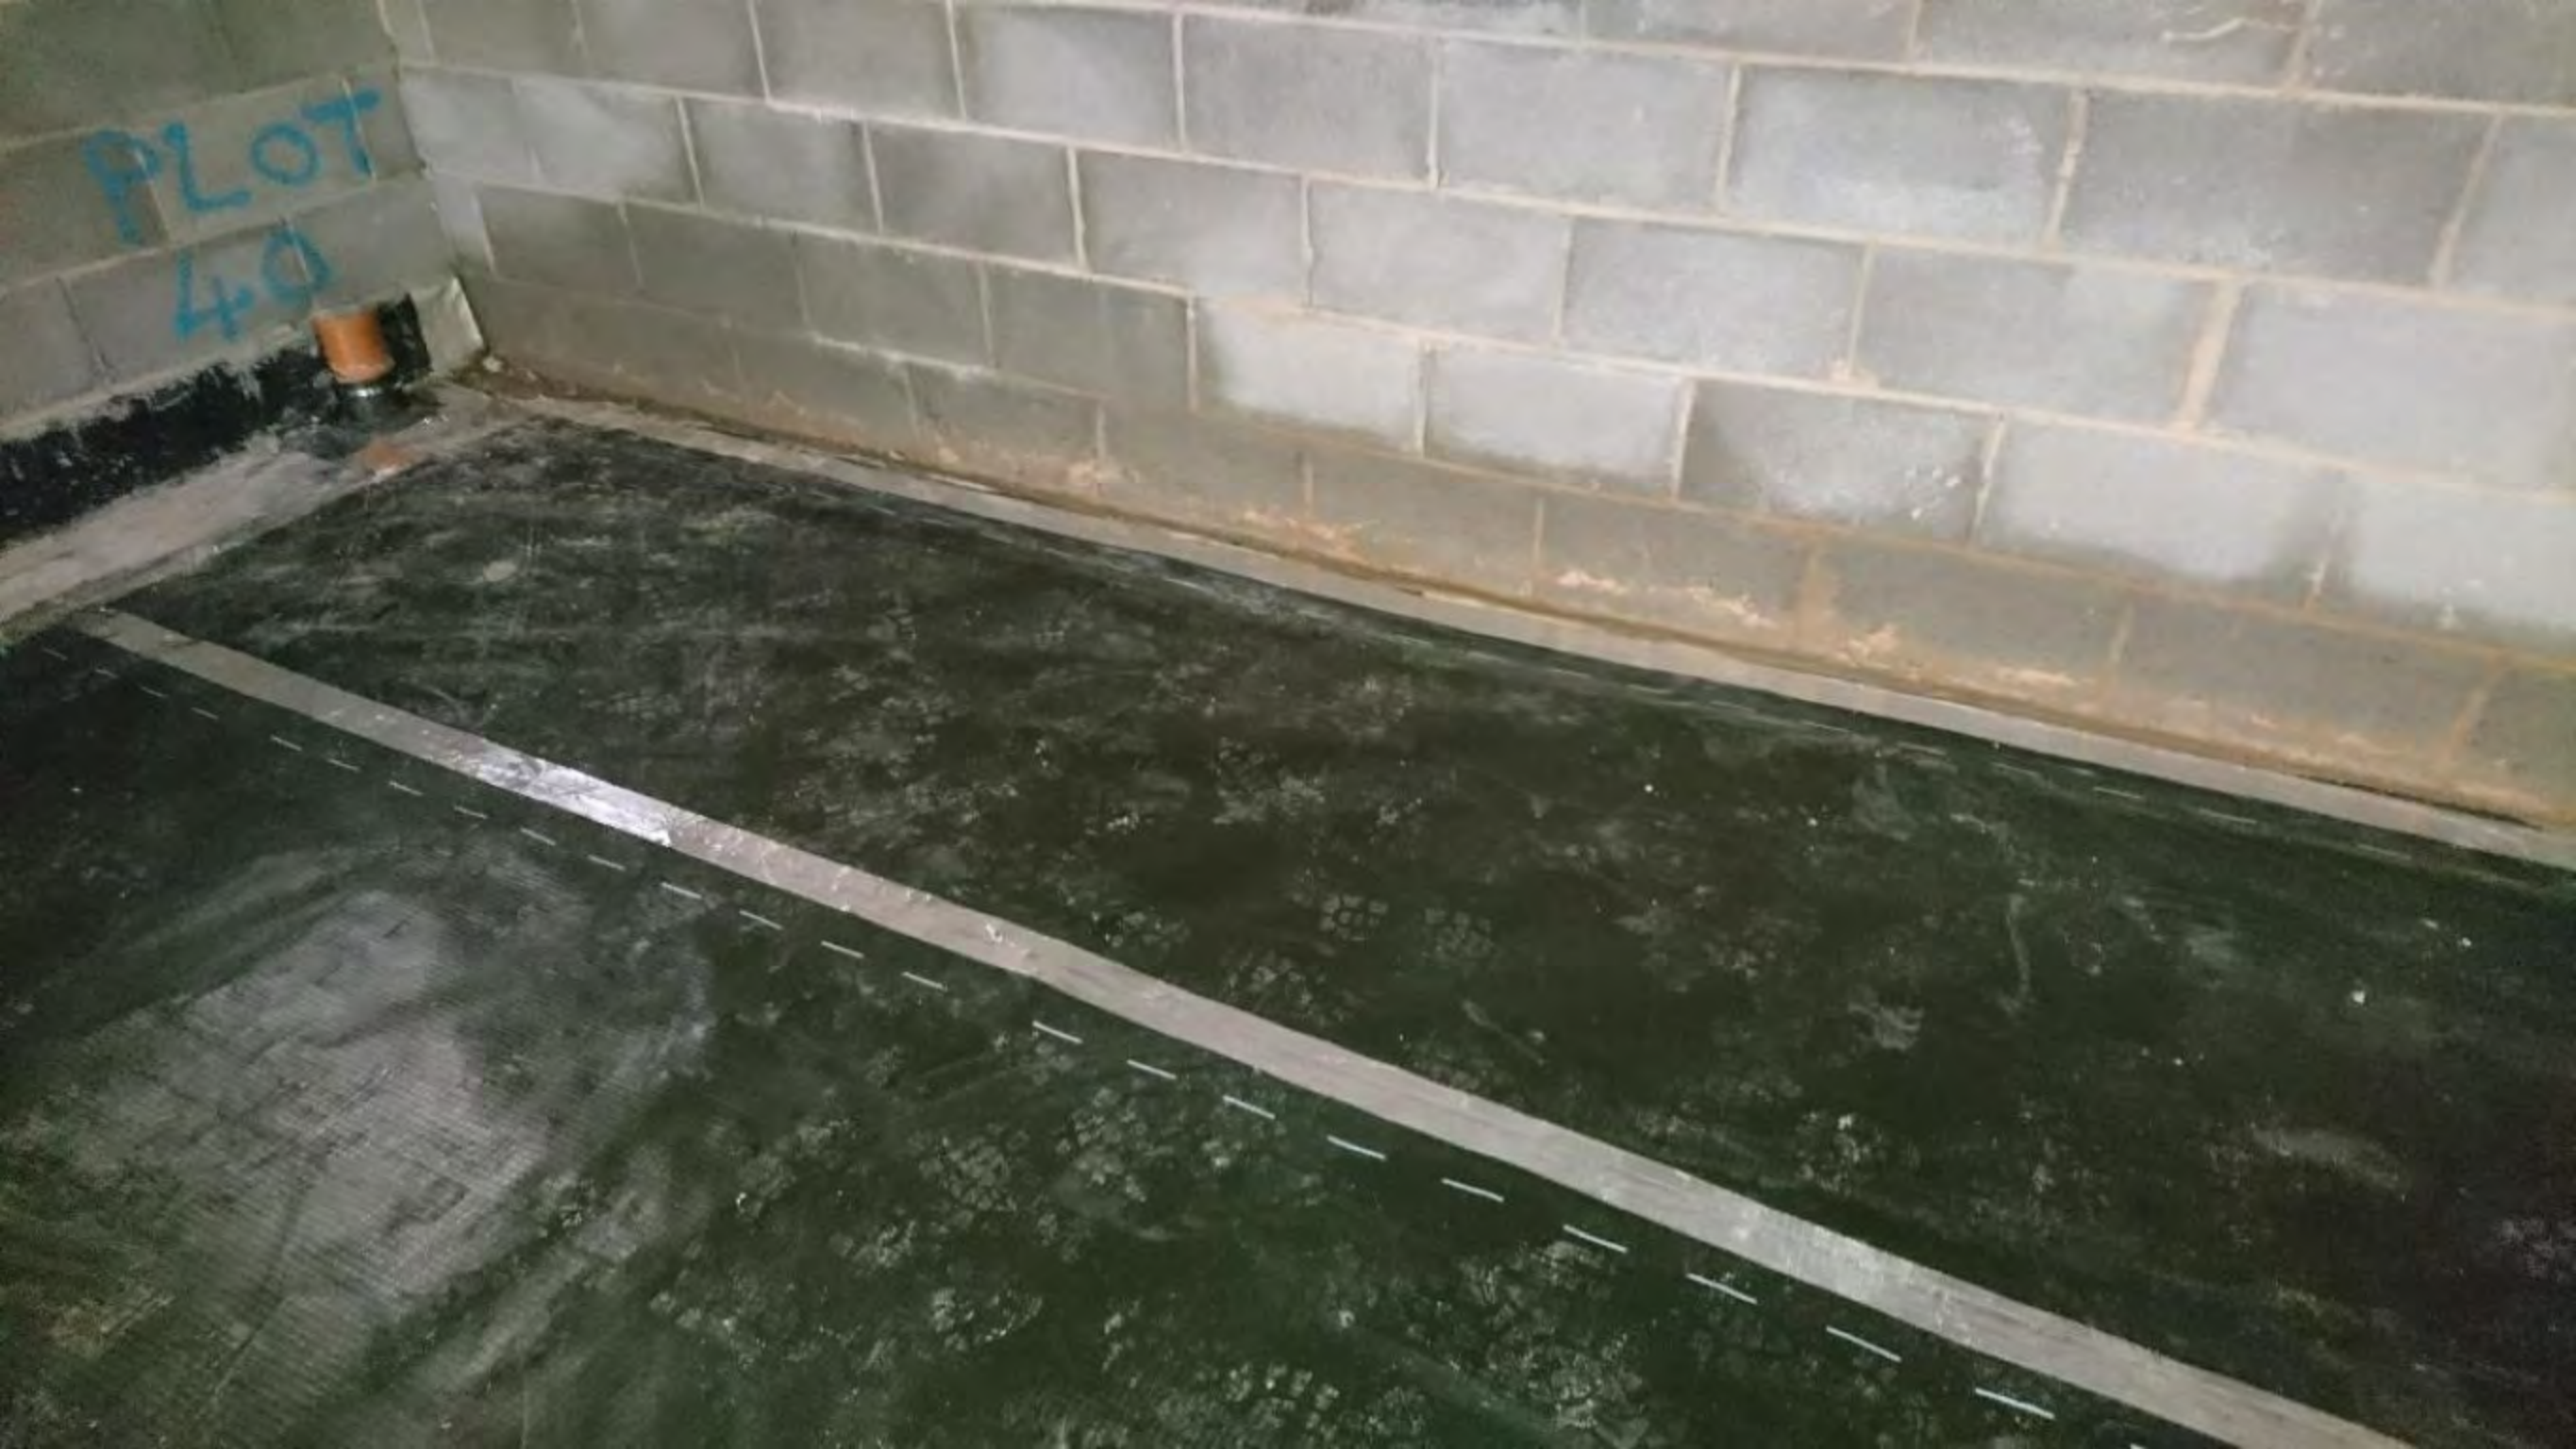
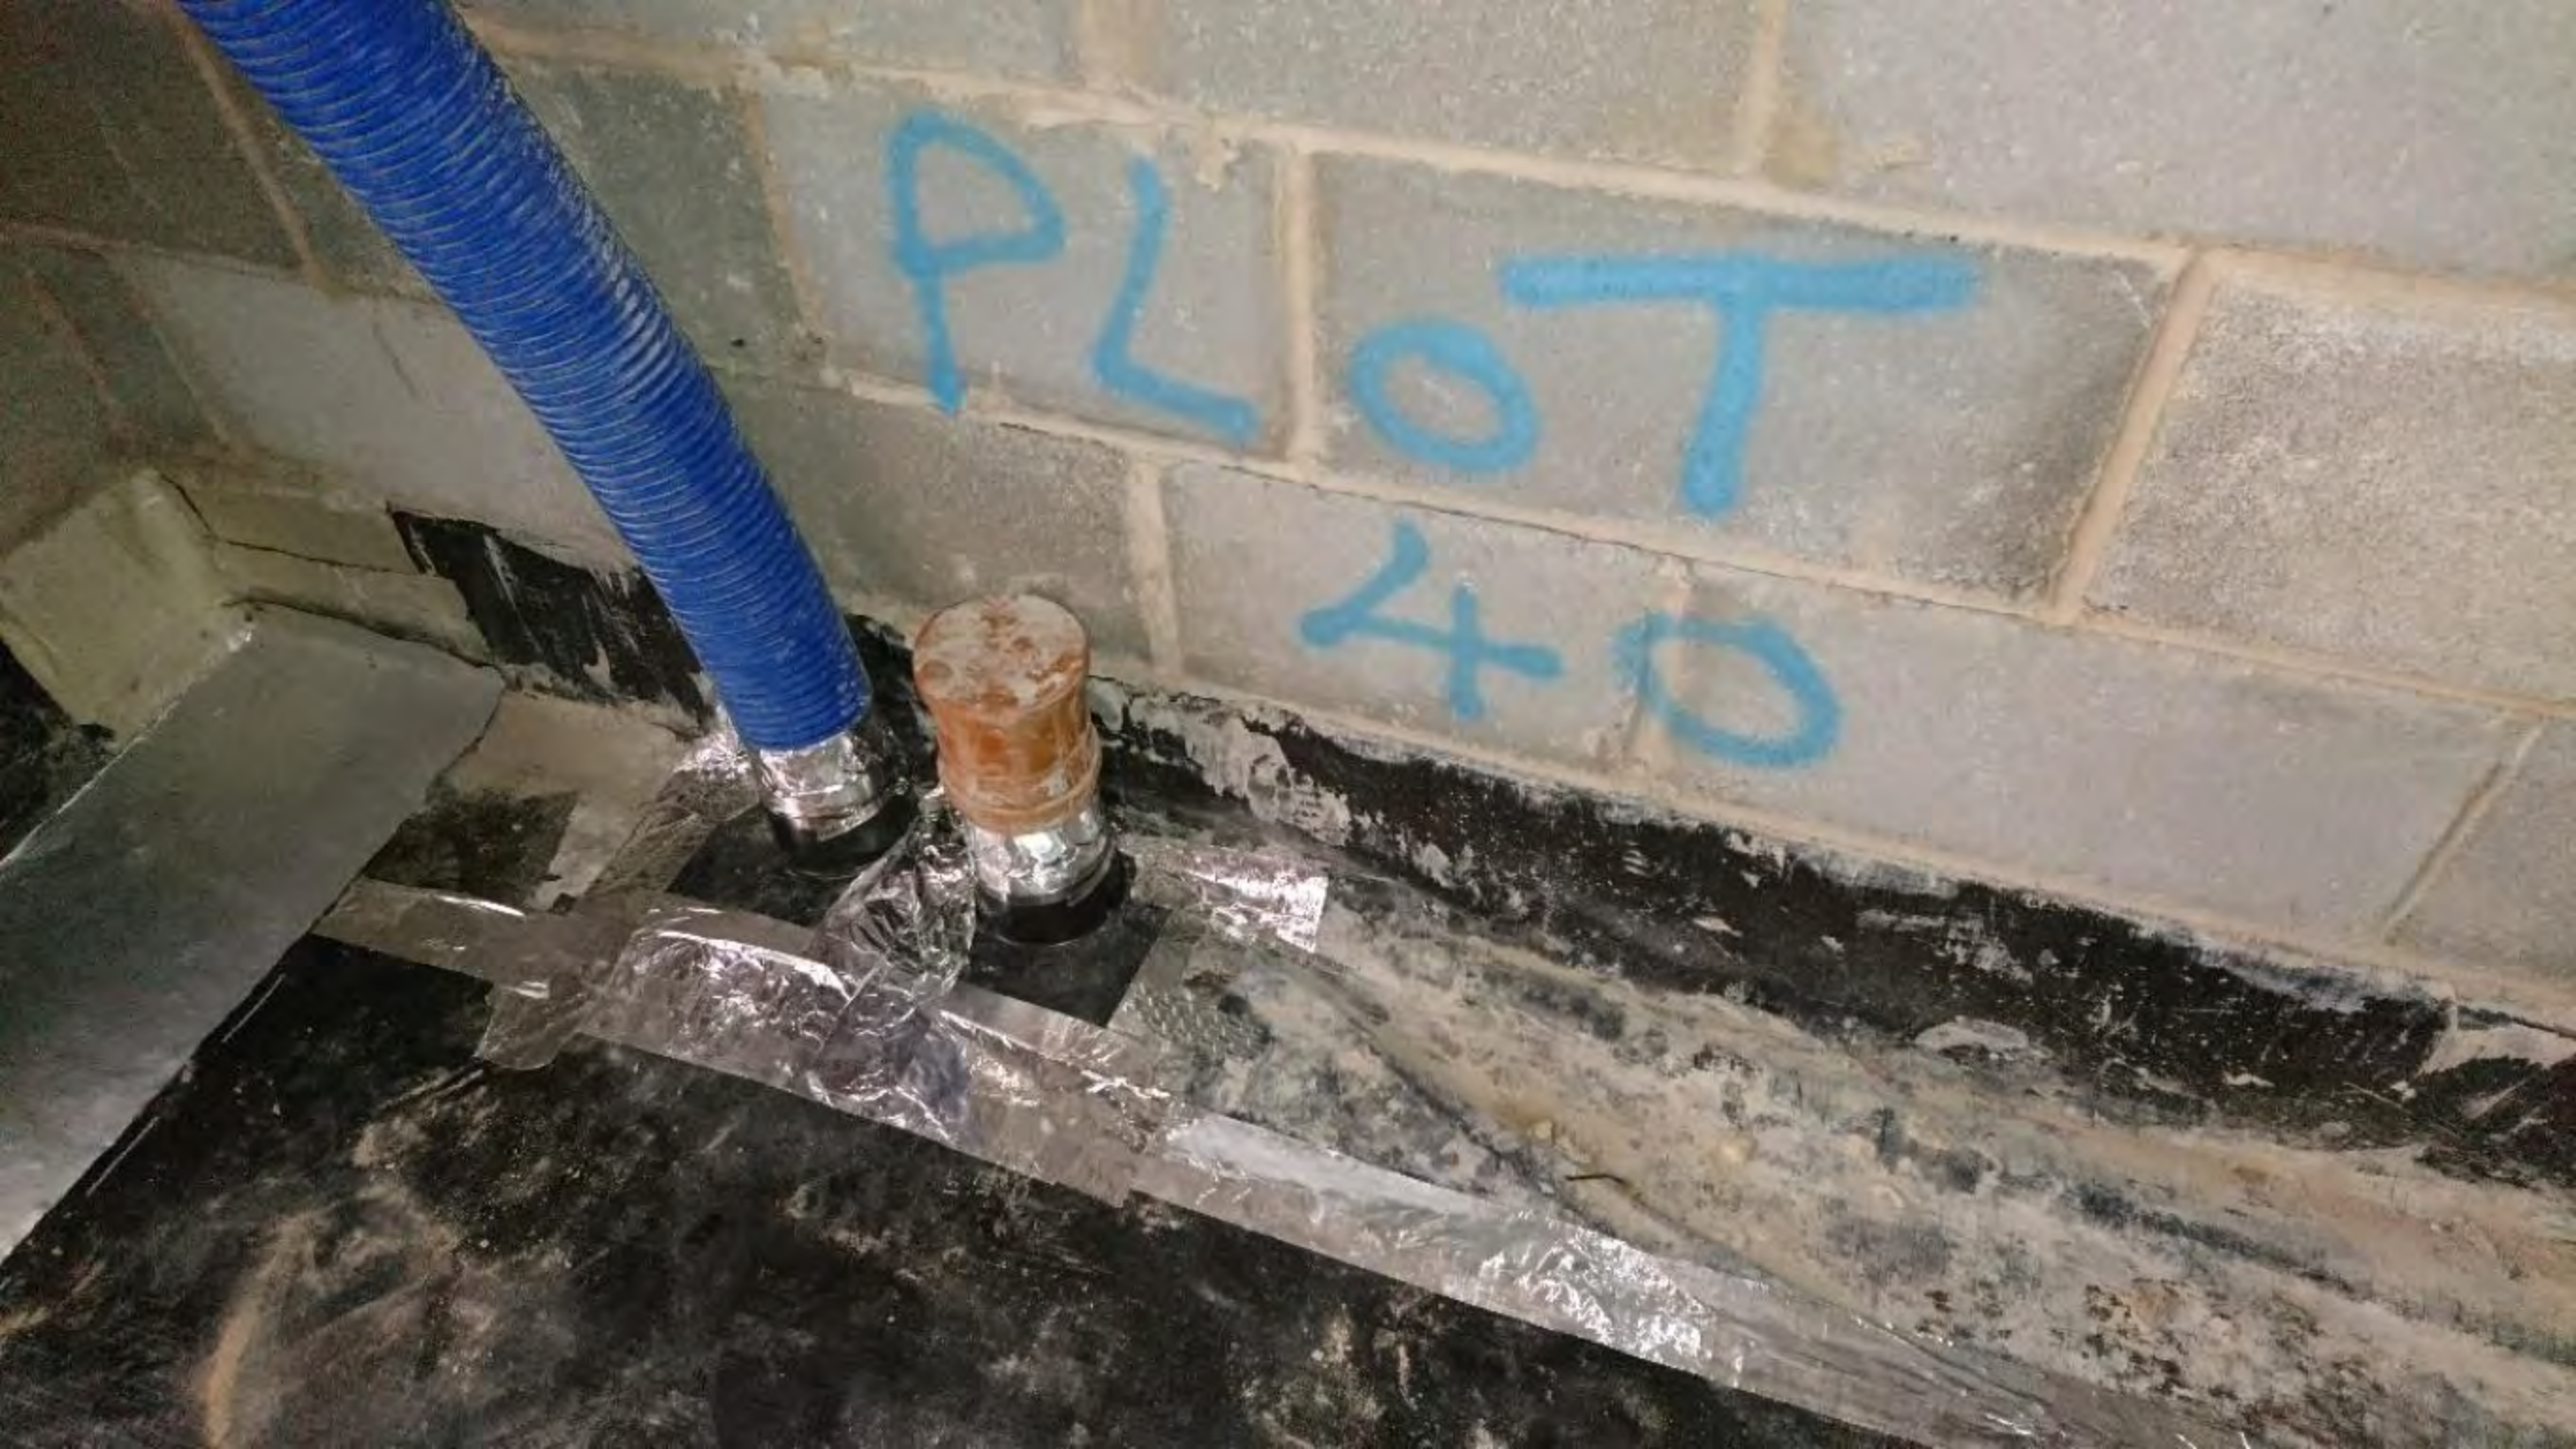
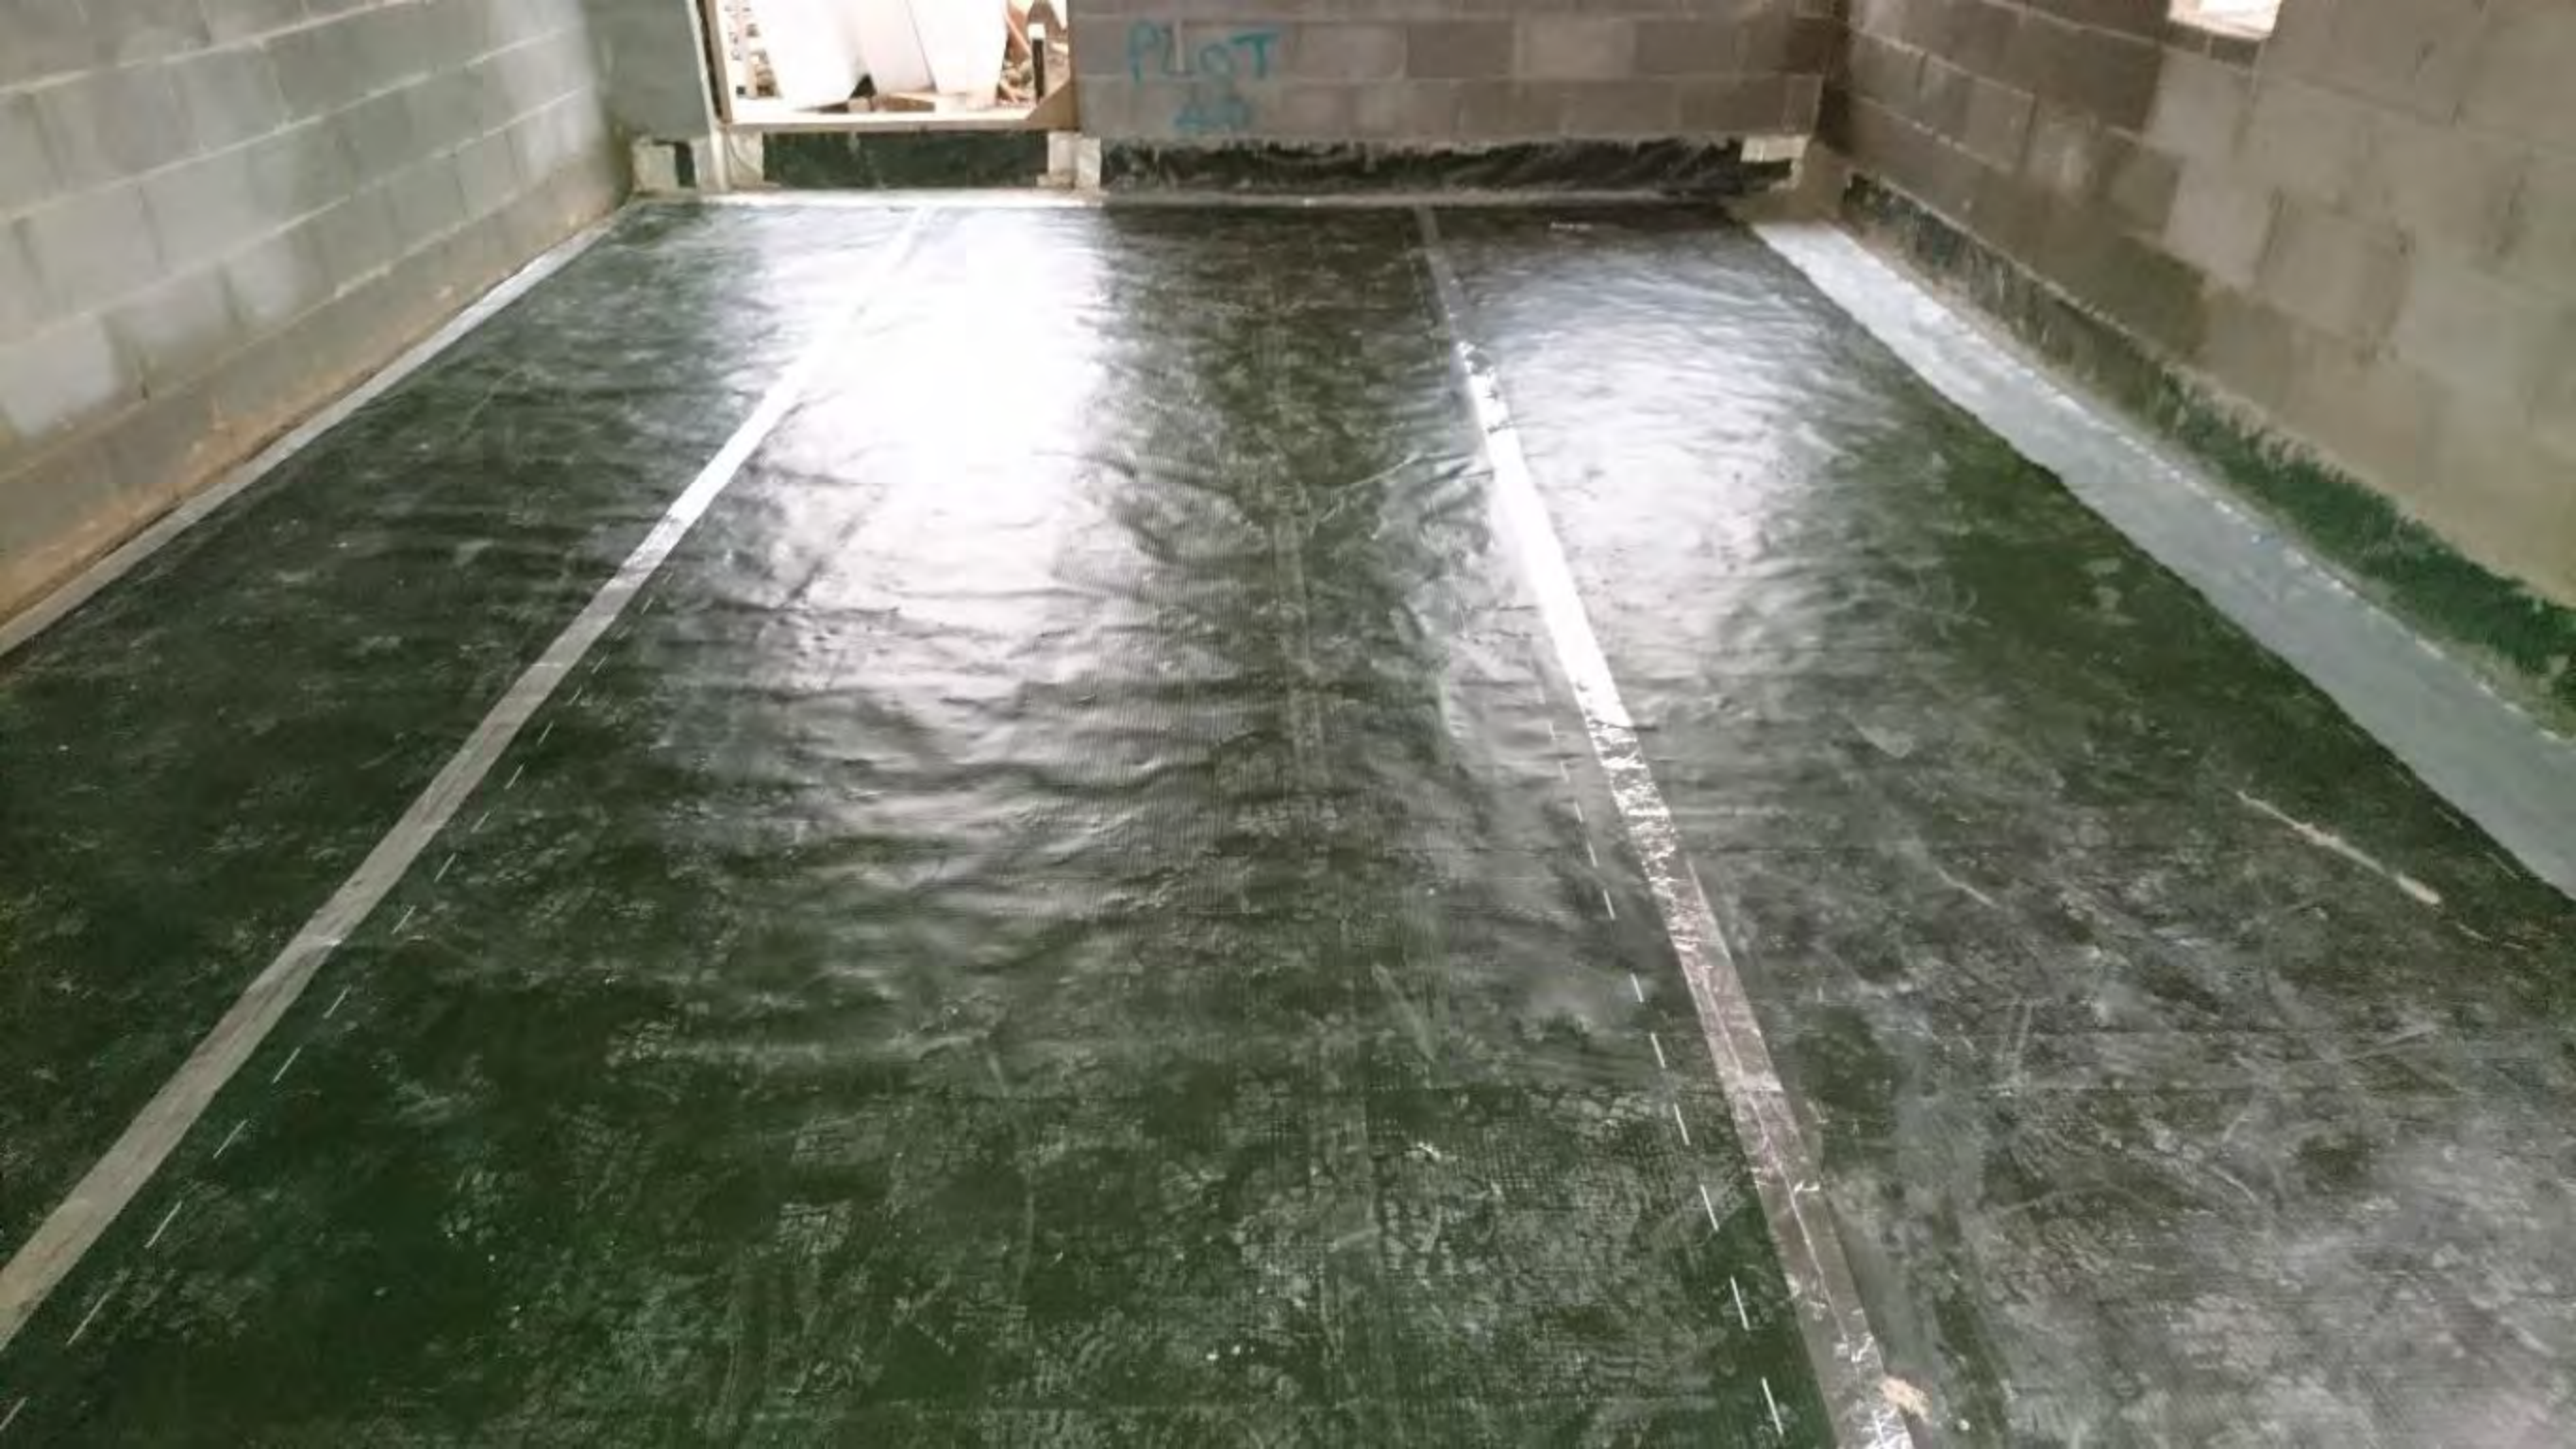
PLOT 40

| 2.2 | Condition of sub-grade & underside of gas membrane | <u>FLOOR BRUSHED AND ALL TAPES APPLIED WELL. SEALED TO A GOOD QUALITY</u> | | | | | |
| 2.4 | Gas membrane condition and coverage | <u>SEALED ON ALL FOUR SIDES - ALL GOOD</u> | | | | | |
| 2.7 | Condition of joints/seals | <u>VISIBLE OVERLAPS, ALL GOOD</u> | | | | | |
| 2.8 | Number and condition of service entry seals | <u>3 NO. TOPHATS FITTED WITH SUBILEE CLIPS, TAPES CHECKED, ALL OK.</u> | | | | | |
| 2.10 | Repairs or Corrections: | <u>1 NO PUNCTURE - USED 300x20mm WIDE RADBAR S/A DRESS STRIP TO REPAIR</u> | | | | | |
