**This Record sheet is only applicable to block and beam floor slabs for Characteristic Situation 2 gas protection systems**

**For Residential Development at New Church Street, Radcliffe.**

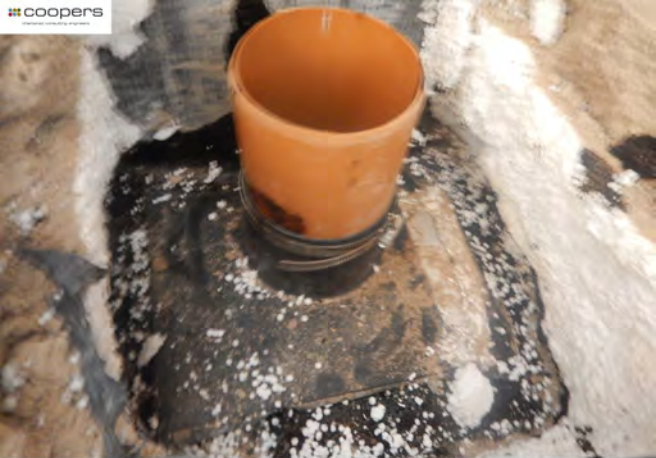
Tophat repair inspected by Coopers, in addition to inspection carried out on site by Kier Living. Photograph dated 1st August 2017.

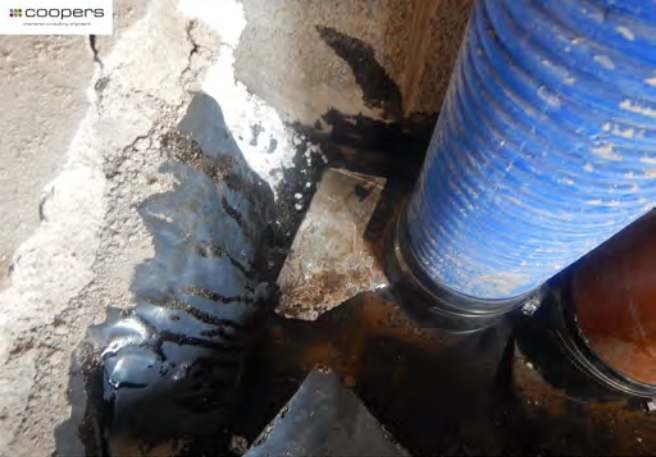
Tophat repair inspected by Coopers, in addition to inspection carried out on site by Kier Living. Photograph dated 1st August 2017.

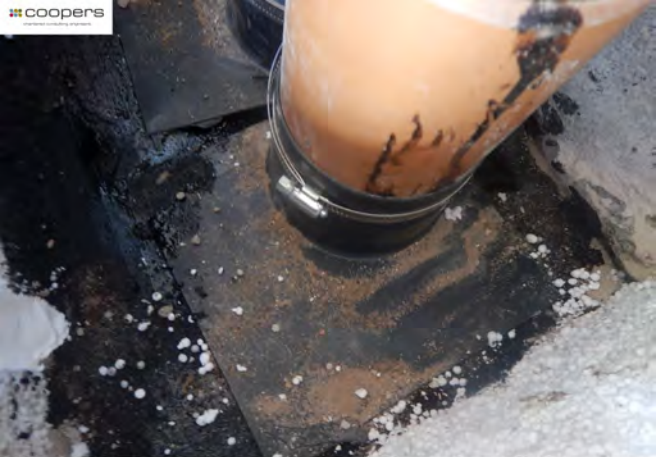
Tophat repair inspected by Coopers, in addition to inspection carried out on site by Kier Living. Photograph dated 1st August 2017.

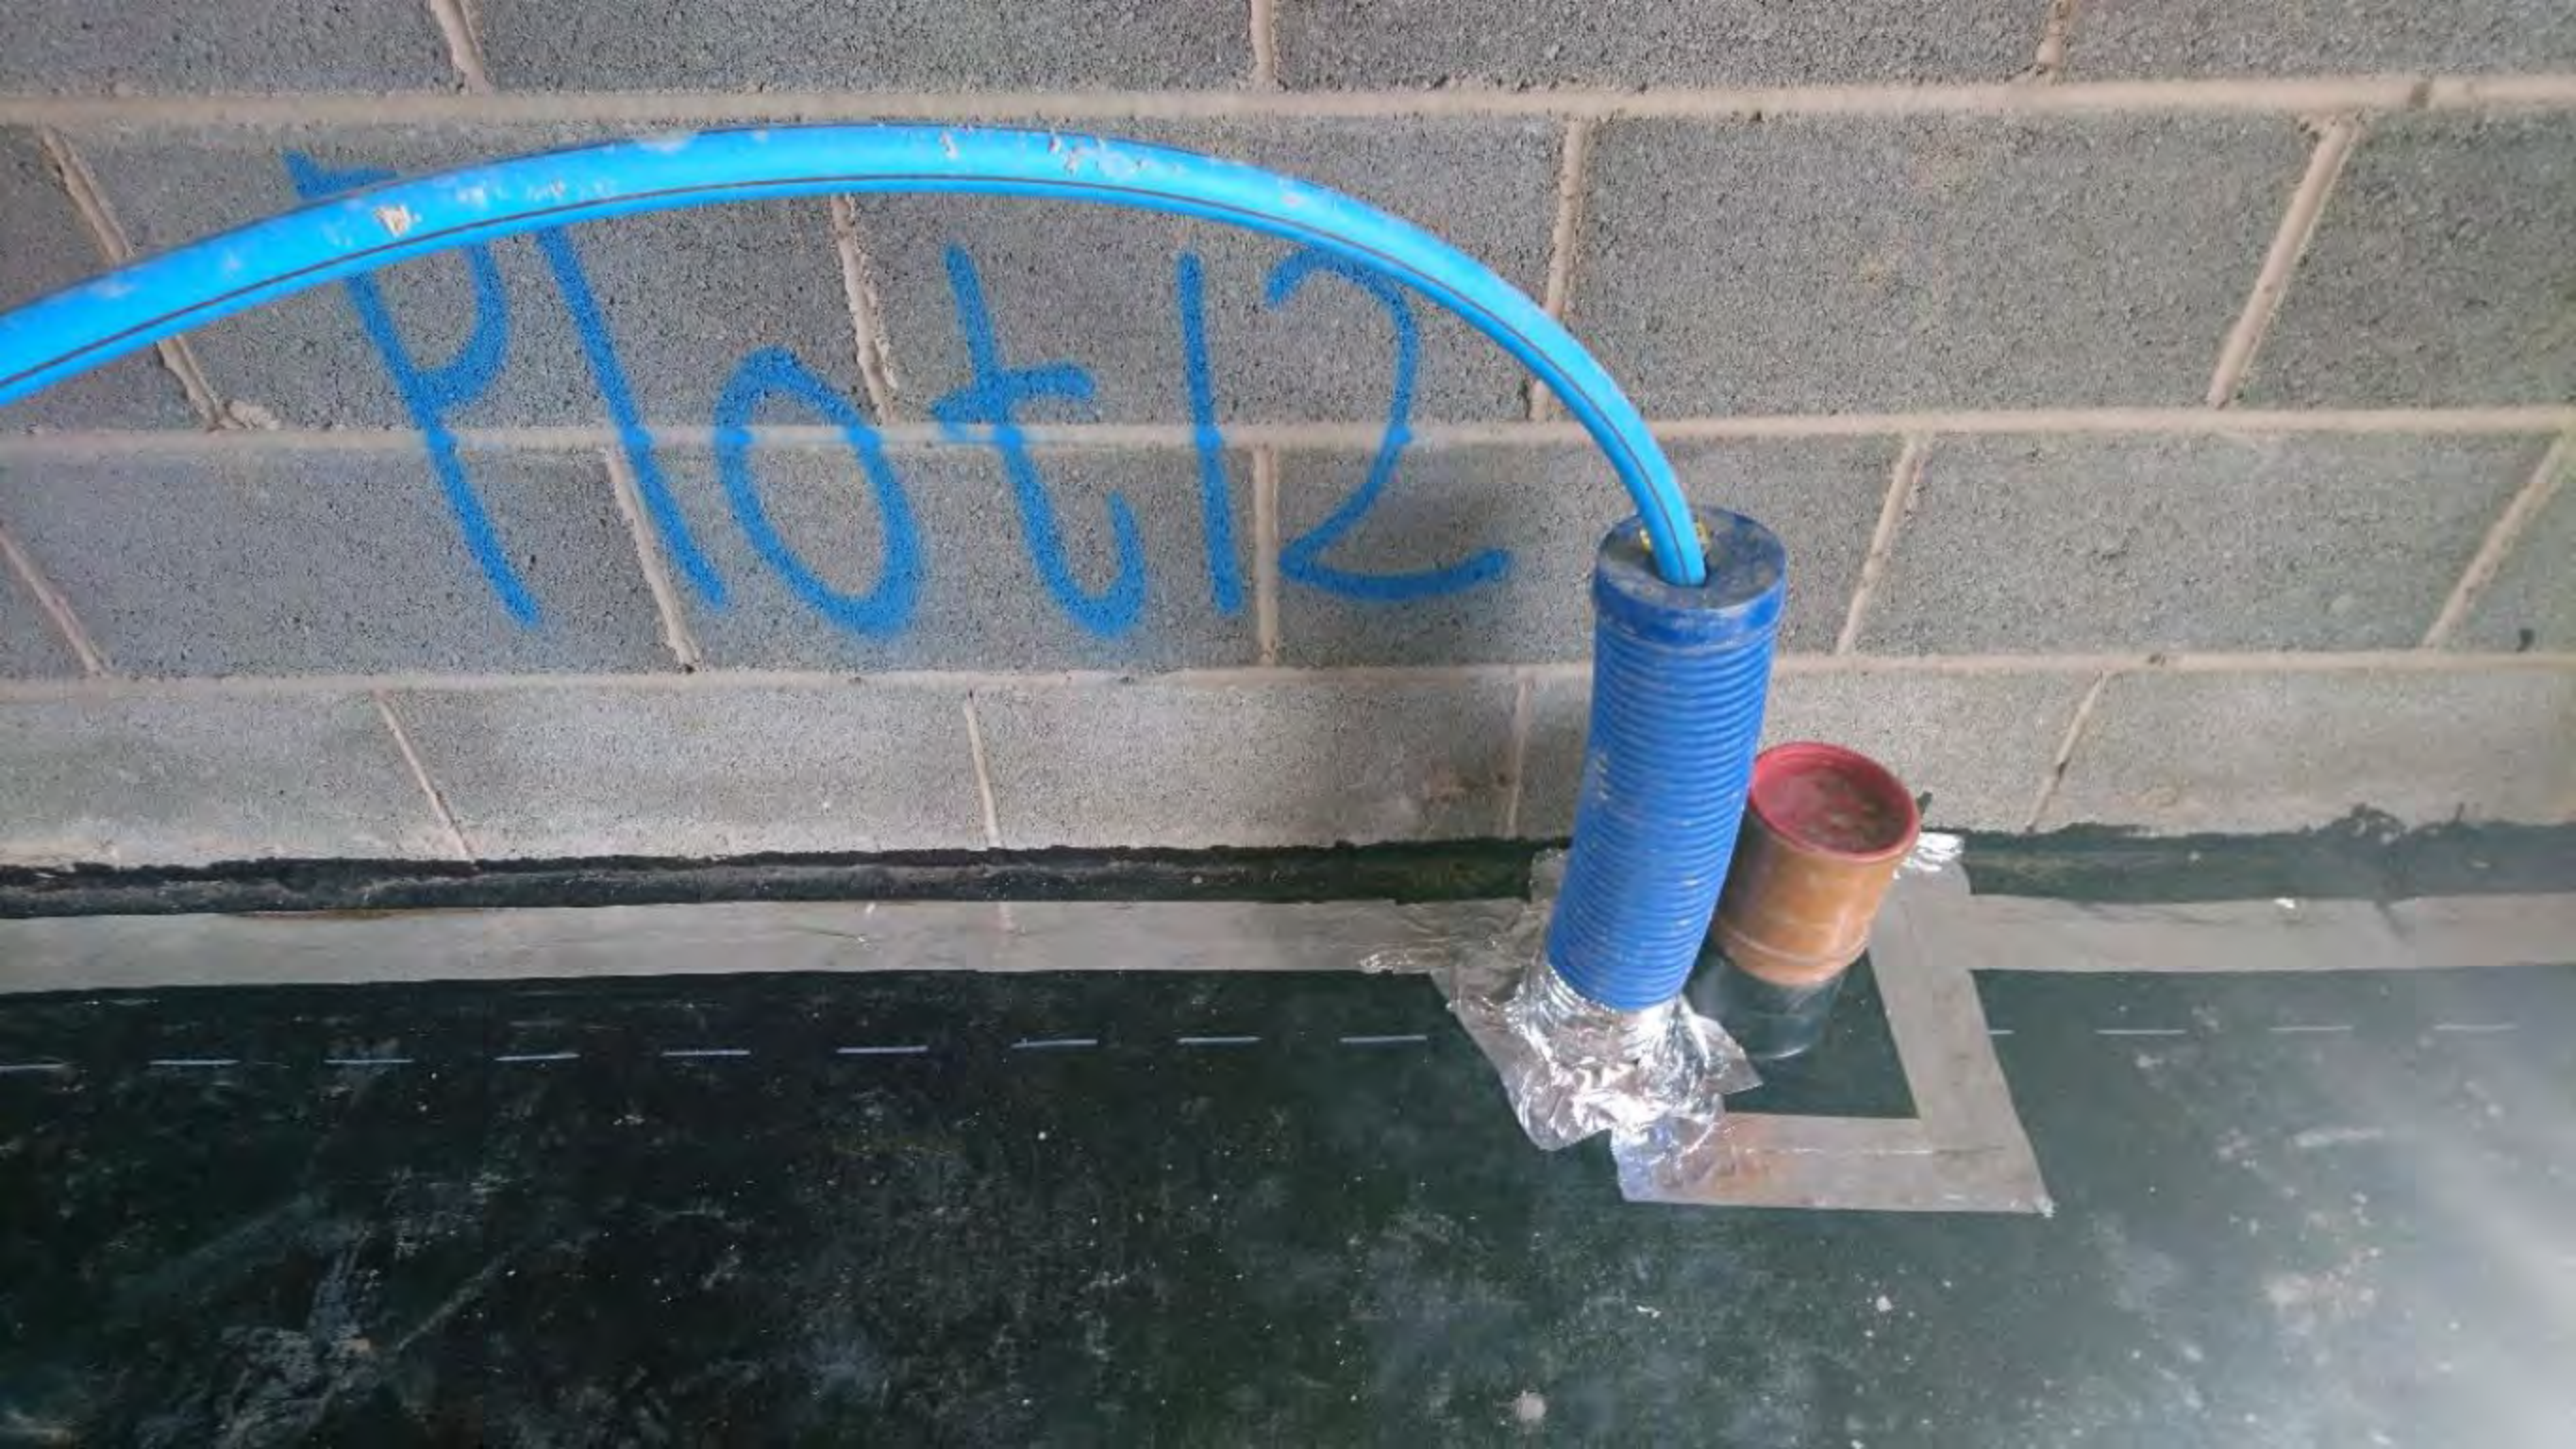
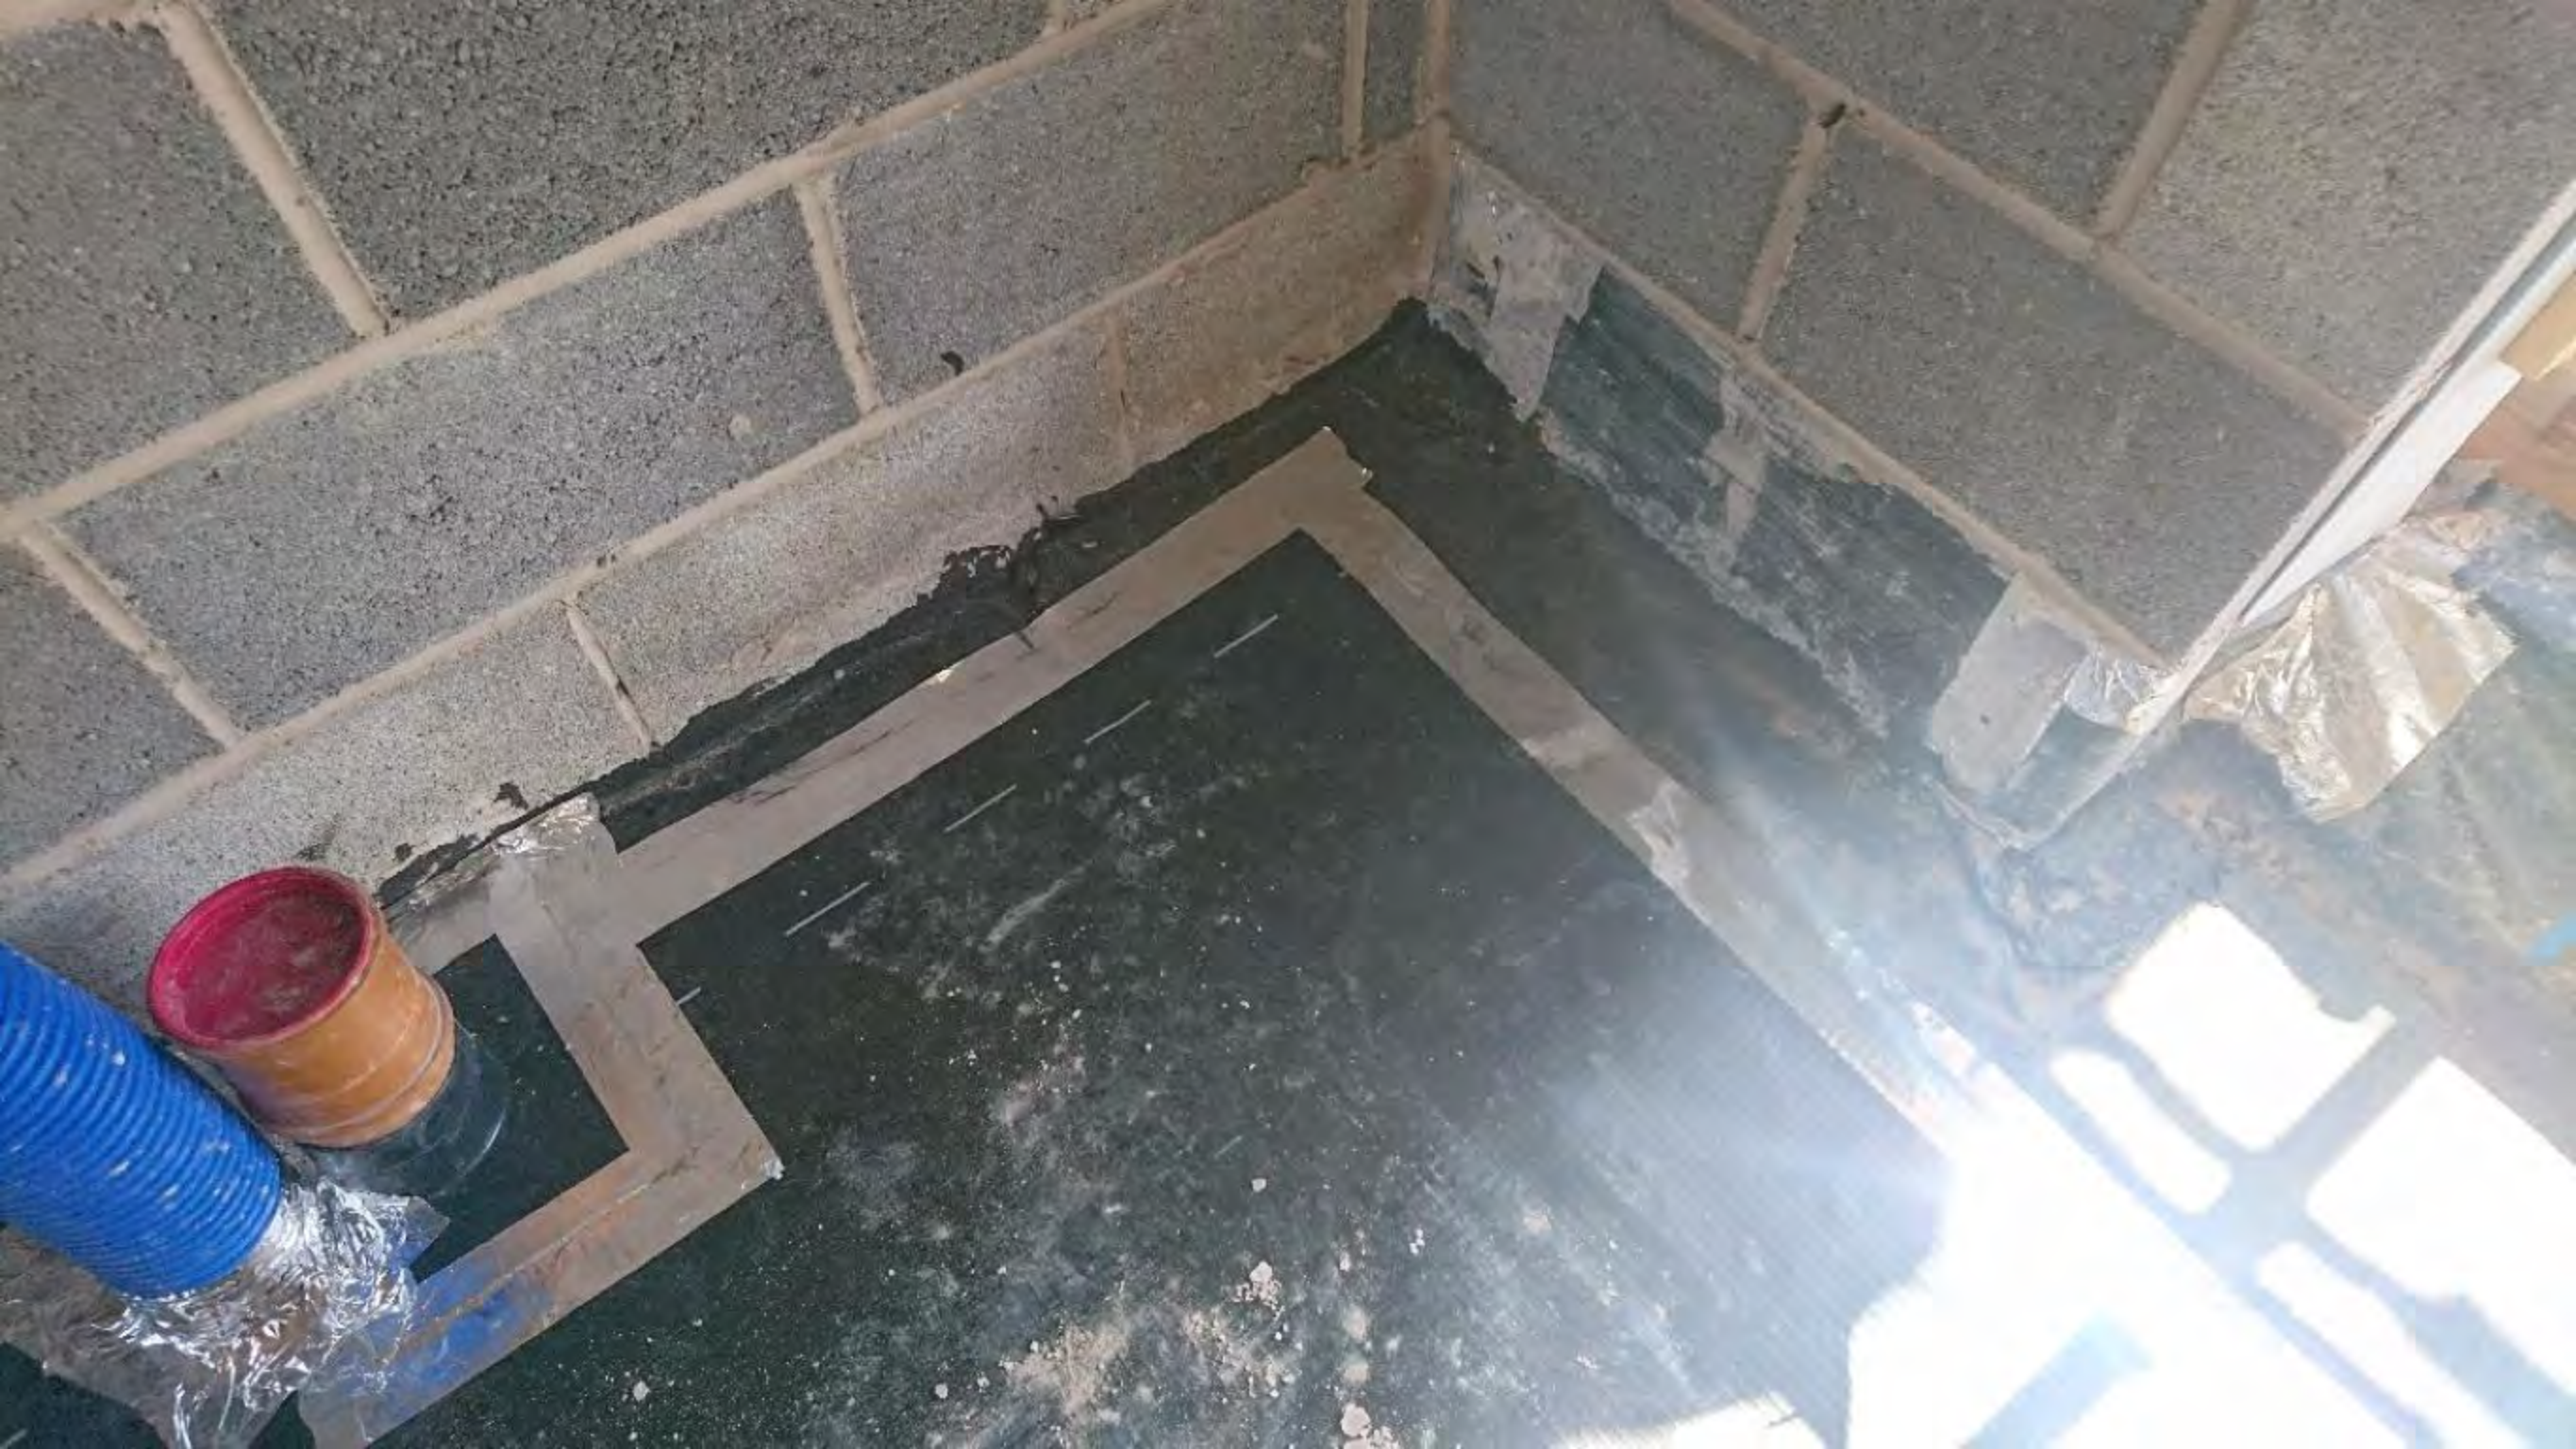
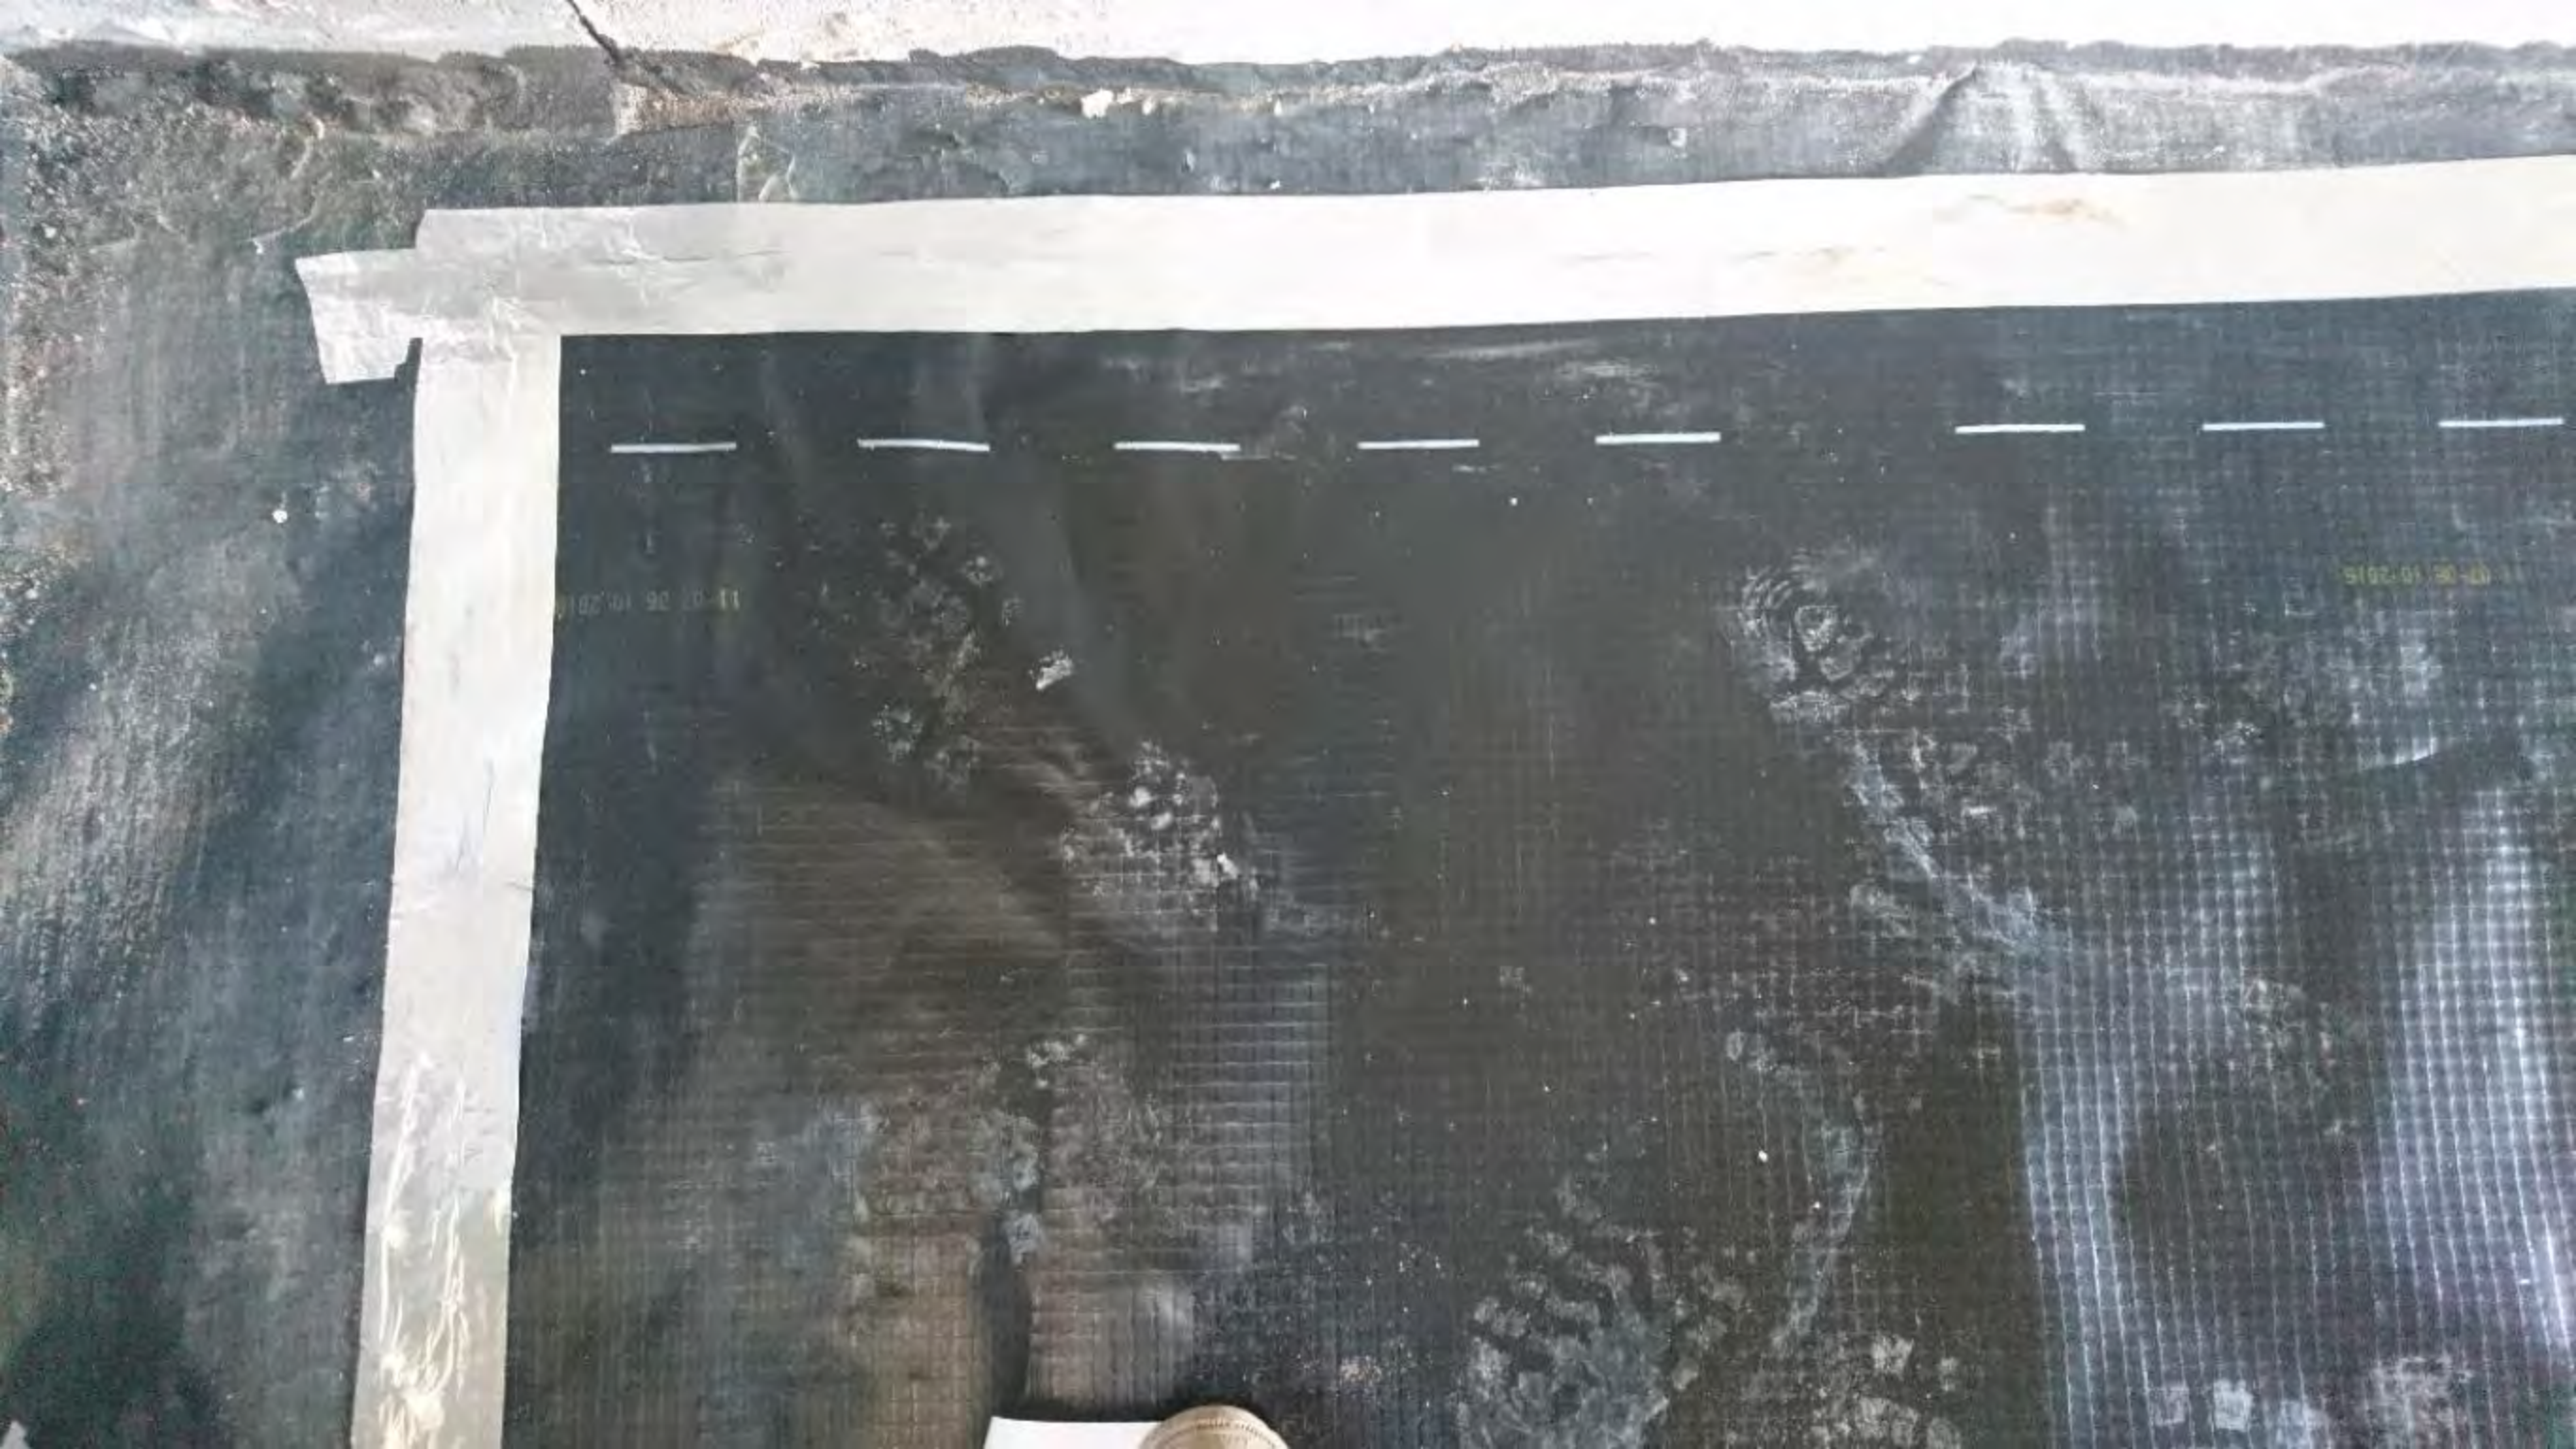
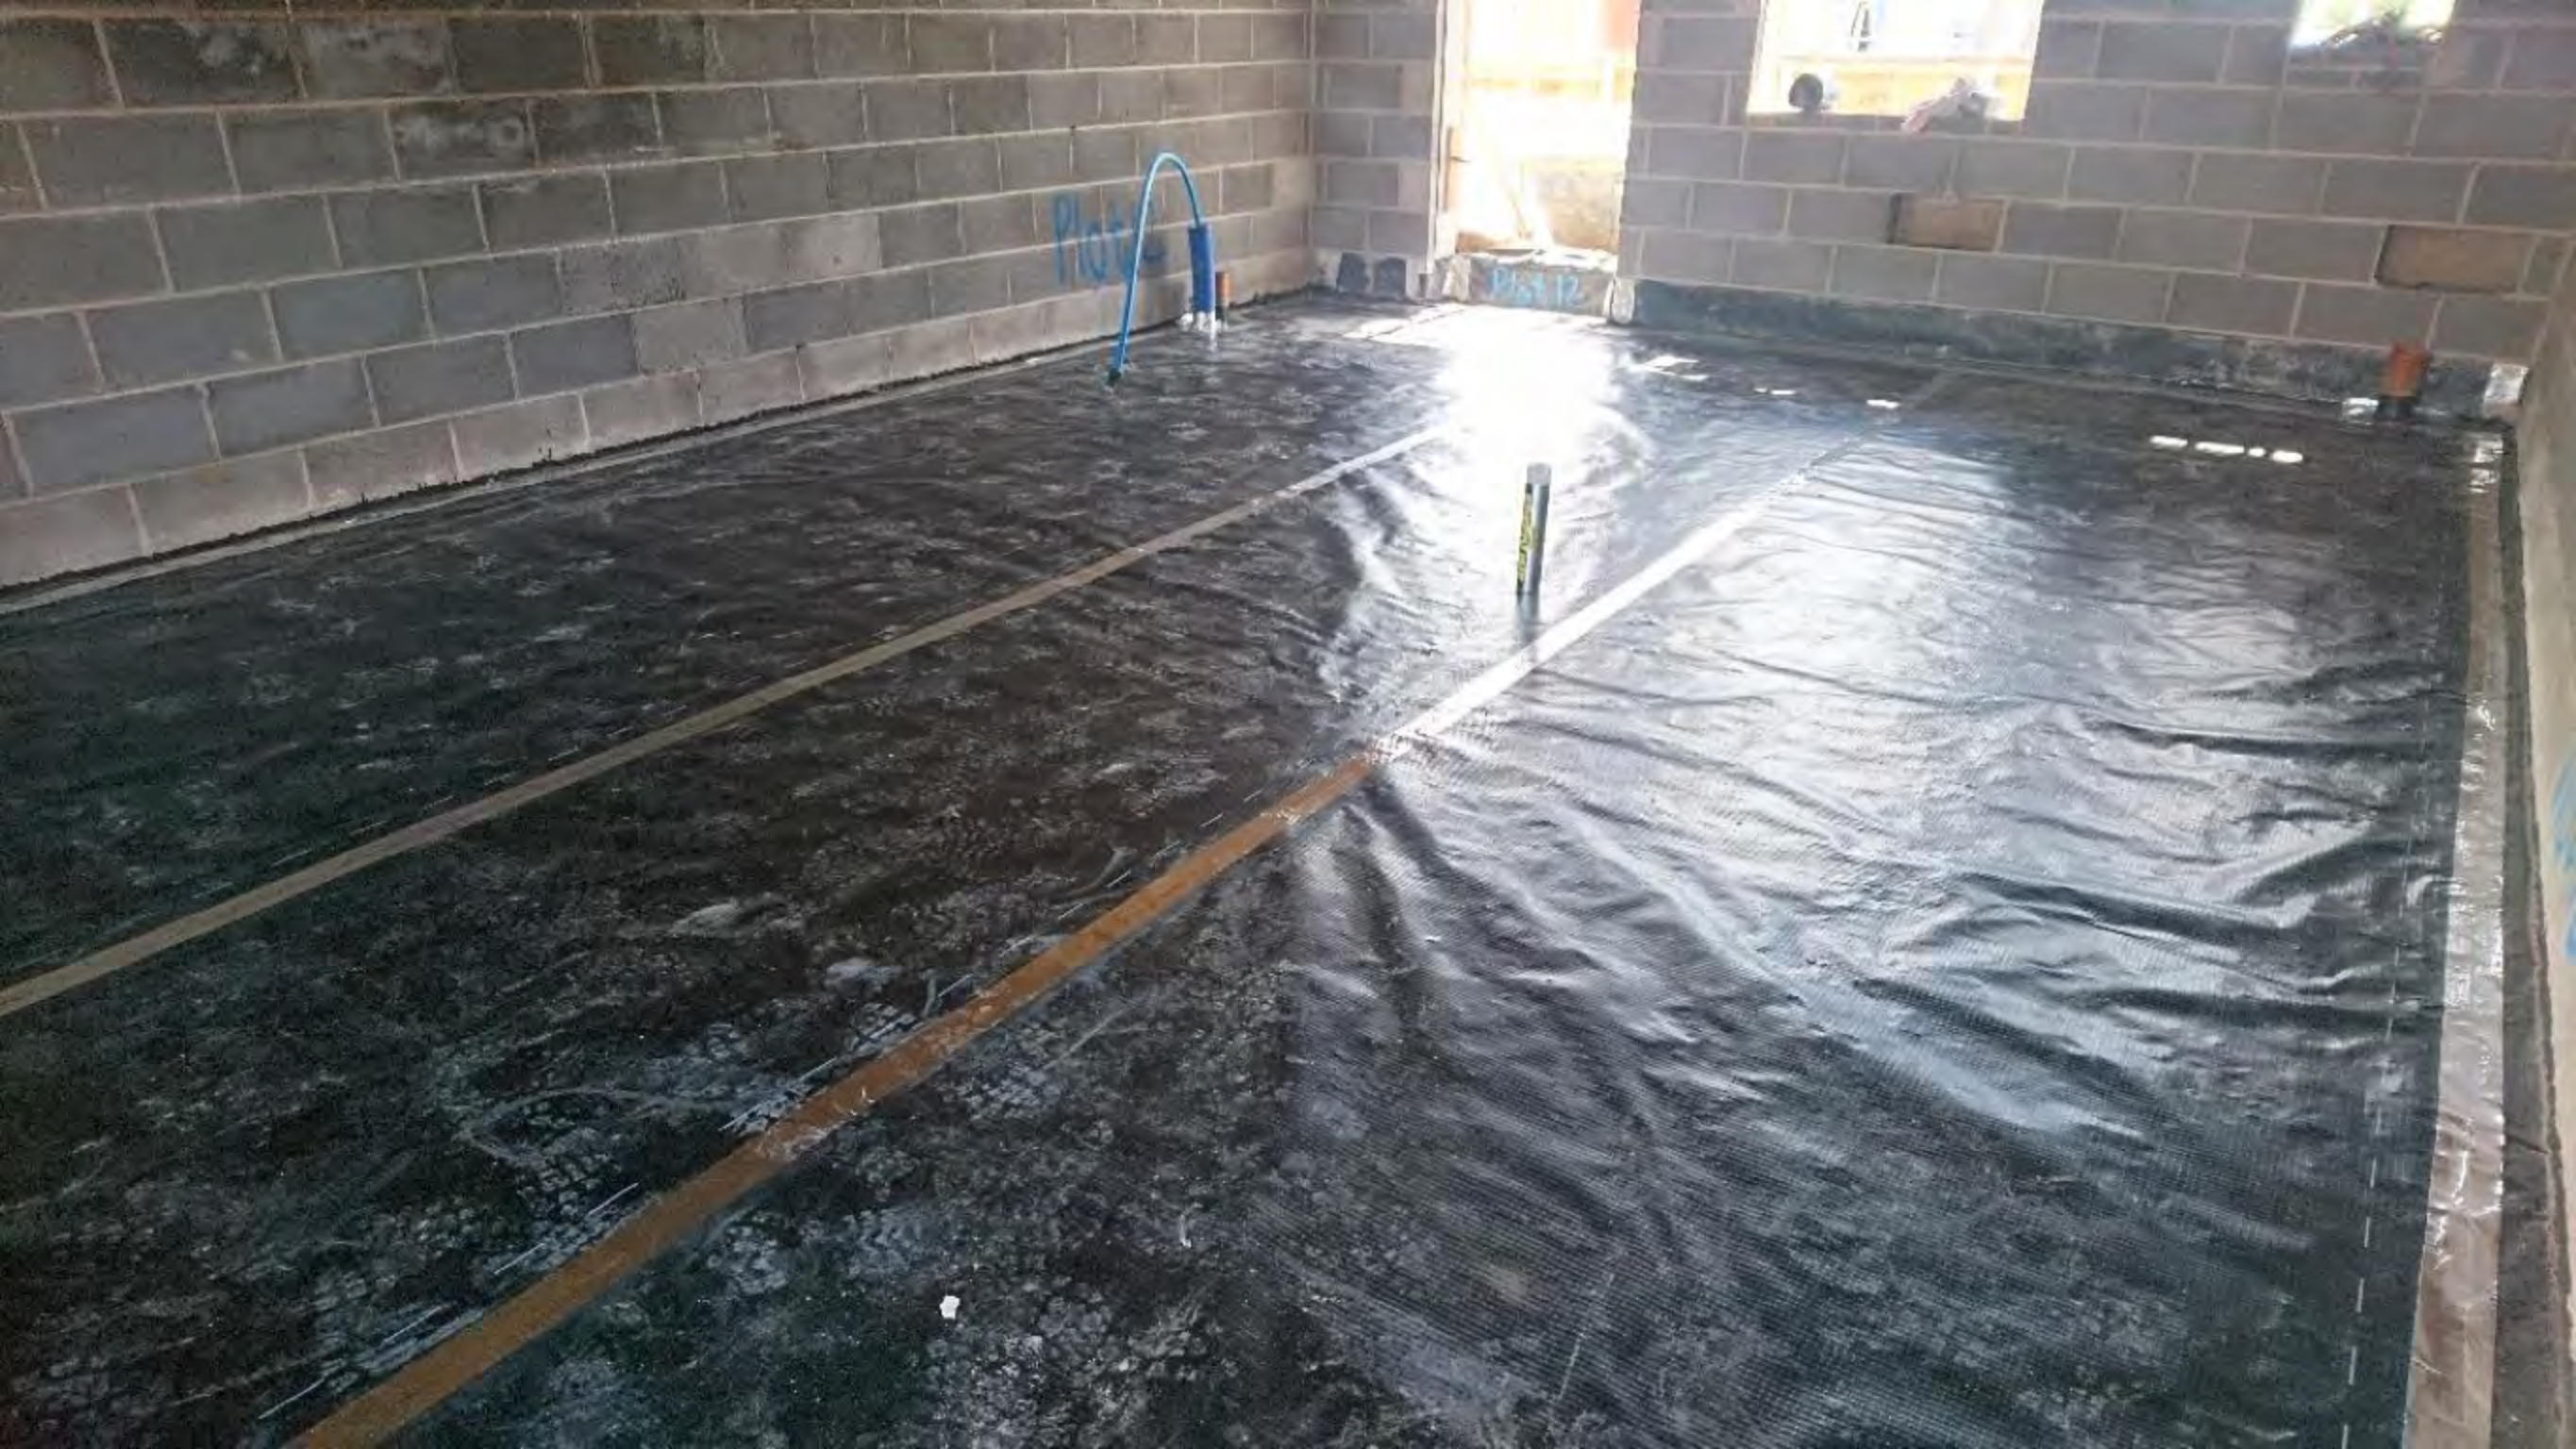
Plot 12

| 2.9 | Repairs or Corrections: | <u>ONE REPAIR IN DROUWAY - SEE PHOTOS ATTACHED.</u> | | | | | |
