**This Record sheet is only applicable to block and beam floor slabs for Characteristic Situation 2 gas protection systems**

**For Residential Development at New Church Street, Radcliffe.**

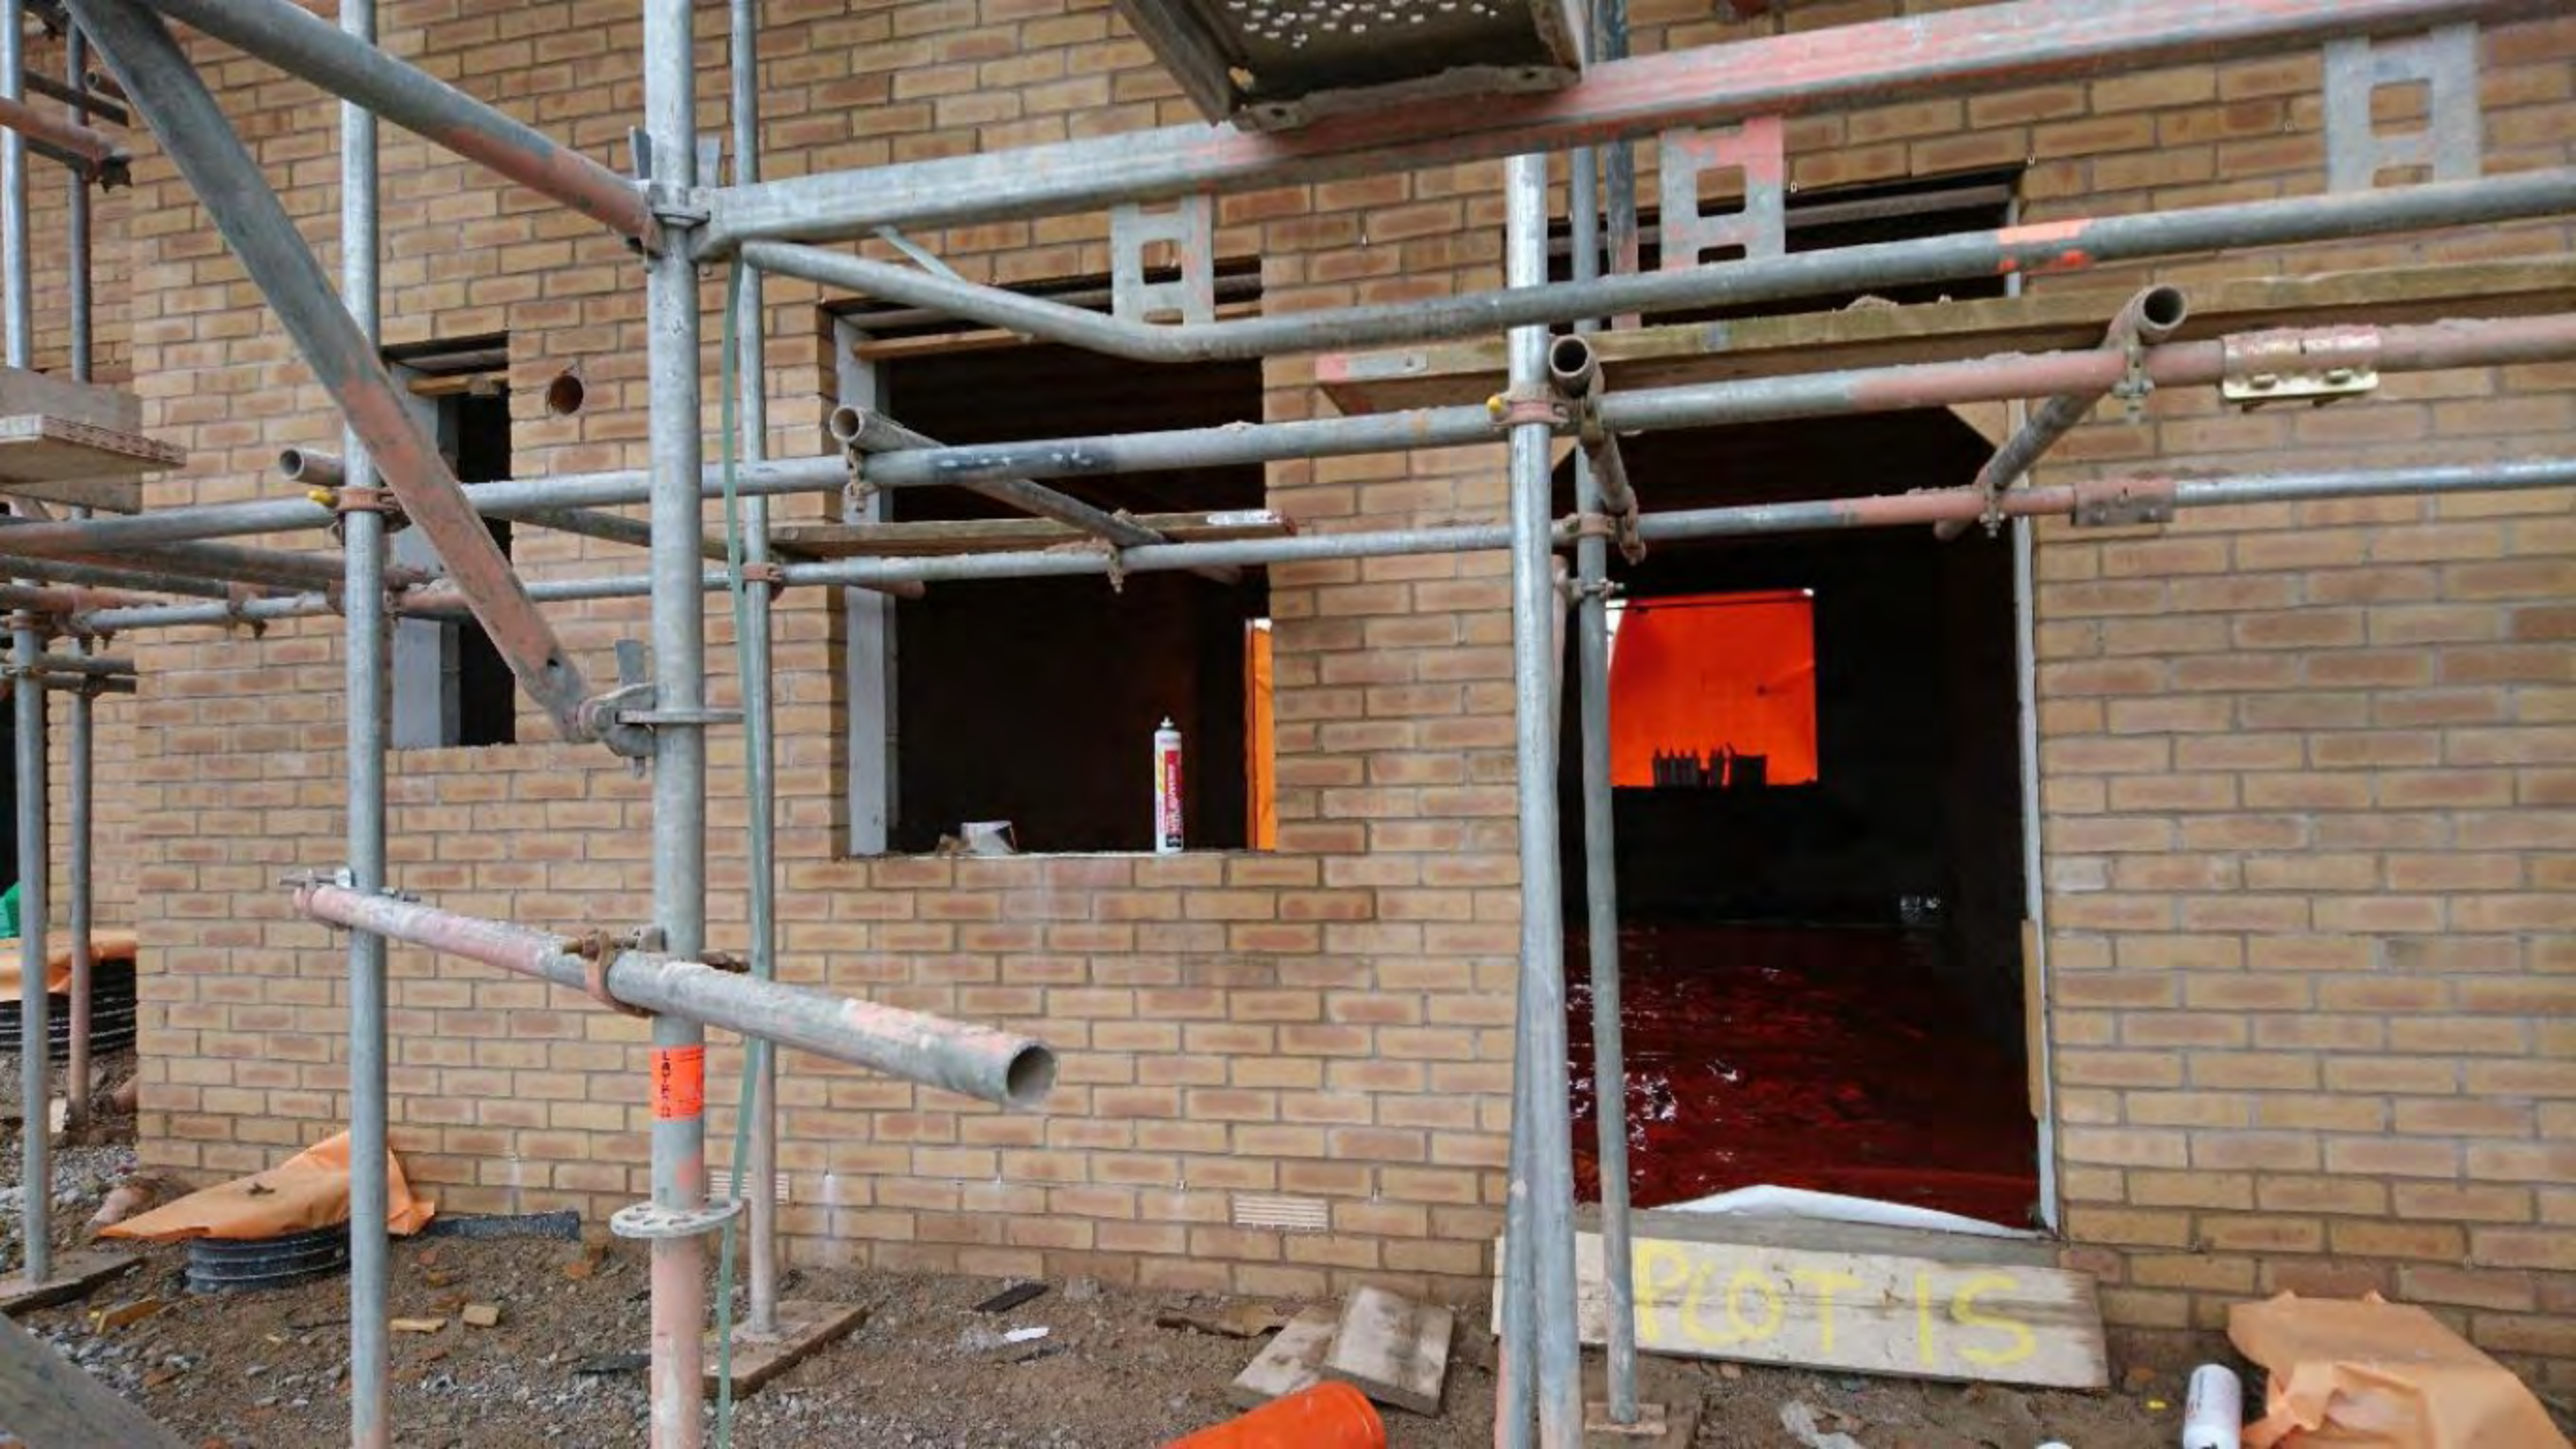
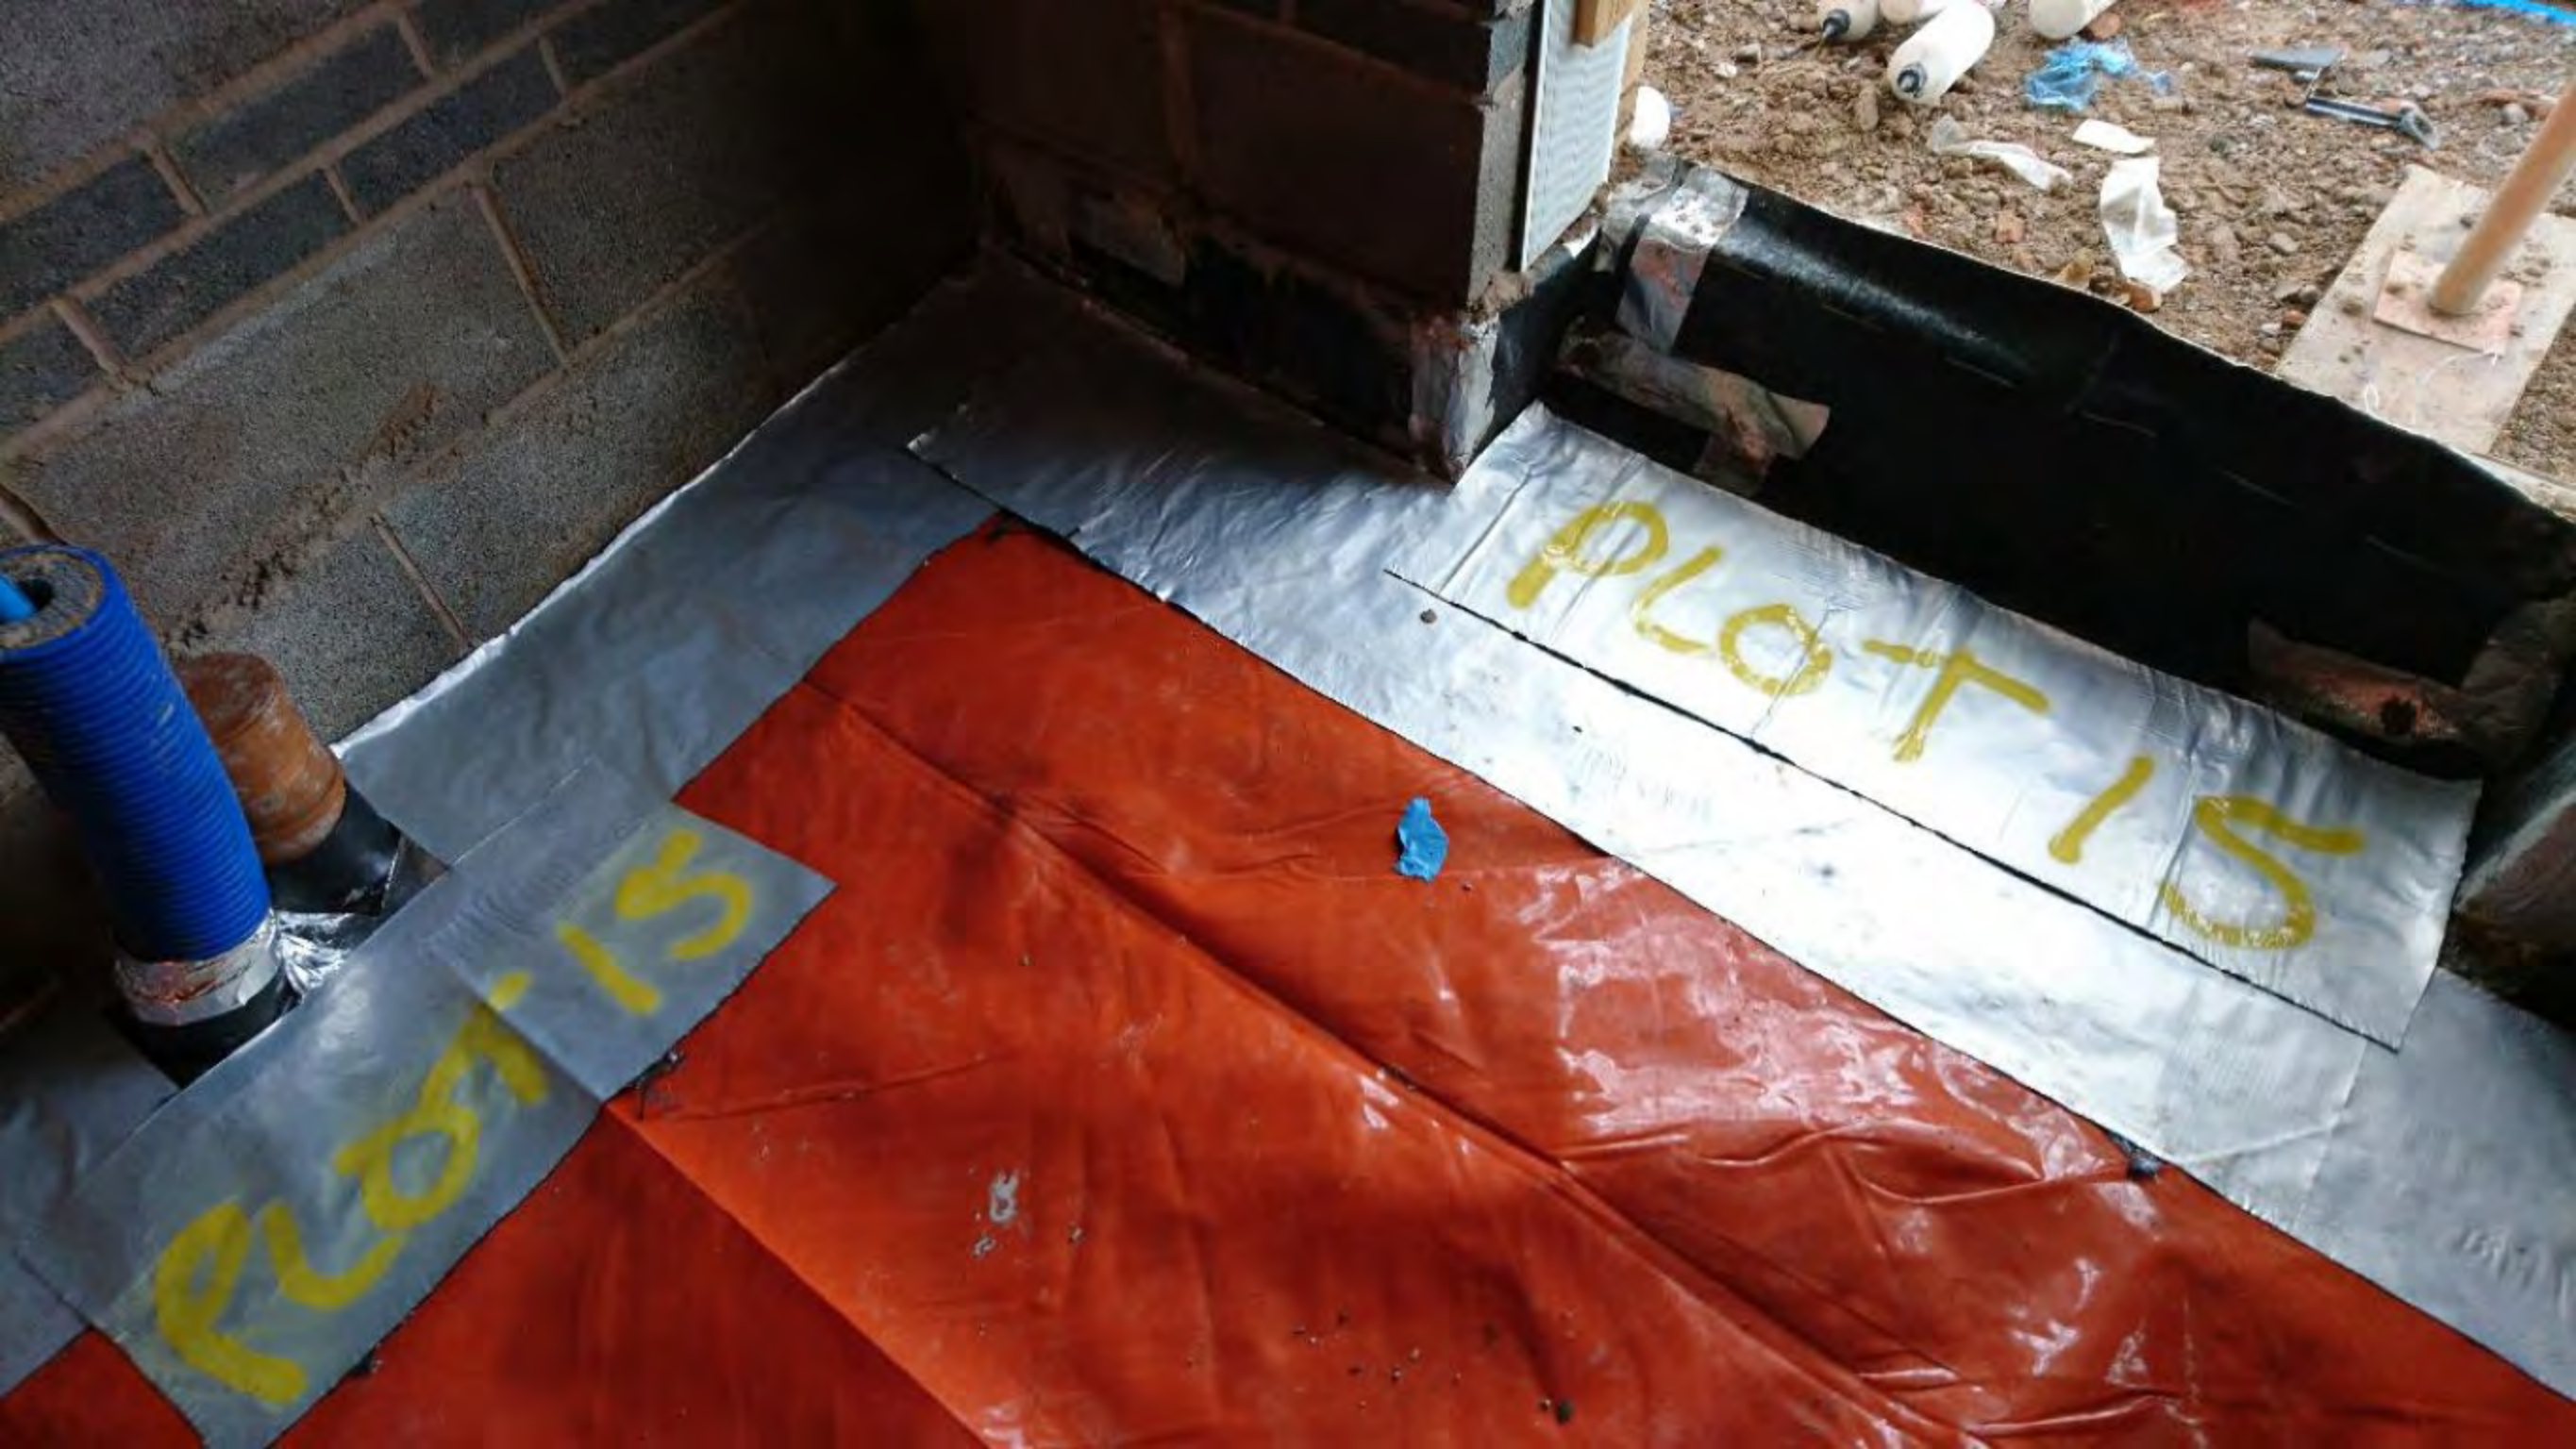
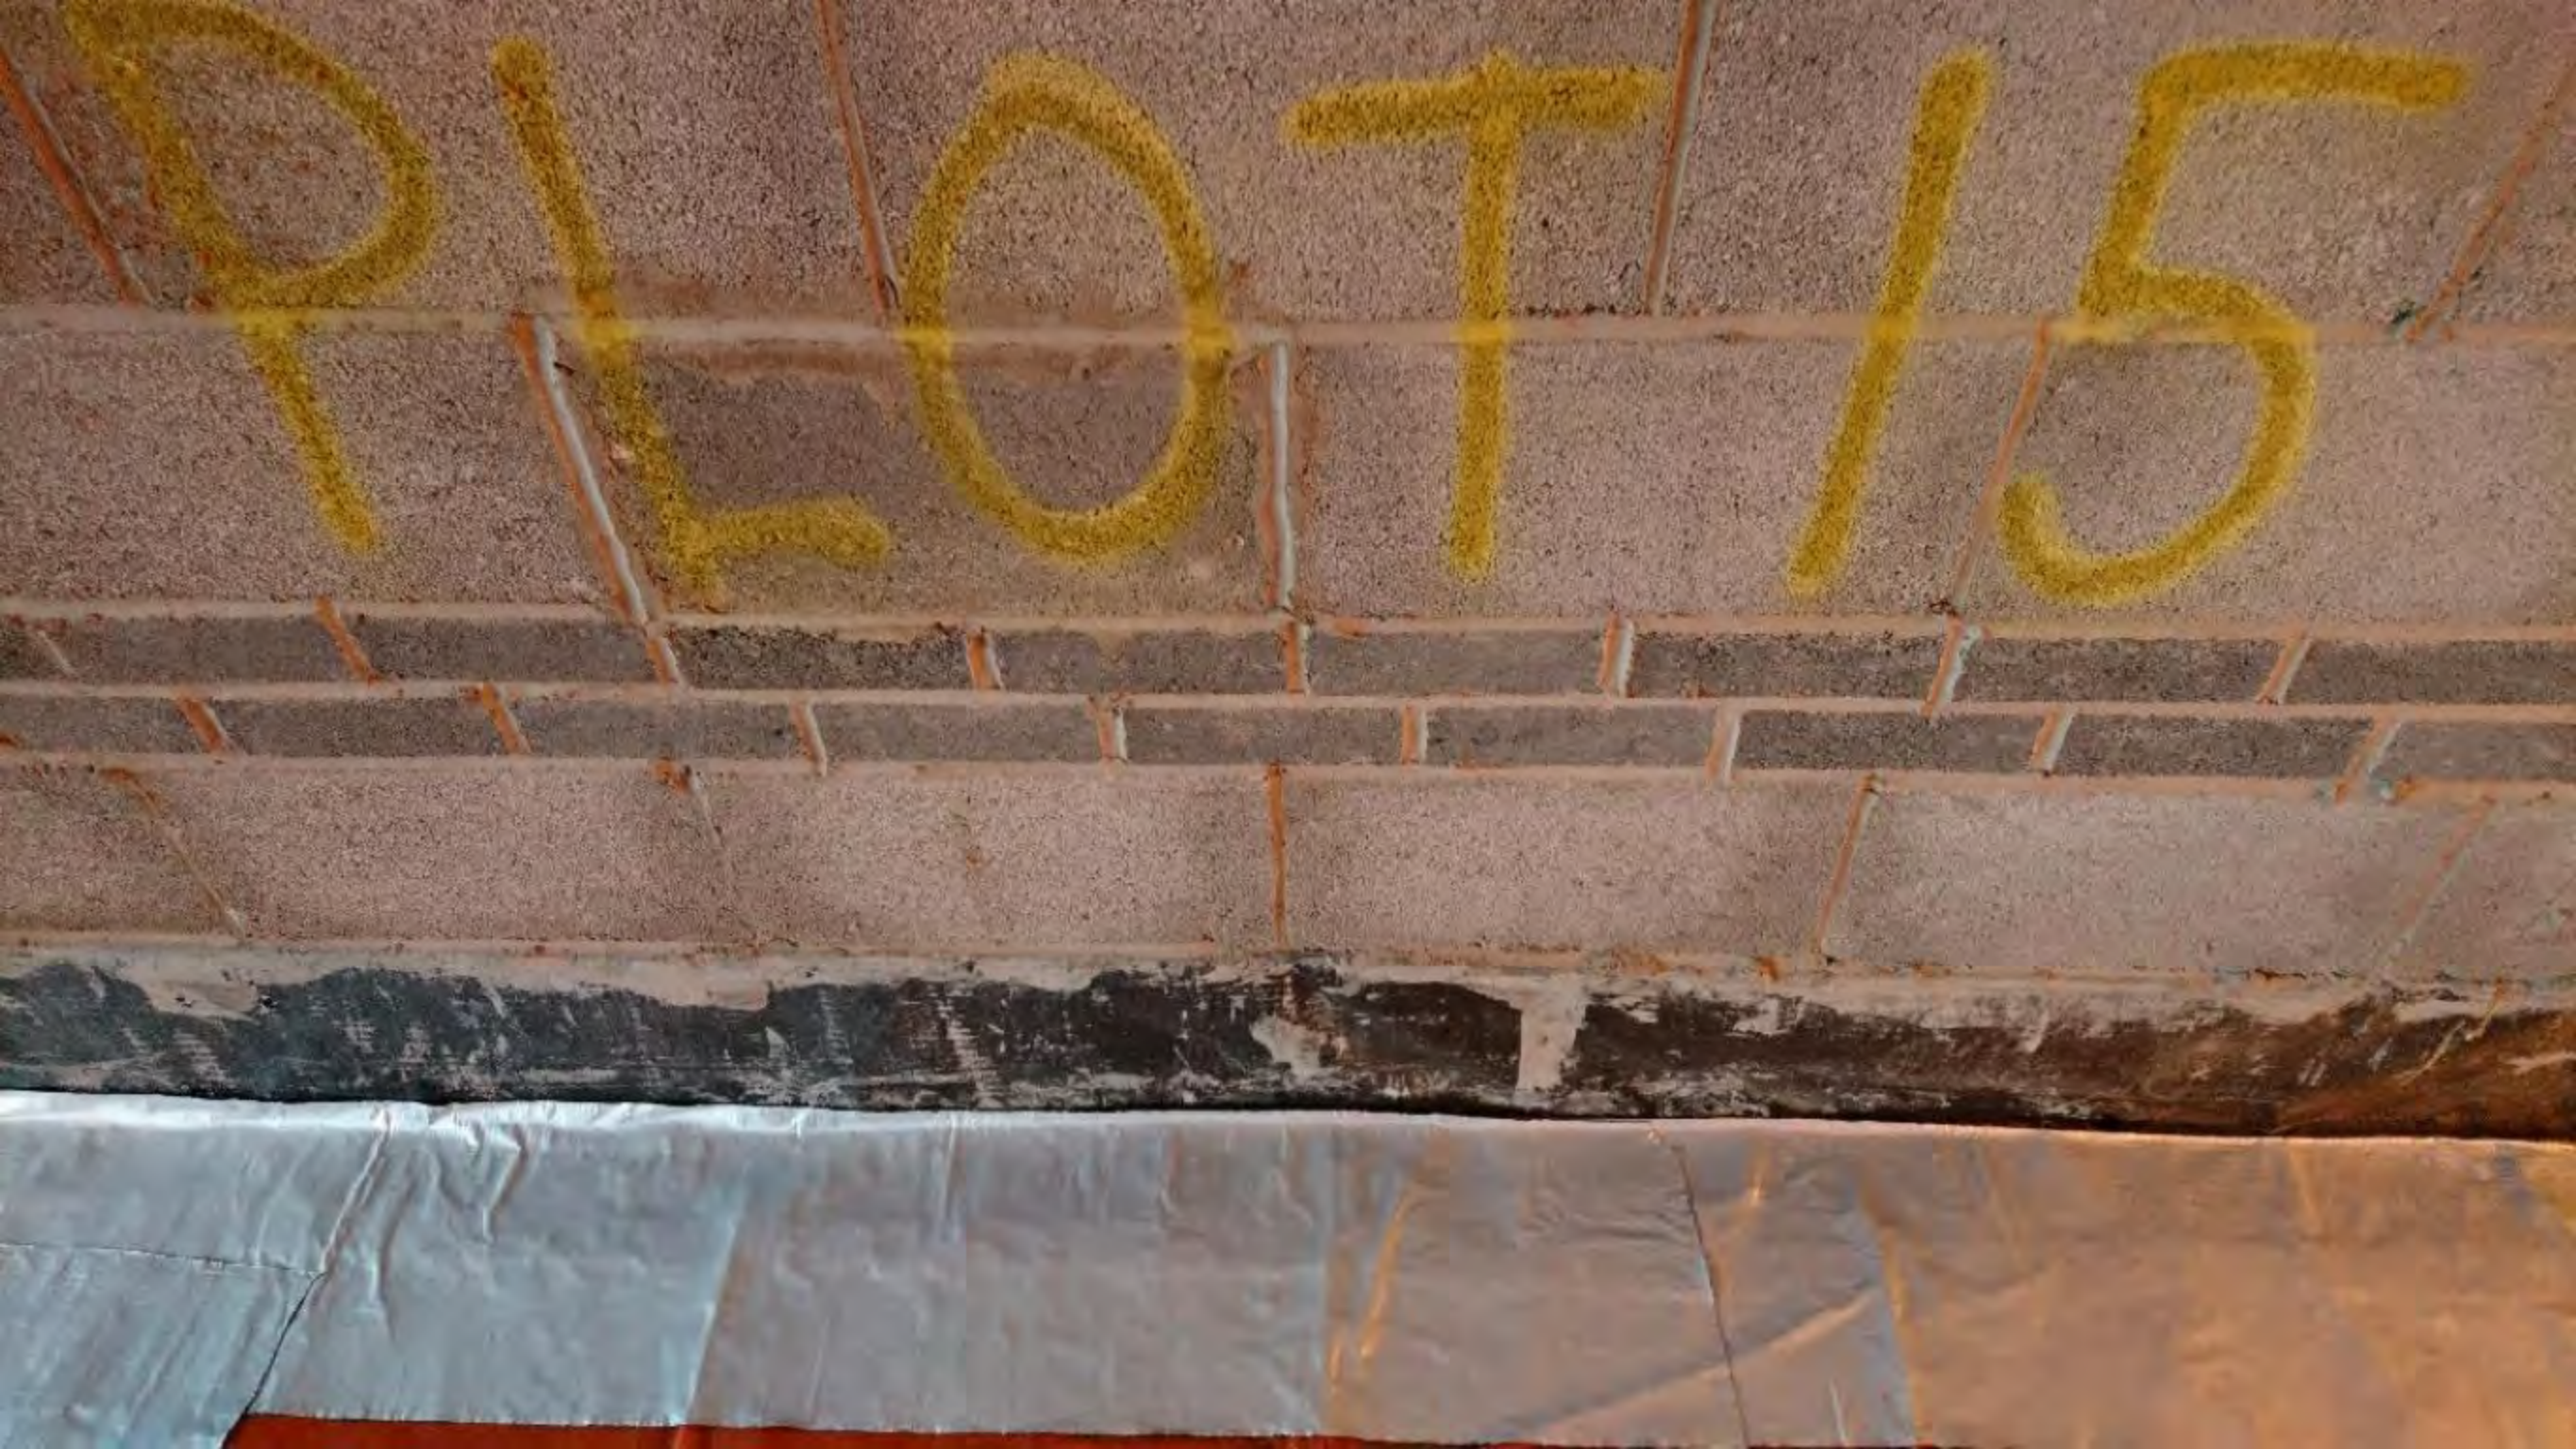
PLOT 15

| 2.6 | Condition of joints/seals | <u>CREASINE PRESENT, SO 300mm RADBAR DETAILING TAPE APPLIED ON FULL PERIMETER.</u> | | | | | |

| 2.9 | Repairs or Corrections: | <u>AS PER PHOTOS, ADDITIONAL 300mm RADBAR DETAILING TAPE USED AS SHOWN</u> | | | | | |

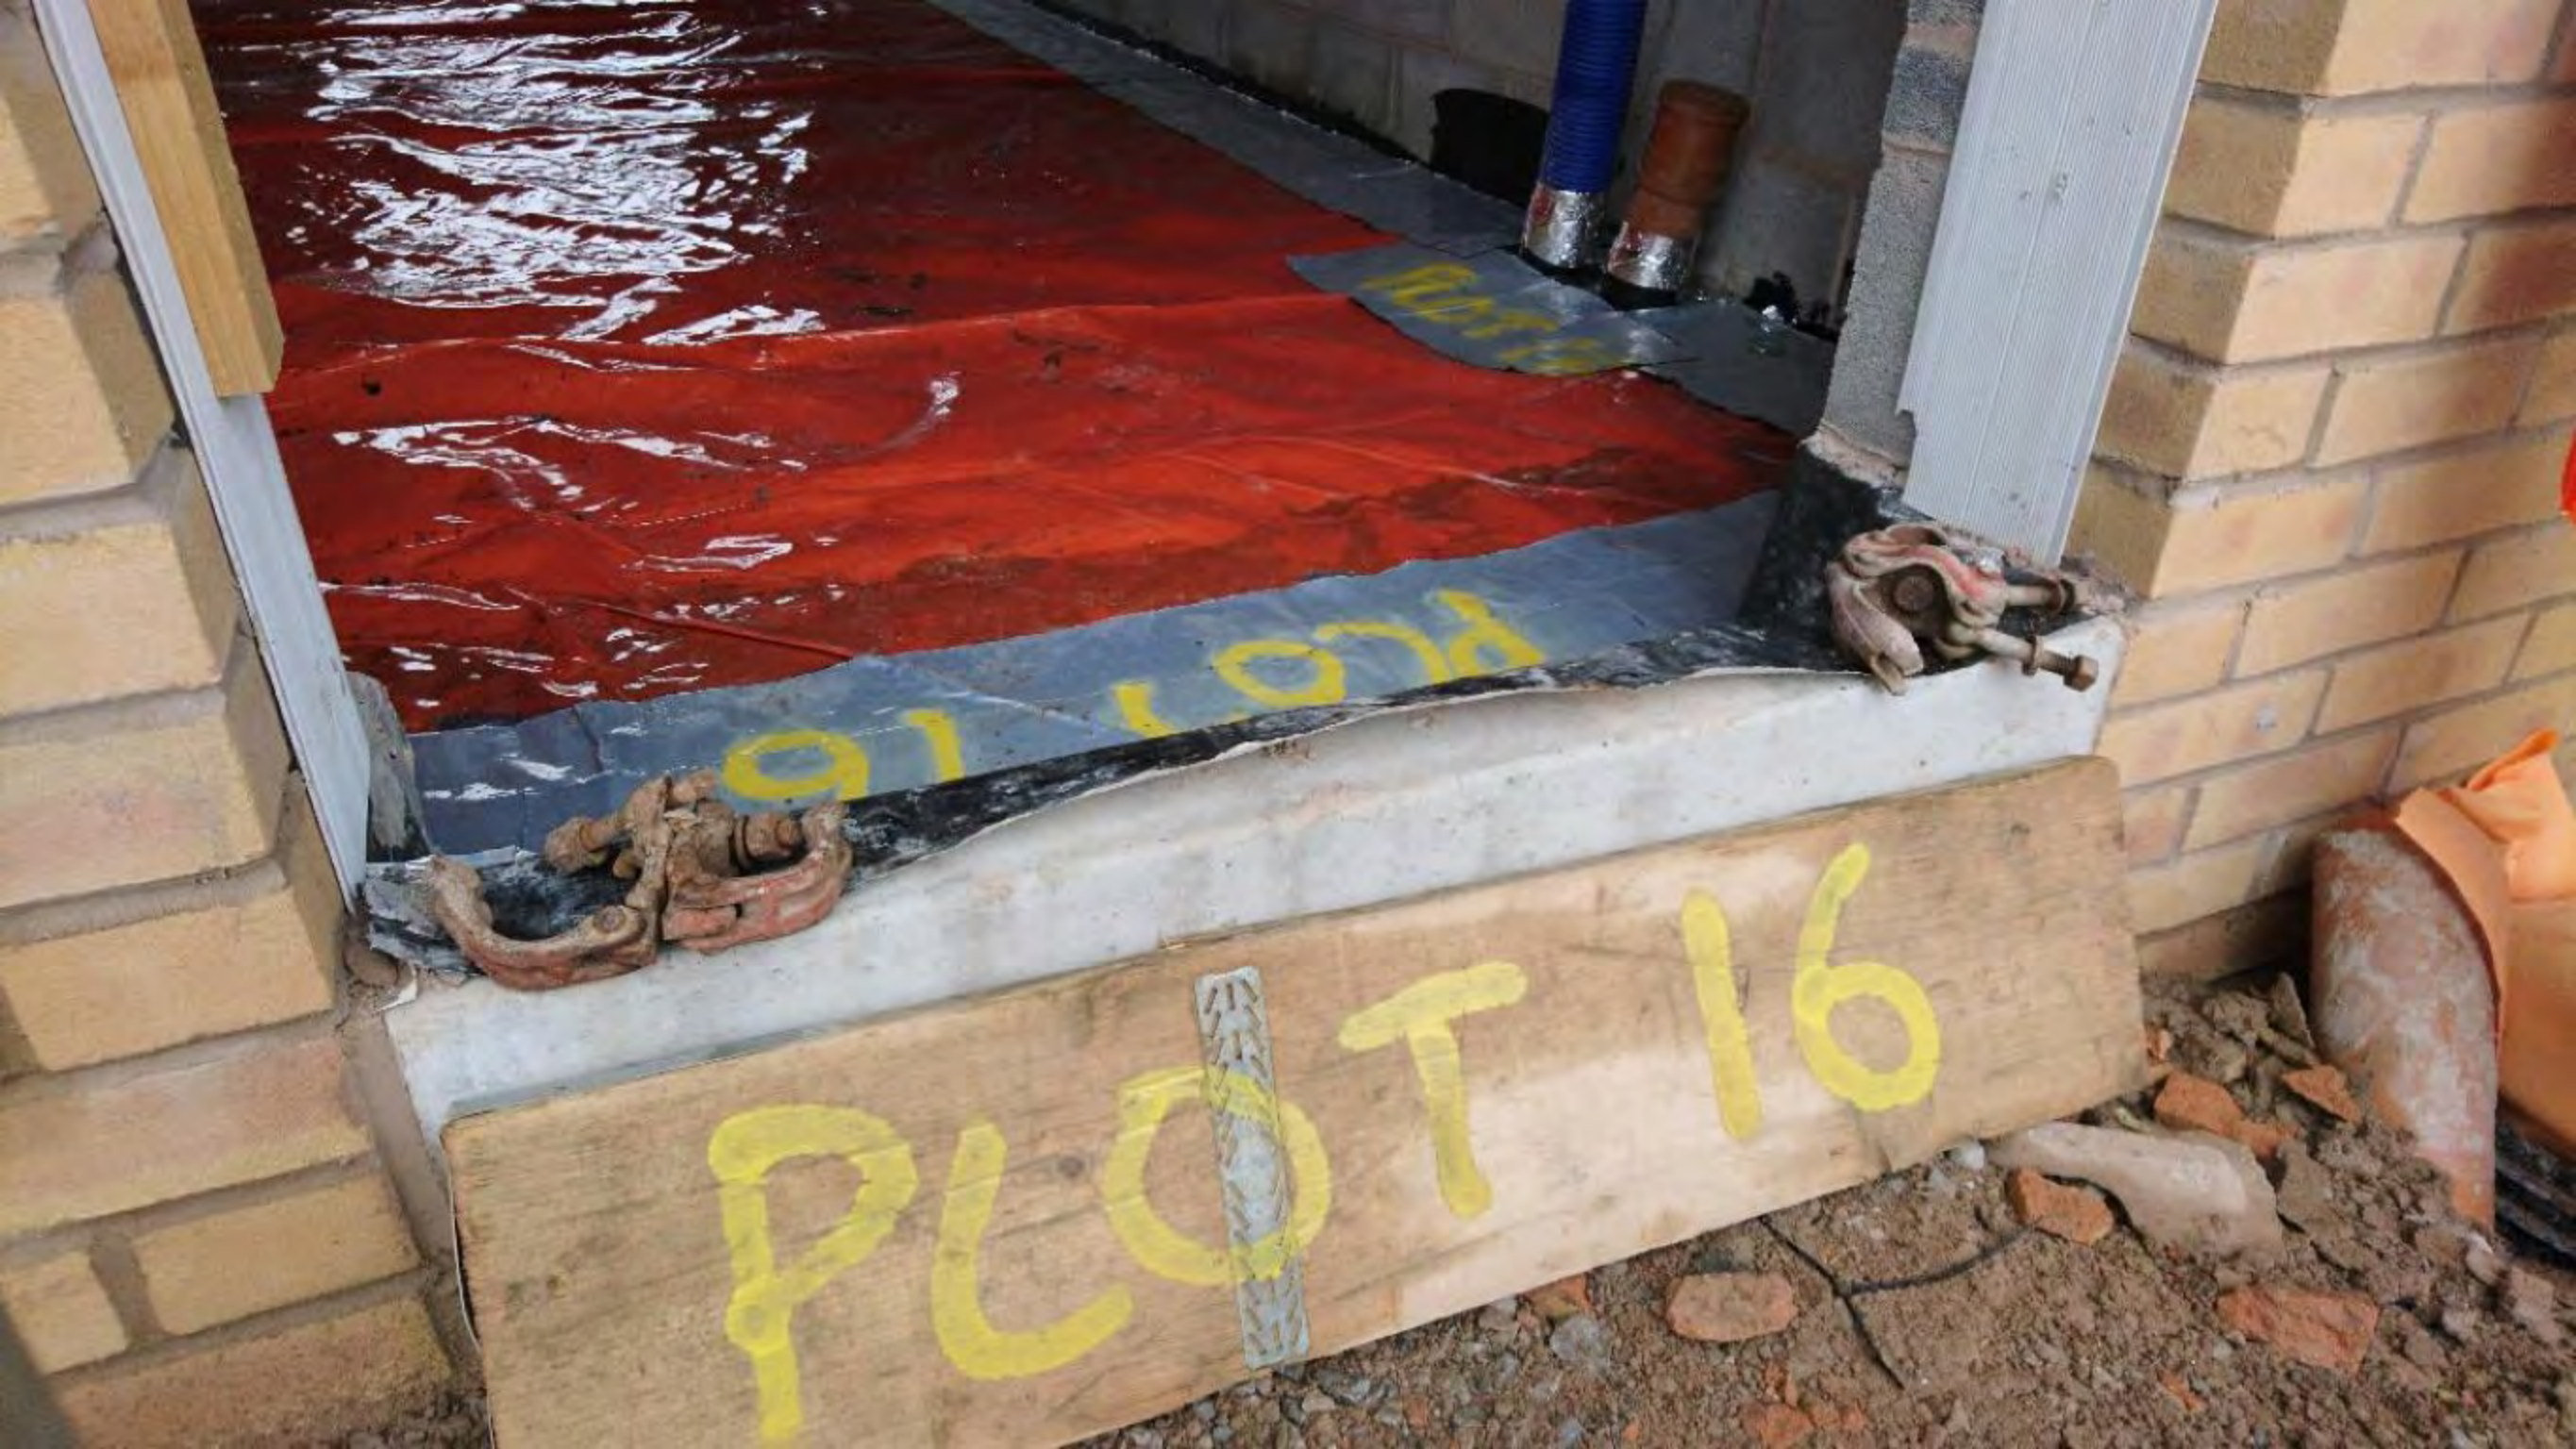
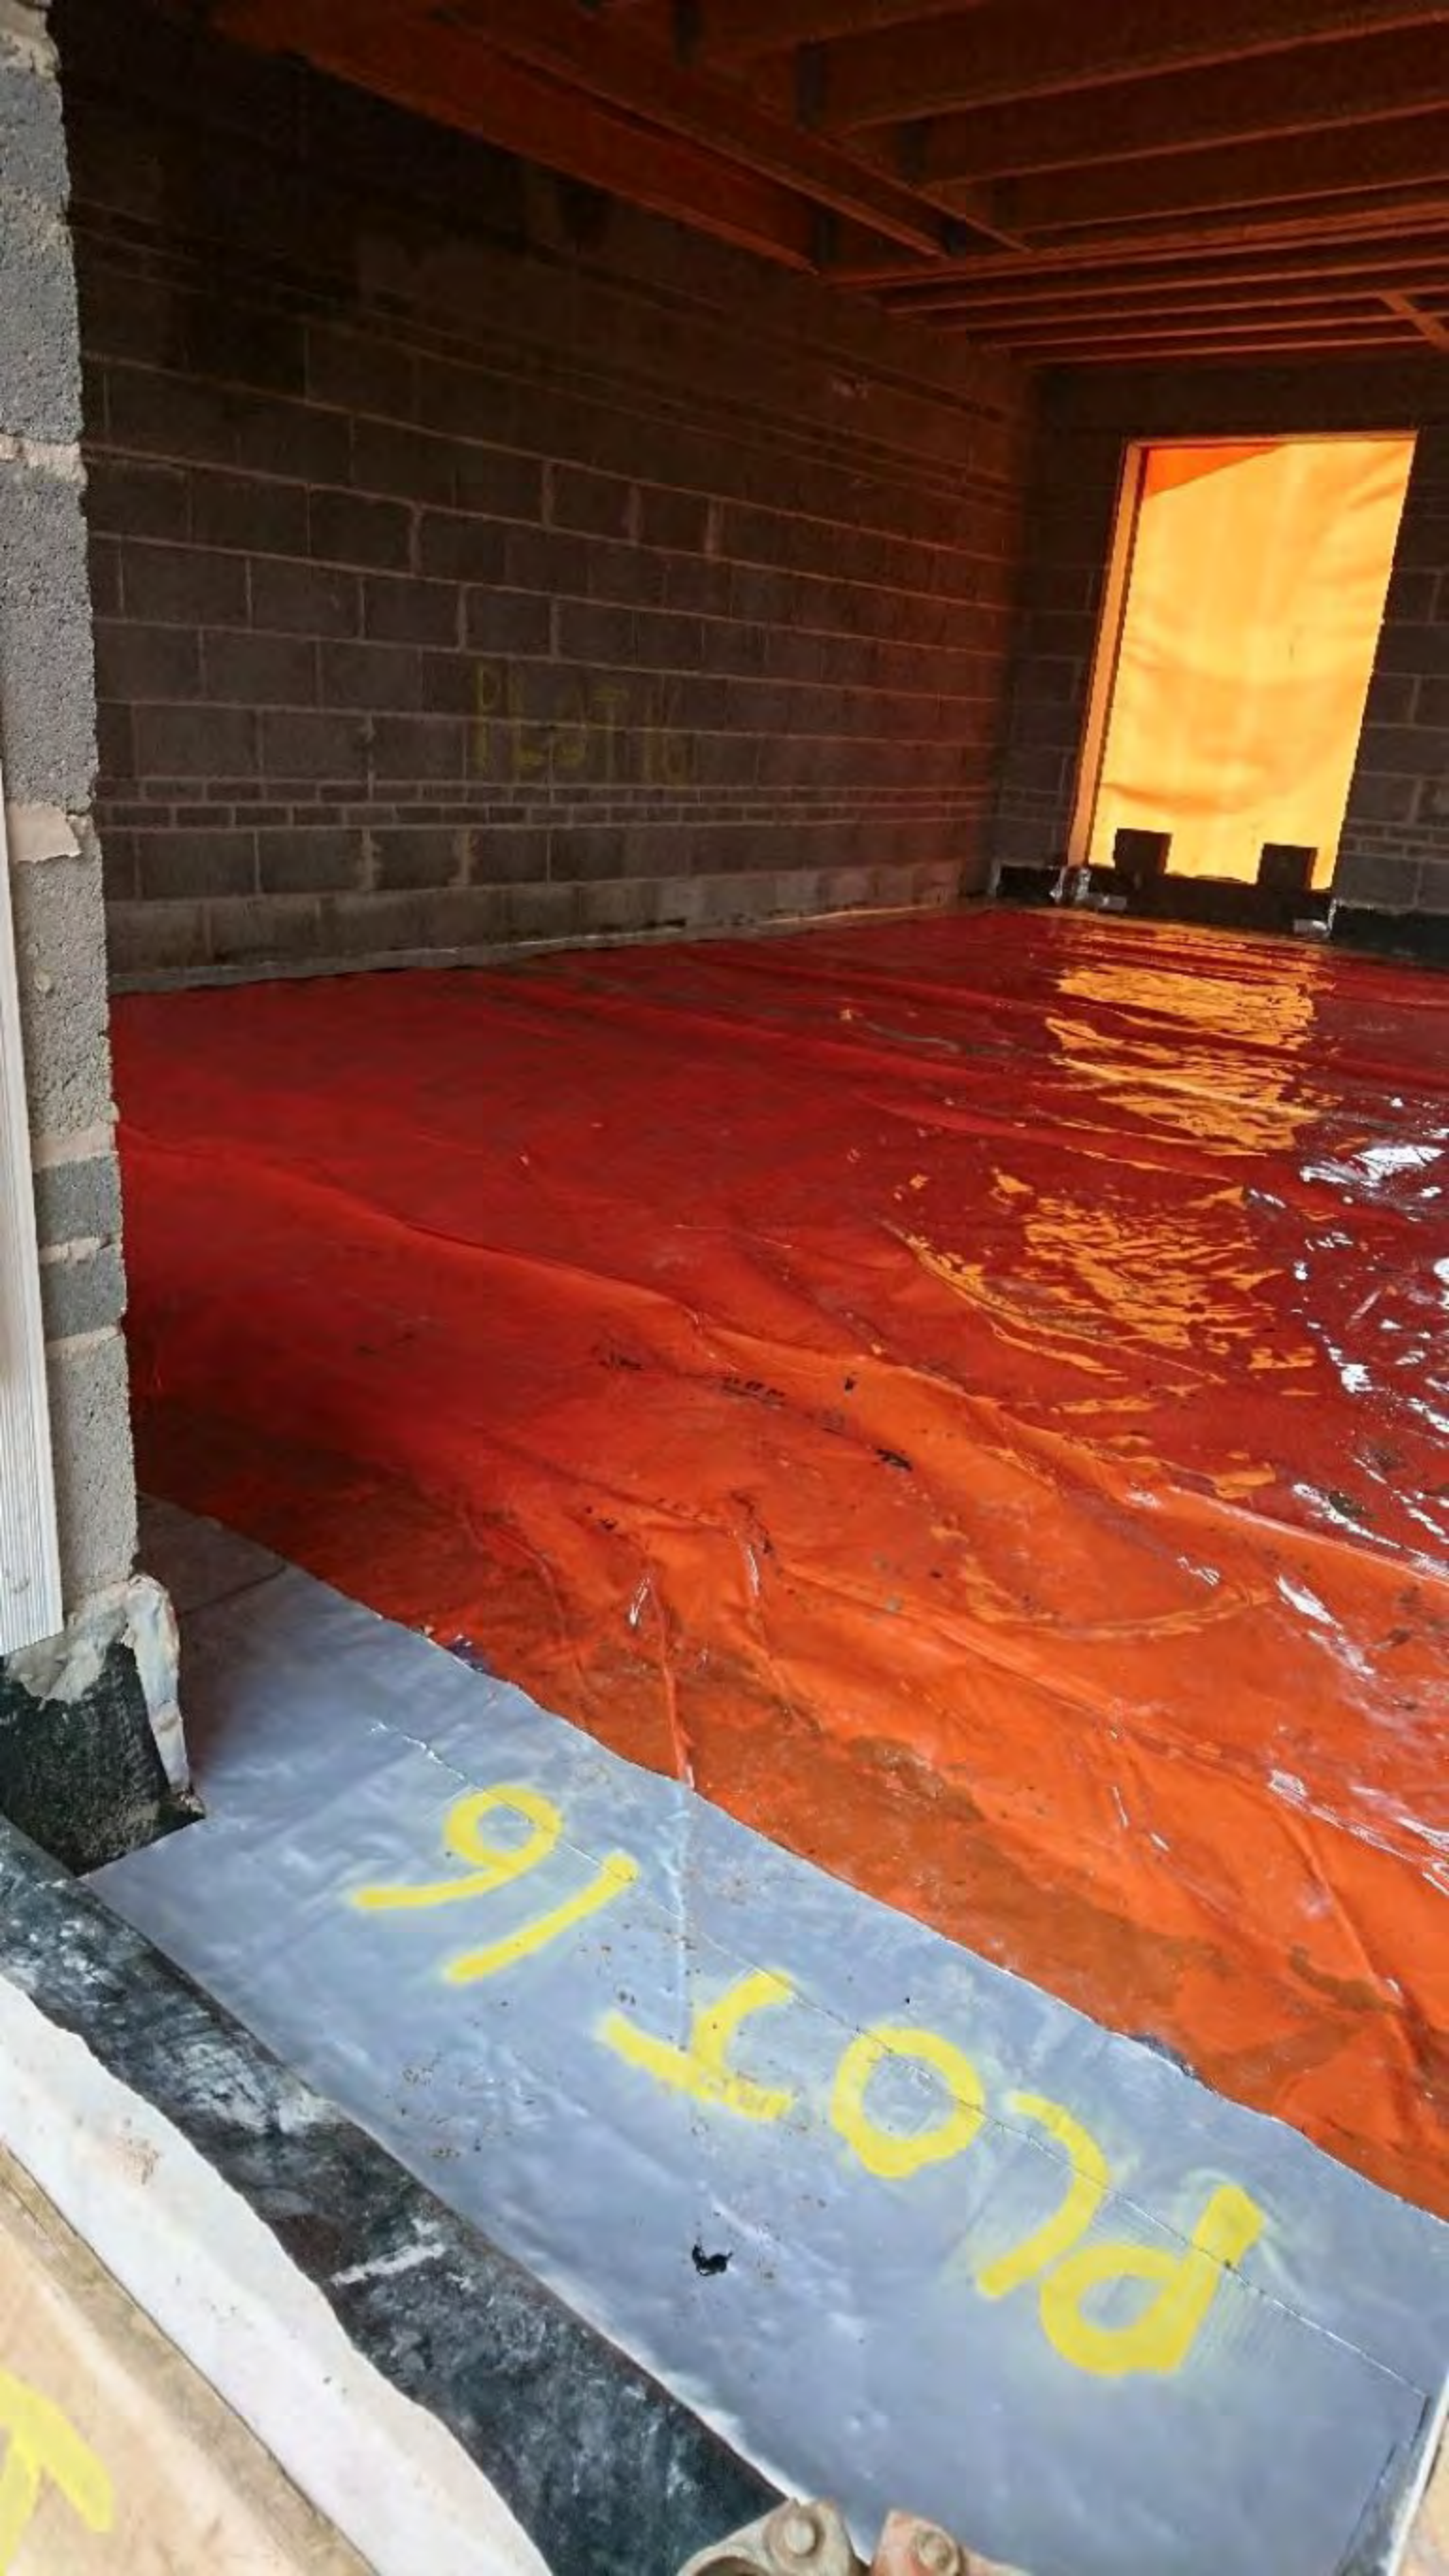
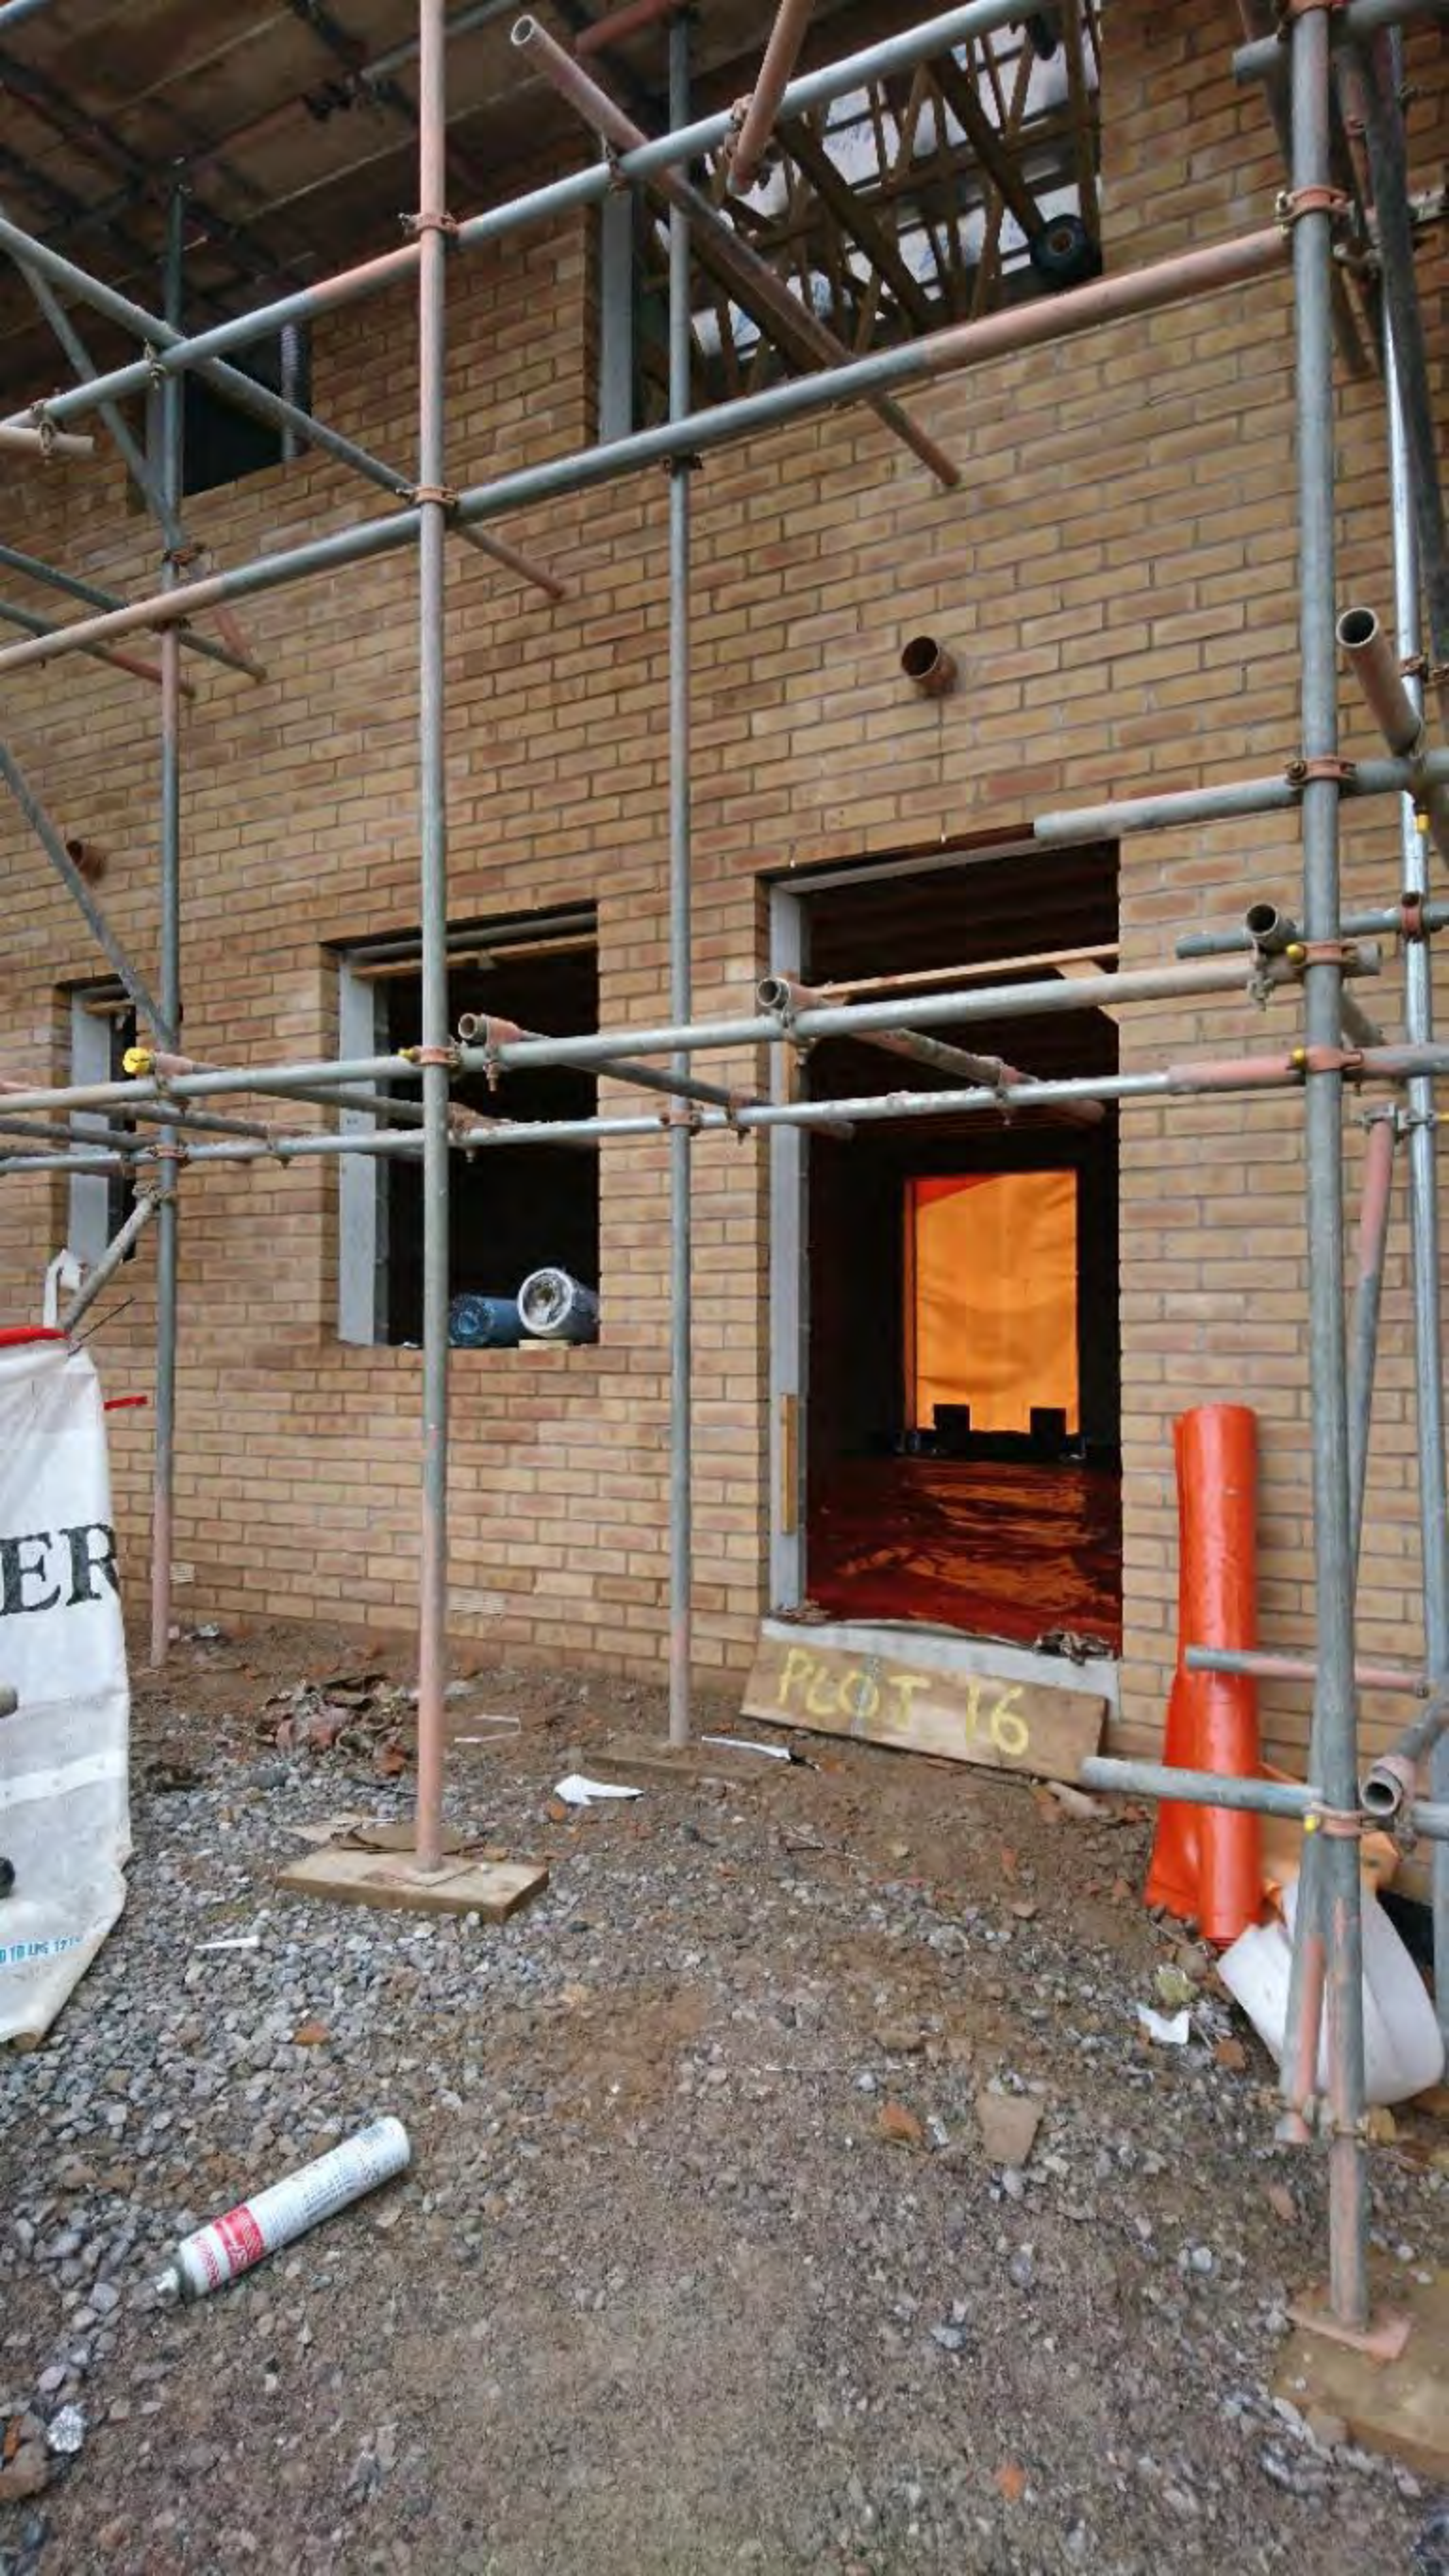
PLOT 16

| 2.6 | Condition of joints/seals | <u>CREASED, 300mm DETAILING TAPE (RADBAR) APPLIED ON FULL PERIMETER TO PREVENT LEAKAGE</u> | | | | | |

| 2.9 | Repairs or Corrections: | <u>AS PER PHOTO'S - 300mm DETAILING TAPE (RADBAR) USED ON PERIMETER.</u> | | | | | |
