## Gas Protection - Validation Record Sheet

**This Record sheet is only applicable to block and beam floor slabs for Characteristic Situation 2 gas protection systems**

**For Residential Development at New Church Street, Radcliffe.**

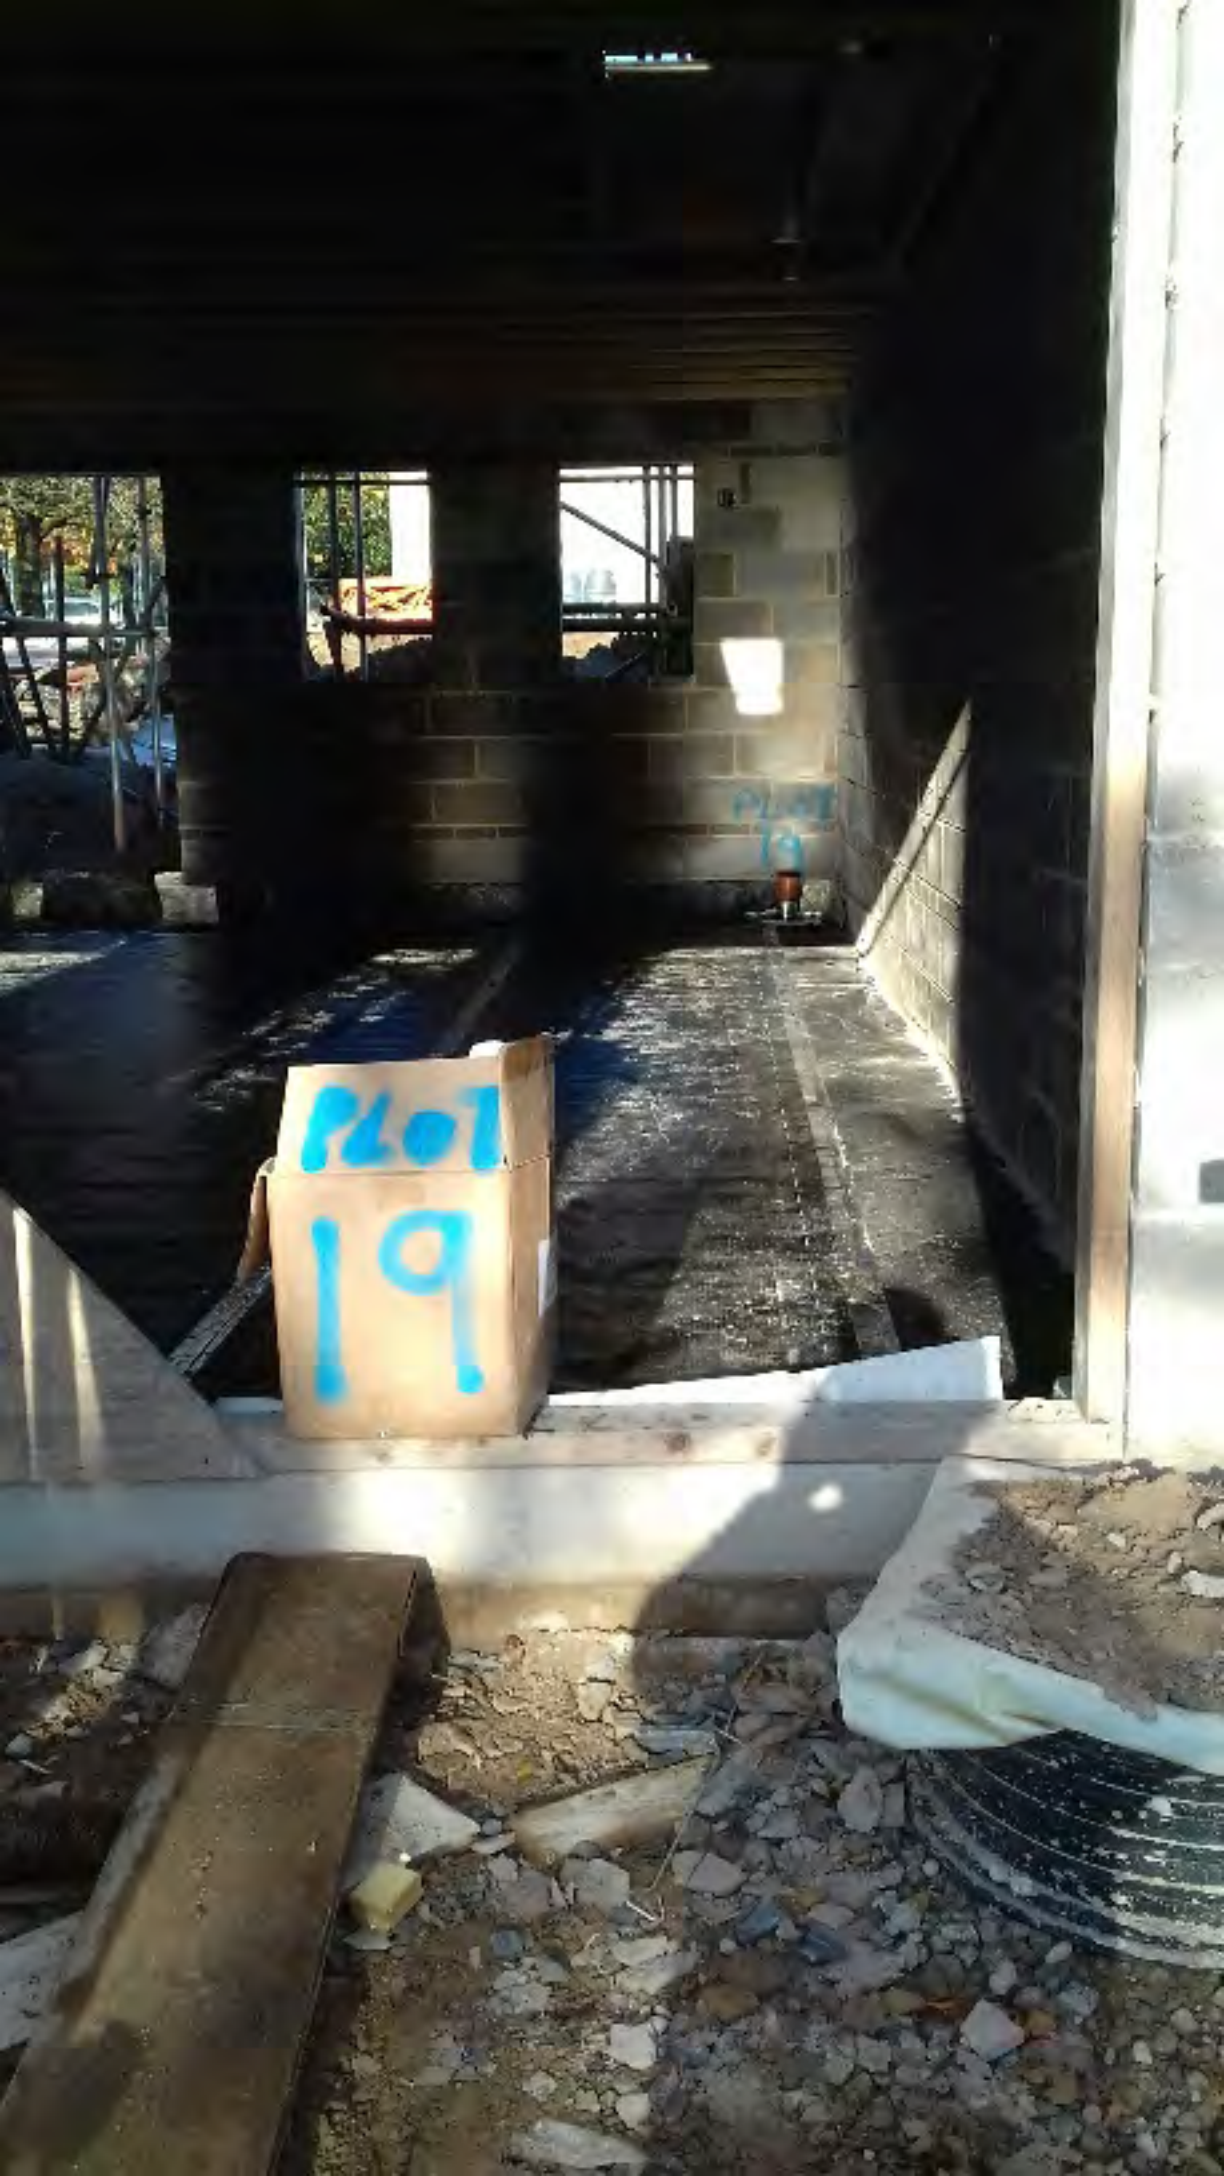
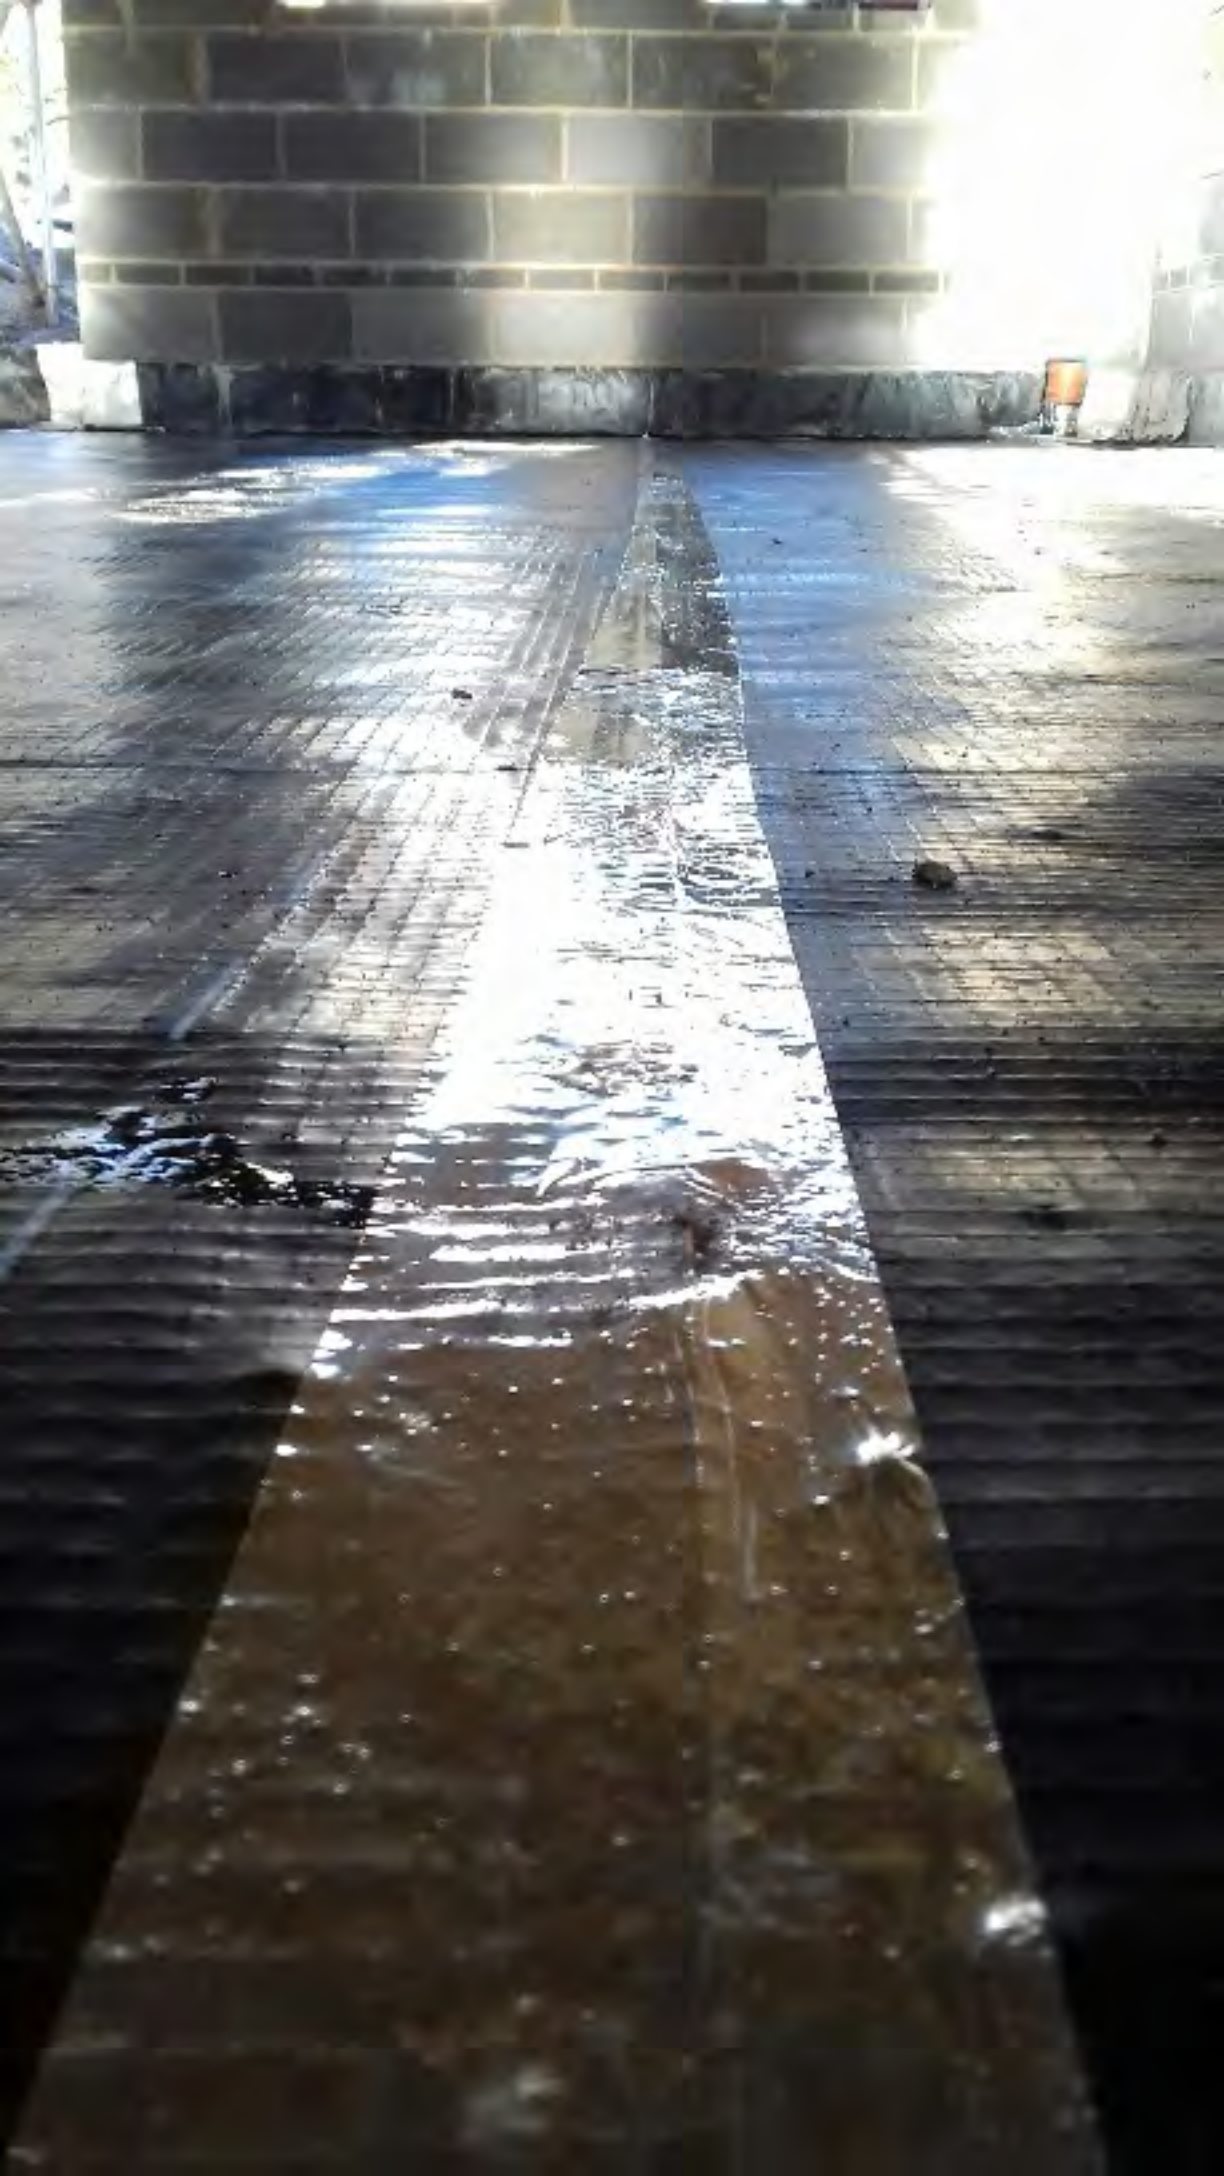
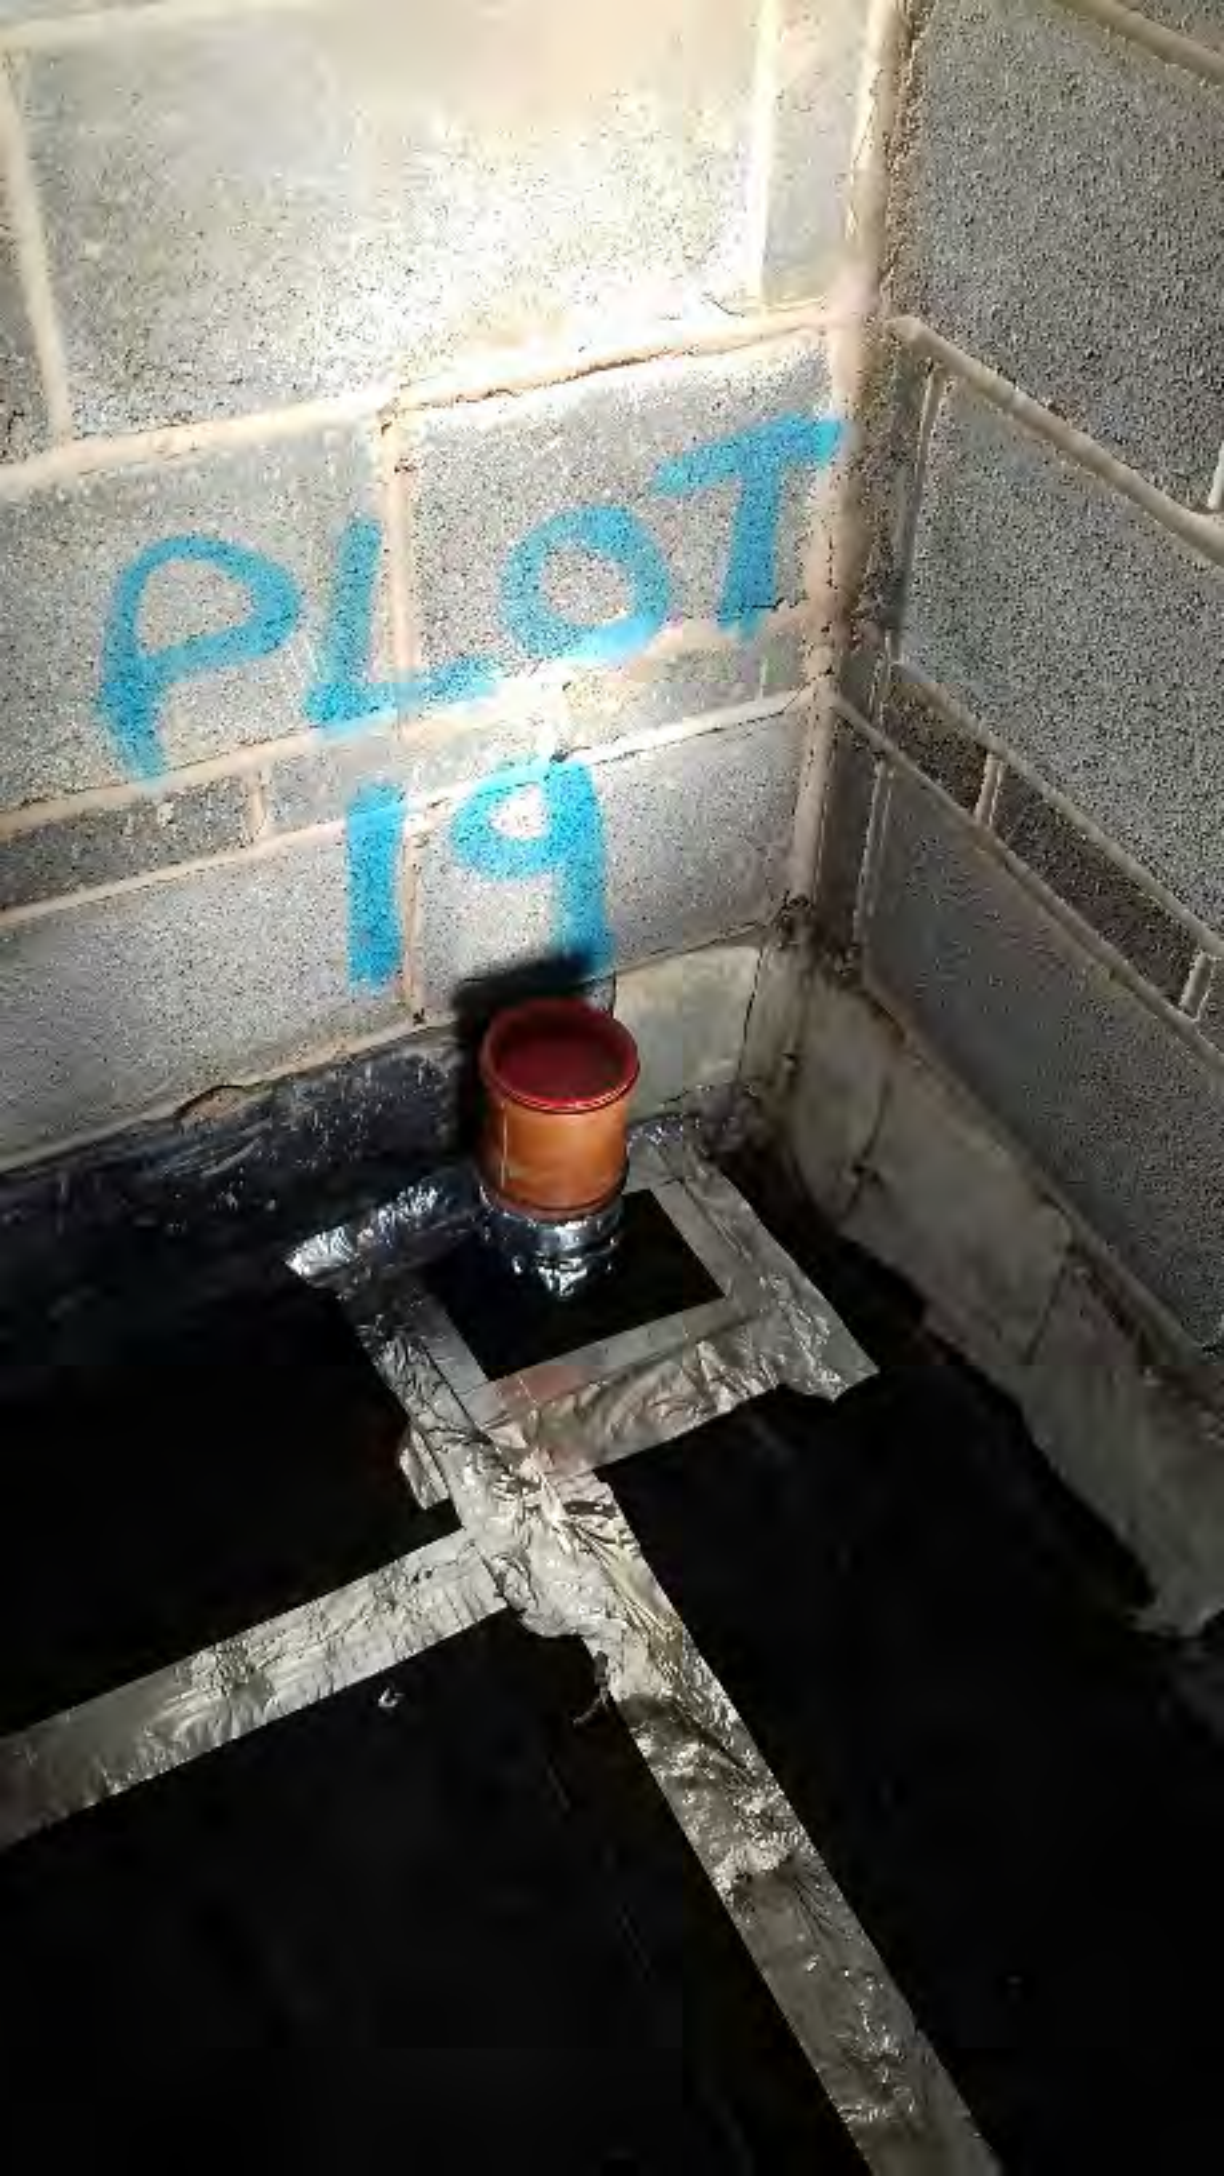
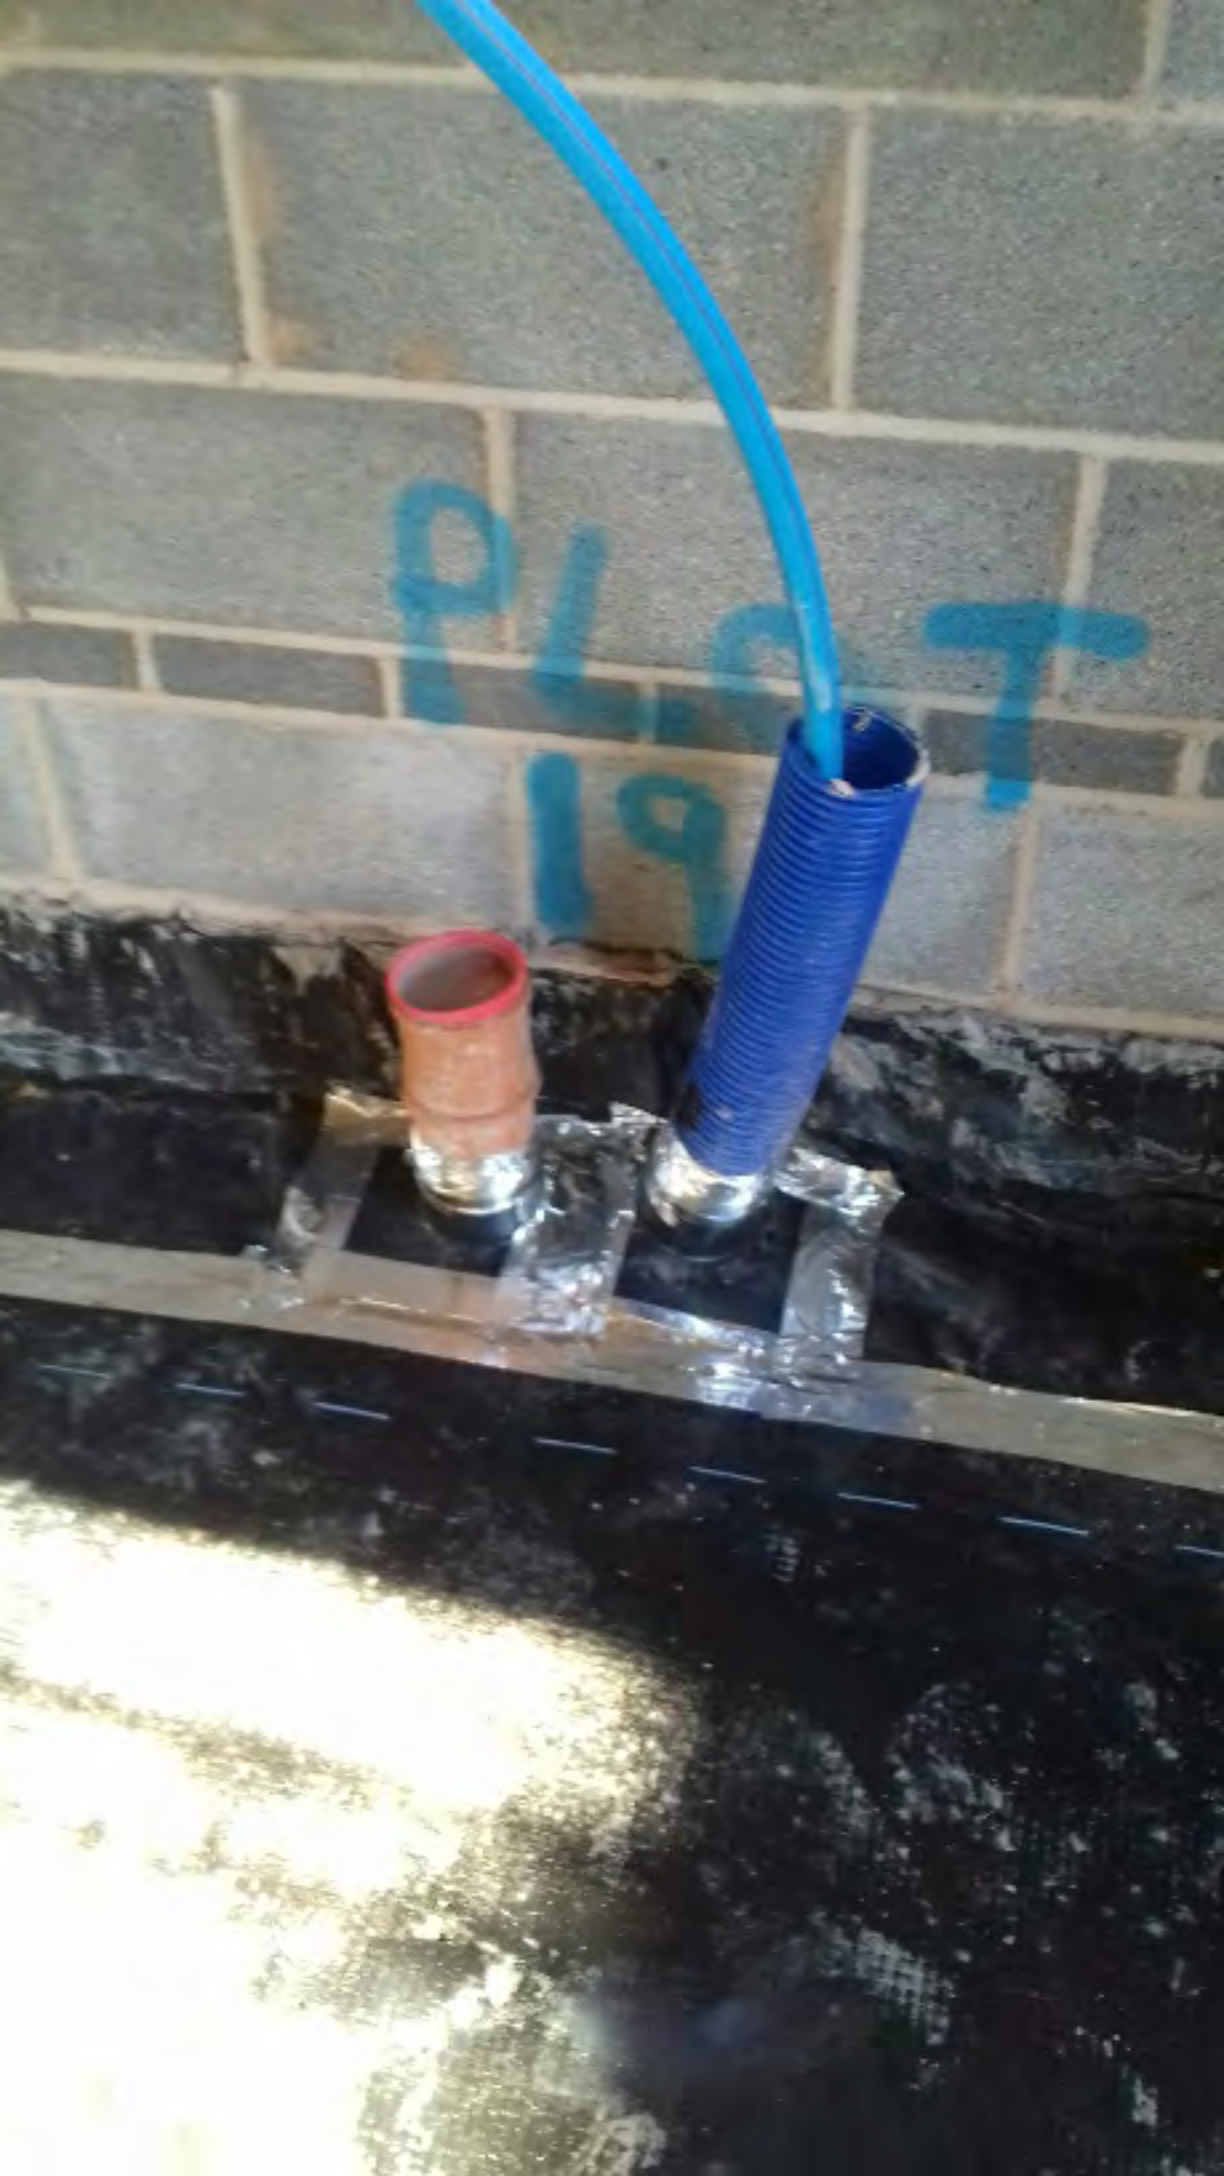
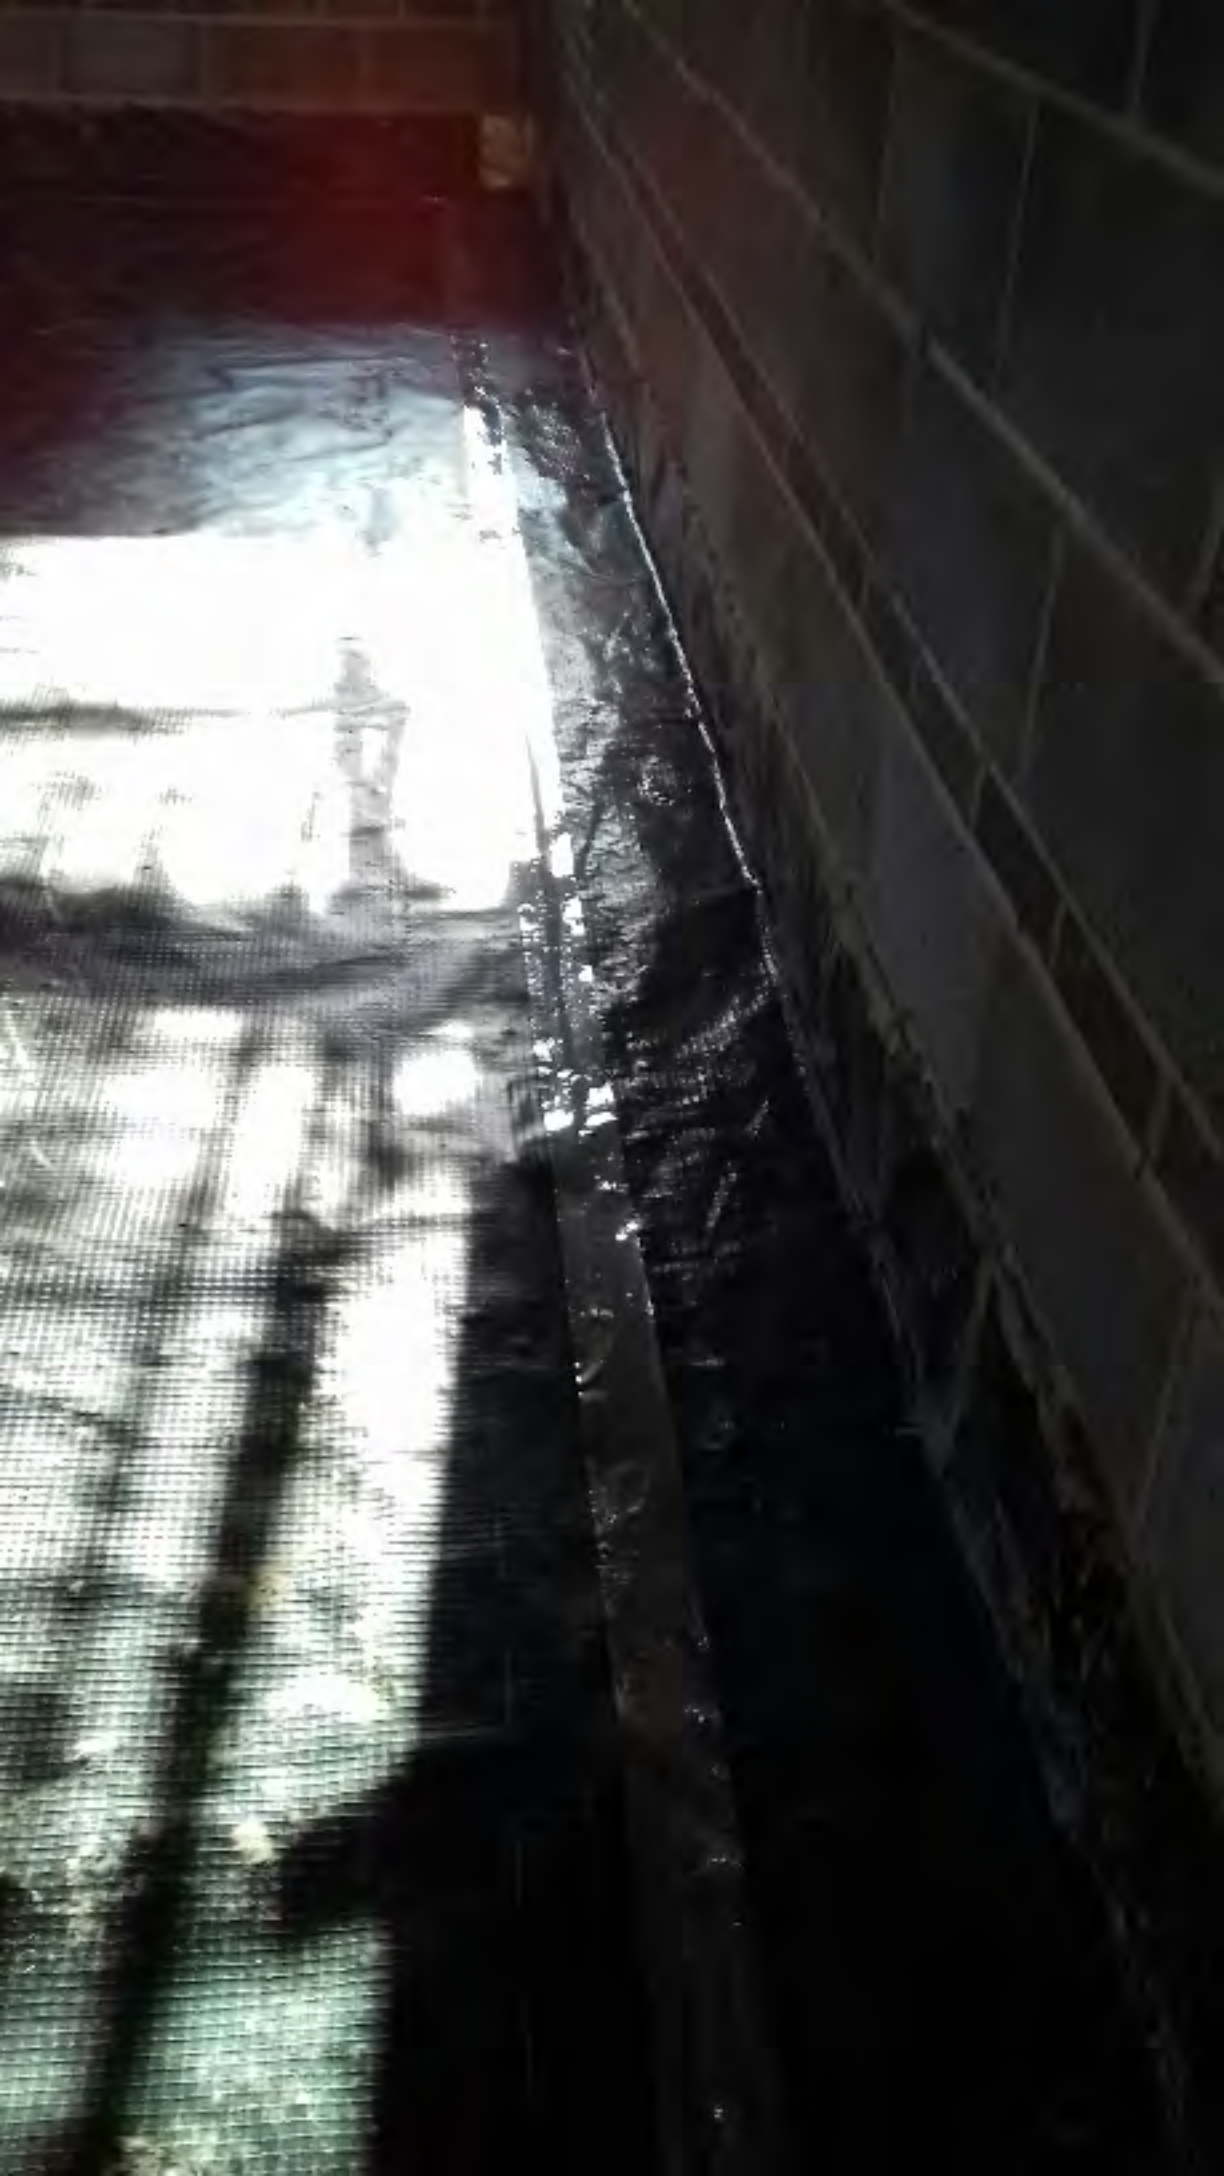
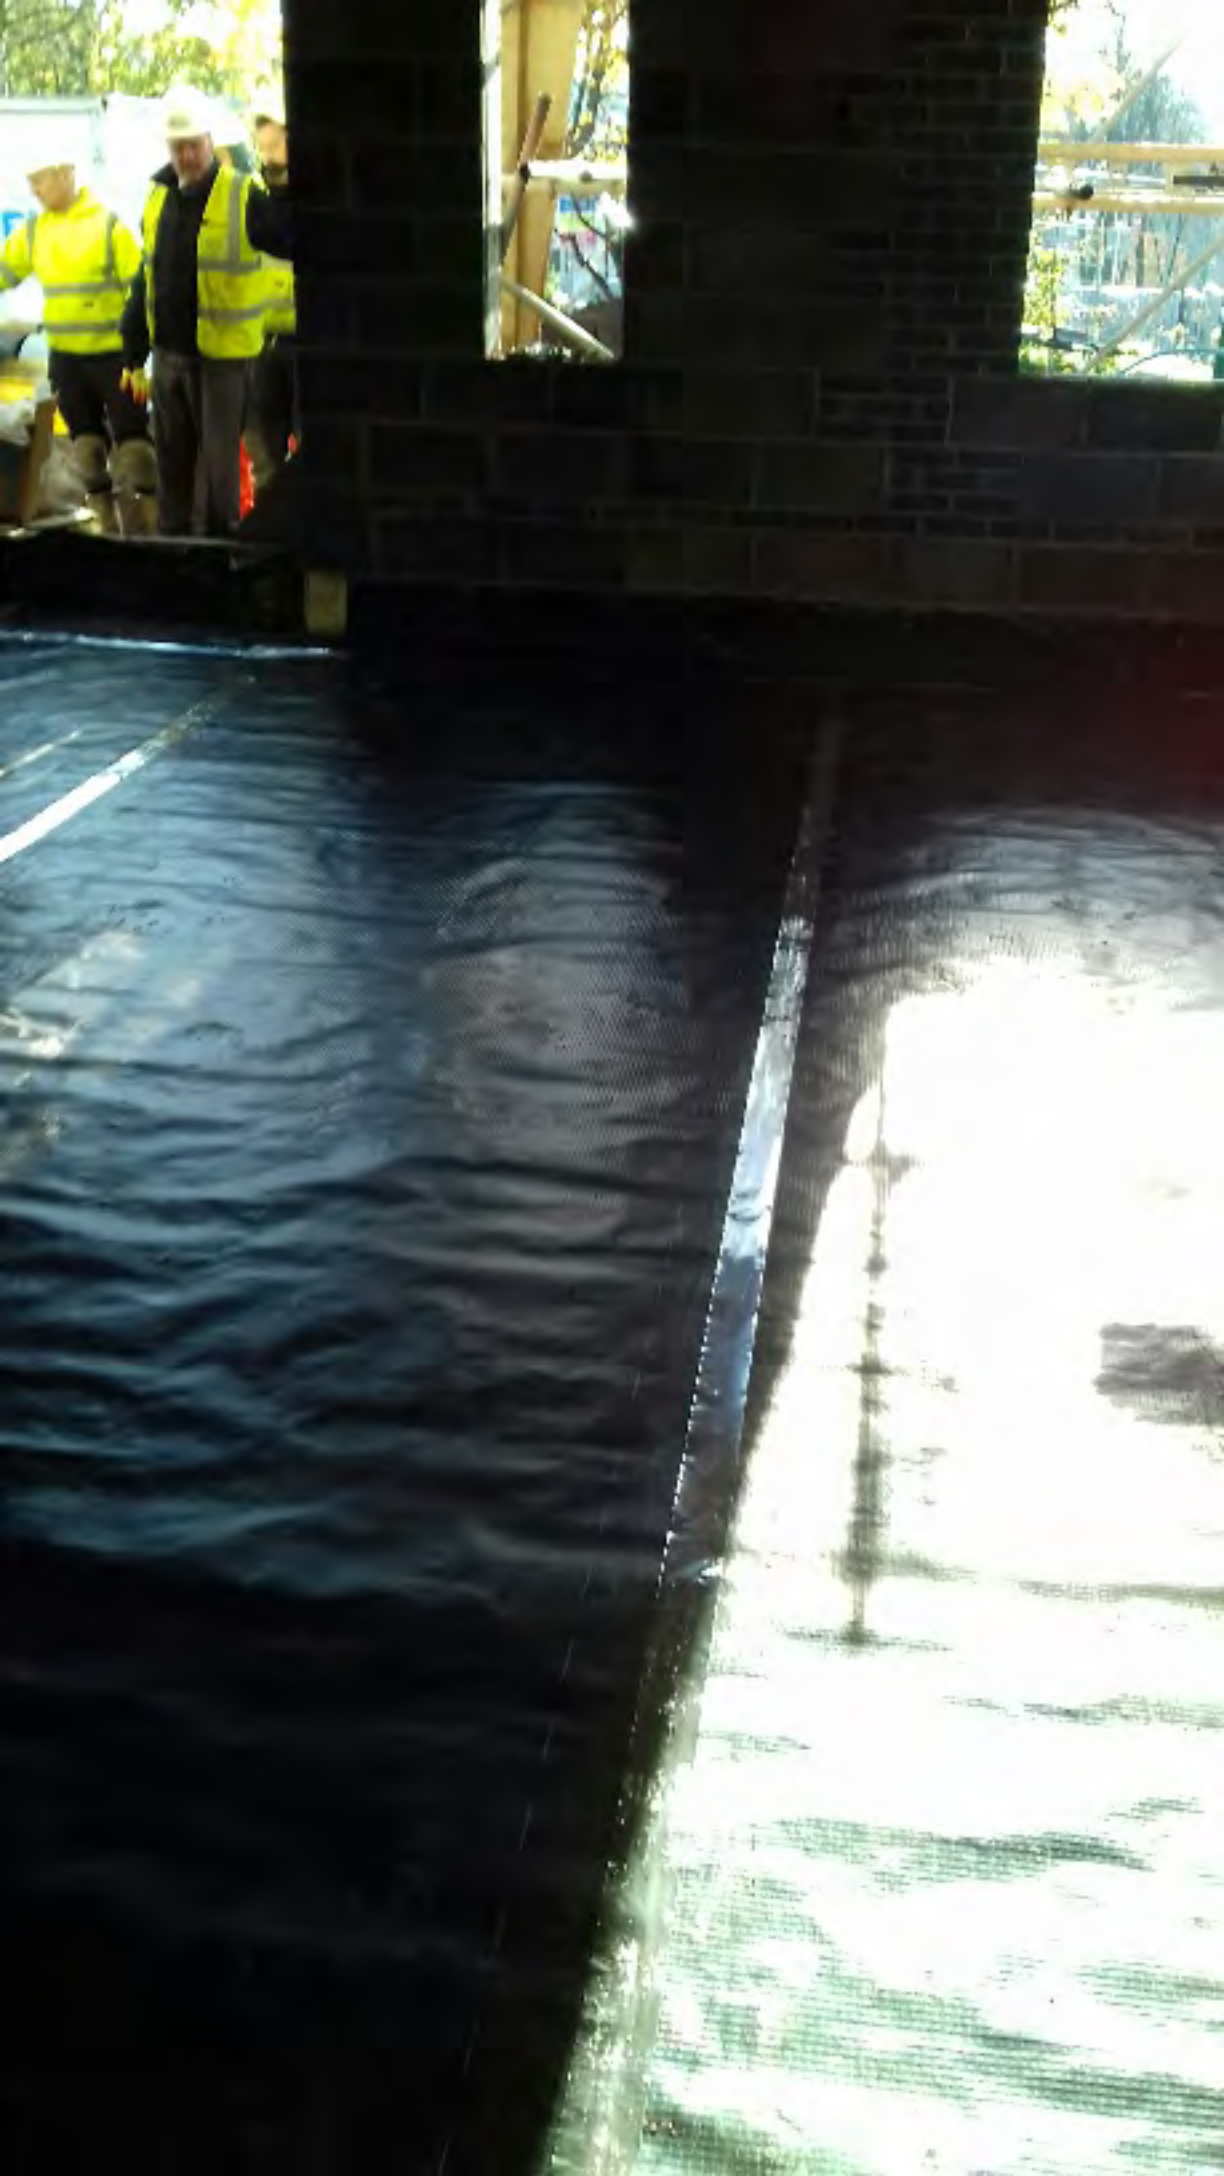
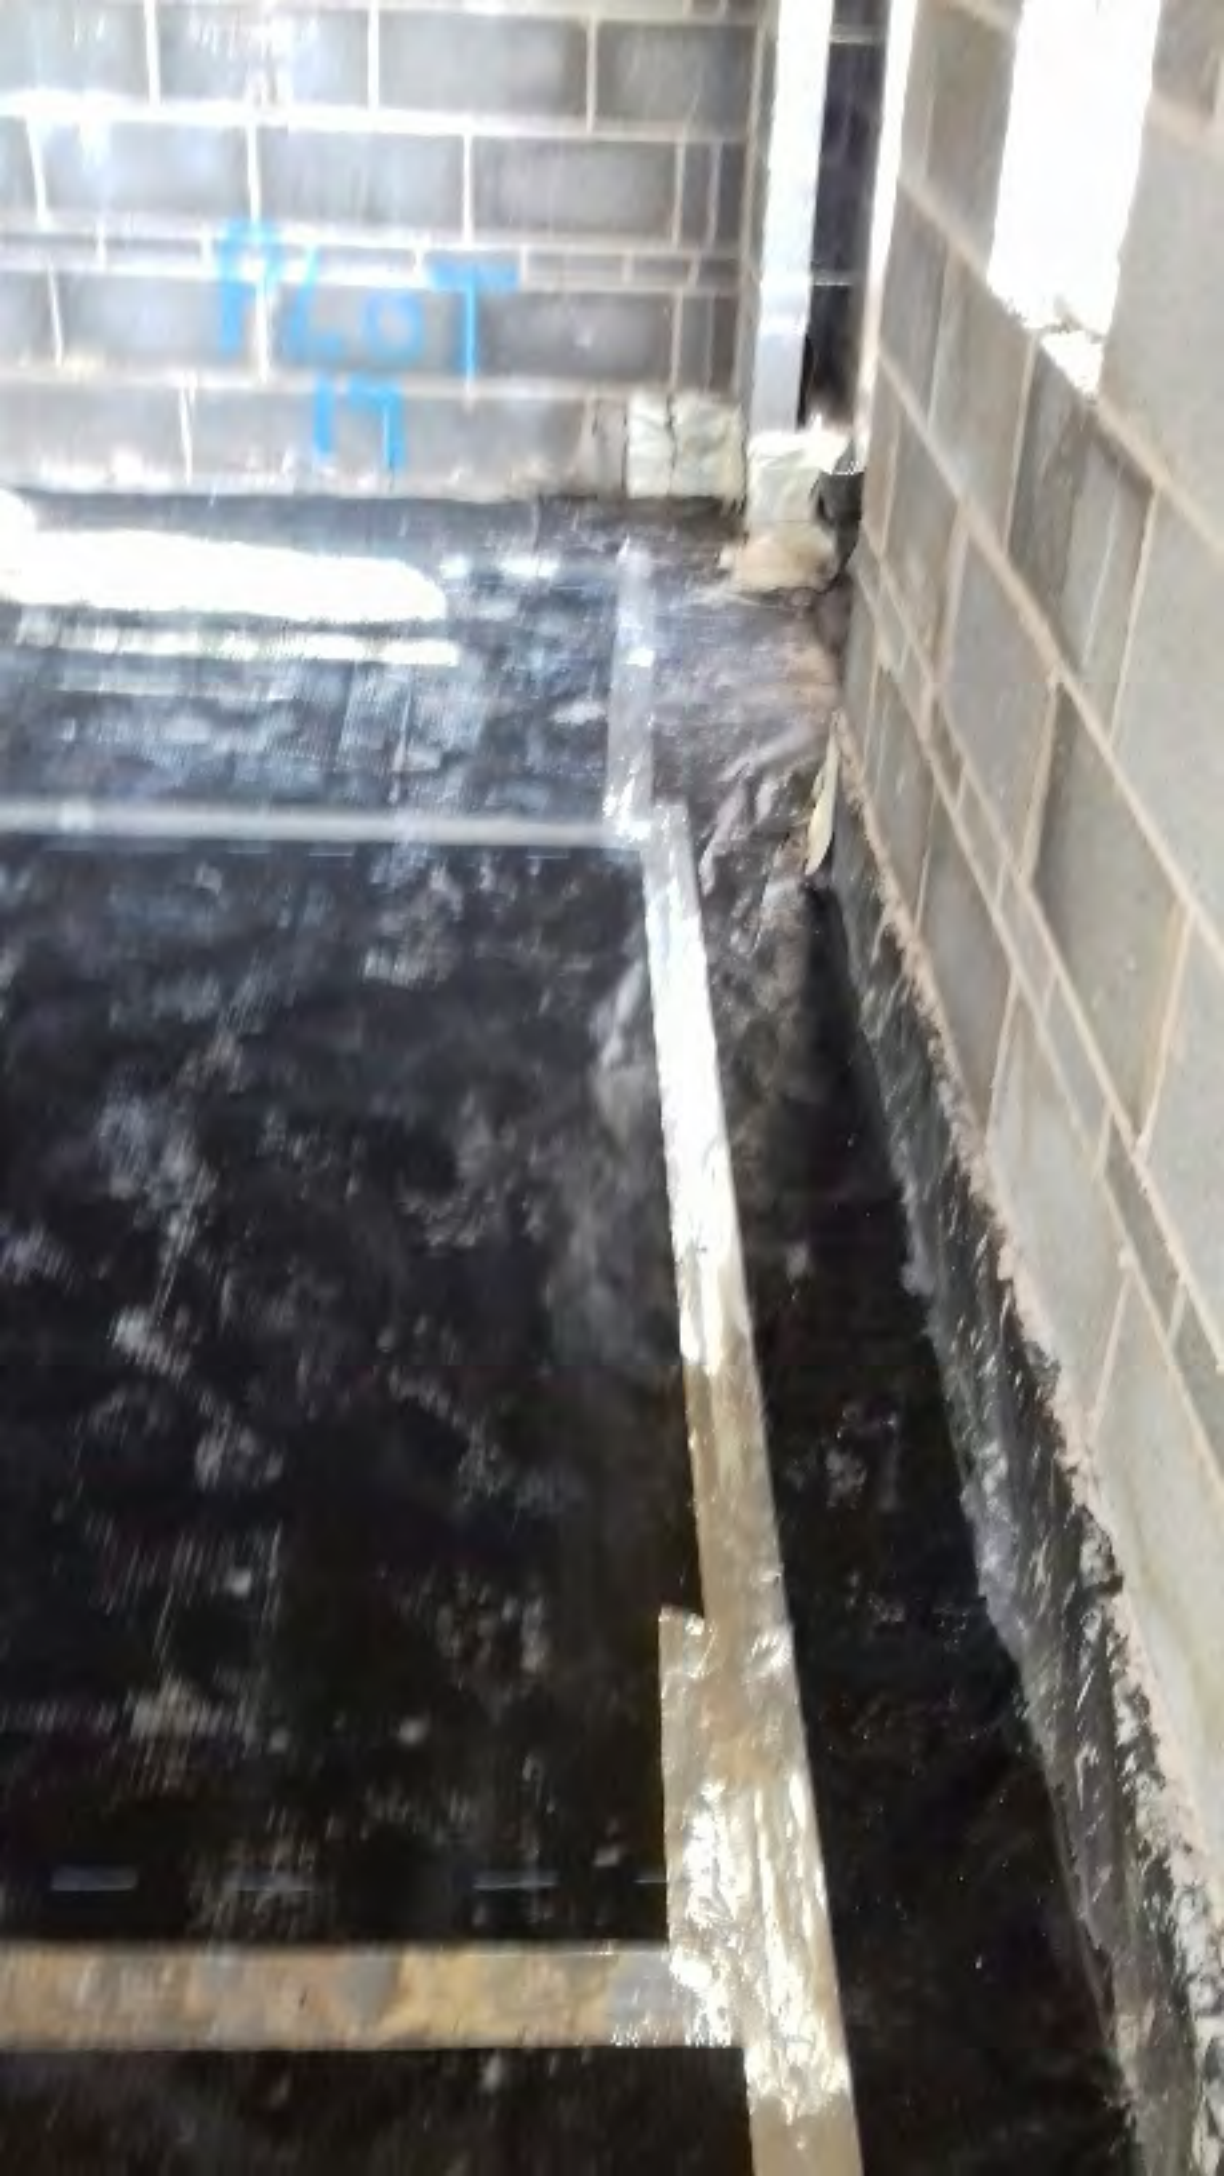
PILOT  
19

| 2.2 | Condition of sub-grade & underside of gas membrane | FLOOR SCRAPPED & BRUSHED, PERIMETER MEMBRANE CLEANED, ALL TAPES APPLIED WELL, SEALED TO A GOOD QUALITY | | | | | |
| 2.4 | Gas membrane condition and coverage | SEALED ON ALL 4 SIDES - ALL GOOD | | | | | |
| 2.7 | Condition of joints/seals | VISIBLE OVERLAPS - ALL GOOD | | | | | |
| 2.8 | Number and condition of service entry seals | 3 <sup>rd</sup> TOP HATS FITTED AROUND DRAINAGE/WATER, JUBILEE CLIPS + TAPED ALL GOOD | | | | | |
