## Gas Protection - Validation Record Sheet

**This Record sheet is only applicable to block and beam floor slabs for Characteristic Situation 2 gas protection systems**

**For Residential Development at New Church Street, Radcliffe.**

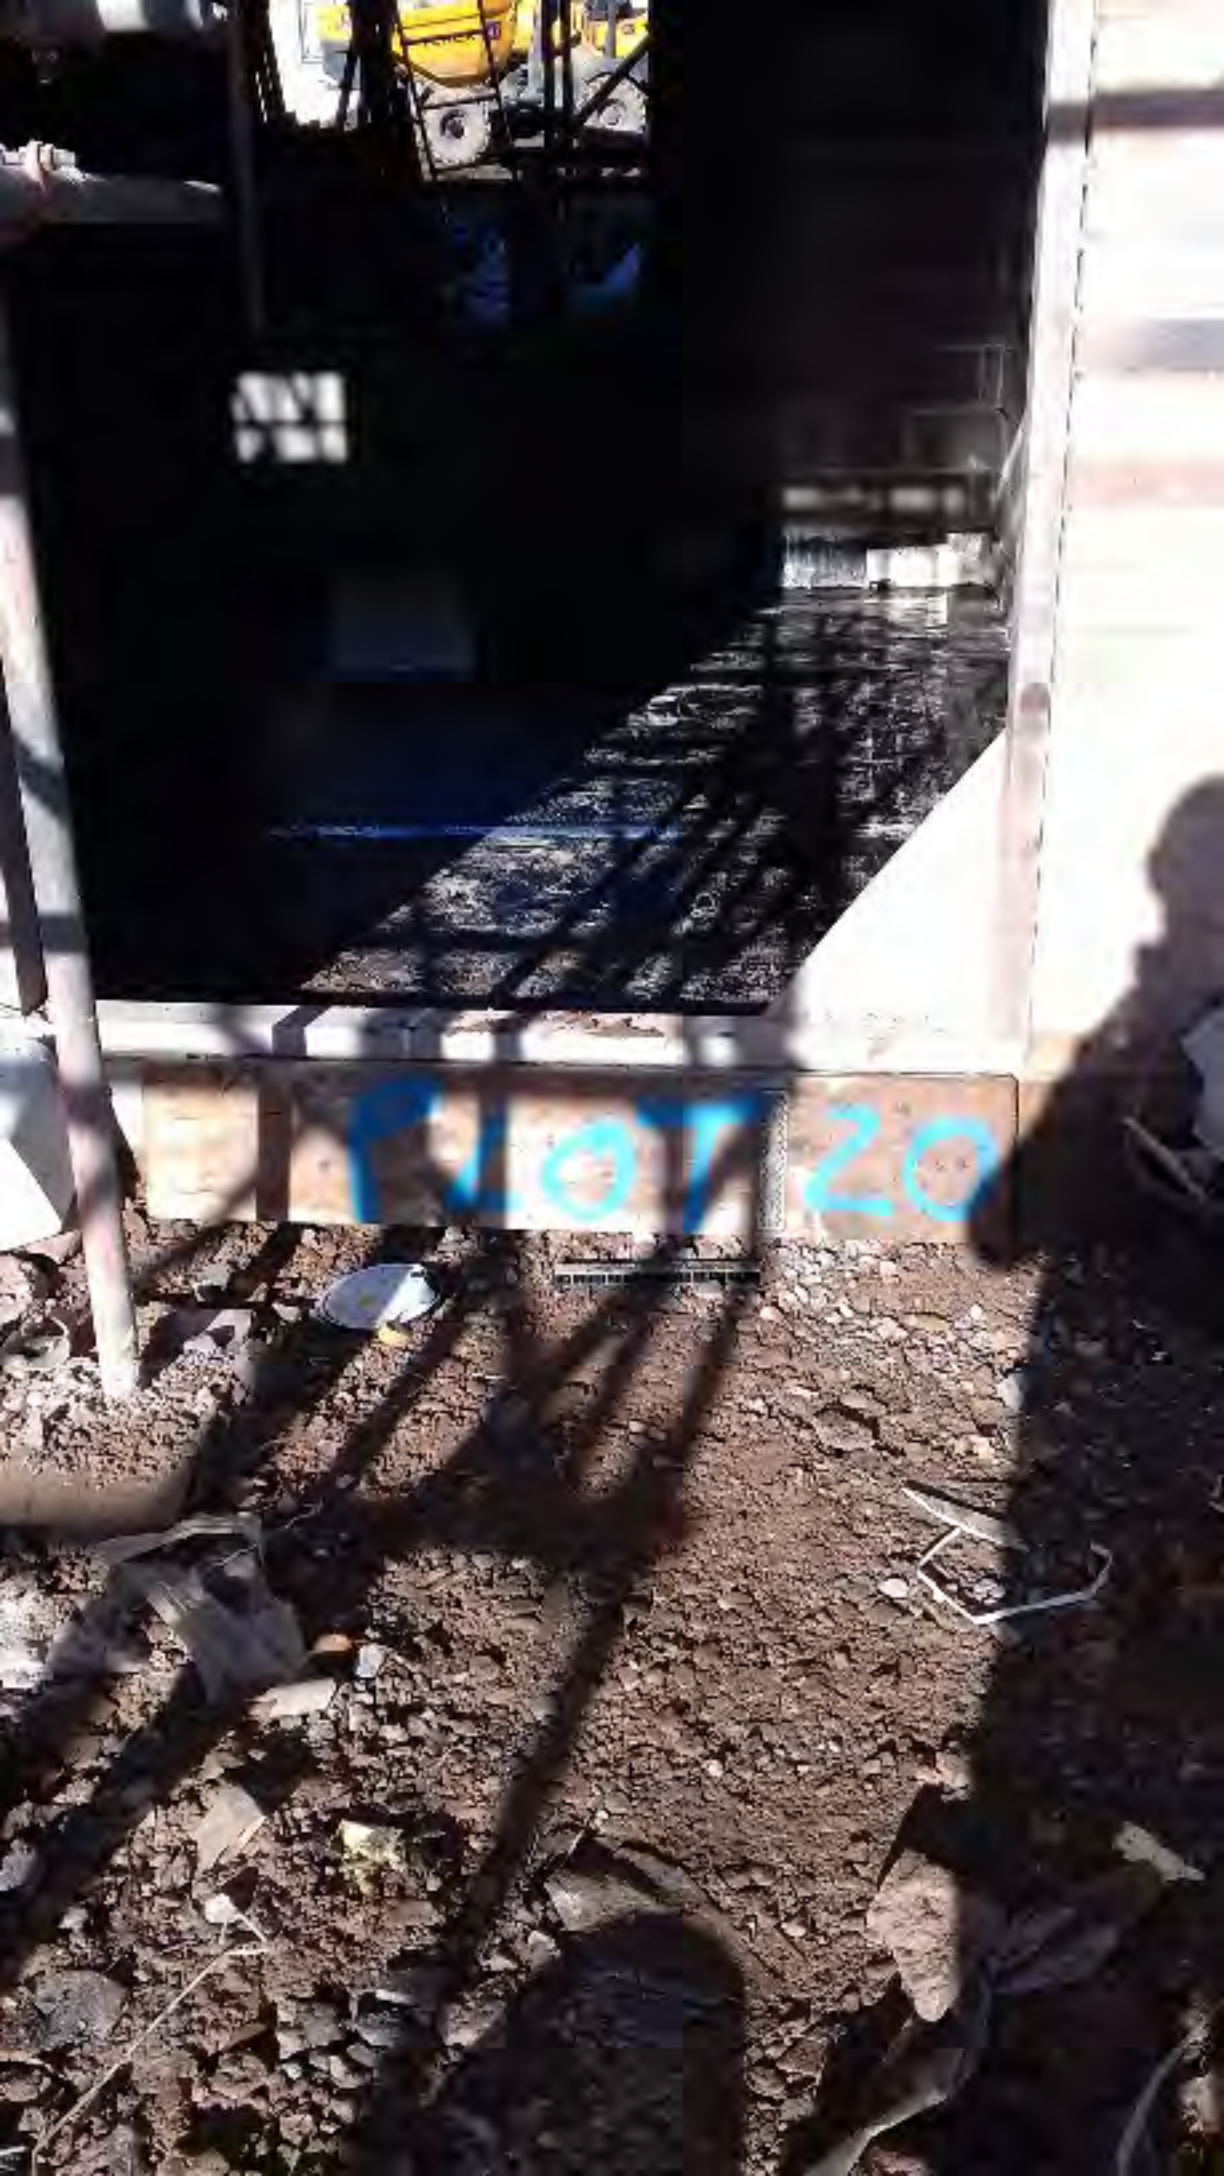
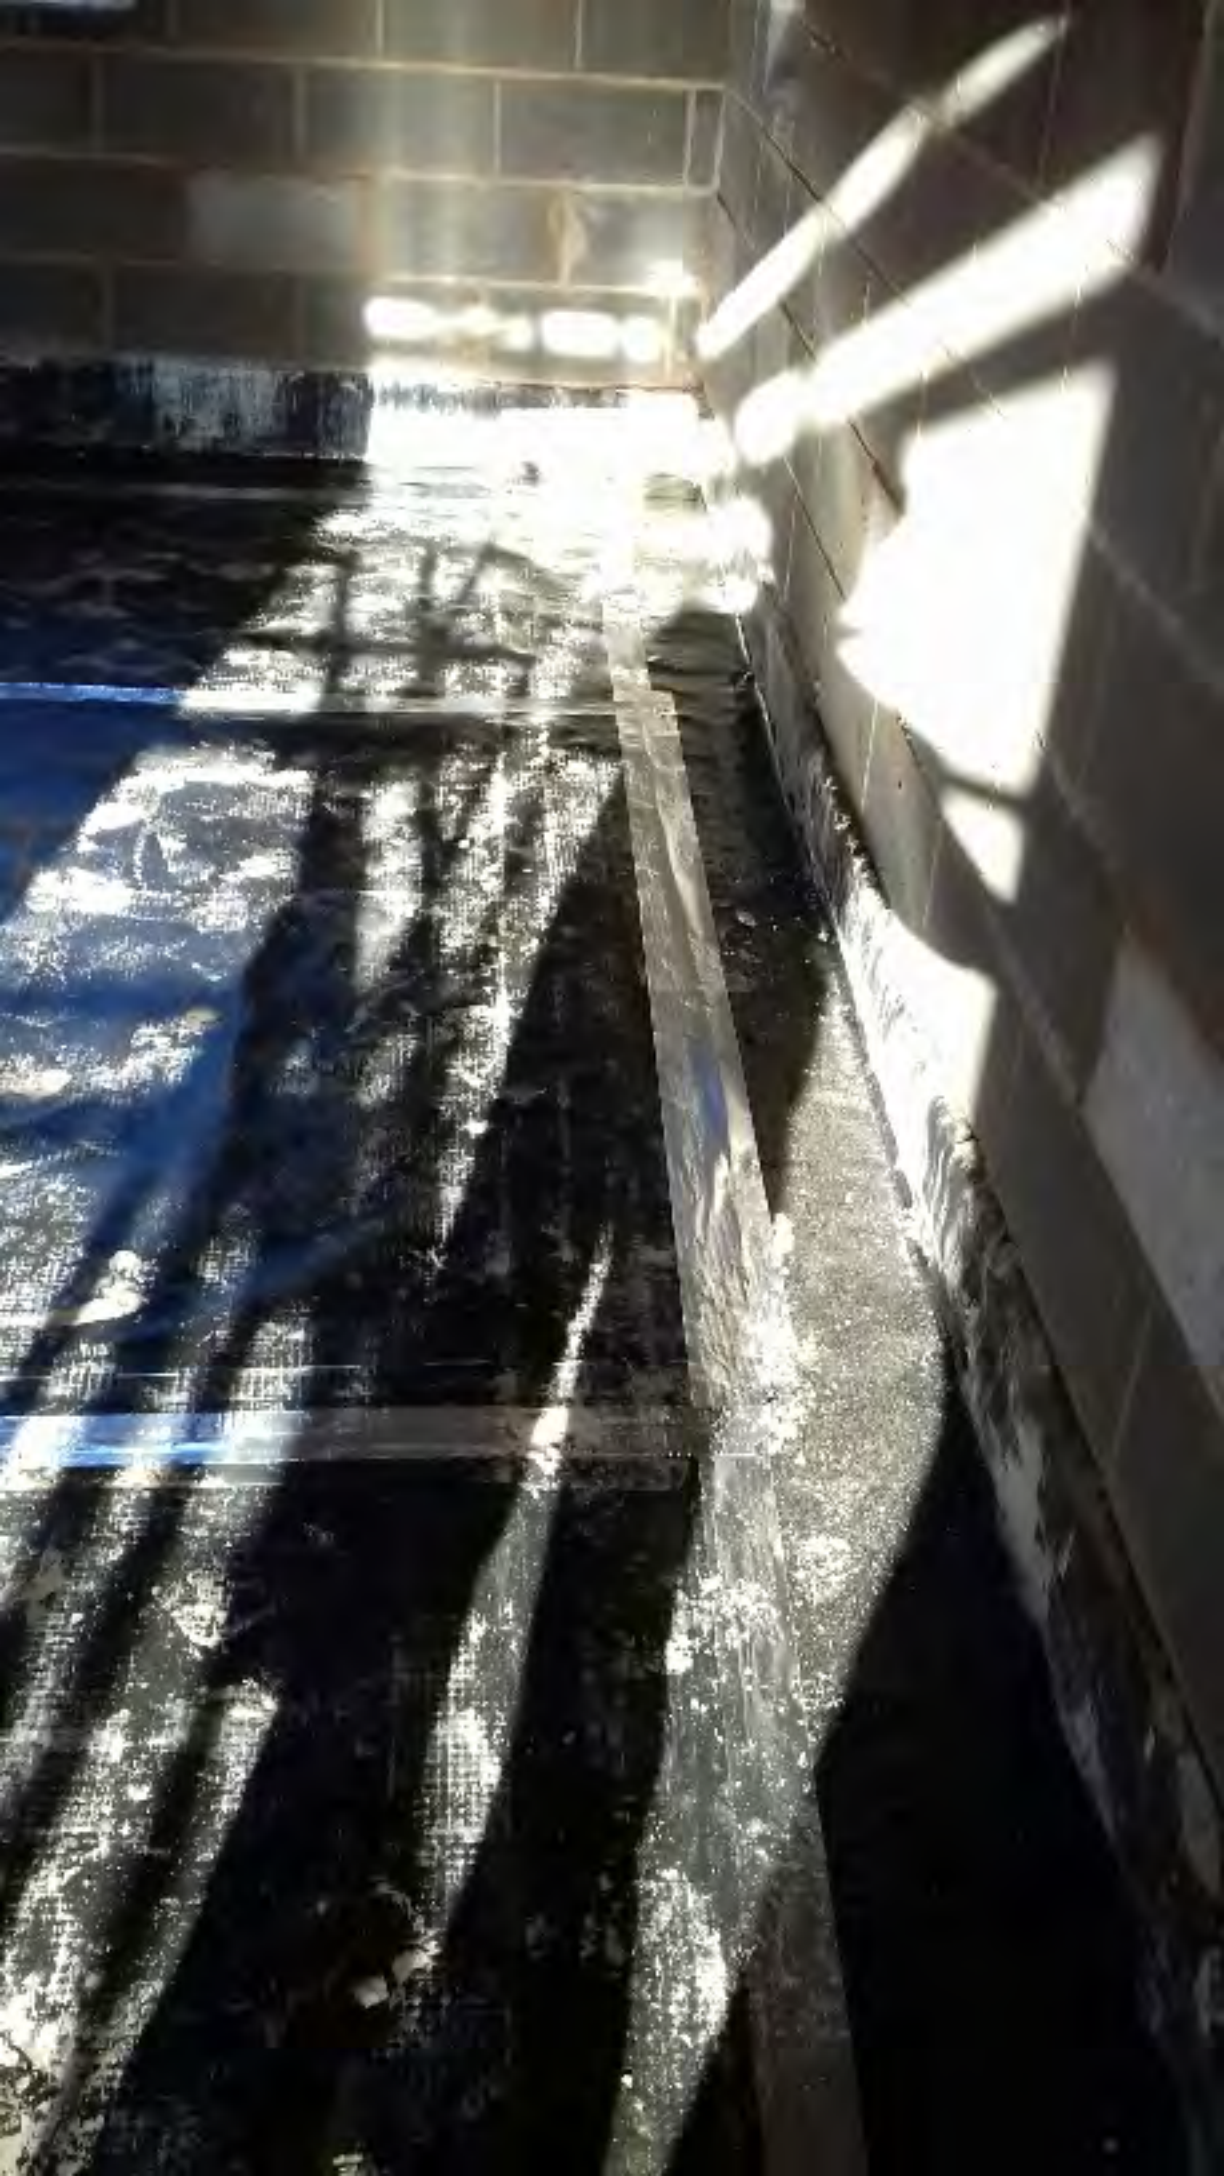
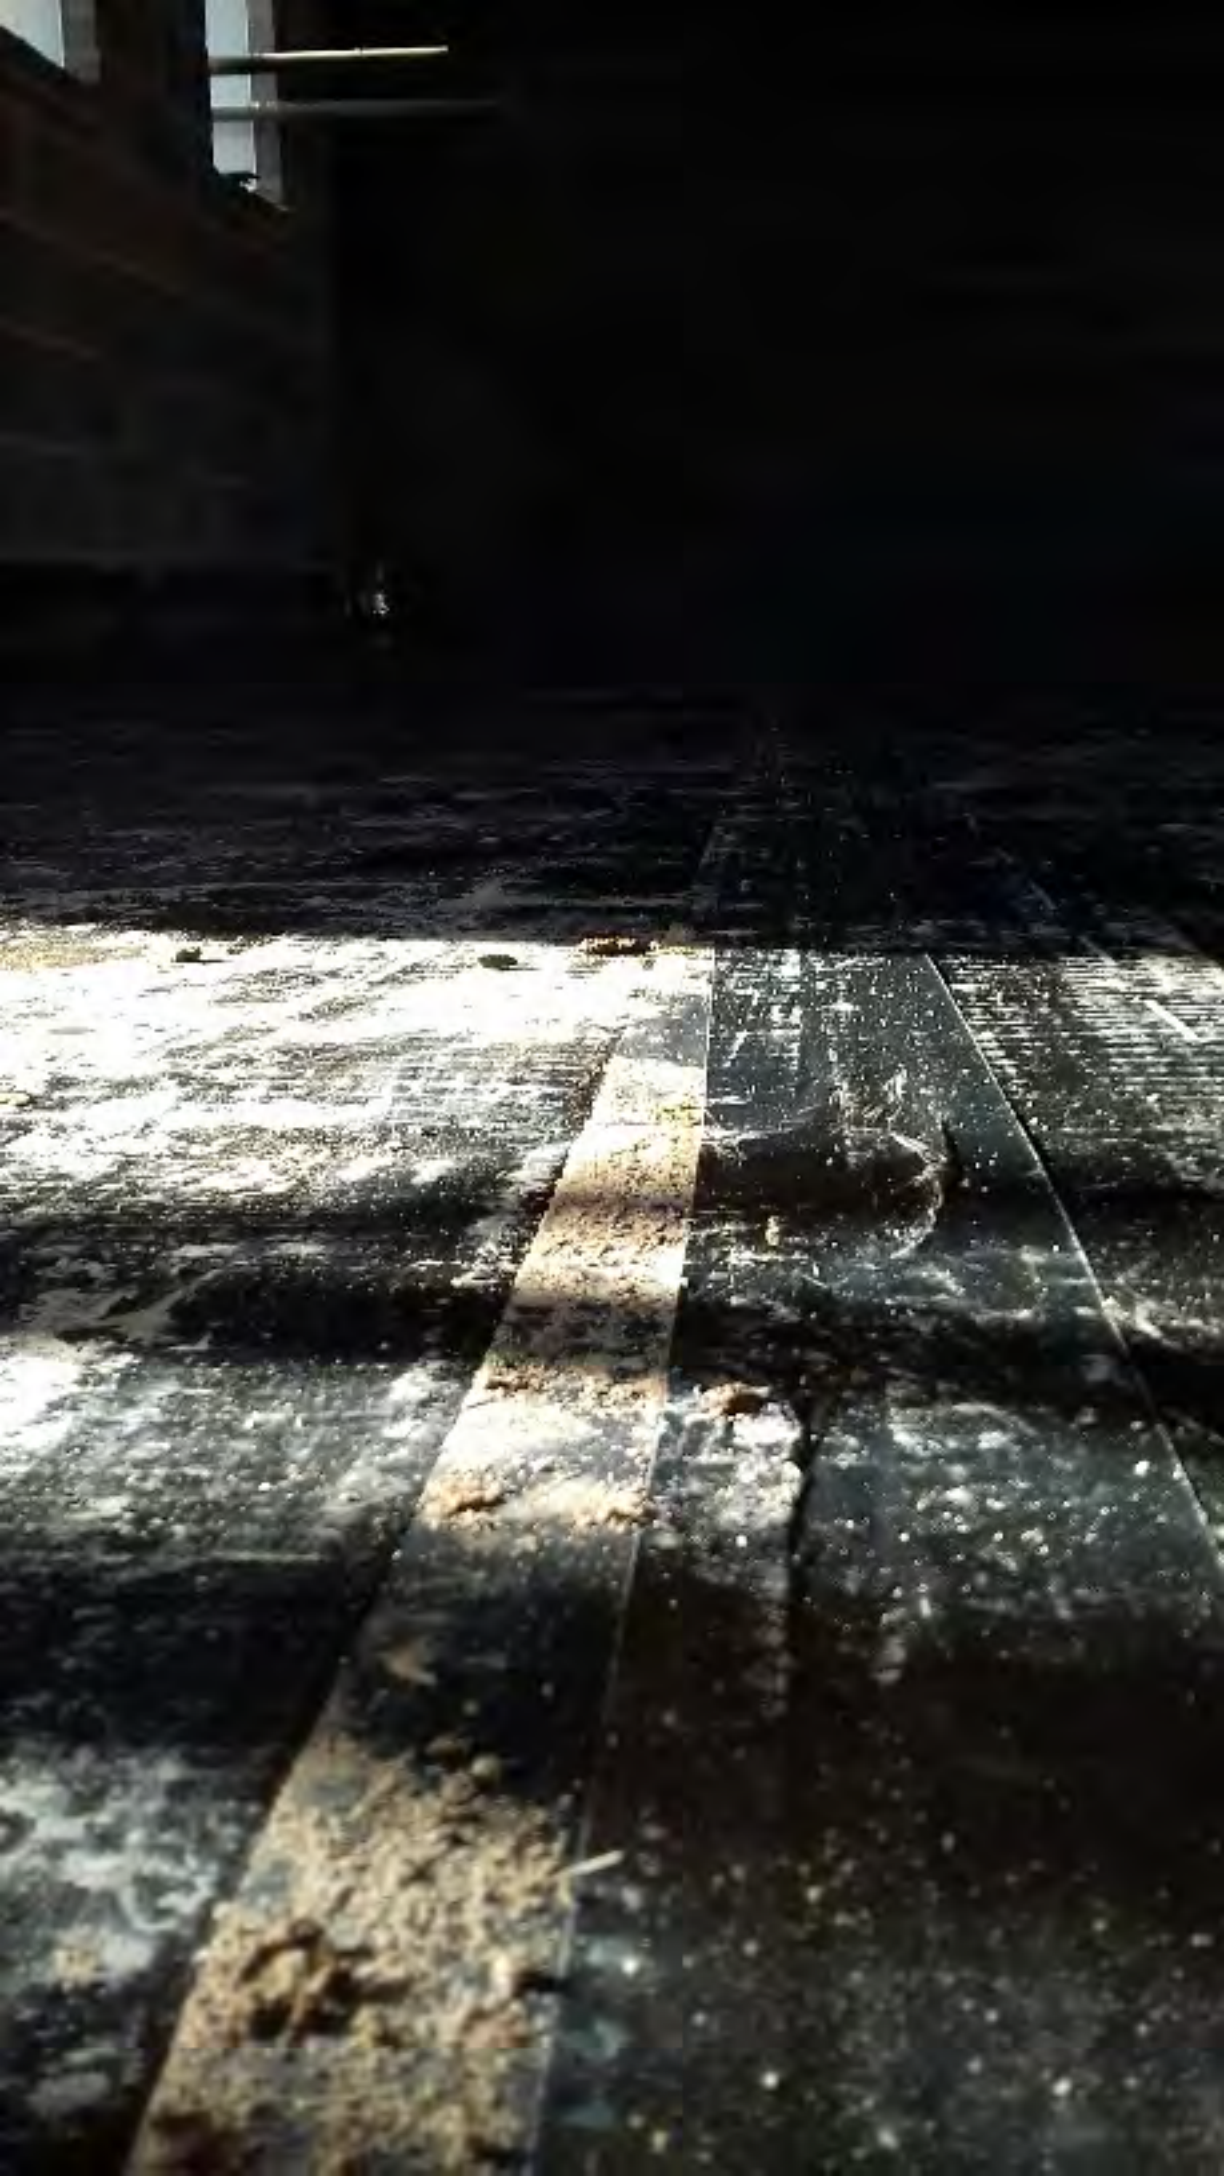
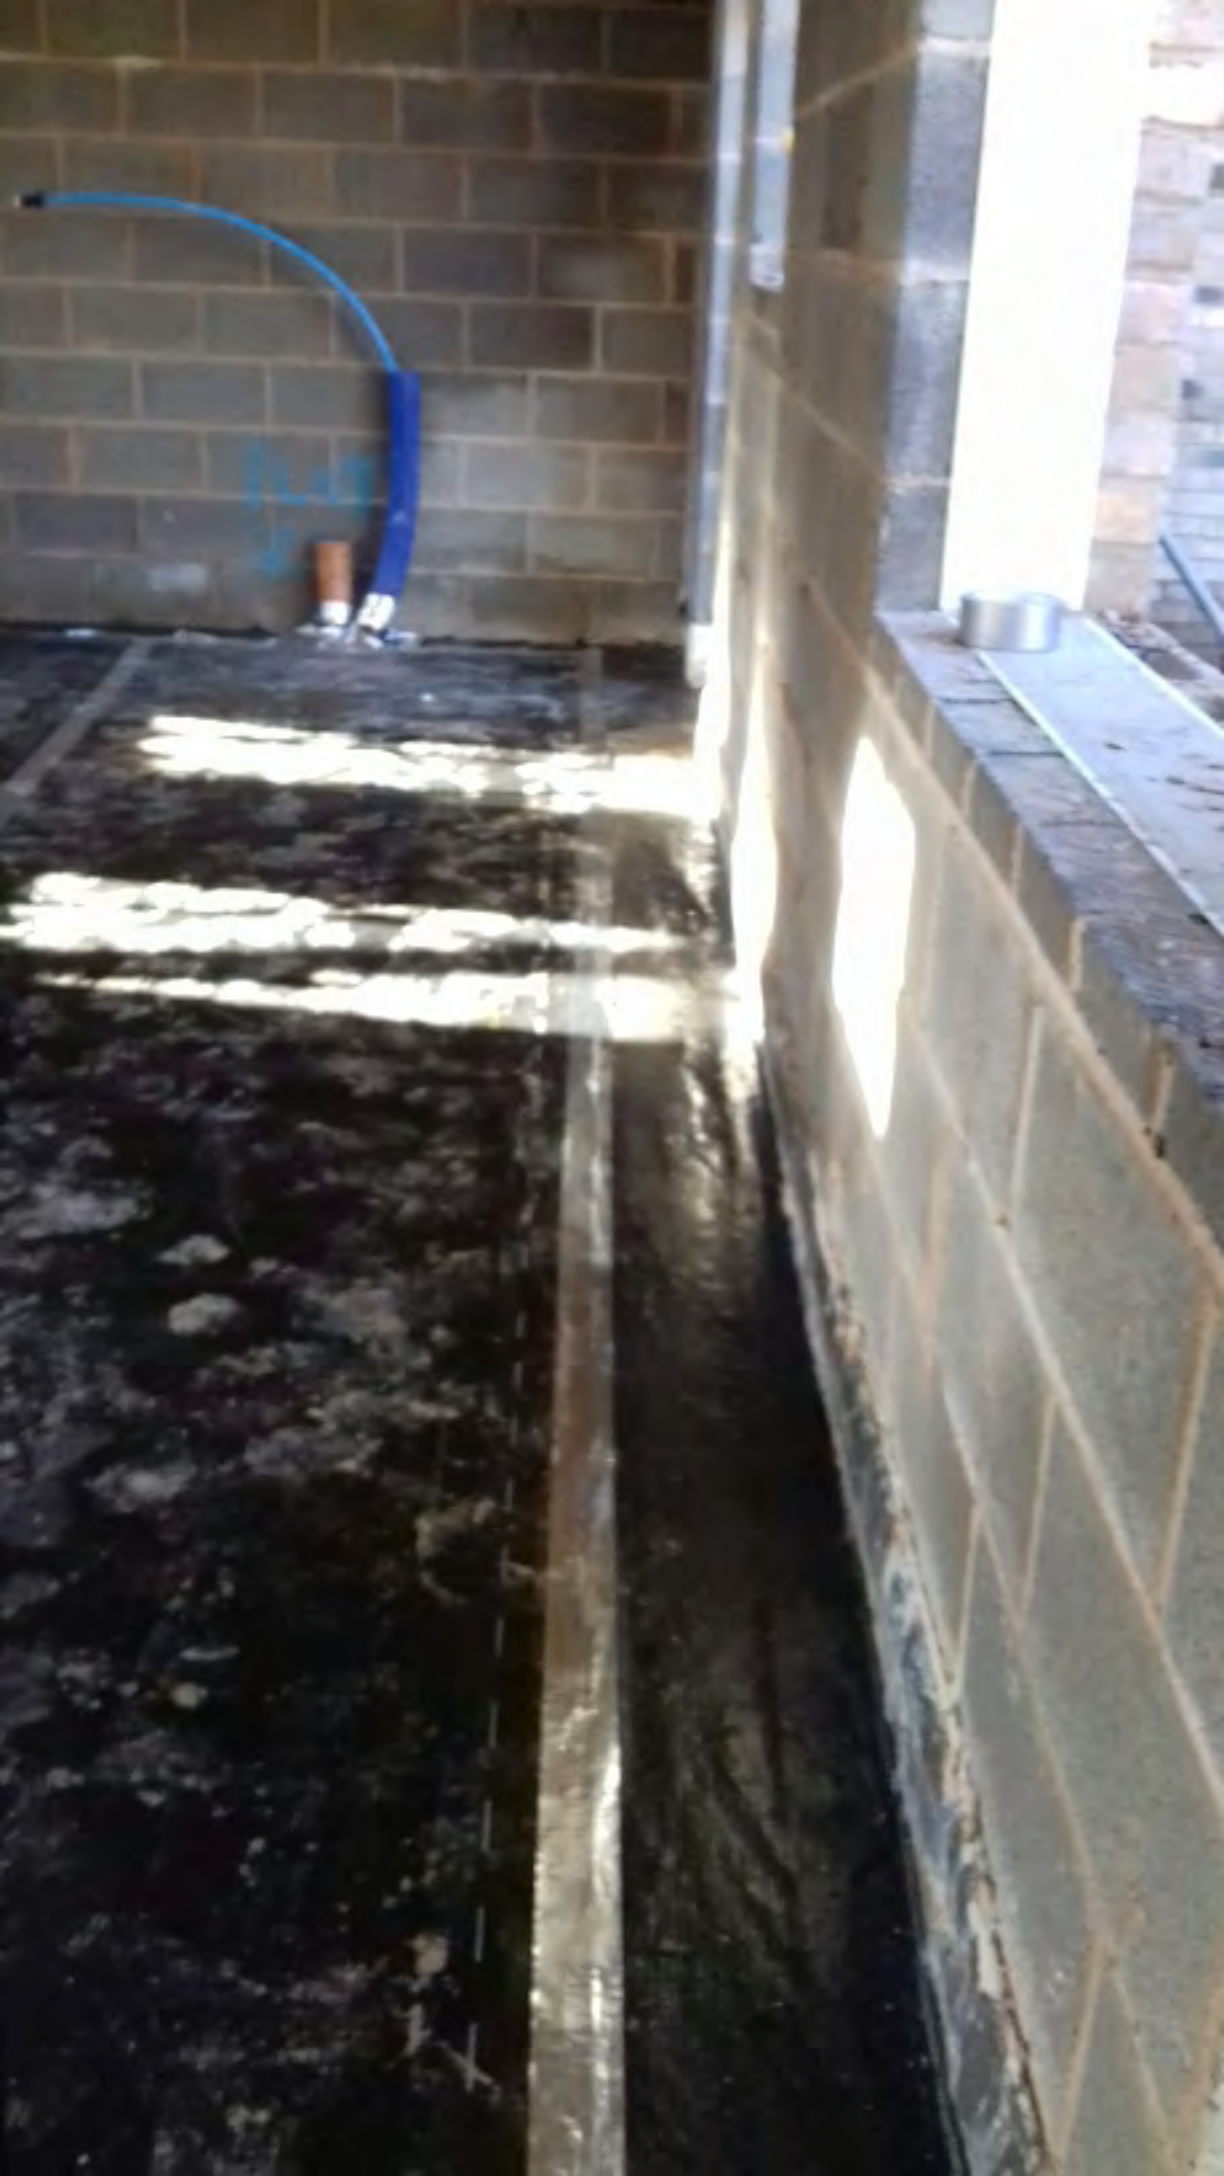
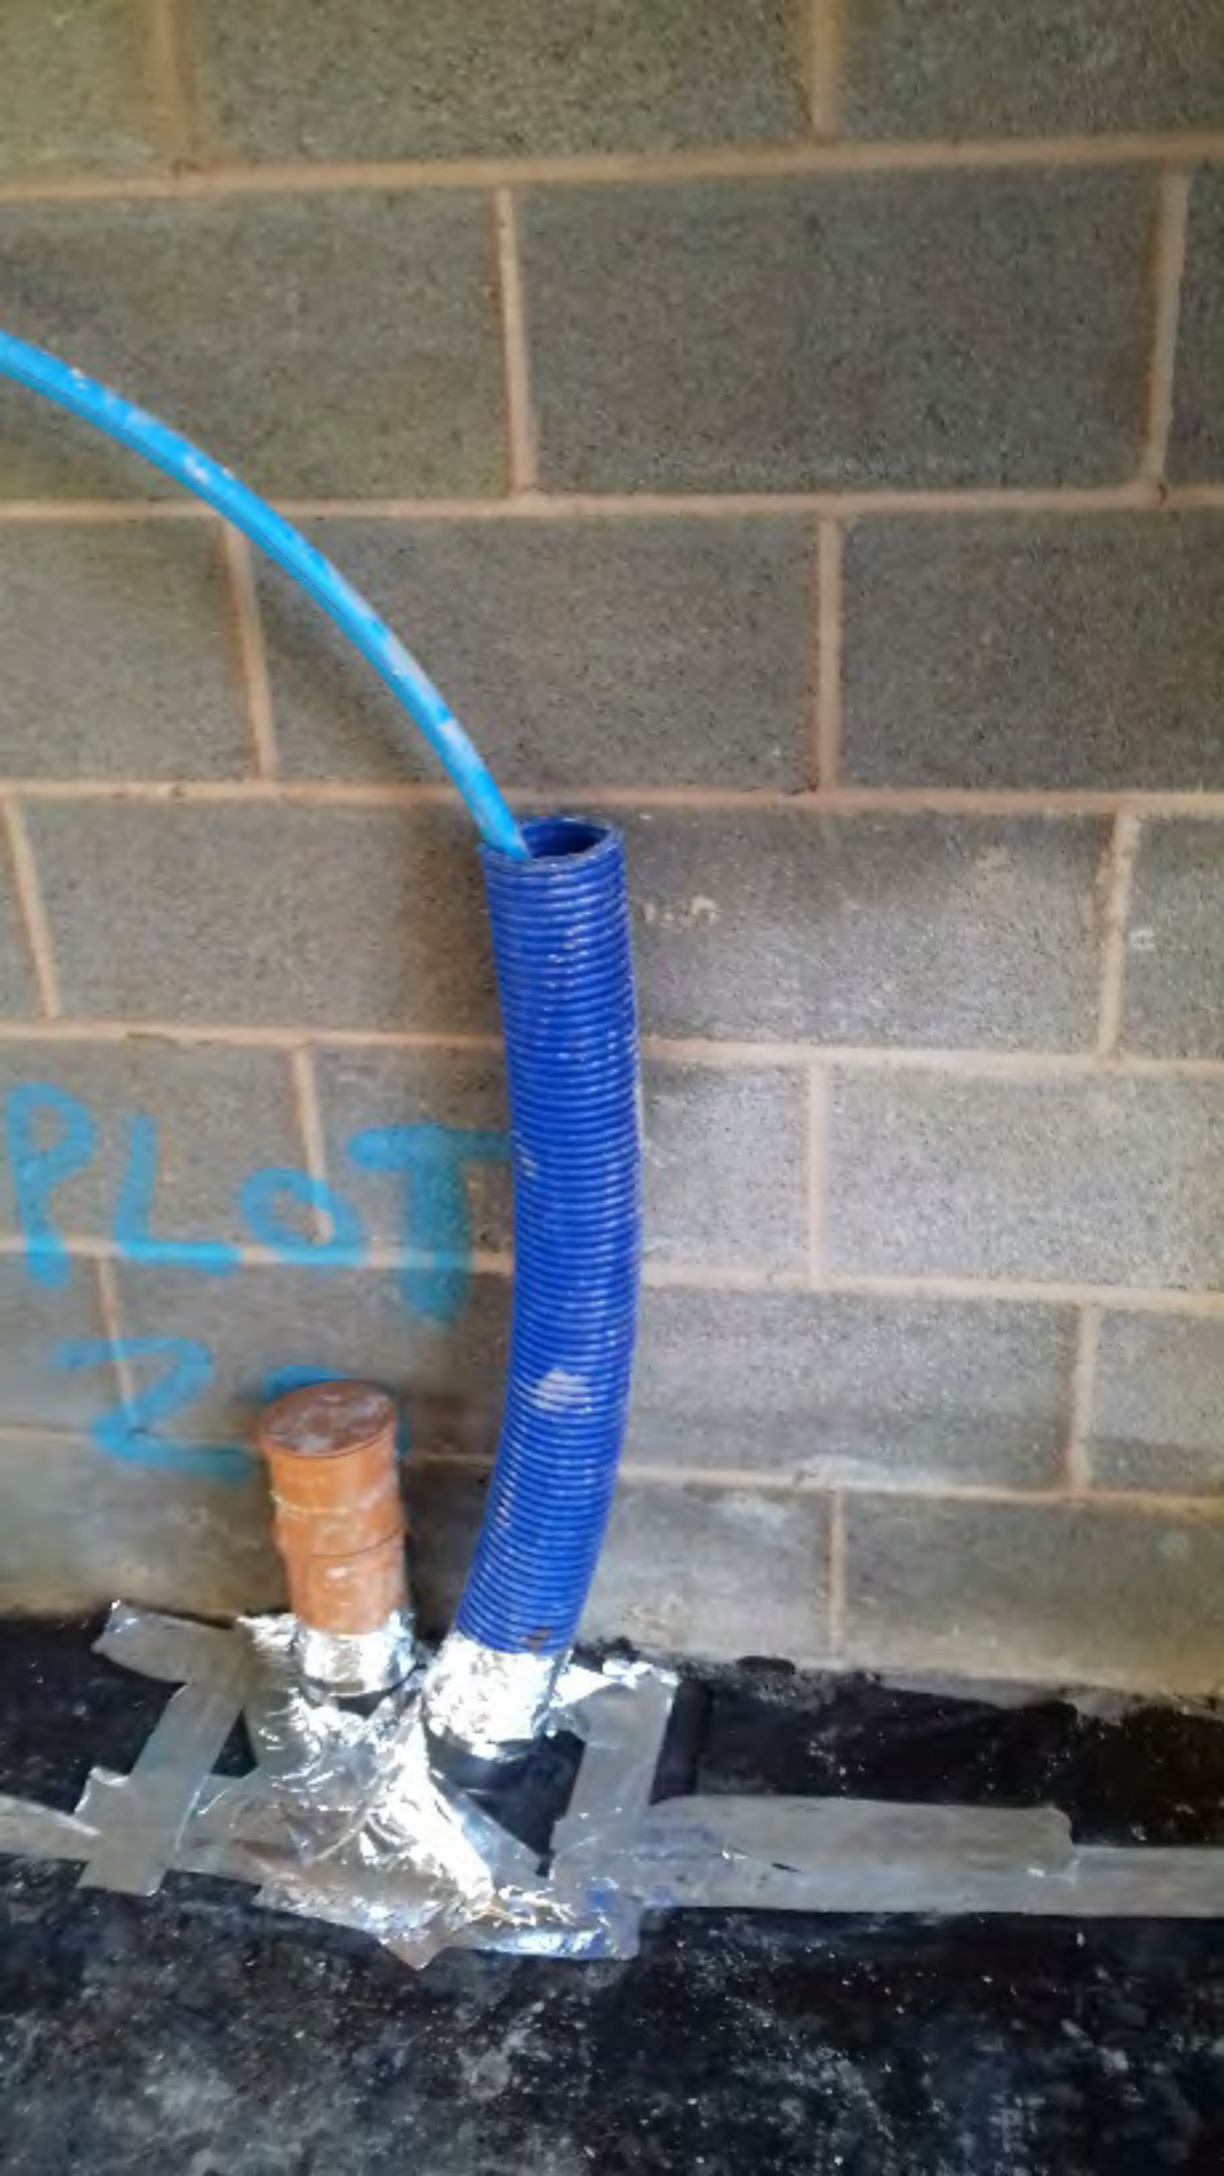
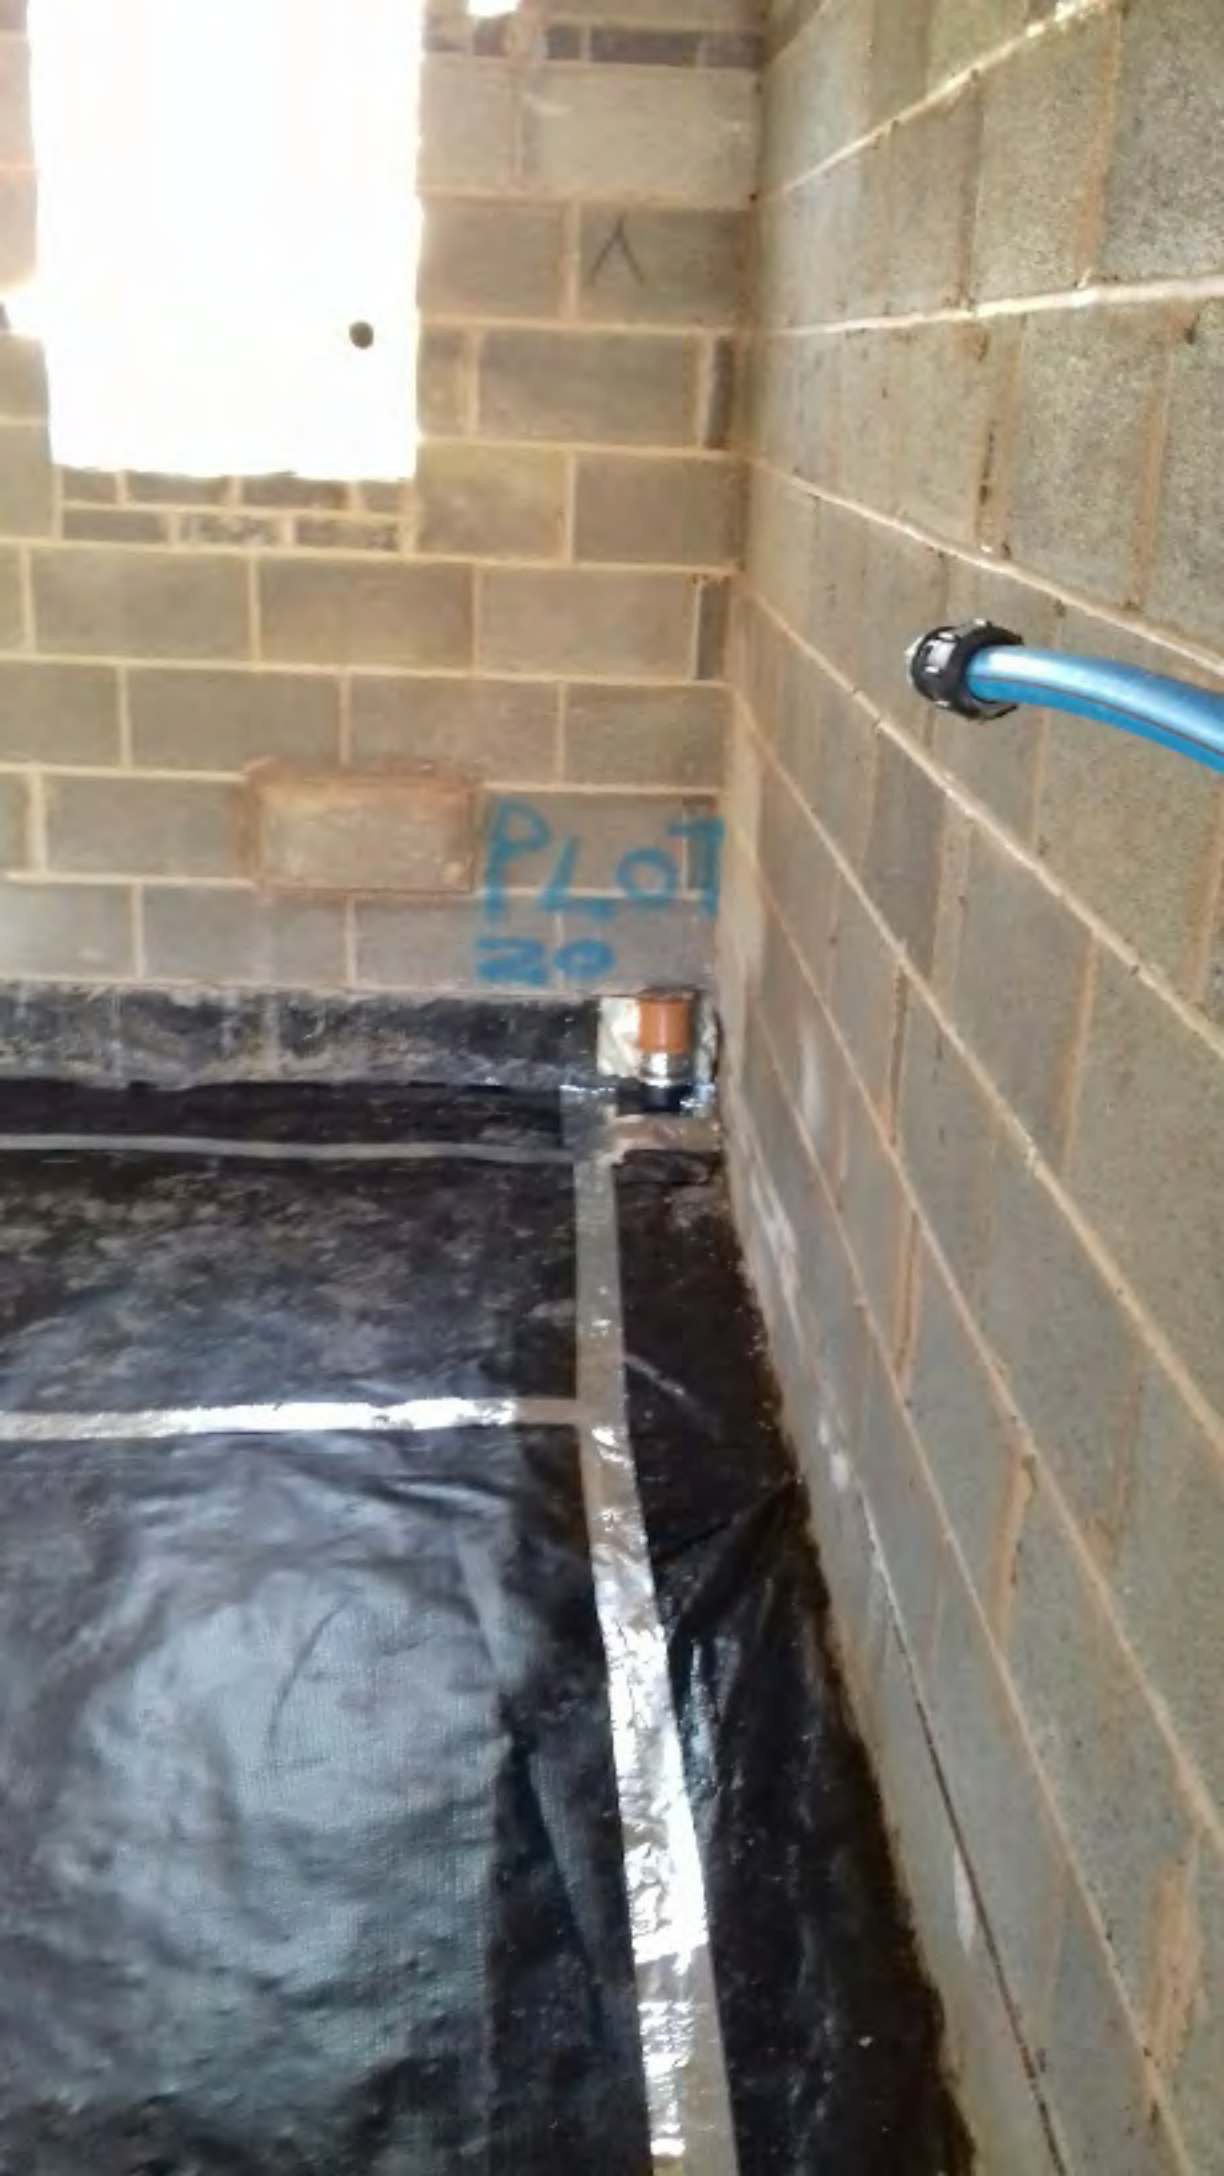
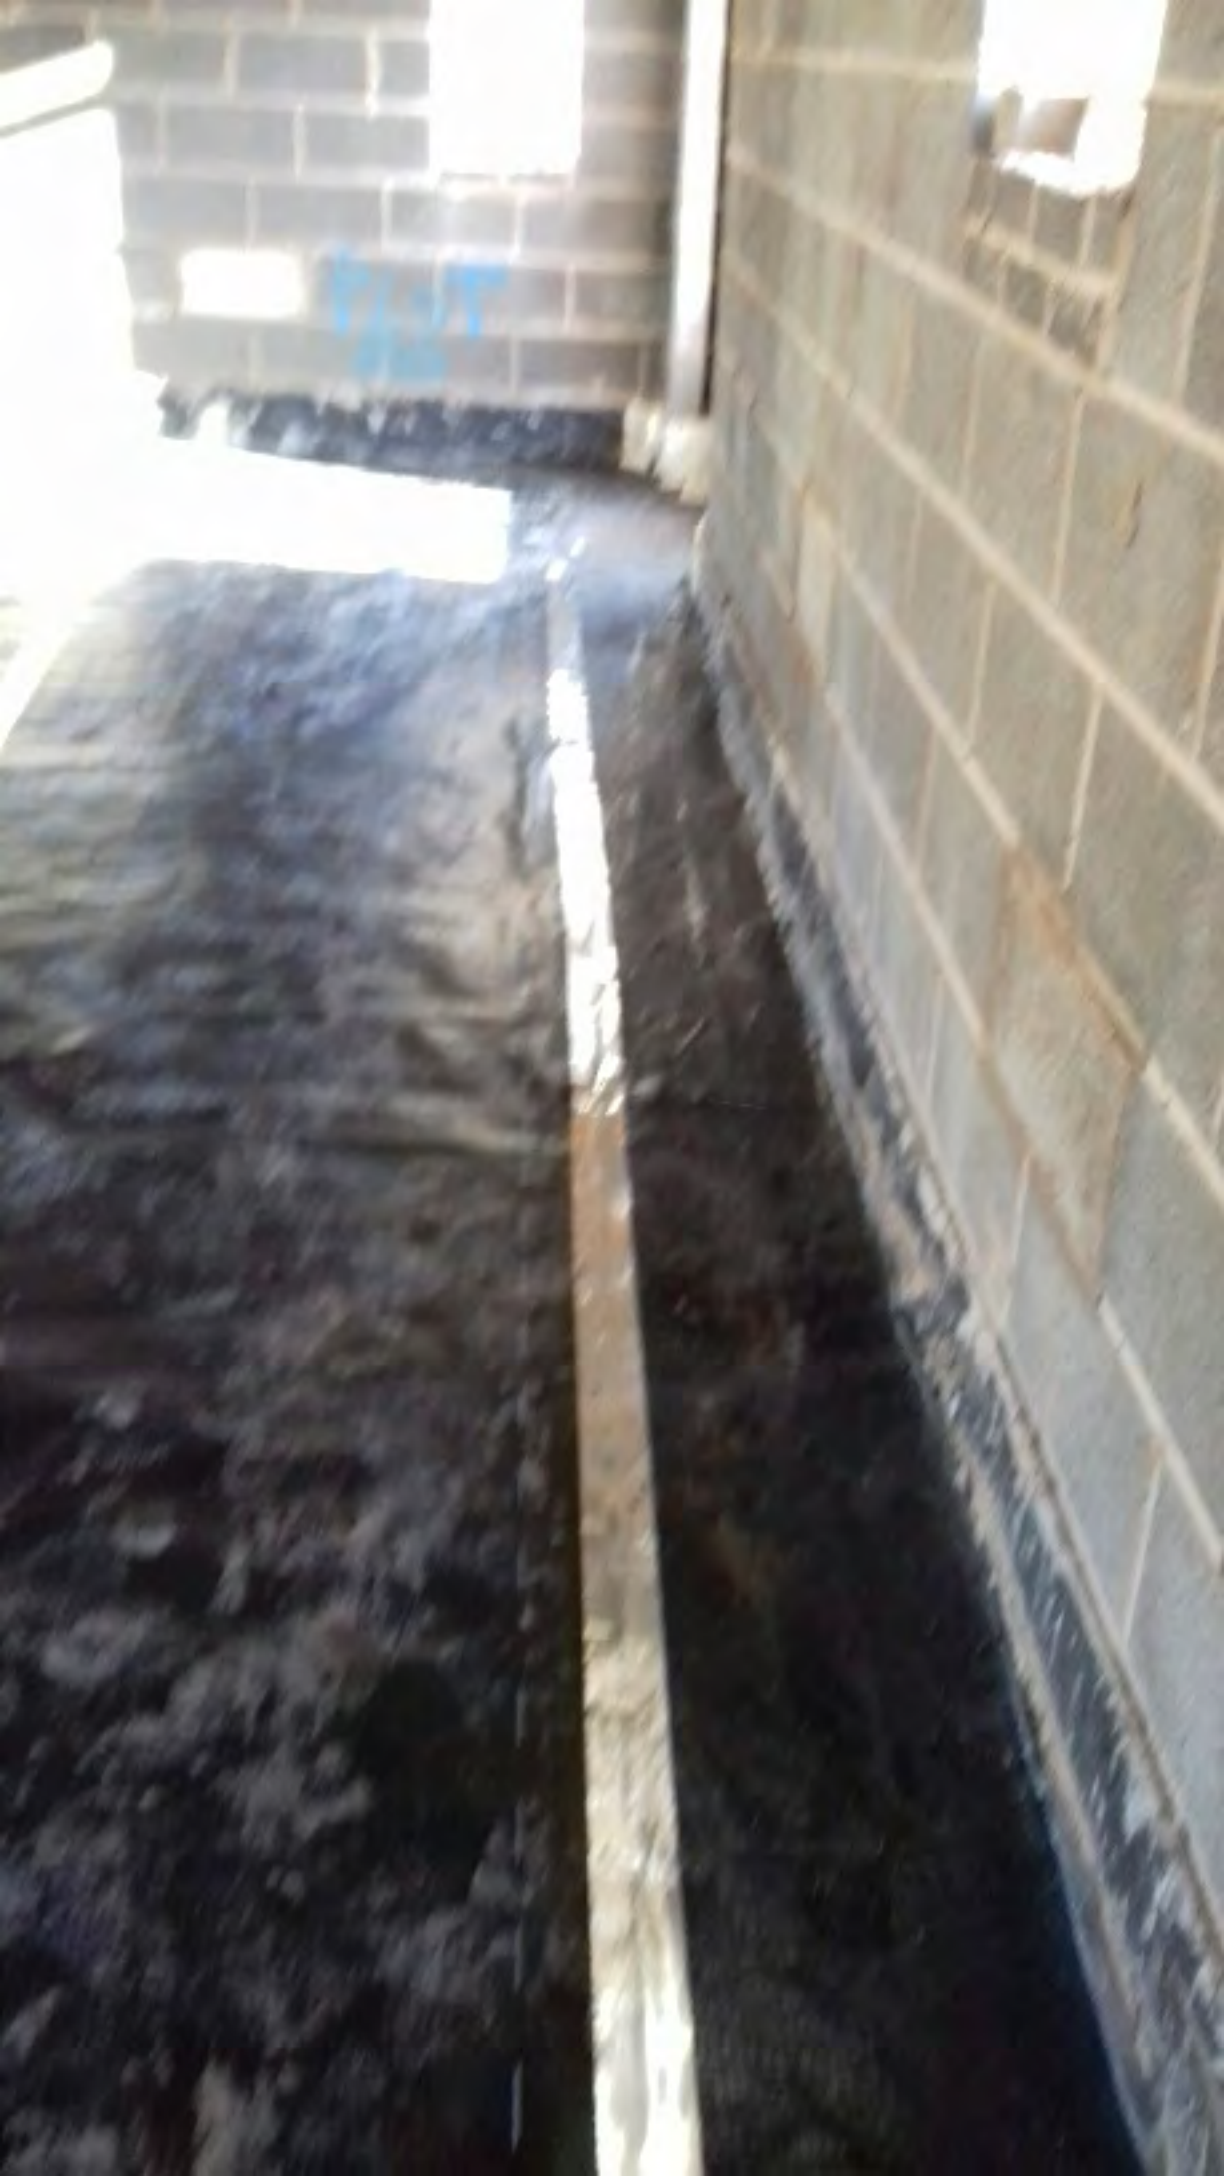
Plot 20

| 2.2 | Condition of sub-grade & underside of gas membrane | FLOOR SCRAPPED & BRUSHED, PERIMETER MEMBRANE CLEANED, ALL TAPES APPLIED WELL. SEALED TO A GOOD QUALITY. | | | | | |
| 2.4 | Gas membrane condition and coverage | SEALED ON ALL FOUR SIDES - ALL GOOD | | | | | |
| 2.7 | Condition of joints/seals | VISIBLE OVERLAPS - ALL GOOD | | | | | |
| 2.8 | Number and condition of service entry seals | 3 NO TOP HATS FITTED AROUND DRAINAGE / WATER, TAPED + JUBILEE CLIPPED | | | | | |
