## Gas Protection - Validation Record Sheet

**This Record sheet is only applicable to block and beam floor slabs for Characteristic Situation 2 gas protection systems**

**For Residential Development at New Church Street, Radcliffe.**

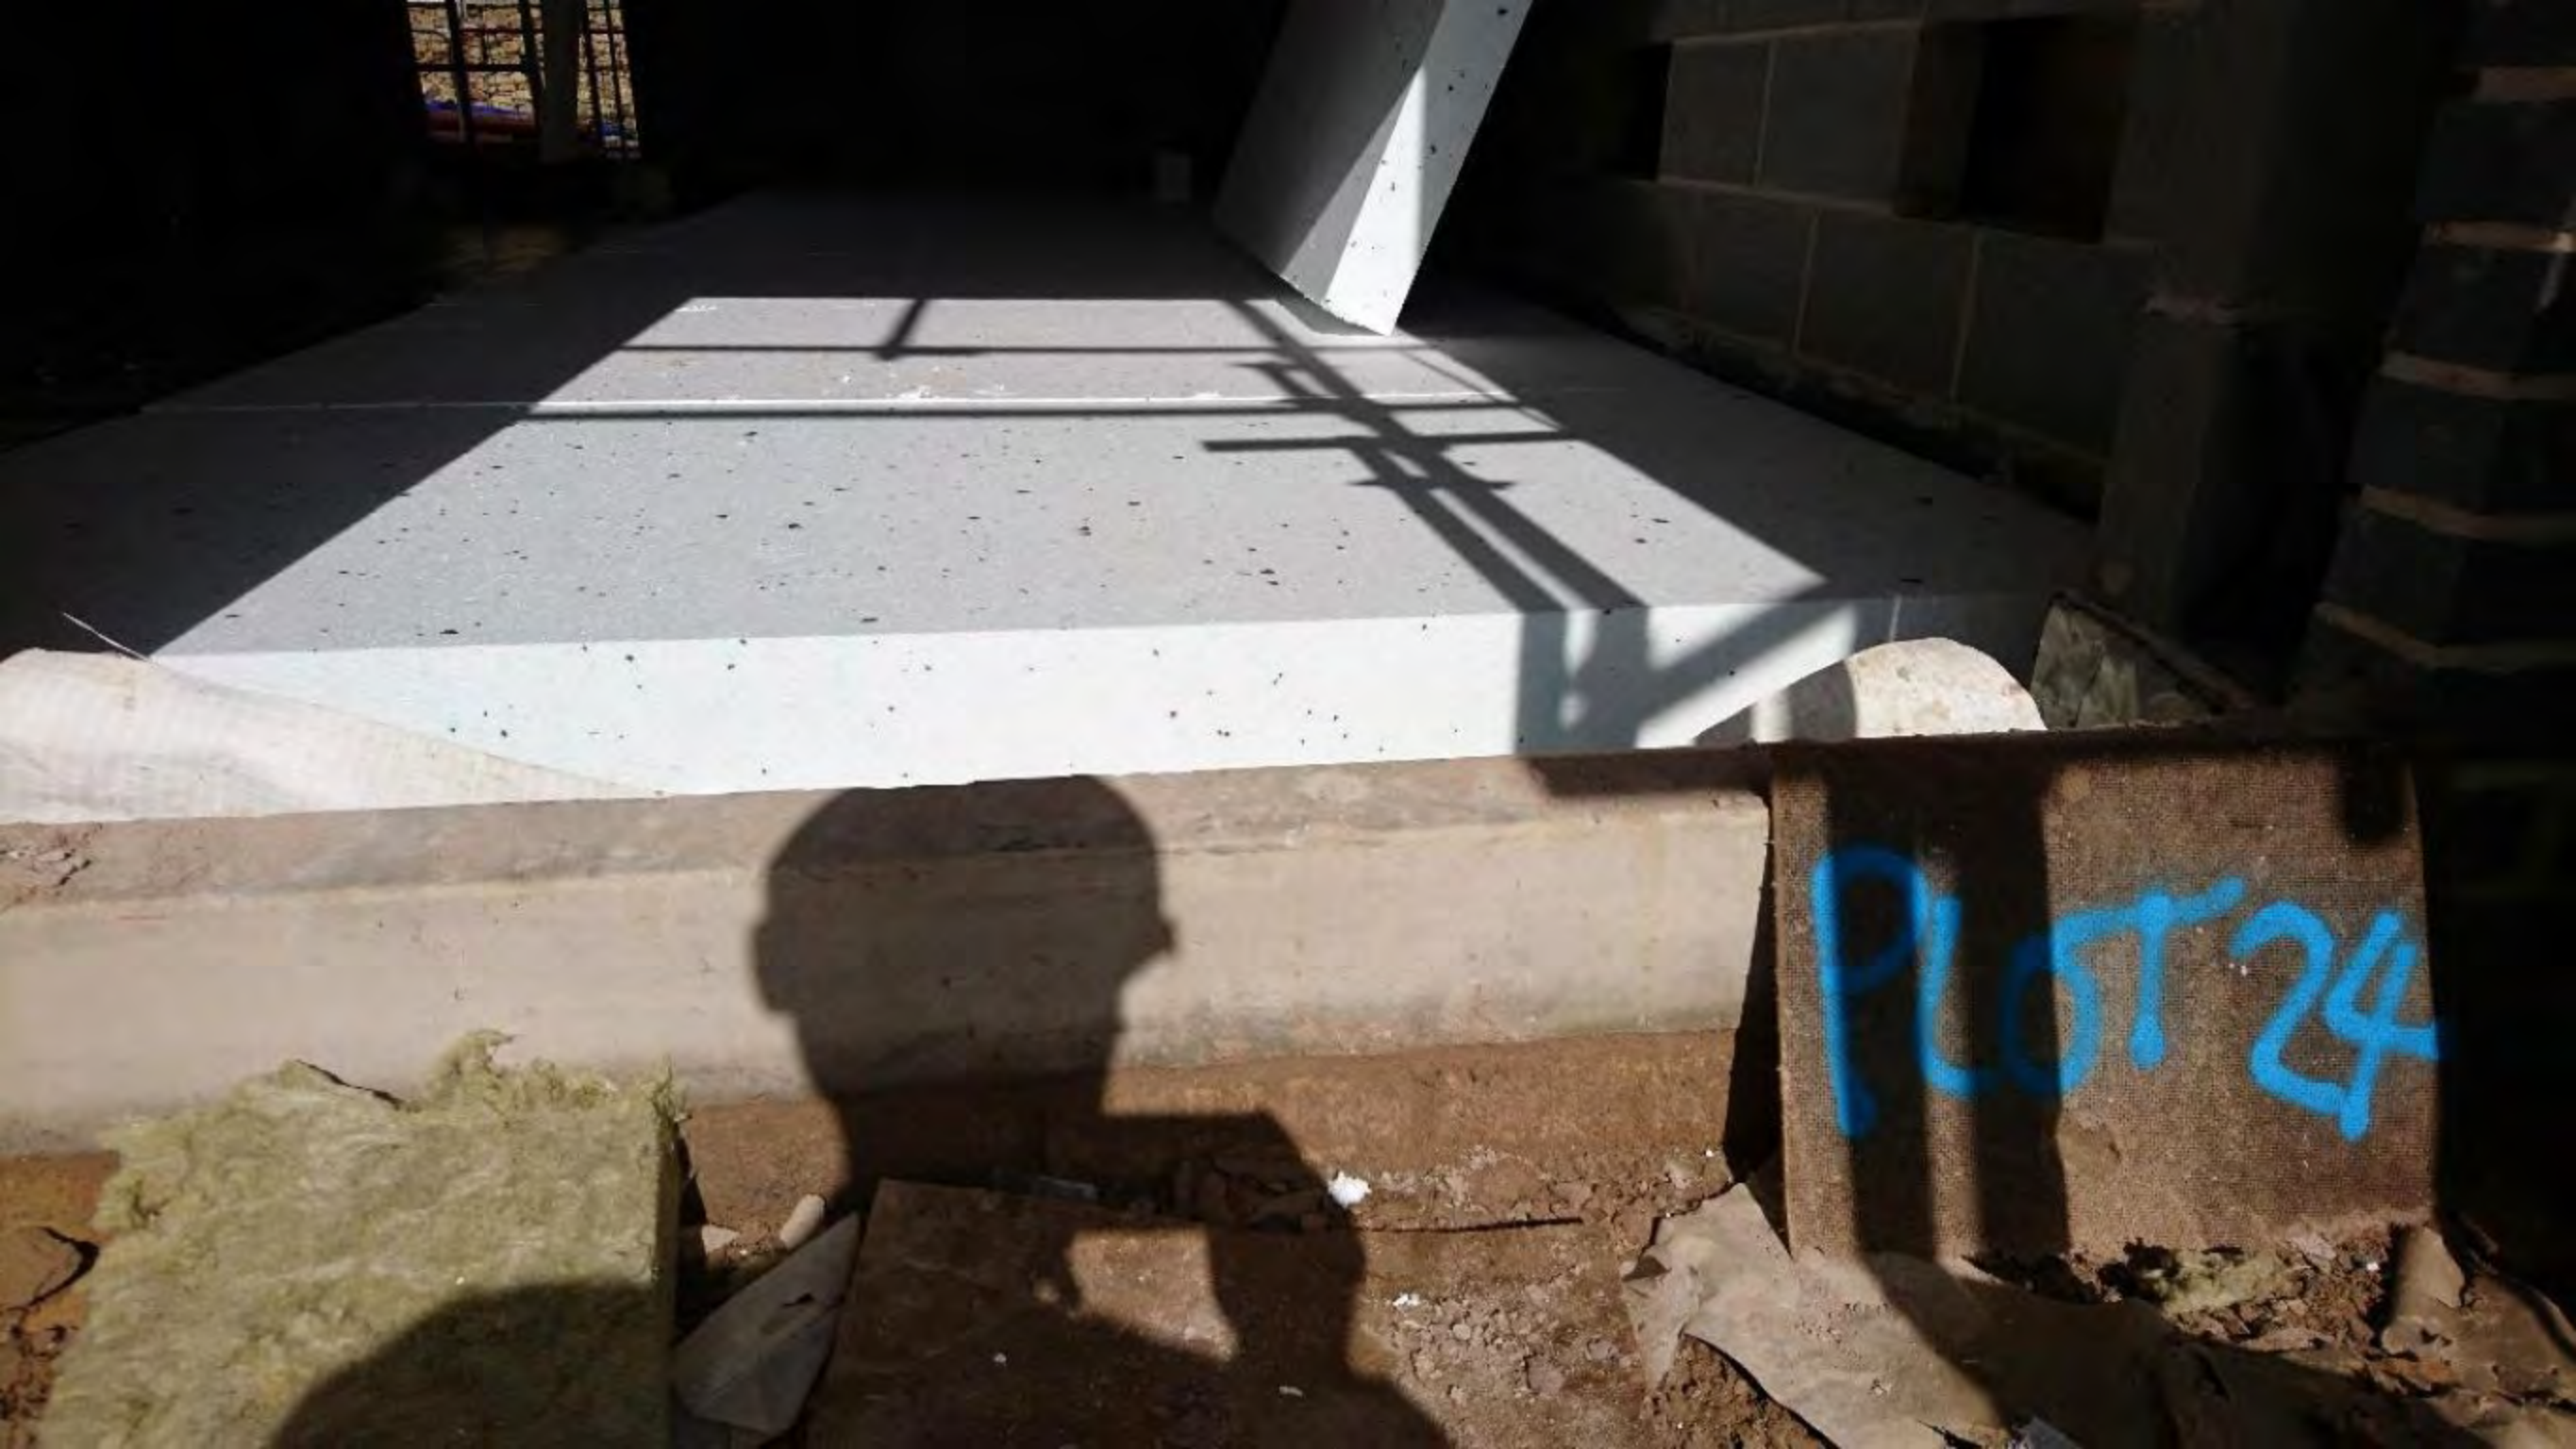
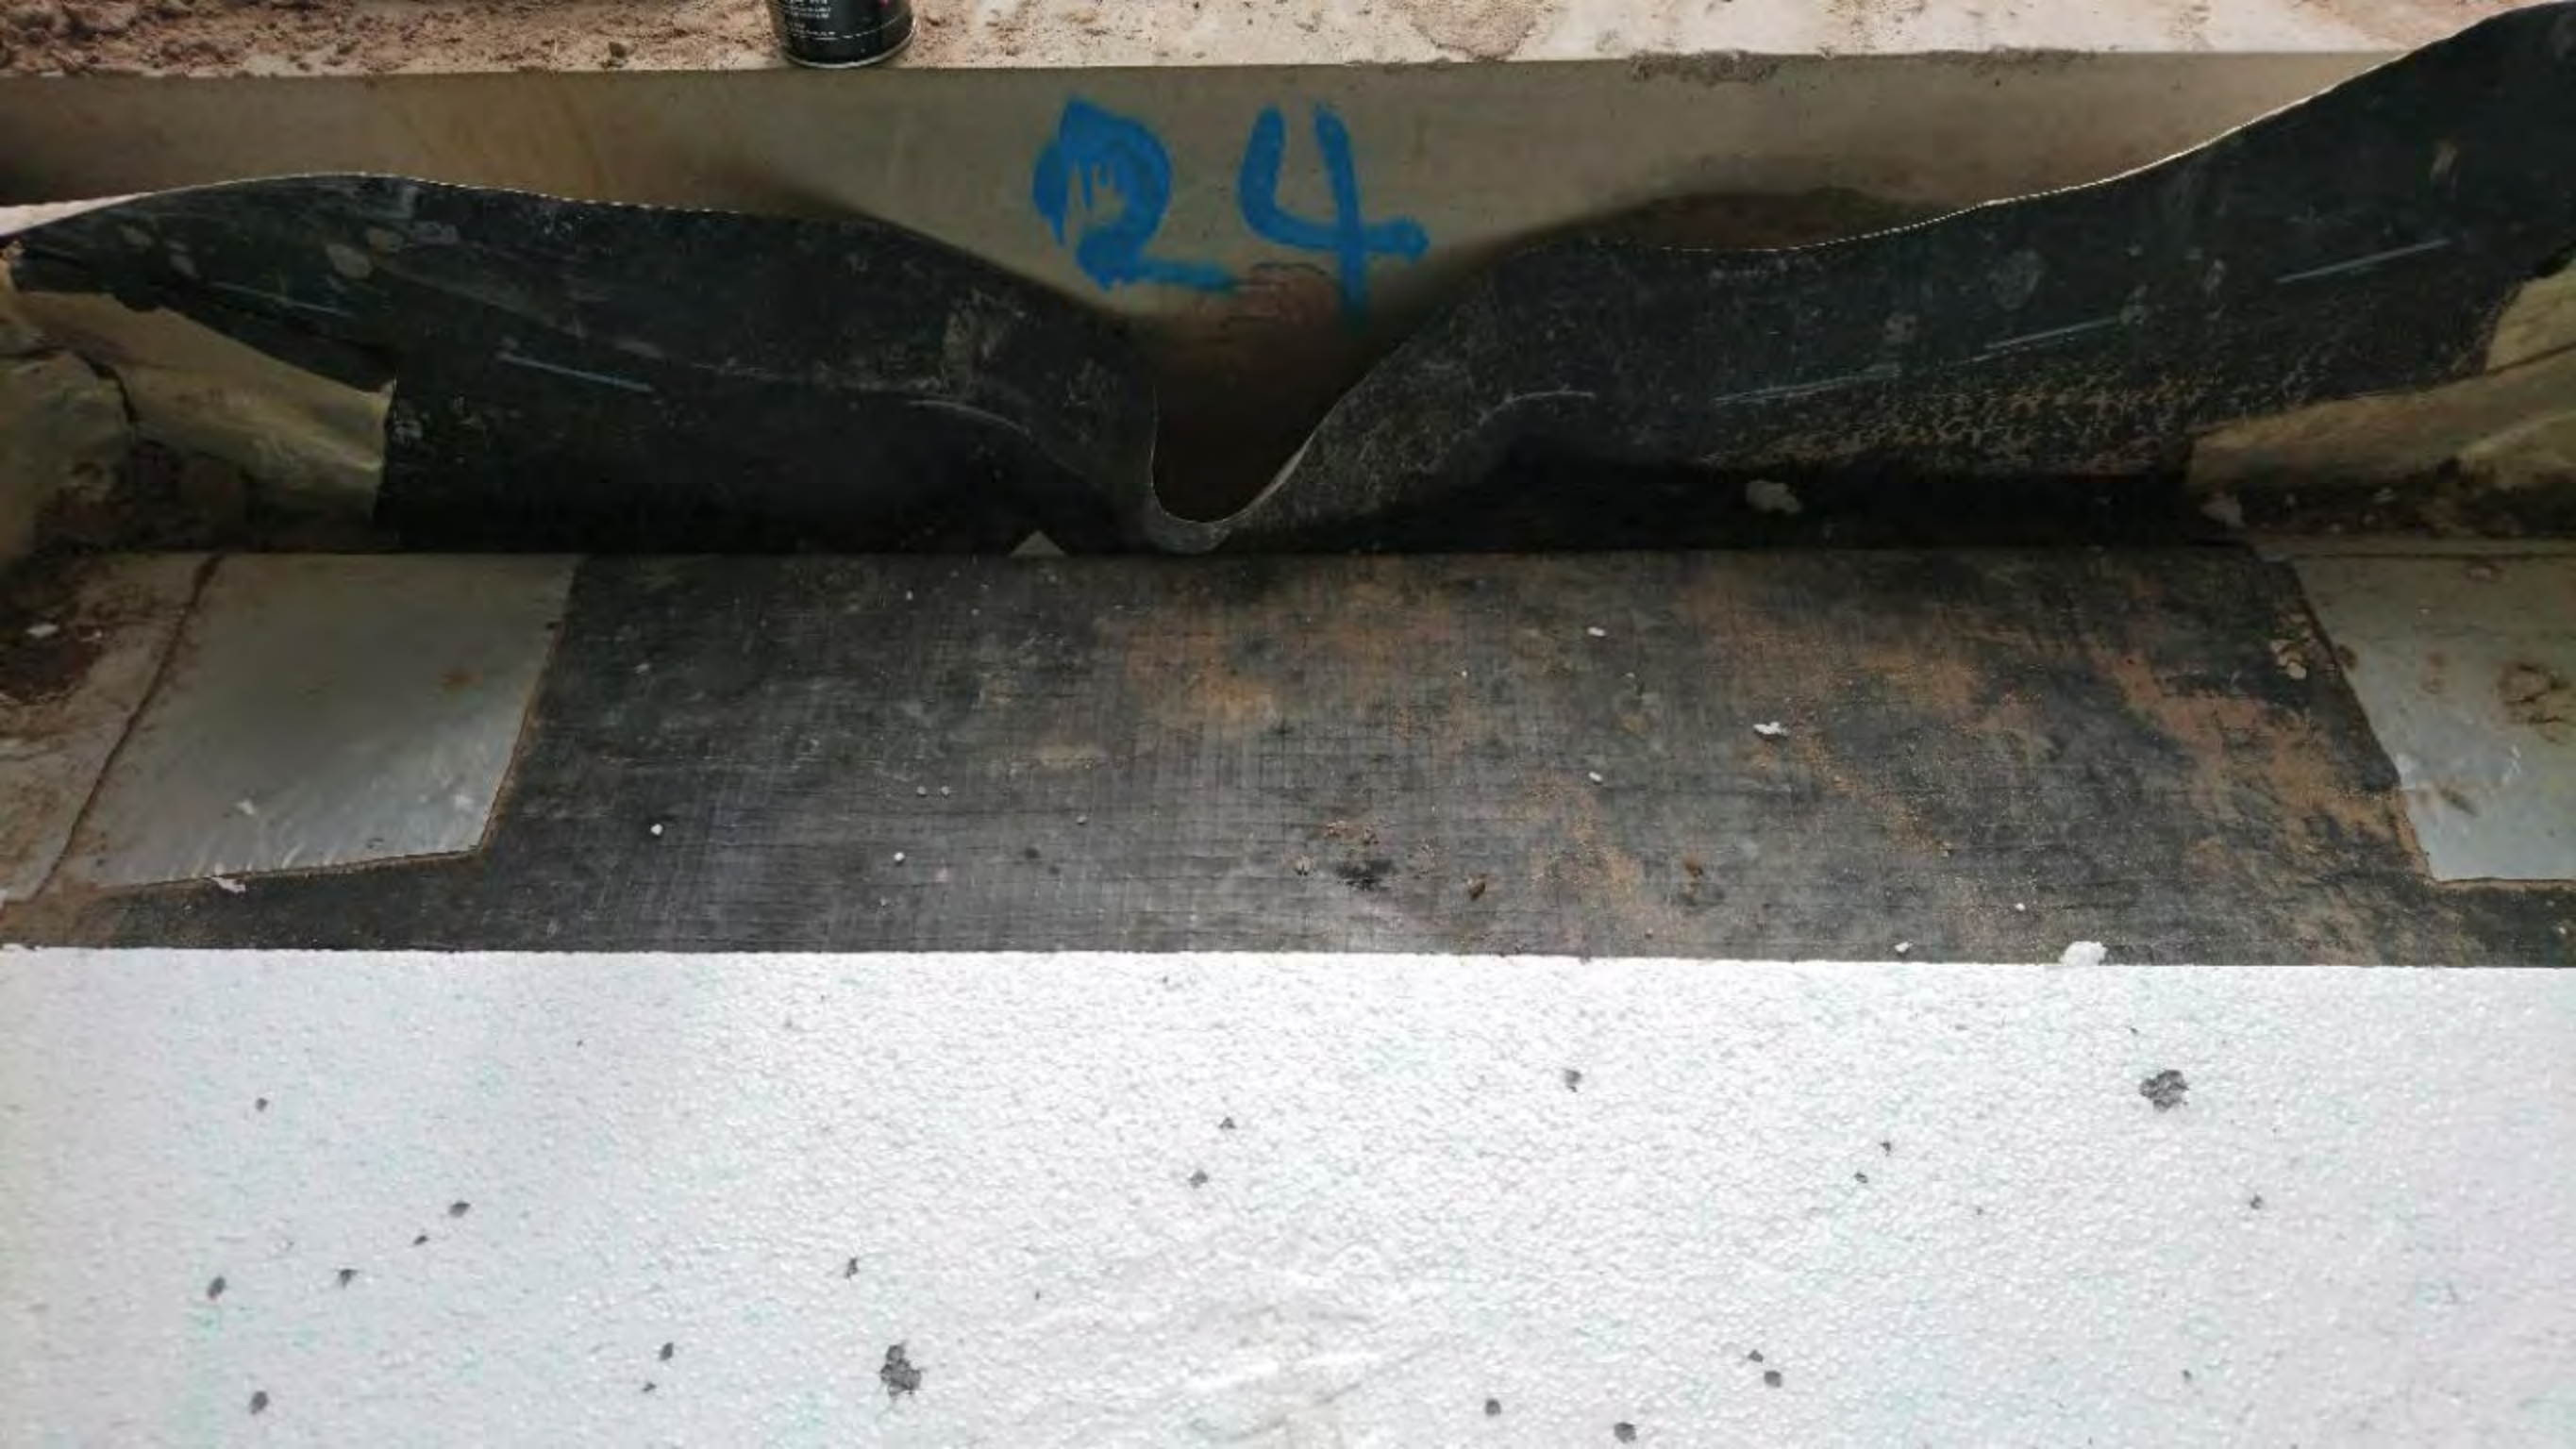
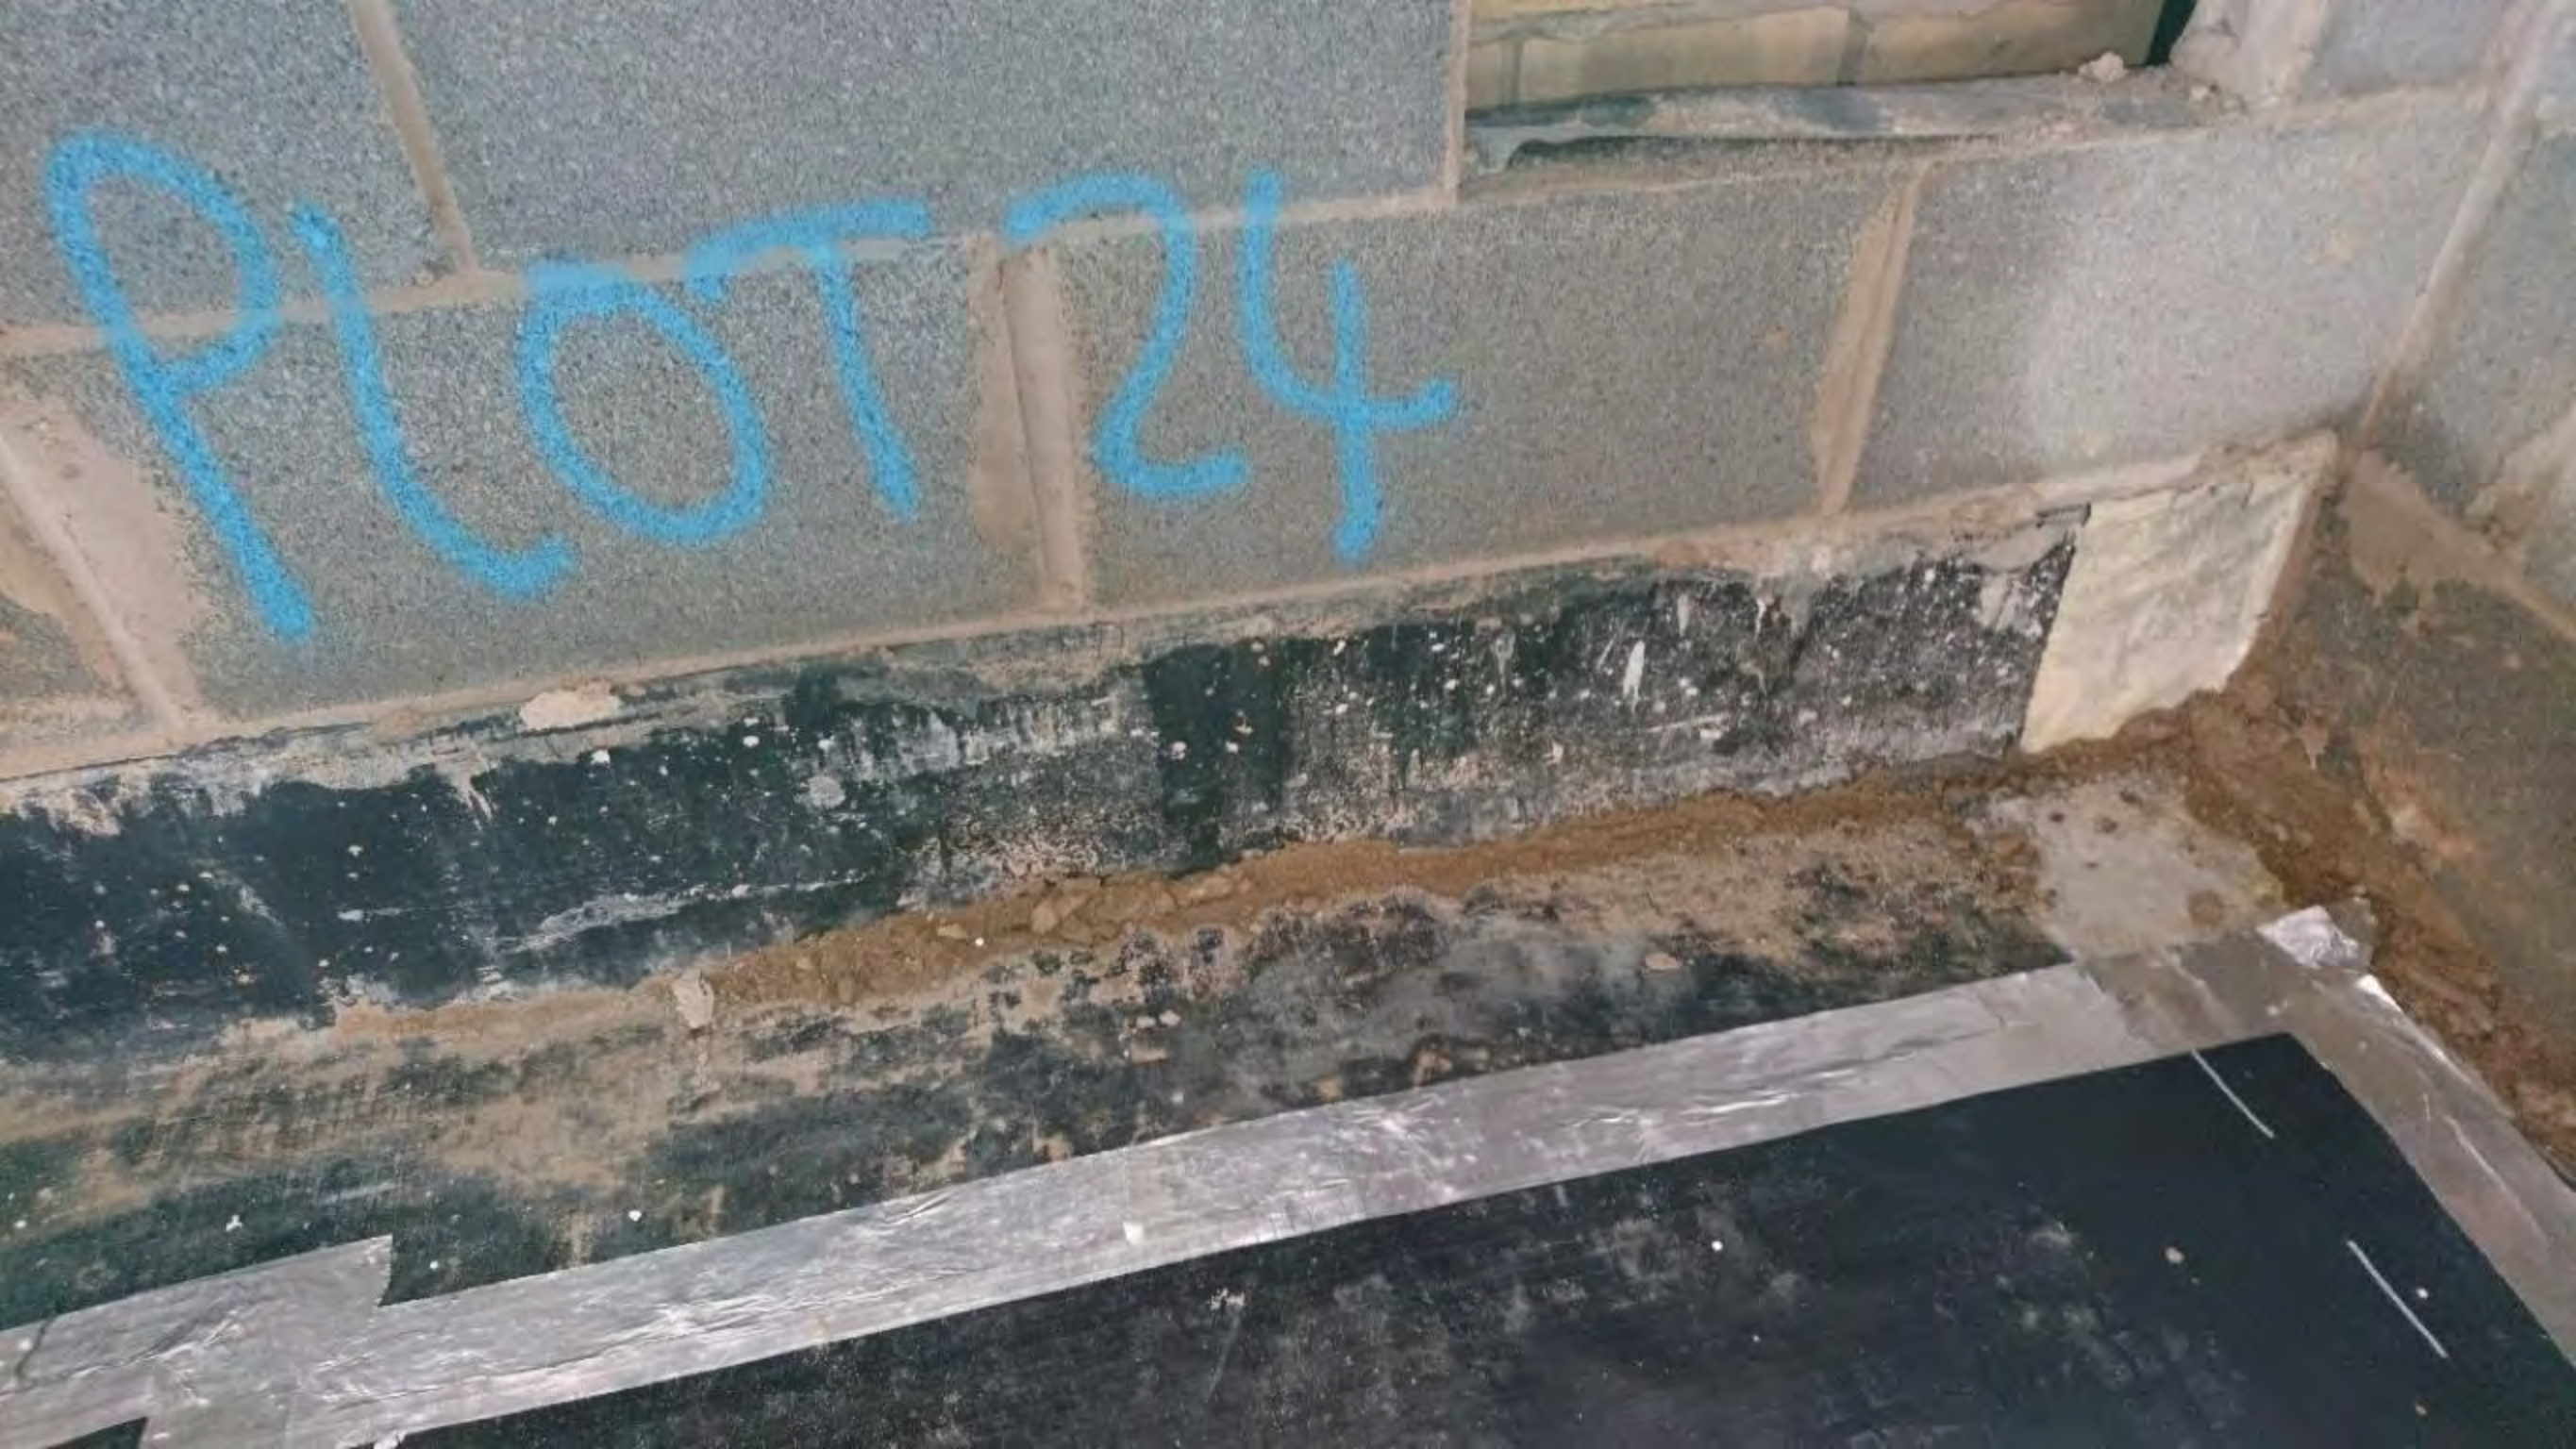
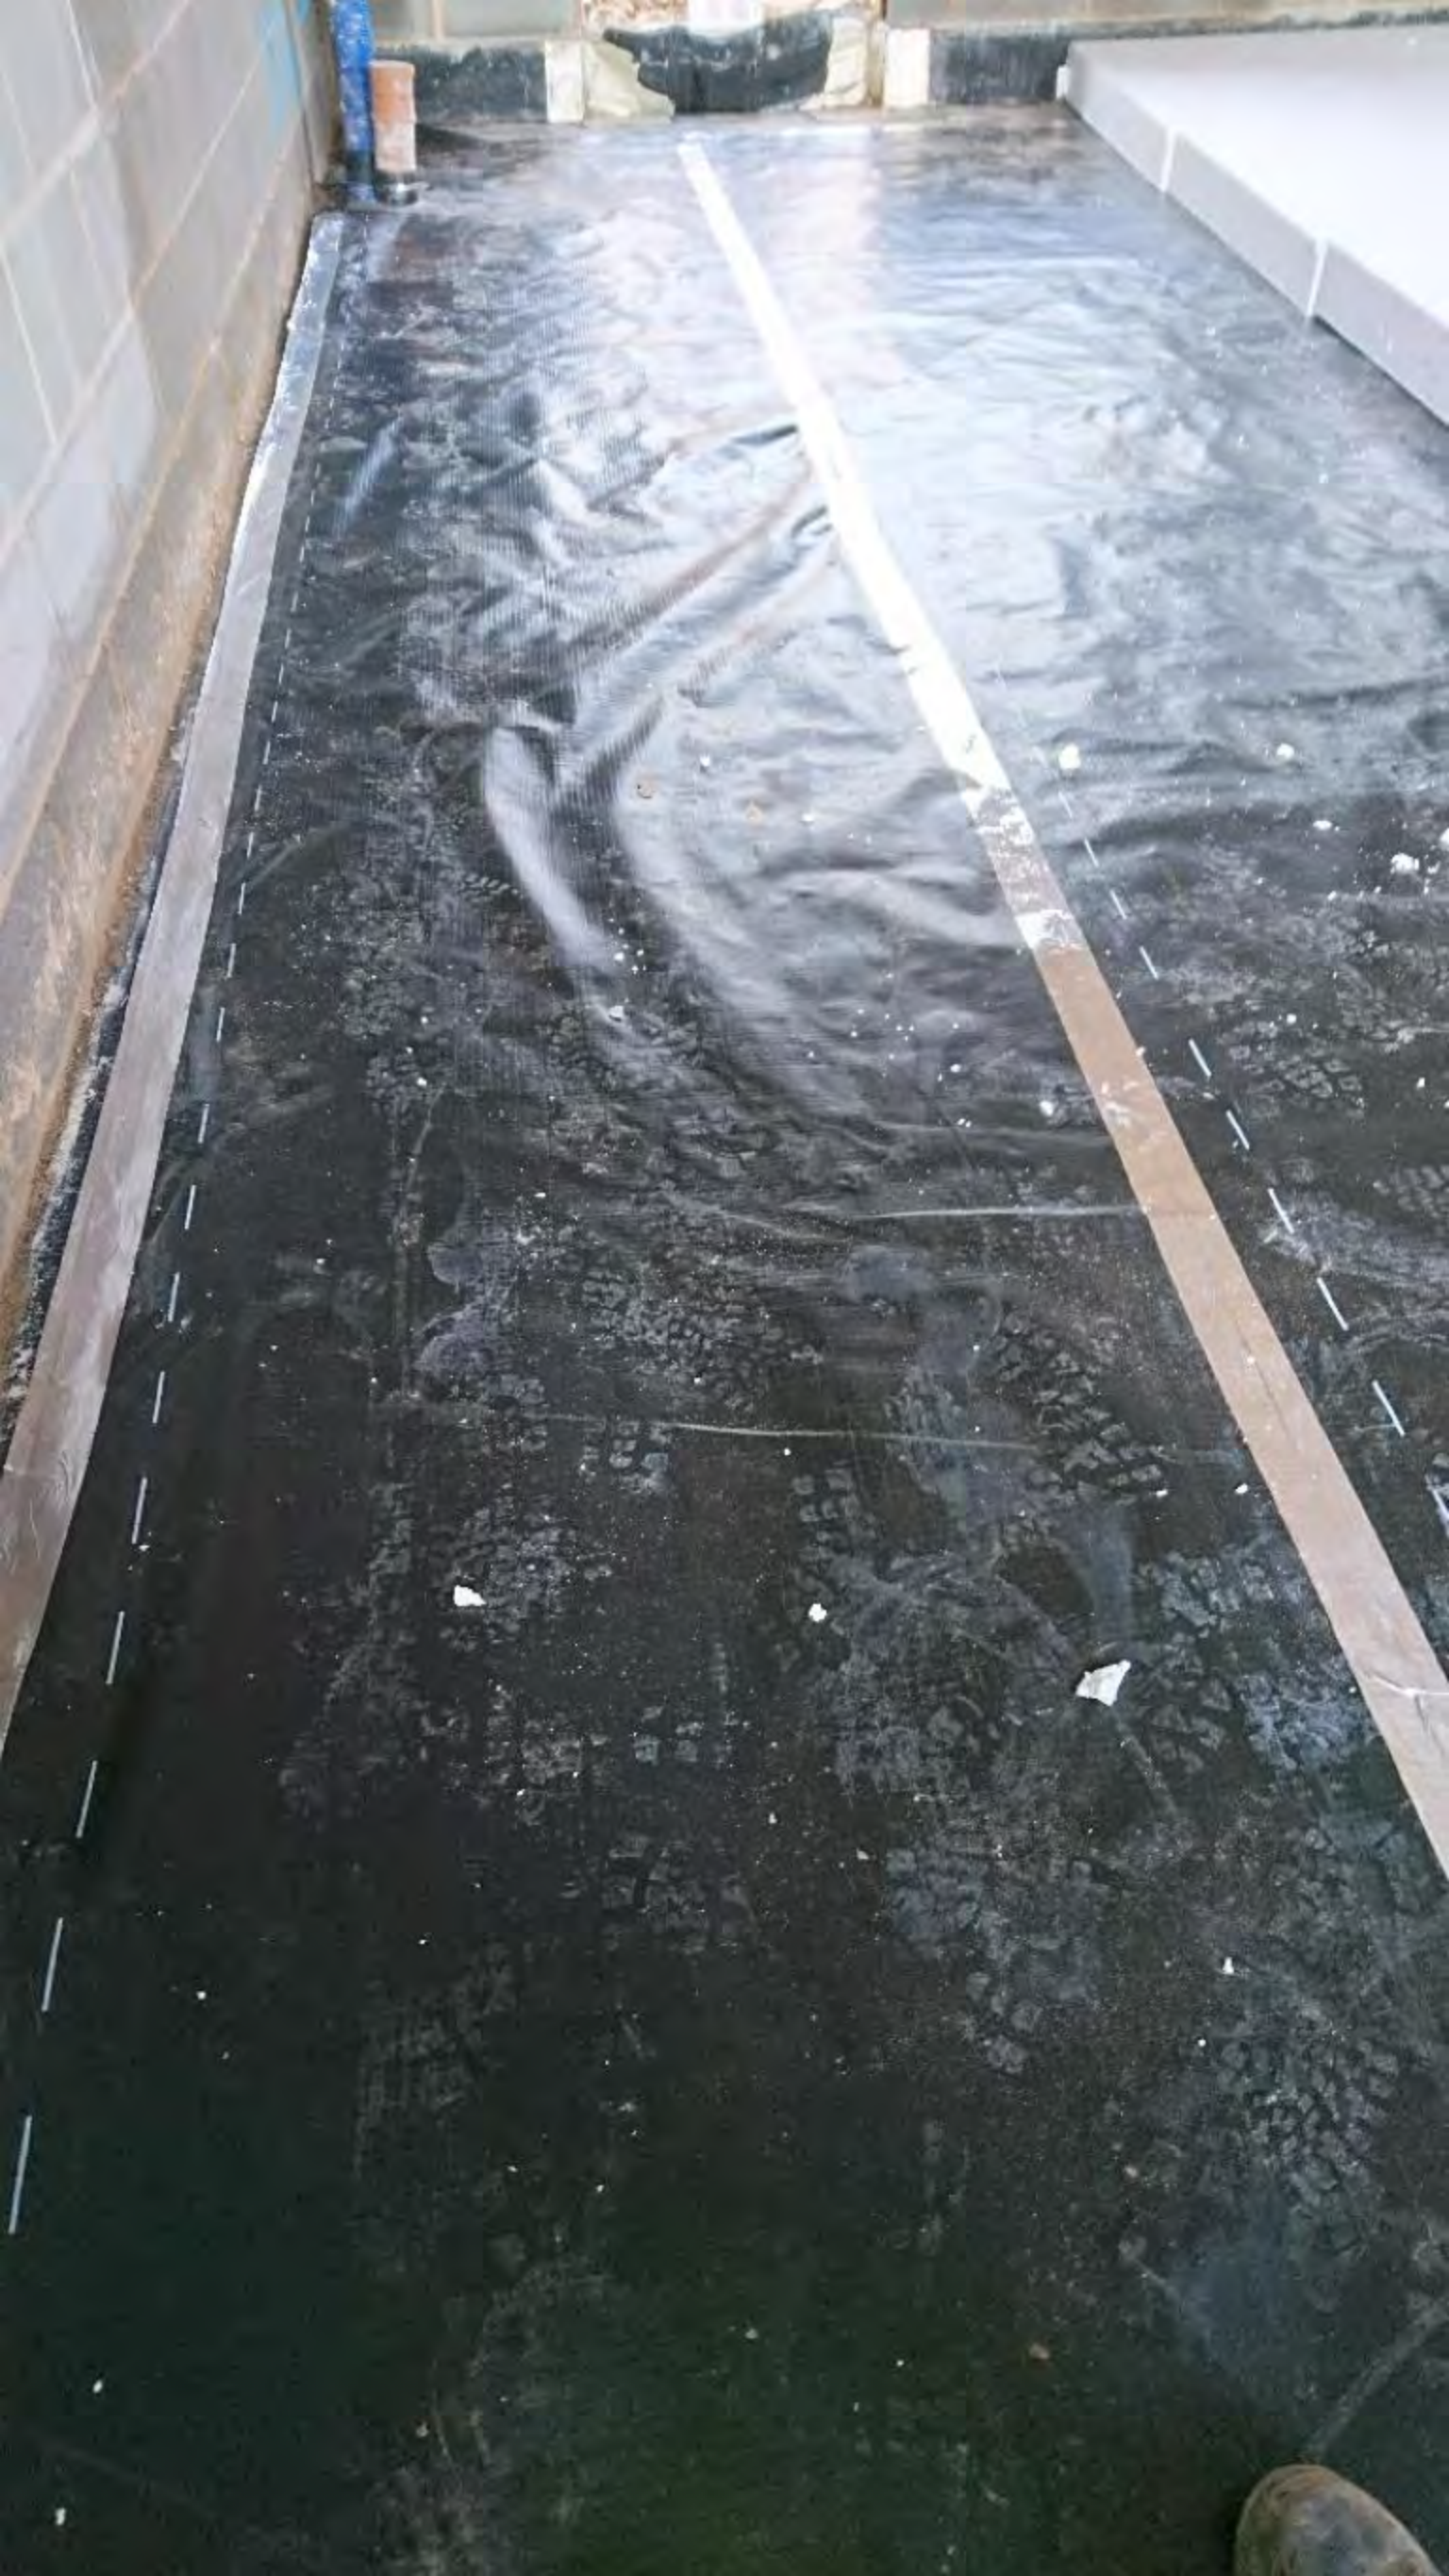
Plot 24

| 2.2 | Condition of sub-grade & underside of gas membrane | FLOOR BRUSHED AND ALL TAPES APPLIED WELL. SEALED TO A GOOD QUALITY | | | | | |
| 2.4 | Gas membrane condition and coverage | GOOD, SEALED ON ALL FOUR SIDES | | | | | |
| 2.7 | Condition of joints/seals | ALL GOOD, VISIBLE OVERLAPS | | | | | |
| 2.8 | Number and condition of service entry seals | 3 NO. TOPHATS WITH JUBILEE CLIPS – TAPES CHECKED, ALL OK | | | | | |
