## Gas Protection - Validation Record Sheet

**This Record sheet is only applicable to block and beam floor slabs for Characteristic Situation 2 gas protection systems**

**For Residential Development at New Church Street, Radcliffe.**

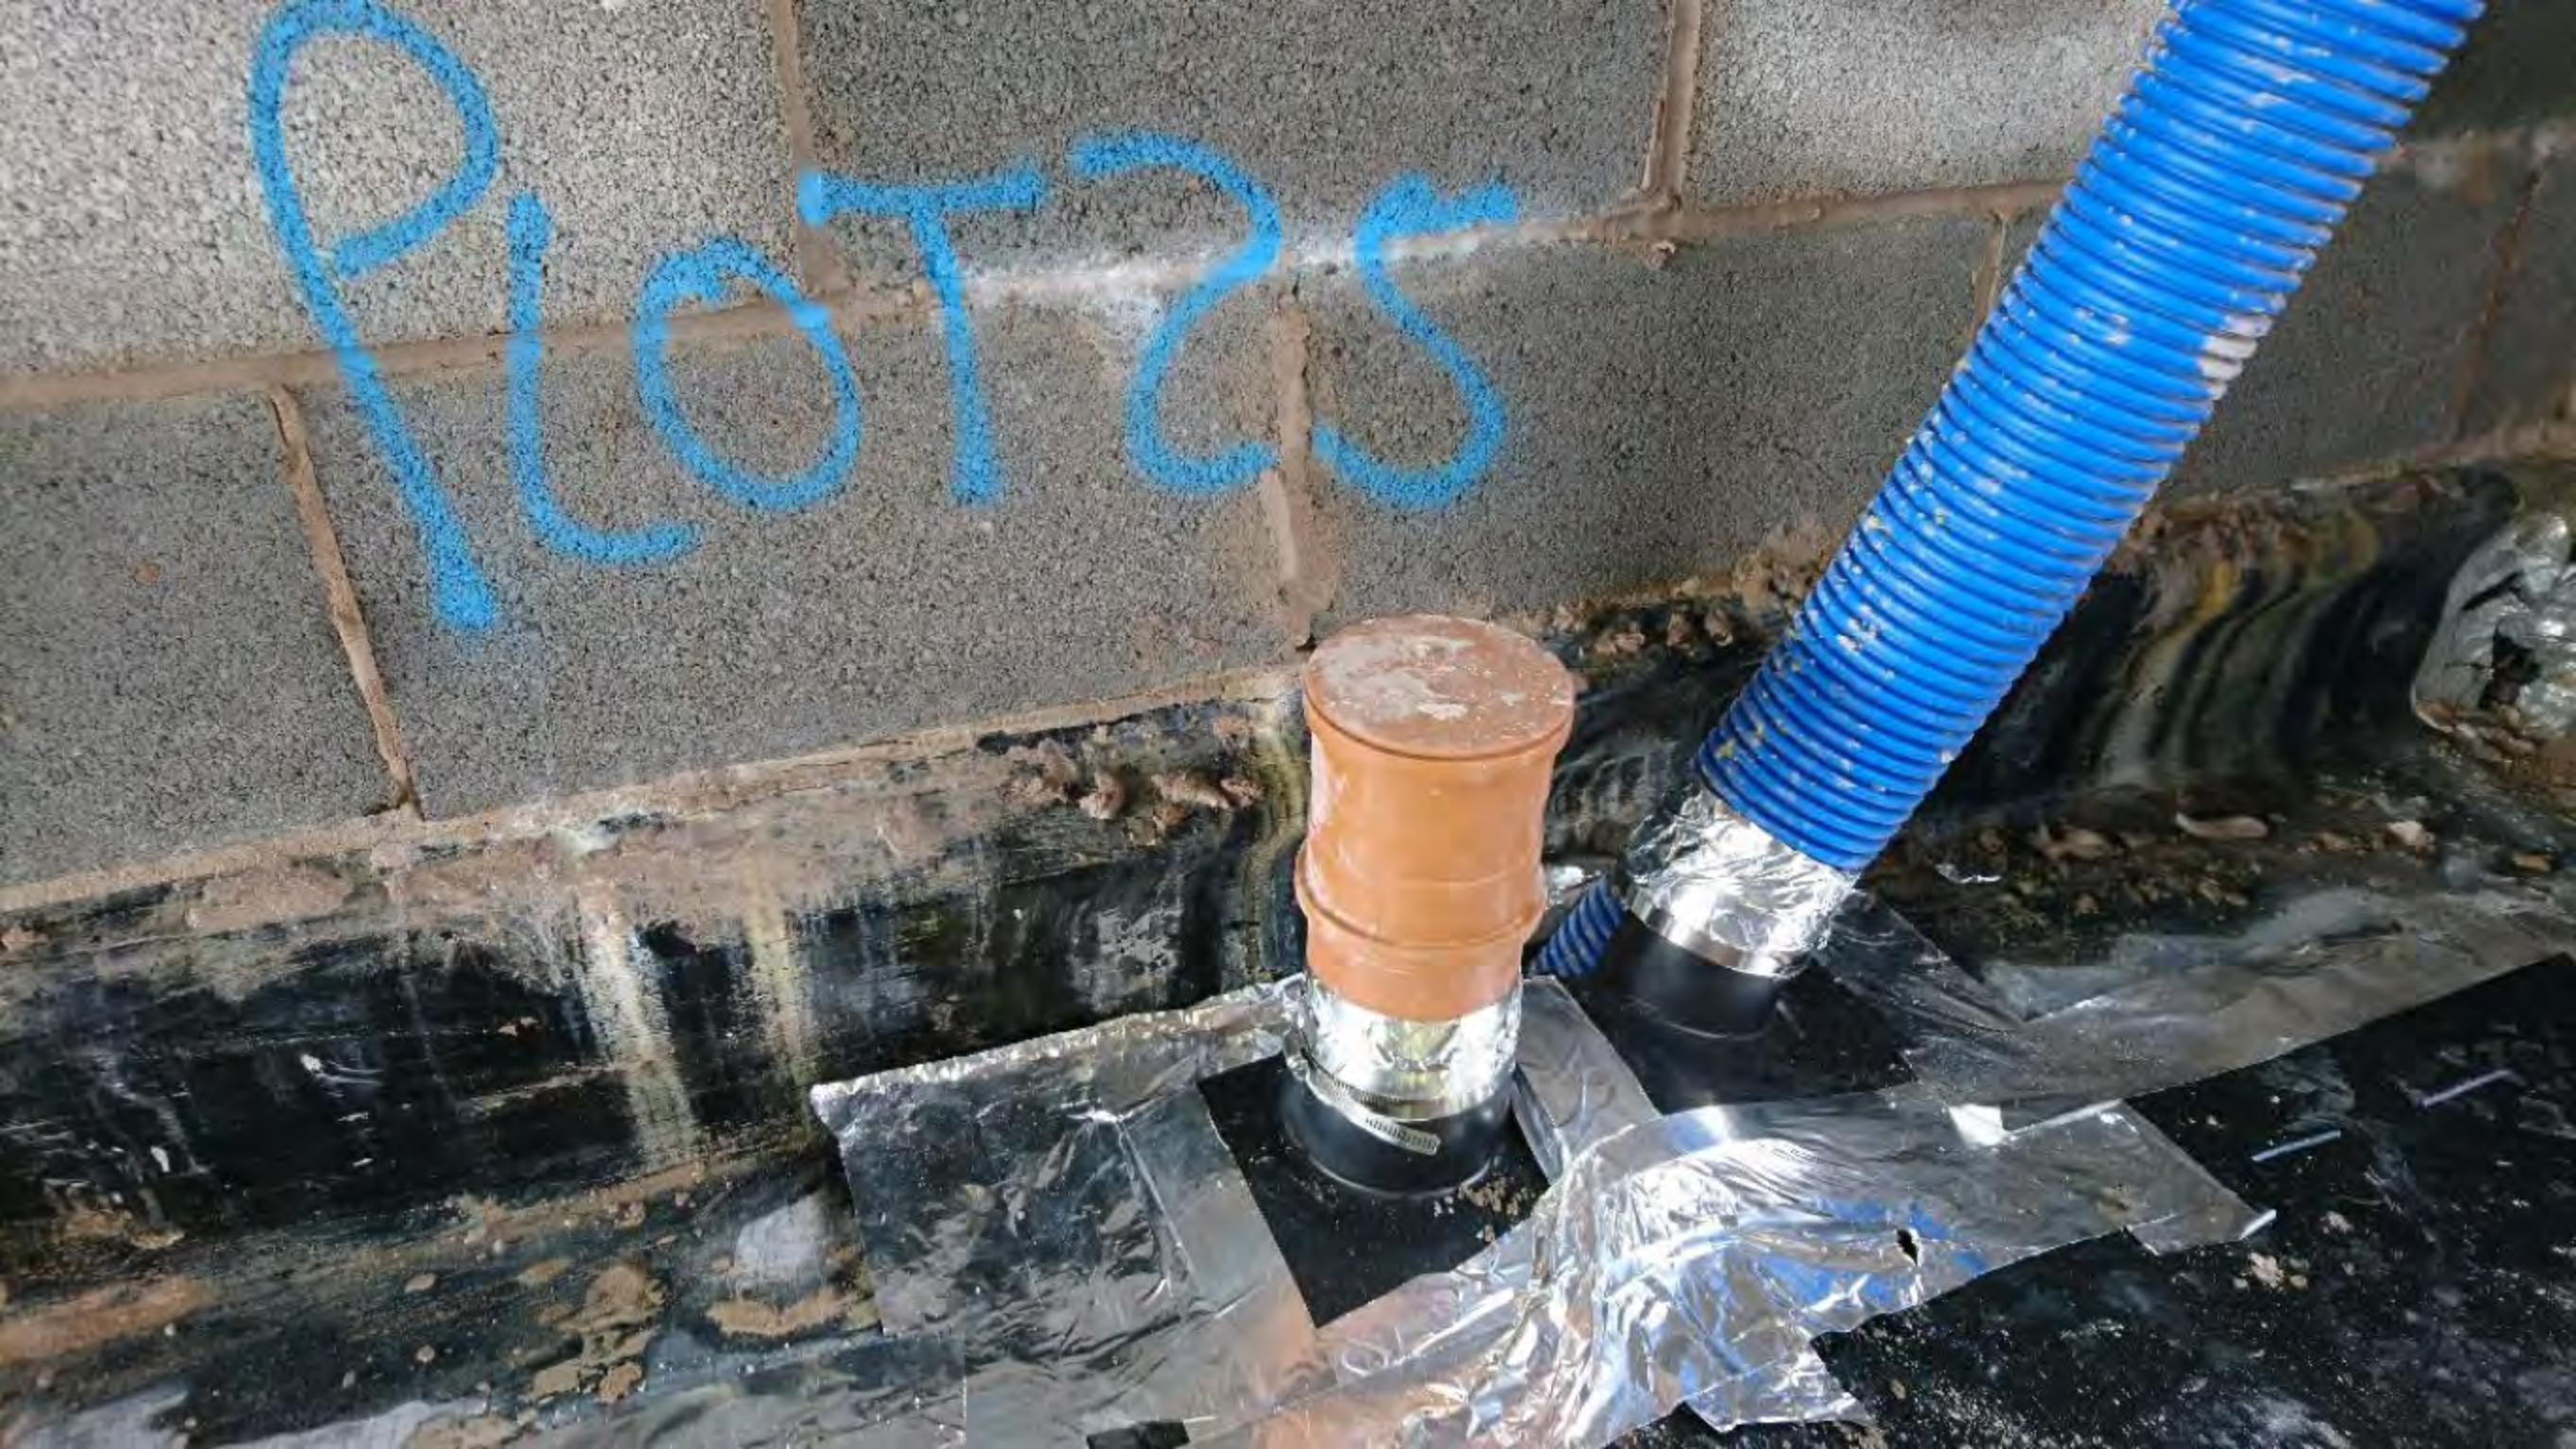
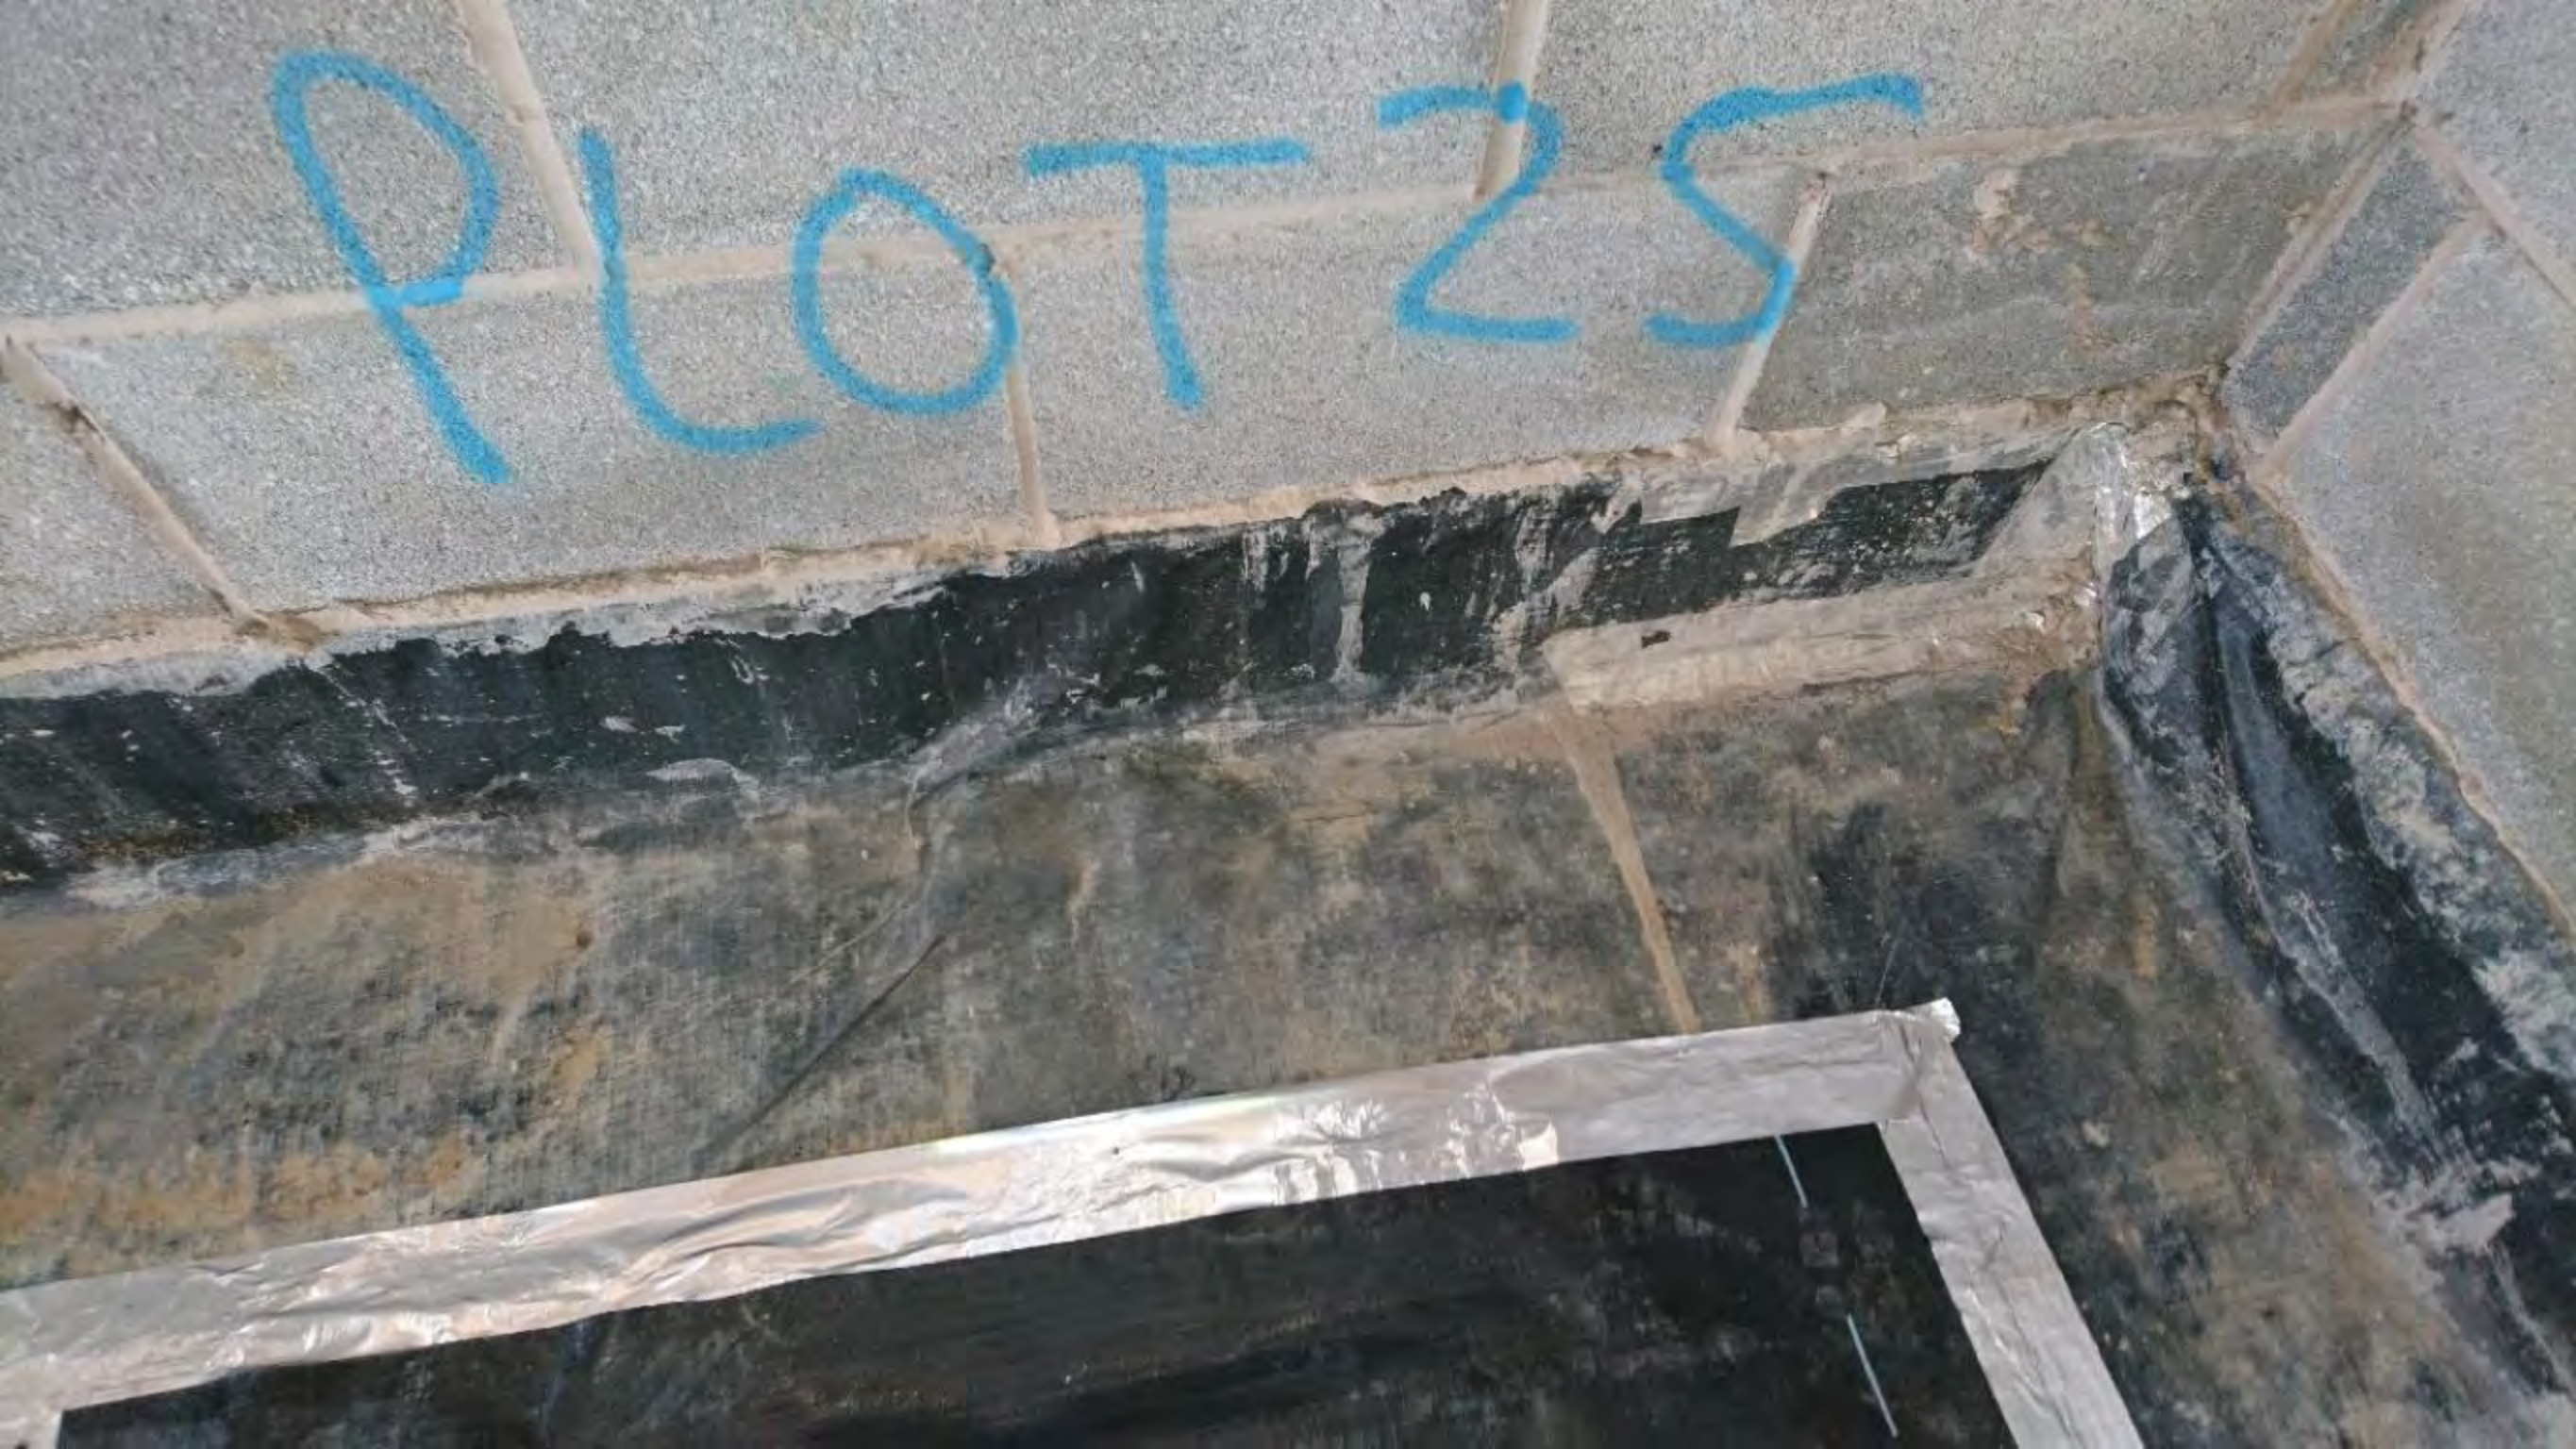
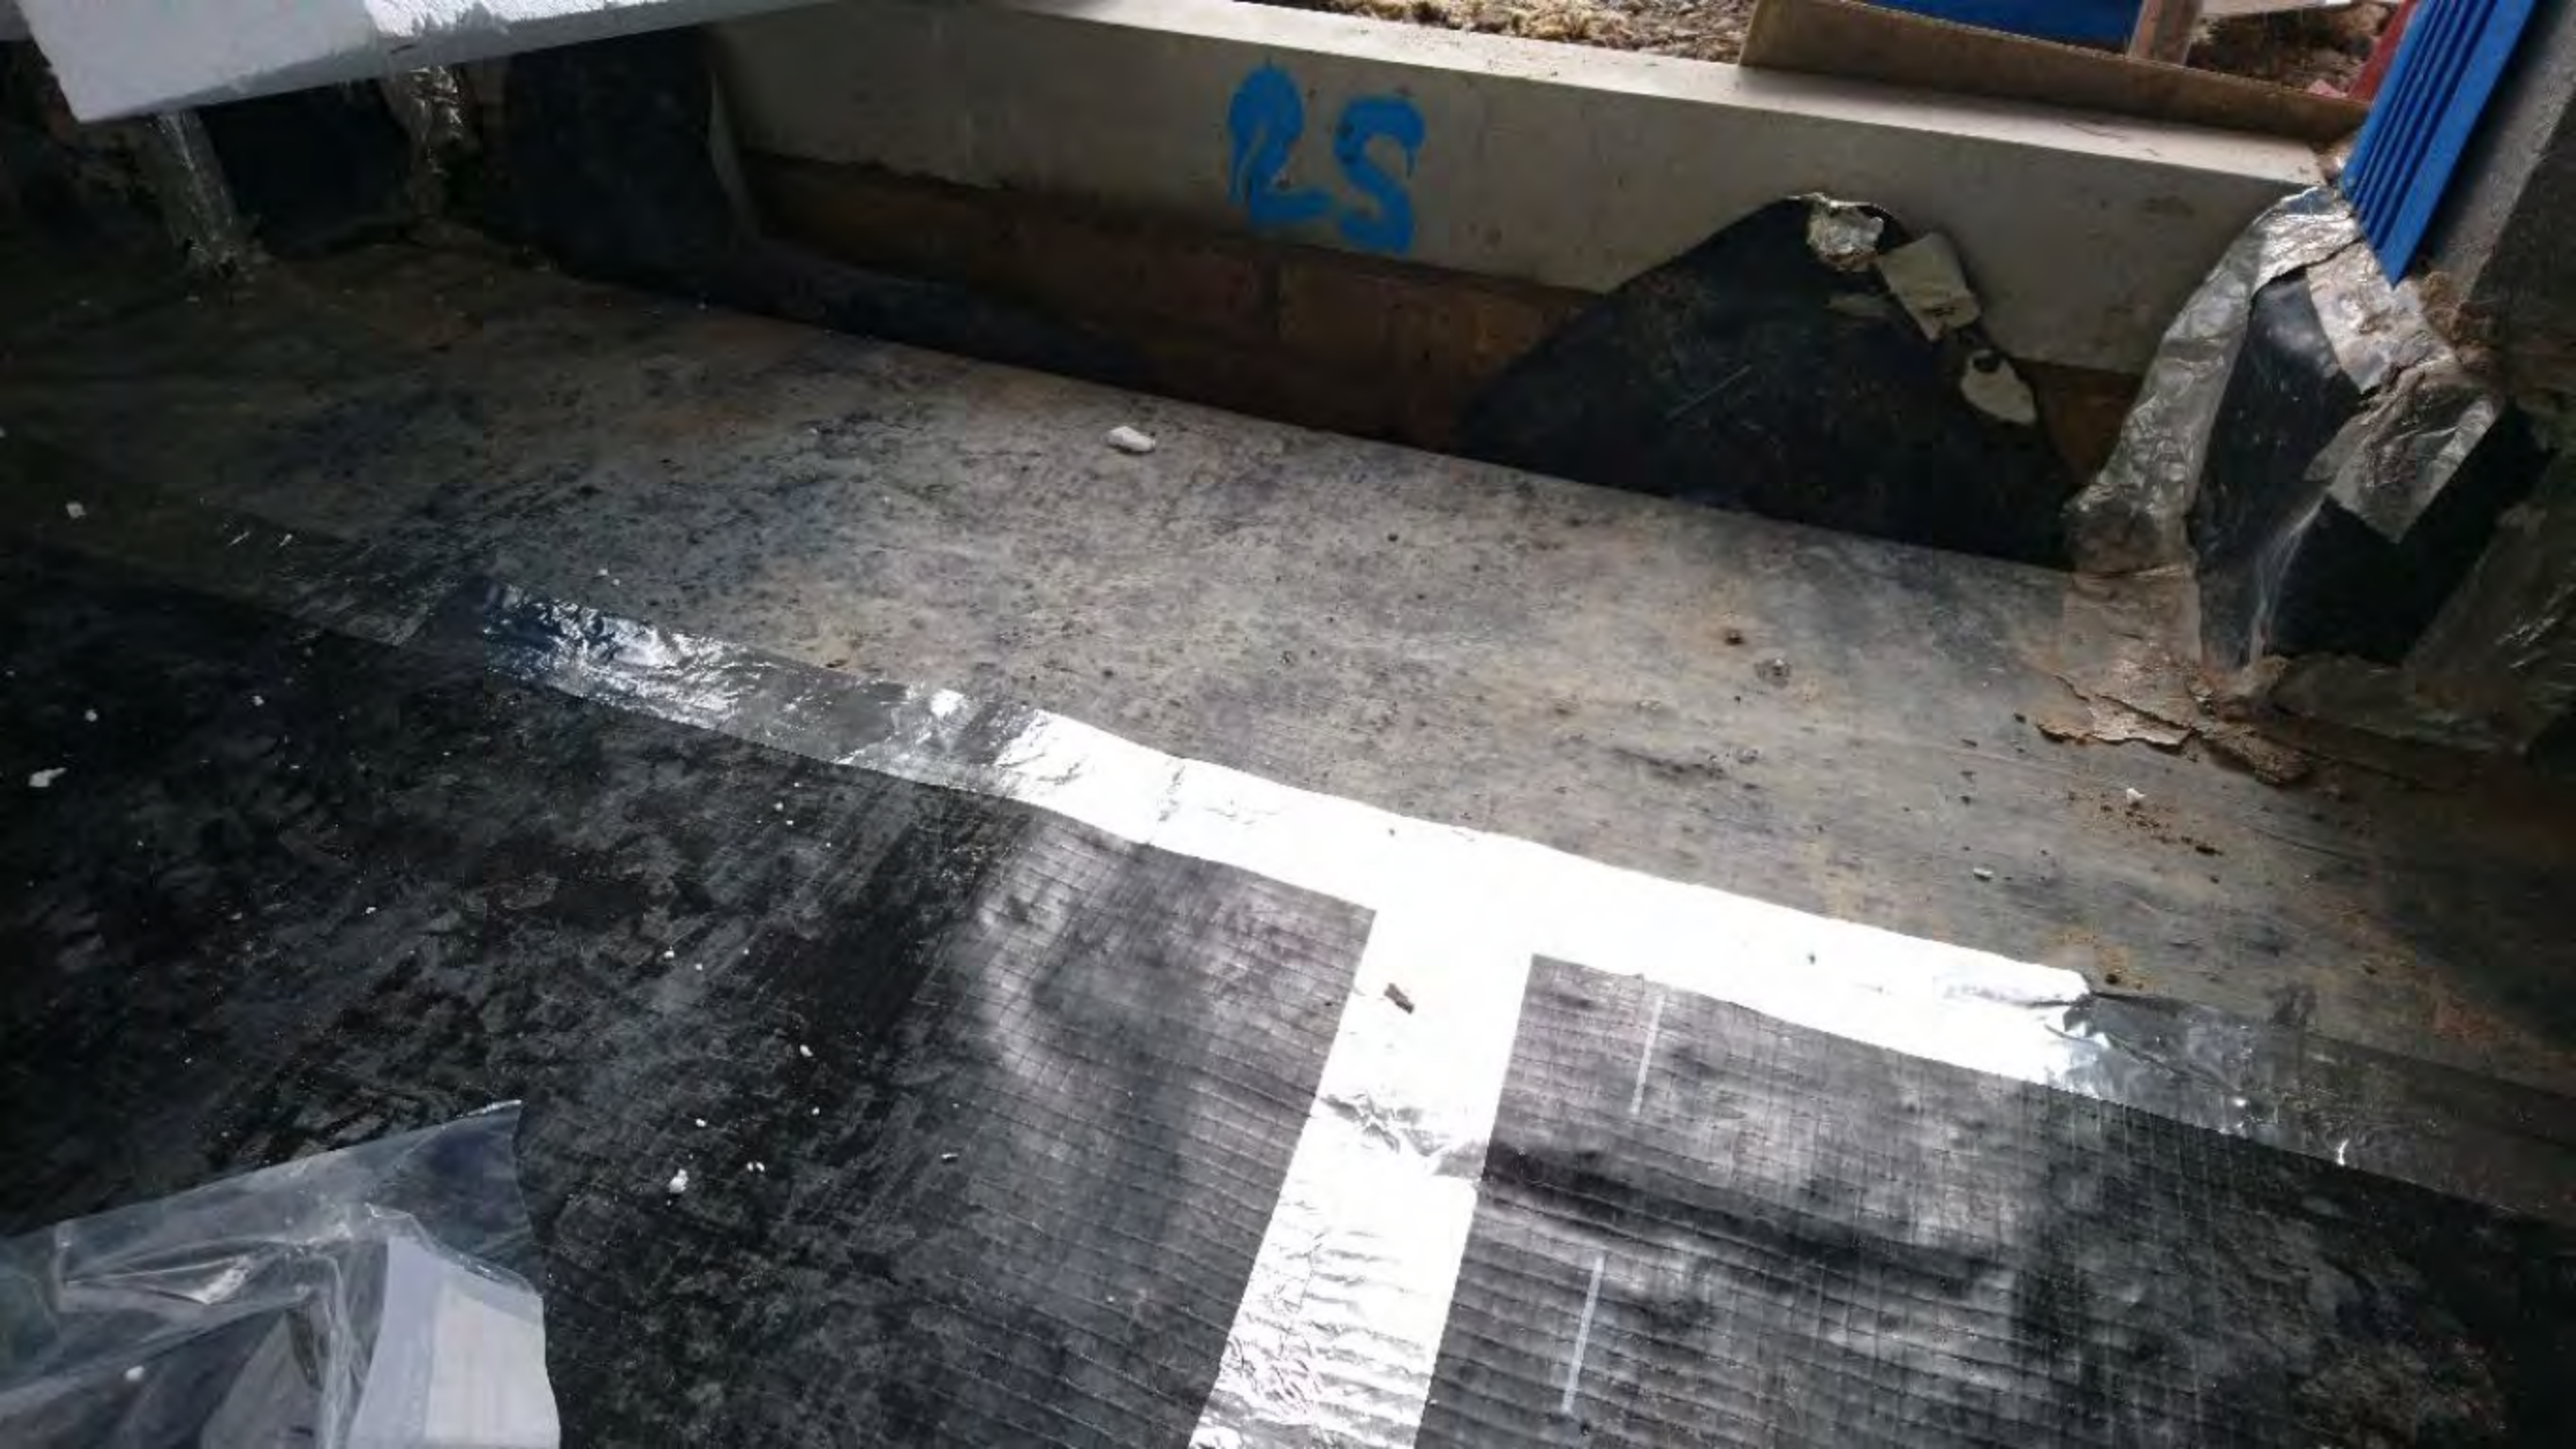
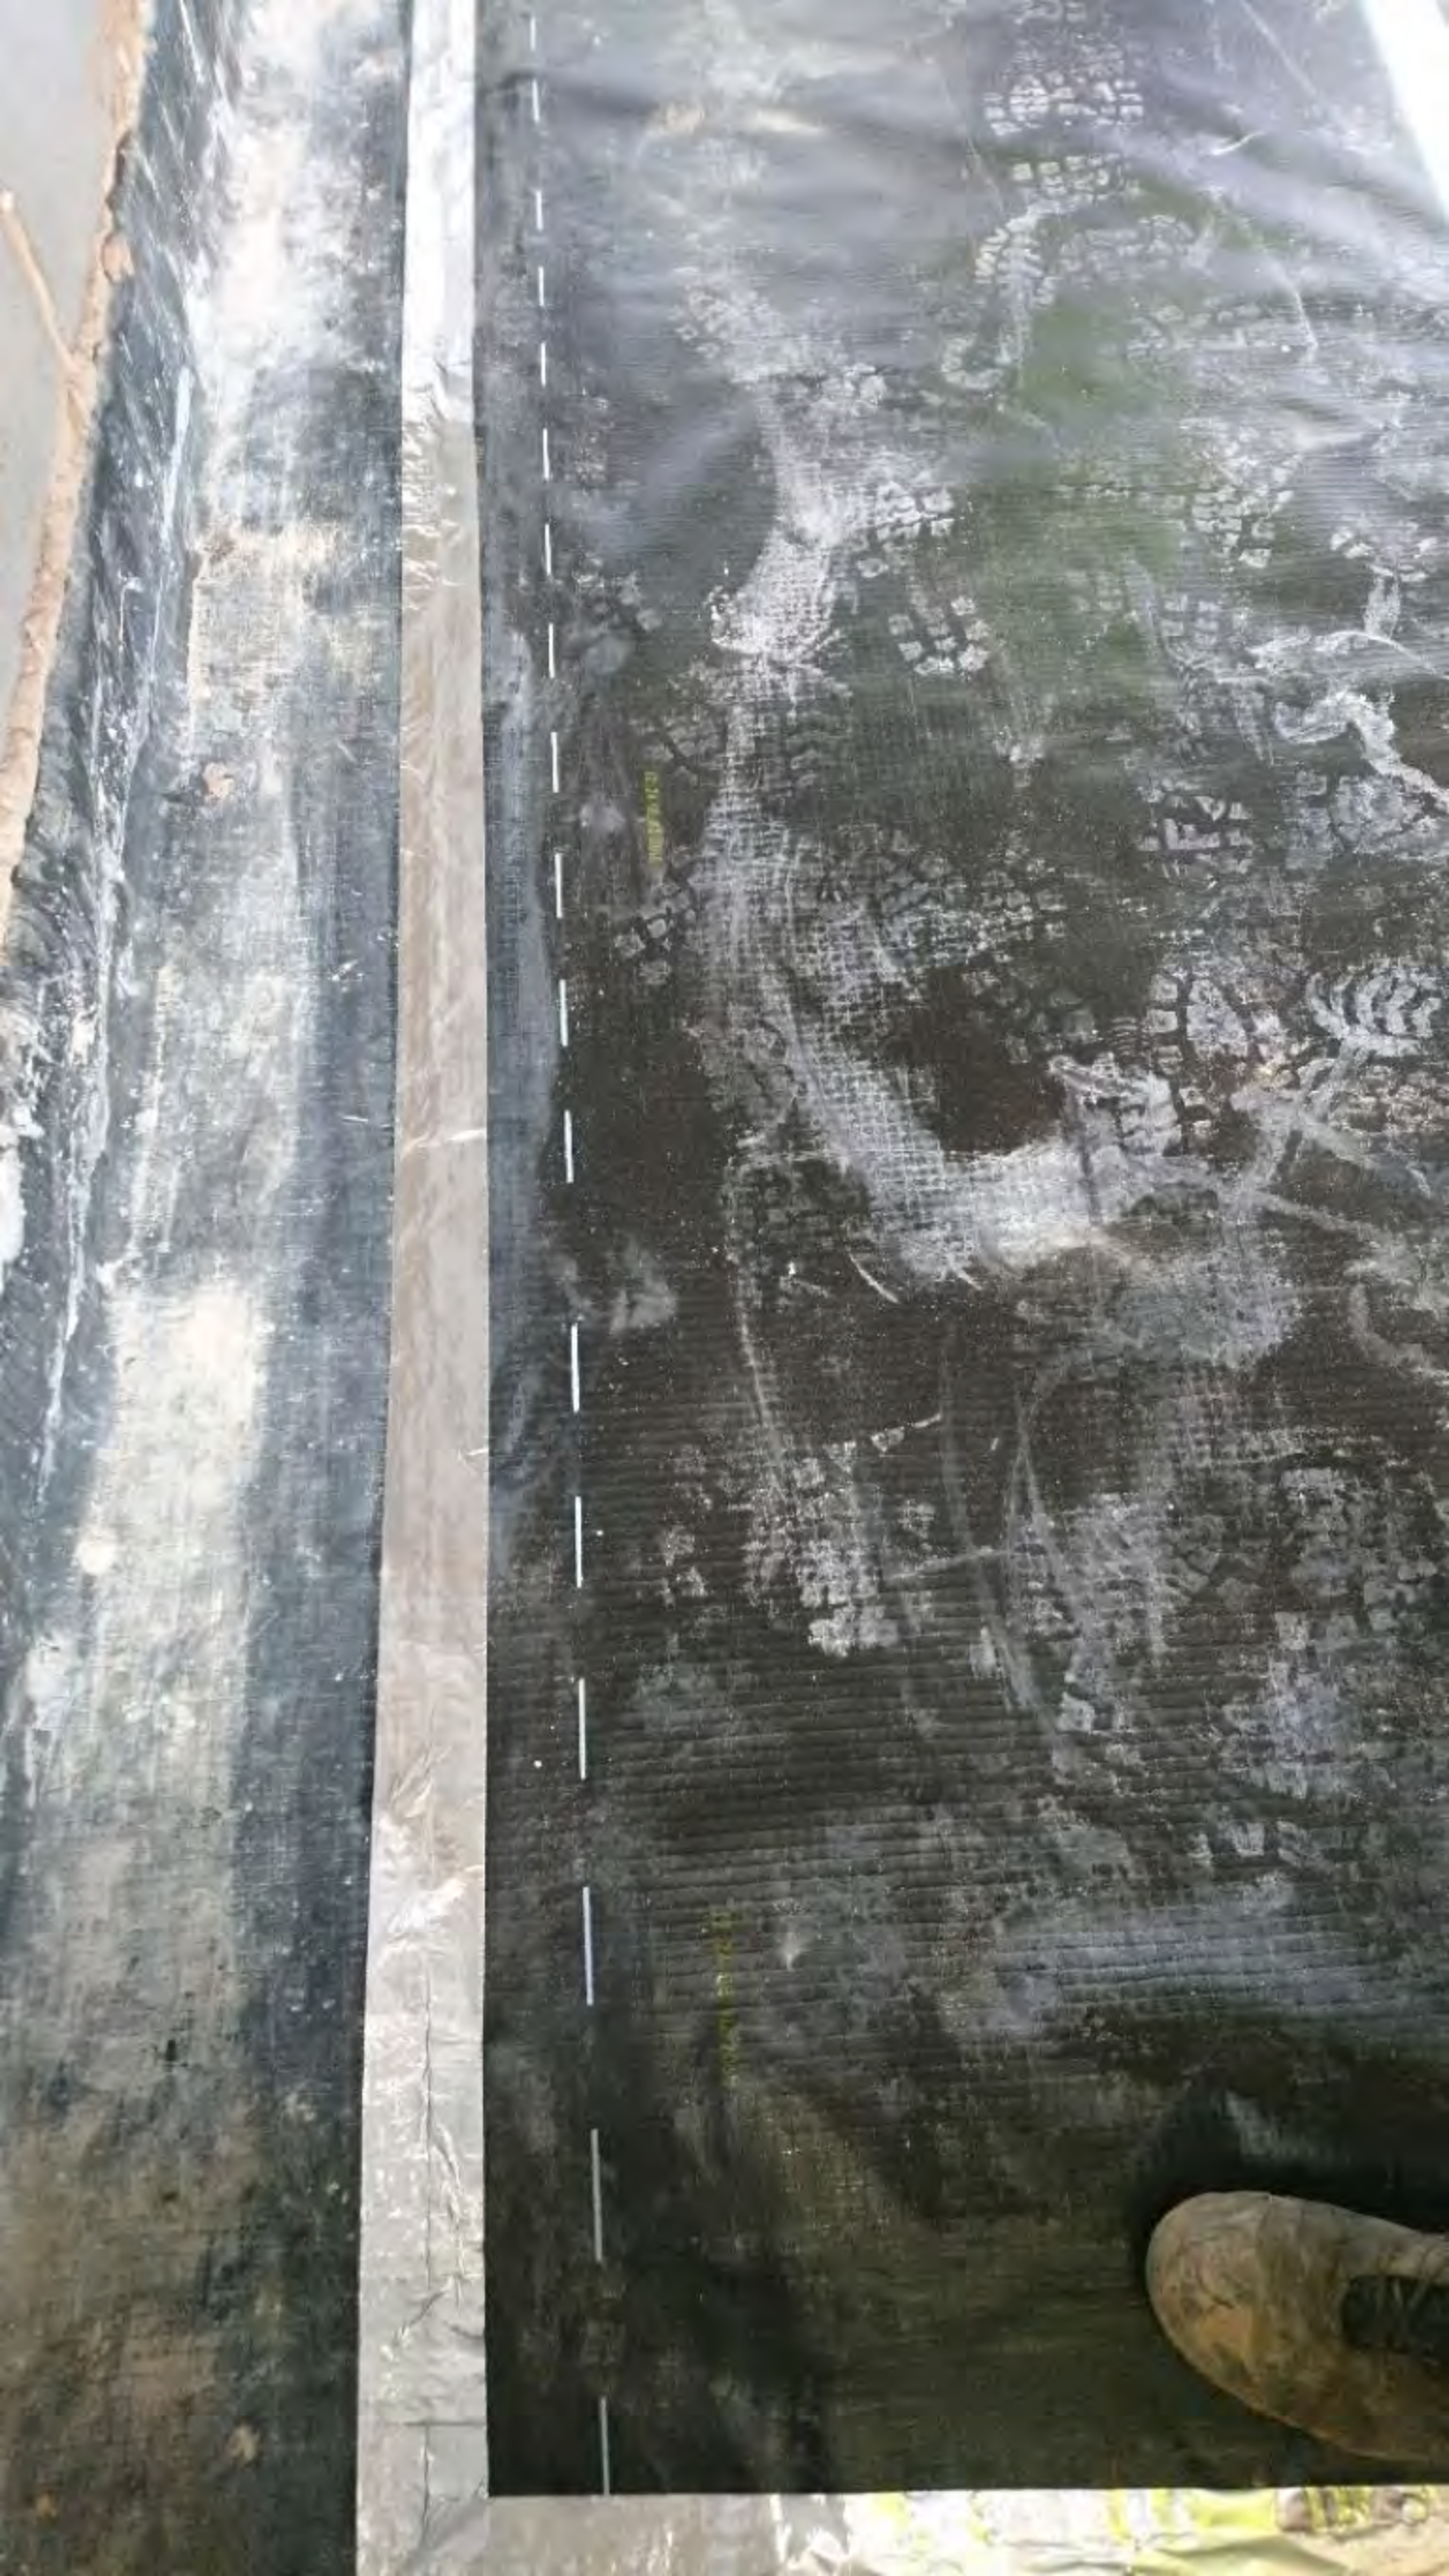
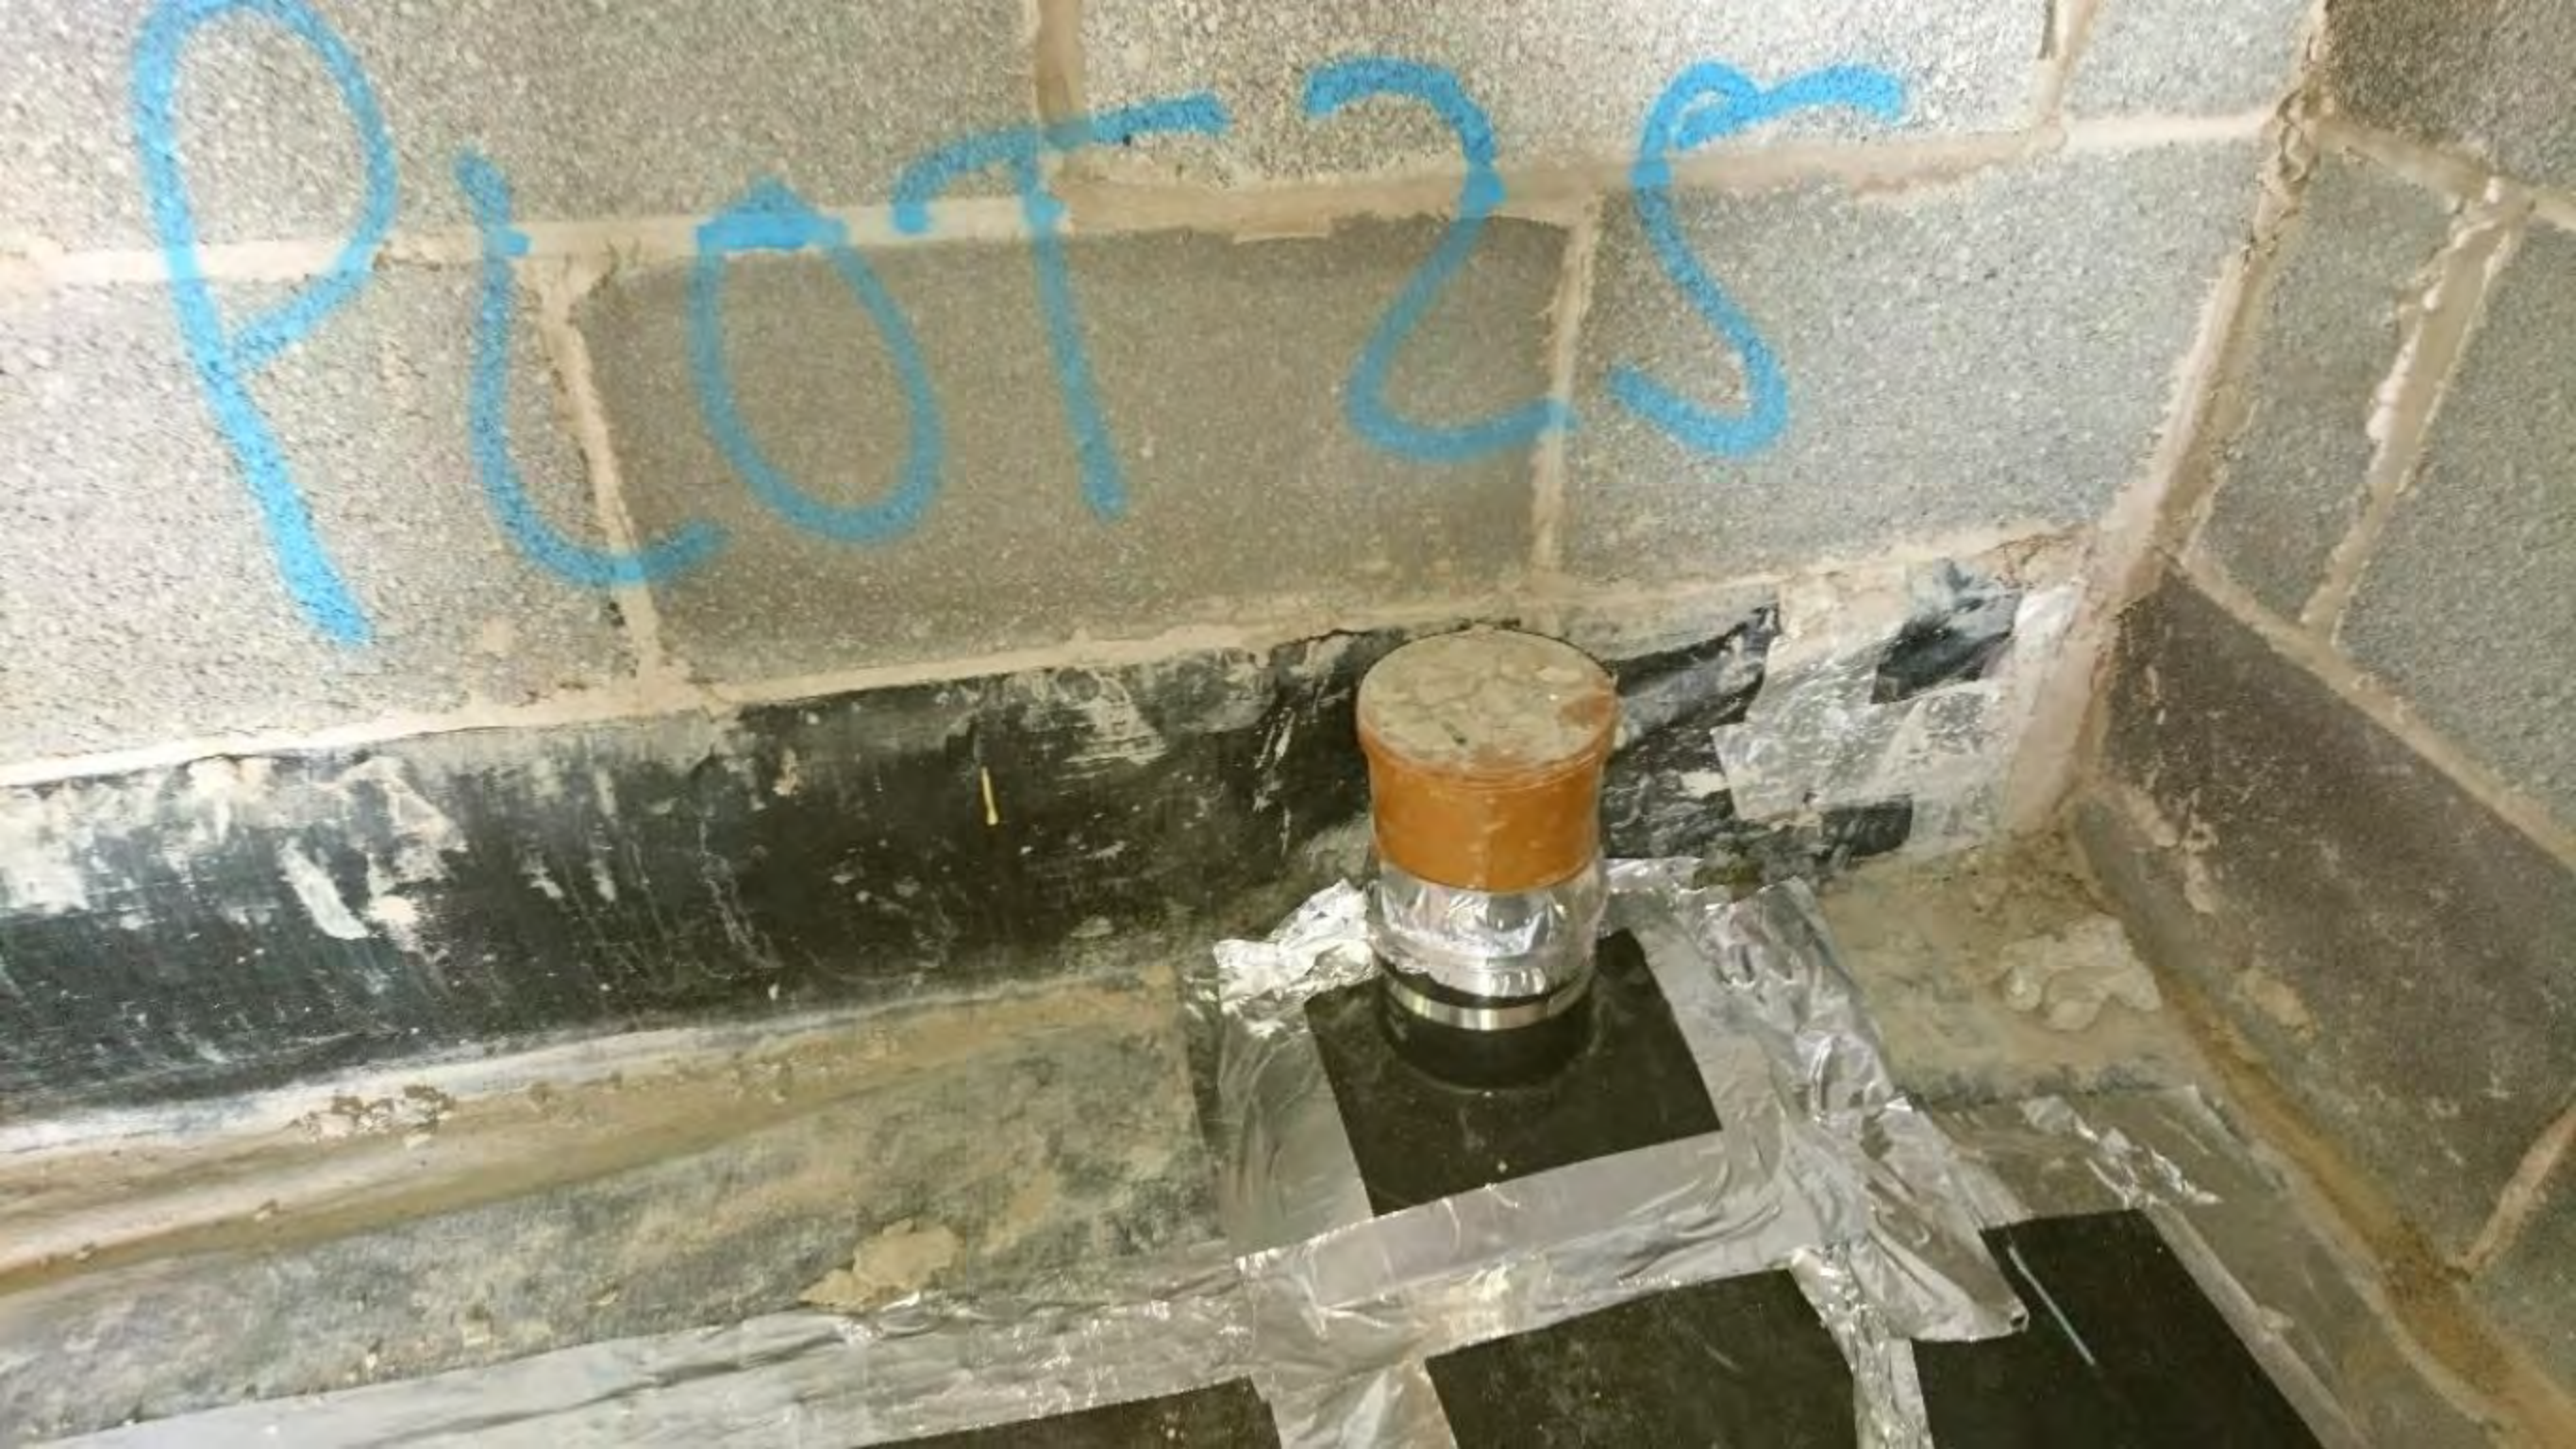
PLOT 25

| 2.2 | Condition of sub-grade & underside of gas membrane | ALL TAPES APPLIED WELL + SEALED TO A GOOD QUALITY. FLOOR BRUSHED | | | | | |
| 2.4 | Gas membrane condition and coverage | GOOD AND SEALED ON ALL FOUR SIDES | | | | | |
| 2.7 | Condition of joints/seals | VISIBLE OVERLAPS, ALL APPEAR GOOD | | | | | |
| 2.8 | Number and condition of service entry seals | 3 NO TOPHATS WITH SUBILEE CLIPS (PICTURED). TAPES CHECKED, ALL OK | | | | | |
