## Gas Protection - Validation Record Sheet

**This Record sheet is only applicable to block and beam floor slabs for Characteristic Situation 2 gas protection systems**

**For Residential Development at New Church Street, Radcliffe.**

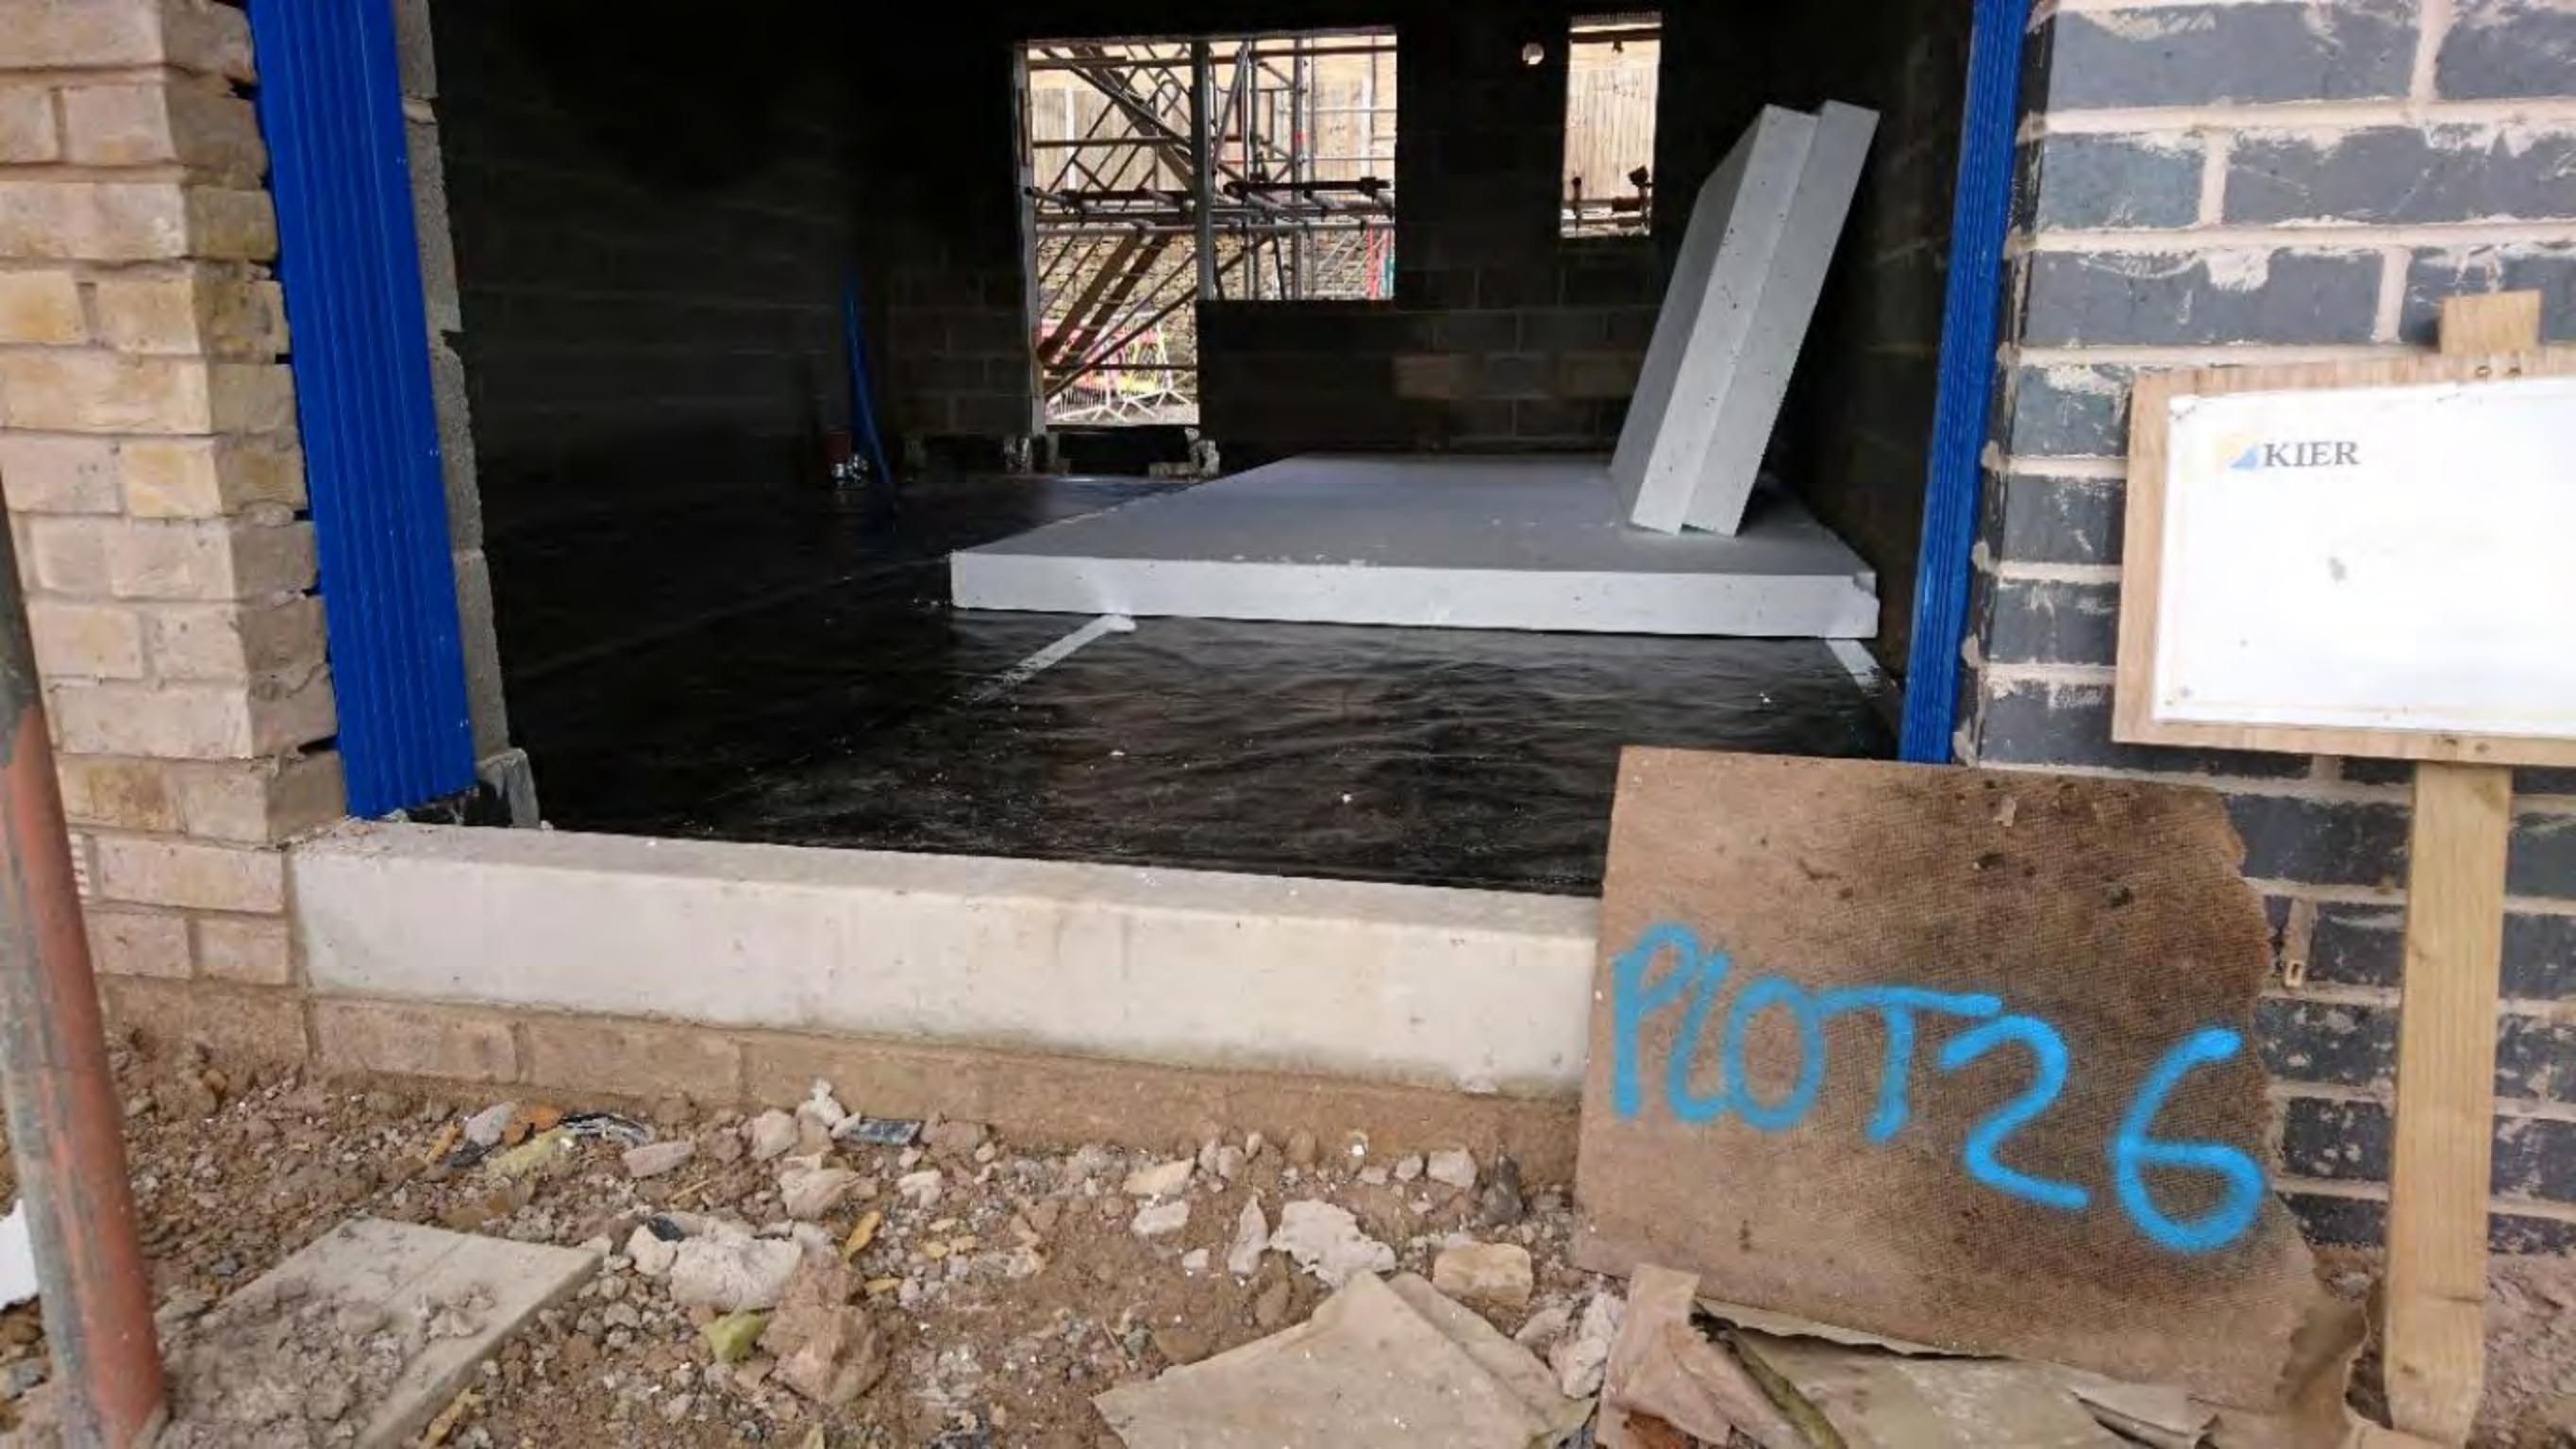
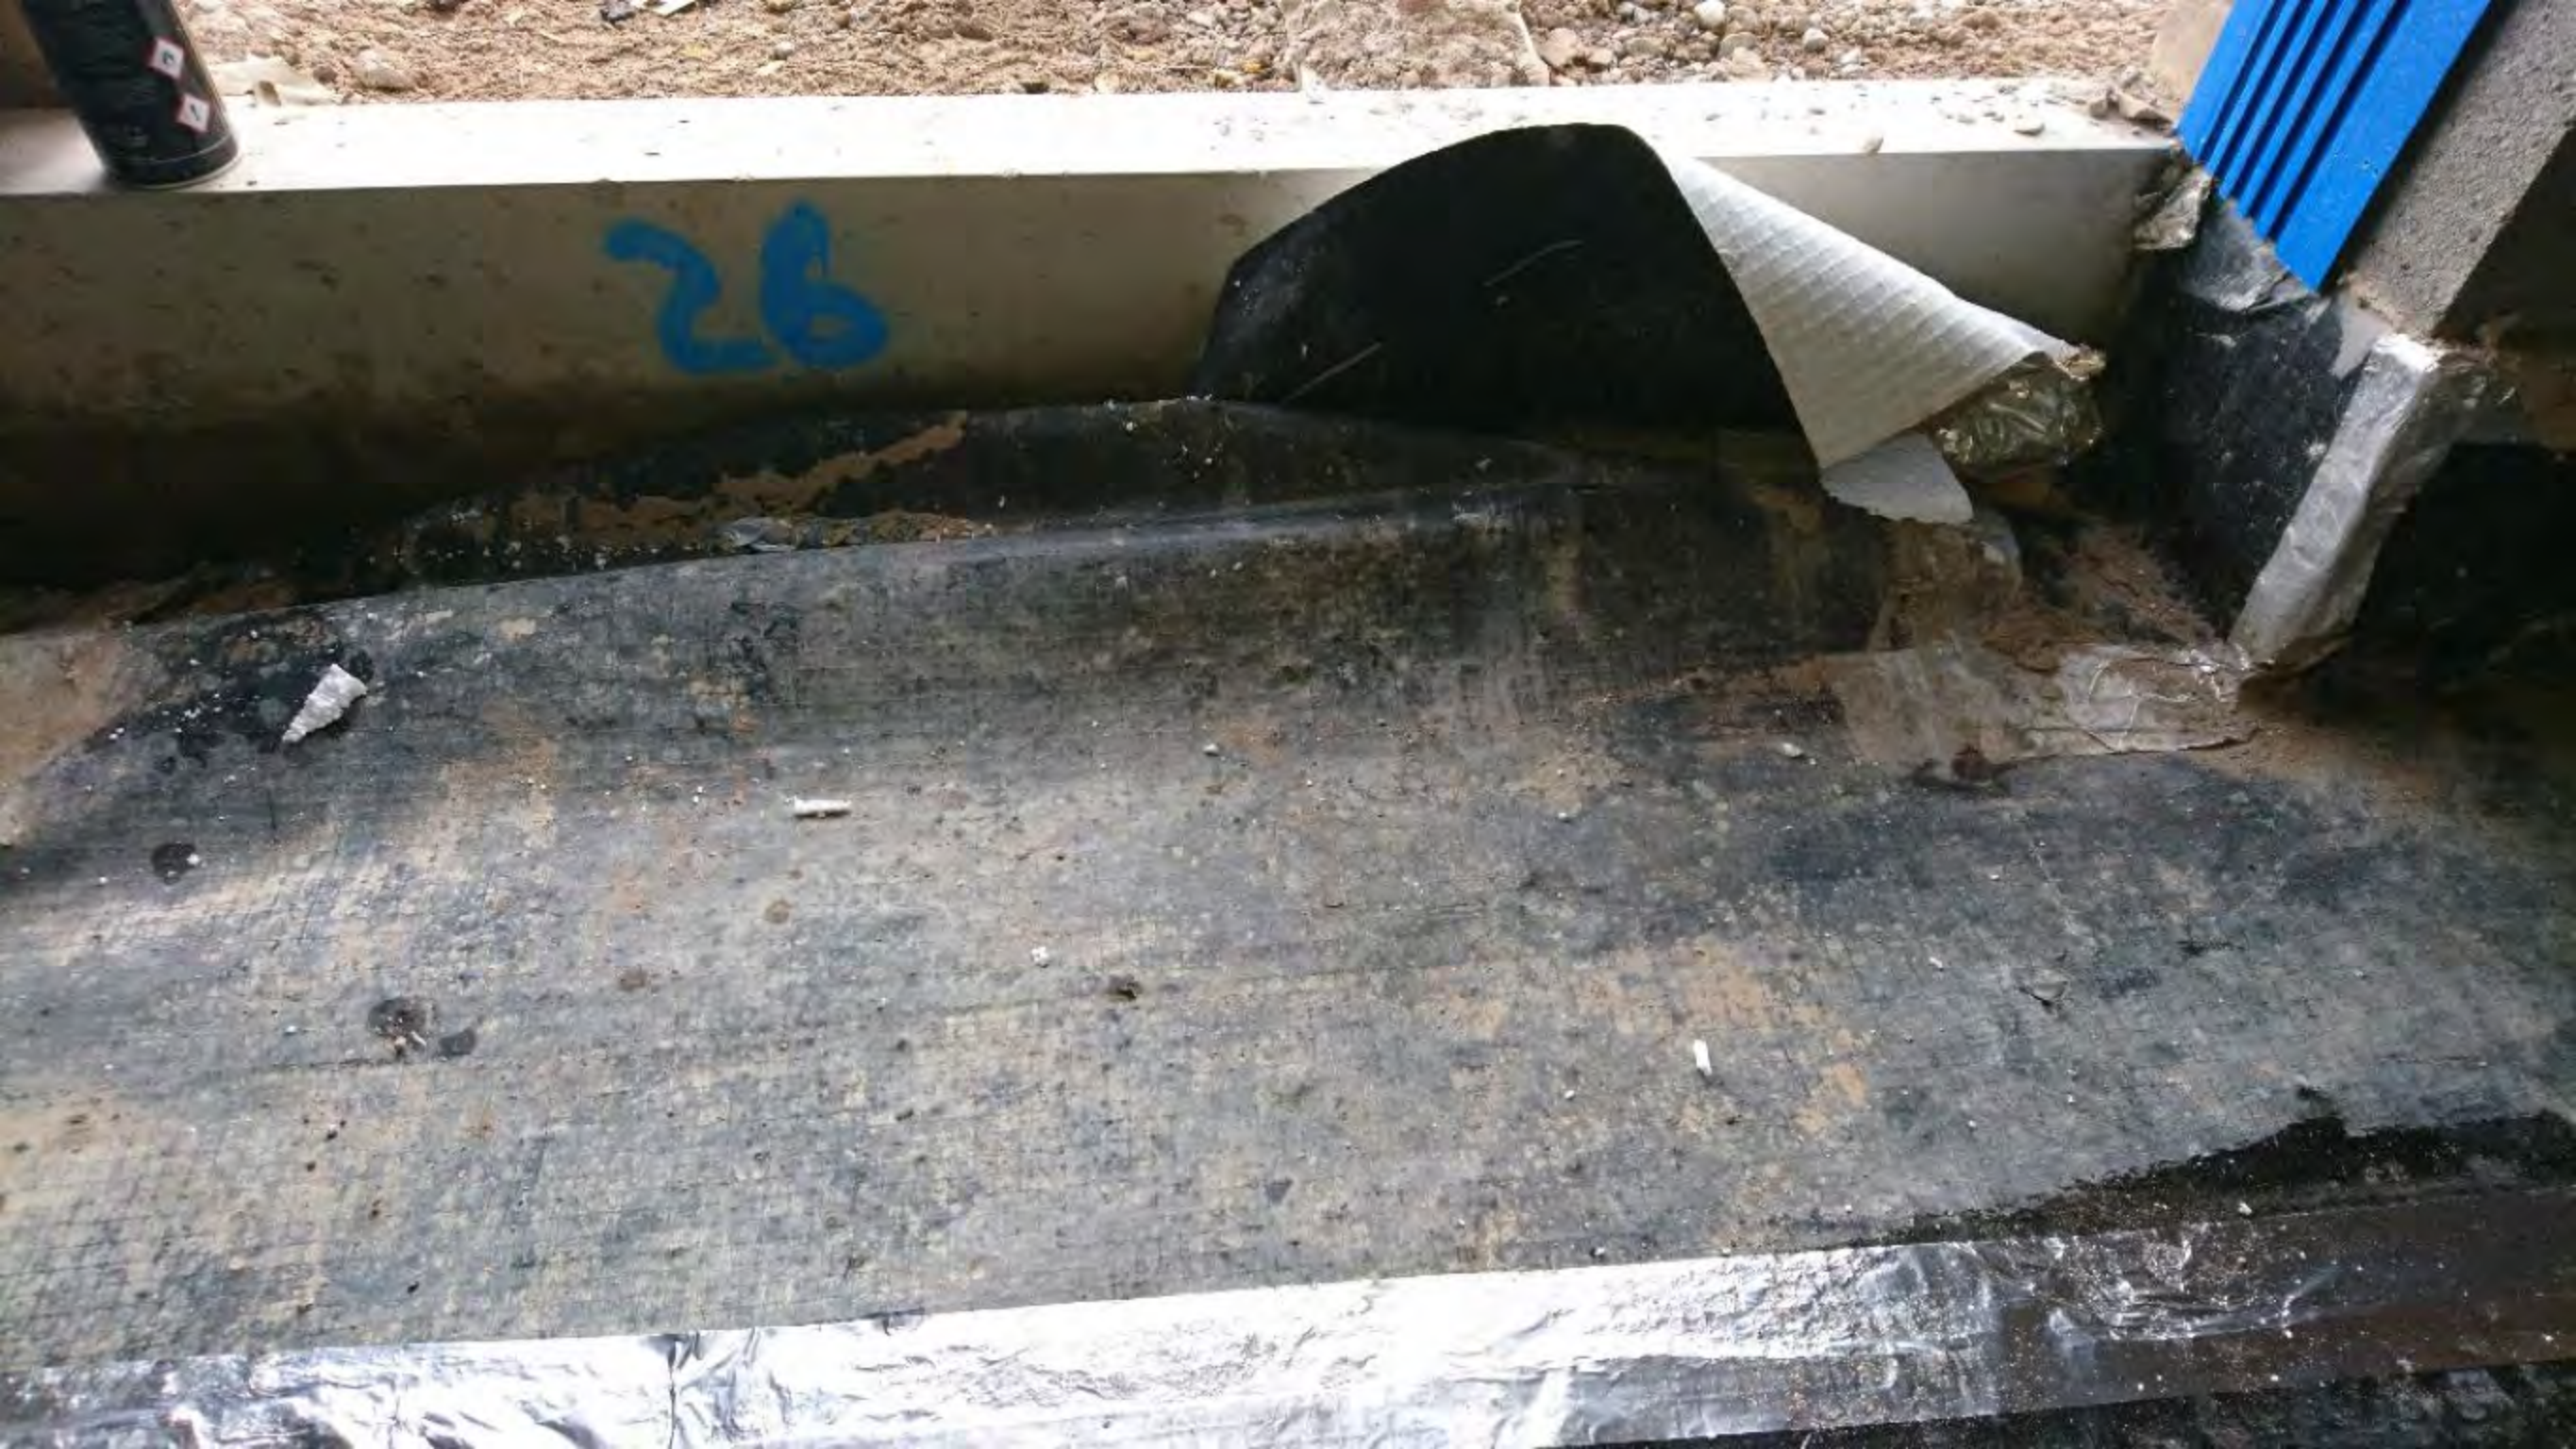
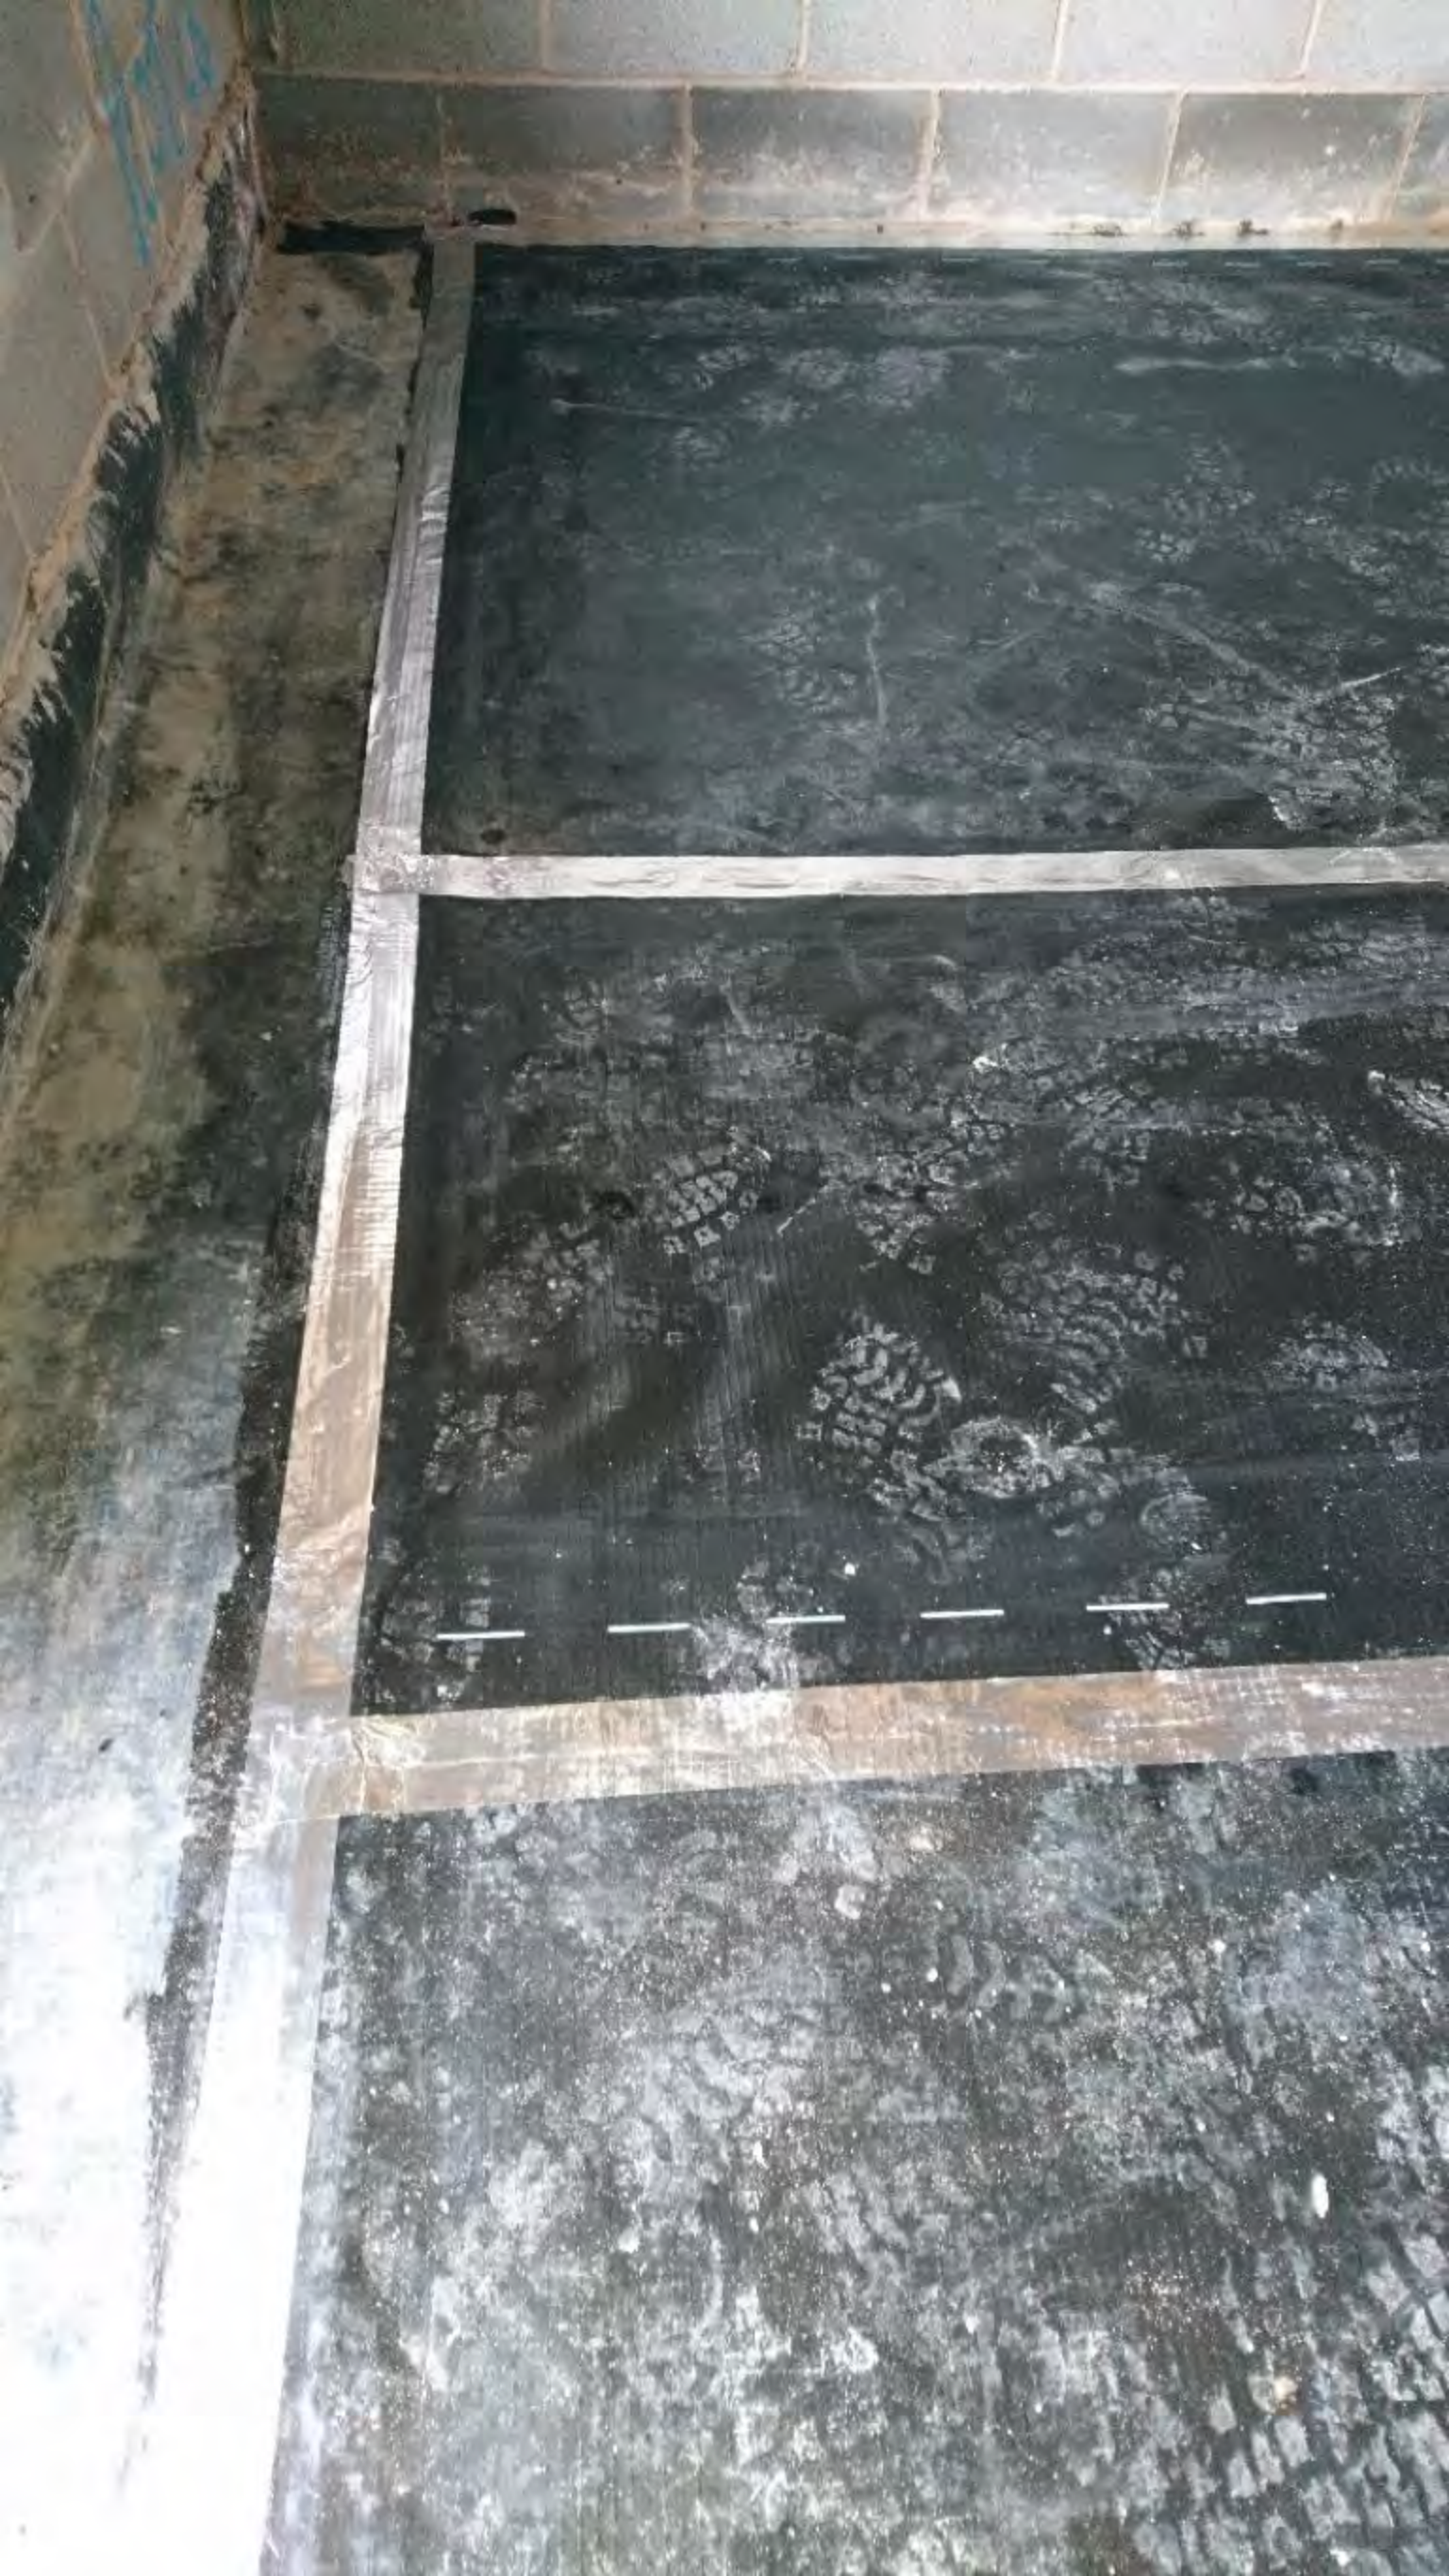
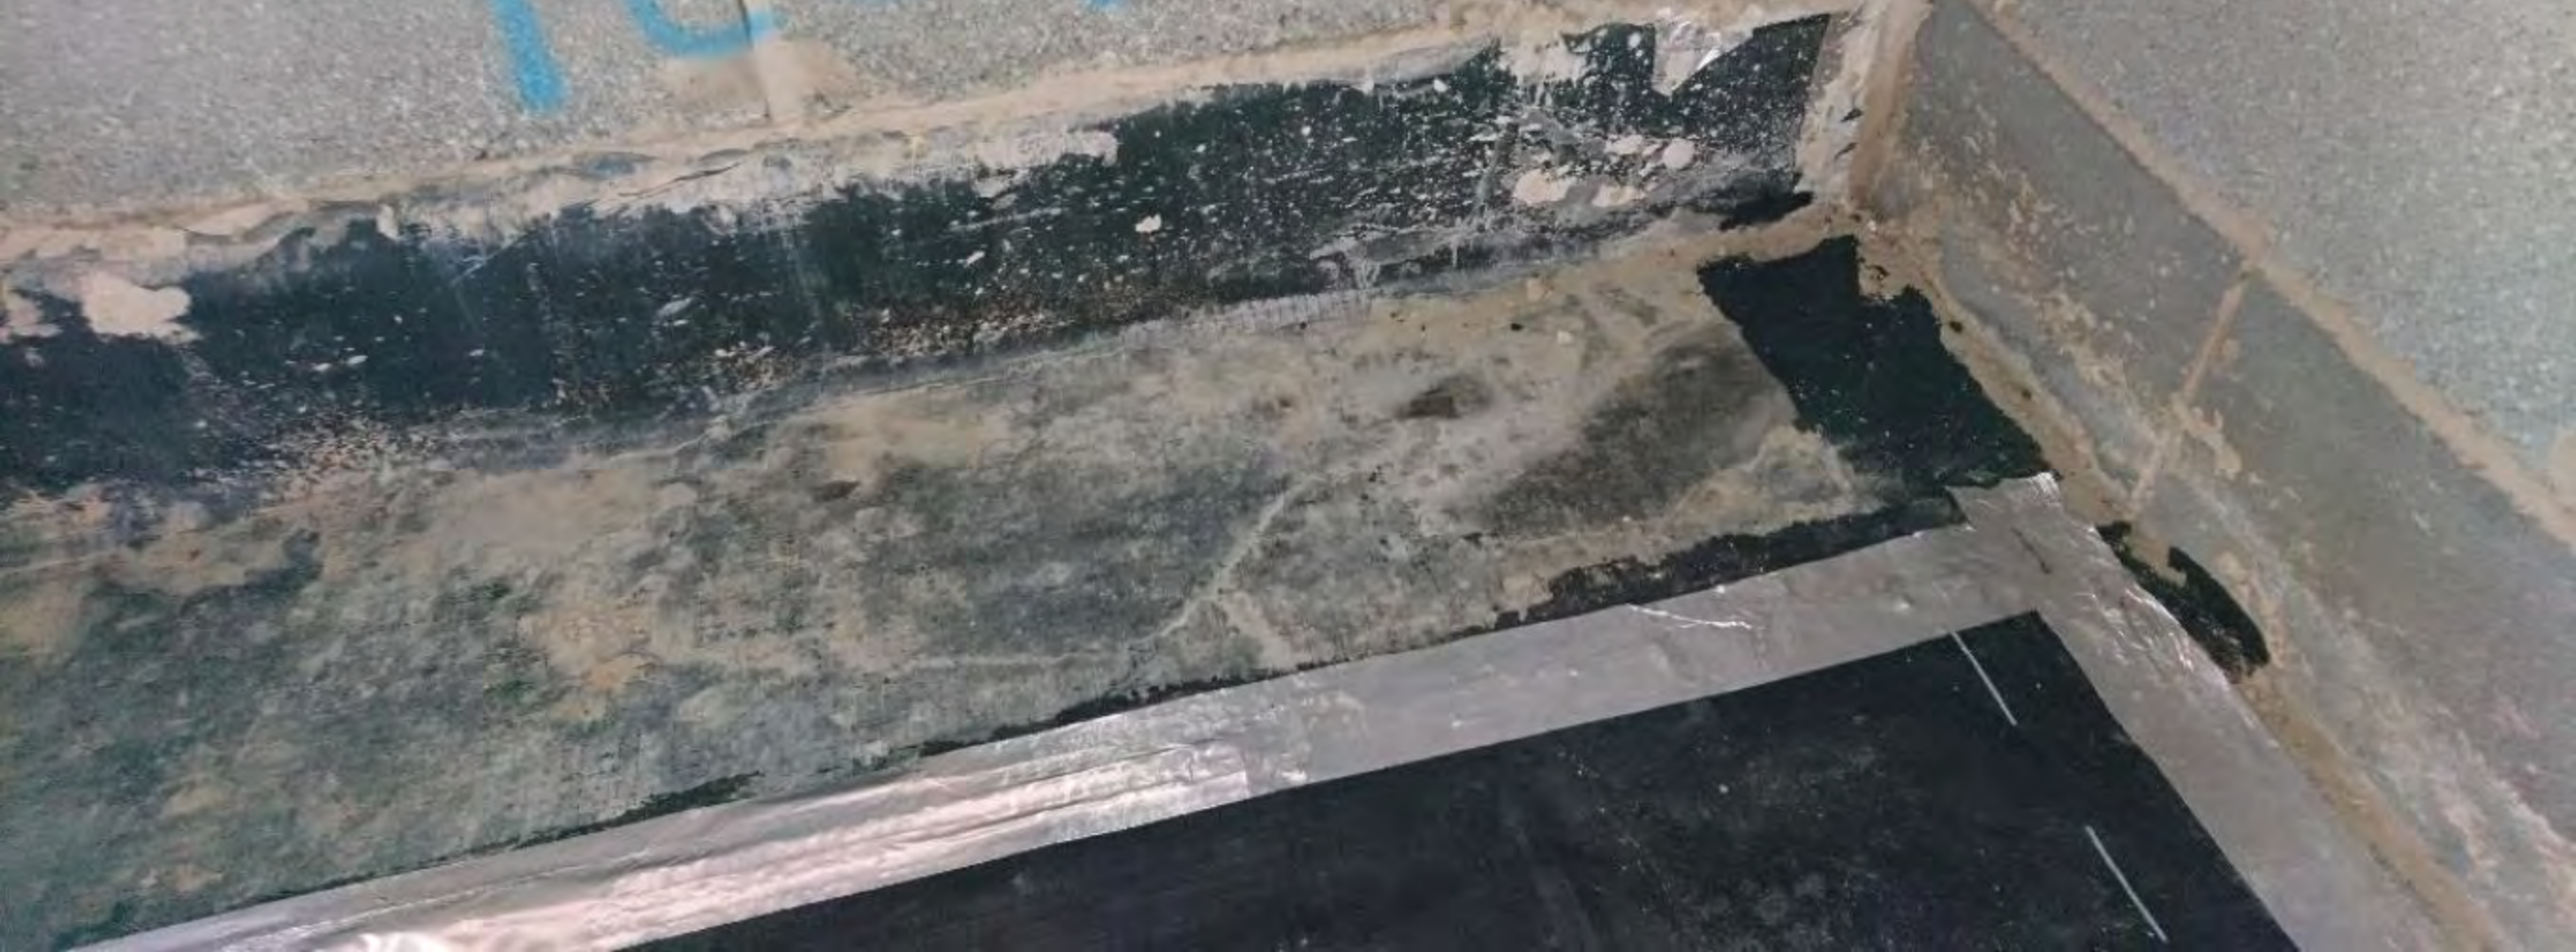
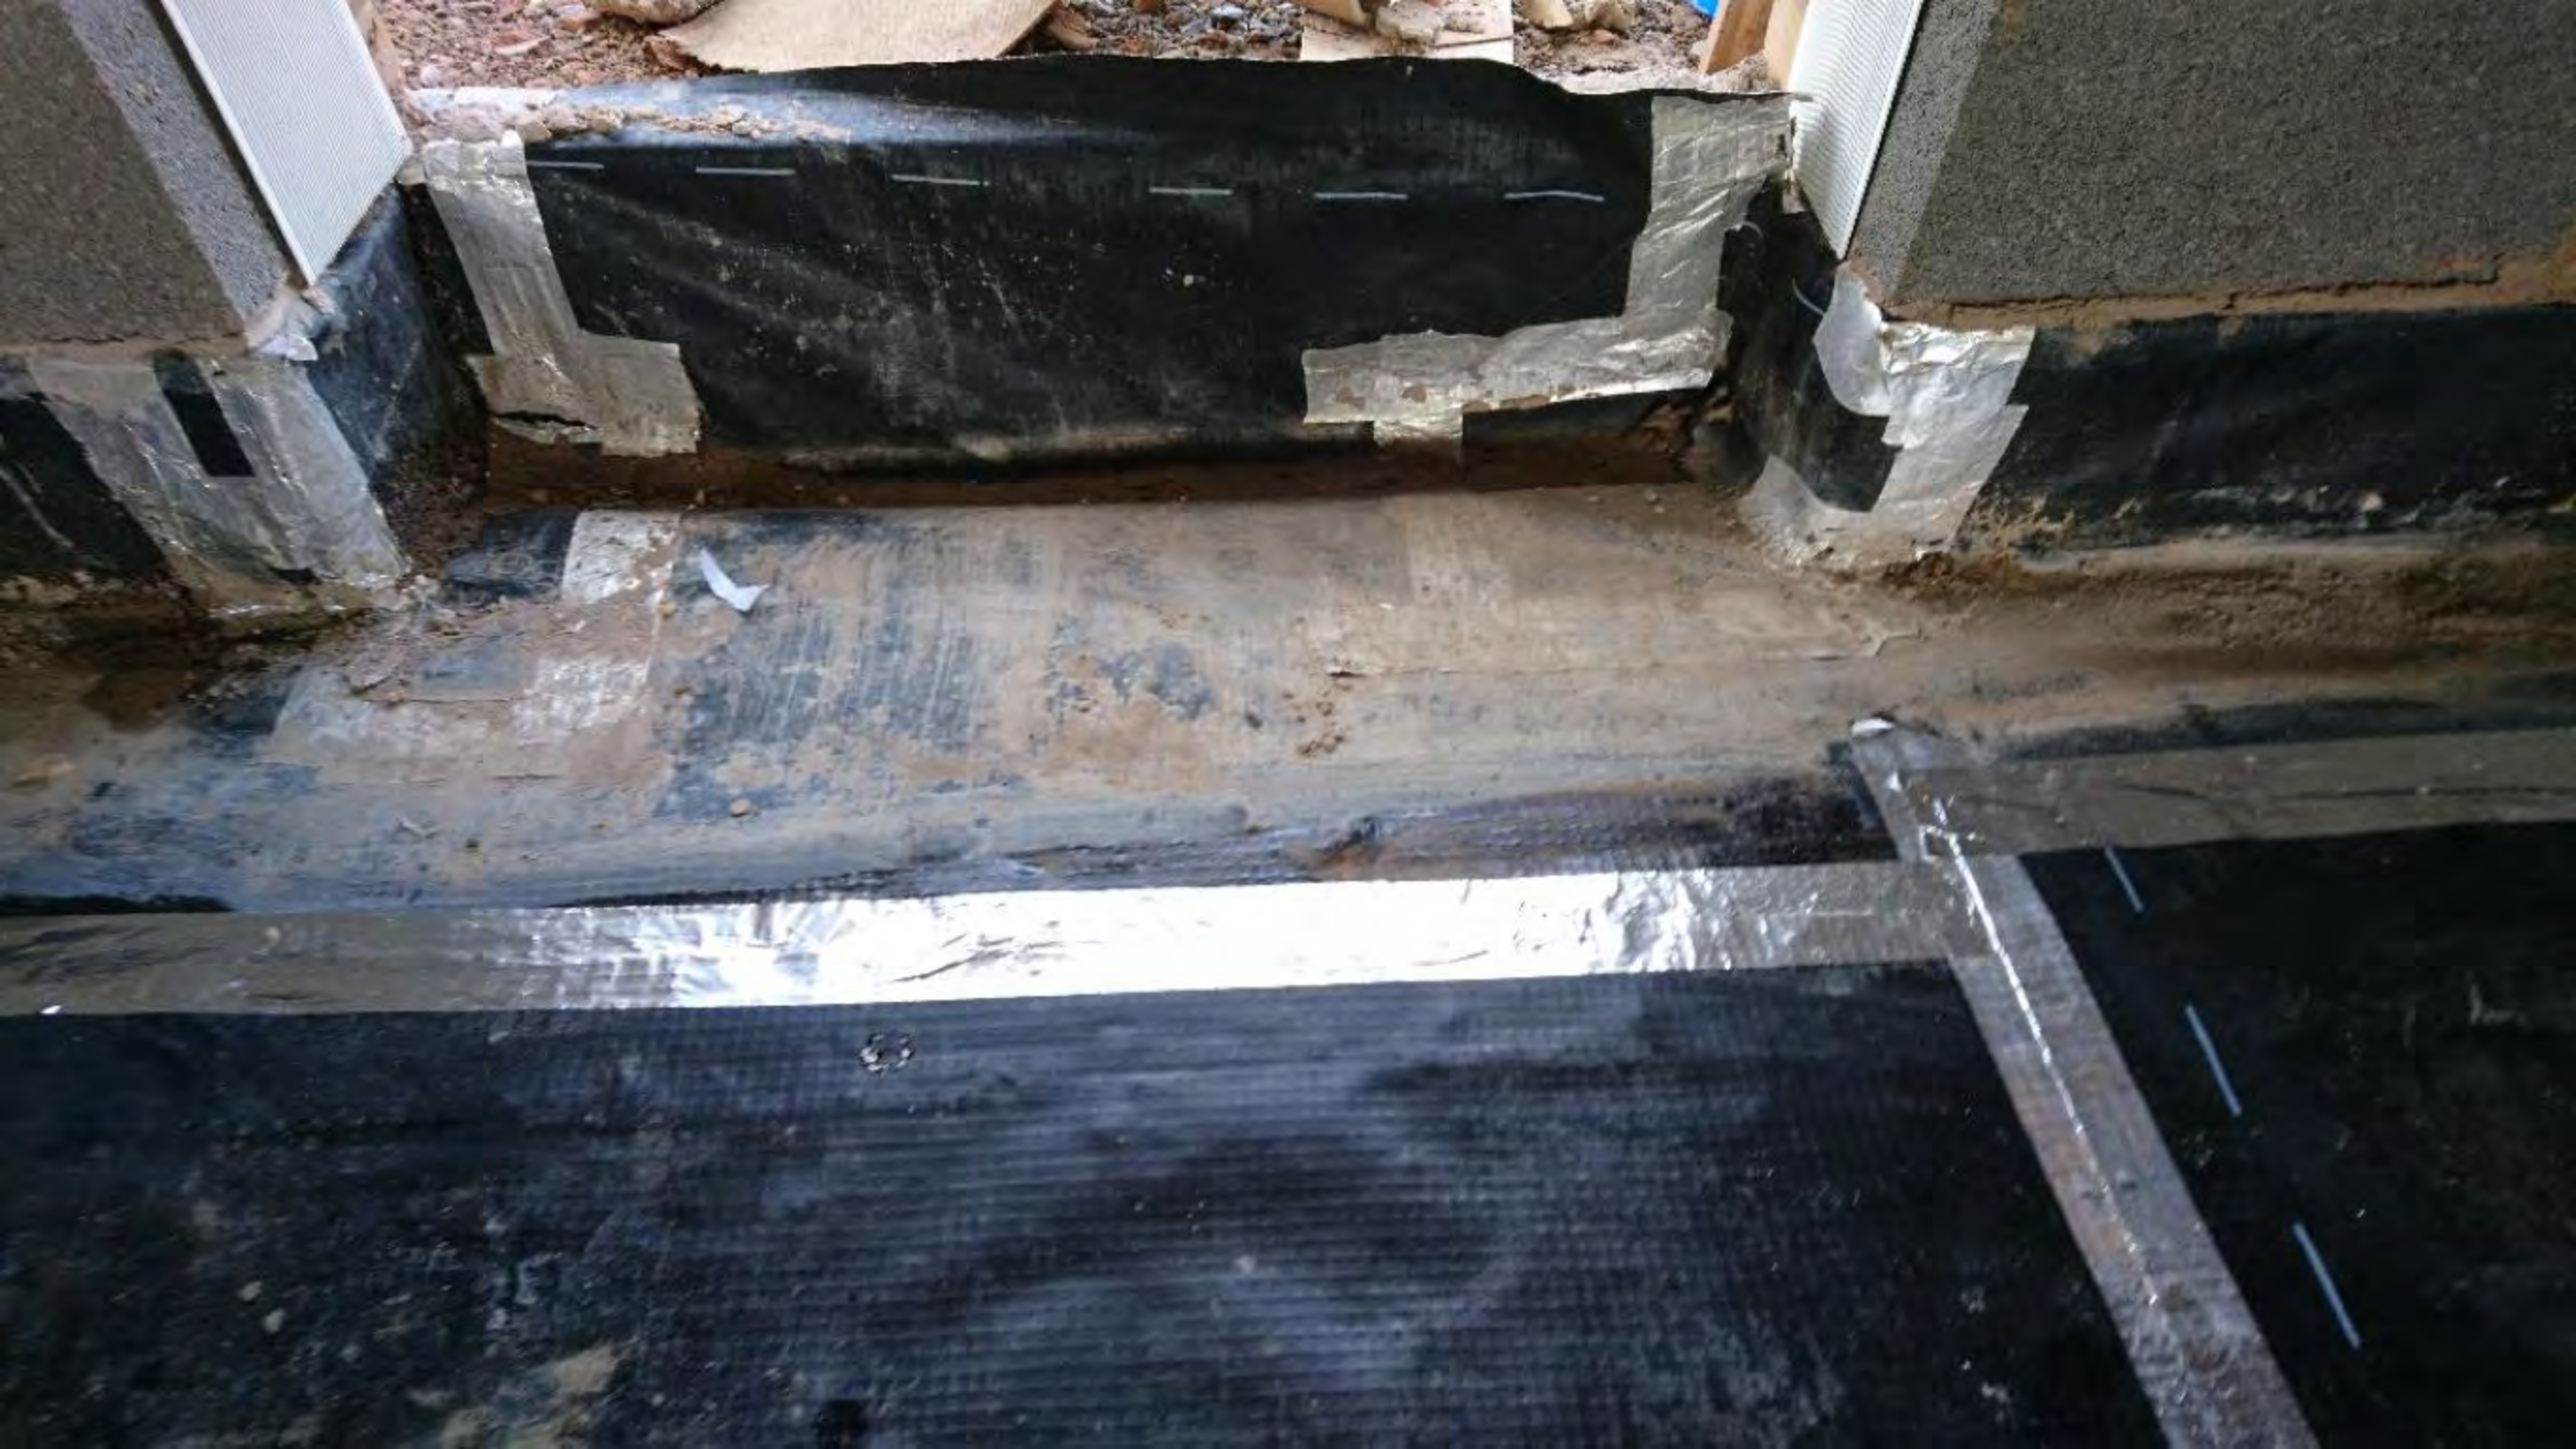
PLOT 26

| 2.2 | Condition of sub-grade & underside of gas membrane | ALL TAPES APPLIED WELL AND SEALED TO A GOOD QUALITY, WITH THE FLOOR FINISHED | | | | | |
| 2.4 | Gas membrane condition and coverage | SEALED ON ALL SIDES AND IN GOOD CONDITION | | | | | |
| 2.7 | Condition of joints/seals | ALL GOOD, WITH VISIBLE OVERLAPS | | | | | |
| 2.8 | Number and condition of service entry seals | 3 NO. TO PLUMBS WITH SUBILKE CLIPS – ALL TAPES CHECKED AND OK | | | | | |
