## Gas Protection - Validation Record Sheet

**This Record sheet is only applicable to block and beam floor slabs for Characteristic Situation 2 gas protection systems**

**For Residential Development at New Church Street, Radcliffe.**

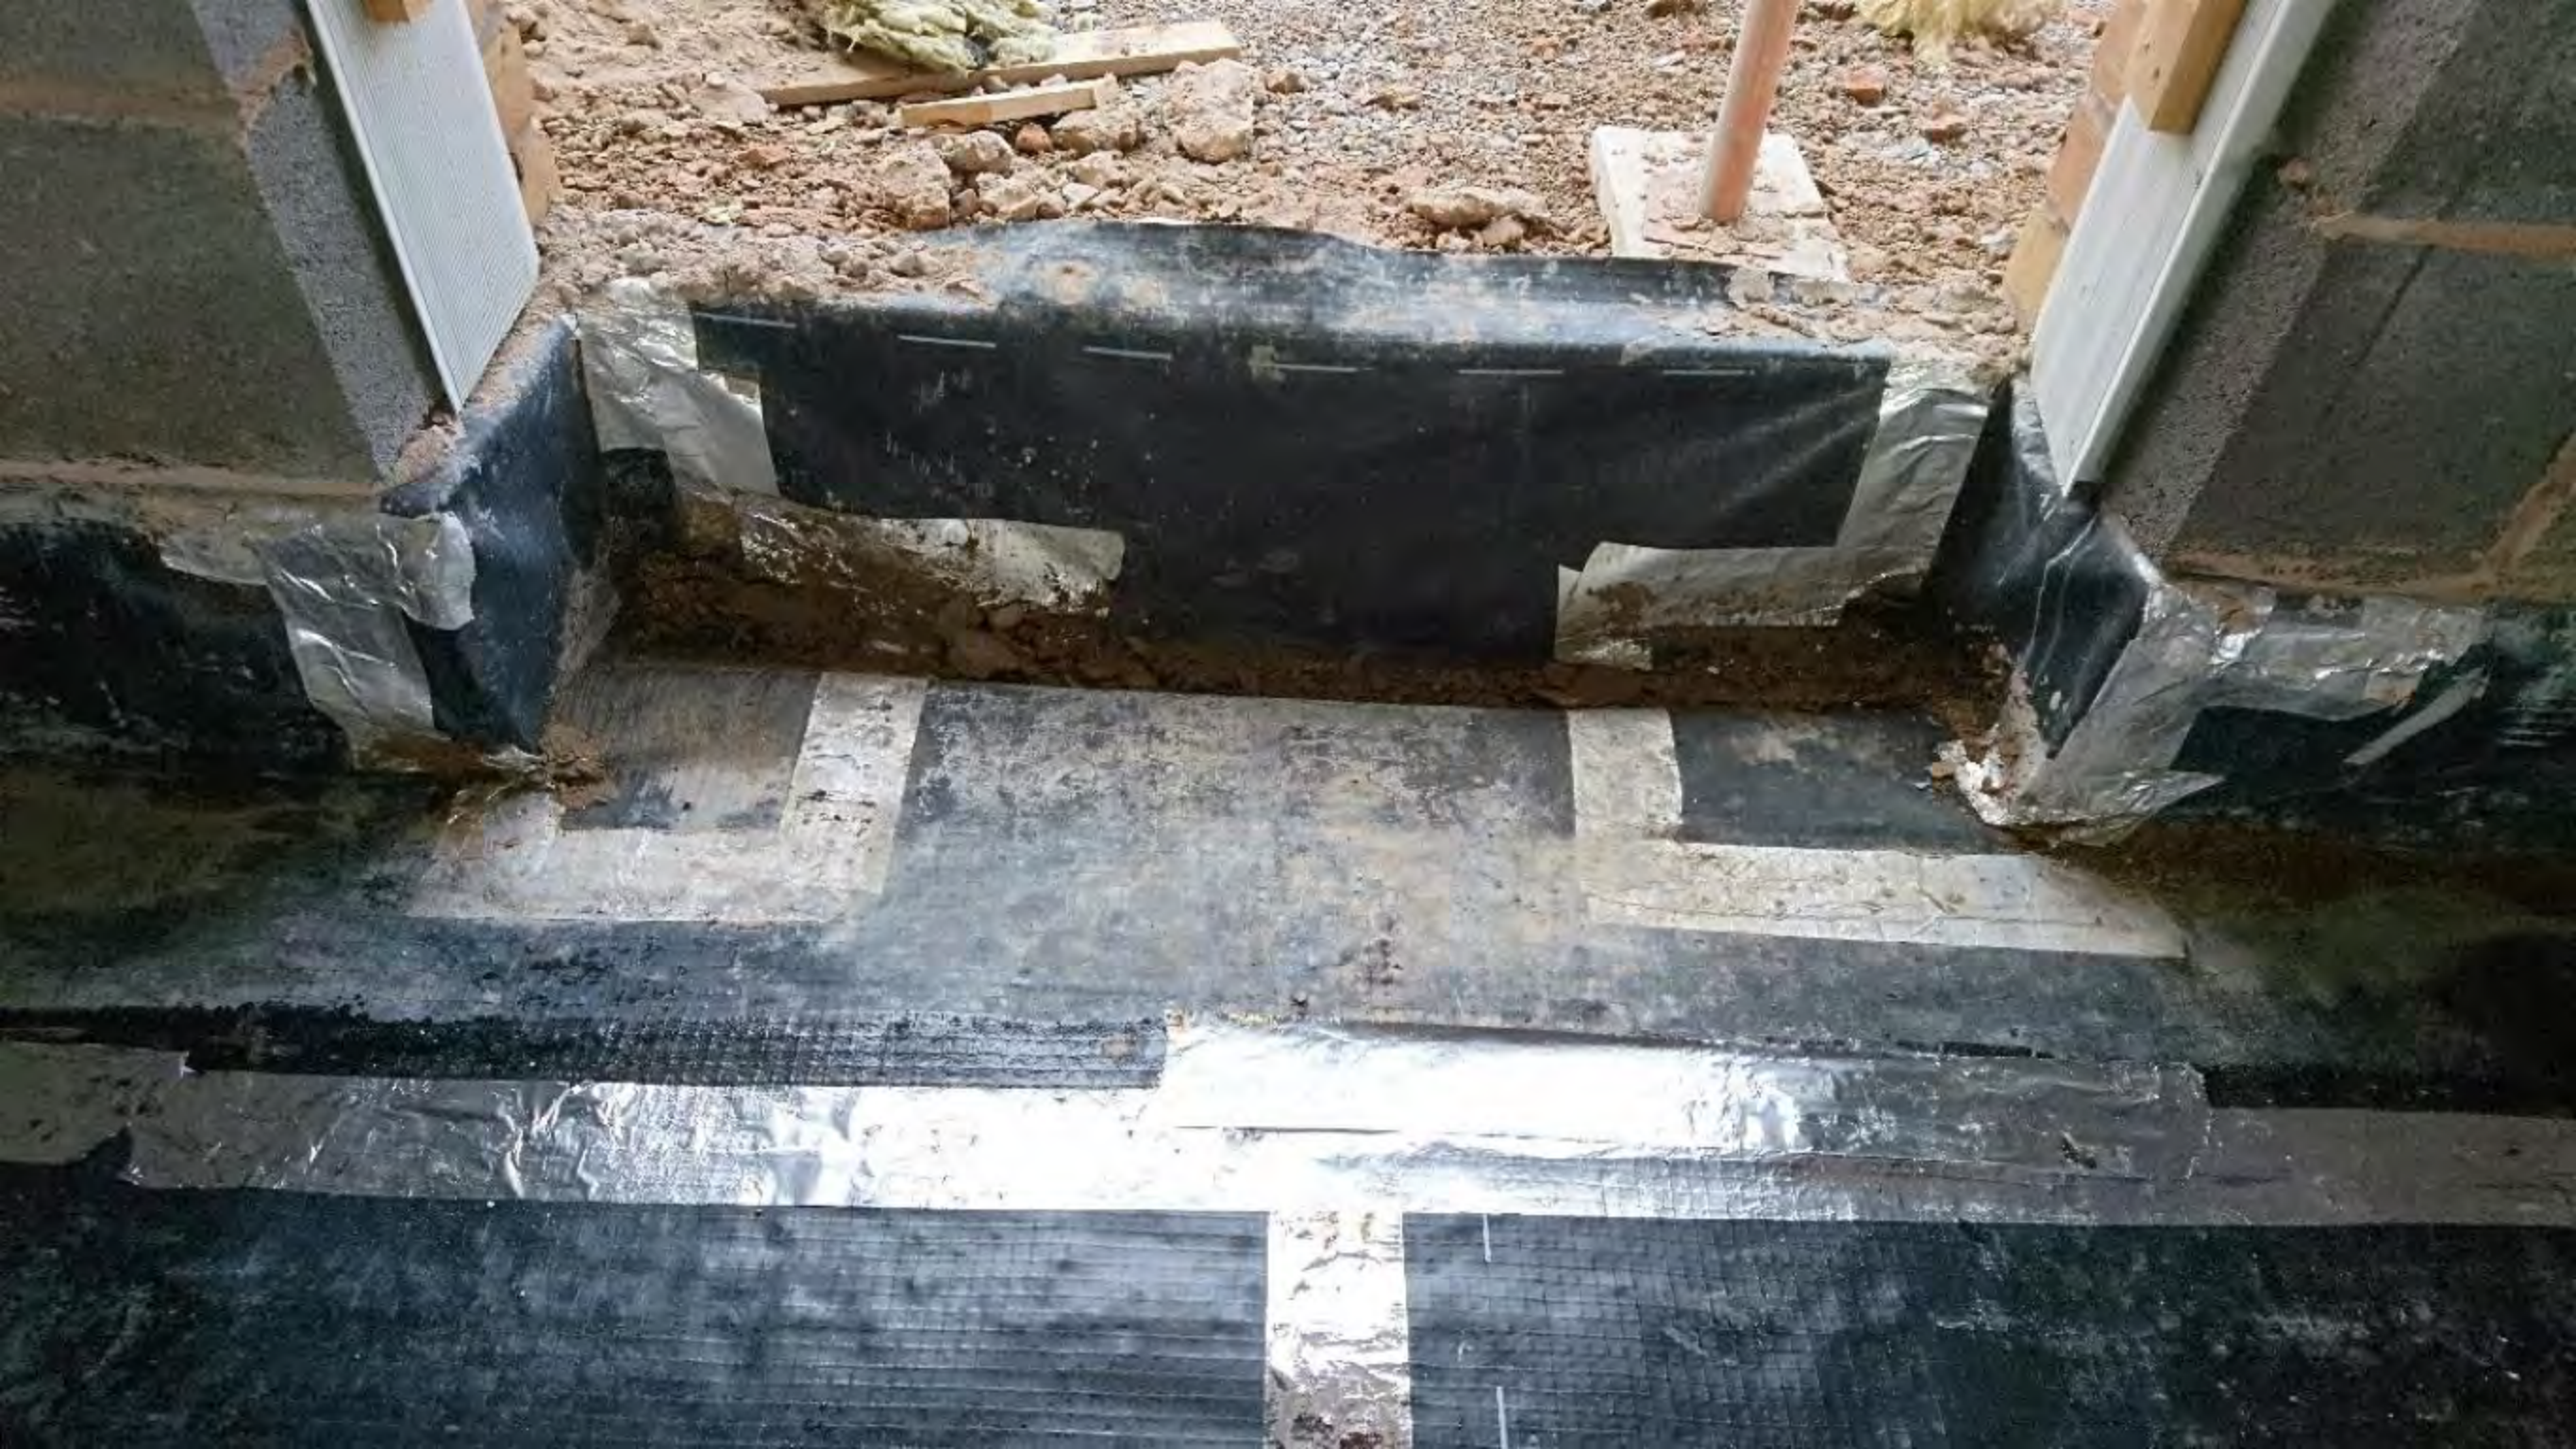
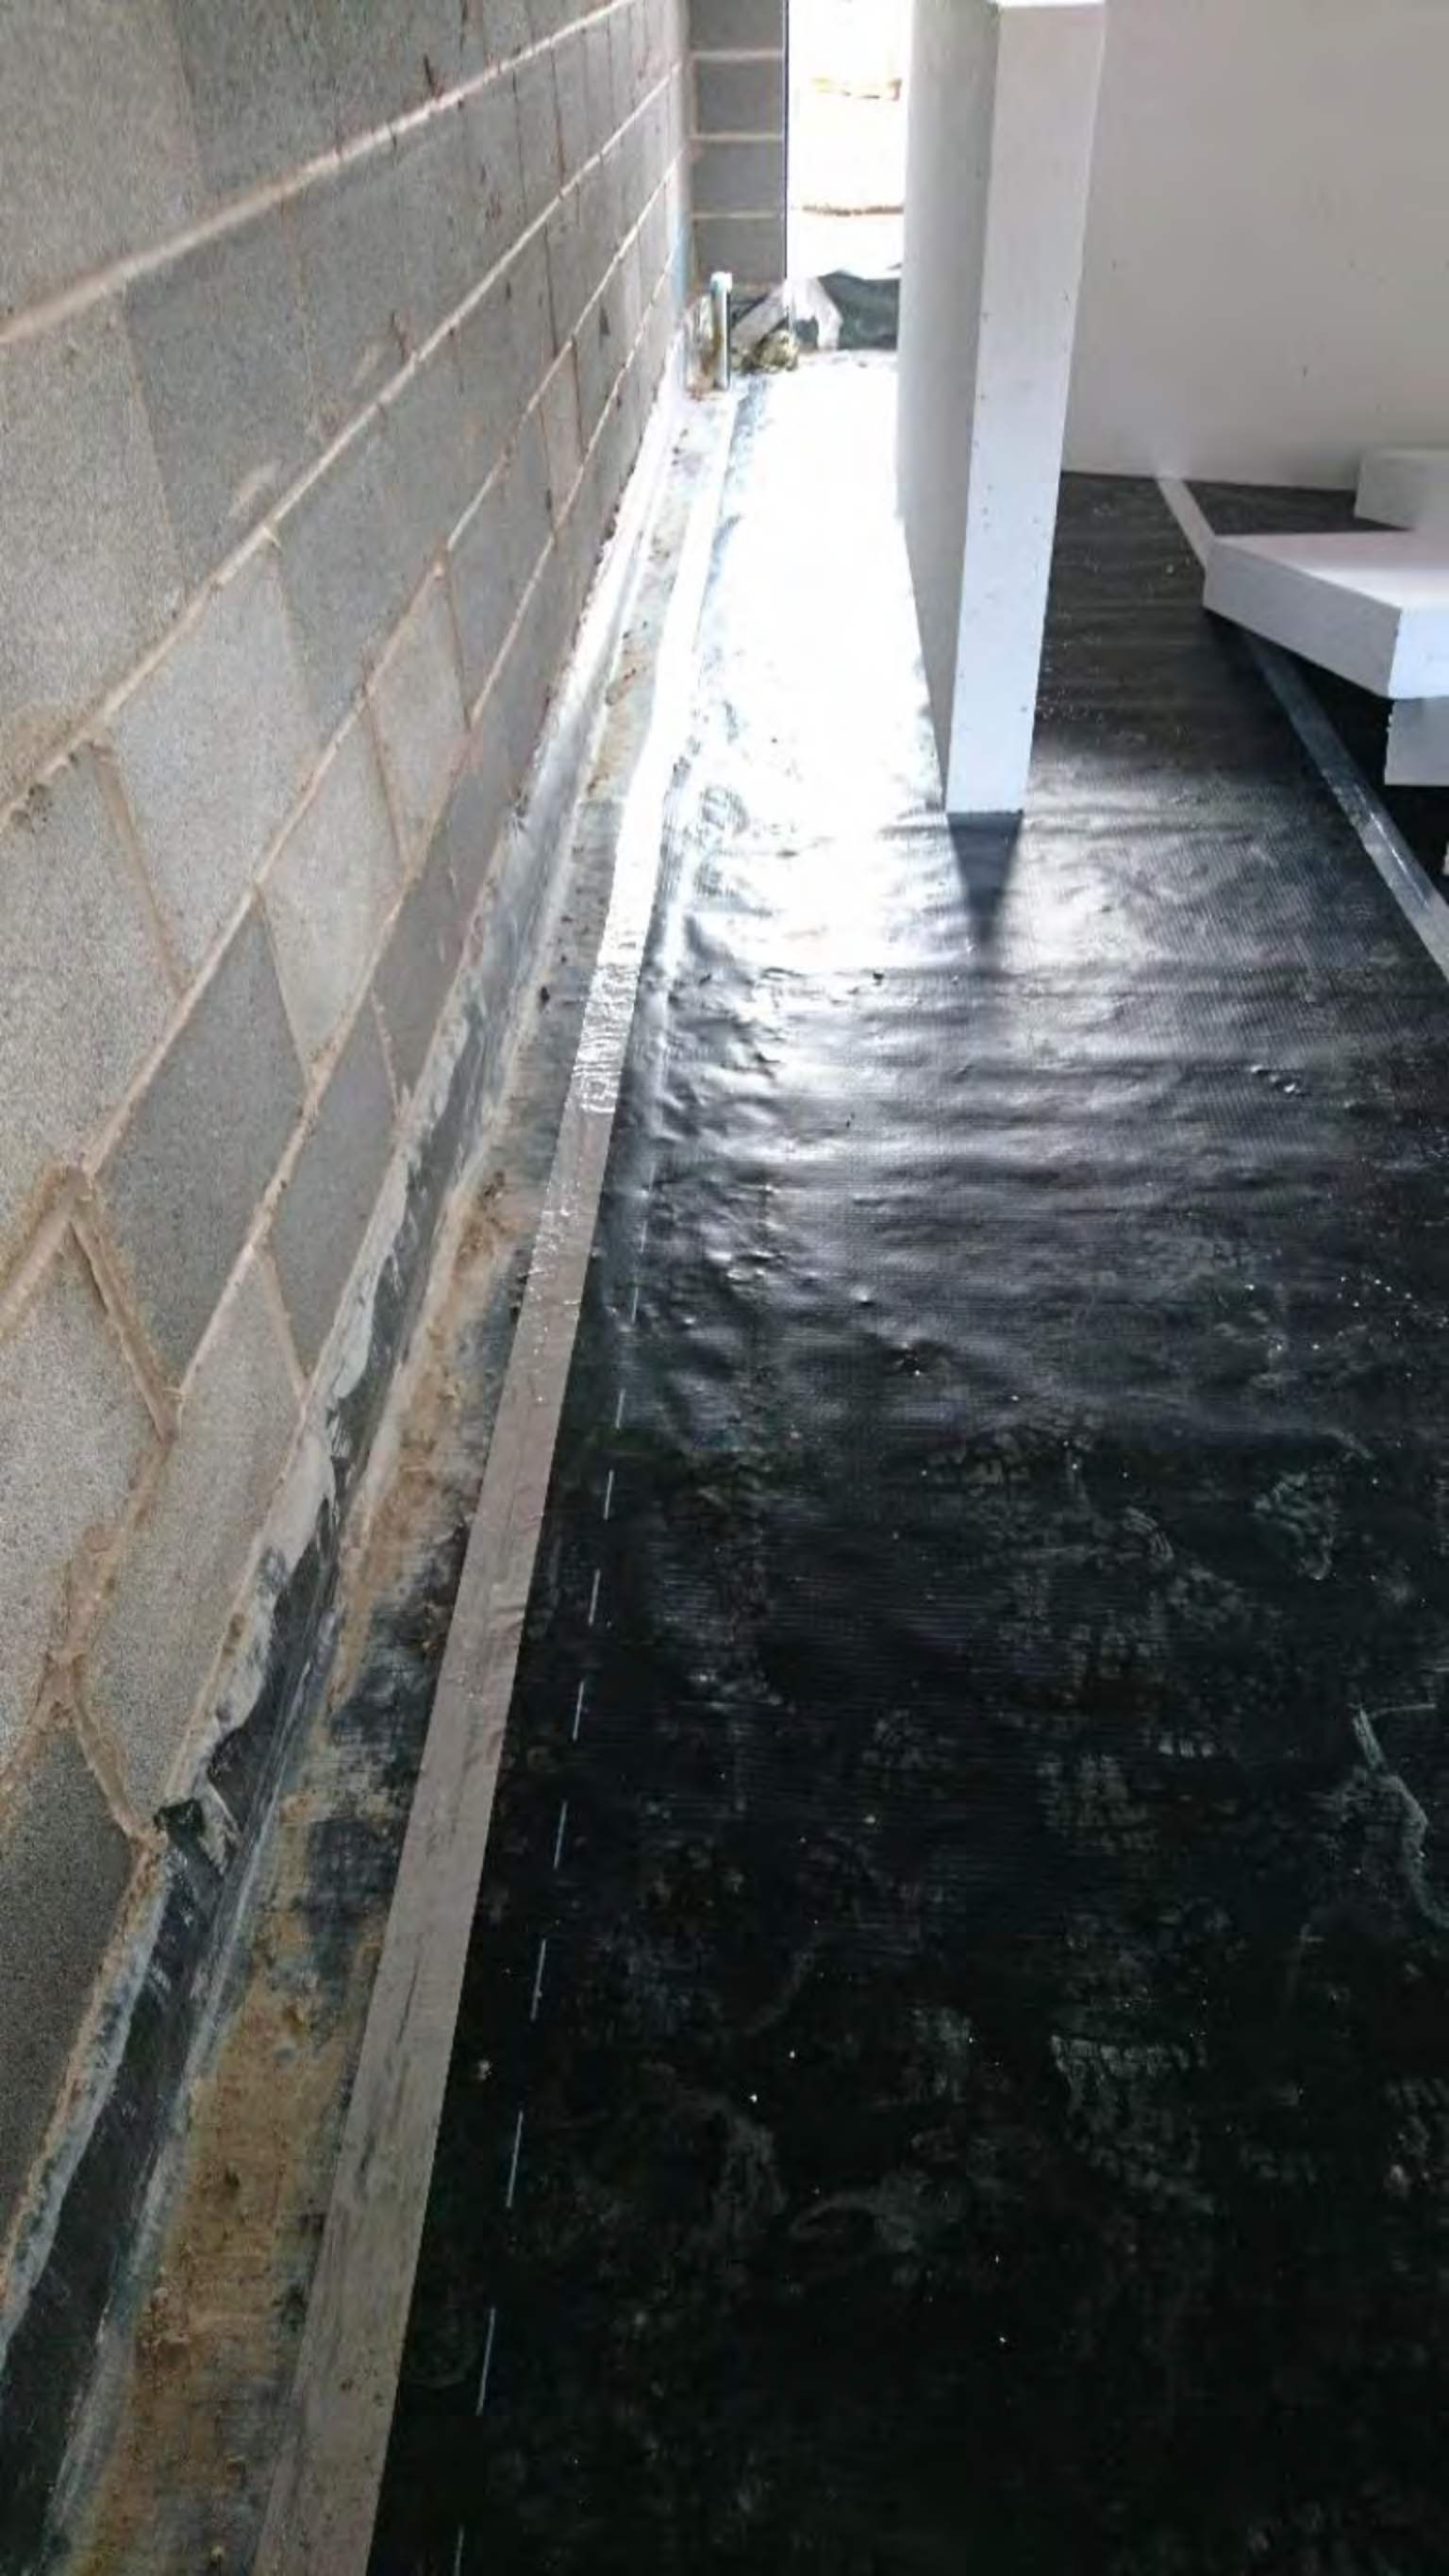
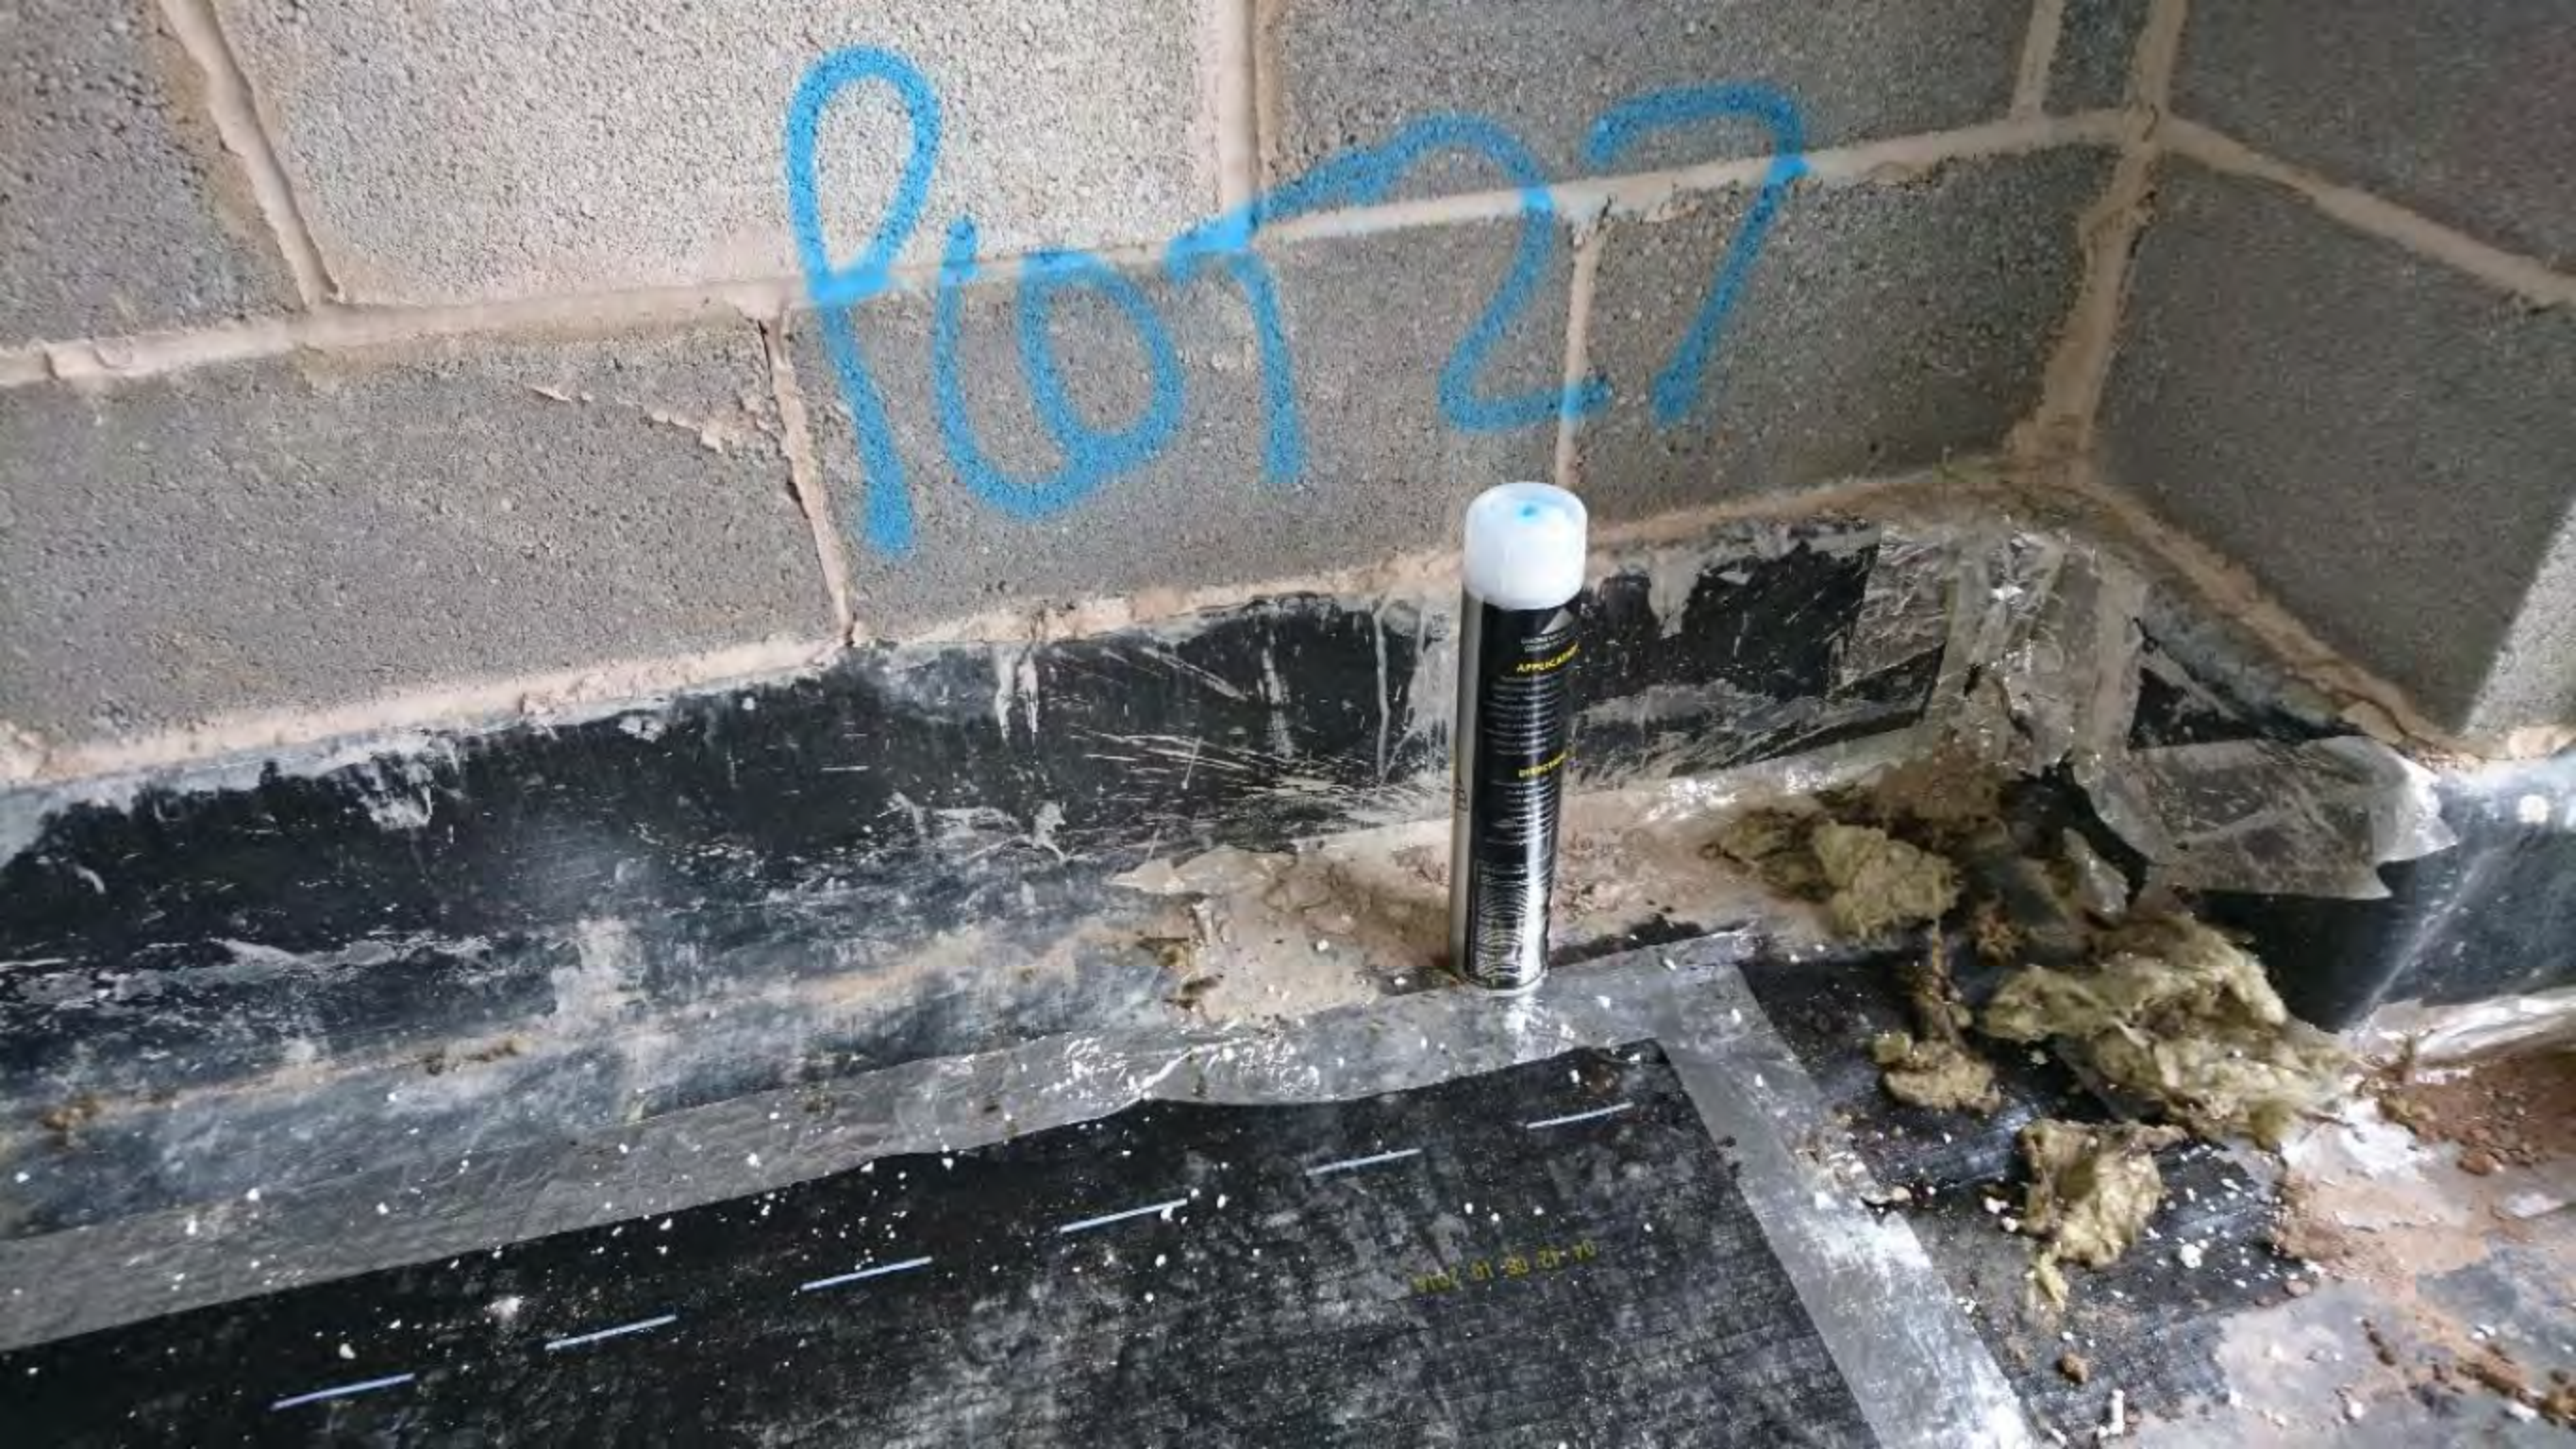
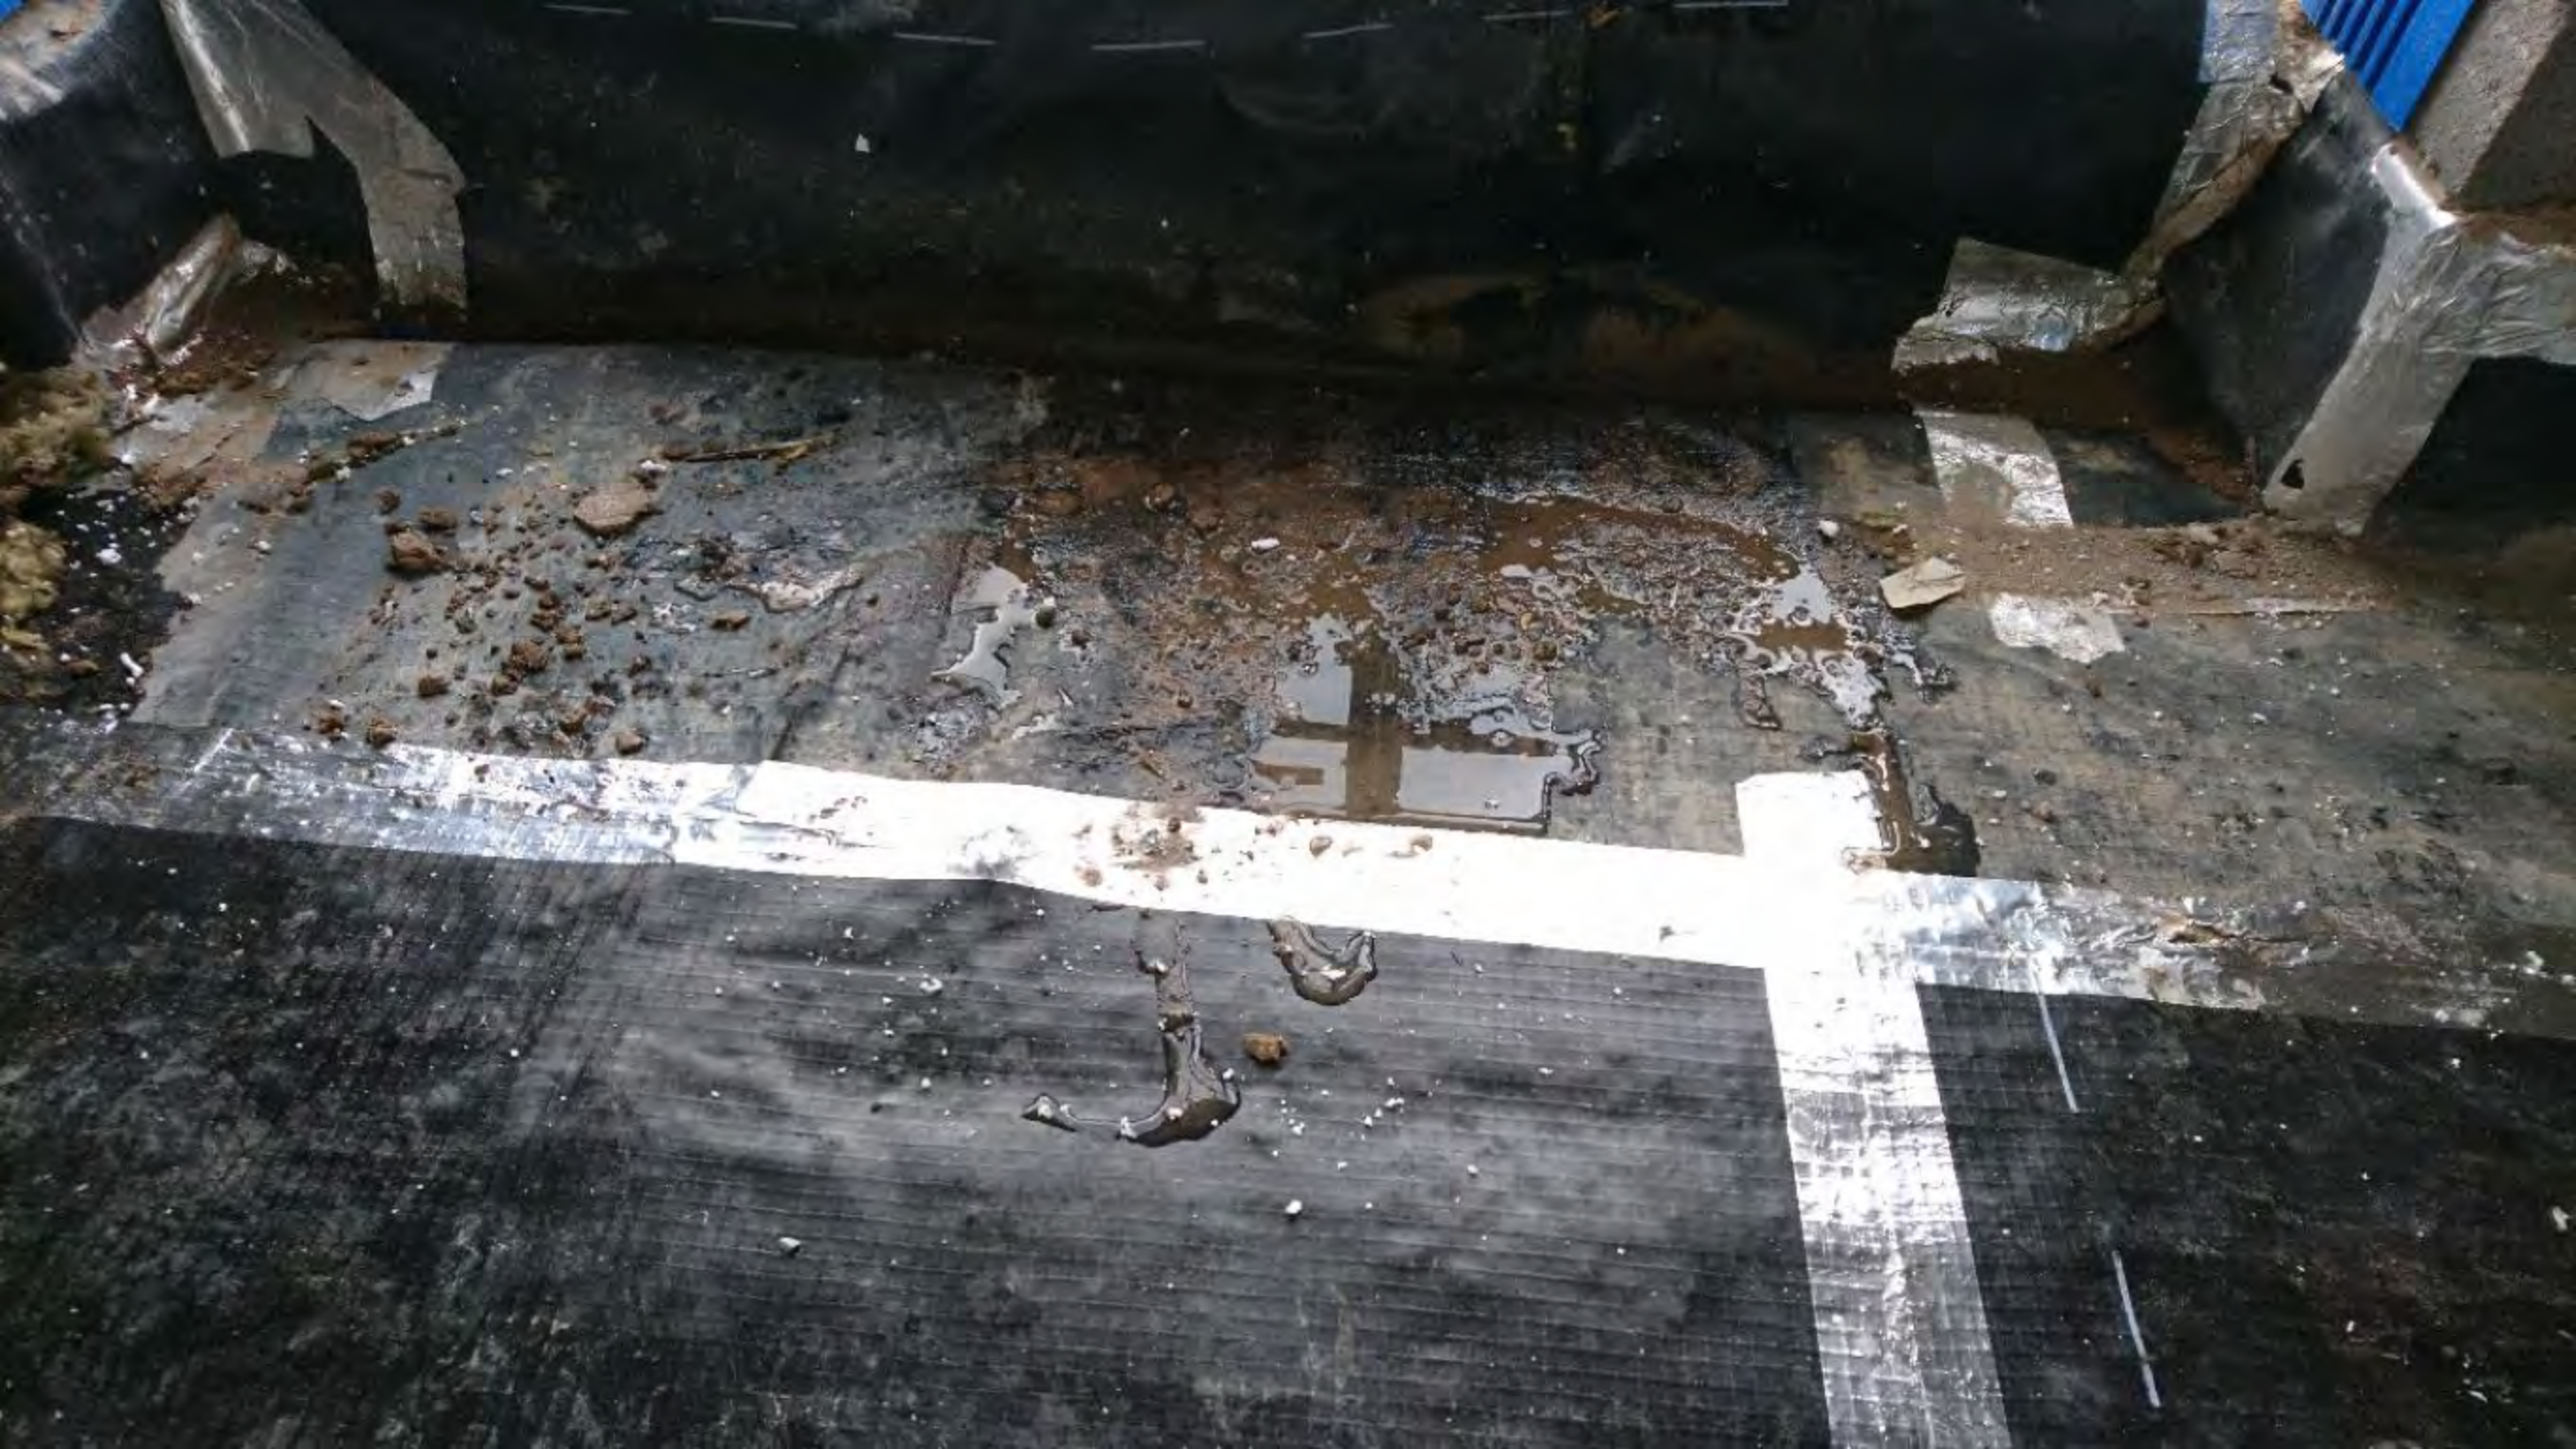
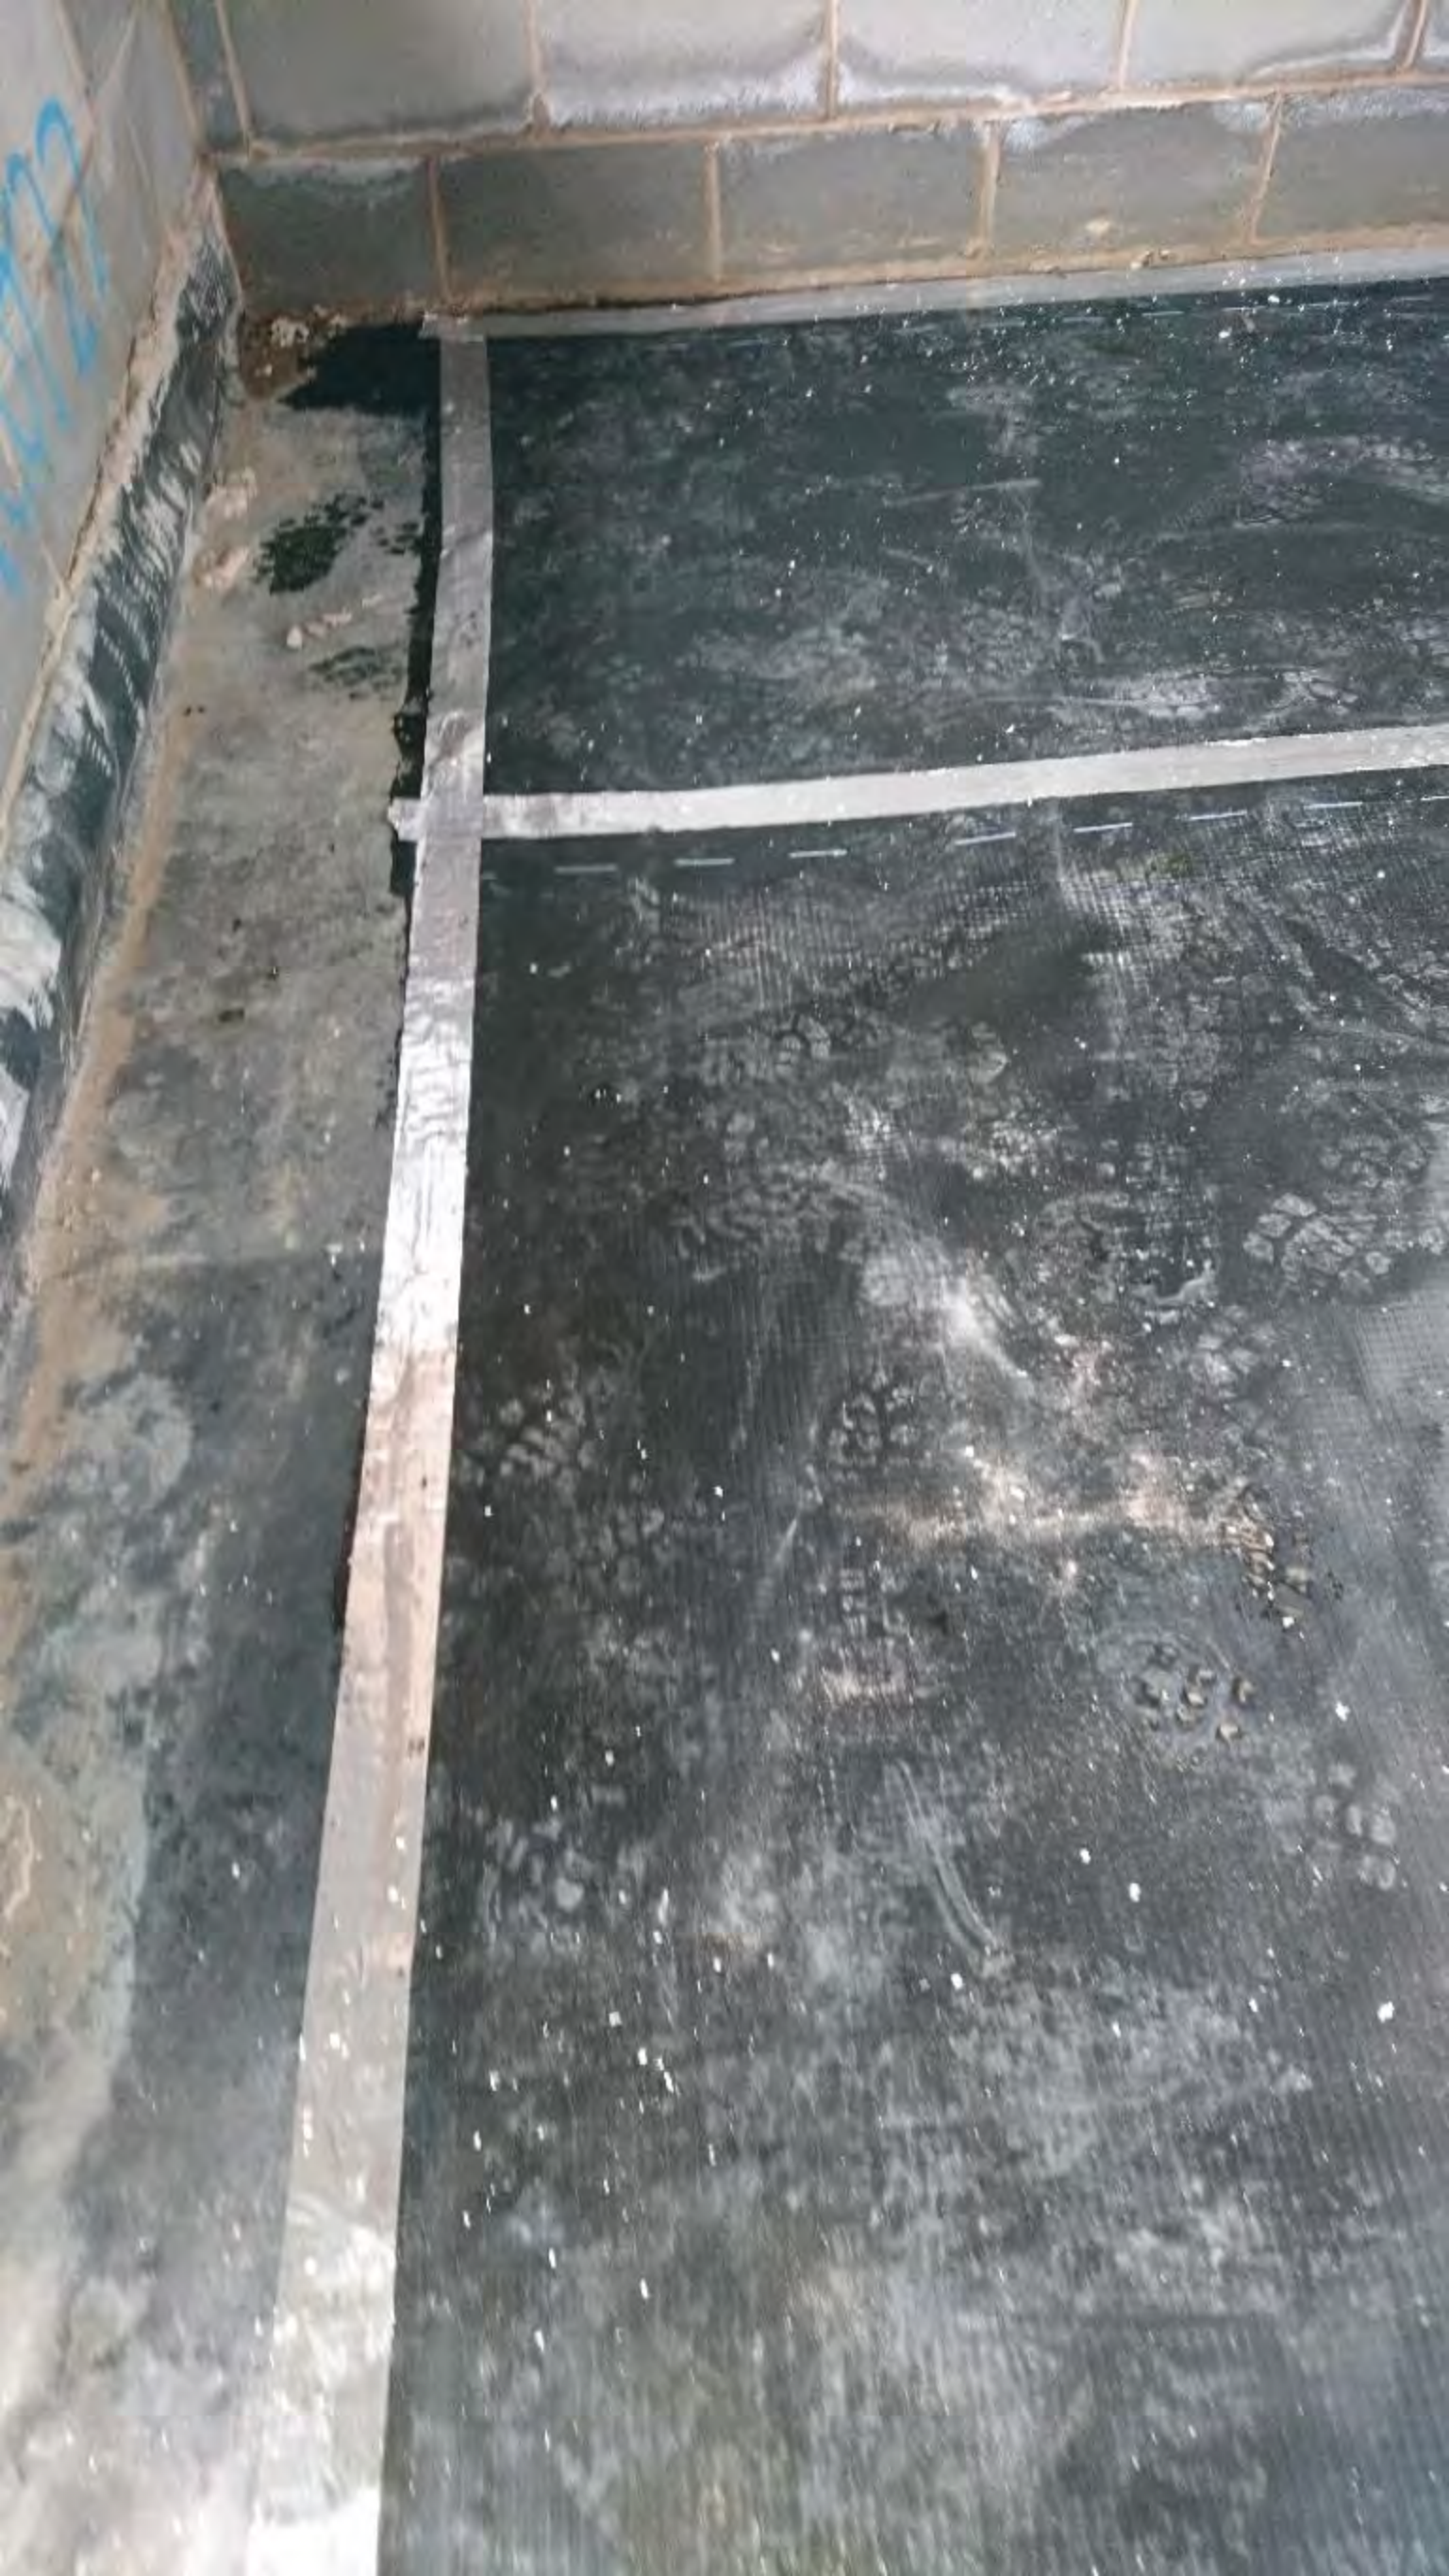
ROT 27

| 2.2 | Condition of sub-grade & underside of gas membrane | SEALED TO A GOOD QUALITY. FLOOR BRUSHED AND ALL TAPES APPLIED WELL | | | | | |
| 2.4 | Gas membrane condition and coverage | SEALED ON ALL FOUR SIDES AND IN GOOD CONDITION | | | | | |
| 2.7 | Condition of joints/seals | VISIBLE OVERLAPS AND ALL GOOD | | | | | |
| 2.8 | Number and condition of service entry seals | 3 NO. TOPHATS WITH JUBILEE CLIPS – TAPES CHECKED AND ALL OK | | | | | |

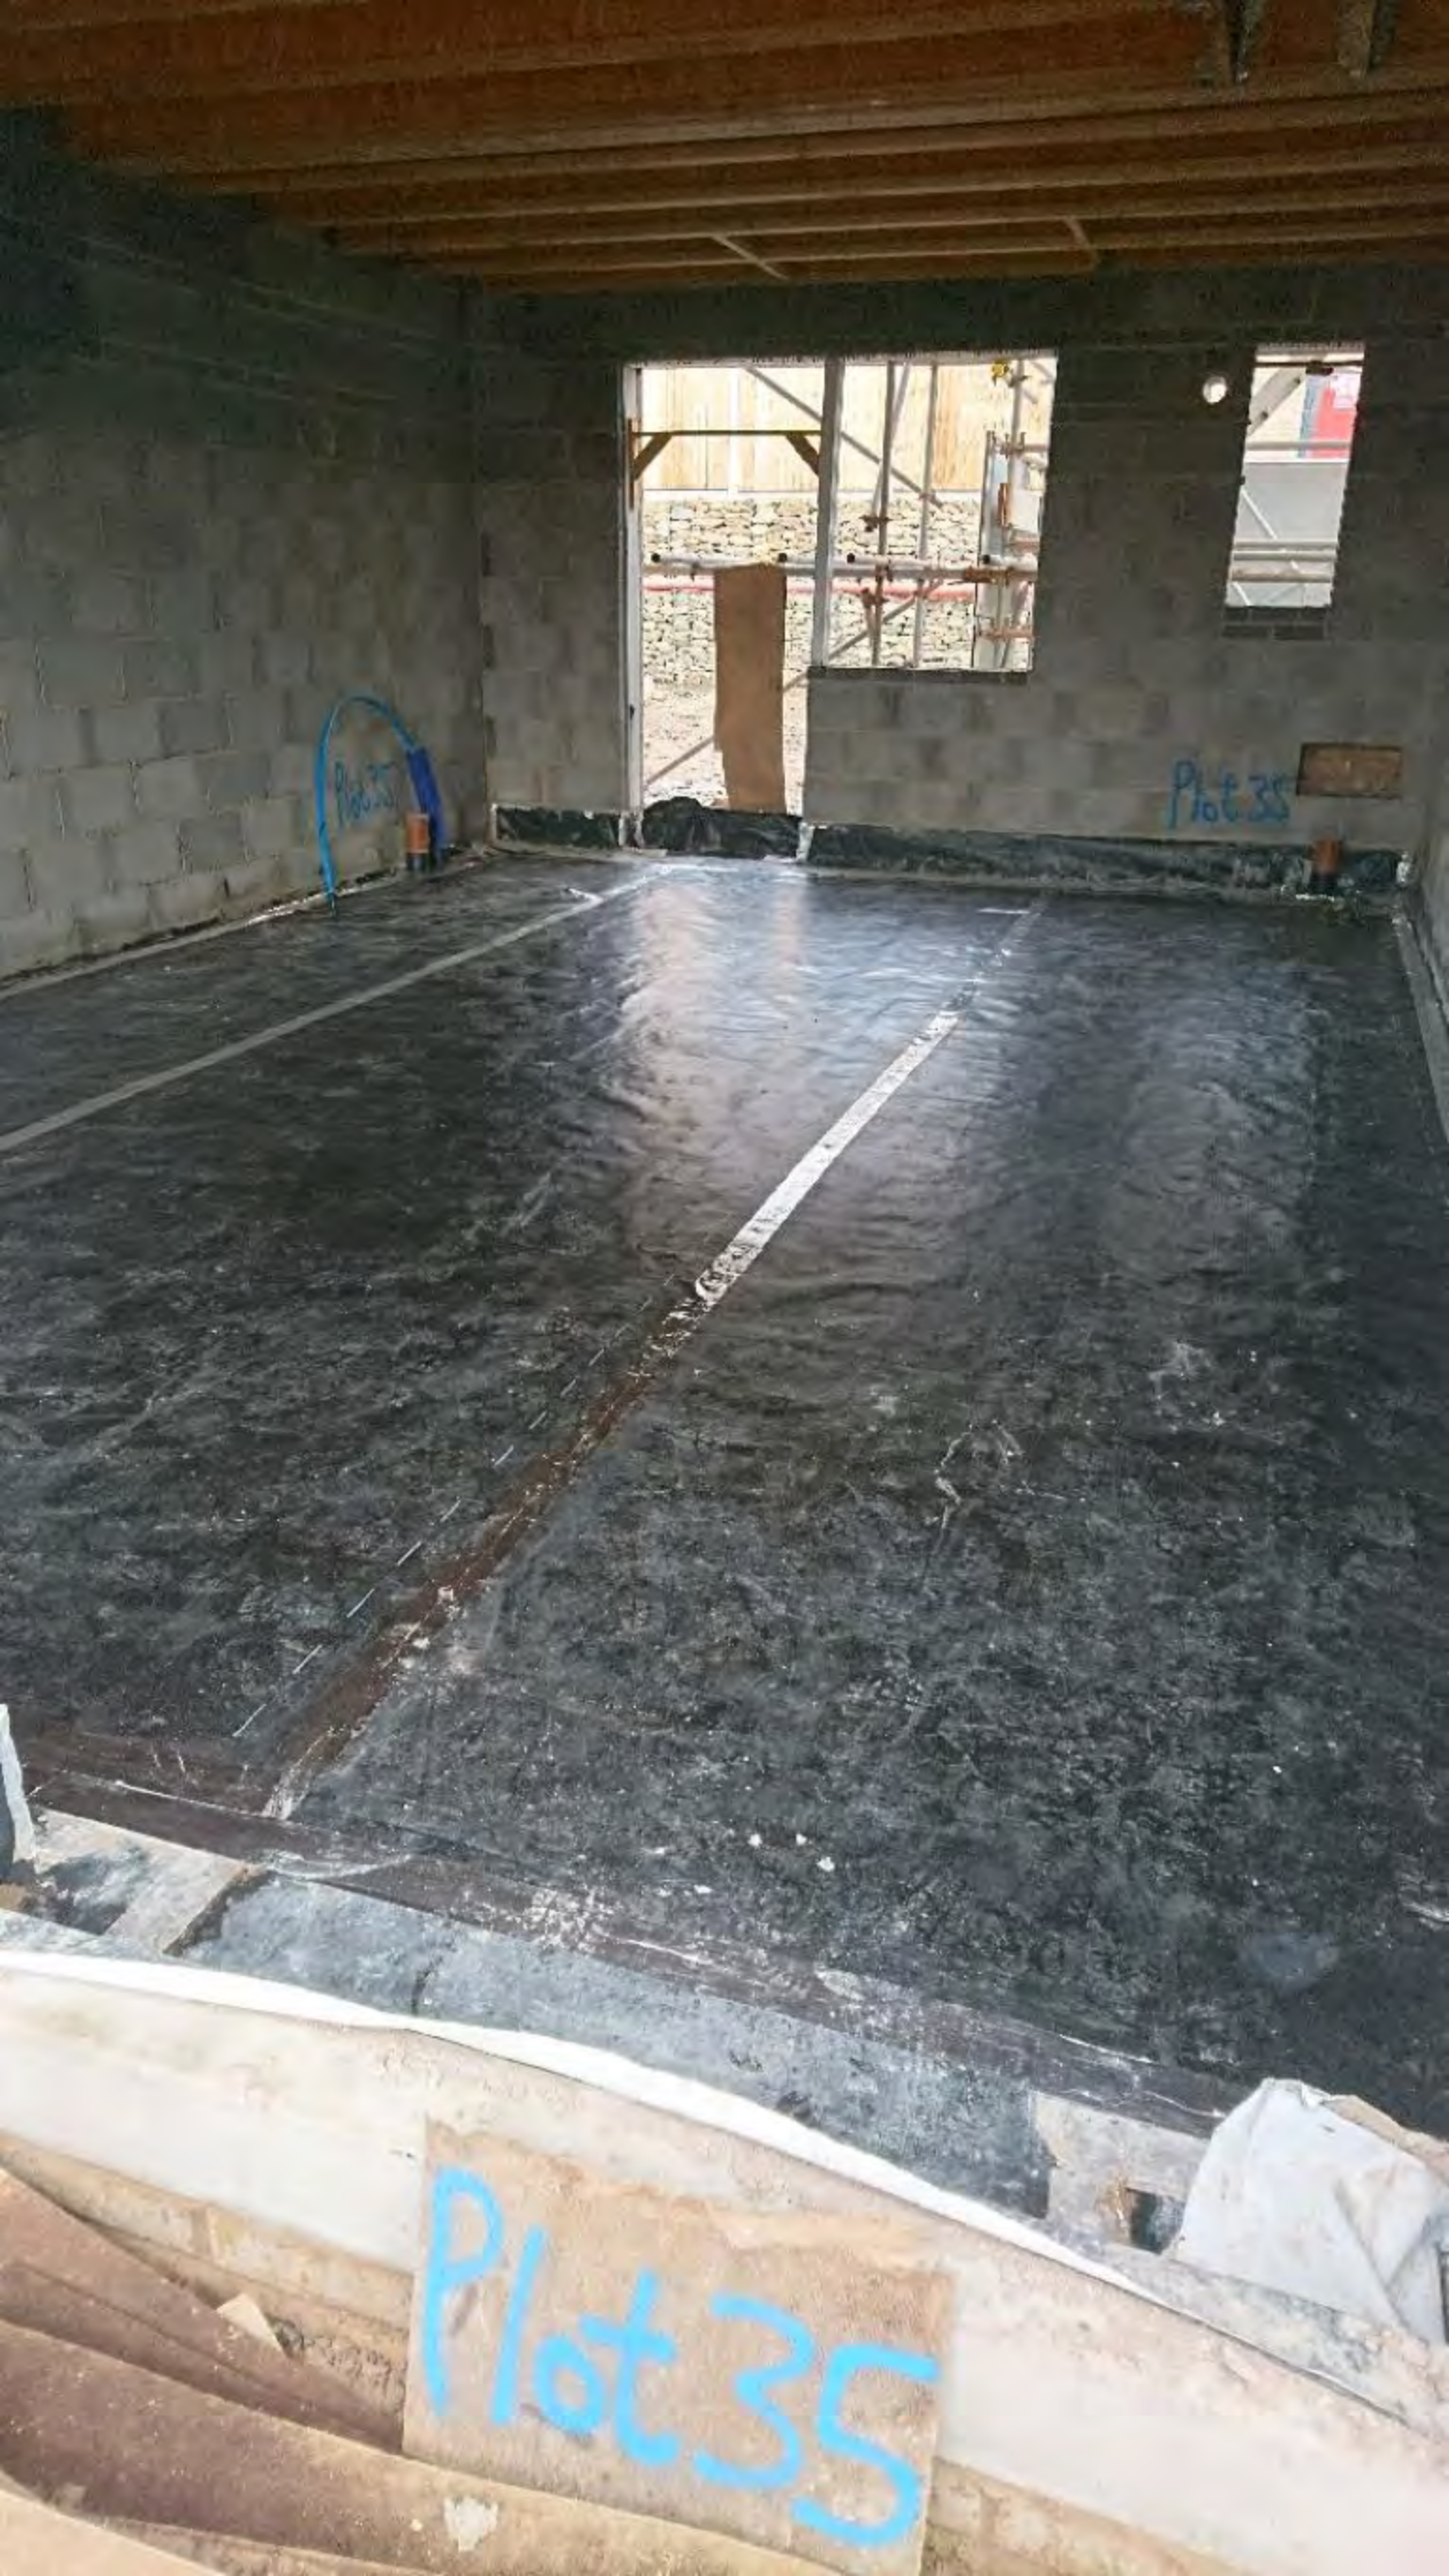
Plot 33

| 2.2 | Condition of sub-grade & underside of gas membrane | GOOD QUALITY, BRUSHED FLOOR, TAPE APPLIED WELL AND SEALED. | | | | | |
| 2.4 | Gas membrane condition and coverage | GOOD, SEALED ON ALL FOUR SIDES. | | | | | |
| 2.7 | Condition of joints/seals | GOOD, OVERLAPS VISIBLE | | | | | |
| 2.8 | Number and condition of service entry seals | ALL GOOD, 3 NO. TOP HATS WITH RUBBER CLIPS, TAPES CHECKED. | | | | | |
