## Pre-Demolition Assessment

The Elms  
Elm Close  
Whitefield  
Manchester

Client Name: Bury Council

Date: 30/09/2022

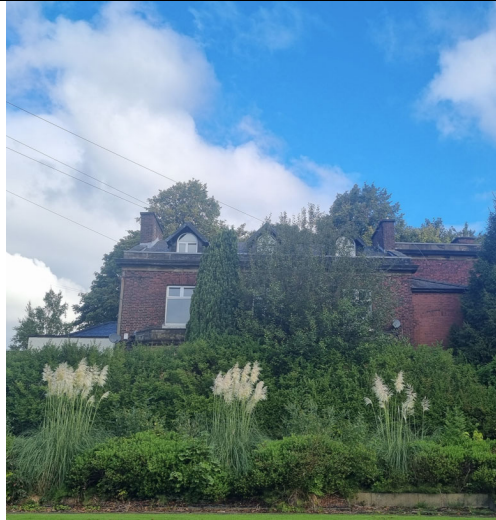
PHOTOGRAPH 1 (Above) – Front elevation with dense vegetation. Note single storey (white) extension to the left and two storey extension to the right with different bricks from that of the original building.

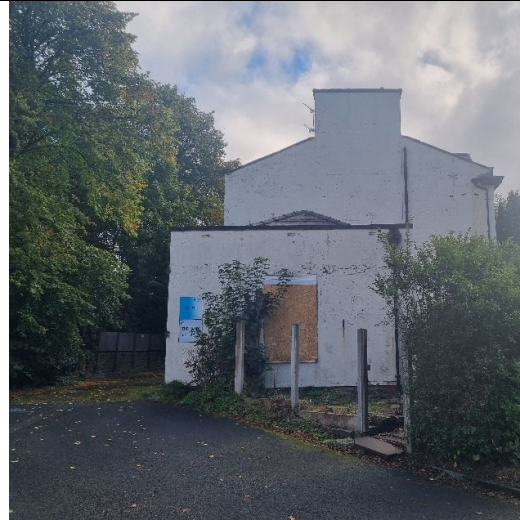
PHOTOGRAPH 2 (Above) – Left hand gable elevation and single storey extension finished in painted sand/cement render. Note chimney stack.

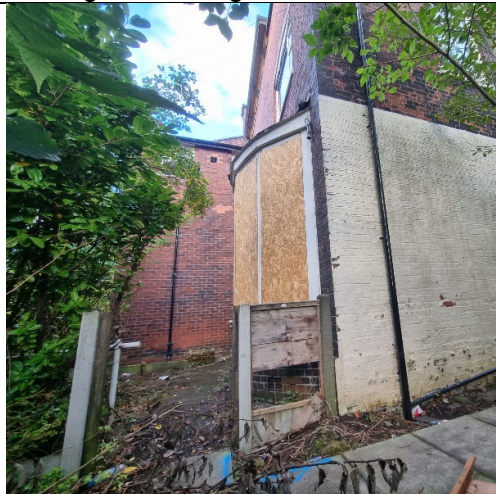
- 5.2.5 There is a cracking to the painted sand/cement render to the right-hand gable elevation and evidence of the render here being loose which is likely due to water ingress through the cracks.

PHOTOGRAPH 3 (Above) – Partial right hand gable elevation

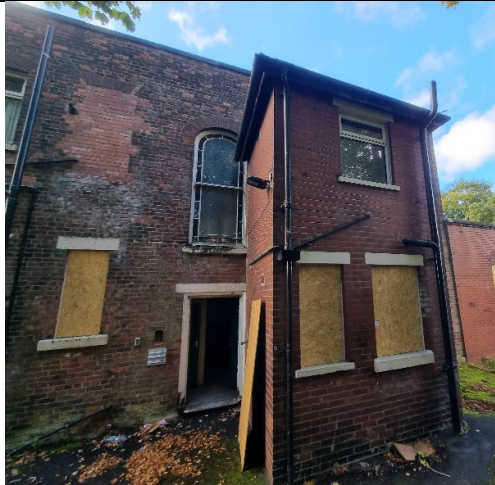
- 5.2.3 There are signs of historic structural movement/settlement to rear double storey outrigger extension which appears to have pulled away from the adjoining original building. There is evidence of historic repairs to tie the outrigger extension brickwork to the original building brickwork.

- 5.2.12 The historic signs of separation between the original building and rear two storey outrigger suggests that the outrigger may not be adequately tied into the original building. The demolition contractor therefore should consider locally dropping the rear outrigger extension prior to removing the external walls to the original building.

PHOTOGRAPH 5 (Above) – Partial rear elevation with two storey outrigger extension

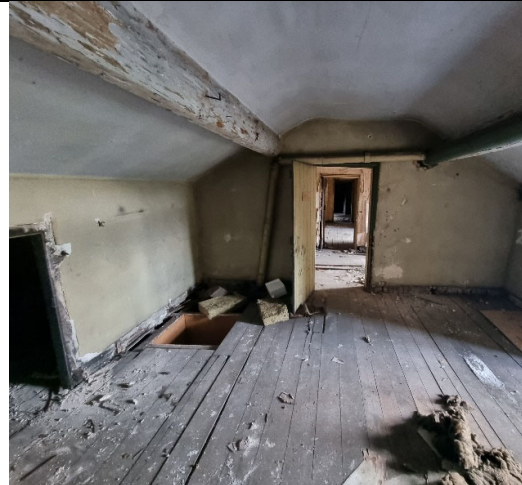
- 5.2.4 There is localised damp to the purlins of the original building and at bearing points due to the areas of missing roof finishes and being exposed to the elements.

PHOTOGRAPH 6 (Above) – Timber roof purlins spanning between gable walls to intermediate masonry spine walls at second floor level

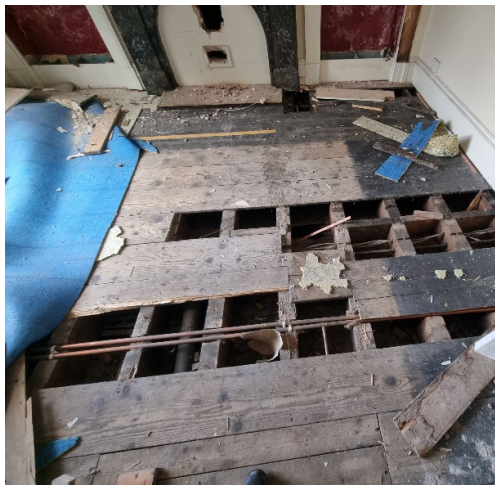
PHOTOGRAPH 7 (Above) – Typical suspended timber floor construction

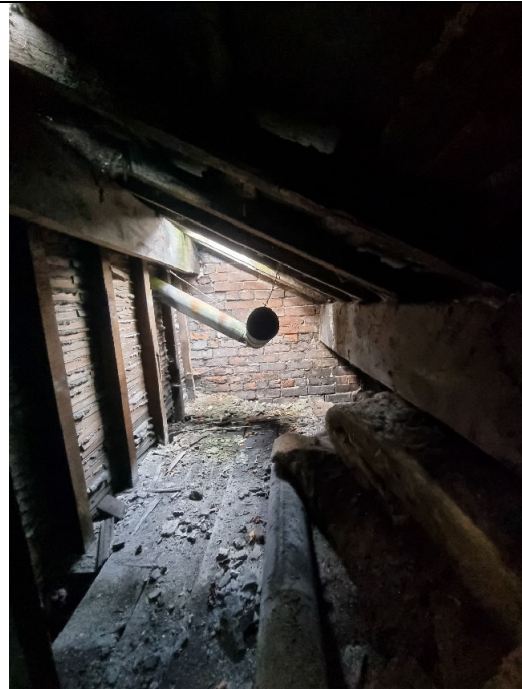
PHOTOGRAPH 8 (Above) - Typical roof construction with timber purlins and rafters. Note area of natural light leaving the 2<sup>nd</sup> floor joists open to the element.

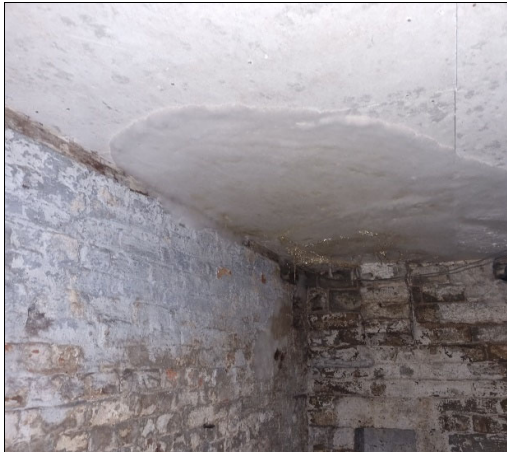
- 5.2.1 There is extensive dry rot to the timber floors at ground floor level which covers approximately 50% of the floor joists when viewed from the basement level below. Elsewhere in the building, there is evidence of dry rot to the timber floors throughout the building. We therefore consider that the existing building is in poor structural condition by virtue of the extensive dry rot to the floor joists.

PHOTOGRAPH 9 (Above) – Dry rot 'blanketing' to the timber ceiling boards of the basement roof.

- 5.2.2 Due to the extensive dry rot to the floor joists we recommend that no soft strip/gutting of the building is undertaken i.e., removal of floor boardings, fireplaces, radiators, boilers, stair lifts etc. We would also advise that the structure should not be entered for health and safety purposes as the structural integrity of the suspended timber floors has been compromised by the dry rot.

- 5.2.7 Due to the extensive dry rot throughout the timber floor joists, all demolition of the building should be undertaken externally via a high reach excavator or similar knocking the building inwards.

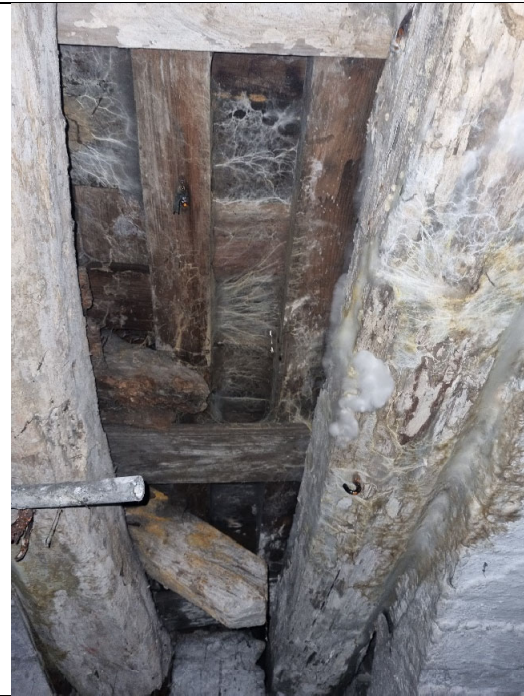
PHOTOGRAPH 10 (Above) – Extensive and active dry timber rot infestation.
