## Prestwich Village

### Existing Buildings Visual Inspection Report

On behalf of **The Prestwich Regeneration LLP**

Project Ref: 332010844-STR-R01 | Rev: - | Date: March 2023

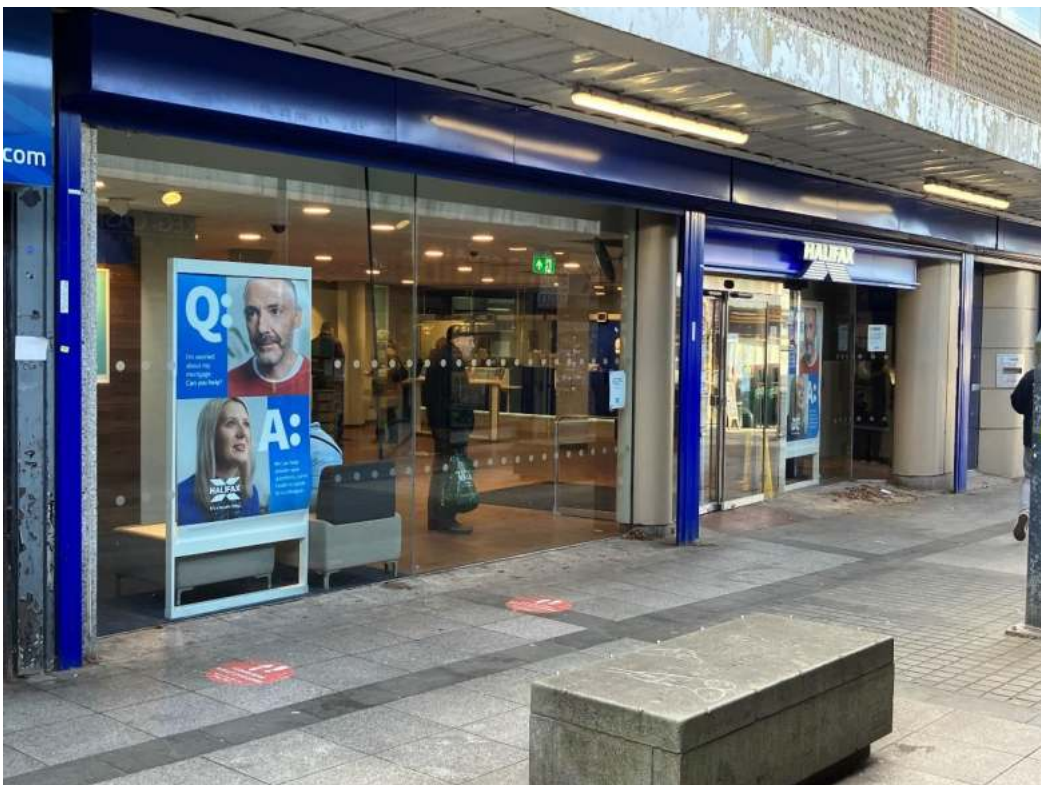
- 2.1.8 The second unit in from the west end is occupied by the “Halifax” and would appear to have undergone many structural changes, now being one open plan unit as opposed to three originally. Access into the “Halifax” was not permitted but we would expect the conversion of the three units into one would have necessitated the introduction of structural steel or reinforced

"Halifax" unit at west end of units

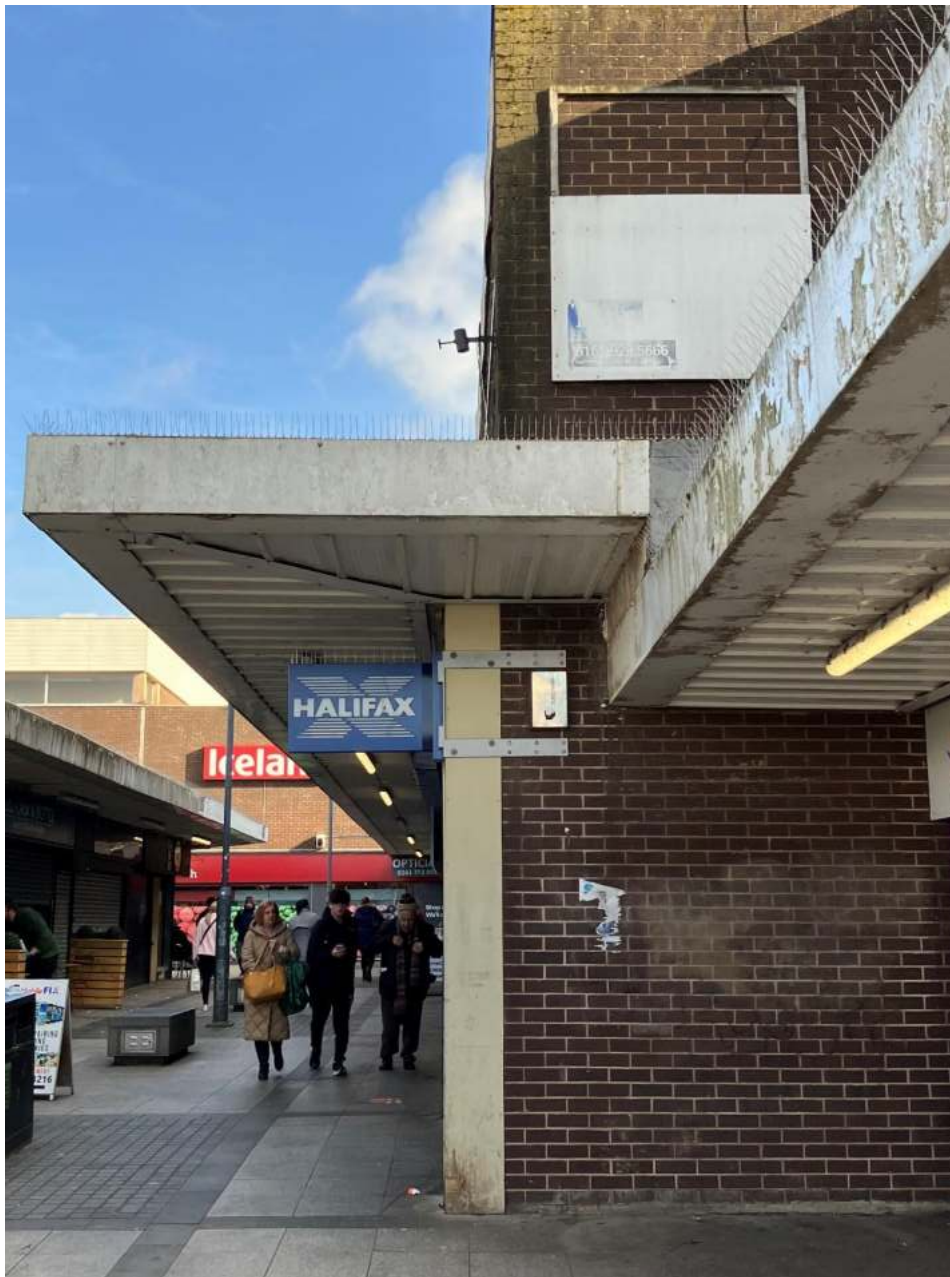
- 2.1.7 To the front of the units is a linear cantilever canopy. While this was not opened up as part of this inspection, the canopy would be expected to be of steel construction which is supported off columns located and fixed back to the outer ends of dividing masonry walls. This is apparent from the face of the supporting columns projecting out further than the first floor face of the building above.

Cantilever canopy to double storey retail units

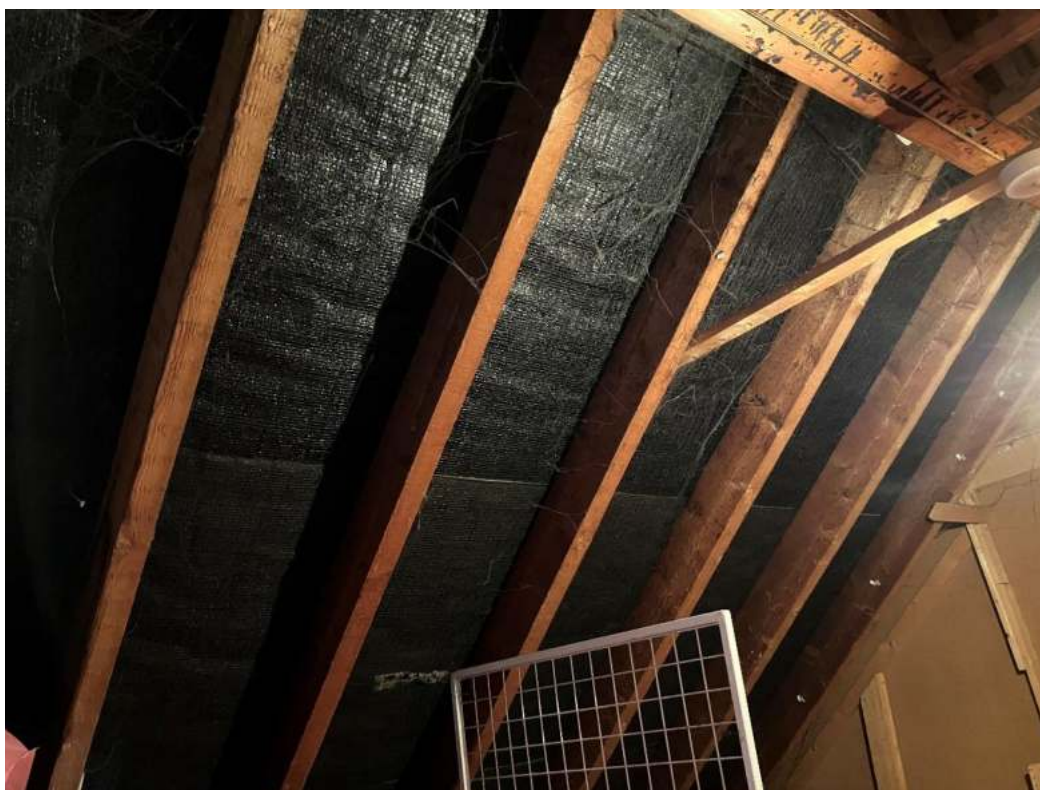
- 2.1.6 The rear sloping roof to these units comprised rafters spanning from the upper level flat roof down to the head of the rear ground floor wall. In the unit inspected, the internal roof slope was felted while the external roof slope was tiled. Localised opening up work had been carried out previously of the underside of the flat roof which revealed this roof to comprise composite timber “I” beams (flanges of solid timber sections with a plywood web sandwiched in between) spanning across the units between adjacent masonry dividing walls. The composite “I” beams in turn supported smaller secondary solid timbers and a plywood timber deck. This was confirmed by the inspection of a single storey unit (see later) which had had all of its ceiling and wall finishes removed as part of a refurbishment exercise. The external covering to the roofs of these units is felt which is understood (from the tenants) to have caused issues in the past with water penetration due to deterioration in the felt.

Internal view of sloping roof to rear of two storey retail units

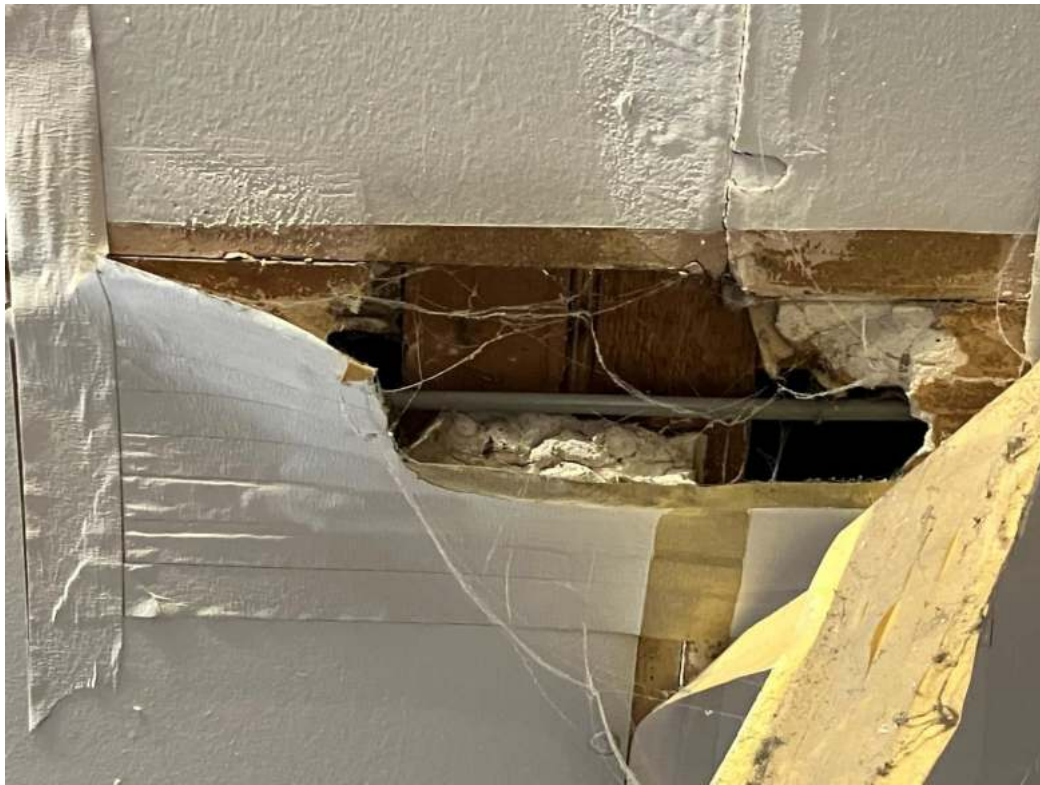
Locally opened up ceiling exposing composite timber "I" beam to roof

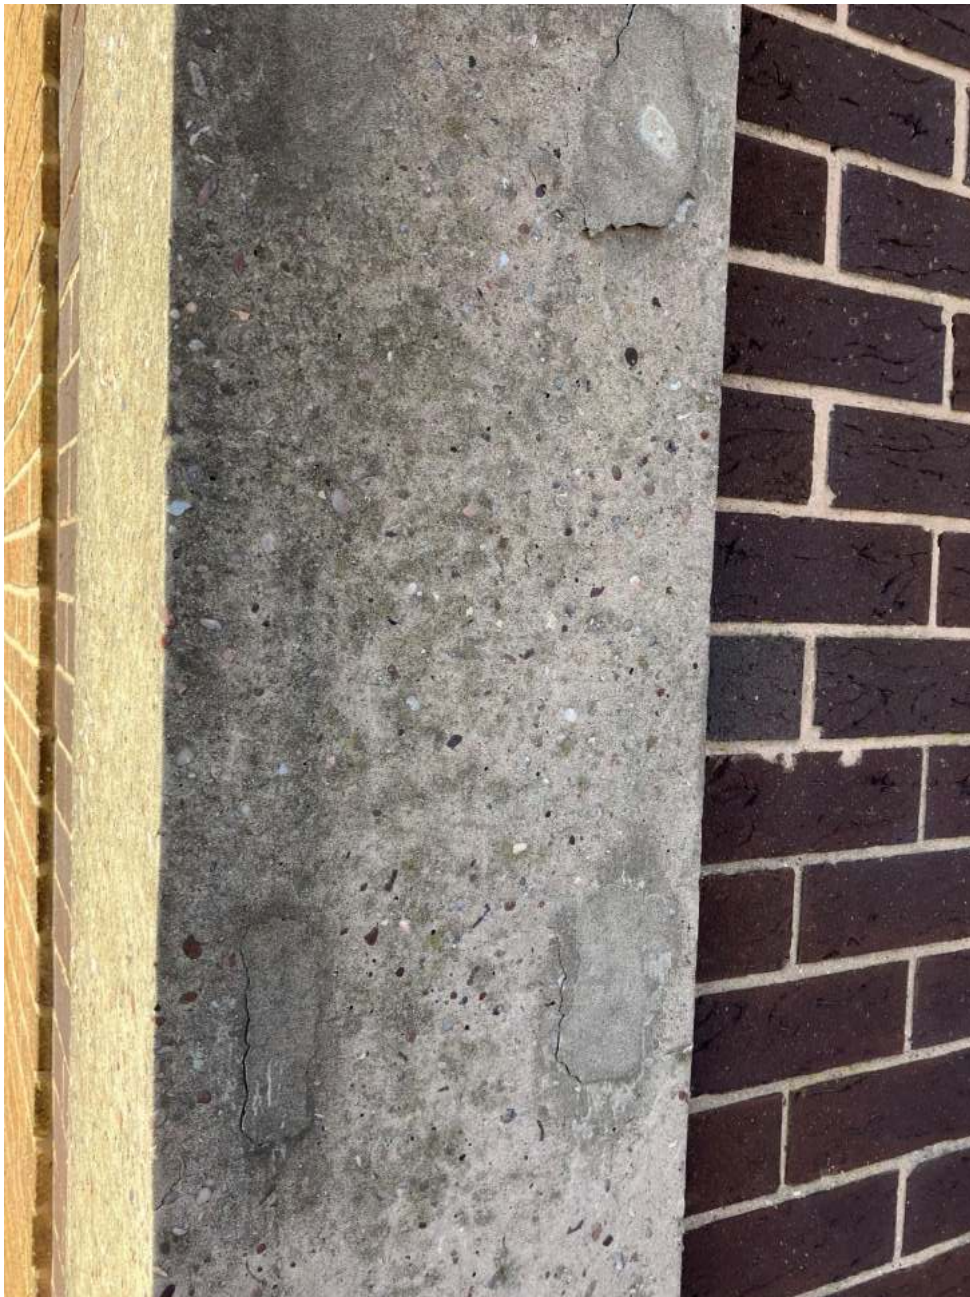
- 2.2.6 The southern flank wall to the units is a double storey height brick and block cavity wall which has been panelised by the presence of two storey high concrete columns that are exposed between adjacent masonry panels. The columns appear to be precast concrete and are generally in an acceptable condition. However, the column to the south east corner is showing signs of localised spalling probably indicative of there being corrosion of embedded steel within. The brickwork itself is in a reasonable condition although there is some weathering to the bricks and loss of pointing near the top of the wall.

Local spalling to external concrete corner column at south east corner of store

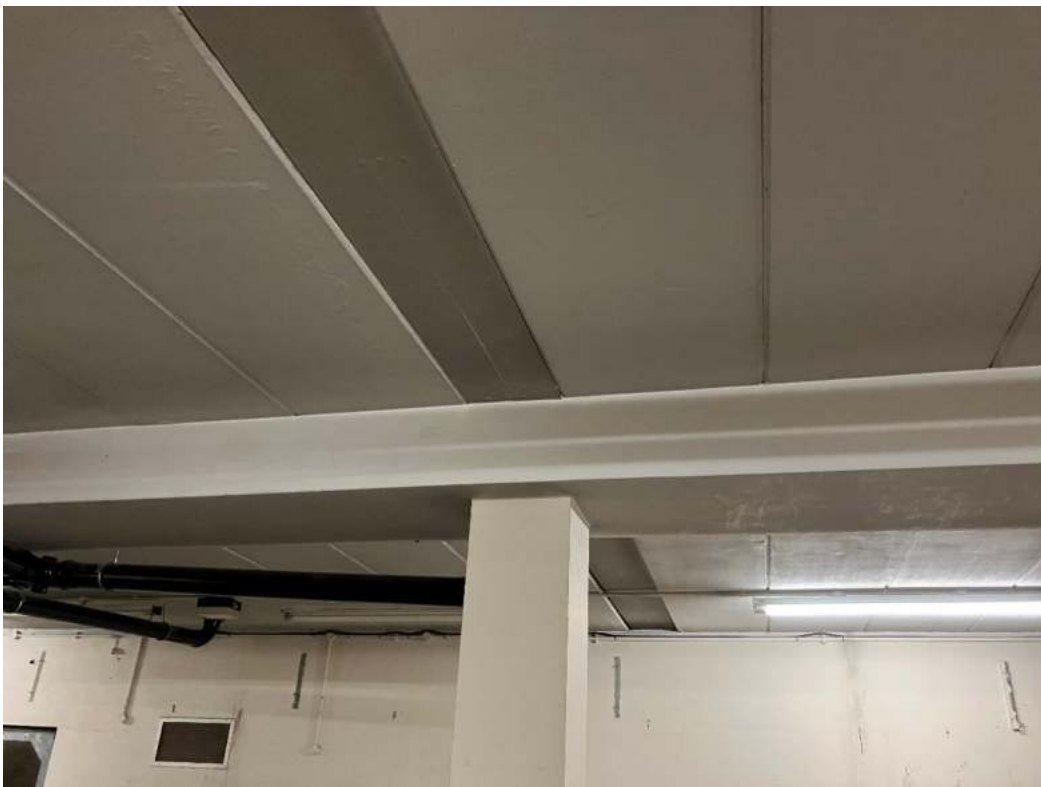
- 2.2.5 The roof over first floor is open to view within the first floor unit and appears to consist of precast planks supported on inverted "T" beams that are supported on concrete columns on an approximate 8 x 6m grid. At column locations, there appear to be insitu concrete tie beams the same depth as the precast planks that are orientated perpendicular to the inverted "T" beams which are possibly present to provided ties between adjacent column heads across the roof. There are several openings through the roof which have been created by removal of sections of the precast planks and supporting the cut plank ends on steel saddles onto the adjacent continuous planks. Those openings that are not currently in use have been boarded over but some are permitting rainwater ingress into the building which at the very least is damaging the internal painted finishes.

Roof planks supported on downstand beams with perpendicular tying beam at column location

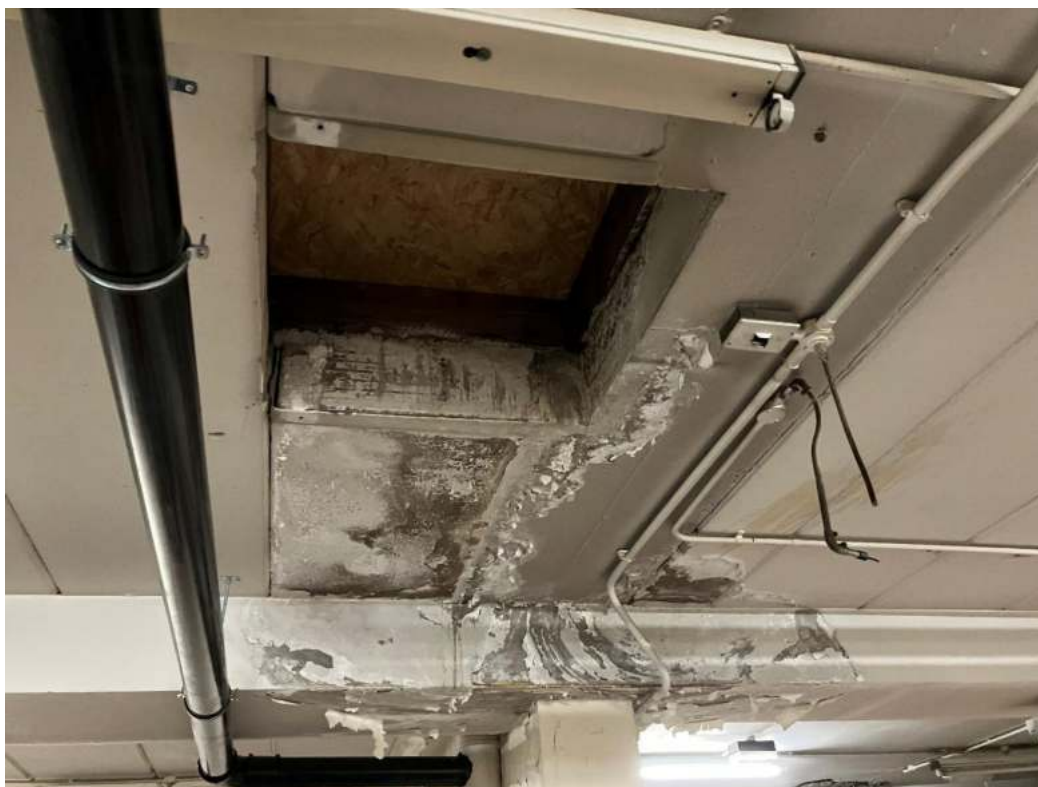
Boarded over opening through roof precast planks with evidence of water penetration

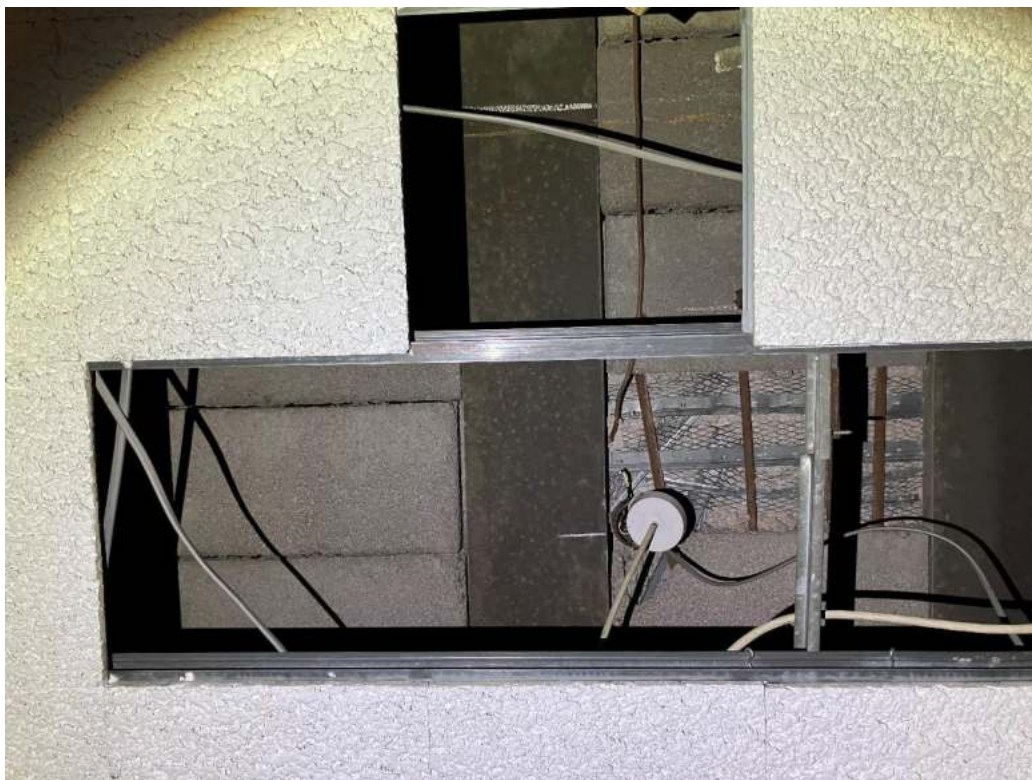
Exposed beam and block floor to first floor

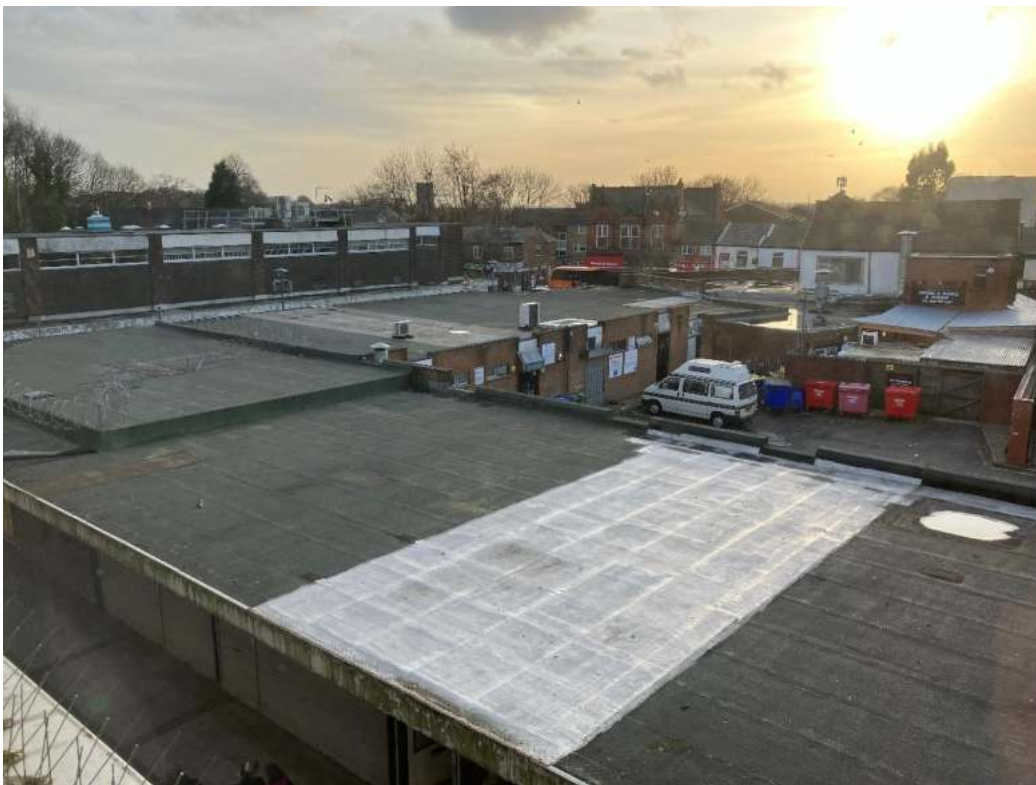
- 2.5.4 The ground floor was solid and while it could not be closely inspected due to finishes, a ground bearing concrete slab would be expected.
- 2.5.5 In the vacant unit inspected, the internal ceiling and wall finishes had all been removed revealing the nature of the roof and dividing walls that would otherwise be hidden. The flat roof comprises composite timber “I” beams (flanges of solid timber sections with a plywood web sandwiched in between) spanning across the units between the masonry dividing walls. In turn the composite timber “I” beams support smaller secondary solid timbers and a plywood timber deck. The external covering to the roofs of these units is felt which is understood (from the tenants) to have caused issues with water penetration in the past. Observation of these roofs from the upper floor of the Longfield suite showed there to have been recent re- or over-covering to a couple of the units together with repair patches to other unit’s roofs.

Flat roof to southern single storey retail units

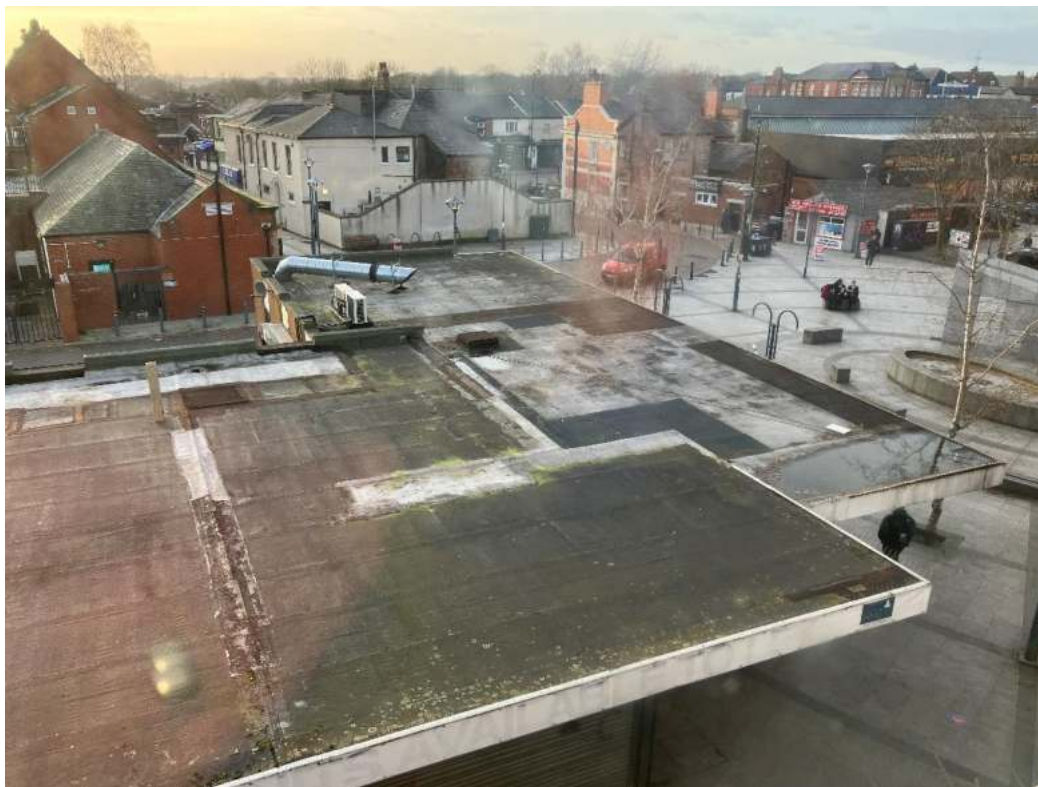
Flat roof to north end single storey retail units

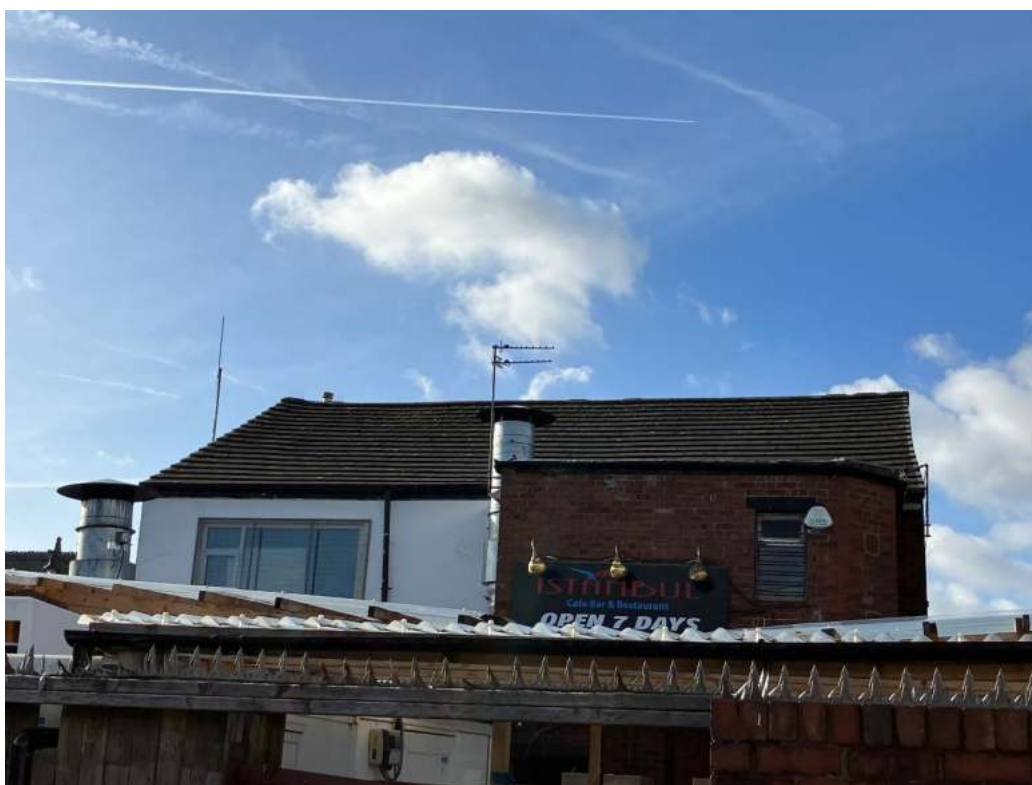
- 2.6.7 The extensions to the south and east of the original building have flat roofs with a membrane finish. At the time of the inspection, the various roofs to the ground floor had areas of standing water to them which is both indicative of the membrane preventing water ingress and slight sagging in the roof.

Rear elevation of “Istanbul” restaurant

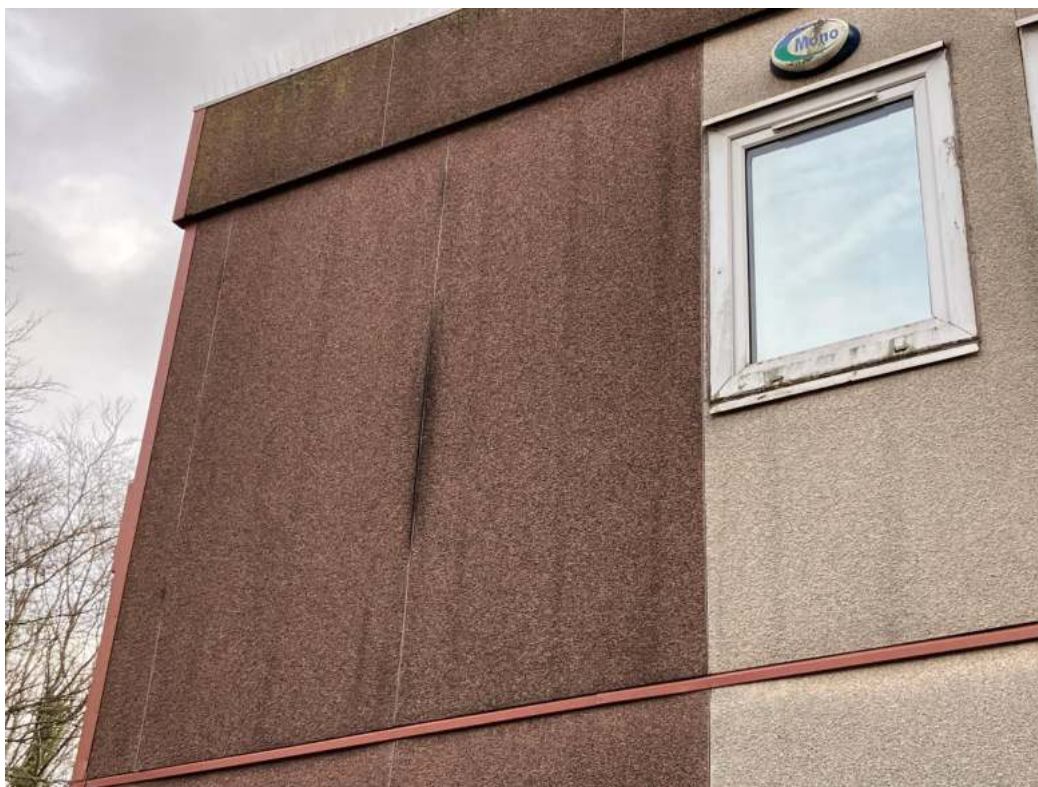
- 2.7.4 The more recent extensions are of modular construction, probably with cold formed steel internal structure to walls, first floor and roof. Although ceiling tiles beneath the first floor and roof were lifted in the Walk In Centre extension, the structure above was not revealed due to fixed soffit finishes similar to internal wall finishes. The internal staircase is of bolted together structural steel construction. External wall elevation finishes comprise a thin sheet material that has an applied coat of fine gravel while horizontal and corner joints in the panelling system have thin metal flashings. Generally, the external walls are in a reasonable condition although there are localised first floor areas near the north east corner and along the southern elevation of the Walk In Centre where the external sheeting appears to be separating at panel joints.

Separation of external cladding to first floor northern elevation of modular extension
