## **Bury Council**

Longfield Shopping Centre, Prestwich, Manchester, M25 1AY

## **Asbestos Management Survey**

10<sup>th</sup> August 2021

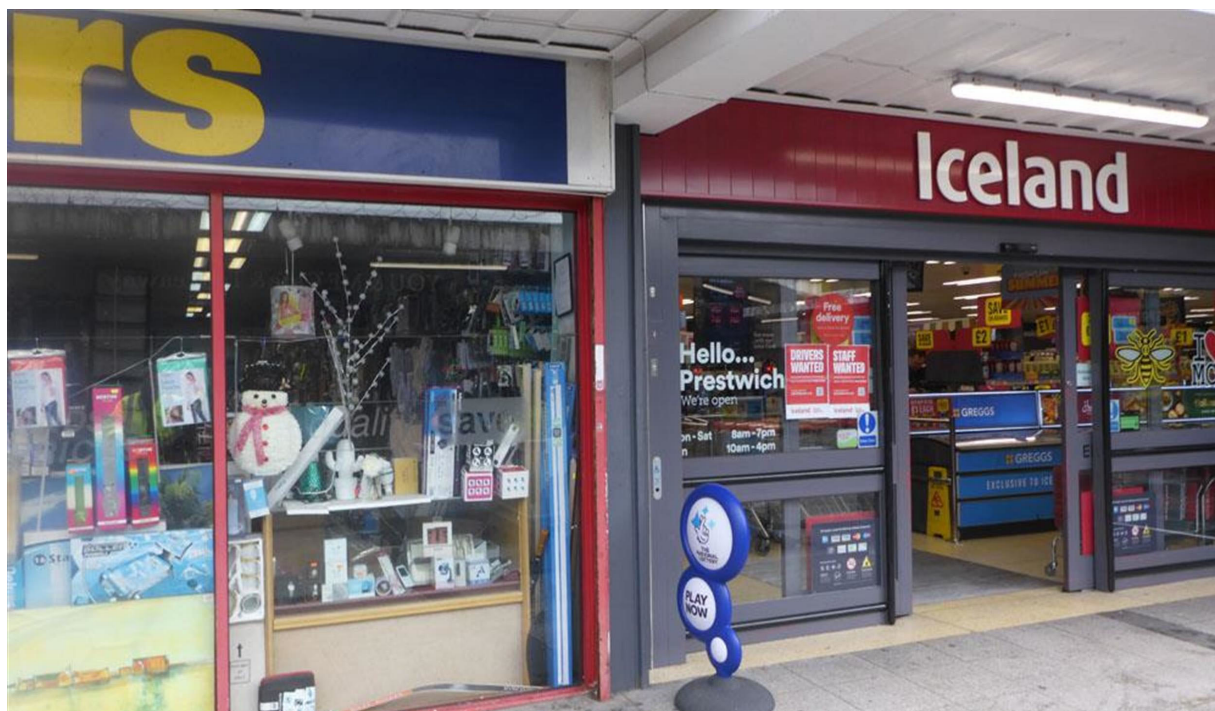
| <b>Position Description</b> | Known and / or presumed asbestos insulation board linings to the metal-clad columns to the shop front | | |

| <b>Position</b> | - External | <b>Damage Risk</b> | - Low |

| <b>Damage Extent</b> | - Low Damage: Scratches, breaks or surface | <b>Friability</b> | - Low |

| <b>Recommendations</b> | The material should be labelled, managed and re-inspected on an annual basis. | | |

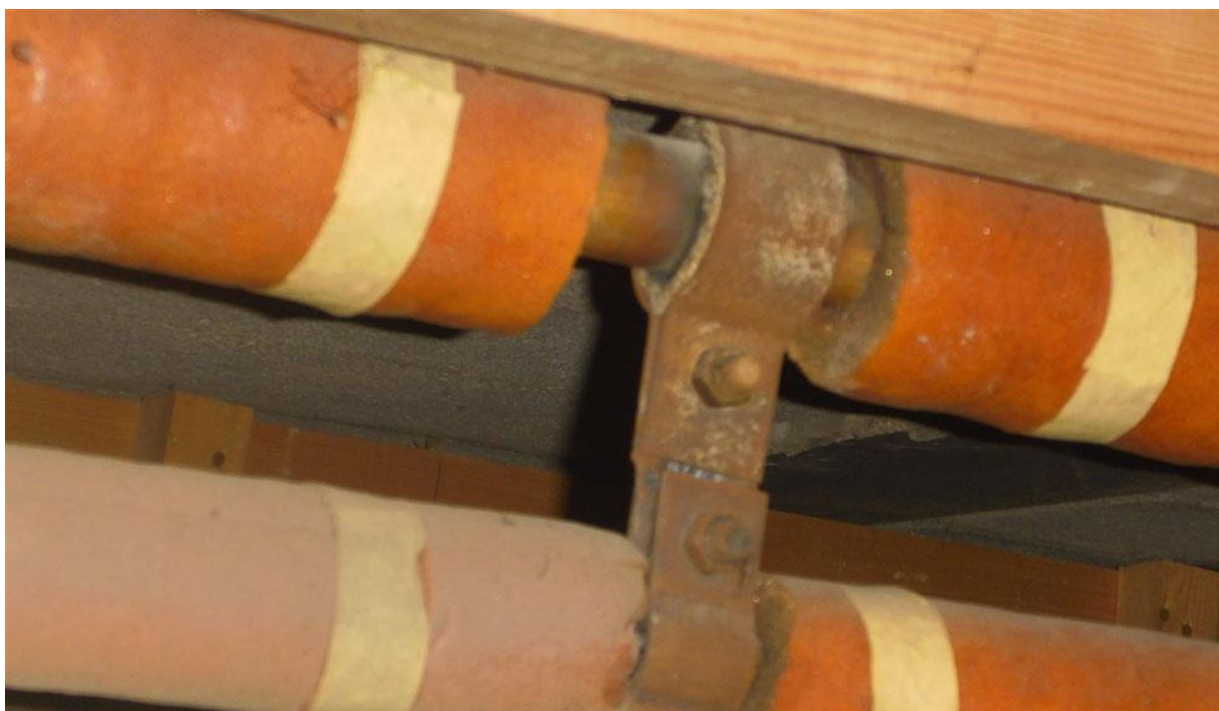
- Asbestos rope packing was identified to the pipe-work hanger brackets within the ceiling void of the Passage to Block A. This material should be managed and reinspected on an annual basis.

| <b>Position Description</b> | Asbestos rope packing to the pipe-work hanger brackets within the Passage Ceiling Void | | |

| <b>Position</b> | - External | <b>Damage Risk</b> | - Low |

| <b>Damage Extent</b> | - Low Damage: Scratches, breaks or surface | <b>Friability</b> | - Low |

| <b>Recommendations</b> | The material should be managed and re-inspected on an annual basis. | | |

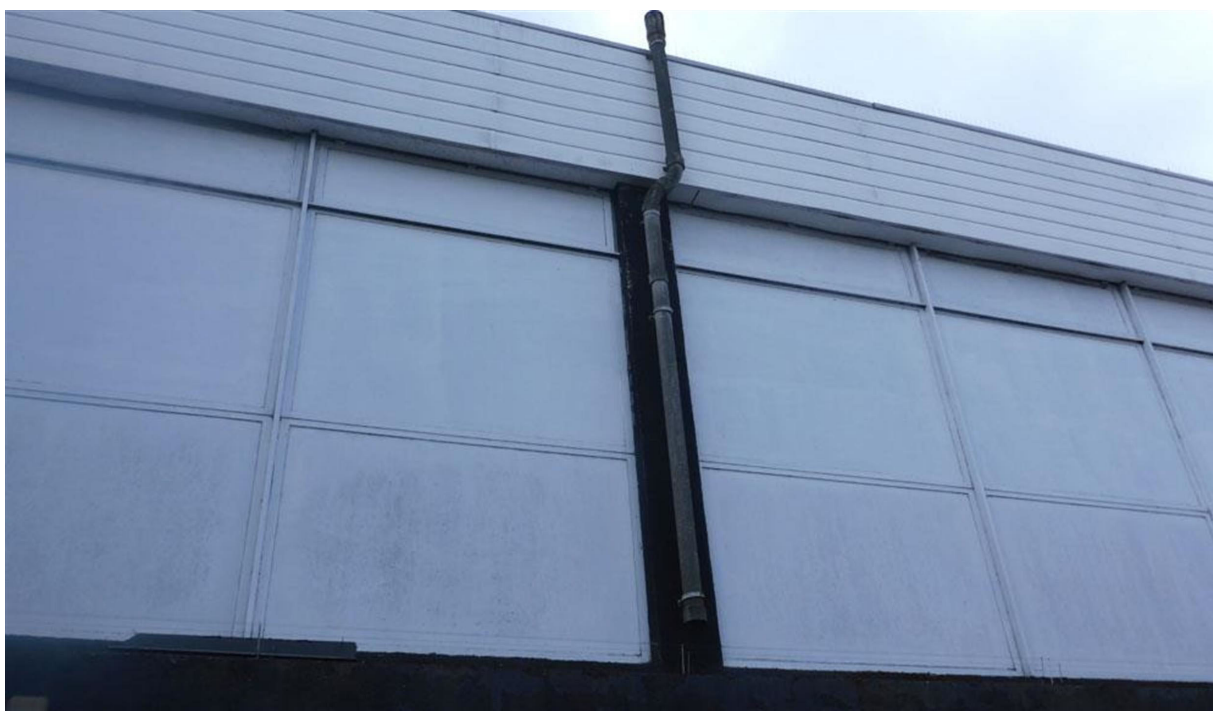
- A redundant asbestos cement flue pipe, measuring approximately 4 Lin m, was identified at high level to the rear of Unit 18/20. This material should be managed and reinspected on an annual basis.

| <b>Position Description</b> | A redundant asbestos cement flue pipe at high level to the rear of Unit 18/20 | | |

| <b>Position</b> | - External | <b>Damage Risk</b> | - Low |

| <b>Damage Extent</b> | - Low Damage: Scratches, breaks or surface | <b>Friability</b> | - Low |

| <b>Recommendations</b> | The material should be labelled, managed and re-inspected on an annual basis. | | |

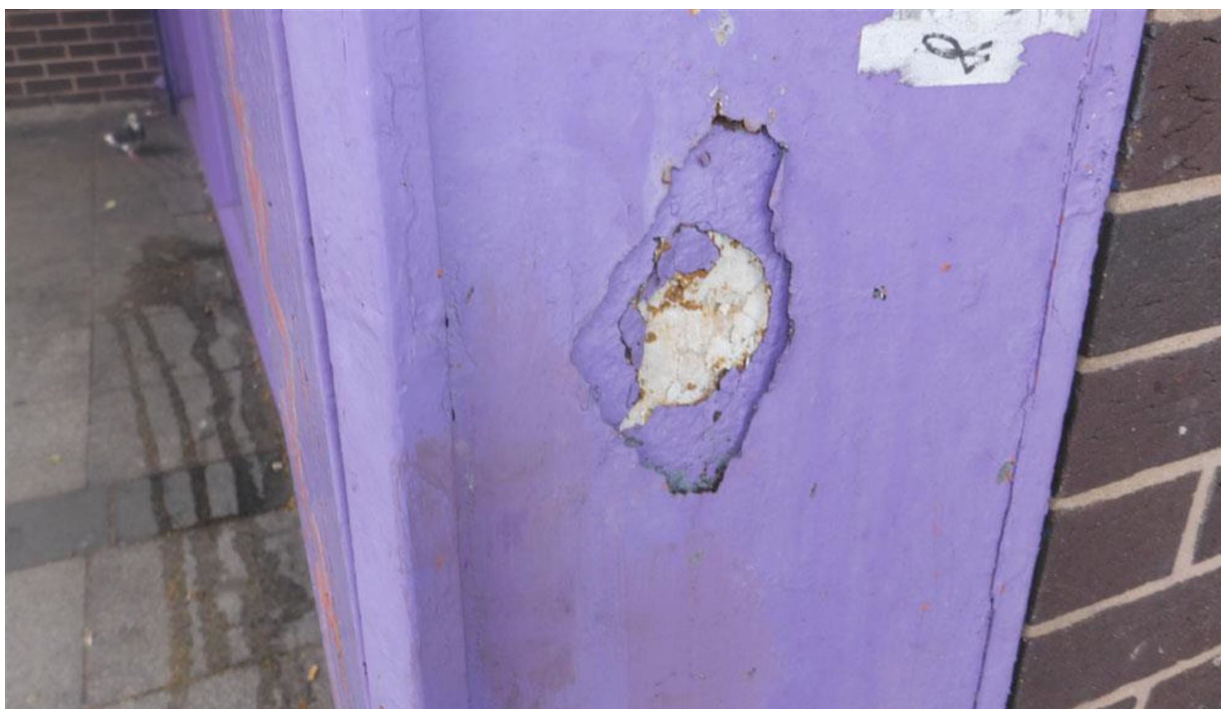
- Asbestos insulation board was identified, and is presumed to be present, within the vertical, metal-clad columns to the shop-fronts throughout Block A, B & C. The asbestos boarding was seen to be present to the columns of Block B, where historic damage has occurred exposing the ACM and is presumed to be present to all other visually similar metal-clad columns. It is recommended that remedial works are undertaken to the damaged columns of Block B at the earliest opportunity. Following which, each column should be labelled and reinspected on an annual basis. (S# 02)

| <b>Position Description</b> | Known and / or presumed asbestos insulation board linings to the metal-clad columns to the shop front | | |

| <b>Position</b> | - External | <b>Damage Risk</b> | - High |
| <b>Asbestos Type</b> | - Amosite Chrysotile | <b>Action</b> | - Repair/encapsulate |

| <b>Damage Extent</b> | - Medium Damage: Significant breakage | <b>Friability</b> | - Low |

| <b>Comments</b> | A sample of the material was analysed and found to contain asbestos. Some columns were seen to have sustained damage and the asbestos material was exposed to the elements. | | |

| <b>Recommendations</b> | The damaged columns should be repaired and the exposed asbestos material encapsulated or effectively enclosed at the earliest opportunity. | | |

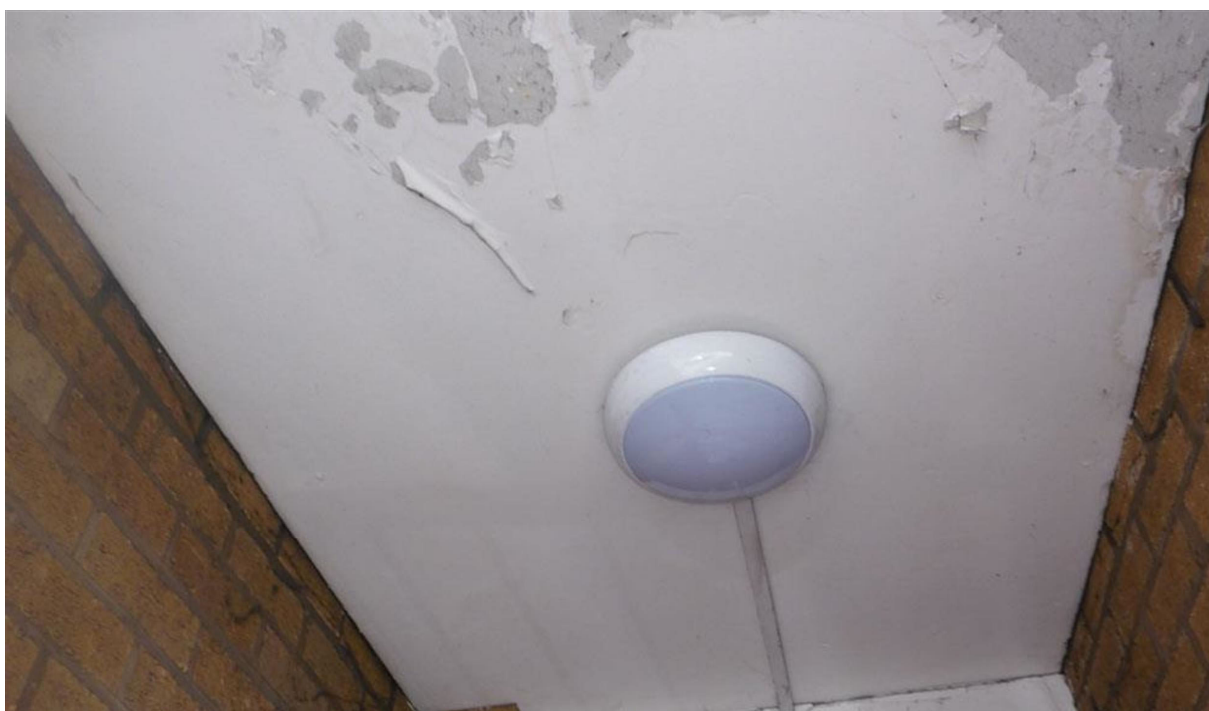
- Approximately 4 Sq. m of asbestos insulation board was identified to the ceiling of the Exit and Store, at the rear of Unit 10. The material was seen to be in need of remediation and encapsulation, which should be undertaken at the earliest opportunity. Following which, the material should be managed and reinspected on an annual basis. (S# 03)

| <b>Position Description</b> | Asbestos insulation board to the ceiling of the Exit and Store at the rear of Unit 10 | | |

| <b>Position</b> | - External | <b>Damage Risk</b> | - Medium |
| <b>Asbestos Type</b> | - Amosite Chrysotile | <b>Action</b> | - Repair/encapsulate |

| <b>Damage Extent</b> | - Medium Damage: Significant breakage | <b>Friability</b> | - Low |

| <b>Comments</b> | A sample of the material was analysed and found to contain asbestos. The material was found to be in poor condition. | | |

| <b>Recommendations</b> | The material should be effectively encapsulated at the earliest opportunity. The material should then be labelled, managed and re-inspected on an annual basis. | | |

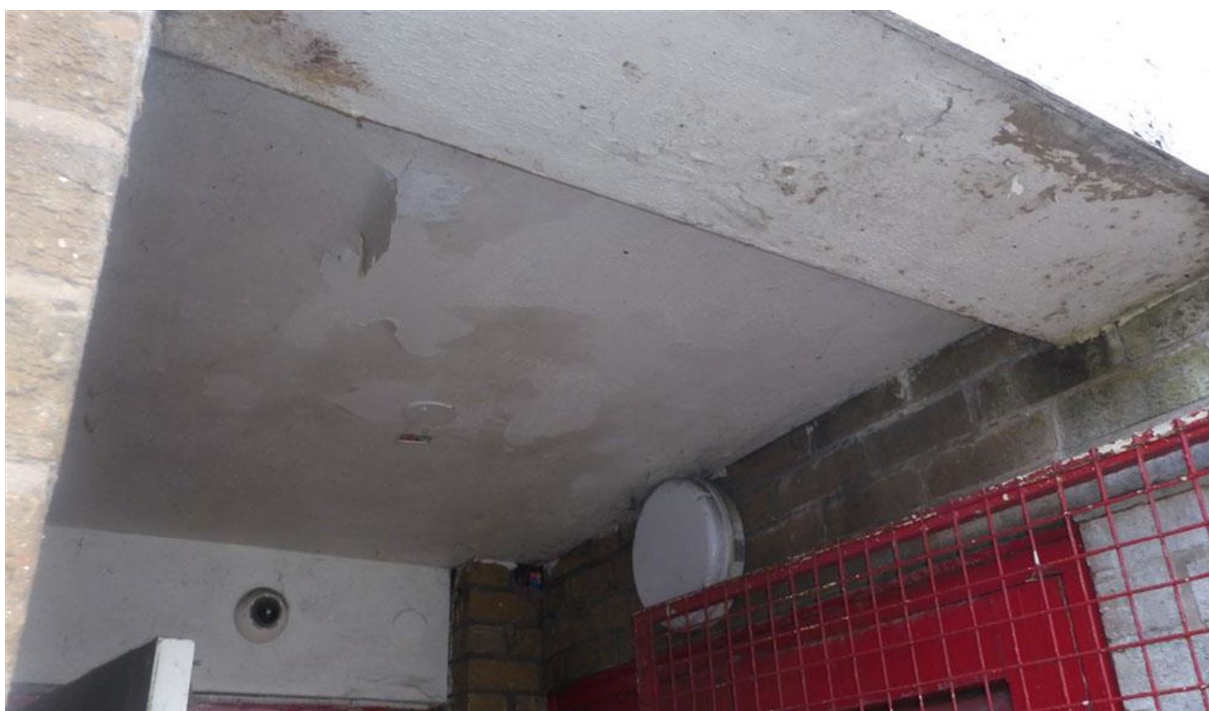
- Approximately 4 Sq. m of asbestos insulation board was identified to the ceiling of the Exit and Store, at the rear of Unit 12. The material was seen to be in need of remediation and encapsulation, which should be undertaken at the earliest opportunity. Following which, the material should be managed and reinspected on an annual basis. (As S# 03)

| <b>Position Description</b> | Asbestos insulation board to the ceiling of the Exit and Store at the rear of Unit 12 | | |

| <b>Position</b> | - External | <b>Damage Risk</b> | - Medium |
| <b>Asbestos Type</b> | - Amosite Chrysotile | <b>Action</b> | - Repair/encapsulate |

| <b>Damage Extent</b> | - Medium Damage: Significant breakage | <b>Friability</b> | - Low |

| <b>Comments</b> | A sample of the material was analysed and found to contain asbestos. The material was found to be in poor condition. | | |

| <b>Recommendations</b> | The material should be effectively encapsulated at the earliest opportunity. The material should then be labelled, managed and re-inspected on an annual basis. | | |

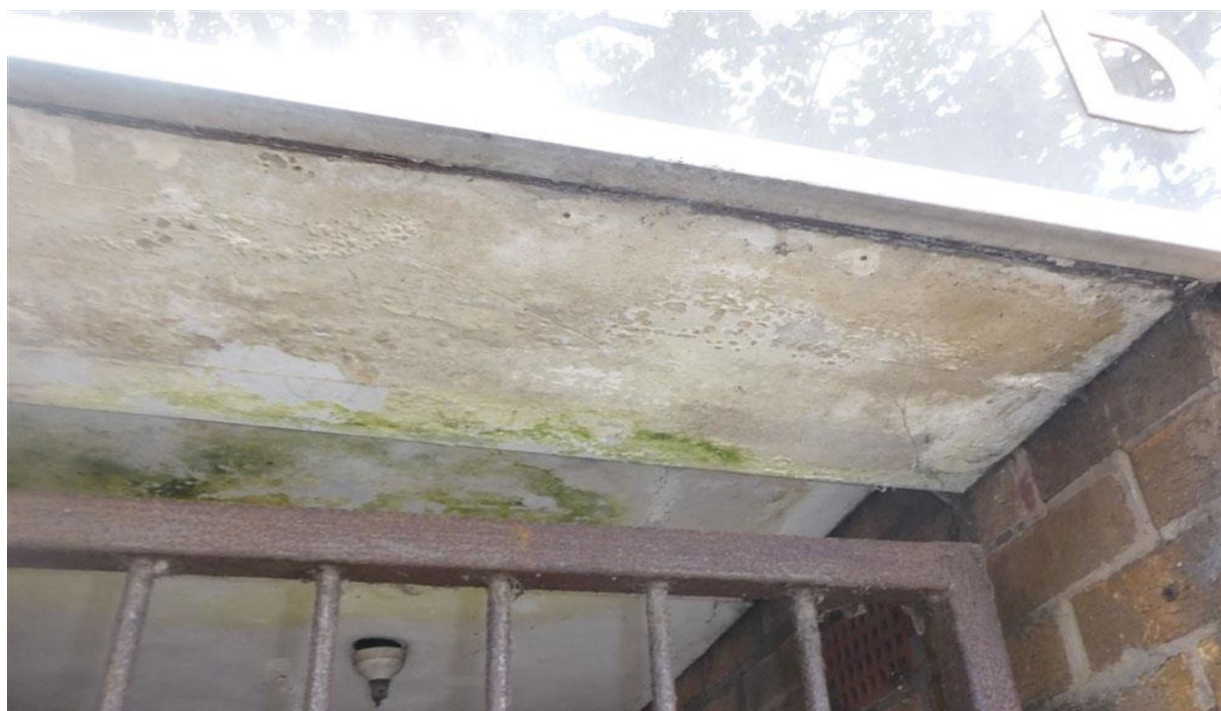
- Approximately 4 Sq. m of asbestos insulation board was identified to the ceiling of the Exit and Store, at the rear of Unit 14. The material was seen to be in need of remediation and encapsulation, which should be undertaken at the earliest opportunity. Following which, the material should be managed and reinspected on an annual basis. (As S# 03)

| <b>Position Description</b> | Asbestos insulation board to the ceiling of the Exit and Store at the rear of Unit 14 | | |

| <b>Position</b> | - External | <b>Damage Risk</b> | - Medium |
| <b>Asbestos Type</b> | - Amosite Chrysotile | <b>Action</b> | - Repair/encapsulate |

| <b>Damage Extent</b> | - Medium Damage: Significant breakage | <b>Friability</b> | - Low |

| <b>Comments</b> | A sample of the material was analysed and found to contain asbestos. The material was found to be in poor condition. | | |

| <b>Recommendations</b> | The material should be effectively encapsulated at the earliest opportunity. The material should then be labelled, managed and re-inspected on an annual basis. | | |

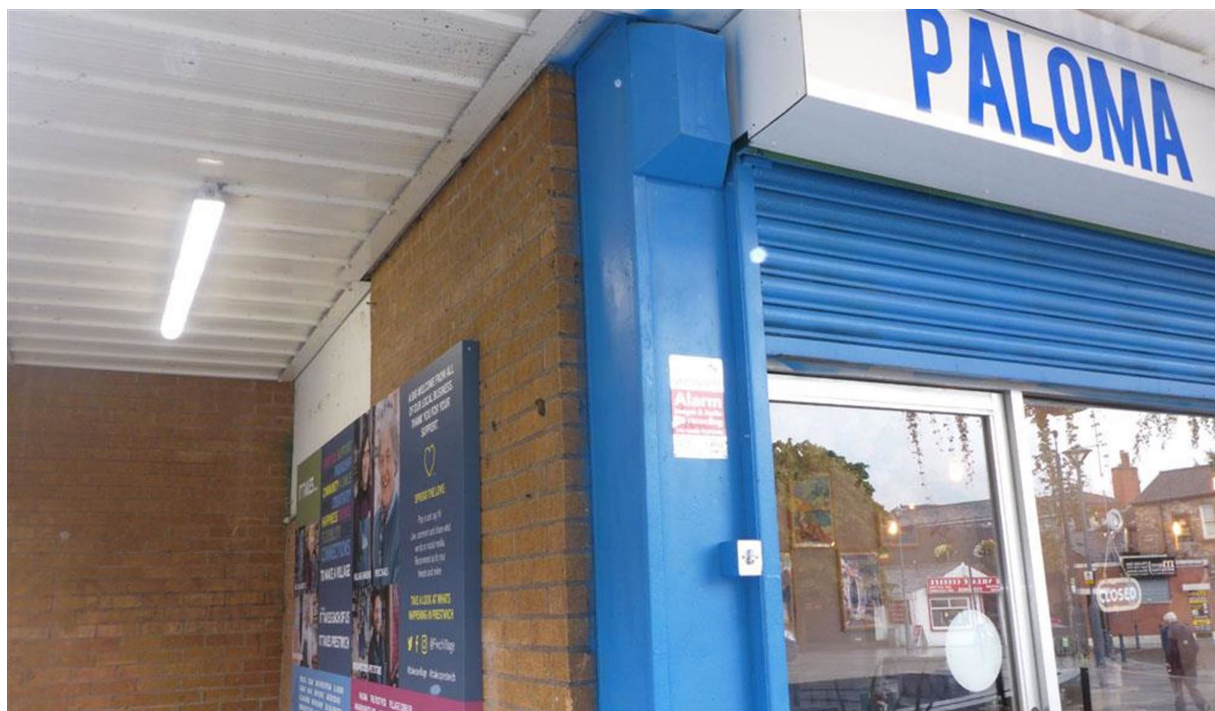
| <b>Position Description</b> | Known and / or presumed asbestos insulation board linings to the metal-clad columns to the shop front | | |

| <b>Position</b> | - External | <b>Damage Risk</b> | - Low |

| <b>Damage Extent</b> | - Low Damage: Scratches, breaks or surface | <b>Friability</b> | - Low |

| <b>Recommendations</b> | - The material should be labelled, managed and re-inspected on an annual basis. | | |

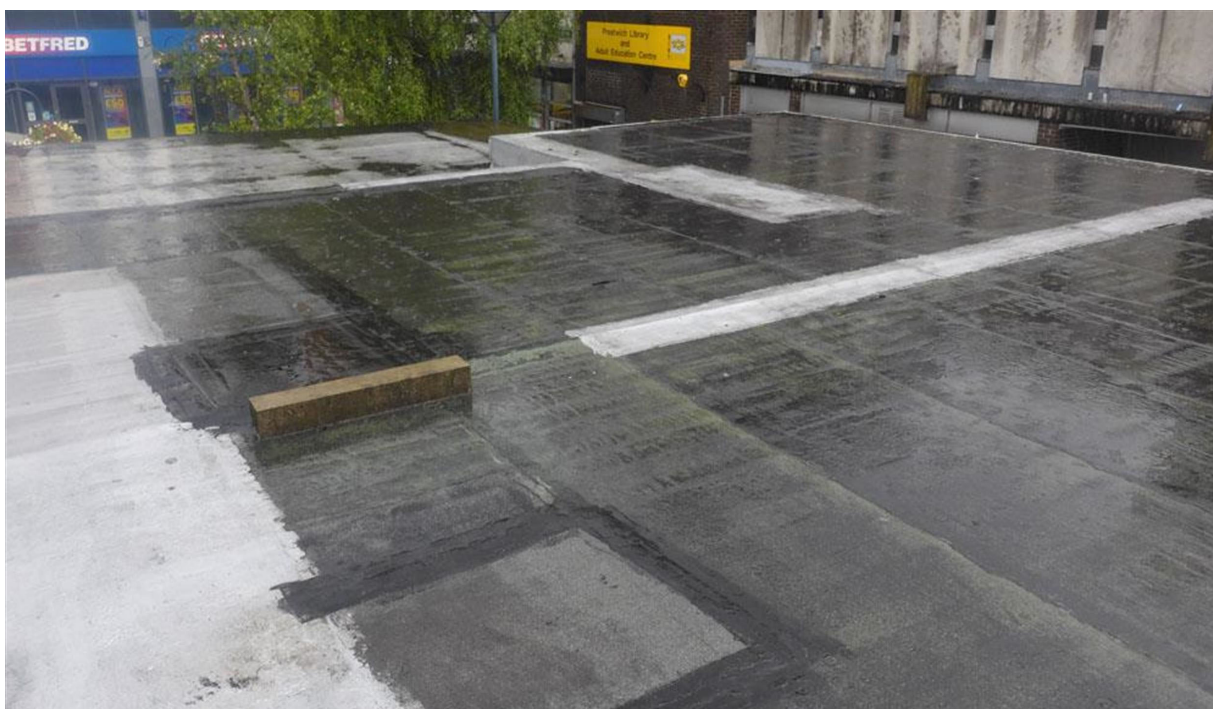
- A non-asbestos bitumen / felt sheeting was identified to the external flat roof of Block C. No further action is required for this material, it is mentioned for identification purposes only. (S# 01)

| <b>Position Description</b> | Non-asbestos bitumen / felt sheeting to the external flat roof of Block C | | |

| <b>Comments</b> | The material was sampled and found to be negative for the presence of asbestos. | | |

| <b>Recommendations</b> | No further action is required for this material, it is mentioned for identification purposes only. | | |
