**Lead Surveyor:** Doug Burgess  
**Assistant Surveyor(s):** N/A  
**Date of Survey(s):** 13th December 2022  
**Report Reference:** CH.22.12.227.LW  
**Date Report Issued:** 6<sup>th</sup> January 2023  
**Purpose of Survey:**  
(Refer to Section 2.2  
of this report for  
clarification)

## Report on Survey of Asbestos Materials at

**13 Blackburn Street  
Radcliffe  
Greater Manchester  
M26 1NN**

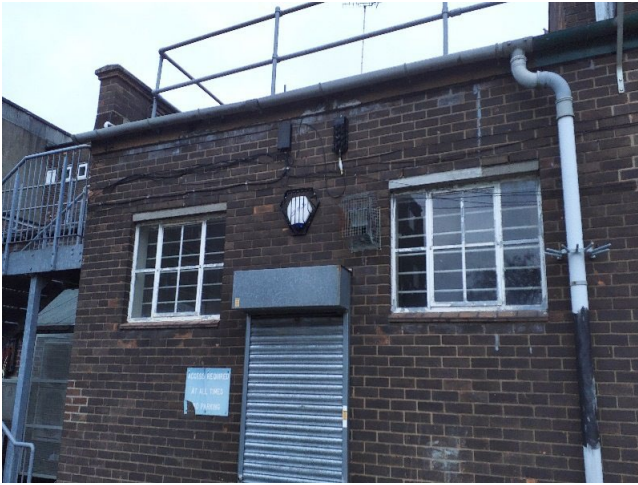
Sample No: 22/12/B/13/DAB12  
External  
Below windowsill and frames  
Bitumen vapor barrier  
**No Asbestos Detected**

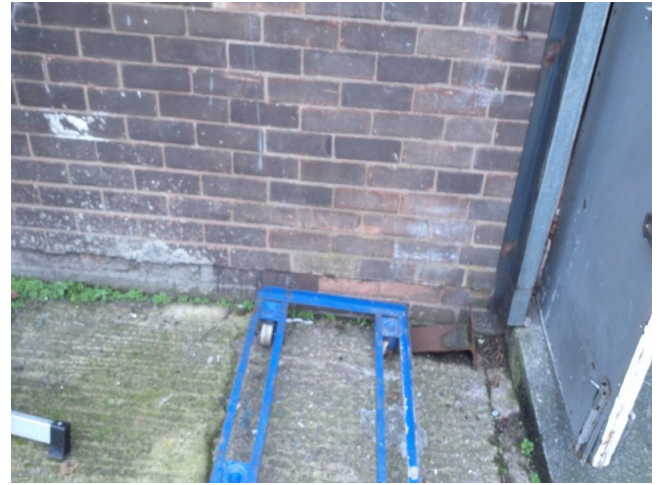
Sample No: 22/12/B/13/DAB13  
External  
Damp proof course  
Bitumen Layer  
**No Asbestos Detected**

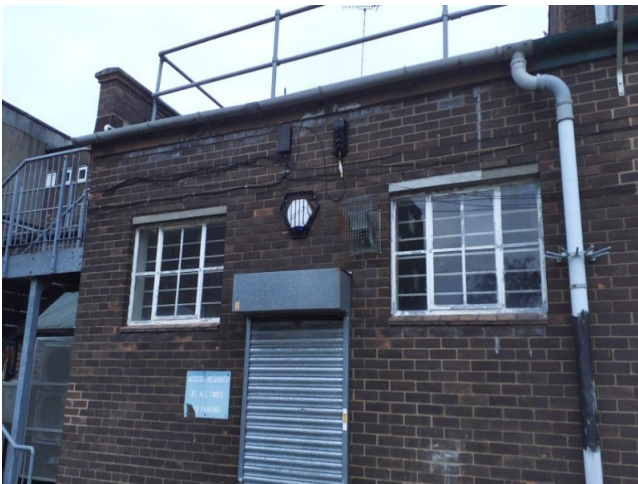
Sample No: Refer to Sample 22/12/B/13/DAB12  
External  
Below windowsill and frames  
Bitumen vapor barrier  
**No Asbestos Detected**

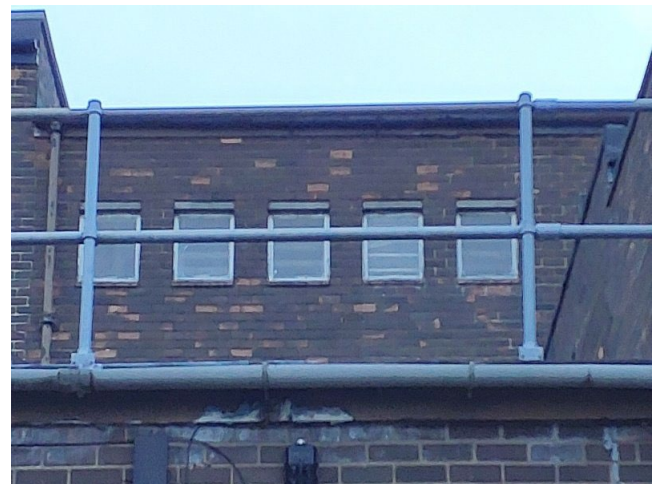
Sample No: Refer to Sample 22/12/B/13/DAB12  
External  
Below windowsill and frames  
Bitumen vapor barrier  
**No Asbestos Detected**

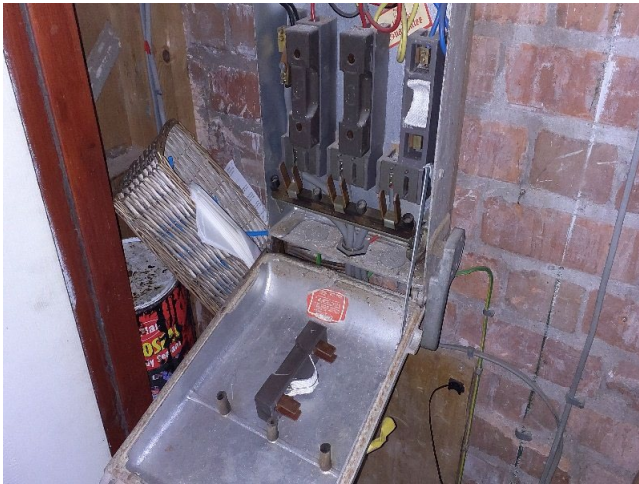
| Sample Number | Location | ACM Type | Material Risk Score | Recommendation |
|---|---|---|---|---|
| 22/12/B/13/DAB1 | G.03 - Electrical cupboard - Electrical fuse box | Woven flash guards | 5 | Remove |

Sample No: 22/12/B/13/DAB1  
G.03 Electrical cupboard  
Electrical fuse box  
Woven flash guards containing:  
**Chrysotile**

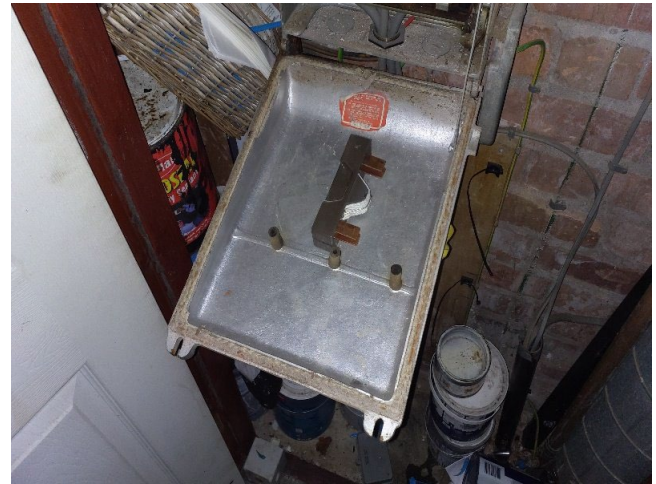
Sample No: 22/12/B/13/DAB2  
G.03 Electrical cupboard  
Electrical fuse box  
Rope seal  
**No Asbestos Detected**

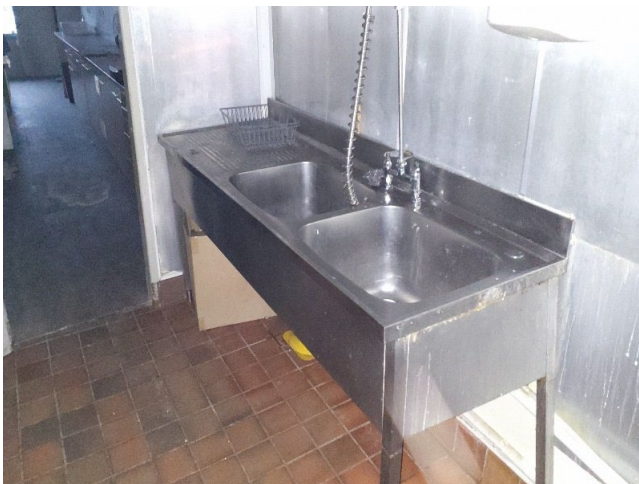
Sample No: 22/12/B/13/DAB3  
G.04 Food preparation room  
Sink  
Sink pad  
**No Asbestos Detected**

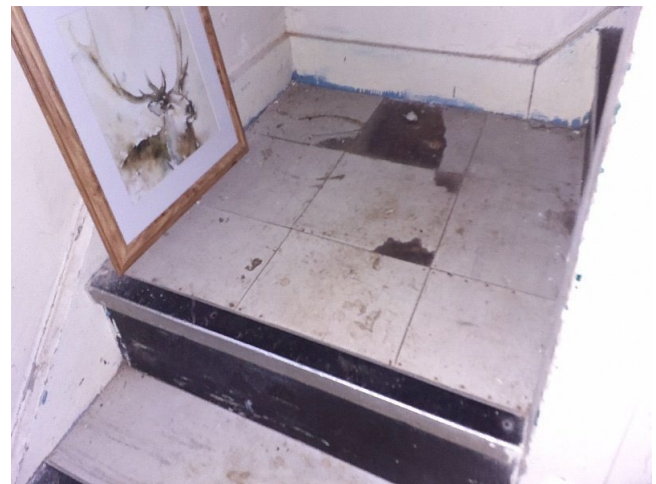
Sample No: 22/12/B/13/DAB4  
G.07 Stairwell  
Stairs  
Vinyl floor tiles  
**No Asbestos Detected**

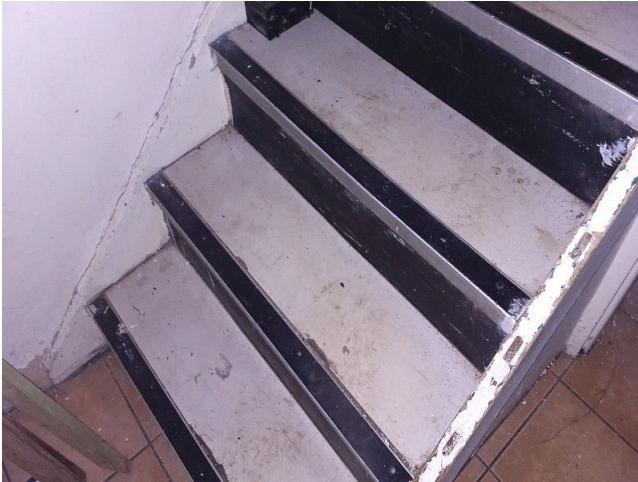
| Sample Number | Location | ACM Type | Material Risk Score | Recommendation |
|---|---|---|---|---|
| 22/12/B/13/DAB5 | G.07 - Stairwell - Stairs | Nose edging | 3 | Remove |

Sample No: 22/12/B/13/DAB5  
G.07 Stairwell  
Stairs  
Nose edging containing:  
**Chrysotile**

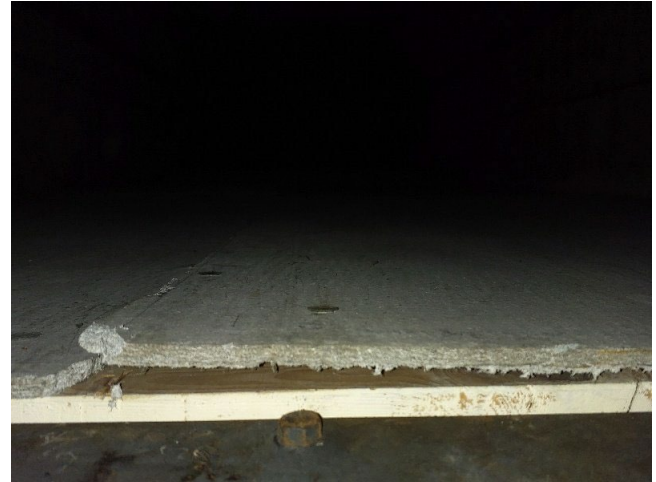
| Sample Number | Location | ACM Type | Material Risk Score | Recommendation |
|---|---|---|---|---|
| 22/12/B/13/DAB6 | G.08 - Lift - Internal Wall | Asbestos Cement | 4 | Remove |

Sample No: 22/12/B/13/DAB6  
G.08 Lift  
Internal Wall  
Asbestos Cement containing:  
**Chrysotile**

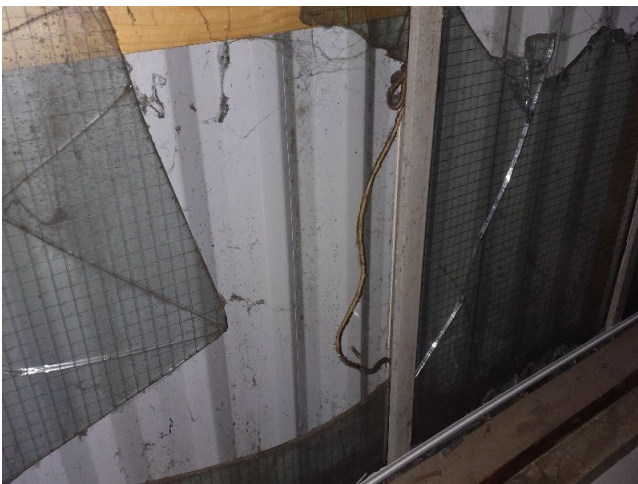
| Sample Number | Location | ACM Type | Material Risk Score | Recommendation |
|---|---|---|---|---|
| 22/12/B/13/DAB7 | 1.01 - Stairwell - Windows | Rope seal | 7 | Remove |

Sample No: 22/12/B/13/DAB7  
1.01 Stairwell  
Windows  
Rope seal containing:  
**Chrysotile**

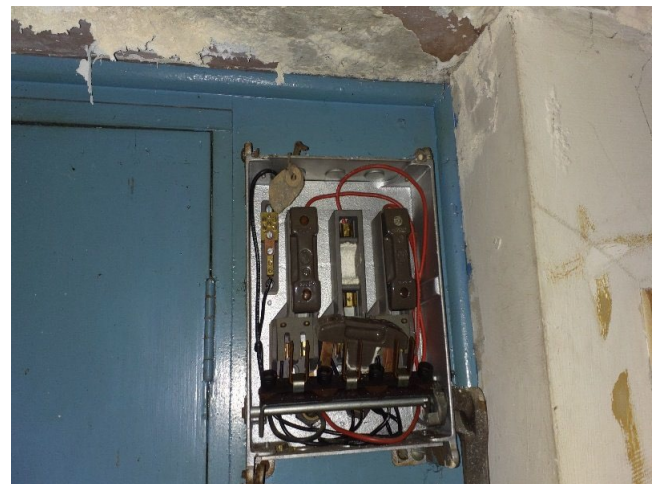
| Sample Number | Location | ACM Type | Material Risk Score | Recommendation |
|---|---|---|---|---|
| Refer to Sample 22/12/B/13/DAB1 | 1.01 - Stairwell - Electrical fuse box | Woven flash guards | 5 | Remove |

Sample No: Refer to Sample 22/12/B/13/DAB1  
1.01 Stairwell  
Electrical fuse box  
Woven flash guards containing:  
**Chrysotile**

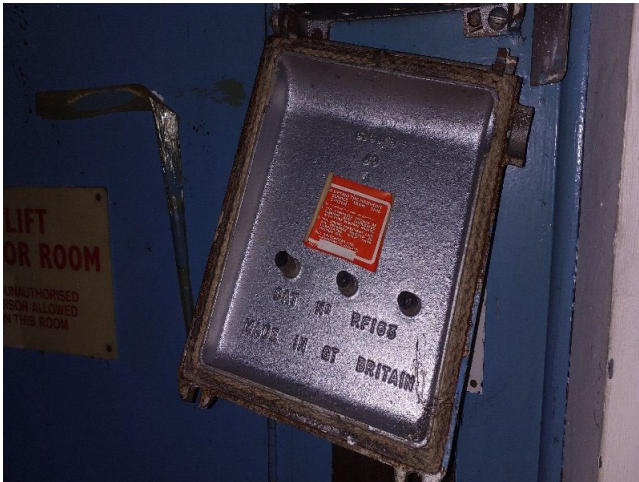
Sample No: Refer to Sample 22/12/B/13/DAB2  
1.01 Stairwell  
Electrical fuse box  
Rope seal  
**No Asbestos Detected**

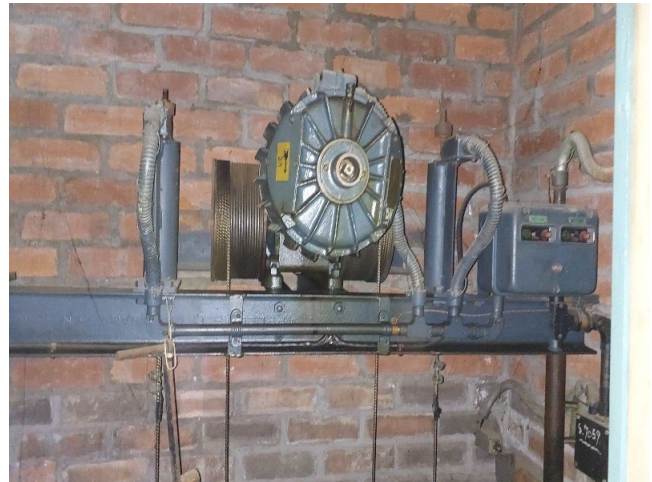
| Sample Number | Location | ACM Type | Material Risk Score | Recommendation |
|---|---|---|---|---|
| No Sample | 1.02 - Lift - Lift | Brake pads | 5 | Remove |

Sample No: No Sample  
1.02 Lift  
Lift  
Brake pads containing:  
**Chrysotile**

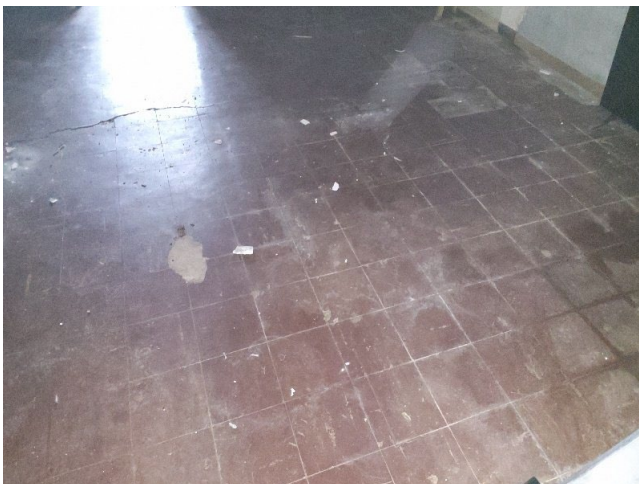
| Sample Number | Location | ACM Type | Material Risk Score | Recommendation |
|---|---|---|---|---|
| 22/12/B/13/DAB8 | 1.03 - Store room - Floor | Vinyl floor tiles | 3 | Remove |

Sample No: 22/12/B/13/DAB8  
1.03 Store room  
Floor  
Vinyl floor tiles containing:  
**Chrysotile (In both tile and bitumen)**

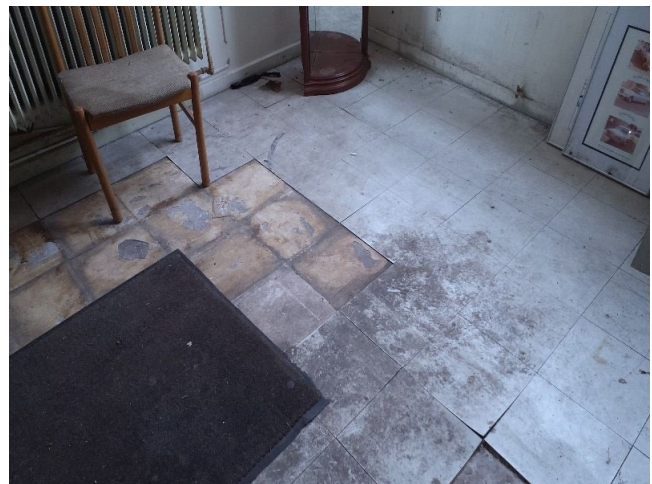
Sample No: 22/12/B/13/DAB9  
1.04 Kitchen  
Floor  
Vinyl floor tiles  
**No Asbestos Detected**

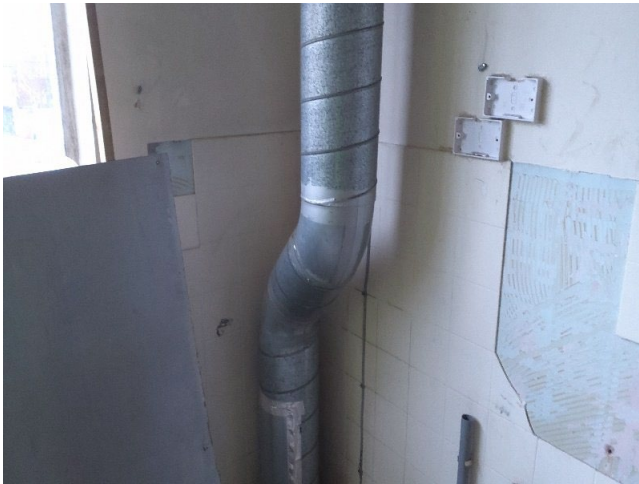
Sample No: 22/12/B/13/DAB10  
1.04 Kitchen  
Flue  
Putty to metal flue  
**No Asbestos Detected**

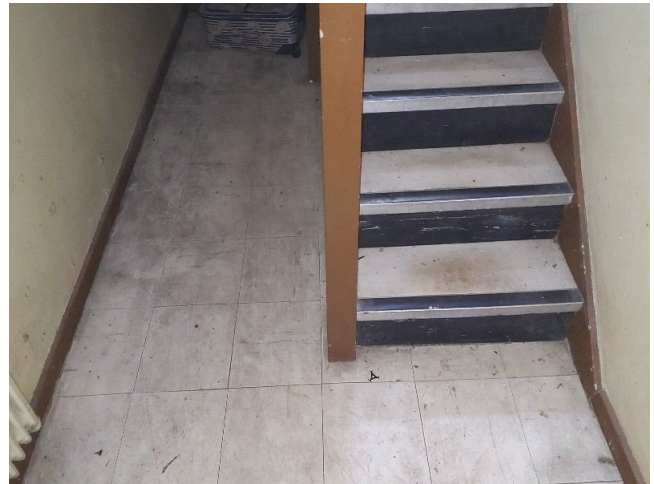
Sample No: Refer to Sample 22/12/B/13/DAB9  
1.05 Stairwell  
Floor  
Vinyl floor tiles  
**No Asbestos Detected**

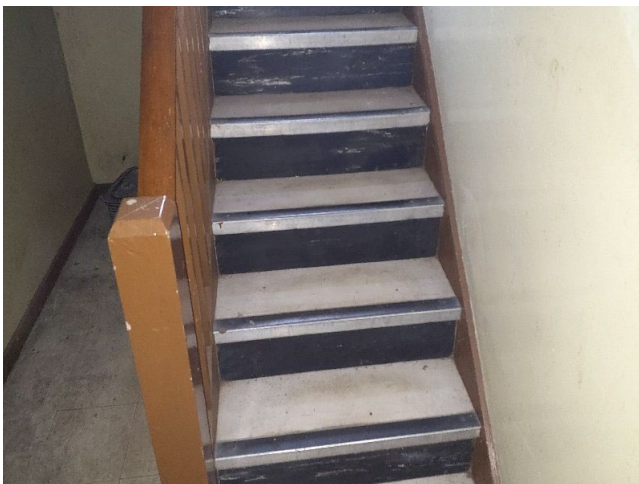
| Sample Number | Location | ACM Type | Material Risk Score | Recommendation |
|---|---|---|---|---|
| Refer to Sample 22/12/B/13/DAB5 | 1.05 - Stairwell - Stairs | Nose edging | 3 | Remove |

Sample No: Refer to Sample 22/12/B/13/DAB5  
1.05 Stairwell  
Stairs  
Nose edging containing:  
**Chrysotile**

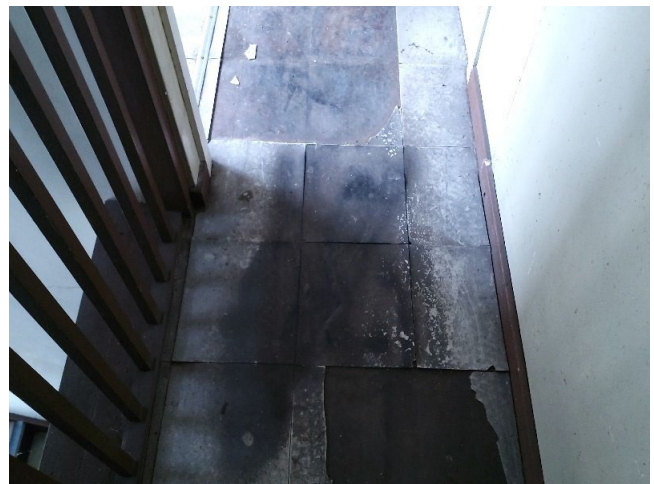
Sample No: Refer to Sample 22/12/B/13/DAB9  
2.01 Landing  
Floor  
Vinyl floor tiles  
**No Asbestos Detected**

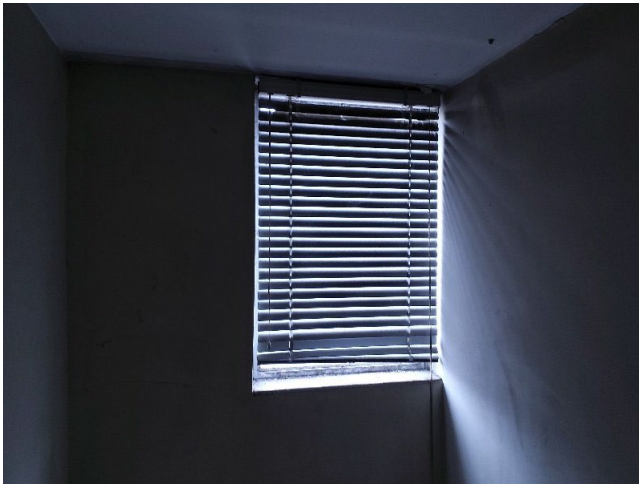
| Sample Number | Location | ACM Type | Material Risk Score | Recommendation |
|---|---|---|---|---|
| Refer to Sample 22/12/B/13/DAB7 | 2.01 - Landing - Windows | Rope seal | 7 | Remove |

Sample No: Refer to Sample 22/12/B/13/DAB7  
2.01 Landing  
Windows  
Rope seal containing:  
**Chrysotile**

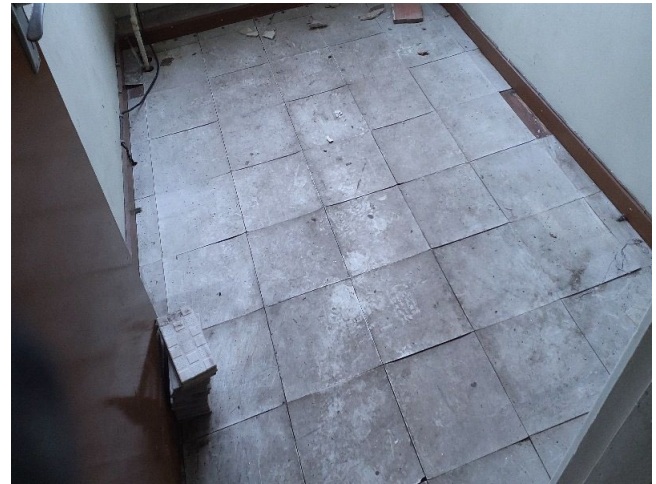
Sample No: Refer to Sample 22/12/B/13/DAB9  
2.02 Store  
Floor  
Vinyl floor tiles  
**No Asbestos Detected**

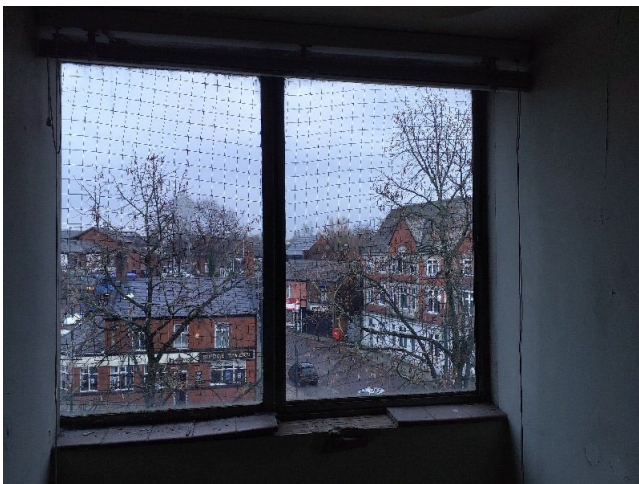
| Sample Number | Location | ACM Type | Material Risk Score | Recommendation |
|---|---|---|---|---|
| Refer to Sample 22/12/B/13/DAB7 | 2.02 - Store - Windows | Rope seal | 7 | Remove |

Sample No: Refer to Sample 22/12/B/13/DAB7  
2.02 Store  
Windows  
Rope seal containing:  
**Chrysotile**

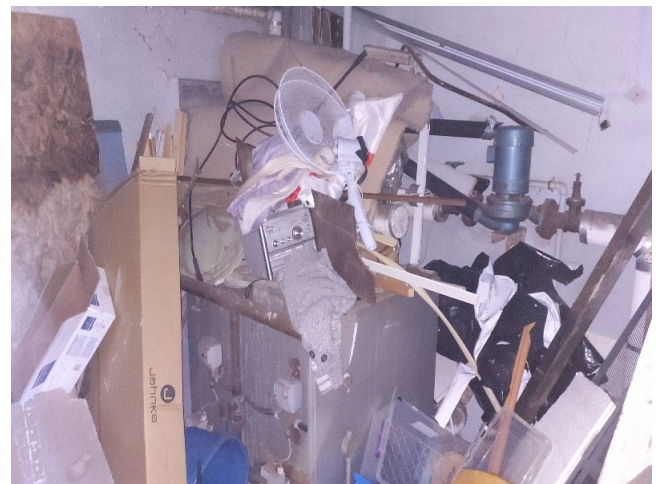
| Sample Number | Location | ACM Type | Material Risk Score | Recommendation |
|---|---|---|---|---|
| No Sample | 2.03 - Boiler room - Boiler and associated pipework | Gaskets | 7 | Remove |

Sample No: No Sample  
2.03 Boiler room  
Boiler and associated pipework  
Gaskets containing:  
**Crocidolite**

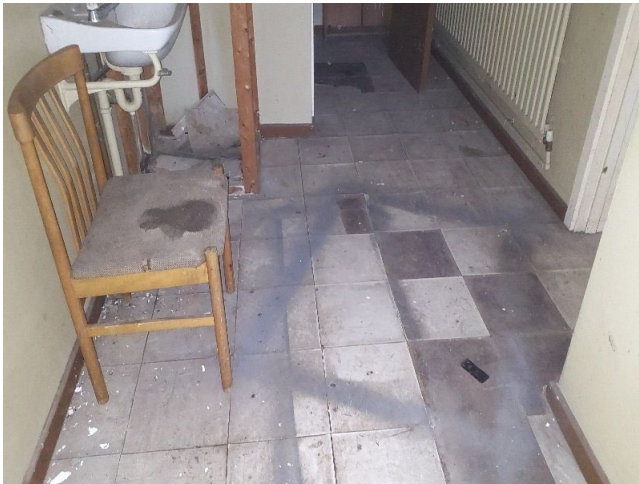
Sample No: Refer to Sample 22/12/B/13/DAB9  
2.04 Store Room  
Floor  
Vinyl floor tiles  
**No Asbestos Detected**

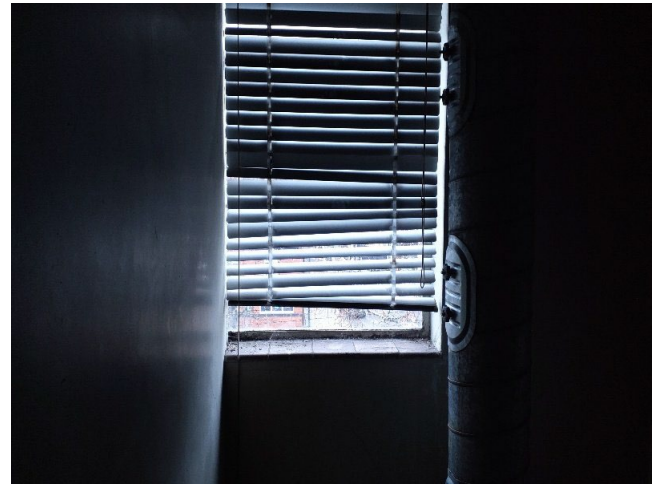
| Sample Number | Location | ACM Type | Material Risk Score | Recommendation |
|---|---|---|---|---|
| Refer to Sample 22/12/B/13/DAB7 | 2.04 - Store Room - Windows | Rope seal | 7 | Remove |

Sample No: Refer to Sample 22/12/B/13/DAB7  
2.04 Store Room  
Windows  
Rope seal containing:  
**Chrysotile**

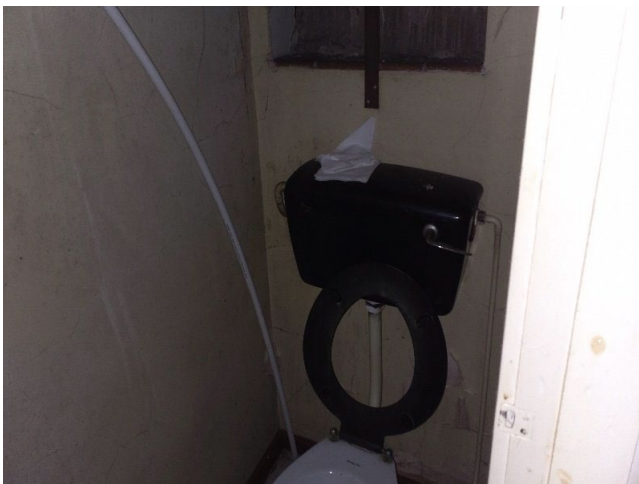
| Sample Number | Location | ACM Type | Material Risk Score | Recommendation |
|---|---|---|---|---|
| 22/12/B/13/DAB11 | 2.05 - Toilet - Toilet cistern | Thermoplastic | 4 | Remove |

Sample No: 22/12/B/13/DAB11  
2.05 Toilet  
Toilet cistern  
Thermoplastic containing:  
**Amosite**

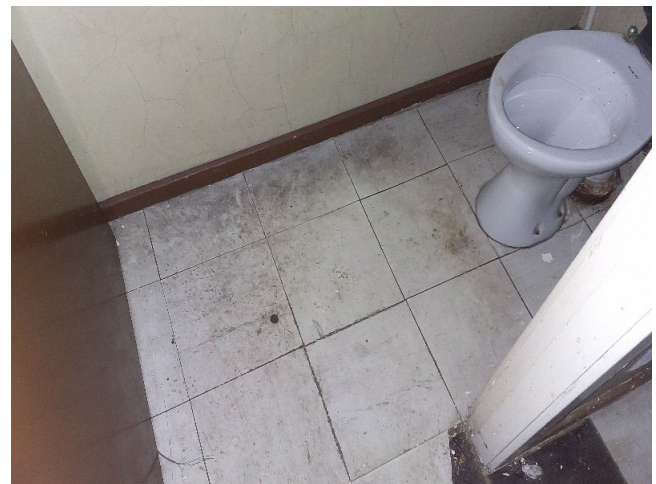
Sample No: Refer to Sample 22/12/B/13/DAB9  
2.05 Toilet  
Floor  
Vinyl floor tiles  
**No Asbestos Detected**
