<table><tr><td><b>Management</b></td><td></td></tr><tr><td><b>Demolition</b></td><td>X</td></tr></table>

**Report on Survey of Asbestos Materials**  
**at**  
**3**  
**Dale Street**  
**Radcliffe**  
**M26 1AB**

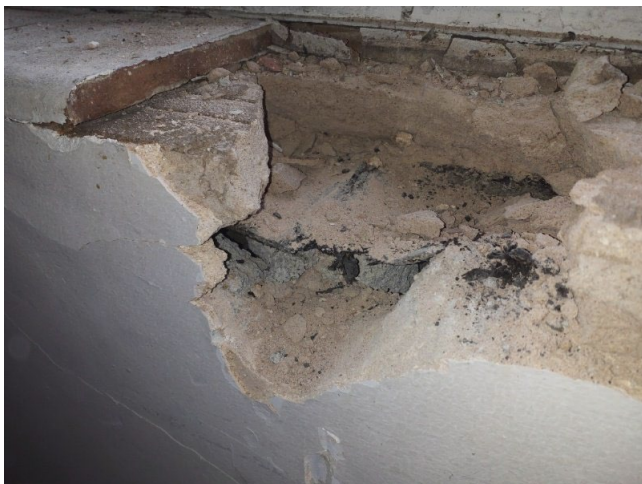
Sample No: 22/12/B/13/SAW3  
 External  
 Windows  
 Bitumen vapour barrier to wall cavities  
**No Asbestos Detected**

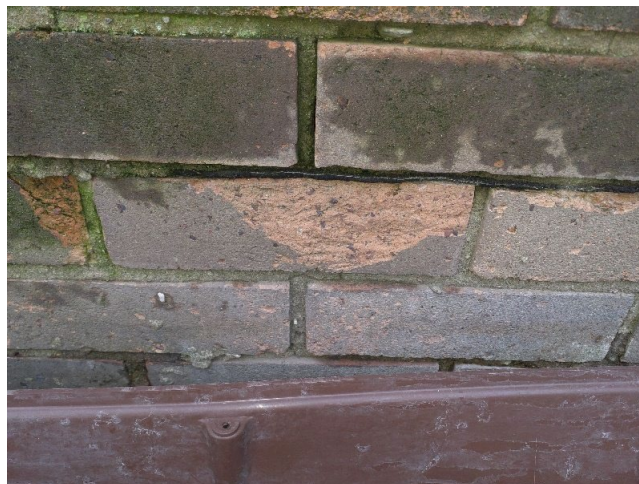
Sample No: 22/12/B/13/SAW4  
 External  
 Damp proof course  
 Bitumen Layer  
**No Asbestos Detected**

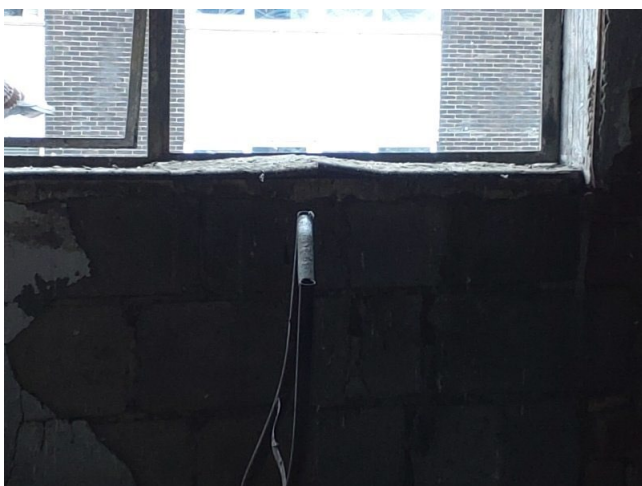
Sample No: Refer to Sample 22/12/B/13/SAW3  
 External  
 Windows  
 Bitumen vapour barrier to wall cavities  
**No Asbestos Detected**

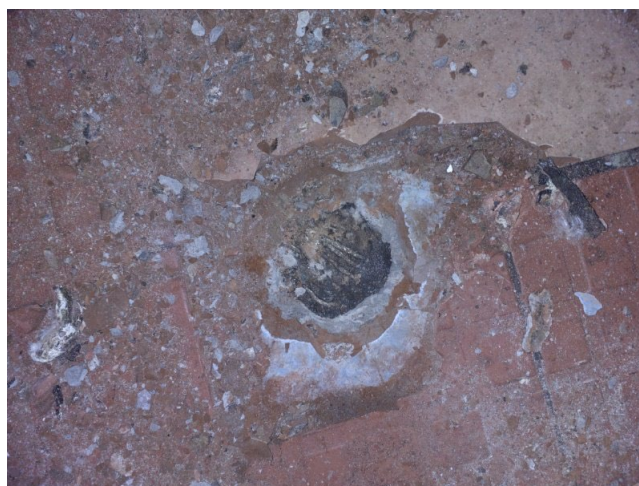
| Sample Number | Location | ACM Type | Material Risk Score | Recommendation |
|---|---|---|---|---|
| 22/12/B/13/SAW1 | G.01 - Shop area - Floor beneath screed | Bitumen residuals | 3 | Remove |

Sample No: 22/12/B/13/SAW1  
 G.01 Shop area  
 Floor beneath screed  
 Bitumen residuals containing:  
**Chrysotile**

| <b>Recommendation</b> | Fair<br>These materials should be removed and disposed of prior to demolition, by suitably trained and equipped personnel only, working under the guidance of a safe working procedure and in accordance with the requirements of The Control of Asbestos Regulations 2012 and The Hazardous Waste (England and Wales) Regulations 2005 (as amended in 2009). |

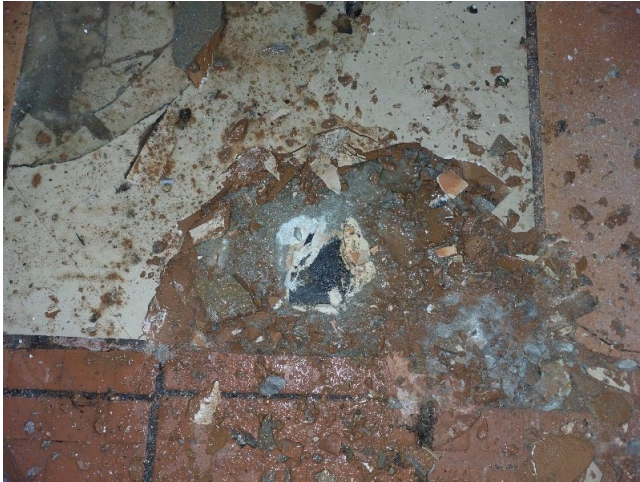
| Sample Number | Location | ACM Type | Material Risk Score | Recommendation |
|---|---|---|---|---|
| Refer to Sample 22/12/B/13/SAW1 | G.02 - Food prep area - Floor beneath screed | Bitumen residuals | 3 | Remove |

Sample No: Refer to Sample 22/12/B/13/SAW1  
G.02 Food prep area  
Floor beneath screed  
Bitumen residuals containing:  
**Chrysotile**

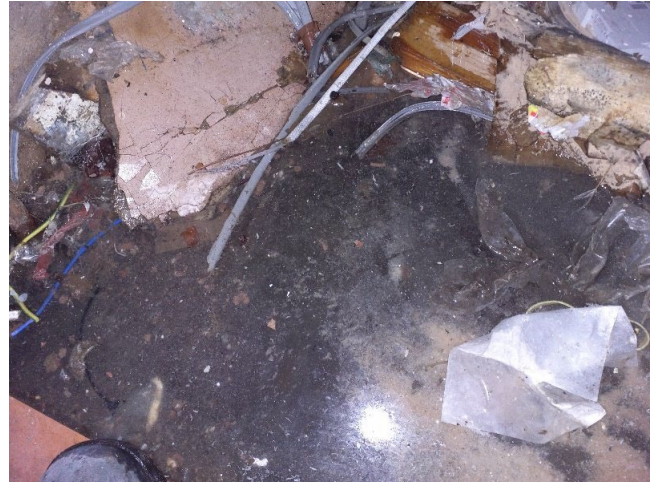
| Sample Number | Location | ACM Type | Material Risk Score | Recommendation |
|---|---|---|---|---|
| Refer to Sample 22/12/B/13/SAW1 | G.03 - Under stairs cupboard - Floor beneath screed | Bitumen residuals | 3 | Remove |

Sample No: Refer to Sample 22/12/B/13/SAW1  
G.03 Under stairs cupboard  
Floor beneath screed  
Bitumen residuals containing:  
**Chrysotile**

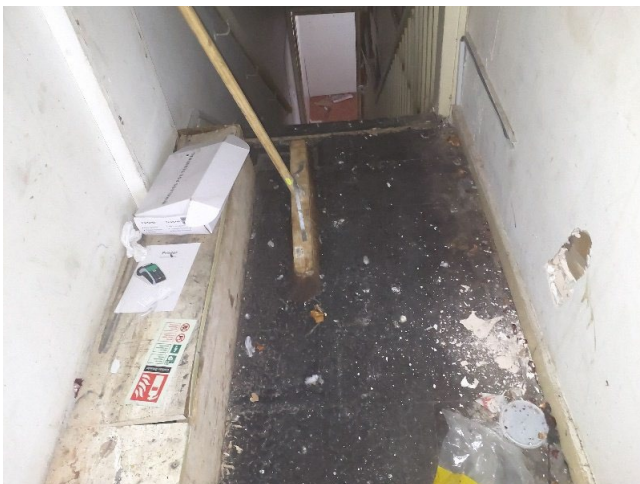
| Sample Number | Location | ACM Type | Material Risk Score | Recommendation |
|---|---|---|---|---|
| 22/12/B/13/SAW2 | 1.01 - Landing - Floor | Vinyl floor tiles with bitumen adhesive | 3 | Remove |

Sample No: 22/12/B/13/SAW2  
1.01 Landing  
Floor  
Vinyl floor tiles with bitumen adhesive containing:  
**Chrysotile (In both tile and bitumen)**

| <b>Recommendation</b> | Fair<br>These materials should be removed and disposed of prior to demolition, by suitably trained and equipped personnel only, working under the guidance of a safe working procedure and in accordance with the requirements of The Control of Asbestos Regulations 2012 and The Hazardous Waste (England and Wales) Regulations 2005 (as amended in 2009). |

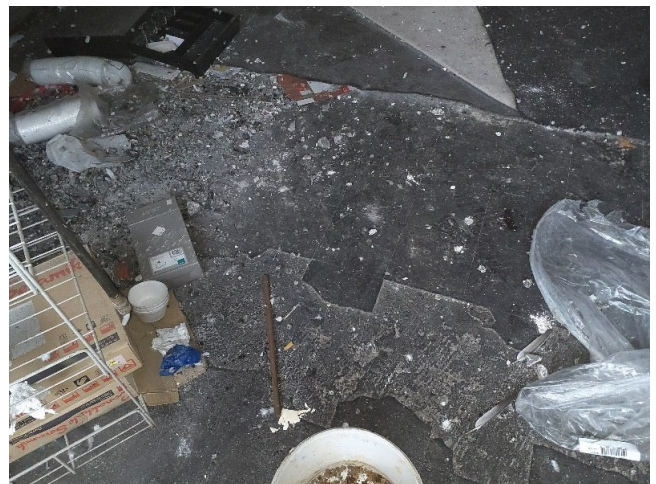
| Sample Number | Location | ACM Type | Material Risk Score | Recommendation |
|---|---|---|---|---|
| Refer to Sample 22/12/B/13/SAW2 | 1.02 - Storage area - Floor | Vinyl floor tiles with bitumen adhesive | 4 | Remove |

Sample No: Refer to Sample 22/12/B/13/SAW2  
1.02 Storage area  
Floor  
Vinyl floor tiles with bitumen adhesive containing:  
**Chrysotile (In both tile and bitumen)**

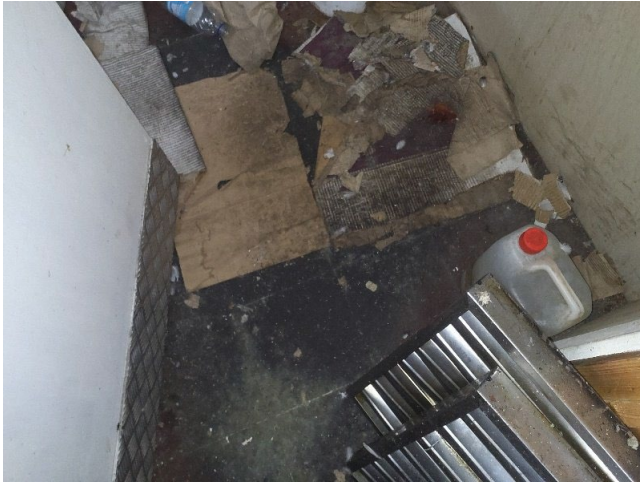
| Sample Number | Location | ACM Type | Material Risk Score | Recommendation |
|---|---|---|---|---|
| Refer to Sample 22/12/B/13/SAW2 | 1.03 - Toilet - Floor | Vinyl floor tiles with bitumen adhesive | 3 | Remove |

Sample No: Refer to Sample 22/12/B/13/SAW2  
1.03 Toilet  
Floor

Vinyl floor tiles with bitumen adhesive containing:  
**Chrysotile (In both tile and bitumen)**

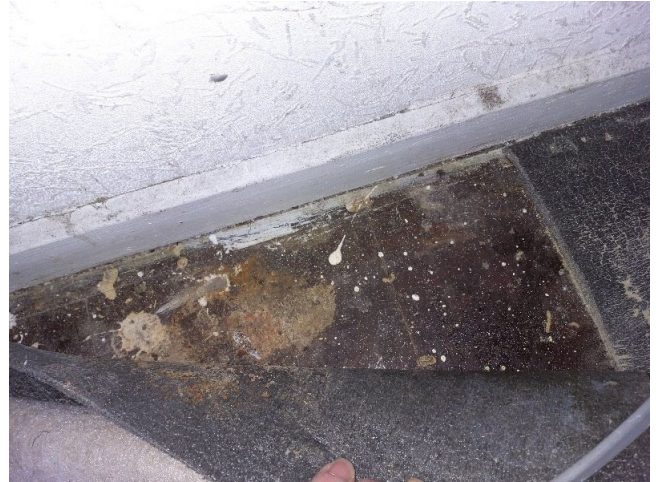
| Sample Number | Location | ACM Type | Material Risk Score | Recommendation |
|---|---|---|---|---|
| Refer to Sample 22/12/B/13/SAW2 | 1.04 - Circulation - Floor | Vinyl floor tiles with bitumen adhesive | 3 | Remove |

Sample No: Refer to Sample 22/12/B/13/SAW2  
1.04 Circulation  
Floor

Vinyl floor tiles with bitumen adhesive containing:  
**Chrysotile (In both tile and bitumen)**

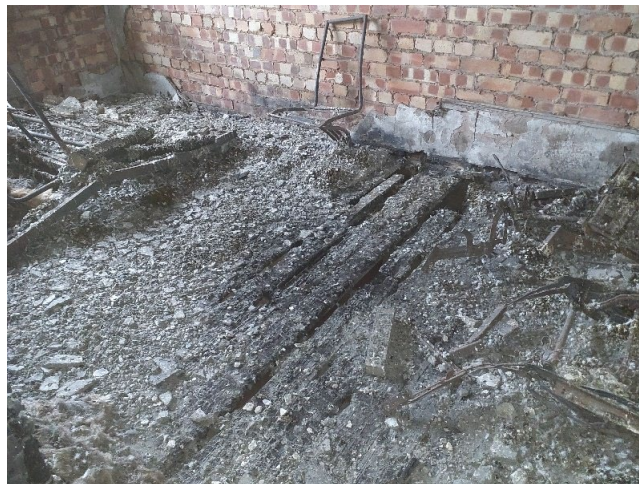
Fire damaged office 2.04
