**Lead Surveyor:** M. Crompton  
**Assistant Surveyor(s):** N/A  
**Date of Survey(s):** 13th December 2022  
**Report Reference:** CH.22.12.231.LW  
**Date Report Issued:** 6<sup>th</sup> January 2023  
**Purpose of Survey:**  
(Refer to Section 2.2  
of this report for  
clarification)

## Report on Survey of Asbestos Materials at

**1**  
**Dale Street**  
**Radcliffe**  
**M26 1AB**

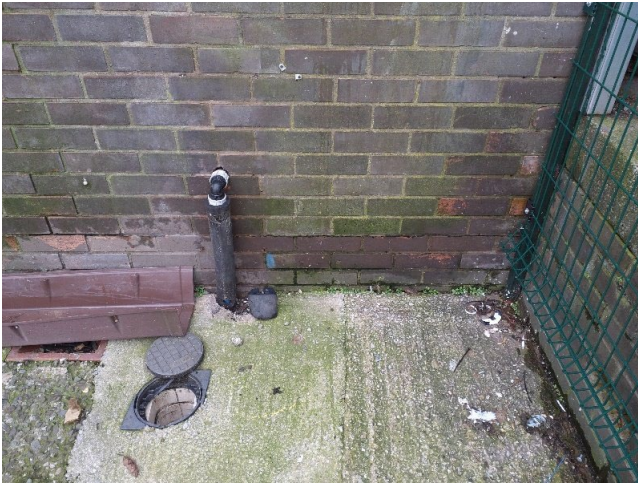
Sample No: 22/12/B/13/MAC3  
External  
Walls  
Bitumen DPC  
**No Asbestos Detected**

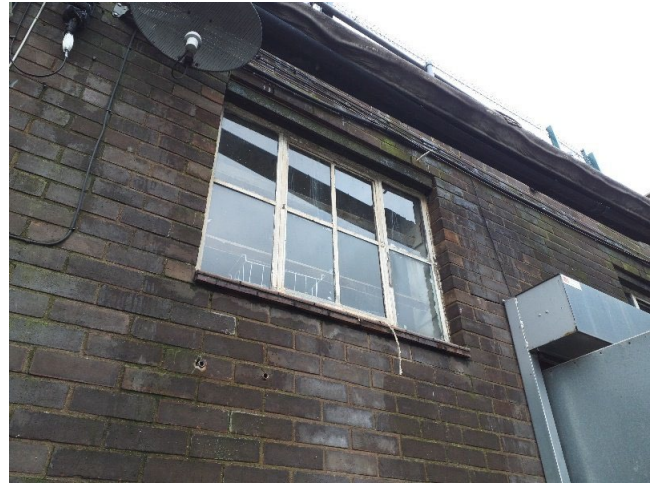
Sample No: 22/12/B/13/MAC4  
External  
Below window sills/frames  
Bitumen vapour barrier  
**No Asbestos Detected**

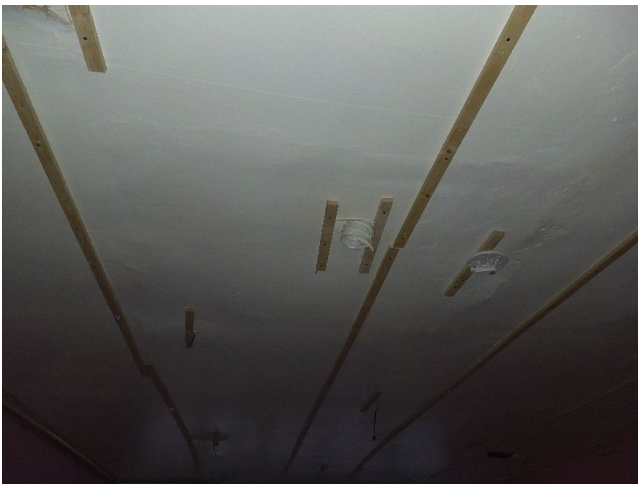
Sample No: 22/12/B/13/MAC1  
G.01 Shop front  
Ceiling  
Fibreboard  
**No Asbestos Detected**

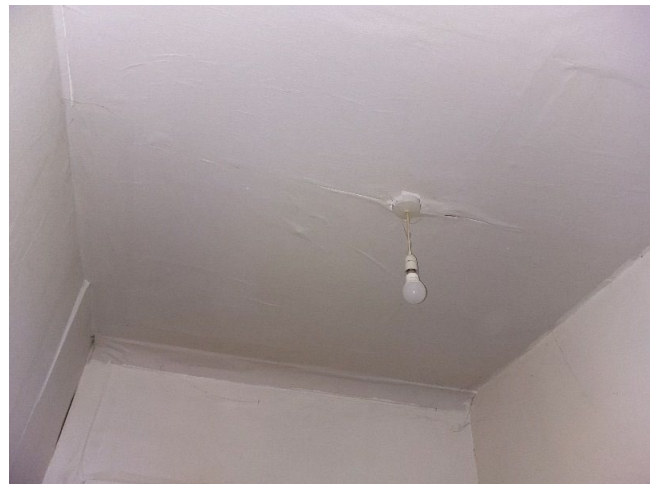
Sample No: Refer to Sample 22/12/B/13/MAC1  
G.02 Store room  
Ceiling  
Fibreboard  
**No Asbestos Detected**

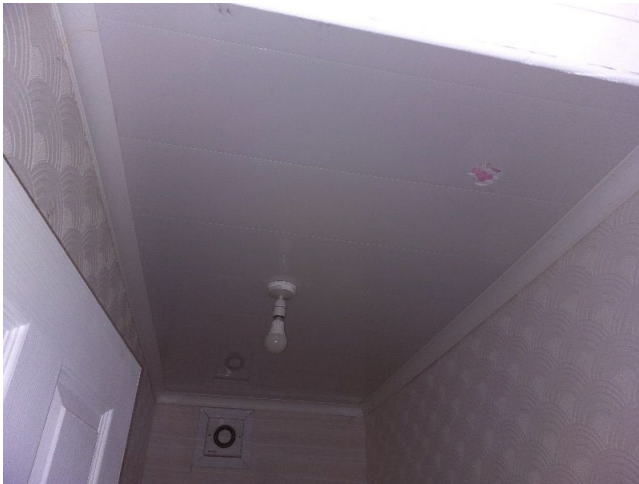
Sample No: Refer to Sample 22/12/B/13/MAC1  
G.03 Toilet  
Ceiling  
Fibreboard  
**No Asbestos Detected**

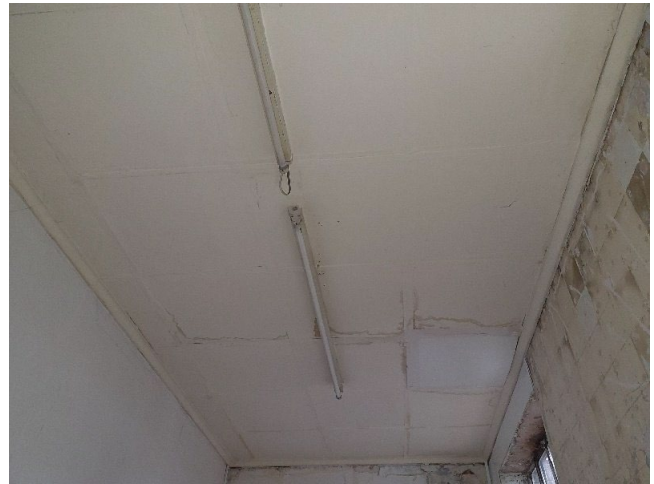
Sample No: Refer to Sample 22/12/B/13/MAC1  
G.06 Kitchen  
Ceiling  
Fibreboard  
**No Asbestos Detected**

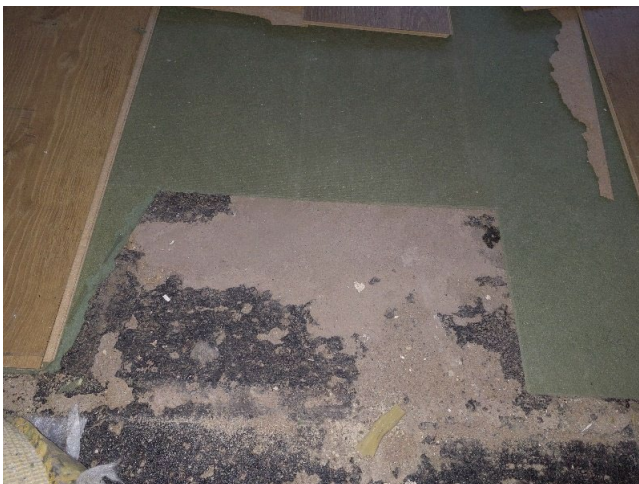
| Sample Number | Location | ACM Type | Material Risk Score | Recommendation |
|---|---|---|---|---|
| 22/12/B/13/MAC2 | 1.01 - Living room - Floor below laminate flooring | Residual bitumen adhesive | 3 | Remove |

Sample No: 22/12/B/13/MAC2  
1.01 Living room  
Floor below laminate flooring  
Residual bitumen adhesive containing:  
**Chrysotile**

| <b>Recommendation</b> | These materials should be removed and disposed of prior to demolition, by <u>suitably trained and equipped personnel only</u> , working under the guidance of a safe working procedure and in accordance with the requirements of The Control of Asbestos Regulations 2012 and The Hazardous Waste (England and Wales) Regulations 2005 (as amended in 2009). |

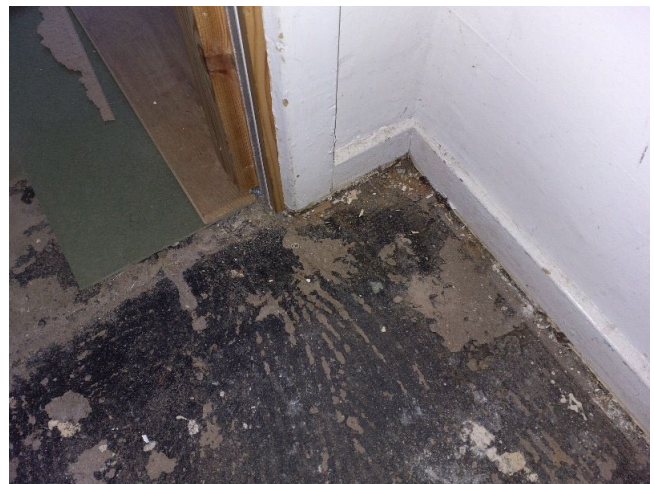
| Sample Number | Location | ACM Type | Material Risk Score | Recommendation |
|---|---|---|---|---|
| Refer to Sample 22/12/B/13/MAC2 | 1.02 - Landing - Floor below carpet | Residual bitumen adhesive | 3 | Remove |

Sample No: Refer to Sample 22/12/B/13/MAC2  
1.02 Landing  
Floor below carpet  
Residual bitumen adhesive containing:  
**Chrysotile**

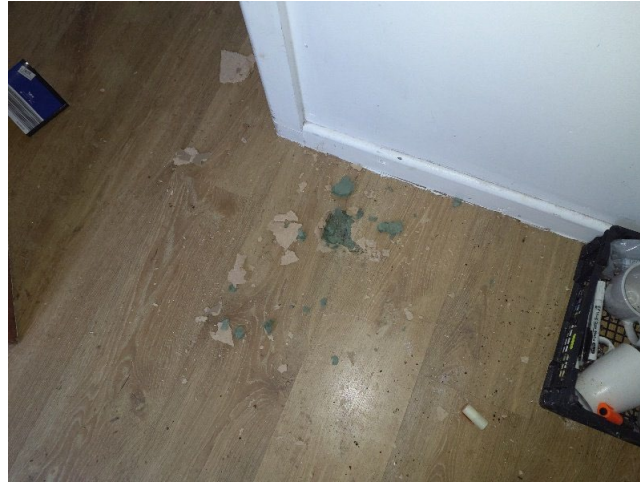
| Sample Number | Location | ACM Type | Material Risk Score | Recommendation |
|---|---|---|---|---|
| Refer to Sample 22/12/B/13/MAC2 | 1.03 - First floor entrance - Floor below laminate flooring | Residual bitumen adhesive | 3 | Remove |

Sample No: Refer to Sample 22/12/B/13/MAC2  
1.03 First floor entrance  
Floor below laminate flooring  
Residual bitumen adhesive containing:  
**Chrysotile**

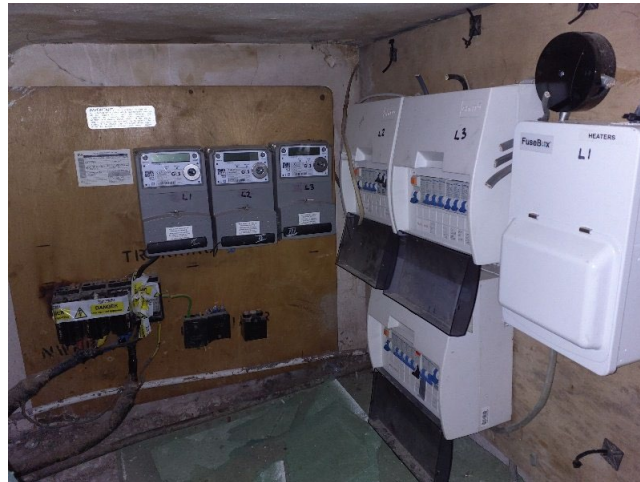
Modern electrics
