**Lead Surveyor:** J. Shirley  
**Assistant Surveyor(s):** P Keeling  
**Date of Survey(s):** 18th April 2023  
**Report Reference:** CH.23.4.244.LW  
**Date Report Issued:** 21 April 2023  
**Purpose of Survey:**  
(Refer to Section 2.2  
of this report for  
clarification)

**Report on Survey of Asbestos Materials  
at  
23  
Blackburn Street  
Radcliffe  
Bury  
M26 1AB**

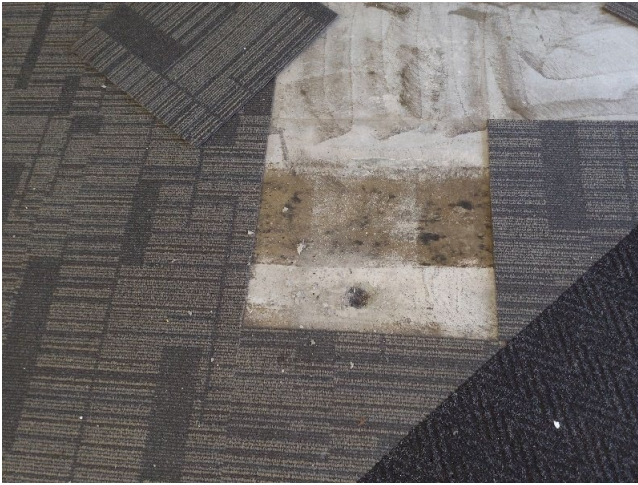
Sample No: 23/4/B/18/JPS1  
G.01 Retail Area  
Floor Area (Below Carpet & Screed)  
Asphalt & Bitumen Adhesive  
**No Asbestos Detected**

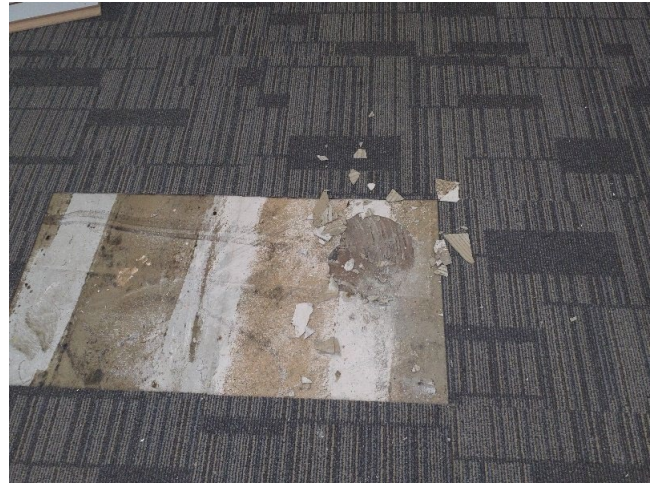
Sample No: 23/4/B/18/JPS2  
G.01 Retail Area  
Floor Area (Below Carpet & Screed)  
Floor Tiles and Bitumen Adhesive  
**No Asbestos Detected**

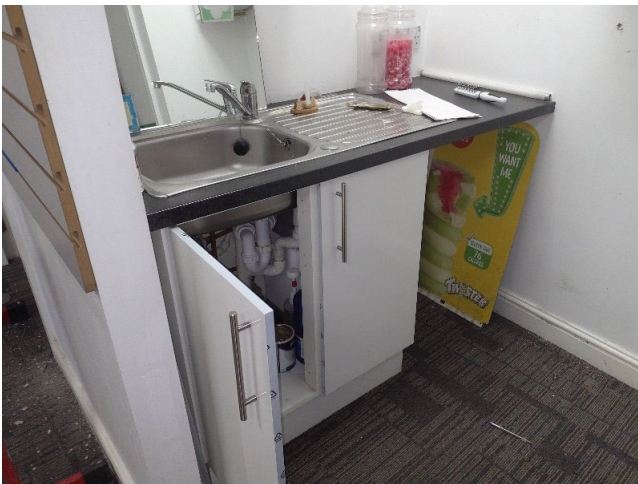
Sample No: 23/4/B/18/JPS3  
G.01 Retail Area  
Sink  
Bitumen Pad  
**No Asbestos Detected**

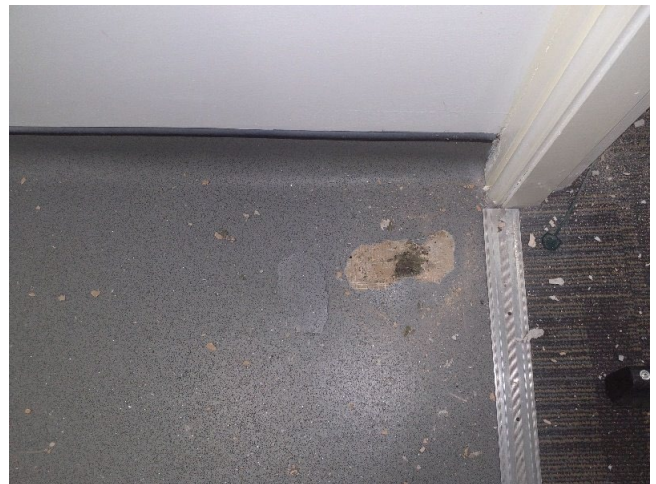
Sample No: 23/4/B/18/JPS4  
G.02 Disabled Toilet  
Floor Area Below Modern Vinyl and Screed  
Vinyl Floor Covering  
**No Asbestos Detected**

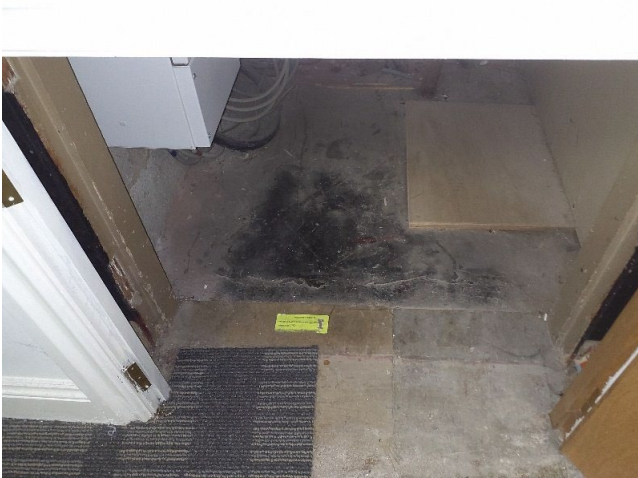
Sample No: 23/4/B/18/JPS5  
G.03 Understairs Store  
Floor Area Below Floor Screed  
Vinyl Floor Tiles and Bitumen Adhesive  
**No Asbestos Detected**

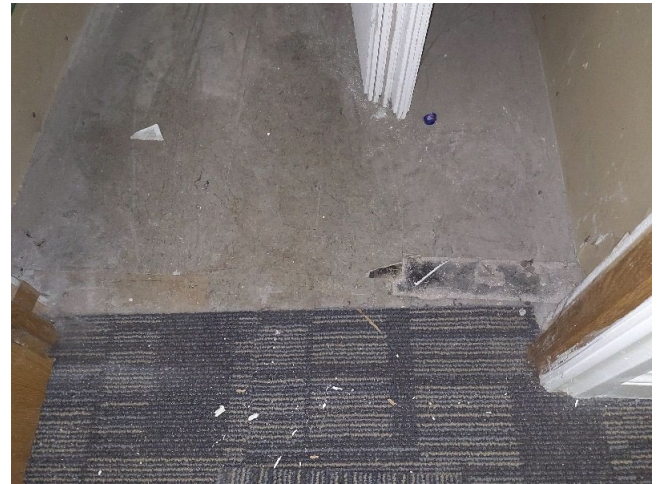
Sample No: Refer to Sample 23/4/B/18/JPS5  
G.04 Understairs Store  
Floor Area Below Floor Screed  
Vinyl Floor Tiles and Bitumen Adhesive  
**No Asbestos Detected**
