**Lead Surveyor:** J. Shirley  
**Assistant Surveyor(s):** N/A  
**Date of Survey(s):** 18th April 2023  
**Report Reference:** CH.23.4.246.LW  
**Date Report Issued:** 21 April 2023  
**Purpose of Survey:**  
(Refer to Section 2.2  
of this report for  
clarification)

## Report on Survey of Asbestos Materials at

**21B  
Blackburn Street  
Radcliffe  
Bury  
M26 1AB**

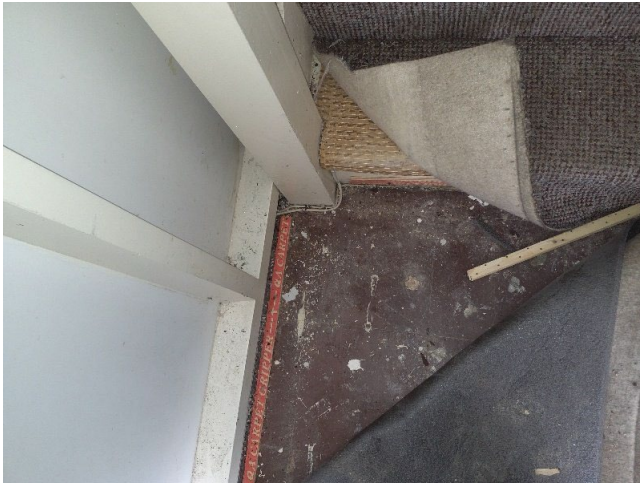
| Sample Number | Location | ACM Type | Material Risk Score | Recommendation |
|---|---|---|---|---|
| 23/4/B/18/JPS6 | 1.01 - Entrance Lobby - Below Carpet | Vinyl Floor Tiles and Bitumen Adhesive | 2 | Remove |

Sample No: 23/4/B/18/JPS6  
1.01 Entrance Lobby  
Below Carpet  
Vinyl Floor Tiles and Bitumen Adhesive containing:  
**Chrysotile (In both tile and bitumen)**

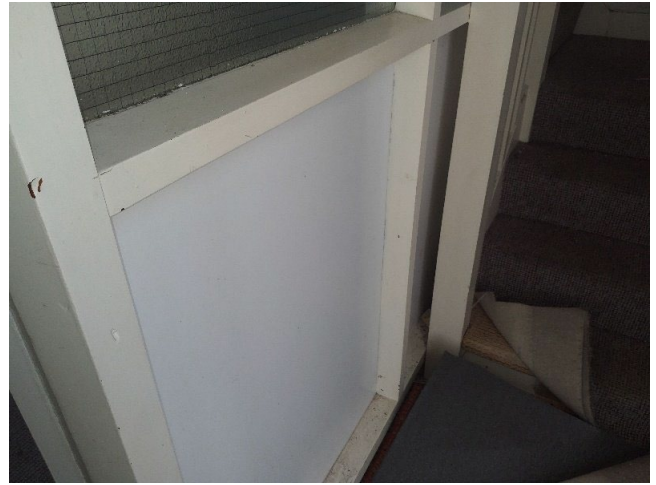
Sample No: 23/4/B/18/JPS7  
1.01 Entrance Lobby  
Combination Frame Spandrel Panels  
Composite Board  
**No Asbestos Detected**

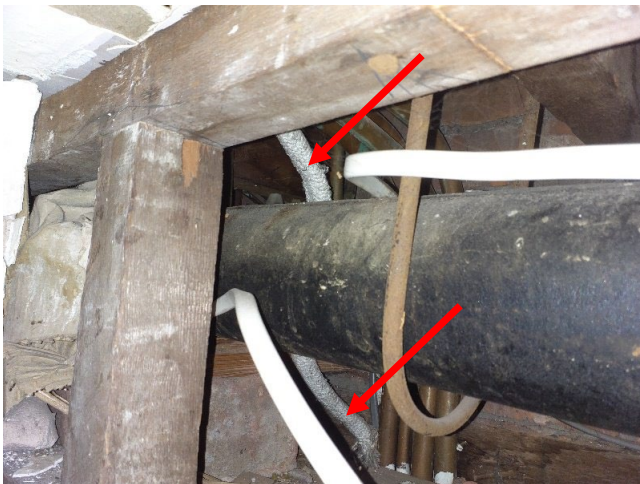
| Sample Number | Location | ACM Type | Material Risk Score | Recommendation |
|---|---|---|---|---|
| 23/4/B/18/JPS8 | 1.02 - Store Room - High Level Horizontal Riser | Woven Rope to Electrical Cabling | 4 | Remove |

Sample No: 23/4/B/18/JPS8  
1.02 Store Room  
High Level Horizontal Riser  
Woven Rope to Electrical Cabling containing:  
**Chrysotile**

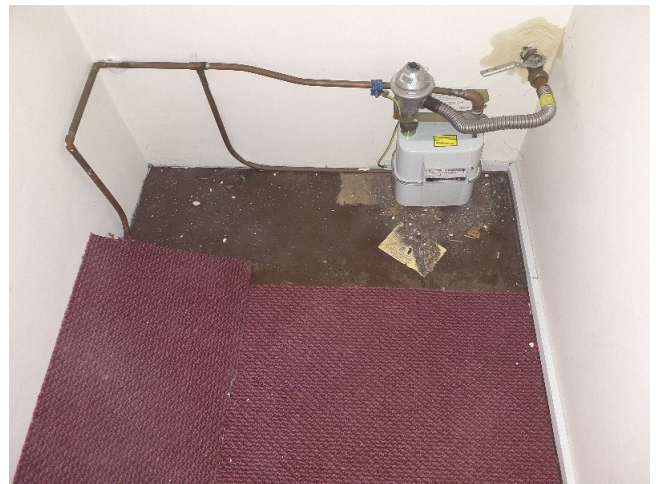
| Sample Number | Location | ACM Type | Material Risk Score | Recommendation |
|---|---|---|---|---|
| Refer to Sample 23/4/B/18/JPS6 | 1.02 - Store Room - Below Carpet | Vinyl Floor Tiles and Bitumen Adhesive | 2 | Remove |

Sample No: Refer to Sample 23/4/B/18/JPS6  
1.02 Store Room  
Below Carpet  
Vinyl Floor Tiles and Bitumen Adhesive containing:  
**Chrysotile (In both tile and bitumen)**

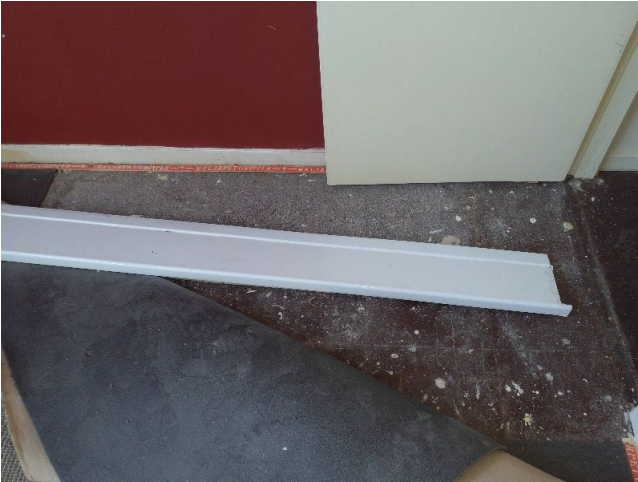
| Sample Number | Location | ACM Type | Material Risk Score | Recommendation |
|---|---|---|---|---|
| Refer to Sample 23/4/B/18/JPS6 | 1.03 - Lounge - Below Carpet | Vinyl Floor Tiles and Bitumen Adhesive | 2 | Remove |

Sample No: Refer to Sample 23/4/B/18/JPS6  
1.03 Lounge  
Below Carpet  
Vinyl Floor Tiles and Bitumen Adhesive containing:  
**Chrysotile (In both tile and bitumen)**

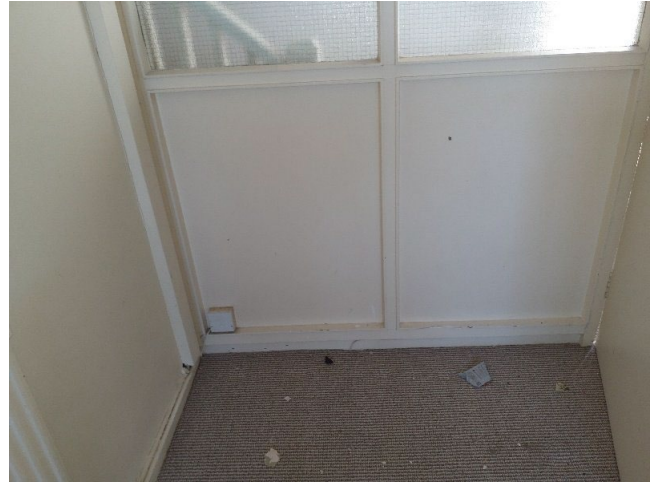
Sample No: Refer to Sample 23/4/B/18/JPS7  
1.03 Lounge  
Combination Frame Spandrel Panels  
Composite Board  
**No Asbestos Detected**

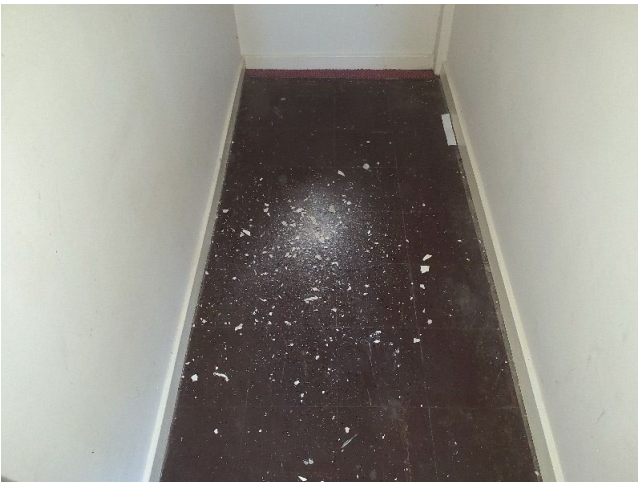
| Sample Number | Location | ACM Type | Material Risk Score | Recommendation |
|---|---|---|---|---|
| Refer to Sample 23/4/B/18/JPS6 | 1.04 - Understairs Cupboard - Below Carpet | Vinyl Floor Tiles and Bitumen Adhesive | 2 | Remove |

Sample No: Refer to Sample 23/4/B/18/JPS6  
1.04 Understairs Cupboard  
Below Carpet  
Vinyl Floor Tiles and Bitumen Adhesive containing:  
**Chrysotile (In both tile and bitumen)**

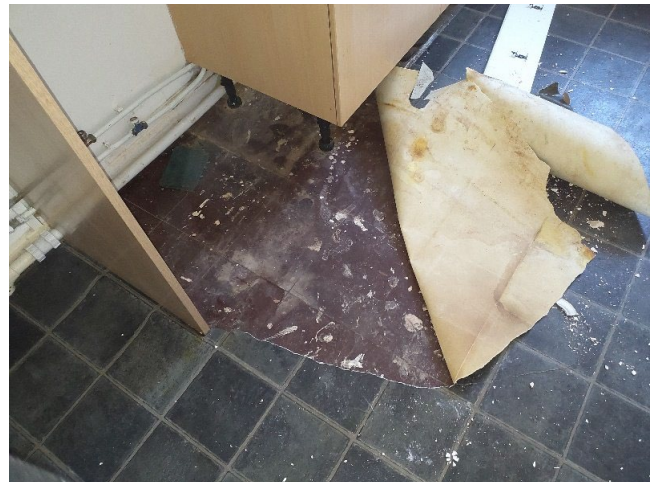
| Sample Number | Location | ACM Type | Material Risk Score | Recommendation |
|---|---|---|---|---|
| Refer to Sample 23/4/B/18/JPS6 | 1.05 - Kitchen - Below Modern Vinyl Flooring | Vinyl Floor Tiles and Bitumen Adhesive | 2 | Remove |

Sample No: Refer to Sample 23/4/B/18/JPS6  
1.05 Kitchen  
Below Modern Vinyl Flooring  
Vinyl Floor Tiles and Bitumen Adhesive containing:  
**Chrysotile (In both tile and bitumen)**

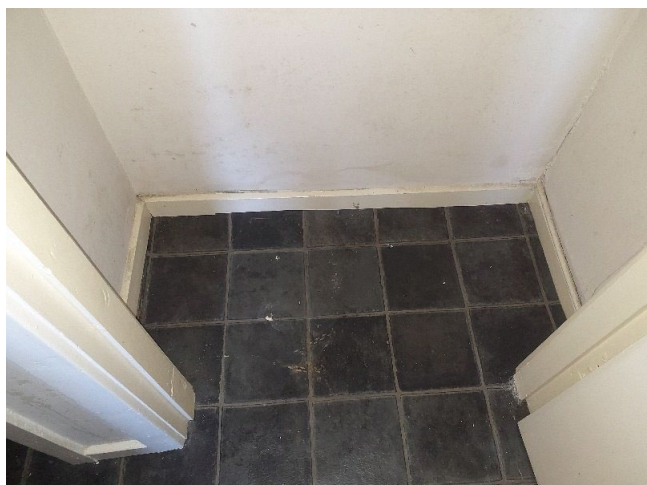
| Sample Number | Location | ACM Type | Material Risk Score | Recommendation |
|---|---|---|---|---|
| Refer to Sample 23/4/B/18/JPS6 | 1.06 - Store Cupboard - Below Carpet | Vinyl Floor Tiles and Bitumen Adhesive | 2 | Remove |

Sample No: Refer to Sample 23/4/B/18/JPS6  
1.06 Store Cupboard  
Below Carpet

Vinyl Floor Tiles and Bitumen Adhesive containing:  
**Chrysotile (In both tile and bitumen)**

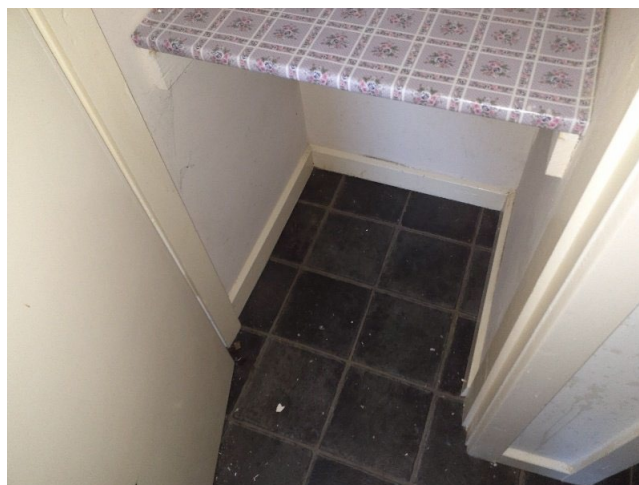
| Sample Number | Location | ACM Type | Material Risk Score | Recommendation |
|---|---|---|---|---|
| Refer to Sample 23/4/B/18/JPS6 | 1.07 - Store Cupboard - Below Carpet | Vinyl Floor Tiles and Bitumen Adhesive | 2 | Remove |

Sample No: Refer to Sample 23/4/B/18/JPS6  
1.07 Store Cupboard  
Below Carpet

Vinyl Floor Tiles and Bitumen Adhesive containing:  
**Chrysotile (In both tile and bitumen)**
