**Lead Surveyor:** J. Shirley  
**Assistant Surveyor(s):** S. Warburton & A. Alker  
**Date of Survey(s):** 25<sup>th</sup> April 2023  
**Report Reference:** CH.23.4.368.LW  
**Date Report Issued:** 28<sup>th</sup> April 2023

## Report on Survey of Asbestos Materials at

**Former Boots Store**  
**11 Blackburn Street**  
**Radcliffe**  
**Manchester**  
**M26 1NN**

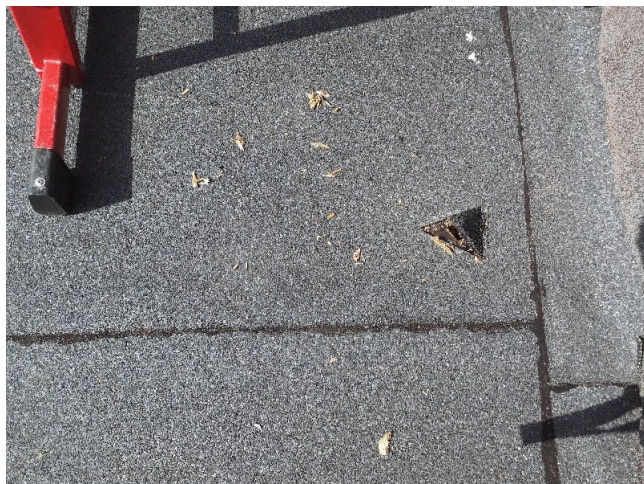
Sample No: 23/4/B/25/JPS21  
External  
Flat Roof Area  
Core Sample  
**No Asbestos Detected**

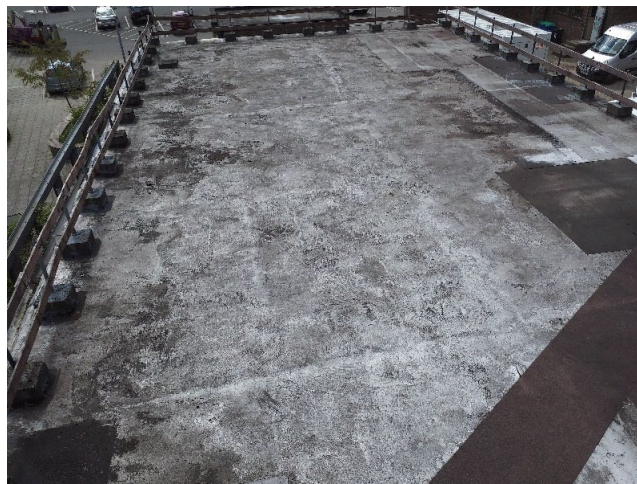
Sample No: 23/4/B/25/JPS22  
External  
Flat Roof Area  
Core Sample  
**No Asbestos Detected**

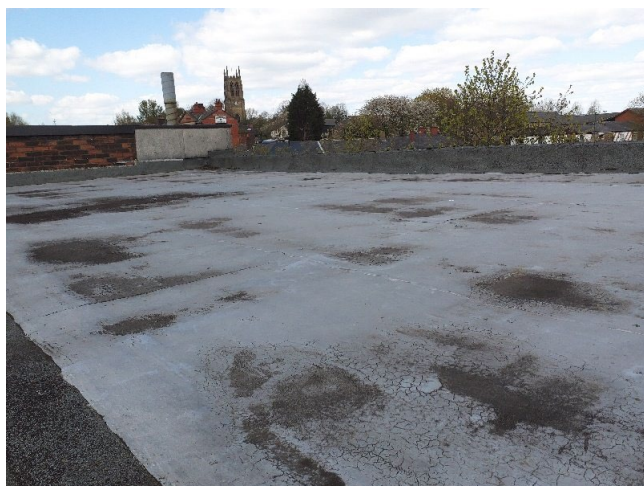
Sample No: 23/4/B/25/JPS23  
External  
Flat Roof Area  
Core Sample  
**No Asbestos Detected**

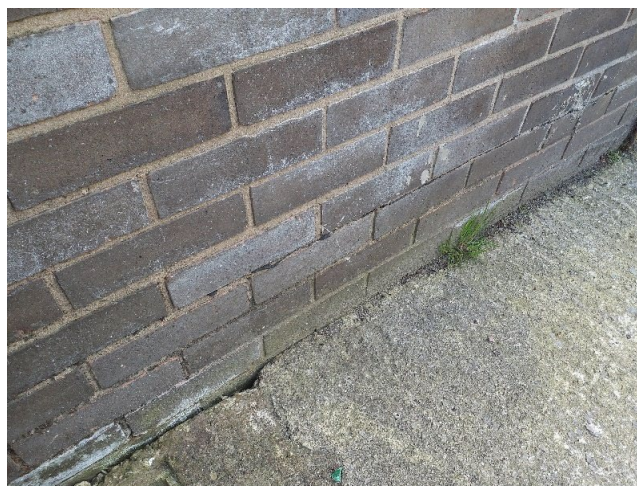
Sample No: 23/4/B/25/JPS24  
External  
Walls  
Bitumen DPC  
**No Asbestos Detected**

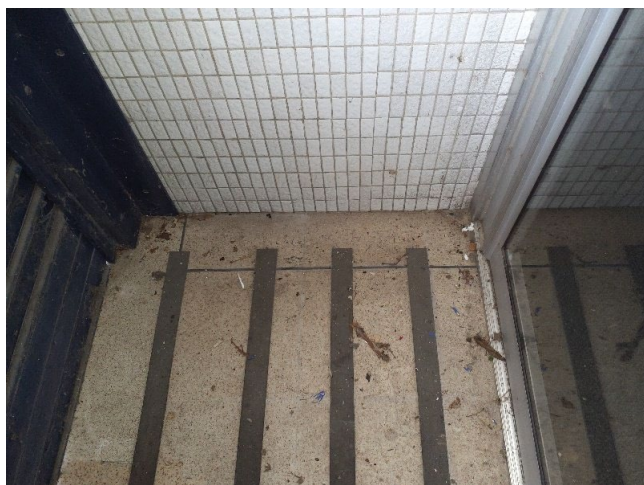
Sample No: 23/4/B/25/JPS1  
G.01 Entrance Lobby  
Floor Area  
Terrazzo Flooring Infill  
**No Asbestos Detected**

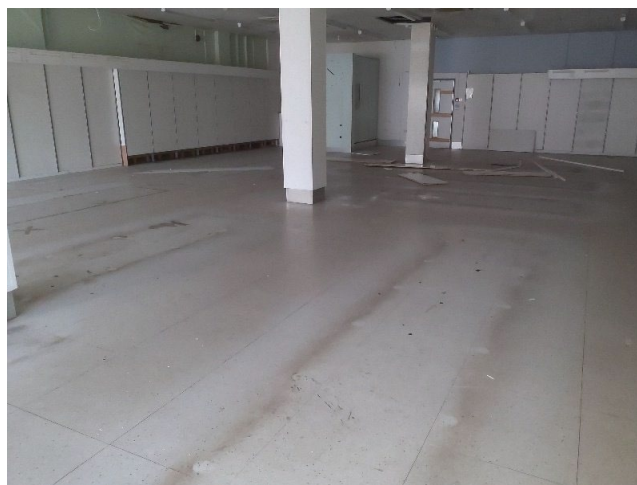
Sample No: 23/4/B/25/JPS2  
G.02 Retail Sales Floor  
Floor Area  
Vinyl Floor Tiles  
**No Asbestos Detected**

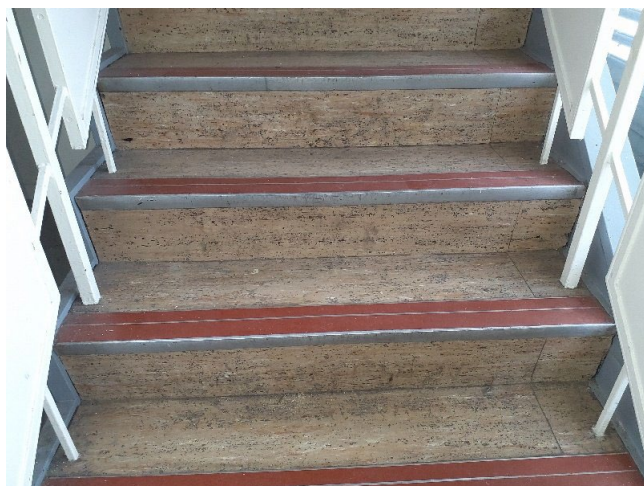
Sample No: 23/4/B/25/JPS3  
G.02 Retail Sales Floor  
Stair Treads & Risers  
Vinyl Floor Tiles  
**No Asbestos Detected**

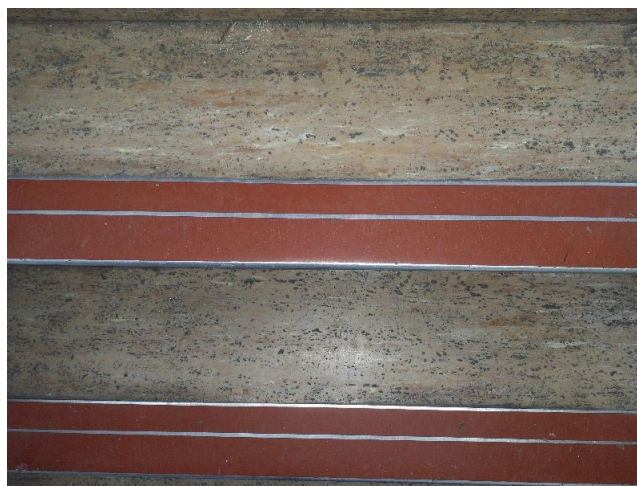
| Sample Number | Location | ACM Type | Material Risk Score | Recommendation |
|---|---|---|---|---|
| 23/4/B/25/JPS4 | G.02 - Retail Sales Floor - Stair Treads | Vinyl Nosing | 2 | Remove |

Sample No: 23/4/B/25/JPS4  
G.02 Retail Sales Floor  
Stair Treads  
Vinyl Nosing containing:  
**Chrysotile**

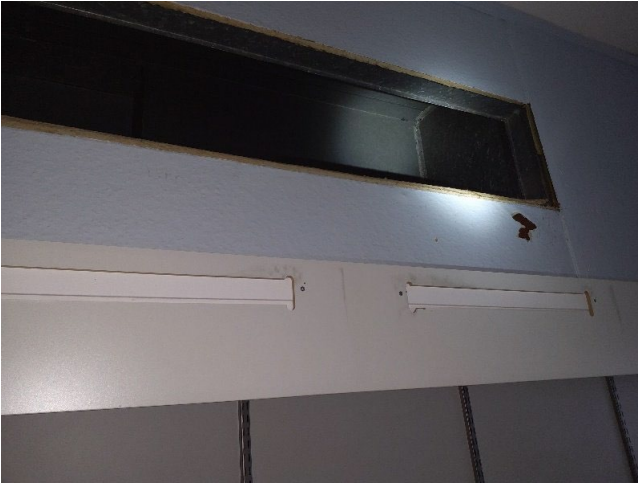
Sample No: 23/4/B/25/JPS5  
G.02 Retail Sales Floor  
Warm Air Ductwork Joints  
Mastic  
**No Asbestos Detected**

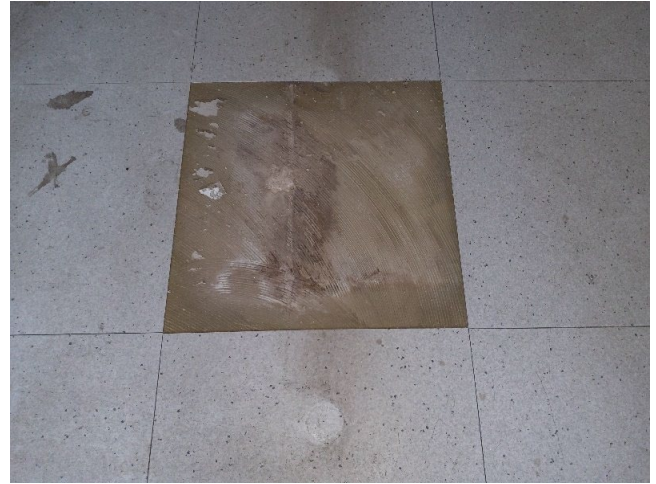
Sample No: Refer to Sample 23/4/B/25/JPS1  
G.02 Retail Sales Floor  
Floor Area Below Vinyl Floor Tiles  
Terrazzo Flooring Infill  
**No Asbestos Detected**

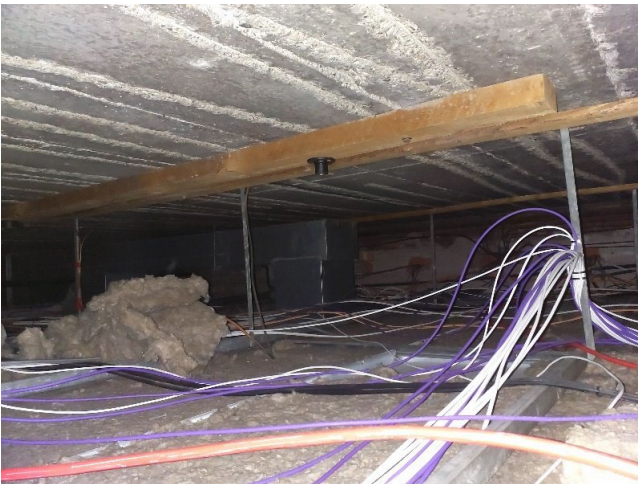
Sample No: Refer to Sample 23/4/B/25/JPS5  
G.02 Retail Sales Floor  
Ceiling Void Warm Air Ductwork Joints  
Mastic  
**No Asbestos Detected**

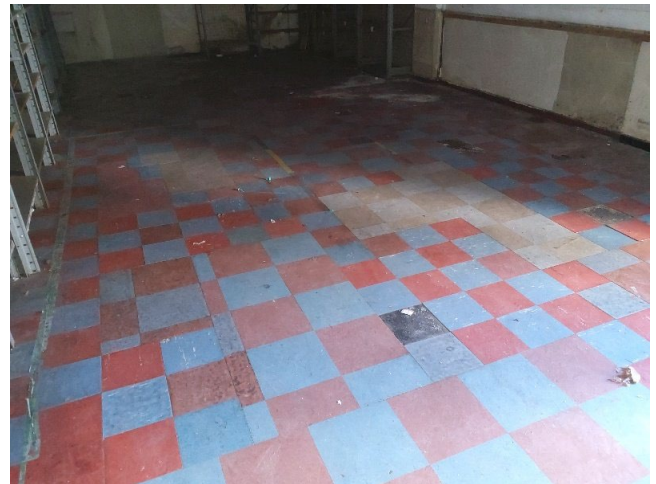
| Sample Number | Location | ACM Type | Material Risk Score | Recommendation |
|---|---|---|---|---|
| 23/4/B/25/JPS6 | G.03 - Warehouse - Floor Area | Vinyl Floor Tiles and Bitumen Adhesive | 4 | Remove |

Sample No: 23/4/B/25/JPS6  
G.03 Warehouse  
Floor Area  
Vinyl Floor Tiles and Bitumen Adhesive containing:  
**Chrysotile (In both tile and bitumen)**

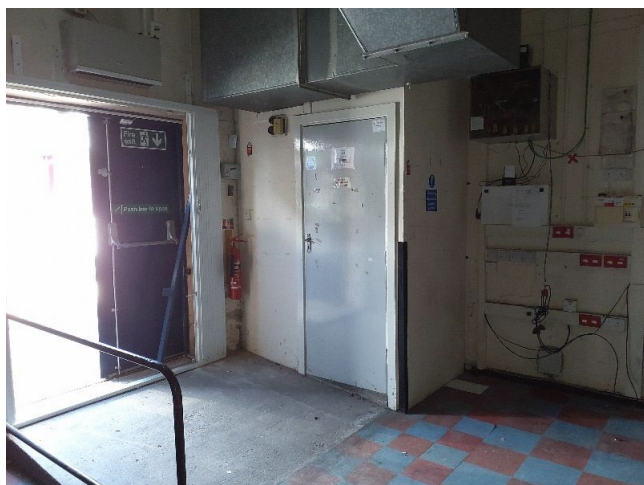
| Sample Number | Location | ACM Type | Material Risk Score | Recommendation |
|---|---|---|---|---|
| 23/4/B/25/JPS7 | G.03 - Warehouse - External Linings to Store Room | Insulating Board | 6 | Remove |

Sample No: 23/4/B/25/JPS7  
G.03 Warehouse  
External Linings to Store Room  
Insulating Board containing:  
**Amosite & Chrysotile**

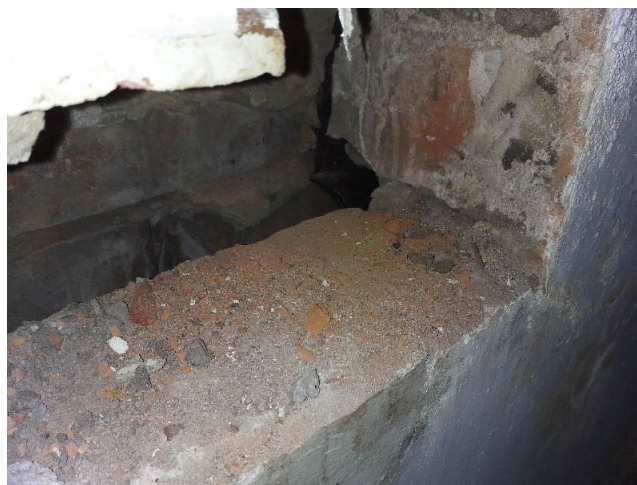
Sample No: 23/4/B/25/JPS8  
G.03 Warehouse  
Window Cavity  
Bitumen Vapour Barrier  
**No Asbestos Detected**

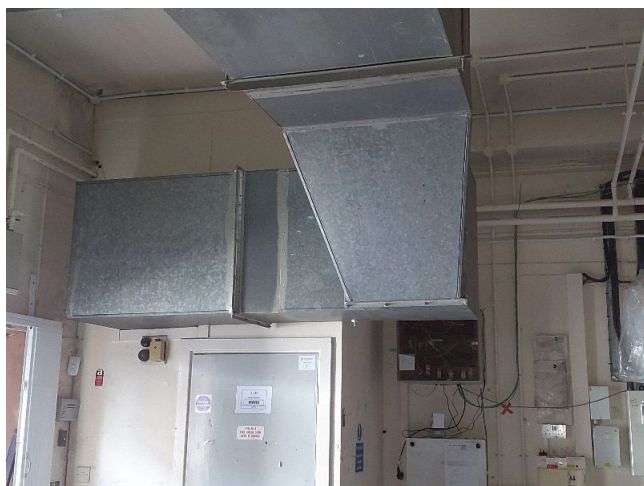
Sample No: Refer to Sample 23/4/B/25/JPS5  
G.03 Warehouse  
Warm Air Ductwork Joints  
Mastic  
**No Asbestos Detected**

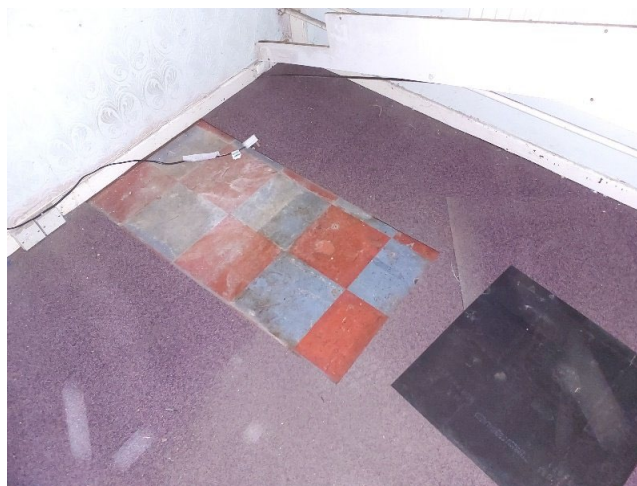
| Sample Number | Location | ACM Type | Material Risk Score | Recommendation |
|---|---|---|---|---|
| Refer to Sample 23/4/B/25/JPS6 | G.04 - Office - Floor Area | Vinyl Floor Tiles and Bitumen Adhesive | 4 | Remove |

Sample No: Refer to Sample 23/4/B/25/JPS6  
G.04 Office  
Floor Area  
Vinyl Floor Tiles and Bitumen Adhesive containing:  
**Chrysotile (In both tile and bitumen)**

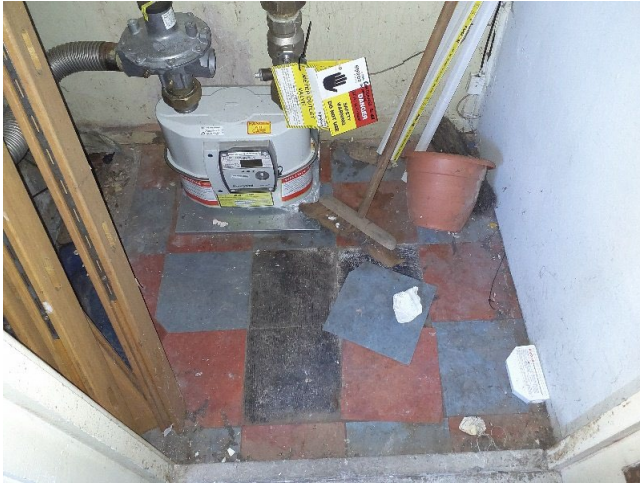
| Sample Number | Location | ACM Type | Material Risk Score | Recommendation |
|---|---|---|---|---|
| Refer to Sample 23/4/B/25/JPS6 | G.05 - Store Room - Floor Area | Vinyl Floor Tiles and Bitumen Adhesive | 4 | Remove |

Sample No: Refer to Sample 23/4/B/25/JPS6  
G.05 Store Room  
Floor Area  
Vinyl Floor Tiles and Bitumen Adhesive containing:  
**Chrysotile (In both tile and bitumen)**

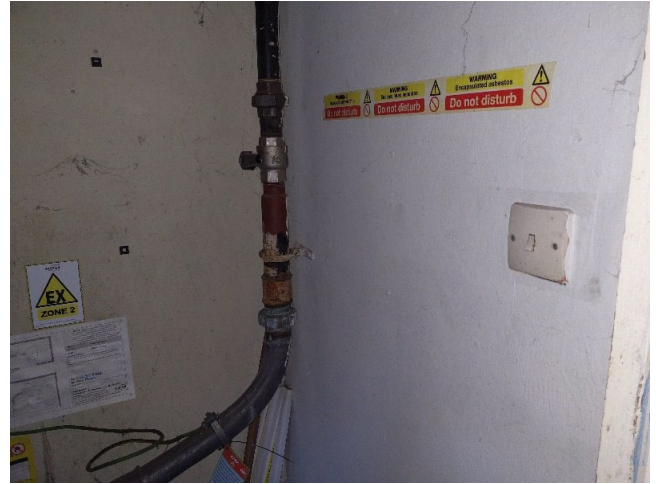
| Sample Number | Location | ACM Type | Material Risk Score | Recommendation |
|---|---|---|---|---|
| Refer to Sample 23/4/B/25/JPS7 | G.05 - Store Room - Internal Linings to Store Room Walls | Insulating Board | 6 | Remove |

Sample No: Refer to Sample 23/4/B/25/JPS7  
G.05 Store Room  
Internal Linings to Store Room Walls  
Insulating Board containing:  
**Amosite & Chrysotile**

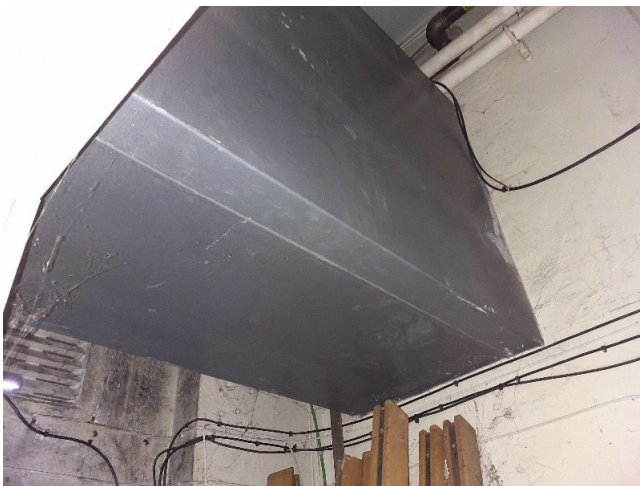
Sample No: Refer to Sample 23/4/B/25/JPS5  
G.05 Store Room  
Warm Air Ductwork Joints  
Mastic  
**No Asbestos Detected**

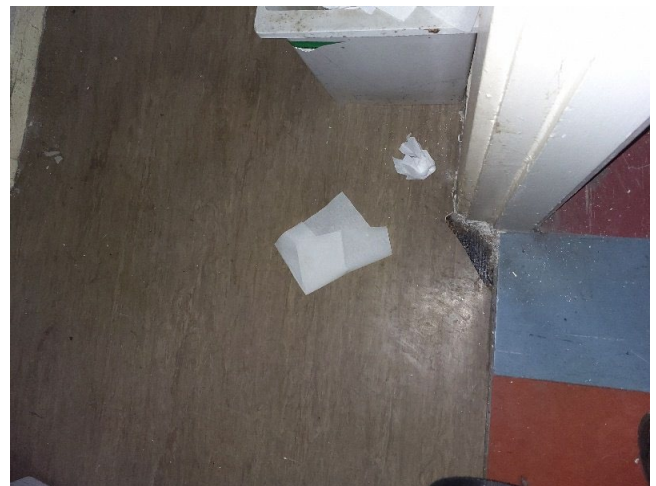
| Sample Number | Location | ACM Type | Material Risk Score | Recommendation |
|---|---|---|---|---|
| 23/4/B/25/JPS9 | G.06 - Ladles Toilet - Floor Area | Vinyl Floor Covering & Bitumen Adhesive | 3 | Remove |

Sample No: 23/4/B/25/JPS9  
G.06 Ladles Toilet  
Floor Area  
Vinyl Floor Covering & Bitumen Adhesive  
containing:  
**Chrysotile (In bitumen only)**

**Location** G.06 Ladles Toilet - Floor Area  
**Items and Content** Vinyl Floor Covering & Bitumen Adhesive containing Chrysotile (In bitumen only)  
**Sample Number** 23/4/B/25/JPS9  
**Condition** Fair  
**Recommendation** We would recommend that these materials are removed prior to demolition by a licensed asbestos removal contractor, working under the guidance of a safe working procedure and in accordance with the requirements of **The Control of Asbestos Regulations 2012 and The Hazardous Waste (England and Wales) Regulations 2005 (as amended in 2009).**

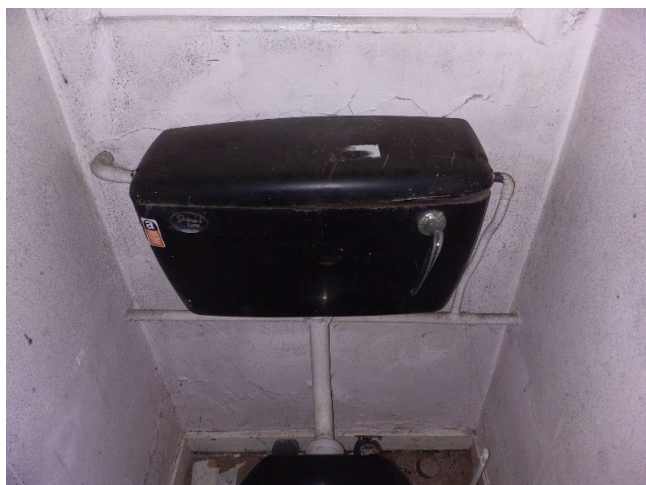
| Sample Number | Location | ACM Type | Material Risk Score | Recommendation |
|---|---|---|---|---|
| 23/4/B/25/JPS10 | G.06 - Ladles Toilet - Cistern | Thermoplastic | 3 | Remove |

Sample No: 23/4/B/25/JPS10  
G.06 Ladles Toilet  
Cistern  
Thermoplastic containing:  
**Amosite**

**Location** G.06 Ladles Toilet - Cistern, G.07 Gents Toilet - Cistern, 1.03 Toilets - Cistern  
**Items and Content** Thermoplastic containing Amosite  
**Sample Number** 23/4/B/25/JPS10, 23/4/B/25/JPS12  
**Condition** Good  
**Recommendation** We would recommend that these materials are removed prior to demolition by a licensed asbestos removal contractor, working under the guidance of a safe working procedure and in accordance with the requirements of **The Control of Asbestos Regulations 2012 and The Hazardous Waste (England and Wales) Regulations 2005 (as amended in 2009).**

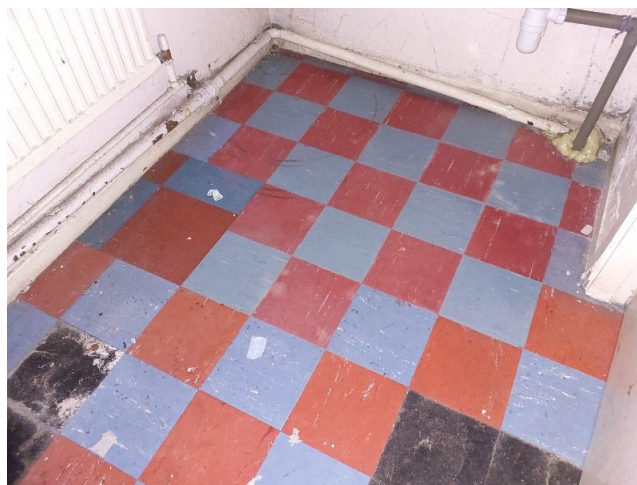
| Sample Number | Location | ACM Type | Material Risk Score | Recommendation |
|---|---|---|---|---|
| Refer to Sample 23/4/B/25/JPS6 | G.07 - Gents Toilet - Floor Area | Vinyl Floor Tiles and Bitumen Adhesive | 4 | Remove |

Sample No: Refer to Sample 23/4/B/25/JPS6  
G.07 Gents Toilet  
Floor Area  
Vinyl Floor Tiles and Bitumen Adhesive containing:  
**Chrysotile (In both tile and bitumen)**

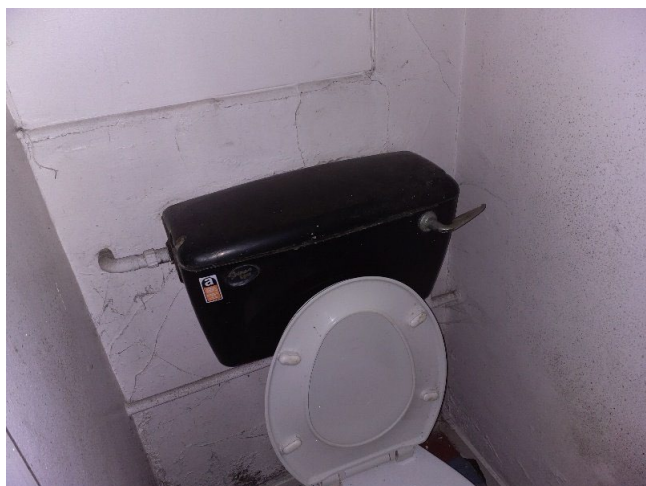
| Sample Number | Location | ACM Type | Material Risk Score | Recommendation |
|---|---|---|---|---|
| Refer to Sample 23/4/B/25/JPS10 | G.07 - Gents Toilet - Cistern | Thermoplastic | 3 | Remove |

Sample No: Refer to Sample 23/4/B/25/JPS10  
G.07 Gents Toilet  
Cistern  
Thermoplastic containing:  
**Amosite**

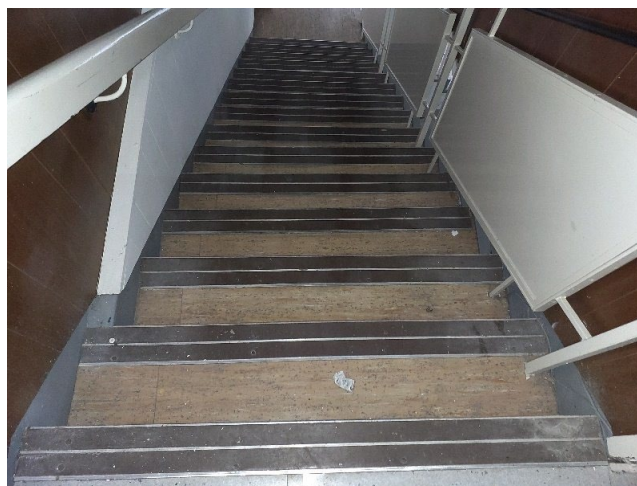
Sample No: Refer to Sample 23/4/B/25/JPS3  
1.01 Stairs / Landing  
Stair Treads & Risers  
Vinyl Floor Tiles  
**No Asbestos Detected**

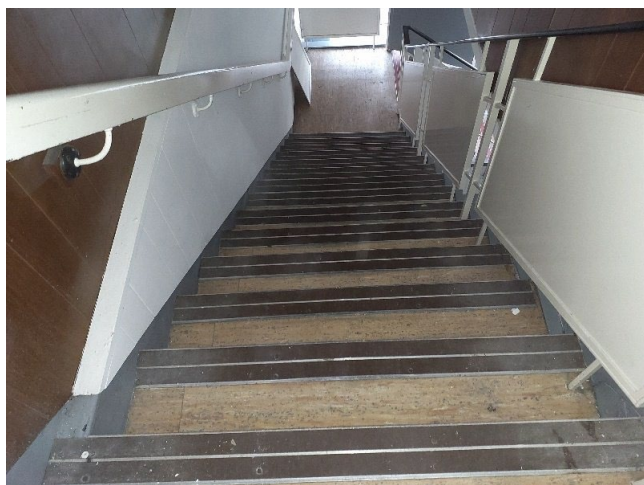
| Sample Number | Location | ACM Type | Material Risk Score | Recommendation |
|---|---|---|---|---|
| Refer to Sample 23/4/B/25/JPS4 | 1.01 - Stairs / Landing - Stair Treads | Vinyl Nosing | 2 | Remove |

Sample No: Refer to Sample 23/4/B/25/JPS4  
1.01 Stairs / Landing  
Stair Treads  
Vinyl Nosing containing:  
**Chrysotile**

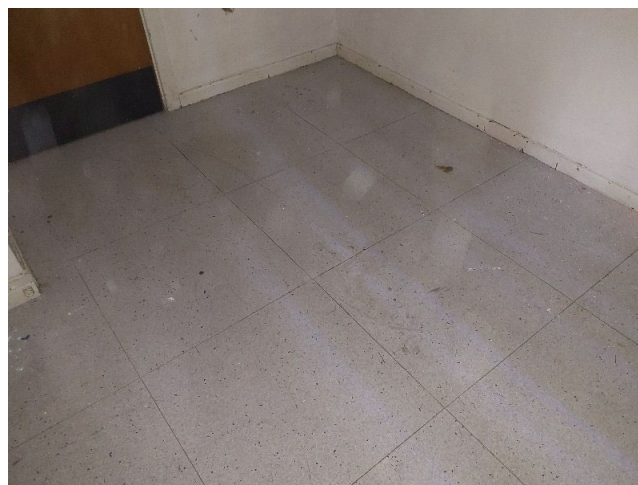
Sample No: Refer to Sample 23/4/B/25/JPS2  
1.01 Stairs / Landing  
Floor Area  
Vinyl Floor Tiles  
**No Asbestos Detected**

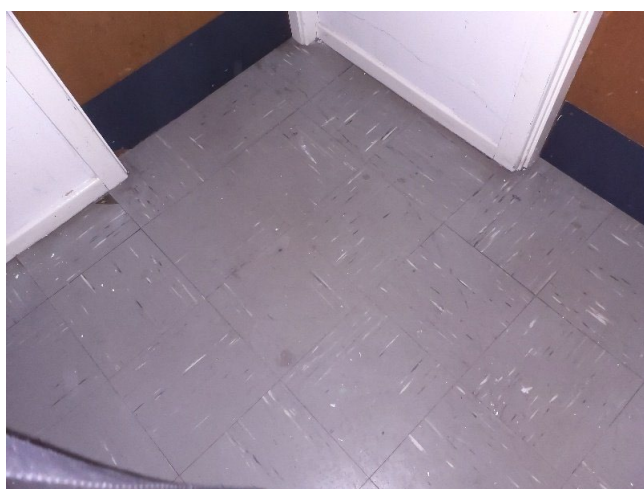
Sample No: 23/4/B/25/JPS11  
1.02 Circulation Area  
Floor Area  
Vinyl Floor Tiles  
**No Asbestos Detected**

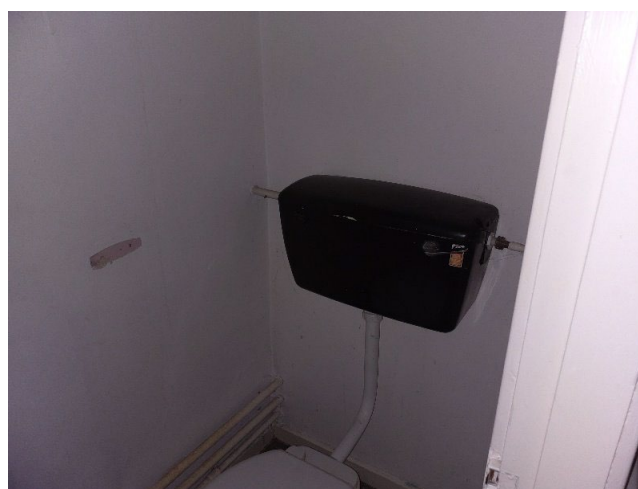
| Sample Number | Location | ACM Type | Material Risk Score | Recommendation |
|---|---|---|---|---|
| 23/4/B/25/JPS12 | 1.03 - Toilets - Cistern | Thermoplastic | 3 | Remove |

Sample No: 23/4/B/25/JPS12  
1.03 Toilets  
Cistern  
Thermoplastic containing:  
**Amosite**

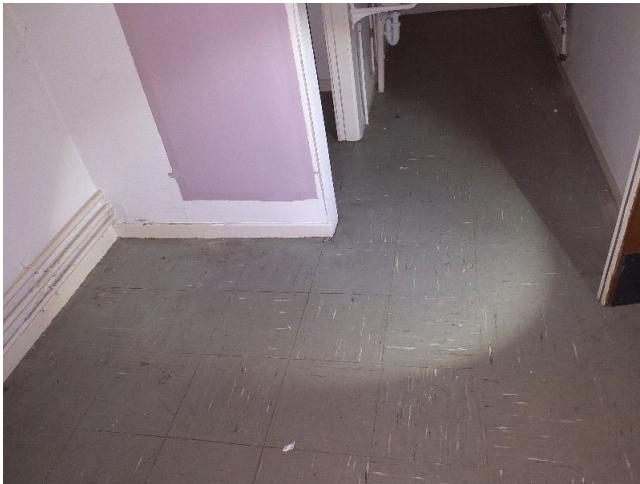
Sample No: Refer to Sample 23/4/B/25/JPS11  
1.03 Toilets  
Floor Area  
Vinyl Floor Tiles  
**No Asbestos Detected**

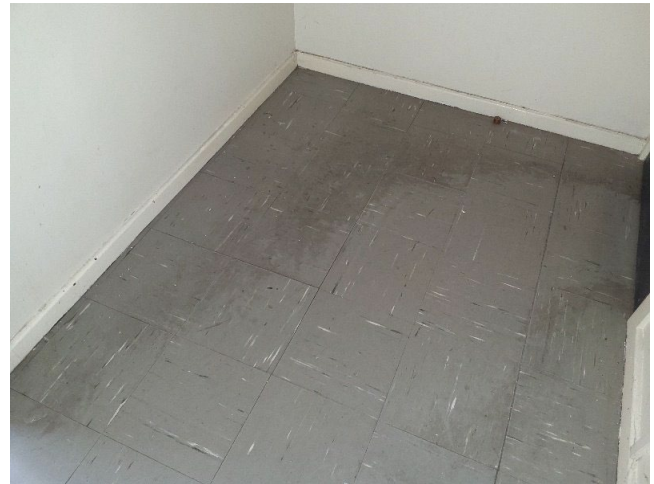
Sample No: Refer to Sample 23/4/B/25/JPS11  
1.04 Circulation Area  
Floor Area  
Vinyl Floor Tiles  
**No Asbestos Detected**

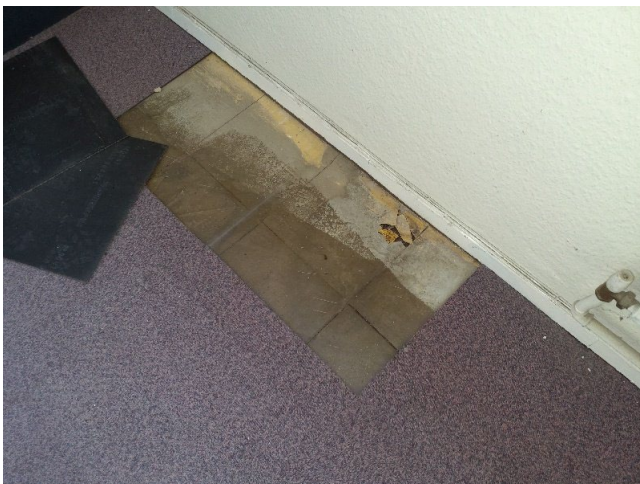
| Sample Number | Location | ACM Type | Material Risk Score | Recommendation |
|---|---|---|---|---|
| 23/4/B/25/JPS13 | 1.05 - Office - Floor Area | Vinyl Floor Tiles & Bitumen Adhesive | 2 | Remove |

Sample No: 23/4/B/25/JPS13  
1.05 Office  
Floor Area  
Vinyl Floor Tiles & Bitumen Adhesive containing:  
**Chrysotile (In both tile and bitumen)**

**Location** 1.05 Office - Floor Area  
**Items and Content** Vinyl Floor Tiles & Bitumen Adhesive containing Chrysotile (In both tile and bitumen)  
**Sample Number** 23/4/B/25/JPS13  
**Condition** Good  
**Recommendation** We would recommend that these materials are removed prior to demolition by a licensed asbestos removal contractor, working under the guidance of a safe working procedure and in accordance with the requirements of **The Control of Asbestos Regulations 2012 and The Hazardous Waste (England and Wales) Regulations 2005 (as amended in 2009).**

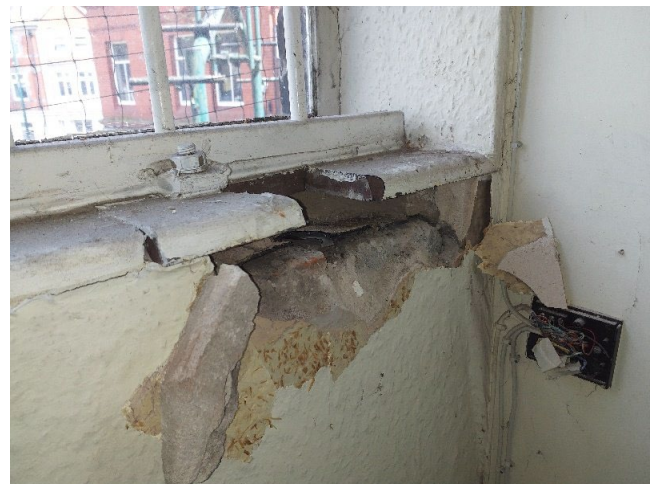
Sample No: 23/4/B/25/JPS14  
1.05 Office  
Window Cavity  
Bitumen Vapour Barrier  
**No Asbestos Detected**

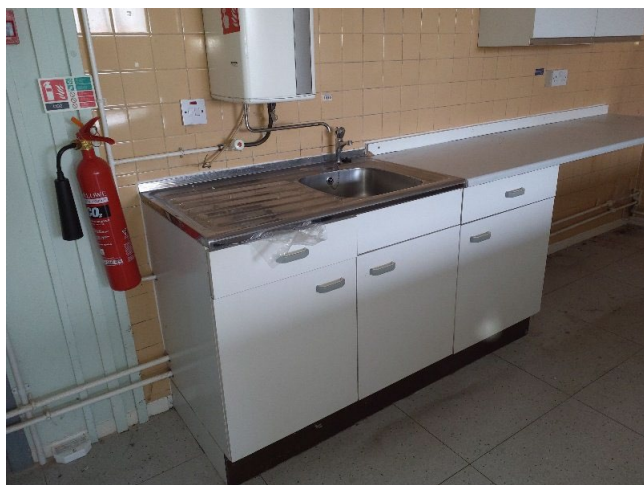
Sample No: 23/4/B/25/JPS15  
1.06 Kitchen  
Sink  
Bitumen Pad  
**No Asbestos Detected**

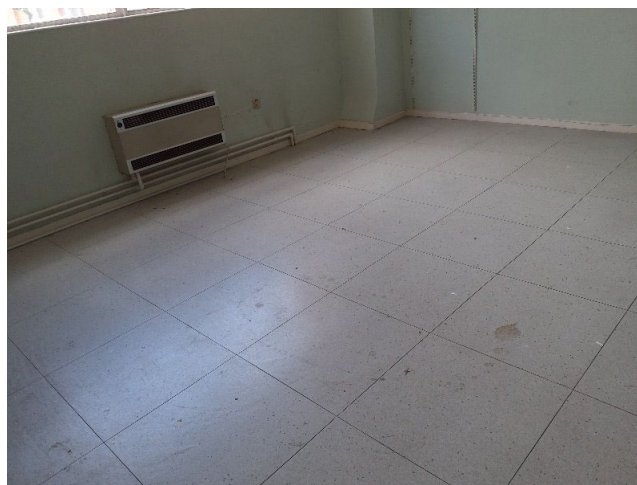
Sample No: Refer to Sample 23/4/B/25/JPS2  
1.06 Kitchen  
Floor Area  
Vinyl Floor Tiles  
**No Asbestos Detected**

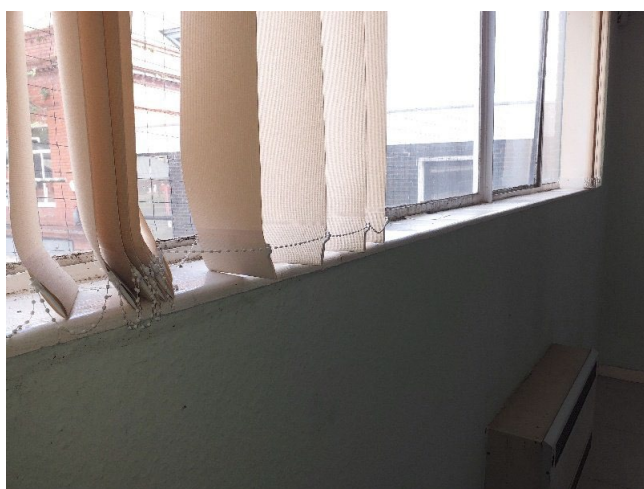
Sample No: Refer to Sample 23/4/B/25/JPS14  
1.06 Kitchen  
Window Cavity  
Bitumen Vapour Barrier  
**No Asbestos Detected**

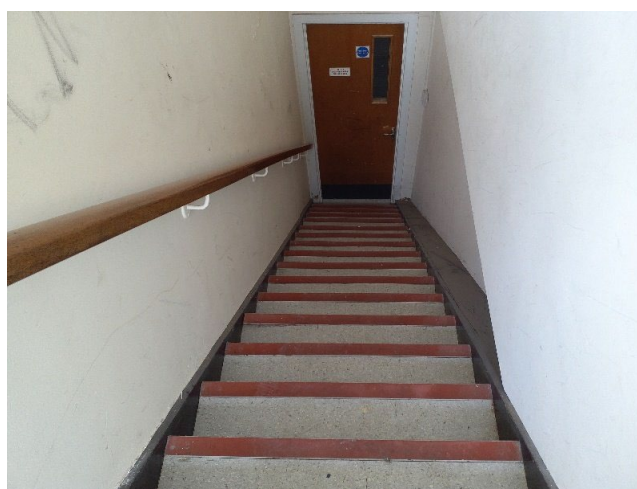
| Sample Number | Location | ACM Type | Material Risk Score | Recommendation |
|---|---|---|---|---|
| 23/4/B/25/JPS16 | 2.01 - Stairs / Storage Area<br>- Stair Treads | Vinyl Nosings | 2 | Remove |

Sample No: 23/4/B/25/JPS16  
2.01 Stairs / Storage Area  
Stair Treads  
Vinyl Nosings containing:  
**Chrysotile**

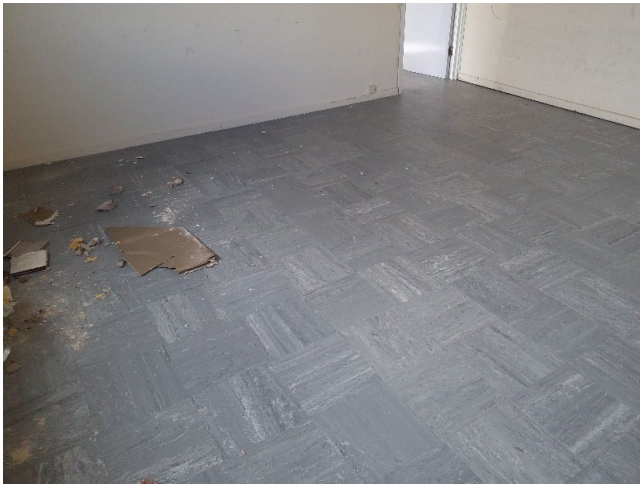
Sample No: 23/4/B/25/JPS17  
2.01 Stairs / Storage Area  
Floor Area  
Vinyl Floor Tiles  
**No Asbestos Detected**

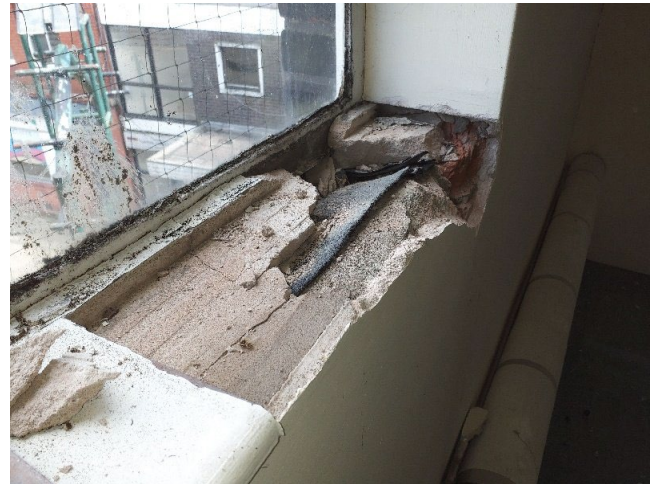
Sample No: 23/4/B/25/JPS18  
2.01 Stairs / Storage Area  
Window Cavity  
Bitumen Vapour Barrier  
**No Asbestos Detected**

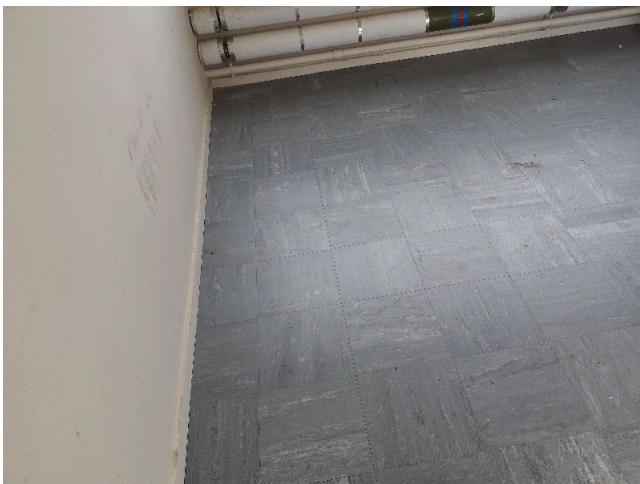
Sample No: Refer to Sample 23/4/B/25/JPS17  
2.02 Store Room  
Floor Area  
Vinyl Floor Tiles  
**No Asbestos Detected**

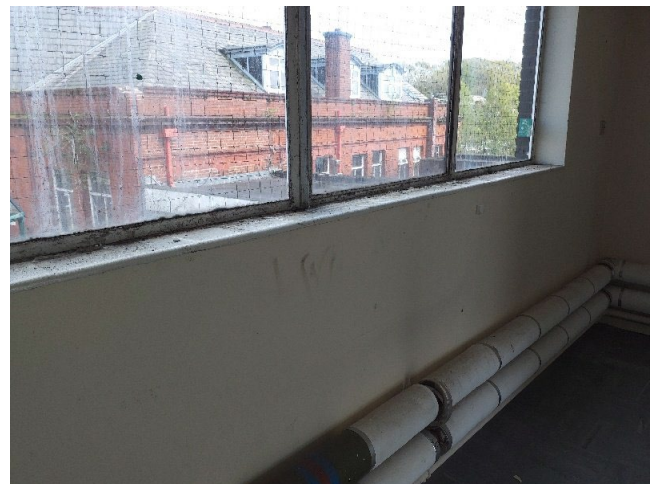
Sample No: Refer to Sample 23/4/B/25/JPS18  
2.02 Store Room  
Window Cavity  
Bitumen Vapour Barrier  
**No Asbestos Detected**

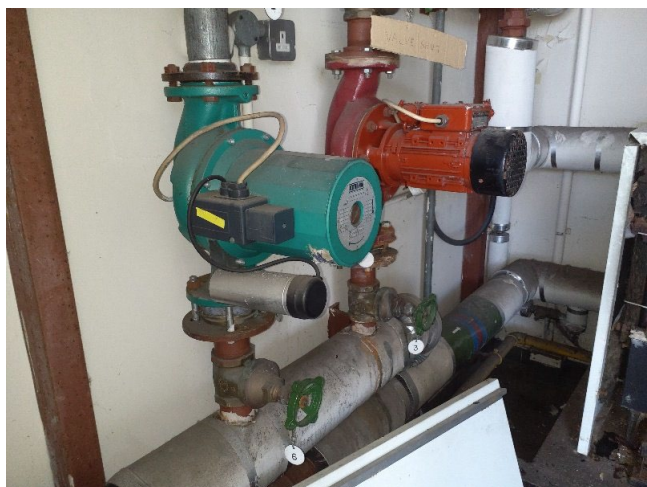
| Sample Number | Location | ACM Type | Material Risk Score | Recommendation |
|---|---|---|---|---|
| 23/4/B/25/JPS19 | 2.03 - Boiler Room -<br>Pipework Flanges | Gaskets | 5 | Remove |

Sample No: 23/4/B/25/JPS19  
2.03 Boiler Room  
Pipework Flanges  
Gaskets containing:  
**Chrysotile**

**Location** 2.03 Boiler Room - Pipework Flanges  
**Items and Content** Gaskets containing Chrysotile  
**Sample Number** 23/4/B/25/JPS19  
**Condition** Fair  
**Recommendation** We would recommend that these materials are removed prior to demolition by a licensed asbestos removal contractor, working under the guidance of a safe working procedure and in accordance with the requirements of **The Control of Asbestos Regulations 2012 and The Hazardous Waste (England and Wales) Regulations 2005 (as amended in 2009).**

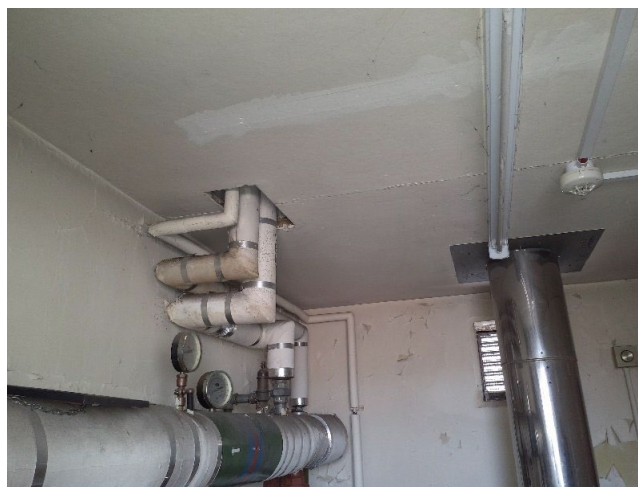
Sample No: 23/4/B/25/JPS20  
2.03 Boiler Room  
Ceiling & Upstand  
Insulating Board  
**No Asbestos Detected**

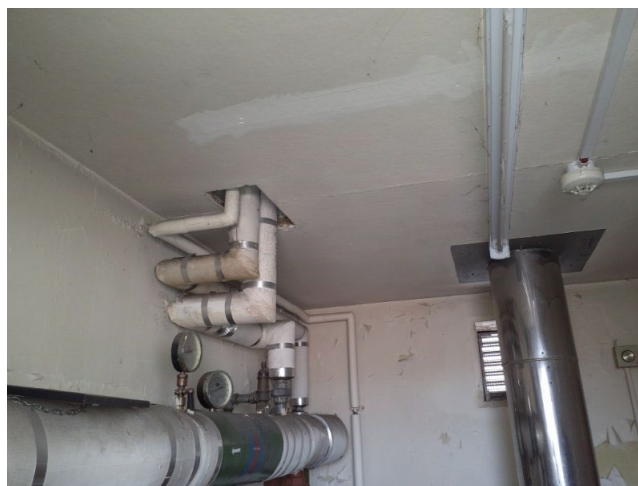
Sample No: Refer to Sample 23/4/B/25/JPS20  
3.01 Tank Room  
Pipework Upstand  
Insulating Board  
**No Asbestos Detected**

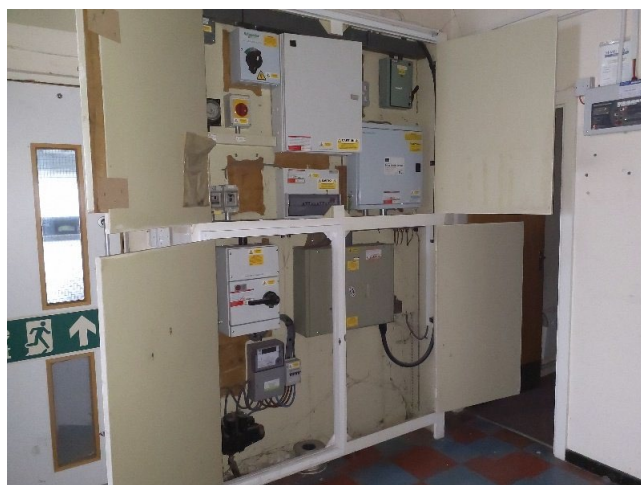
| Location/Item | Reason for non-access | Client Agreed (Y/N) |
|---|---|---|
| G.02 Warehouse - Electrics | Live at Time of Survey | Yes |

G.02 Warehouse - Electrics Live at Time of Survey
