| <b>Client:</b> Bury Metropolitan Borough Council<br>Town Hall<br>Knowsley Street<br>Bury<br>BL9 0SW | <b>Lead Surveyor:</b> S. Warburton<br><b>Assistant Surveyor(s):</b> N/A<br><b>Date of Survey(s):</b> 18th May 2023<br><b>Report Reference:</b> CH.23.5.235.LW<br><b>Date Report Issued:</b> 19 May 2023<br><b>Purpose of Survey:</b><br>(Refer to Section 2.2<br>of this report for<br>clarification) |

**Report on Survey of Asbestos Materials**  
**at**  
**19**  
**Blackburn Street**  
**Radcliffe**  
**M26 1AB**

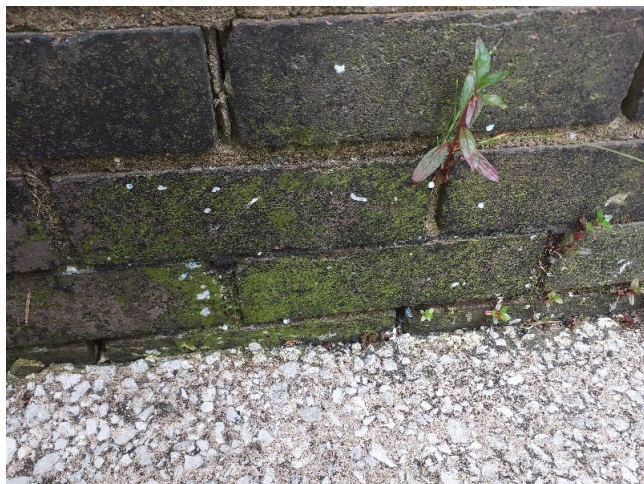
Sample No: 23/5/B/18/SAW16  
External  
Damp proof course  
Bitumen damp proof  
**No Asbestos Detected**

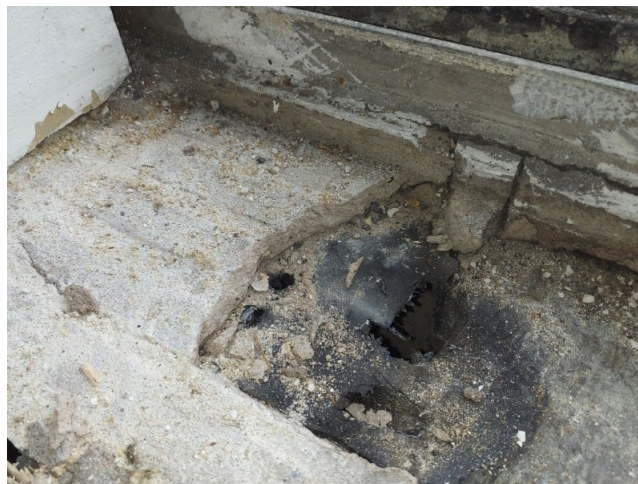
Sample No: 23/5/B/18/SAW17  
External  
Window reveals  
Bitumen vapour barrier  
**No Asbestos Detected**

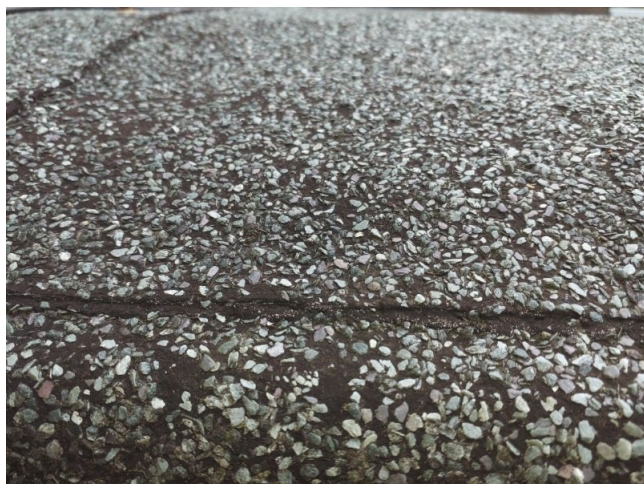
Sample No: 23/5/B/18/SAW18  
External  
Roof above staircase  
Core sample  
**No Asbestos Detected**

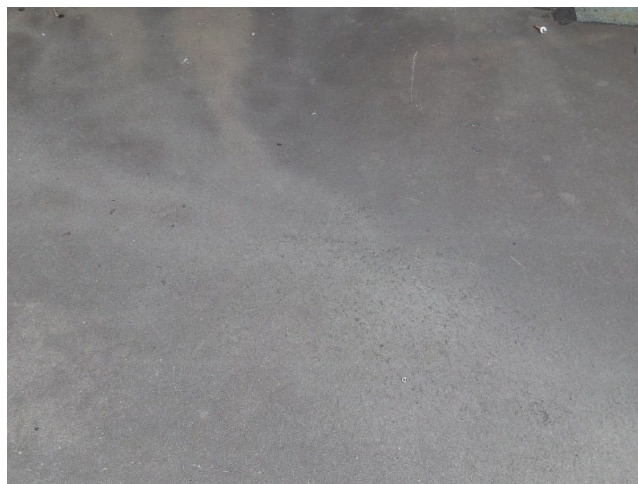
Sample No: 23/5/B/18/SAW19  
External  
Roof  
Core sample  
**No Asbestos Detected**

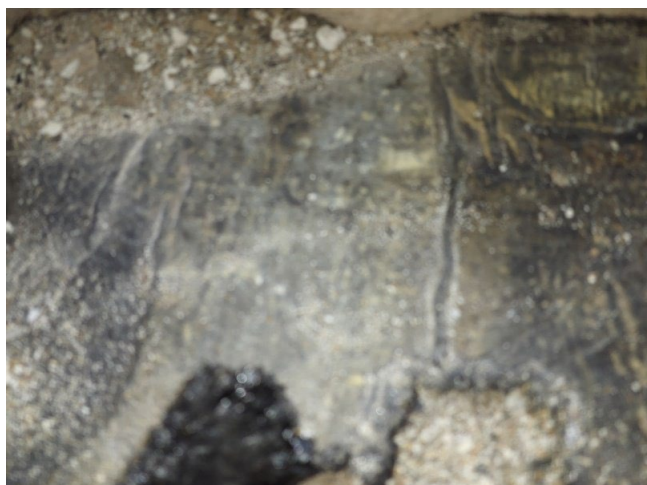
Sample No: Refer to Sample 23/5/B/18/SAW17  
External  
Window reveals  
Bitumen vapour barrier  
**No Asbestos Detected**

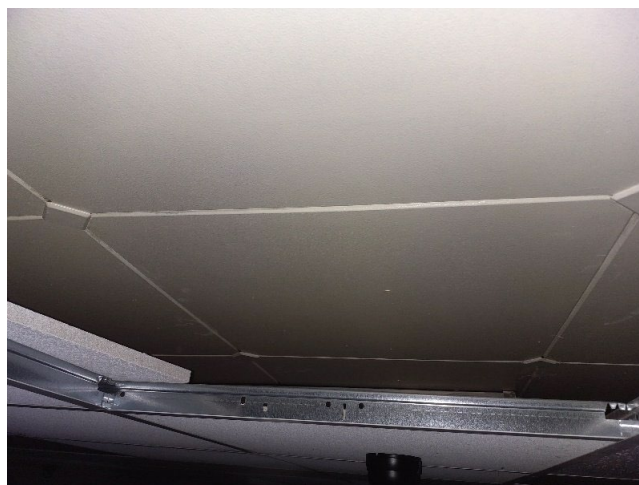
Sample No: 23/5/B/18/SAW14  
G.01 Shop area  
Ceiling void  
Plasterboard ceiling tiles  
**No Asbestos Detected**

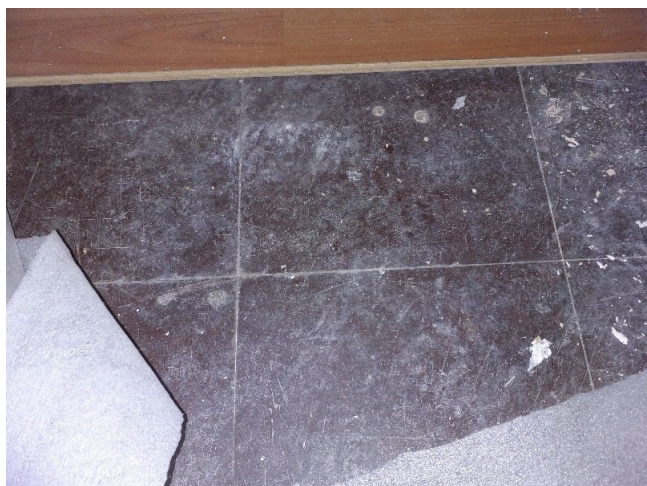
| Sample Number | Location | ACM Type | Material Risk Score | Recommendation |
|---|---|---|---|---|
| 23/5/B/18/SAW15 | 1.01 - Landing - Floor | Vinyl floor tiles with bitumen adhesive | 3 | Remove |

Sample No: 23/5/B/18/SAW15  
1.01 Landing  
Floor  
Vinyl floor tiles with bitumen adhesive containing:  
**Chrysotile (In both tile and bitumen)**

| <b>Recommendation</b> | These materials should be removed and disposed of prior to demolition commencing by suitably trained and equipped personnel only, working under the guidance of a safe working procedure and in accordance with the requirements of The Control of Asbestos Regulations 2012 and The Hazardous Waste (England and Wales) Regulations 2005 (as amended in 2009). |

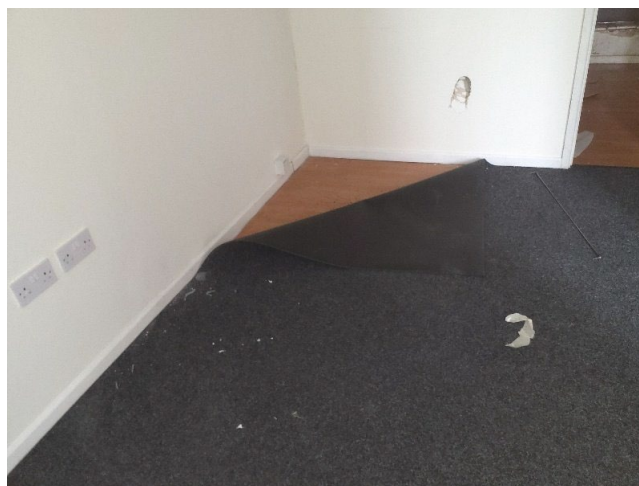
| Sample Number | Location | ACM Type | Material Risk Score | Recommendation |
|---|---|---|---|---|
| Refer to Sample 23/5/B/18/SAW15 | 1.02 - Office - Floor | Vinyl floor tiles with bitumen adhesive | 3 | Remove |

Sample No: Refer to Sample 23/5/B/18/SAW15  
1.02 Office  
Floor  
Vinyl floor tiles with bitumen adhesive containing:  
**Chrysotile (In both tile and bitumen)**

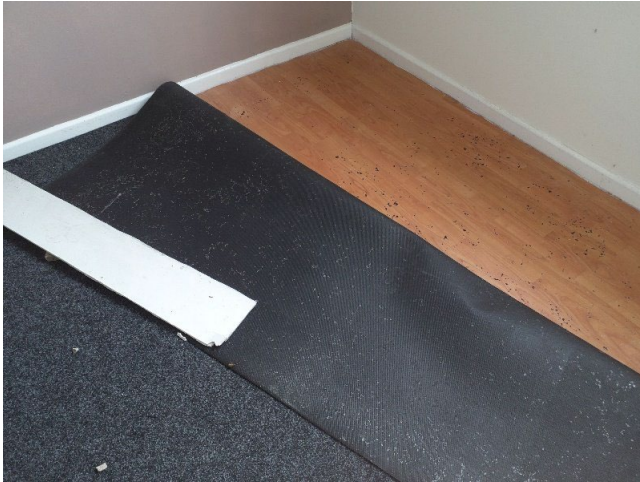
Sample No: Refer to Sample 23/5/B/18/SAW15  
1.03 Office  
Floor

| Sample Number | Location | ACM Type | Material Risk Score | Recommendation |
|---|---|---|---|---|
| Refer to Sample 23/5/B/18/SAW15 | 1.03 - Office - Floor | Vinyl floor tiles with bitumen adhesive | 3 | Remove |

Vinyl floor tiles with bitumen adhesive containing:  
**Chrysotile (In both tile and bitumen)**

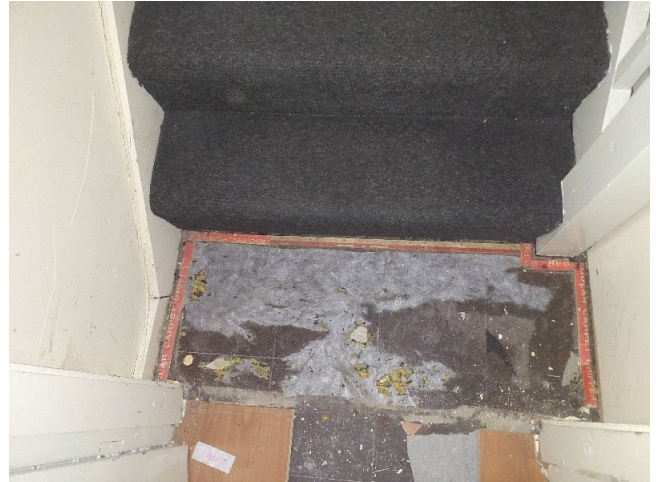
Sample No: Refer to Sample 23/5/B/18/SAW15  
1.04 Stairwell  
Floor

| Sample Number | Location | ACM Type | Material Risk Score | Recommendation |
|---|---|---|---|---|
| Refer to Sample 23/5/B/18/SAW15 | 1.04 - Stairwell - Floor | Vinyl floor tiles with bitumen adhesive | 3 | Remove |

Vinyl floor tiles with bitumen adhesive containing:  
**Chrysotile (In both tile and bitumen)**
