**Lead Surveyor:** S. Warburton  
**Assistant Surveyor(s):** N/A  
**Date of Survey(s):** 18th May 2023  
**Report Reference:** CH.23.5.237.LW  
**Date Report Issued:** 19 May 2023  
**Purpose of Survey:**  
(Refer to Section 2.2  
of this report for  
clarification)

## Report on Survey of Asbestos Materials at

**Former William Hill's Bookmakers**  
**Blackburn Street**  
**Radcliffe**  
**M26 1AB**

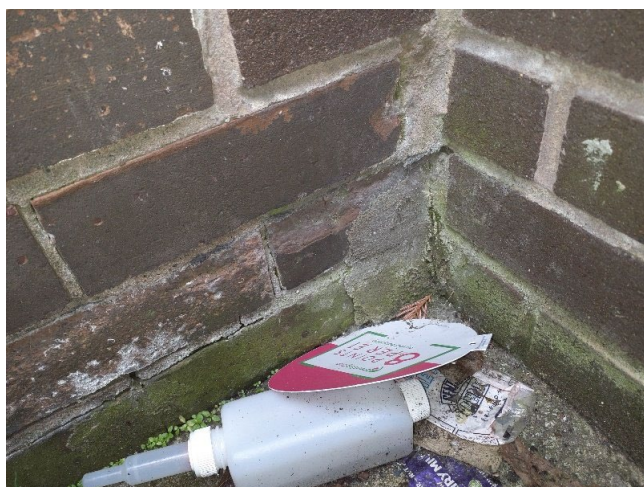
Sample No: 23/5/B/18/SAW10  
External  
Damp proof course  
Bitumen damp proof  
**No Asbestos Detected**

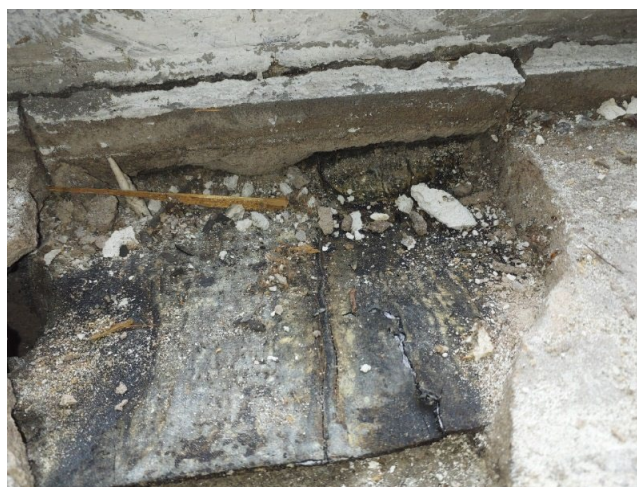
Sample No: 23/5/B/18/SAW11  
External  
Window reveals  
Bitumen vapour barrier  
**No Asbestos Detected**

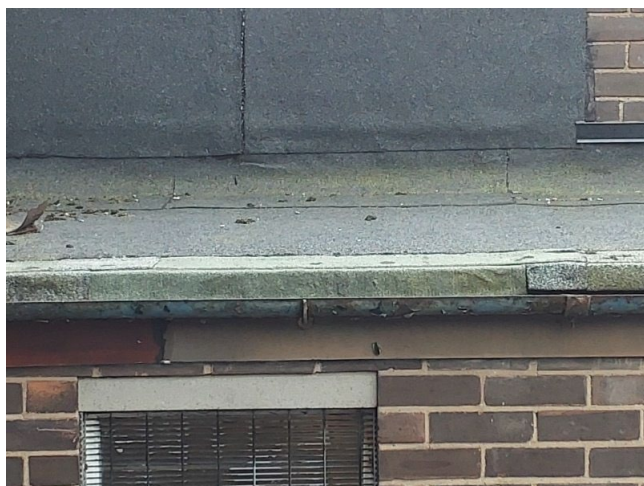
Sample No: 23/5/B/18/SAW12  
External  
Roof  
Core sample  
**No Asbestos Detected**

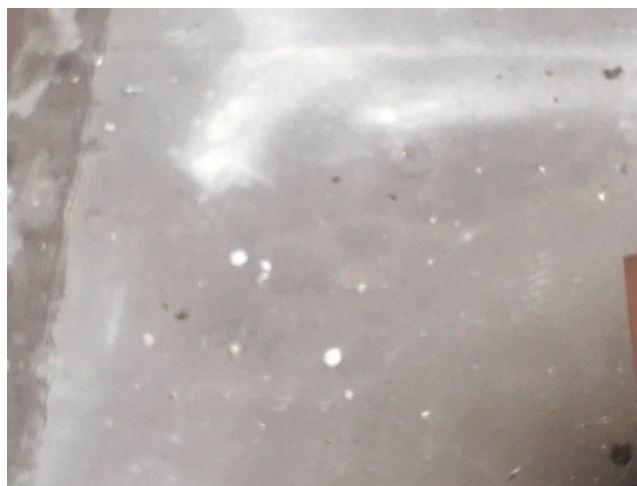
Sample No: 23/5/B/18/SAW13  
External  
Roof  
Core sample  
**No Asbestos Detected**

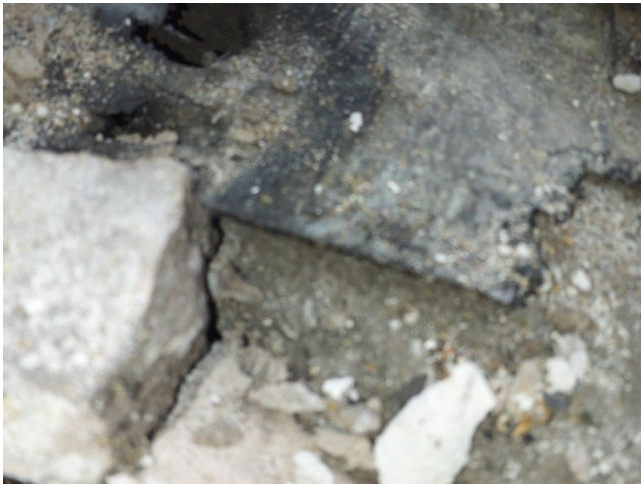
Sample No: Refer to Sample 23/5/B/18/SAW1  
External  
Window reveals  
Bitumen vapour barrier  
**No Asbestos Detected**

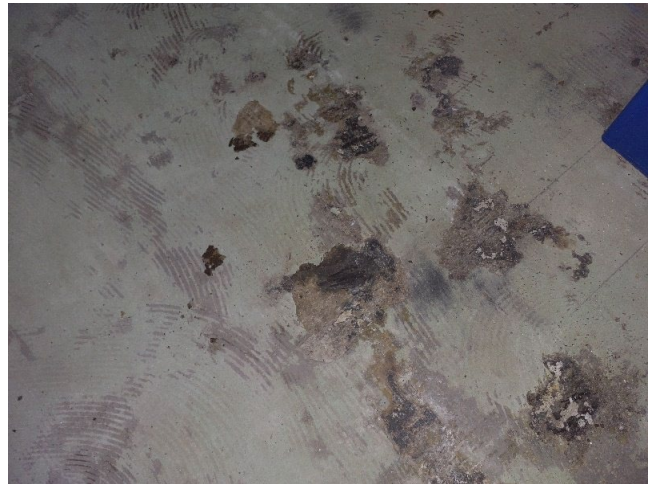
| Sample Number | Location | ACM Type | Material Risk Score | Recommendation |
|---|---|---|---|---|
| 23/5/B/18/SAW1 | G.01 - Shop area - Floor below screed | Bitumen adhesive residuals | 3 | Remove |

Sample No: 23/5/B/18/SAW1  
G.01 Shop area  
Floor below screed  
Bitumen adhesive residuals containing:  
**Chrysotile**

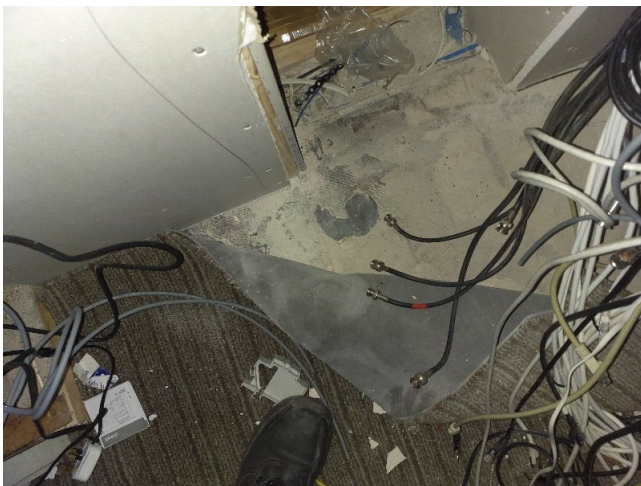
| Sample Number | Location | ACM Type | Material Risk Score | Recommendation |
|---|---|---|---|---|
| Refer to Sample 23/5/B/18/SAW1 | G.02 - Cupboard - Floor below screed | Bitumen adhesive residuals | 3 | Remove |

Sample No: Refer to Sample 23/5/B/18/SAW1  
G.02 Cupboard  
Floor below screed  
Bitumen adhesive residuals containing:  
**Chrysotile**

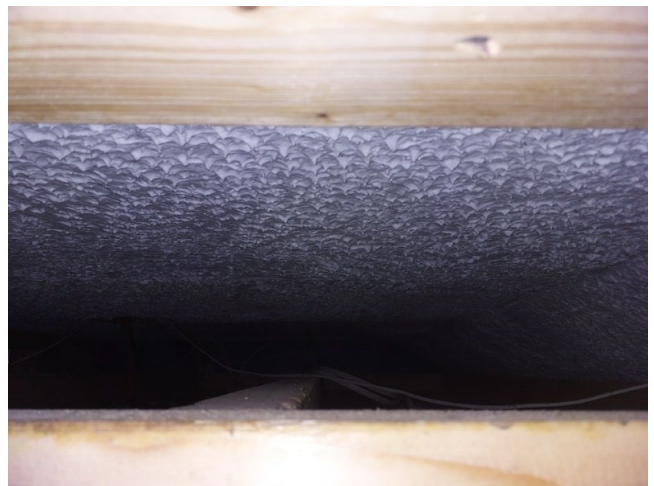
Sample No: 23/5/B/18/SAW2  
G.03 Customer toilet  
Ceiling void  
Textured coating to plasterboard ceiling  
**No Asbestos Detected**

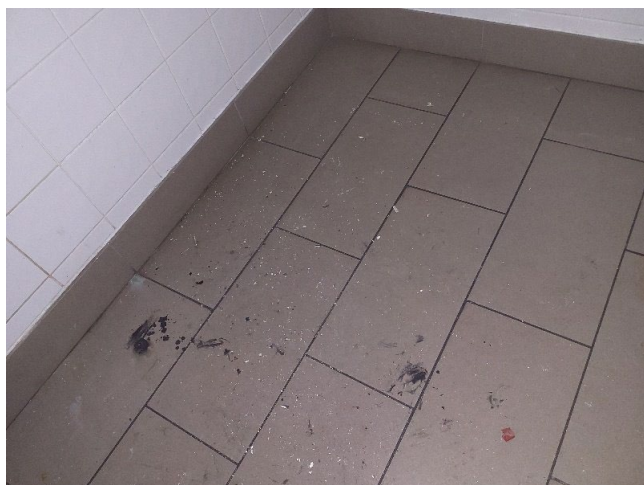
| Sample Number | Location | ACM Type | Material Risk Score | Recommendation |
|---|---|---|---|---|
| Refer to Sample 23/5/B/18/SAW1 | G.03 - Customer toilet - Floor below screed | Bitumen adhesive residuals | 3 | Remove |

Sample No: Refer to Sample 23/5/B/18/SAW1  
G.03 Customer toilet  
Floor below screed  
Bitumen adhesive residuals containing:  
**Chrysotile**

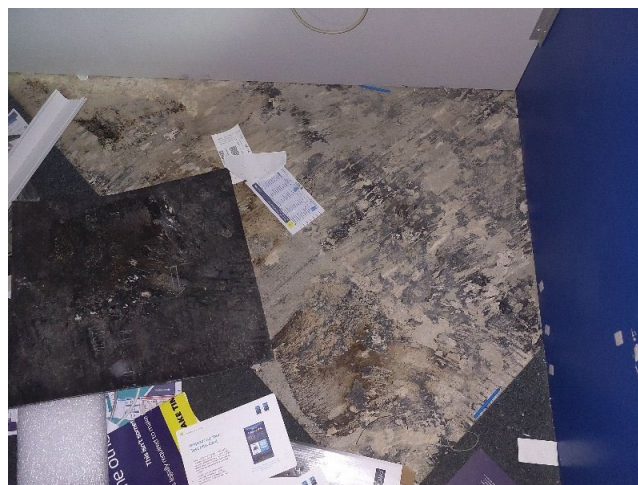
| Sample Number | Location | ACM Type | Material Risk Score | Recommendation |
|---|---|---|---|---|
| Refer to Sample 23/5/B/18/SAW1 | G.04 - Service counter - Floor below screed | Bitumen adhesive residuals | 3 | Remove |

Sample No: Refer to Sample 23/5/B/18/SAW1  
G.04 Service counter  
Floor below screed  
Bitumen adhesive residuals containing:  
**Chrysotile**

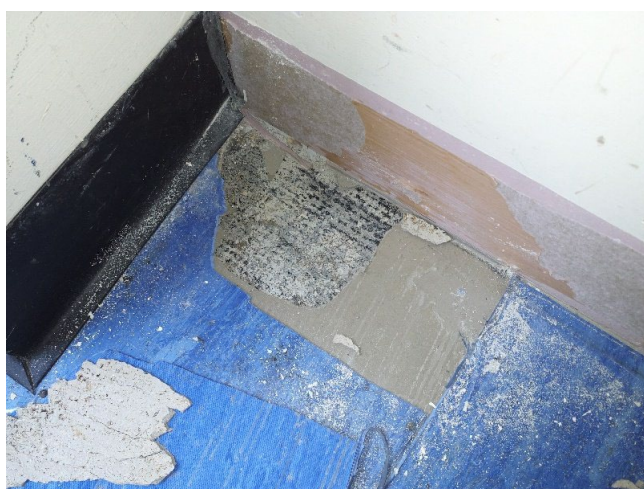
| Sample Number | Location | ACM Type | Material Risk Score | Recommendation |
|---|---|---|---|---|
| Refer to Sample 23/5/B/18/SAW1 | G.05 - Rear circulation - Floor below screed | Bitumen adhesive residuals | 3 | Remove |

Sample No: Refer to Sample 23/5/B/18/SAW1  
G.05 Rear circulation  
Floor below screed  
Bitumen adhesive residuals containing:  
**Chrysotile**

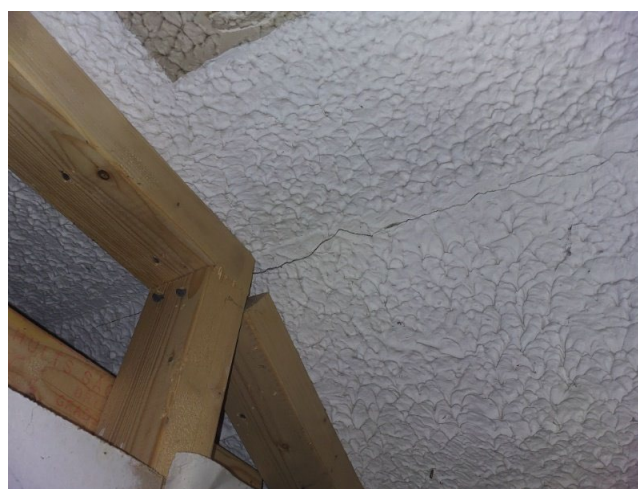
Sample No: Refer to Sample 23/5/B/18/SAW2  
G.05 Rear circulation  
Ceiling void  
Textured coating to plasterboard ceiling  
**No Asbestos Detected**

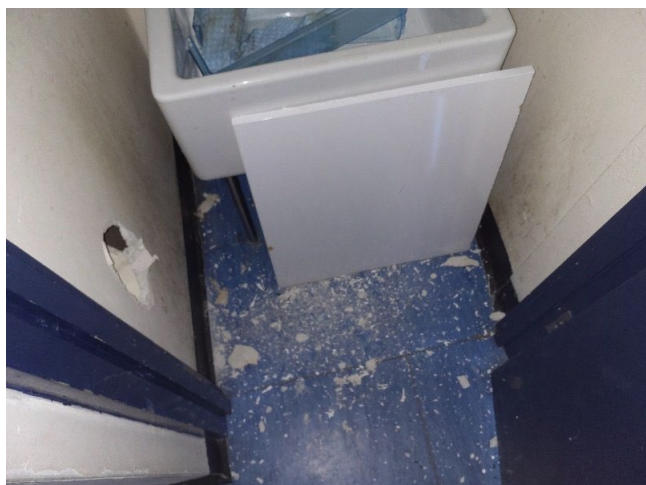
| Sample Number | Location | ACM Type | Material Risk Score | Recommendation |
|---|---|---|---|---|
| Refer to Sample 23/5/B/18/SAW1 | G.06 - Cleaner's cupboard - Floor below screed | Bitumen adhesive residuals | 3 | Remove |

Sample No: Refer to Sample 23/5/B/18/SAW1  
G.06 Cleaner's cupboard  
Floor below screed  
Bitumen adhesive residuals containing:  
**Chrysotile**

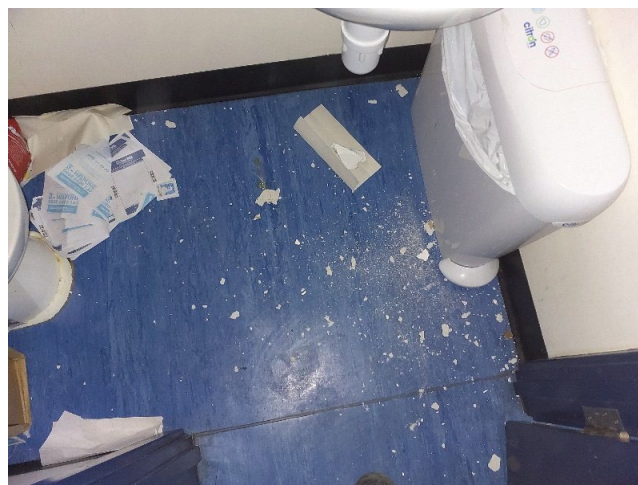
| Sample Number | Location | ACM Type | Material Risk Score | Recommendation |
|---|---|---|---|---|
| Refer to Sample 23/5/B/18/SAW1 | G.07 - Staff toilet - Floor below screed | Bitumen adhesive residuals | 3 | Remove |

Sample No: Refer to Sample 23/5/B/18/SAW1  
G.07 Staff toilet  
Floor below screed  
Bitumen adhesive residuals containing:  
**Chrysotile**

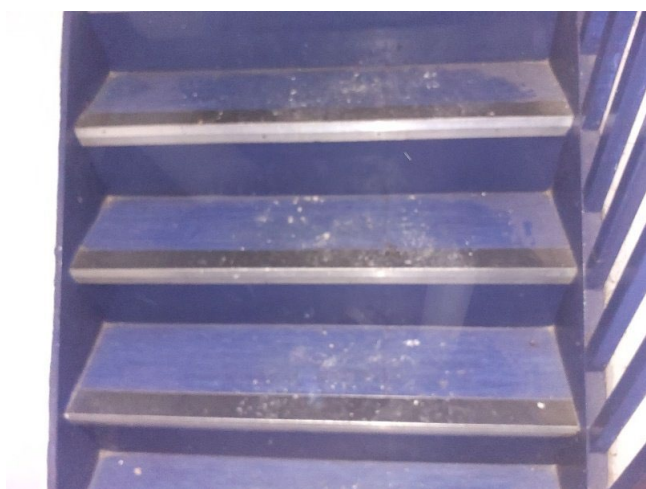
Sample No: 23/5/B/18/SAW3  
G.08 Stairwell  
Staircase  
Nose edgings  
**No Asbestos Detected**

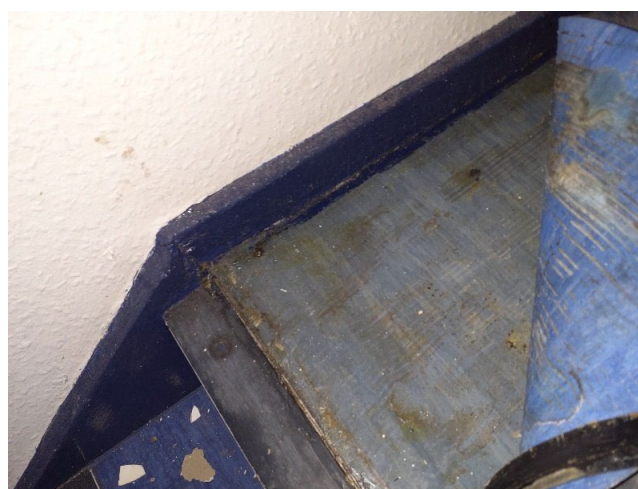
Sample No: 23/5/B/18/SAW4  
1.01 Landing  
Bottom layer of floor covering  
Vinyl floor covering  
**No Asbestos Detected**

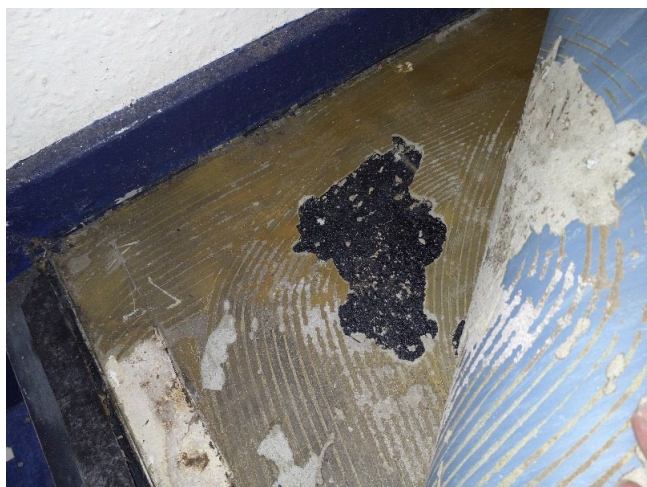
| Sample Number | Location | ACM Type | Material Risk Score | Recommendation |
|---|---|---|---|---|
| 23/5/B/18/SAW5 | 1.01 - Landing - Floor below screed | Bitumen adhesive residuals | 3 | Remove |

Sample No: 23/5/B/18/SAW5  
1.01 Landing  
Floor below screed  
Bitumen adhesive residuals containing:  
**Chrysotile**

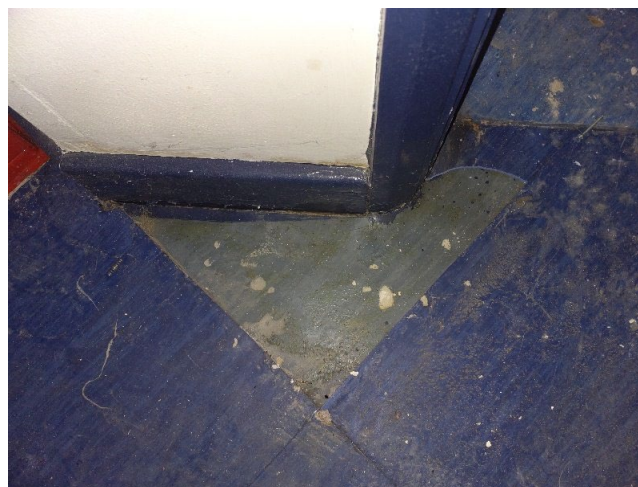
Sample No: Refer to Sample 23/5/B/18/SAW4  
1.02 Circulation  
Bottom layer of floor covering  
Vinyl floor covering  
**No Asbestos Detected**

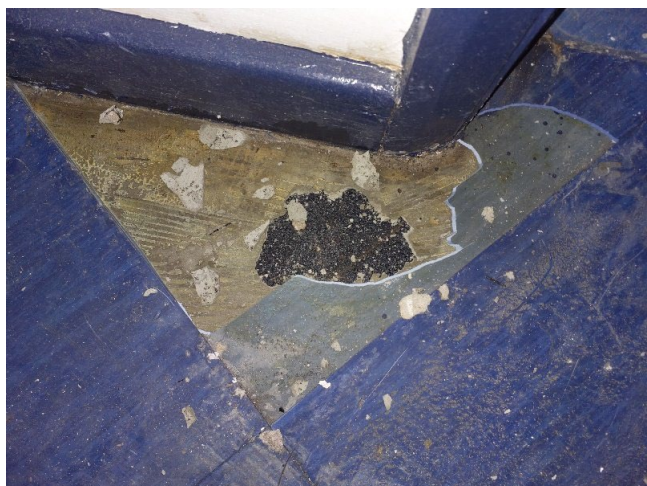
| Sample Number | Location | ACM Type | Material Risk Score | Recommendation |
|---|---|---|---|---|
| Refer to Sample 23/5/B/18/SAW5 | 1.02 - Circulation - Floor below screed | Bitumen adhesive residuals | 3 | Remove |

Sample No: Refer to Sample 23/5/B/18/SAW5  
1.02 Circulation  
Floor below screed  
Bitumen adhesive residuals containing:  
**Chrysotile**

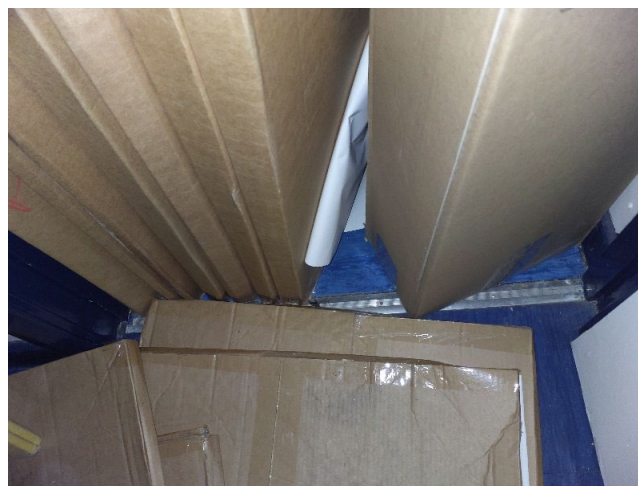
Sample No: Refer to Sample 23/5/B/18/SAW4  
1.03 Cupboard  
Bottom layer of floor covering  
Vinyl floor covering  
**No Asbestos Detected**

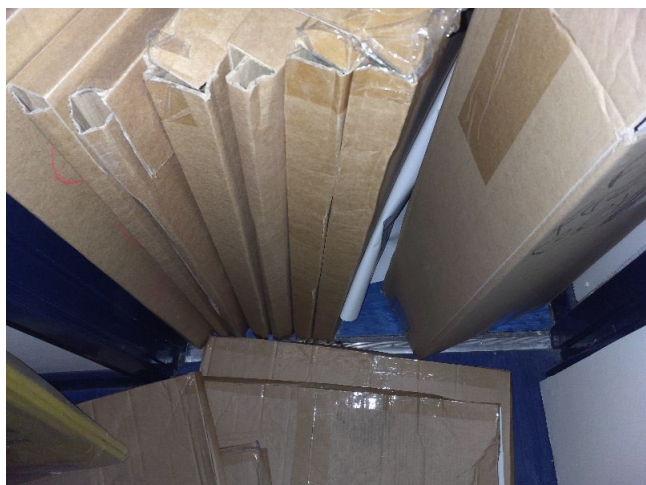
| Sample Number | Location | ACM Type | Material Risk Score | Recommendation |
|---|---|---|---|---|
| Refer to Sample 23/5/B/18/SAW5 | 1.03 - Cupboard - Floor below screed | Bitumen adhesive residuals | 3 | Remove |

Sample No: Refer to Sample 23/5/B/18/SAW5  
1.03 Cupboard  
Floor below screed  
Bitumen adhesive residuals containing:  
**Chrysotile**

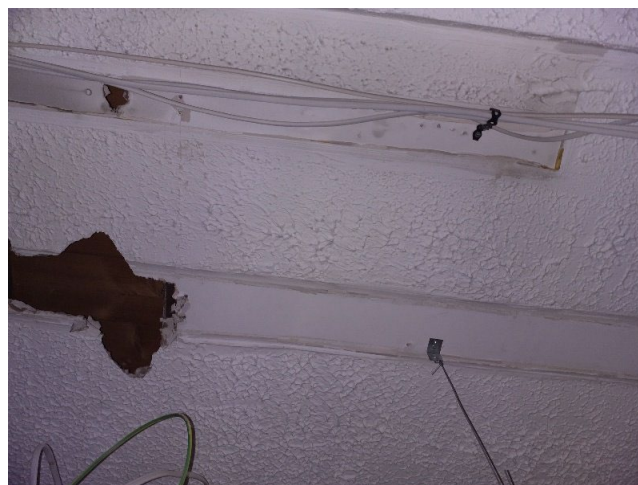
Sample No: 23/5/B/18/SAW6  
1.04 Staff kitchen  
Ceiling void  
Textured coating to plasterboard ceiling  
**No Asbestos Detected**

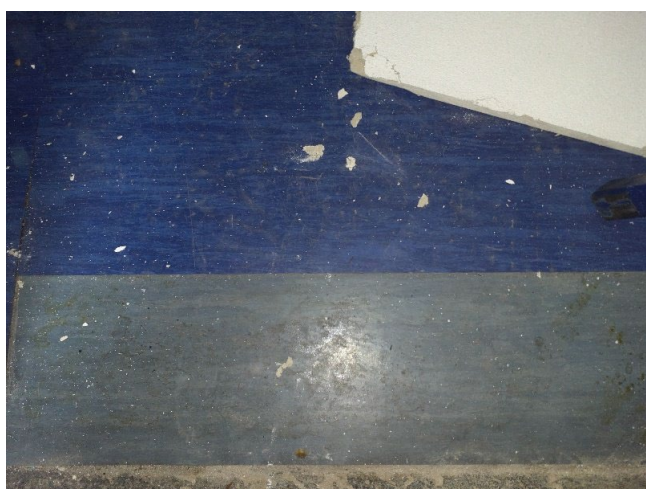
Sample No: Refer to Sample 23/5/B/18/SAW4  
1.05 Toilet and lobby  
Bottom layer of floor covering  
Vinyl floor covering  
**No Asbestos Detected**

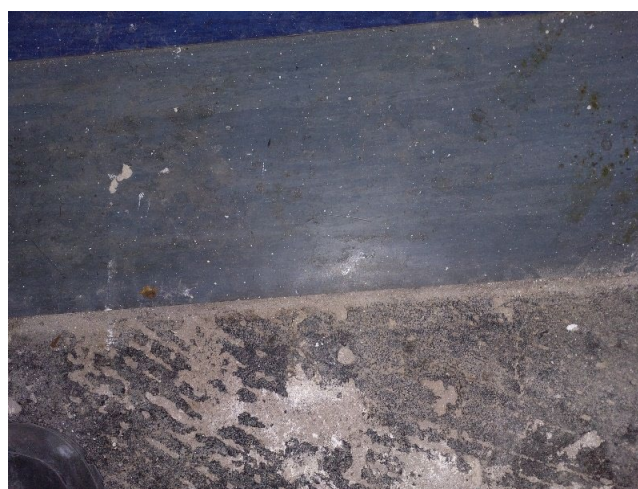
| Sample Number | Location | ACM Type | Material Risk Score | Recommendation |
|---|---|---|---|---|
| Refer to Sample 23/5/B/18/SAW5 | 1.05 - Toilet and lobby - Floor below screed | Bitumen adhesive residuals | 3 | Remove |

Sample No: Refer to Sample 23/5/B/18/SAW5  
1.05 Toilet and lobby  
Floor below screed  
Bitumen adhesive residuals containing:  
**Chrysotile**

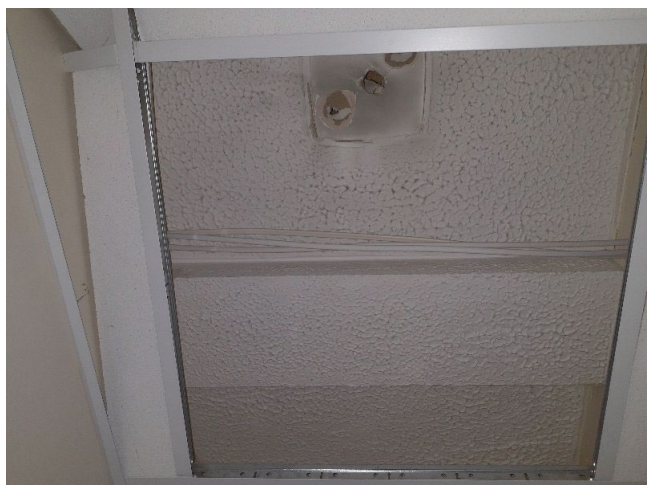
Sample No: Refer to Sample 23/5/B/18/SAW6  
1.05 Toilet and lobby  
Ceiling void  
Textured coating to plasterboard ceiling  
**No Asbestos Detected**

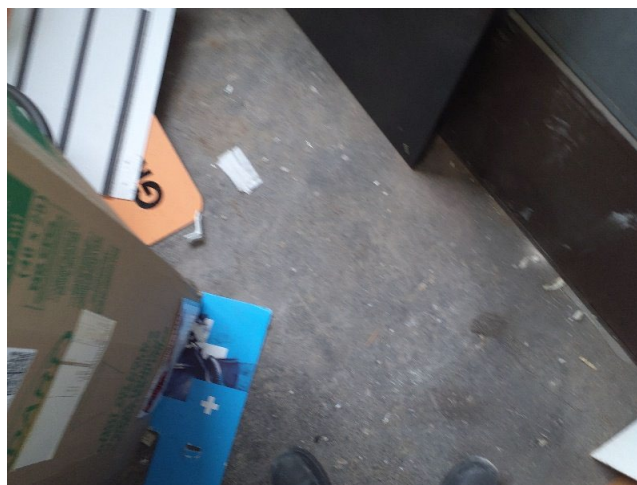
| Sample Number | Location | ACM Type | Material Risk Score | Recommendation |
|---|---|---|---|---|
| Refer to Sample 23/5/B/18/SAW5 | 1.06 - Store room - Floor | Bitumen adhesive residuals | 3 | Remove |

Sample No: Refer to Sample 23/5/B/18/SAW5  
1.06 Store room  
Floor  
Bitumen adhesive residuals containing:  
**Chrysotile**

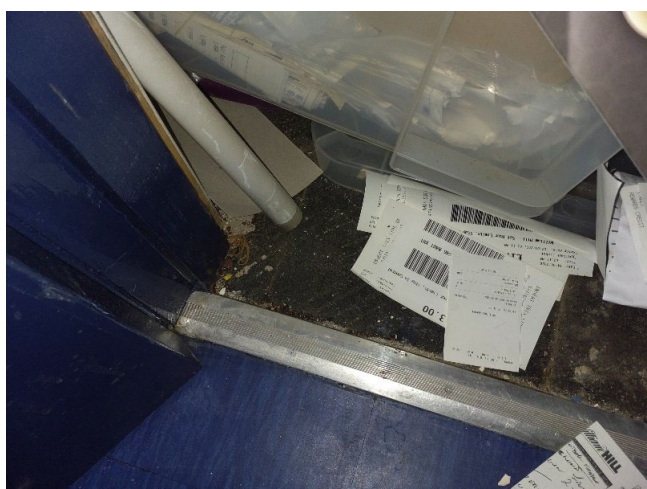
| Sample Number | Location | ACM Type | Material Risk Score | Recommendation |
|---|---|---|---|---|
| Refer to Sample 23/5/B/18/SAW5 | 1.07 - Cupboard - Floor below screed | Bitumen adhesive residuals | 3 | Remove |

Sample No: Refer to Sample 23/5/B/18/SAW5  
1.07 Cupboard  
Floor below screed  
Bitumen adhesive residuals containing:  
**Chrysotile**

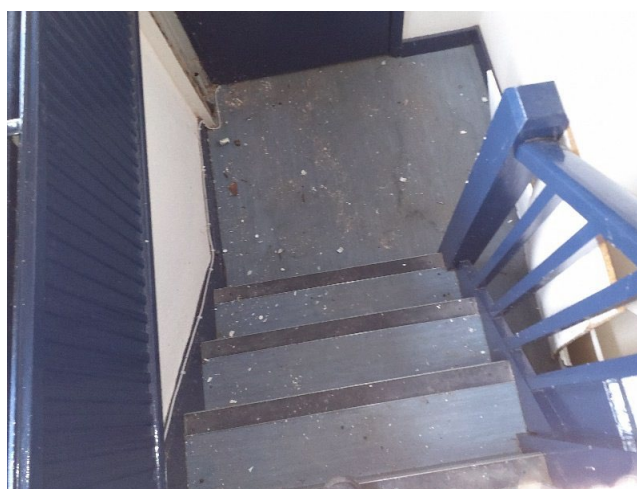
Sample No: Refer to Sample 23/5/B/18/SAW4  
1.08 Stairwell  
Floor and staircase  
Vinyl floor covering  
**No Asbestos Detected**

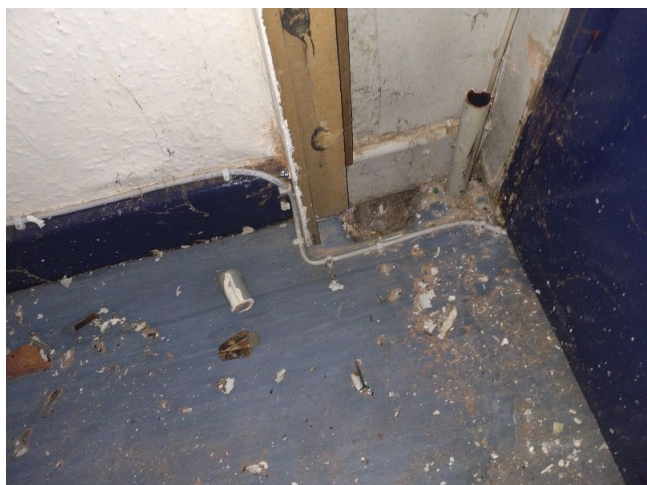
| Sample Number | Location | ACM Type | Material Risk Score | Recommendation |
|---|---|---|---|---|
| Refer to Sample 23/5/B/18/SAW5 | 1.08 - Stairwell - Floor below screed | Bitumen adhesive residuals | 3 | Remove |

Sample No: Refer to Sample 23/5/B/18/SAW5  
1.08 Stairwell  
Floor below screed  
Bitumen adhesive residuals containing:  
**Chrysotile**

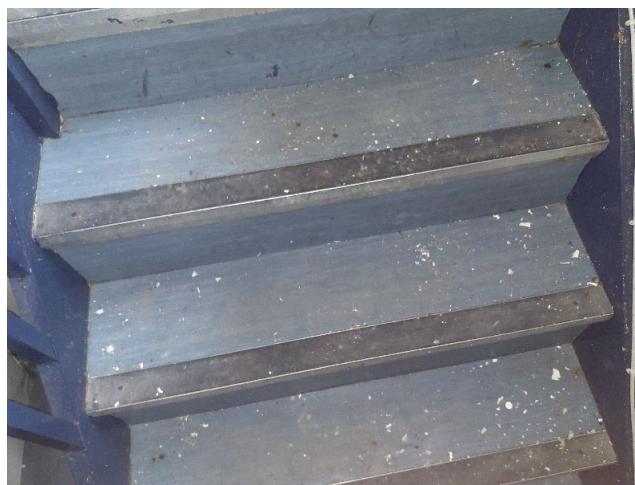
Sample No: Refer to Sample 23/5/B/18/SAW3  
1.08 Stairwell  
Staircase  
Nose edgings  
**No Asbestos Detected**

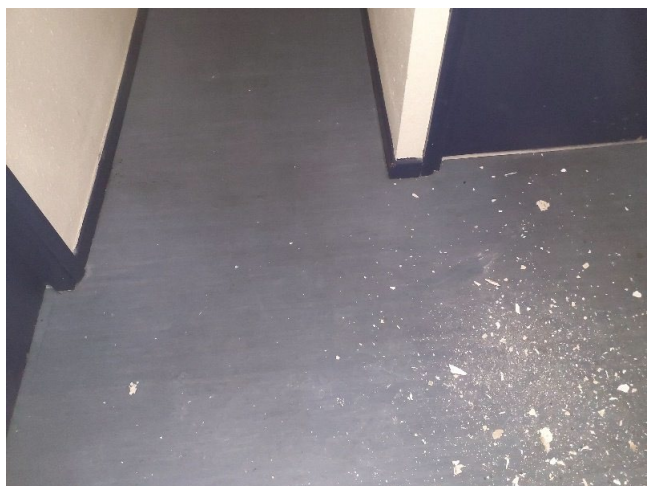
Sample No: 23/5/B/18/SAW7  
2.01 Landing  
Floor  
Vinyl floor covering  
**No Asbestos Detected**

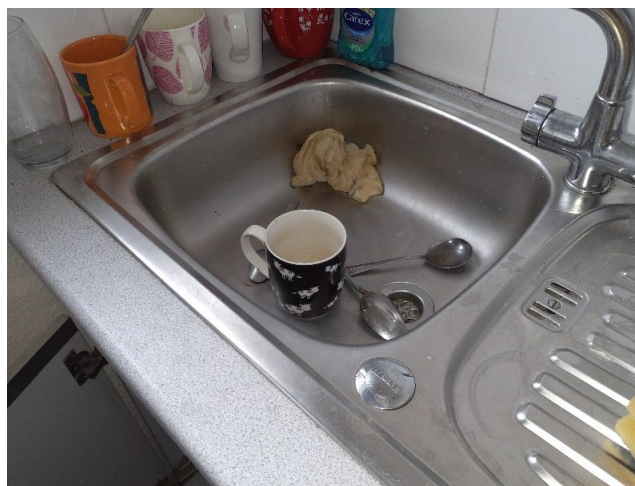
Sample No: 23/5/B/18/SAW8  
2.02 Kitchen  
Sink  
Sink pad  
**No Asbestos Detected**

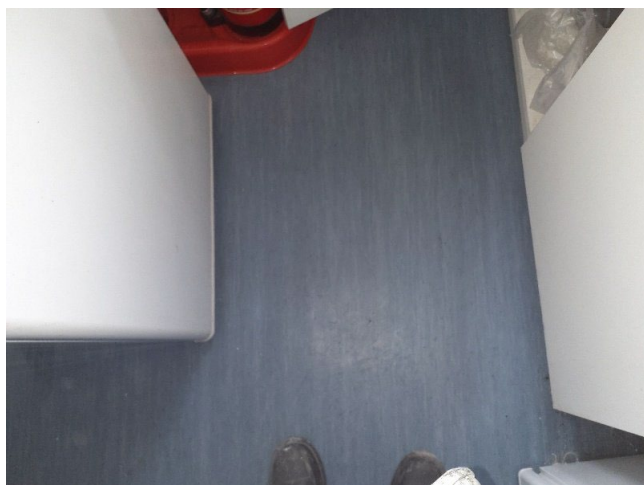
Sample No: Refer to Sample 23/5/B/18/SAW7  
2.02 Kitchen  
Floor  
Vinyl floor covering  
**No Asbestos Detected**

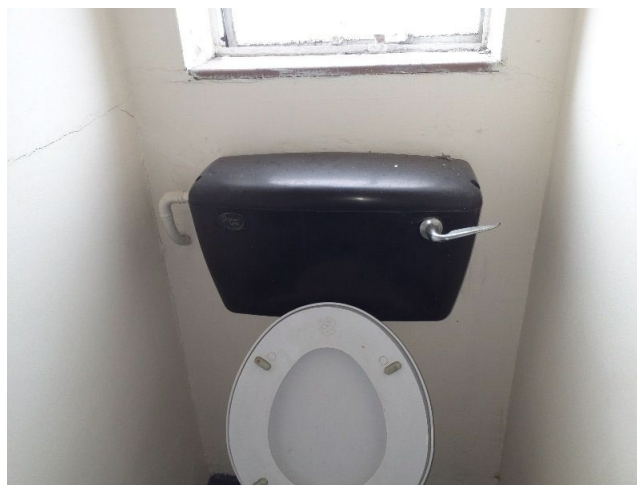
| Sample Number | Location | ACM Type | Material Risk Score | Recommendation |
|---|---|---|---|---|
| 23/5/B/18/SAW9 | 2.03 - Toilet - Wall | Thermoplastic cistern | 4 | Remove |

Sample No: 23/5/B/18/SAW9  
2.03 Toilet  
Wall  
Thermoplastic cistern containing:  
**Amosite**

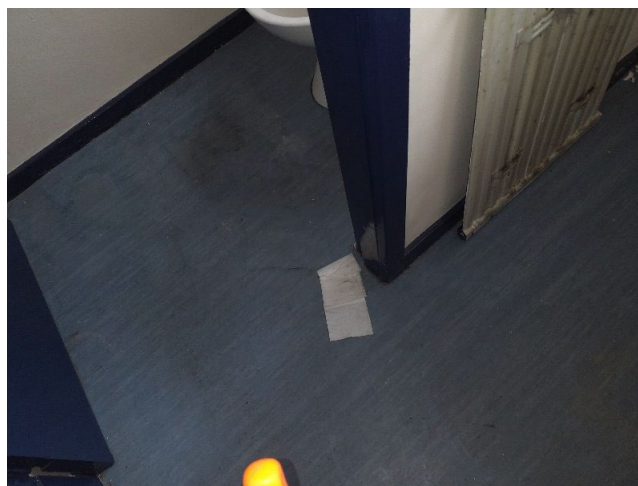
Sample No: Refer to Sample 23/5/B/18/SAW7  
2.03 Toilet  
Floor  
Vinyl floor covering  
**No Asbestos Detected**
