# Preliminary Roost Assessment

54 Ringley Road  
Whitefield  
Manchester  
M45 7LL

For  
Inderjit Kohli

# Gritstone Ecology

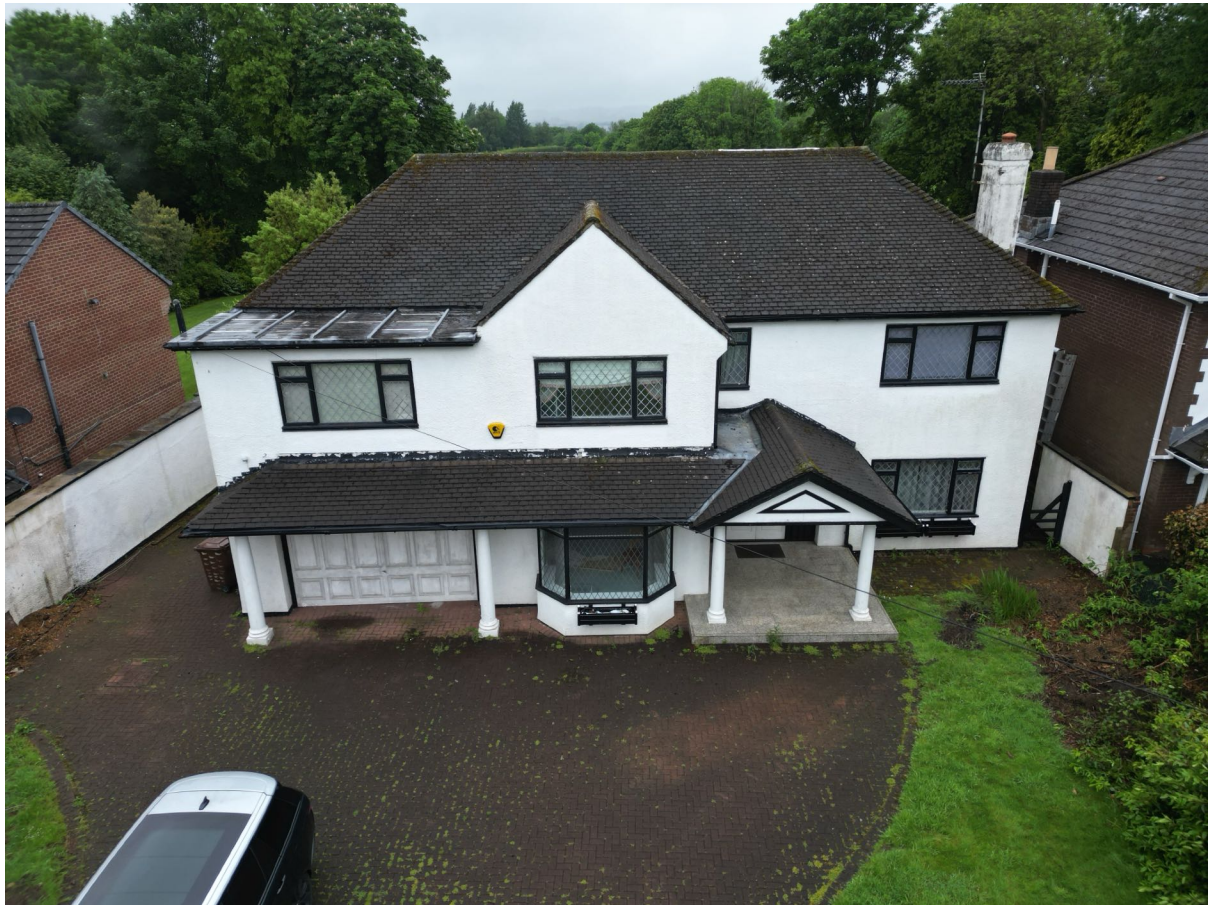
3.1a – The front of the house.

The building is well maintained, and in good condition. Ridge tiles are fixed tightly, there are no damaged or missing ridge tiles. There are no damaged, slipped, or missing roof tiles. Roof tiles are tightly fitted, with no gaps between tiles. Fascia boards and boxed soffits are fitted tightly against the walls with no viable gaps. Walls and render are in good condition, with no missing mortar or cracks.

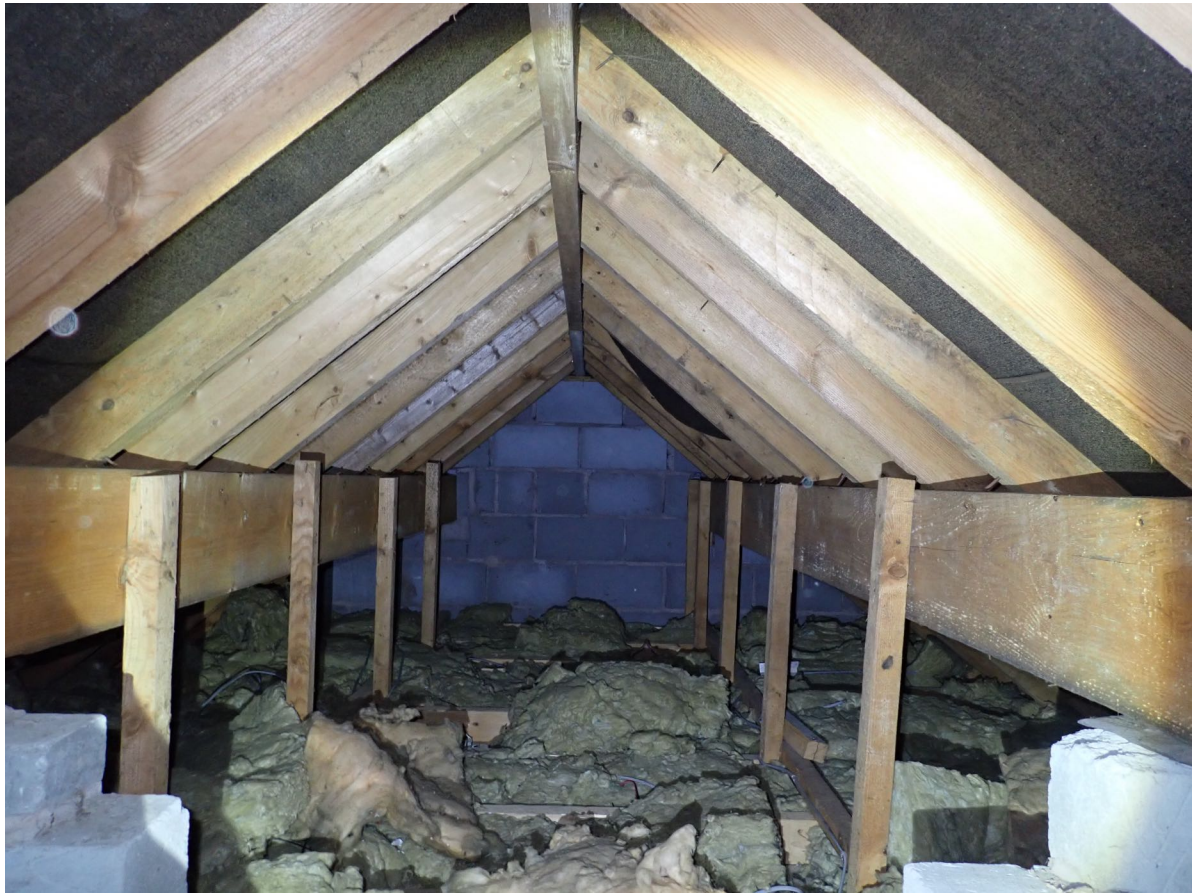
3.2a – The roof void.

The roof has a timber rafter and purlin structure, lined with bitumen felt, and insulated with mineral wool between the ceiling joists. The roof lining is in good condition with no tears, or gaps.

The wall cavity was inspected at the wall plate using an endoscope. There are no gaps at the wall-plate; and there are no gaps which give direct access to the roof void from the outside. Boxed soffits open into the roof void and were inspected from above.

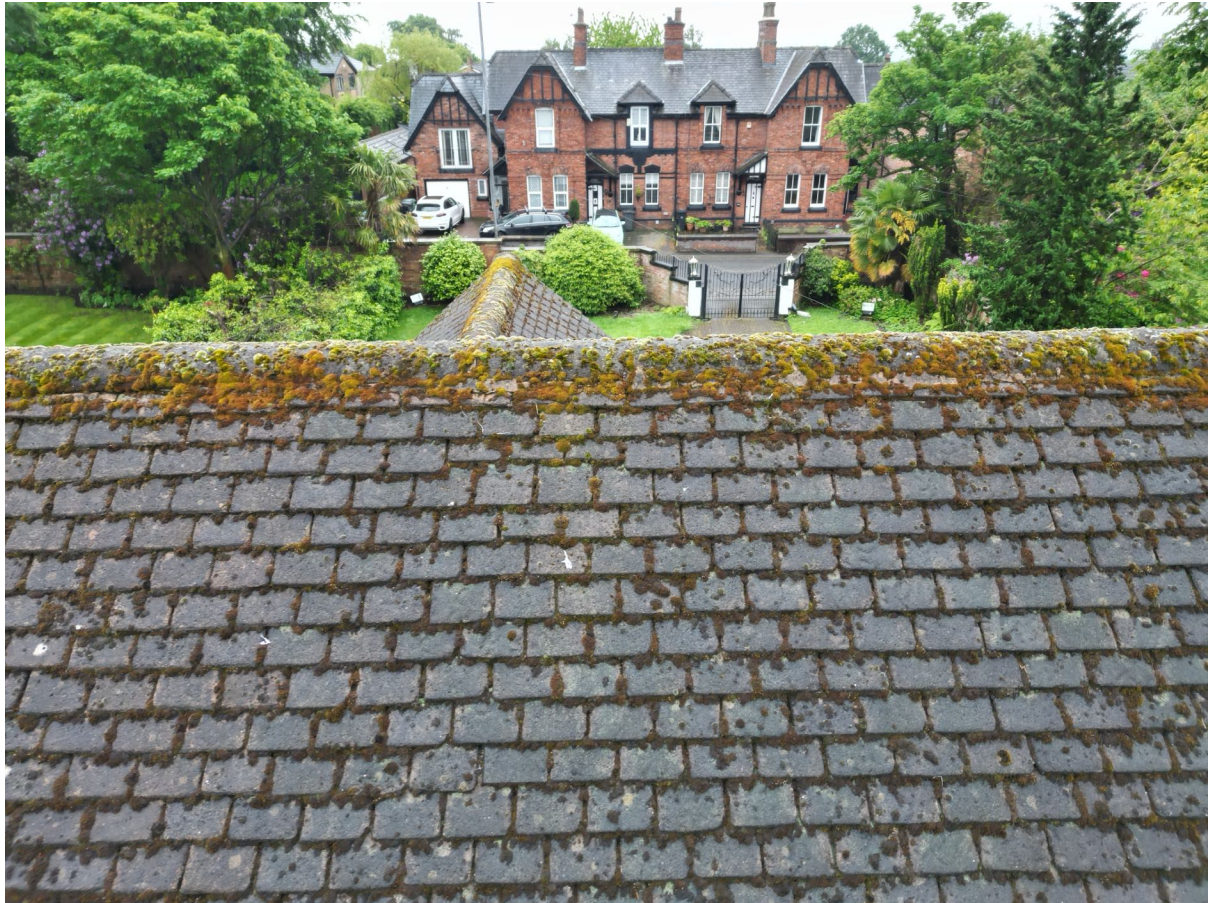
Roof and ridge tiles are in good condition; ridge tiles are sealed with cement. There are no gaps between roofing materials which could be used by roosting bats.

3 – Roof and ridge tiles are in good condition with no suitable gaps.

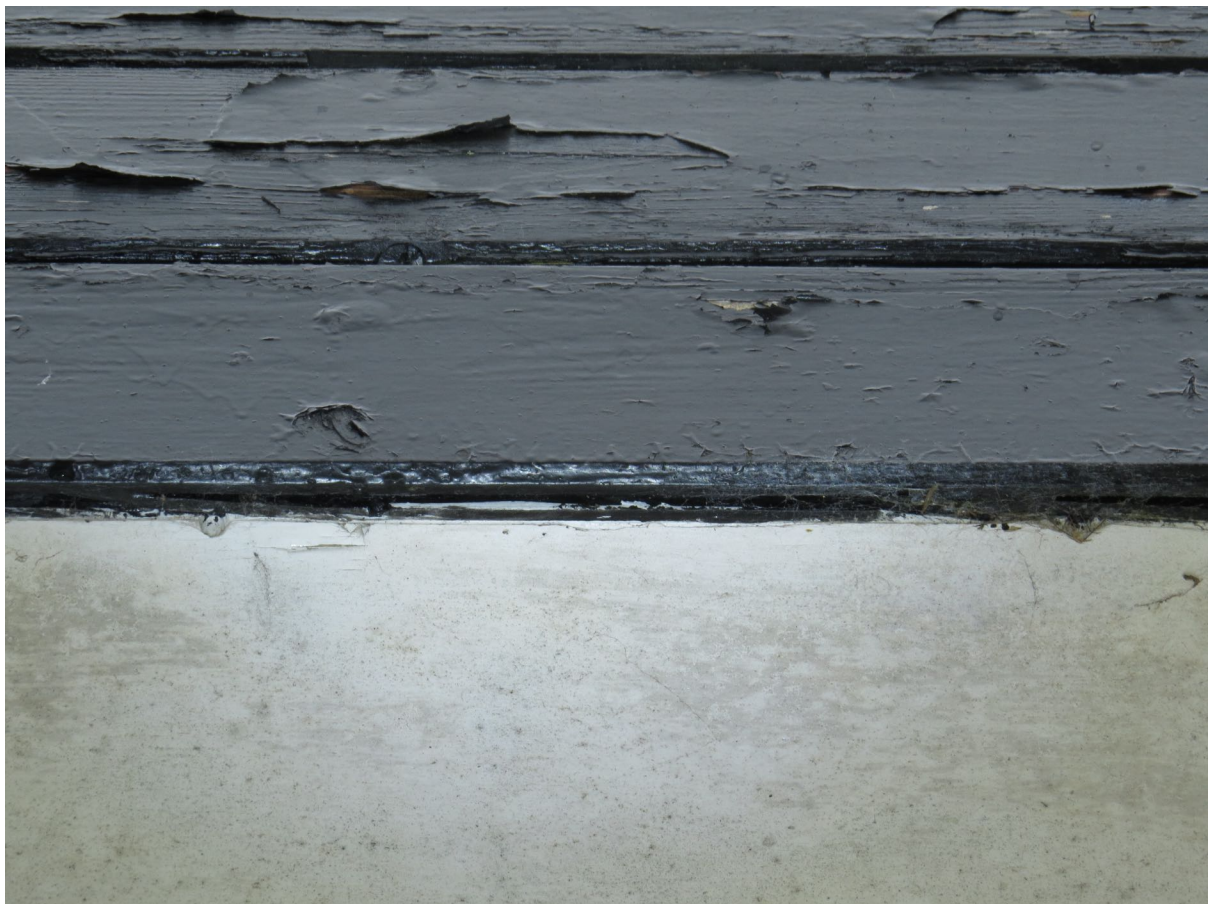
Fascia boards and boxed soffits at the eaves are fixed tightly against brickwork, with no suitable gaps; wall cavities and boxed soffits open into the roof void, and were inspected from above.

4 – Fascia boards and soffits at the eaves are fixed tightly against brickwork.

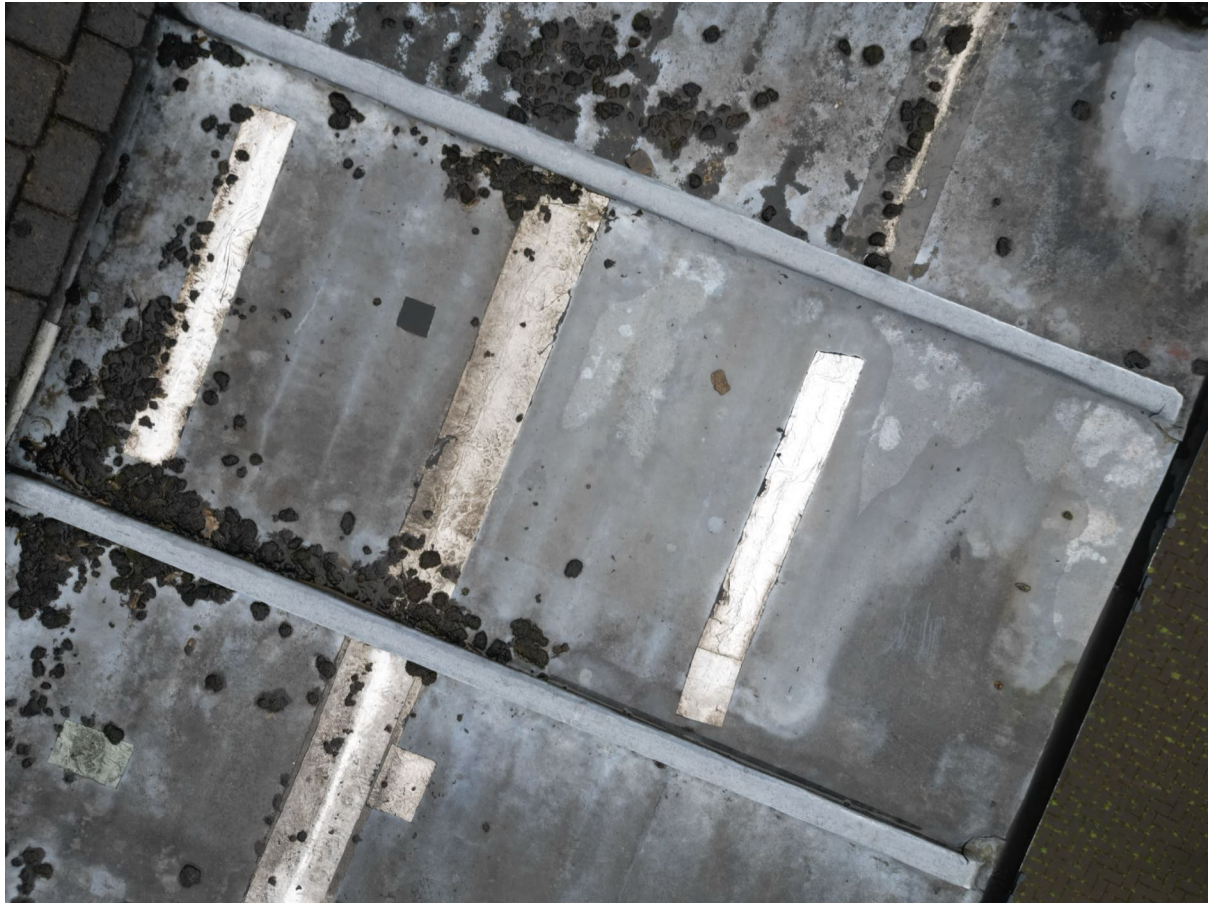
5 – Lead flashing is fitted tightly with no suitable gaps.

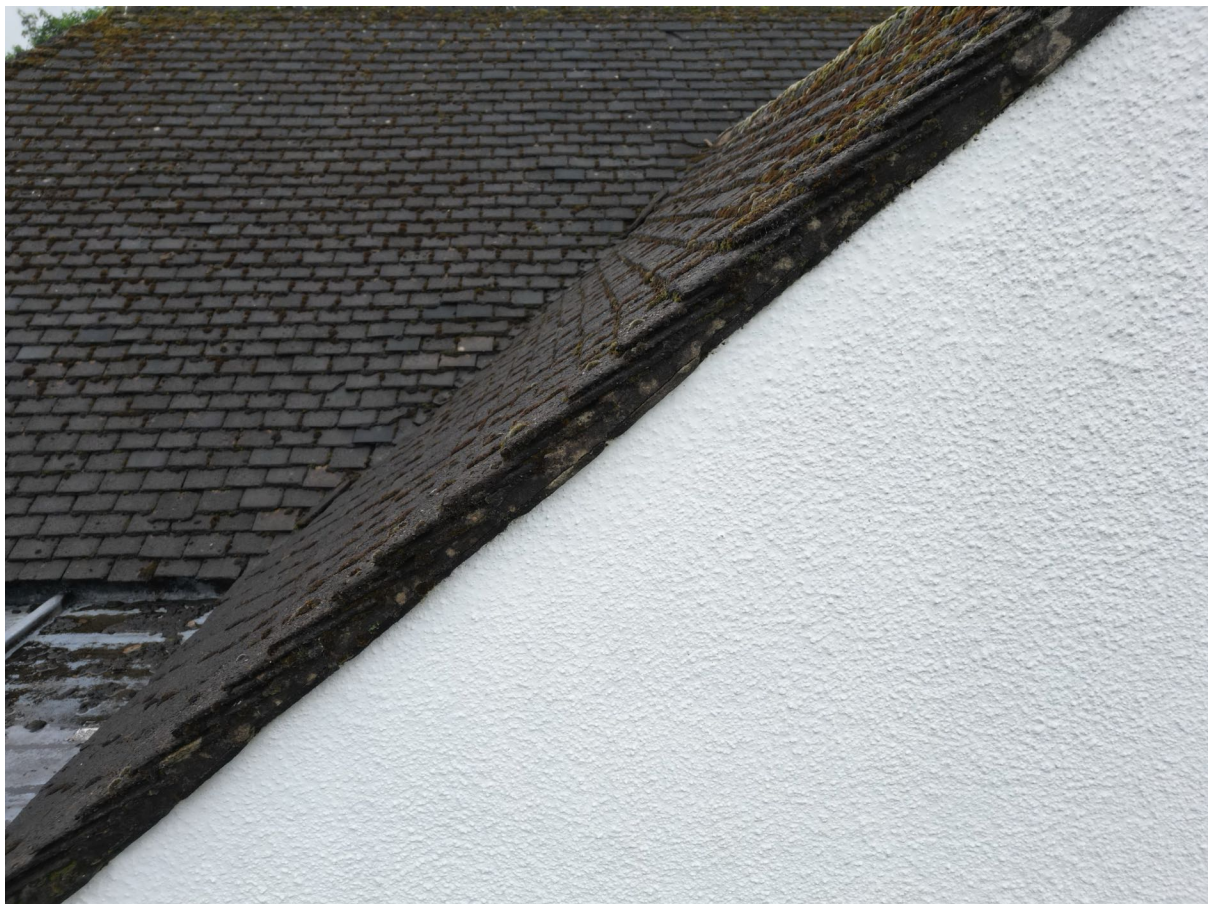
Walls are brick with an insulating cavity. Walls are in good condition, with no cracks, or missing mortar which could be used by crevice dwelling bats.

6 – Brickwork and render are in good condition with no suitable gaps.

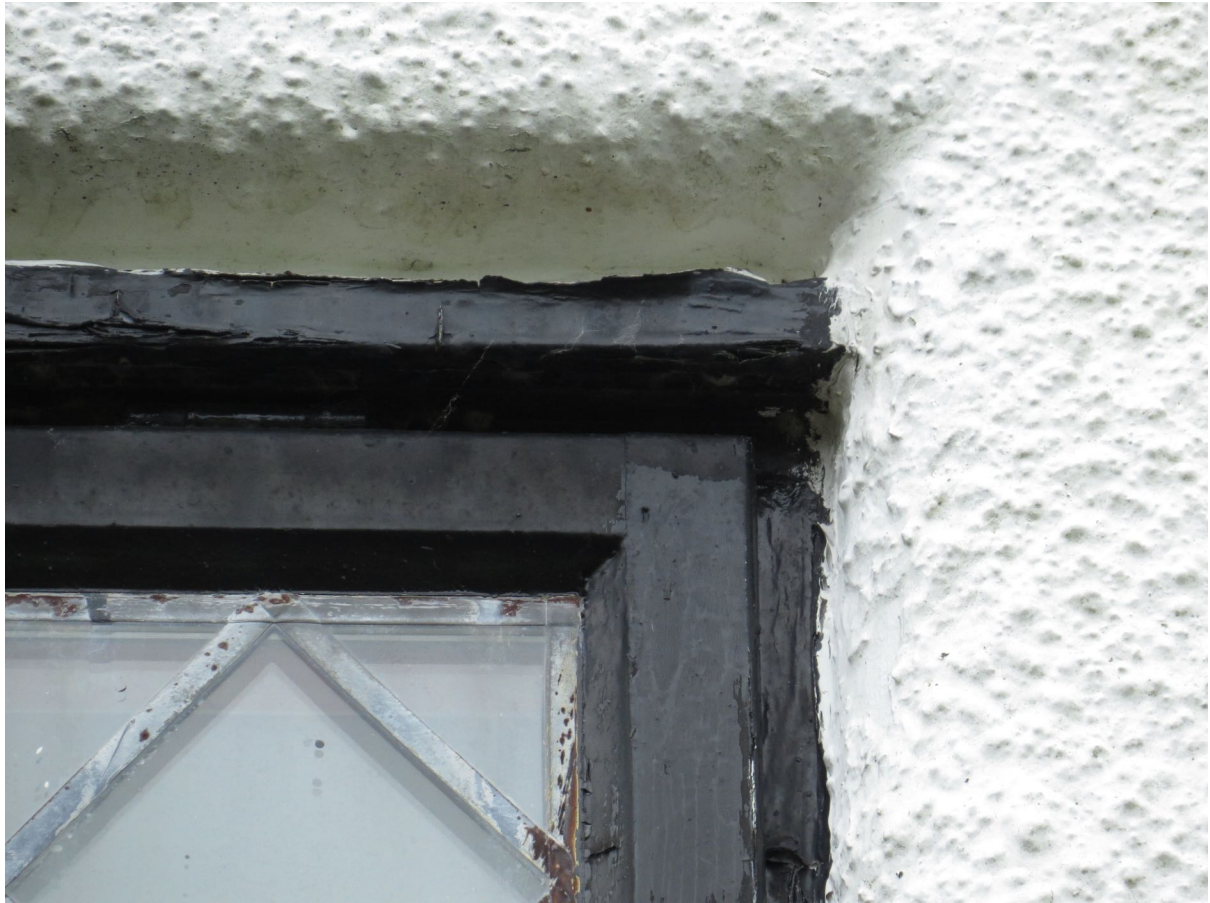
Window and door frames are fixed into the brickwork, gaps are filled with sealant, and offer no suitable roosting opportunities.

7 – Window and door frames are tightly sealed into brickwork with no suitable gaps.

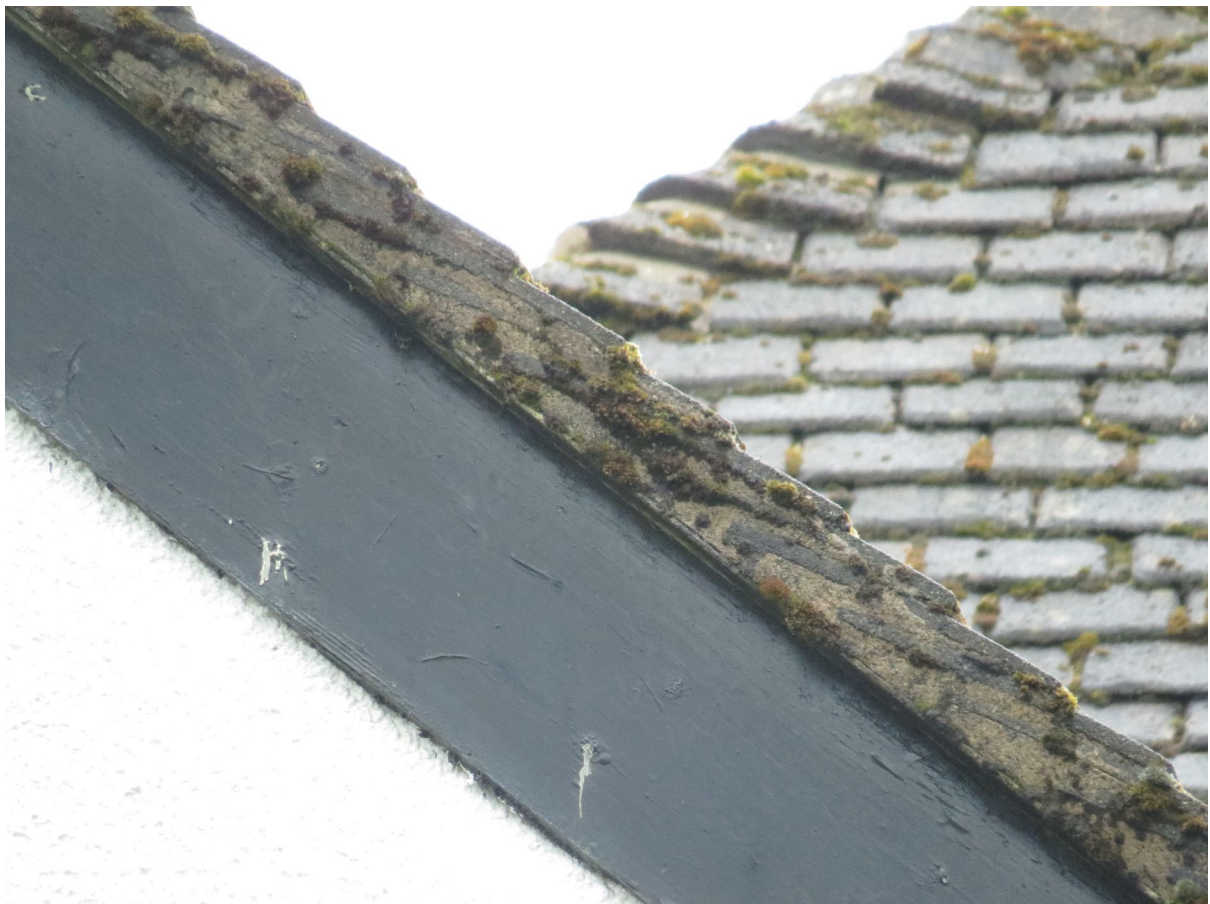
8 – Cement at the verges is in good condition with no suitable gaps.

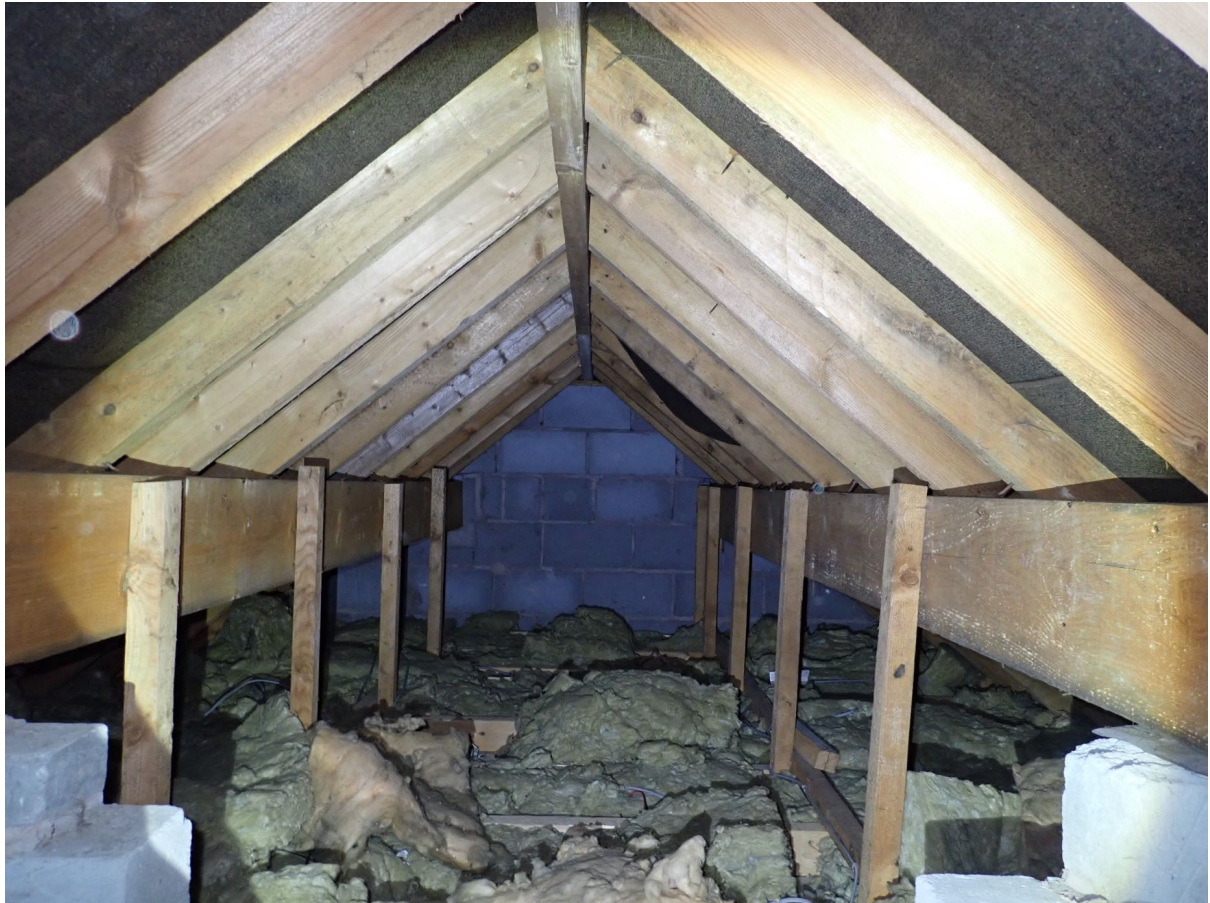
The majority of the roof has been converted to living space. However there are crawl spaces at the eaves, and small loft voids at the gables to the front and rear. The voids are not used for storage, and are accessed infrequently for essential maintenance.

9 – The house has loft voids at the gables and crawl spaces at the eaves.

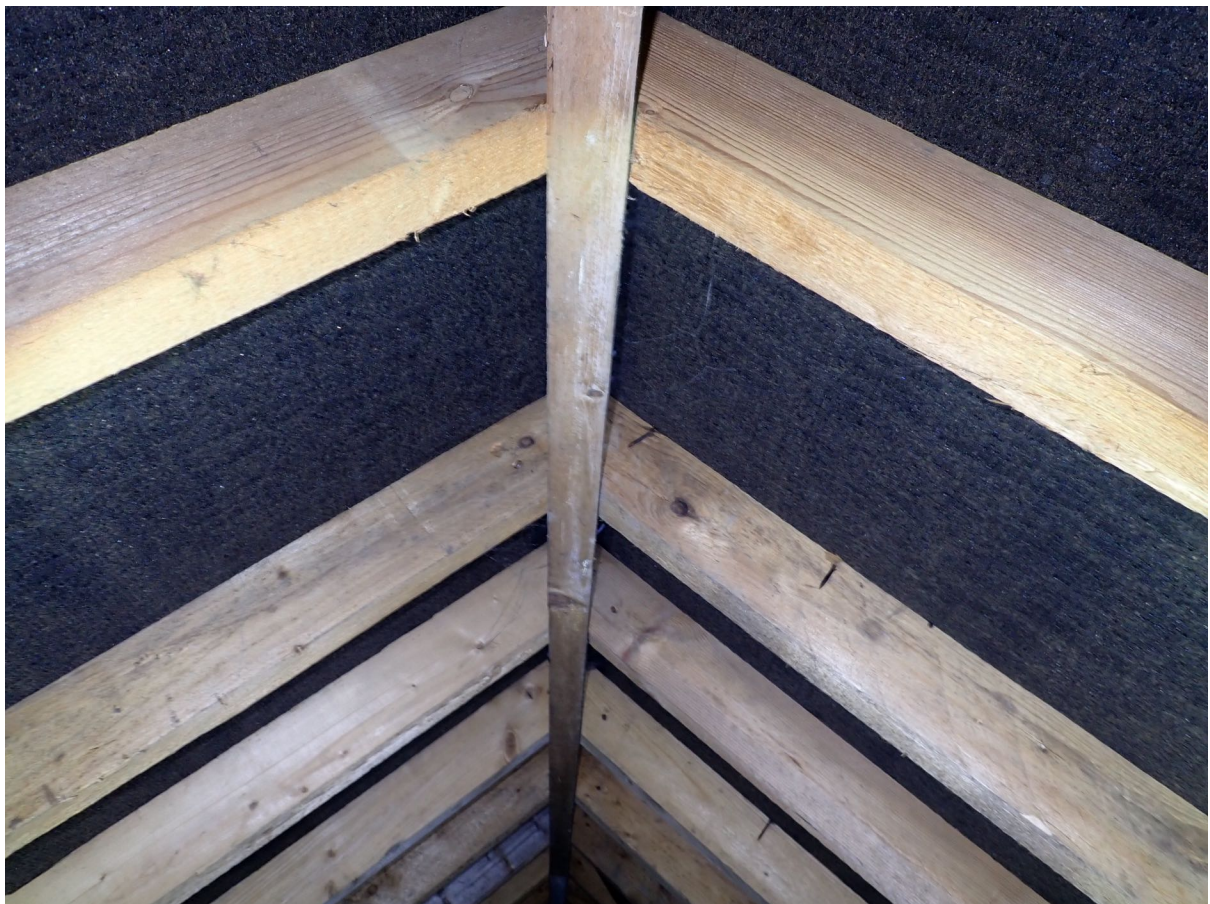
10 – Roof lining is in good condition with no gaps or tears.
