Star Academy, Radcliffe

Remediation Validation Report

PH/C5394/14825 Rev A

August 2026

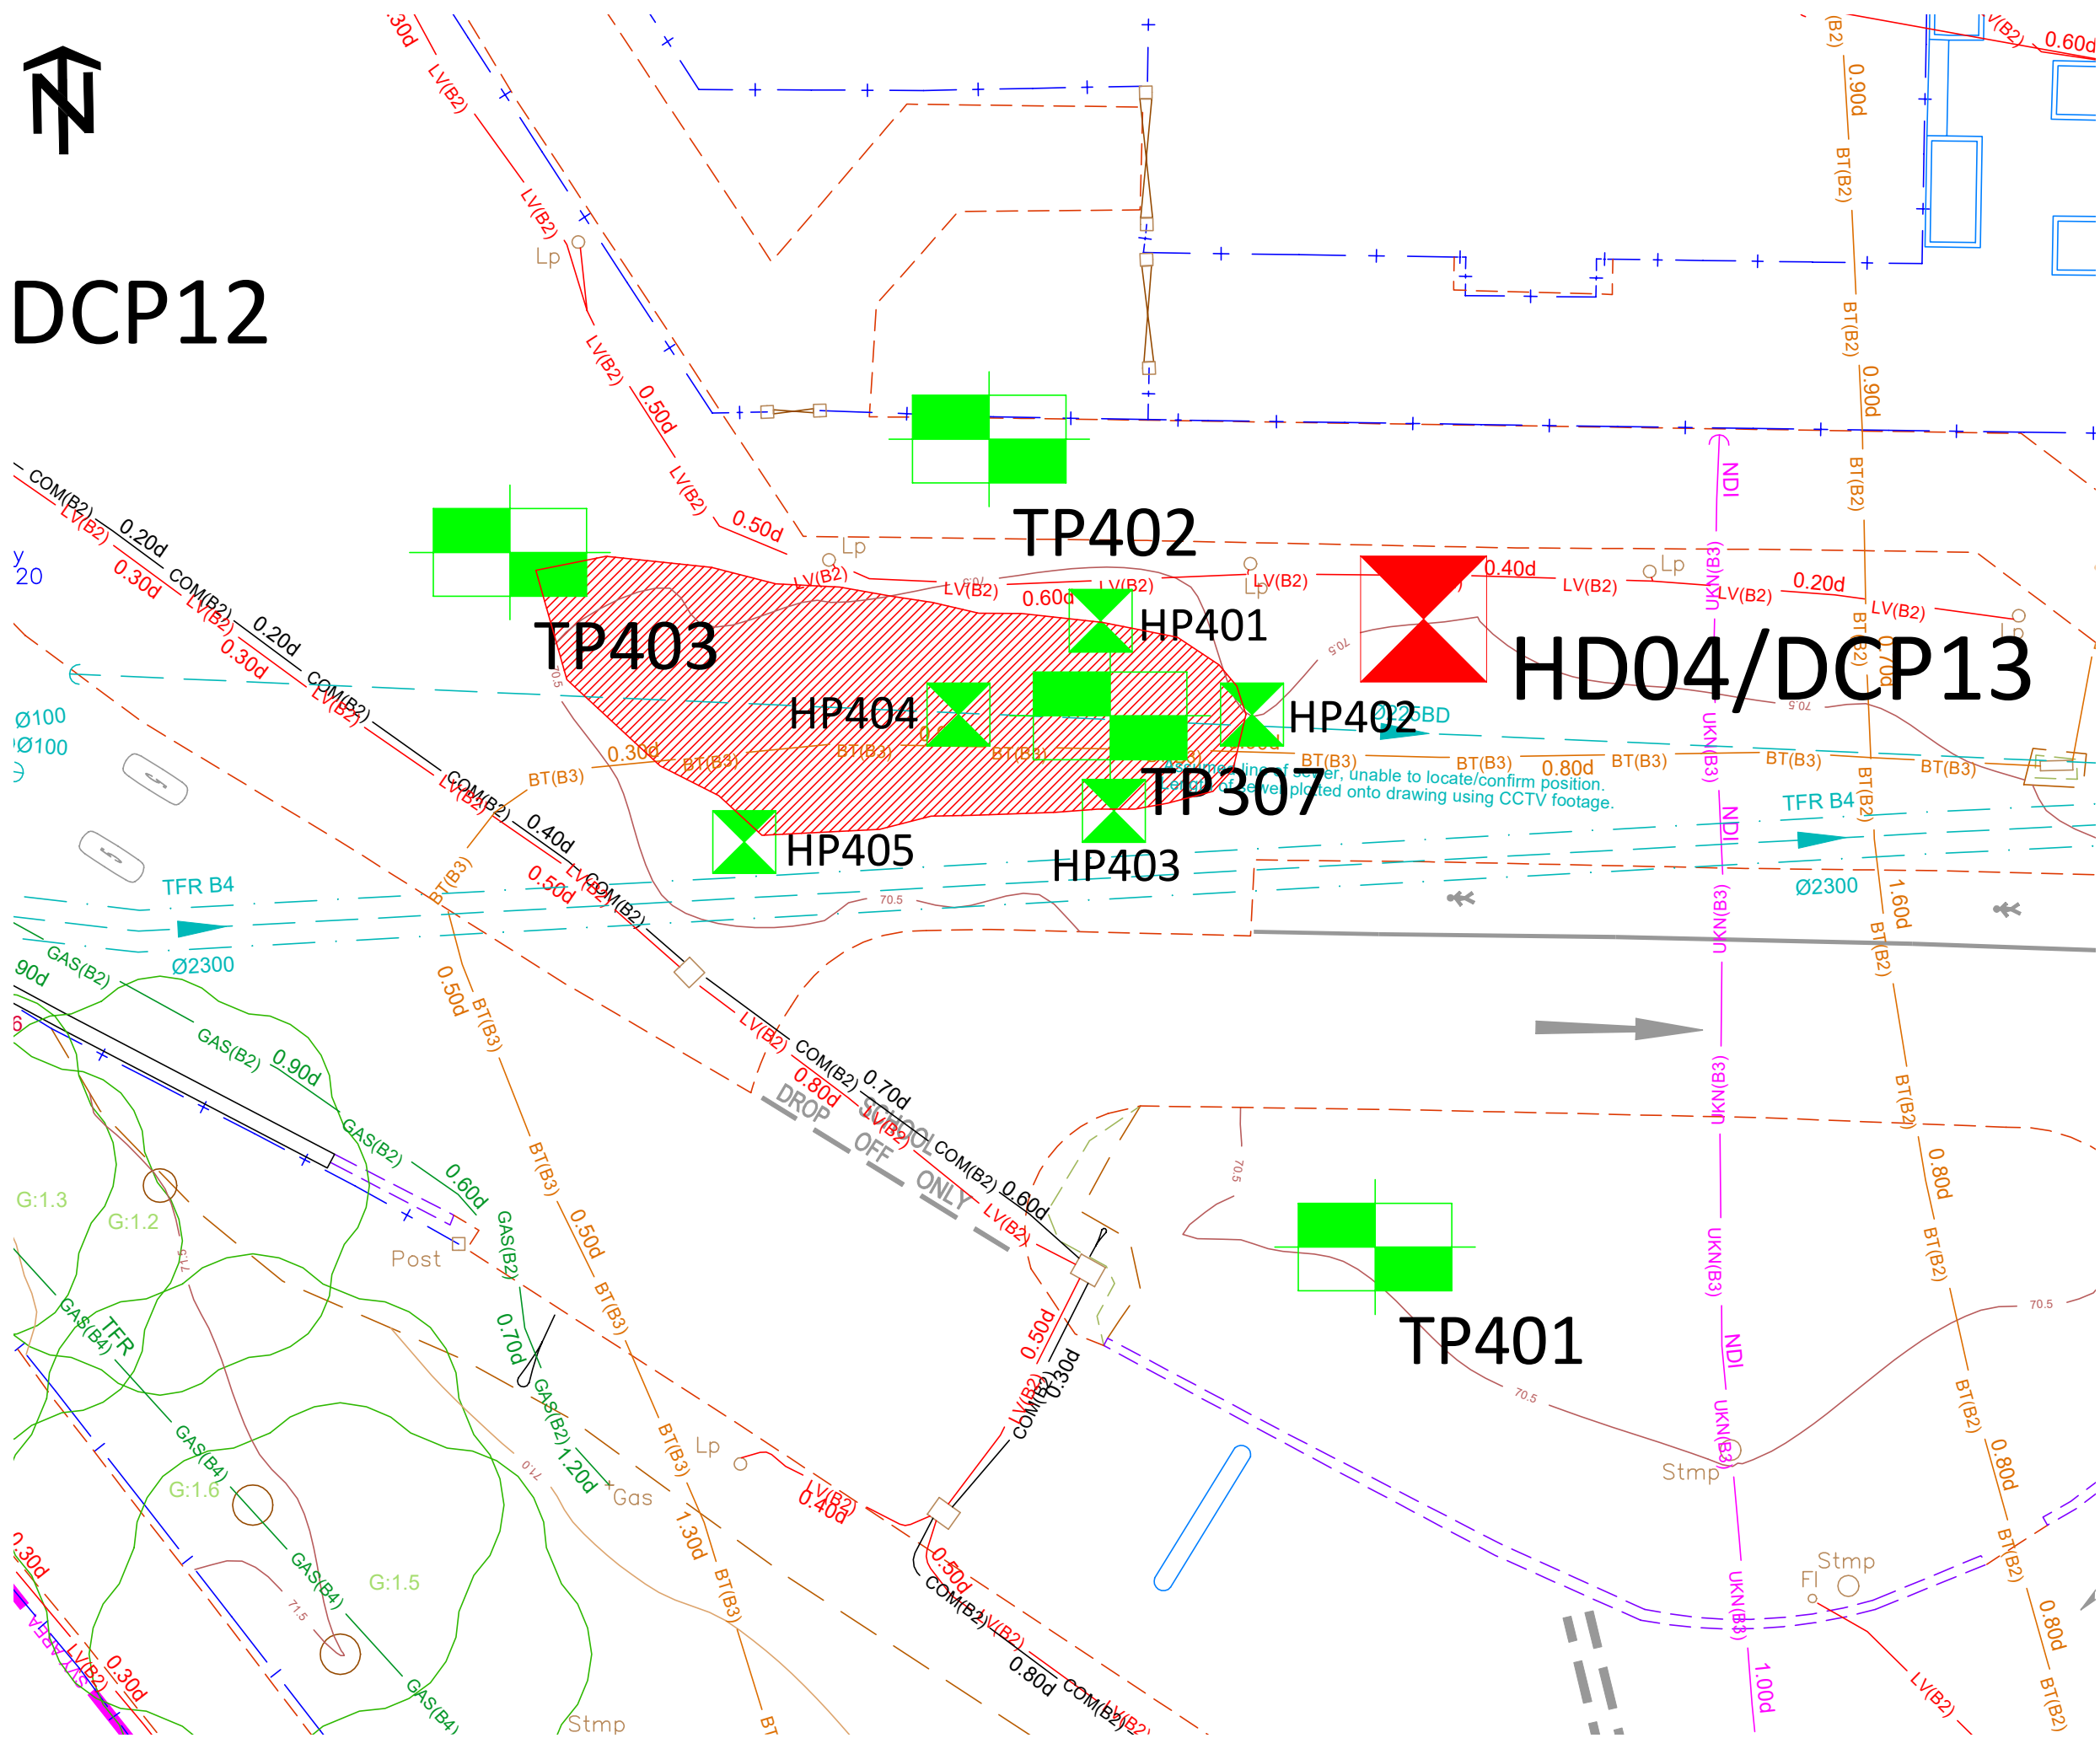
| TP307 HAZARDOUS SOILS EXTENTS PLAN | | | |

During the post-demolition site investigation of the southern section of the site in May 2024, BSL encountered an area of made ground classified as hazardous waste in TP307, shown on the Exploratory Hole Location Plan (drawing ref. C5393/02A). The testing results showed elevated levels of PAHs above the screening criteria for residential without homegrown produce within the made ground, as well as being classified as hazardous in reference to Total Petroleum Hydrocarbons.

Following the above findings, BSL re-attended site to delineate the area of hazardous soils on 7<sup>th</sup> August 2024 by undertaking 8 hand pits and trial pits in the area surrounding the initial sample location, as shown on the TP307 Hazardous Soils Extents Plan (drawing ref. C5394/12). During the sampling for this only HP404 classified as hazardous, which was located close to the original location of TP307.

Hydrocarbon-impacted made ground was identified within the TP307 area during post-demolition investigations, with elevated PAHs and hazardous waste classification associated with TPHs. Further delineation works confirmed the impacted area to be localised, however subsequent watching briefs during access road and service excavations identified additional made ground arisings requiring assessment.

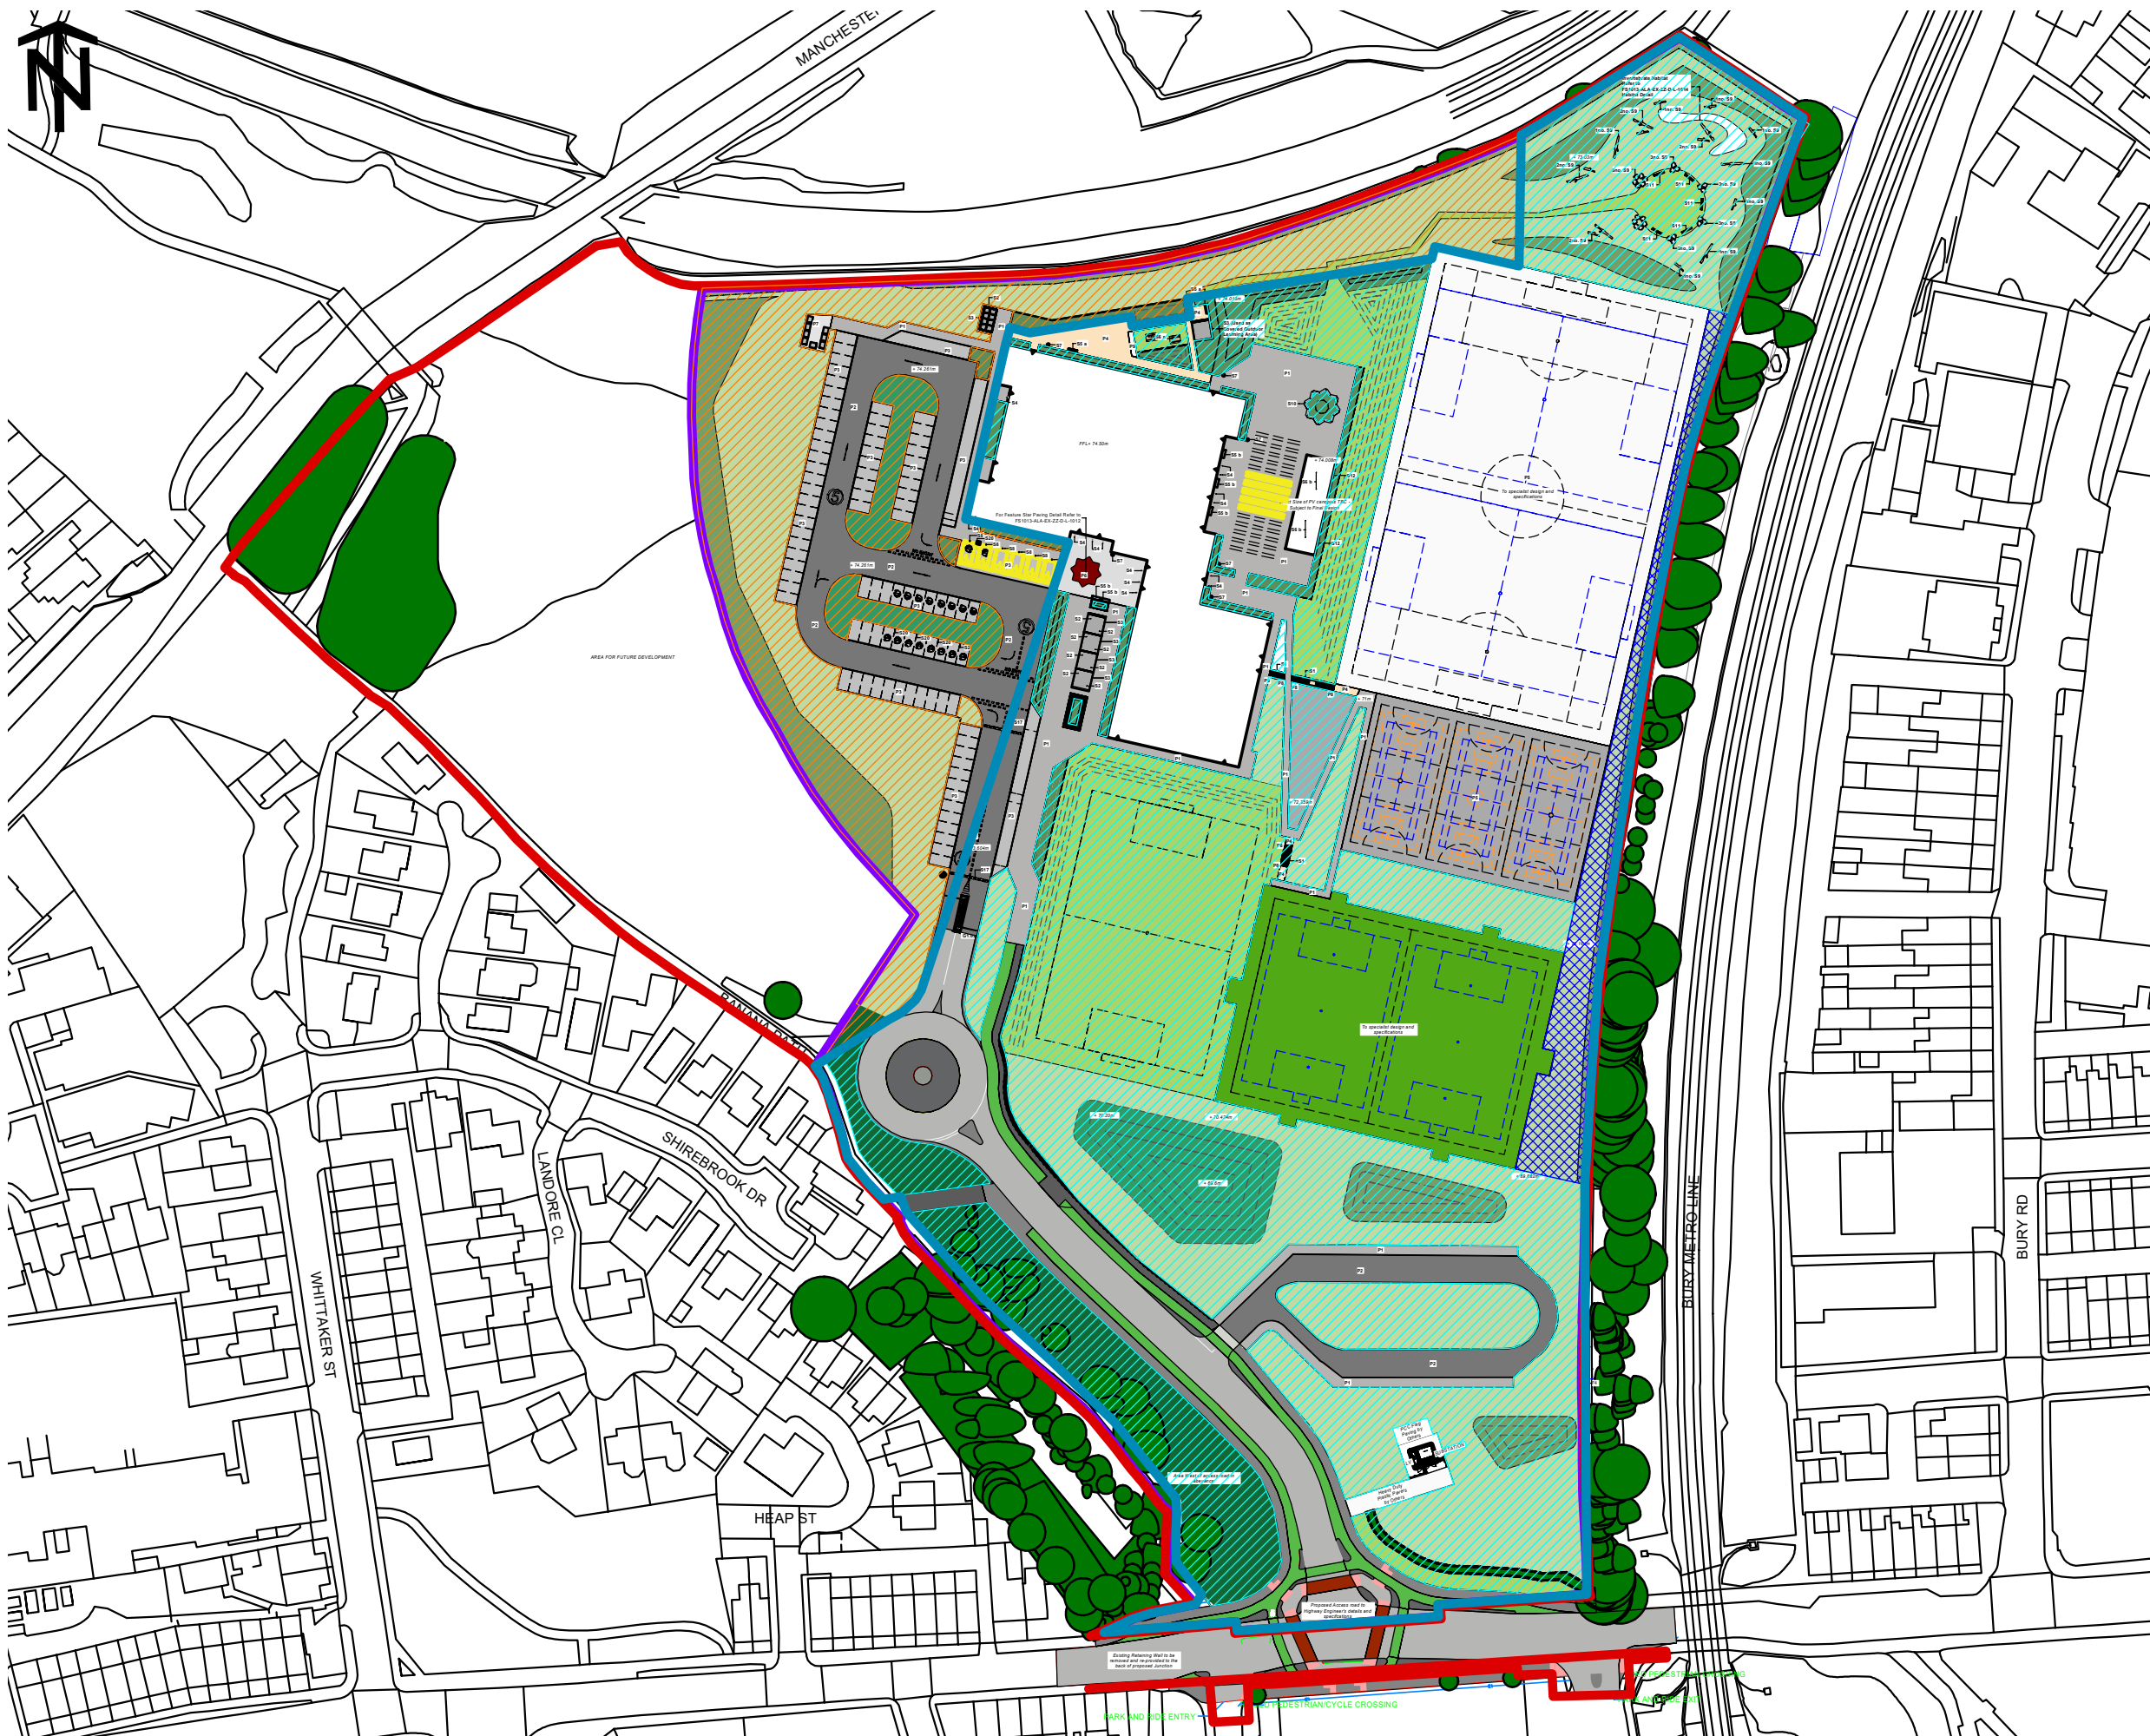
As part of the Remediation Strategy, it was noted that concentrations of PAHs were notably higher in the eastern half of the site in the vicinity of the former school and leisure centre, as well as asbestos fibres at trace concentrations in one location. Therefore, in these areas, an engineered element to the cover system, such as geotextile marker layer at the base and / or a coarse granular ‘hard dig’ layer, should be included to reduce soils mixing particularly due to the notable concentrations of Benzo(a)pyrene recorded within the made ground. In this case, a warning geotextile membrane will be placed between the made ground and the clean cover system soils, but is not required where natural soils are present which do not have elevations of PAHs, as shown on the Clean Cover System and Geotextile Plan (drawing ref. C5394/15 Rev B).

Following acceptance of the report, the client was informed that the north eastern portion of the validation area which failed will need to be re-installed with a geotextile warning membrane. The Clean Cover System and Geotextile Plan (drawing ref. C5394/15 Rev B) was also updated to include the north-western area within the zone which does not require a geotextile membrane.

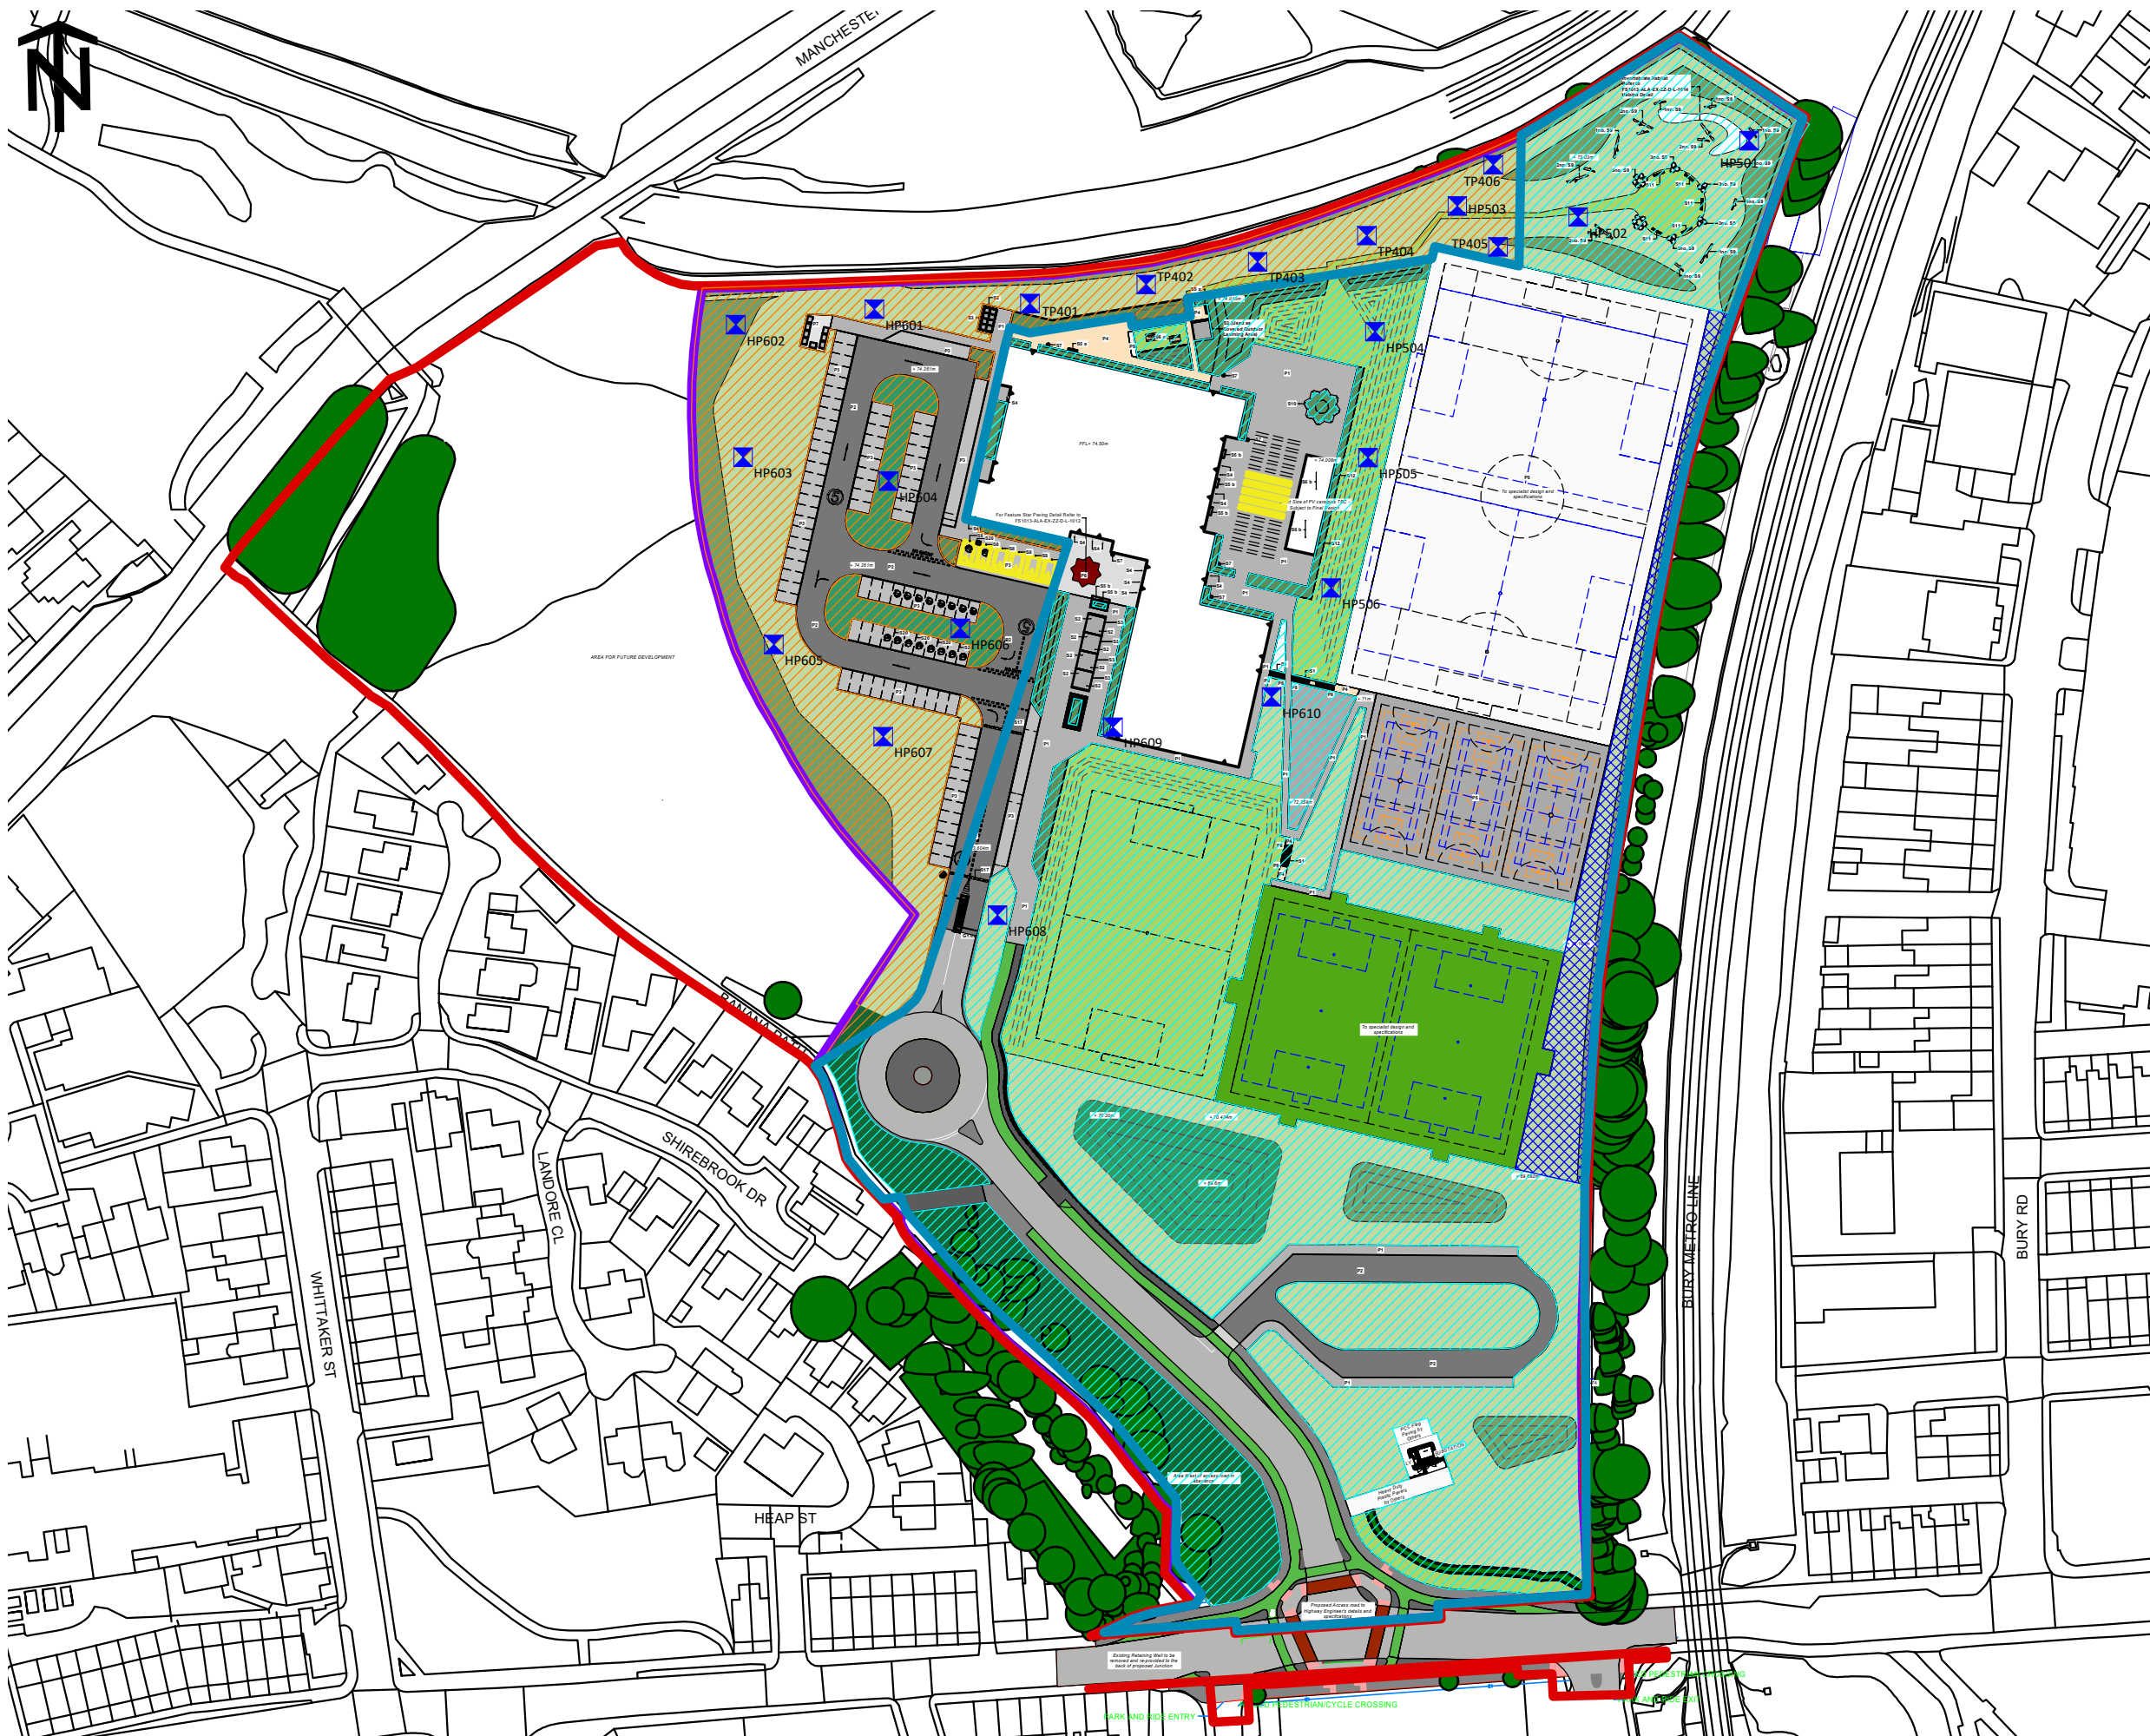
BSL attended site to validate the depth of the clean cover system on the 24<sup>th</sup> July 2026 in the north-west section of the site, as detailed on the Clean Cover Validation Plan (drawing ref. C5395/19 Rev C) dated 23<sup>rd</sup> July 2026. A hand dug trail pit was excavated to at least 450mm below ground level in ten locations by a suitably qualified Geo-Environmental engineer. It should be noted that the locations undertaken as part of this site visit varied between areas that require a warning membrane and areas that do not.

| Location Number | Depth/ Stratum | Pass / Fail |
|---|---|---|
| TP608 | 0-500mm – Topsoil<br>500-700mm – Made Ground (missing geotextile warning membrane) | Fail |

It should be noted that in TP609, a hard dig layer was encountered instead of a Geotextile warning membrane. The hard dig layer comprised of a limestone aggregate which was used as part of the build up in the area surround the main school building. The certificate of provenance is presented in Appendix D.
