KB/C5394/14482

23rd July 2025

**Re: Remediation Strategy Closure Statement - Star Academy, Radcliffe, Manchester (TEMPs 2)**

## VALIDATION RECORD

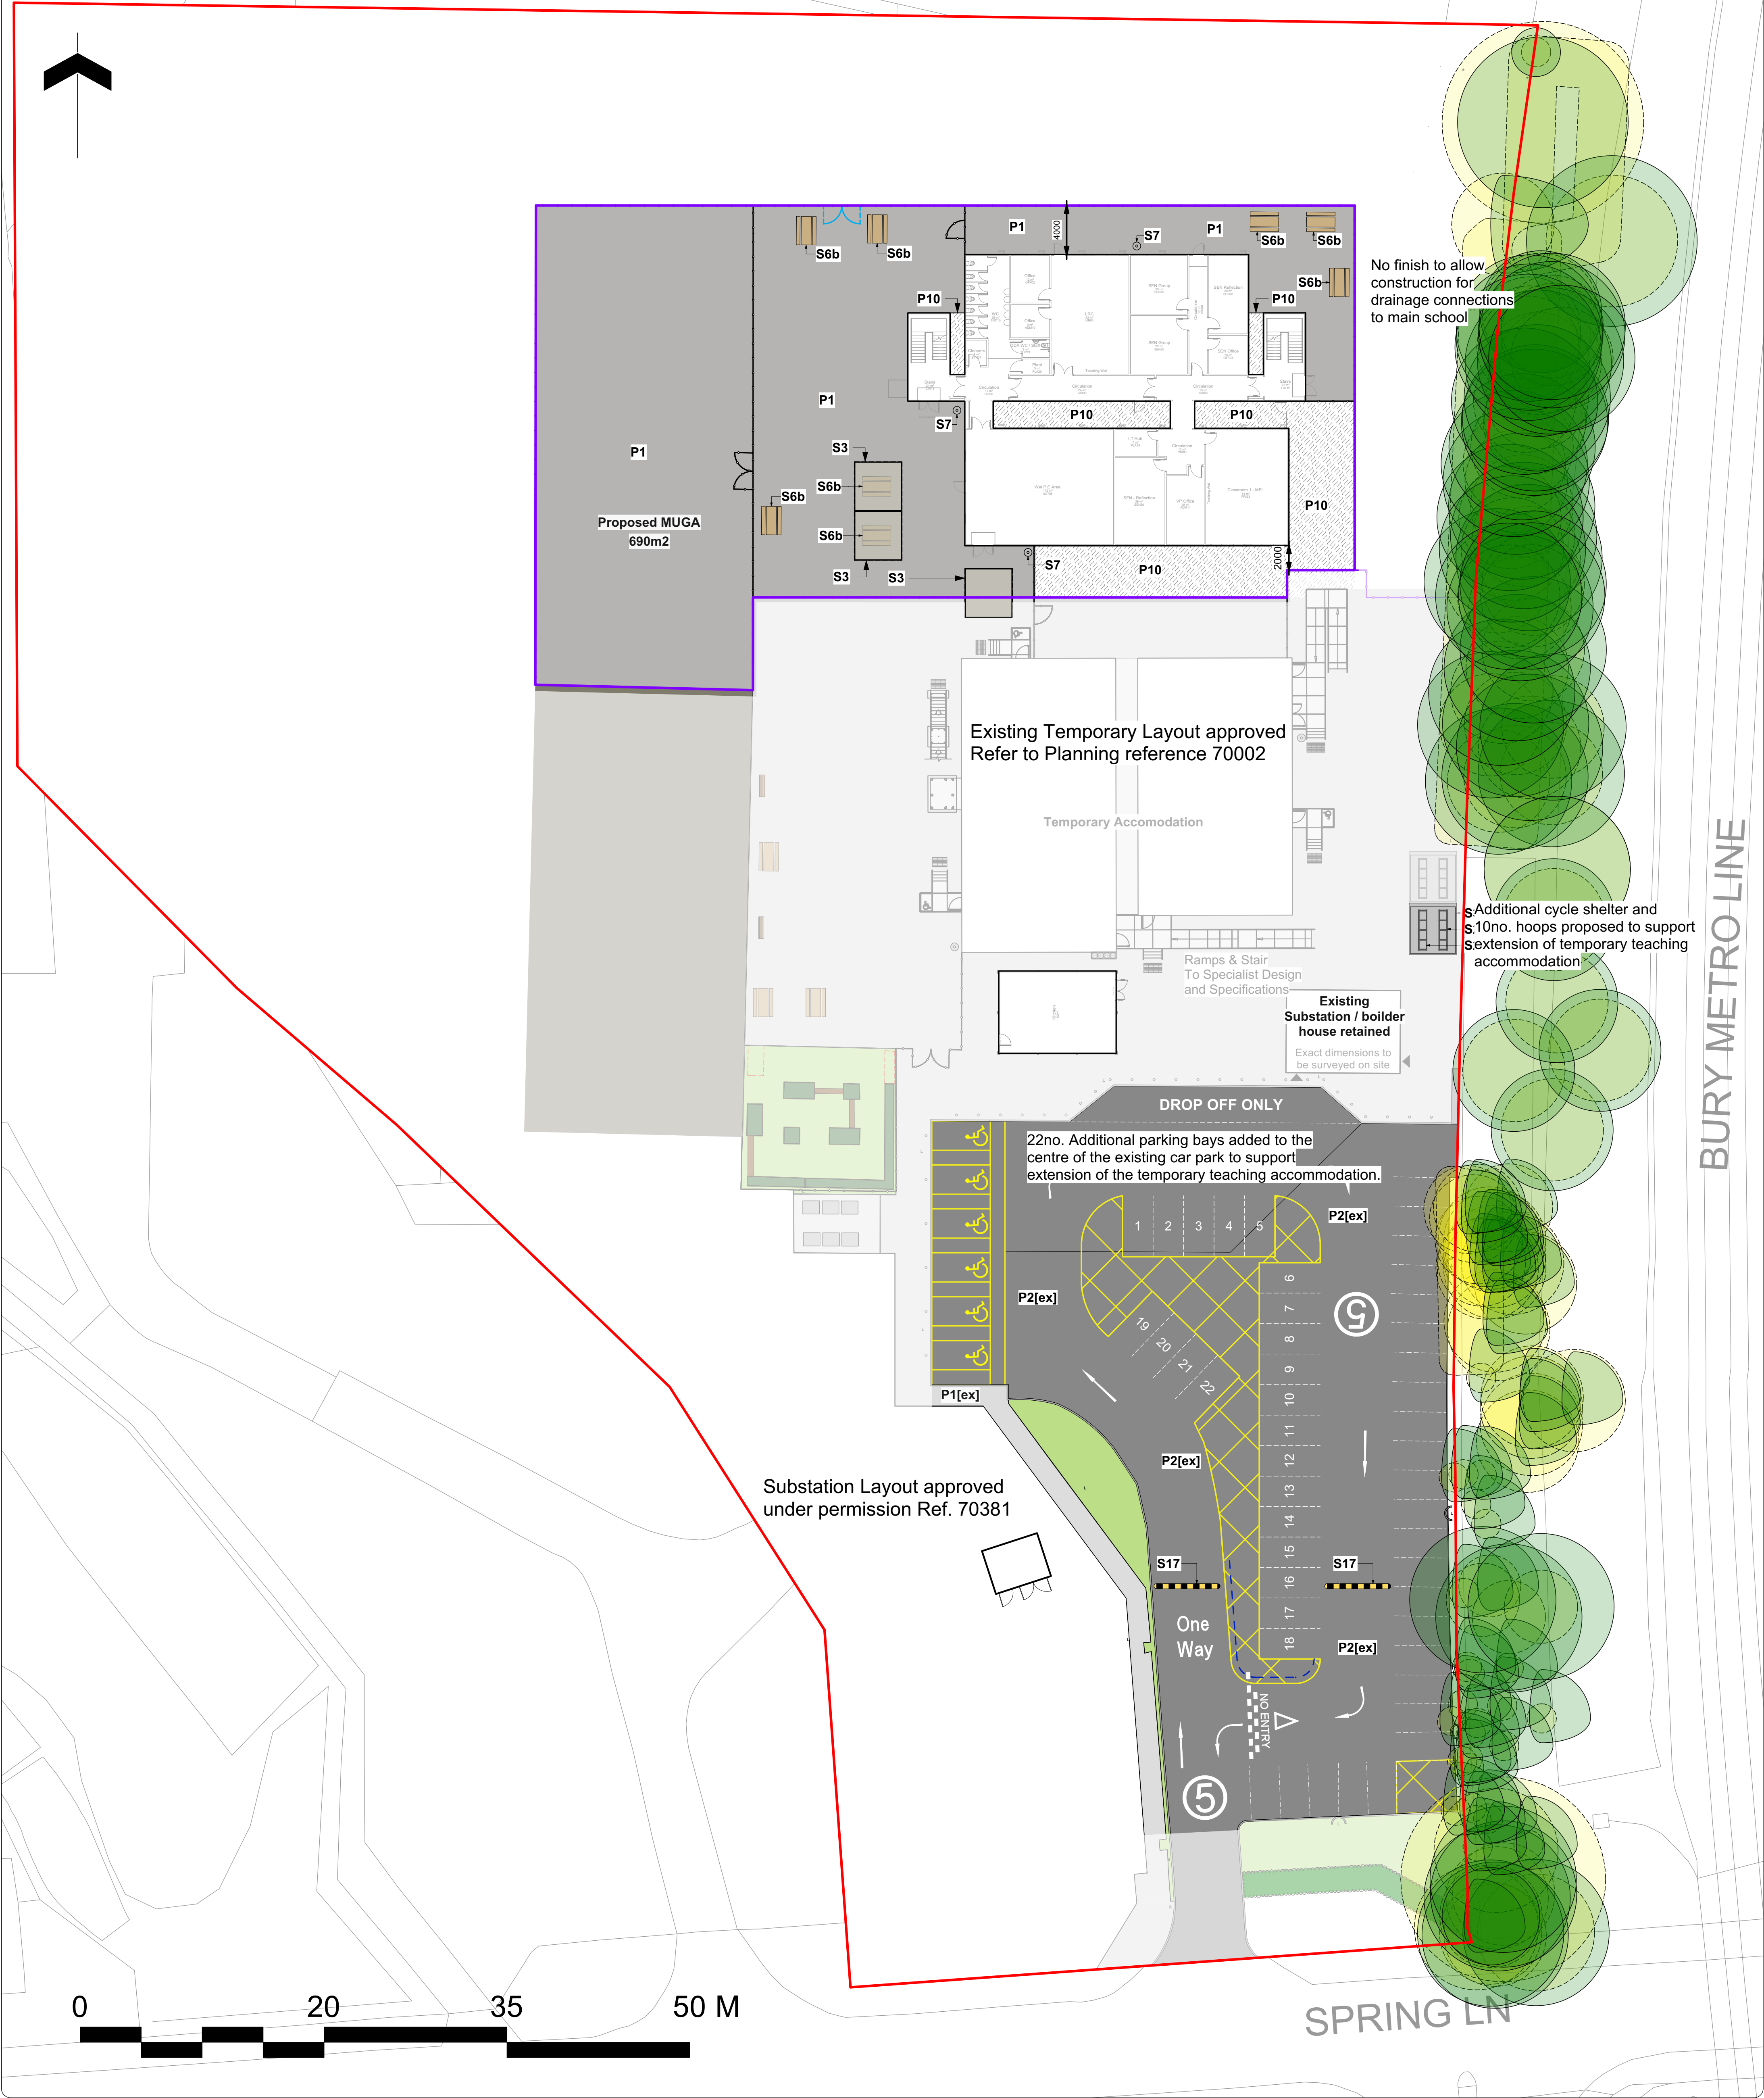
| DRAWING NUMBER :<br><b>FS1013-ALA-EX-ZZ-D-L-0120</b> | STATUS :<br><b>A5</b> |

Based on the current development plans there are no soft landscaping areas within the temporary 2 development and as such there is no remedial requirement to install a clean cover system. The final development plan for which is attached to this report (drawing reference: FS1013-ALA-EX-ZZ-D-L-0120).

Therefore, the entirety of the TEMPs 2 development will either comprises hardstanding or the building footprint. The laying tarmac over the current capping layer in ongoing, upon completion this will be congruent with the attached development plan

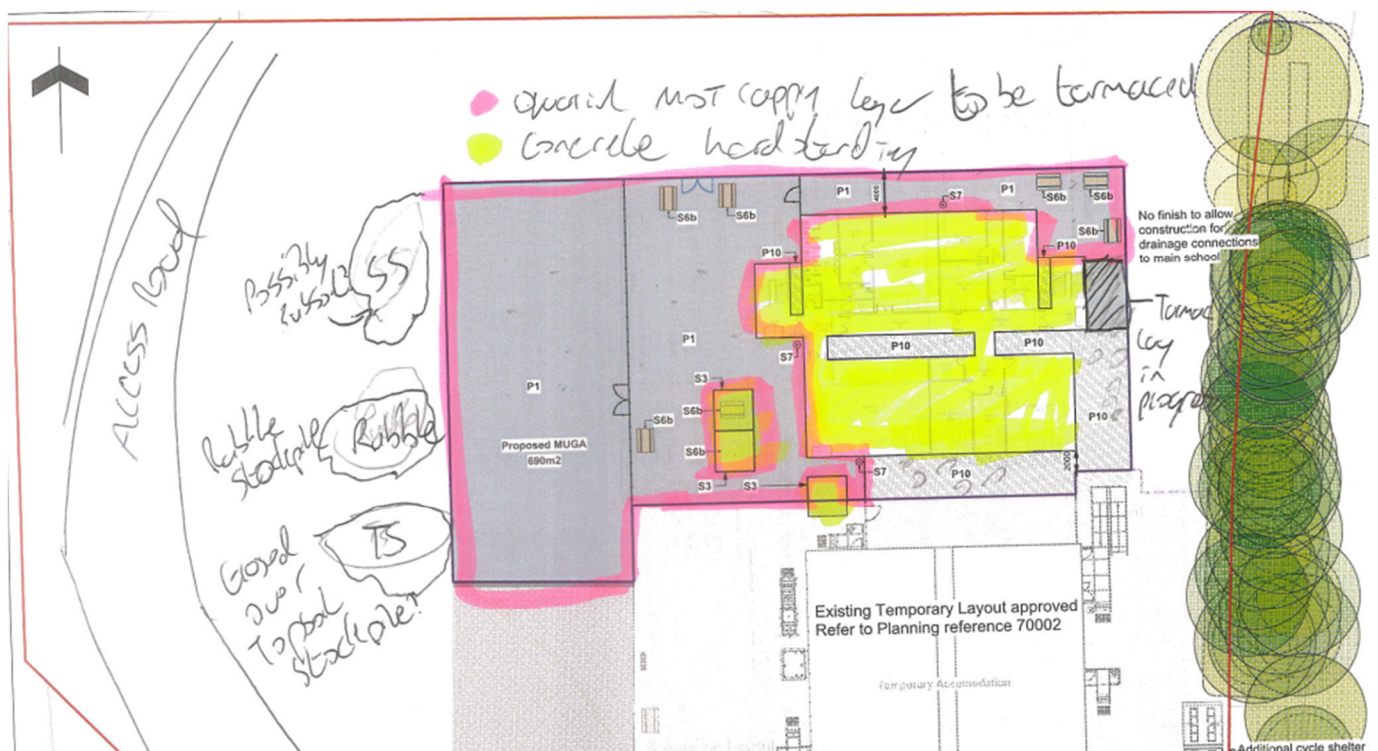
KB arrived on site and reported to site office and site manager Mike Belfield for the TEMPs 2 and was escorted around the development, surfacing of which was largely a quarried MOT sub-base stone capping layer, or concrete hardstanding and the building footprint, a small area at the rear had begun to lay tarmac over the capping layer with the intention to surface the rest over the coming days/weeks.

The marked up temporary 2 design shows the current and projected surfacing conditions.

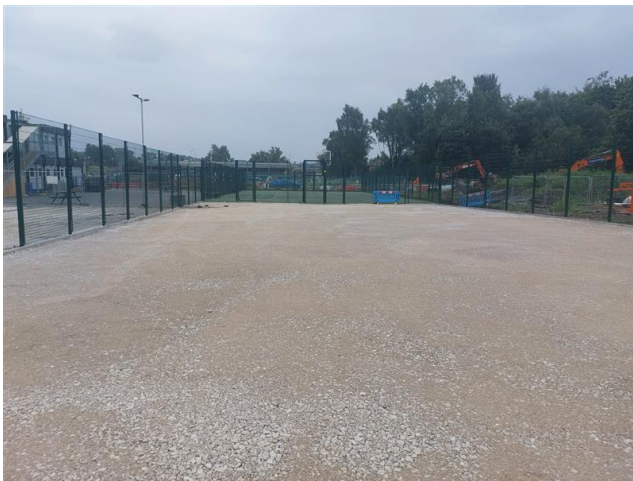
Photograph 1 – View of capping layer prior to laying of tarmac of MUGA pitch

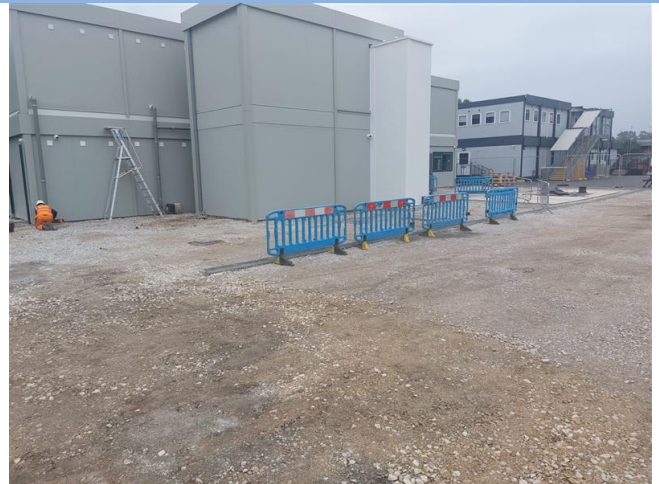
Photograph 2 – View across western area of site to be lain with tarmac

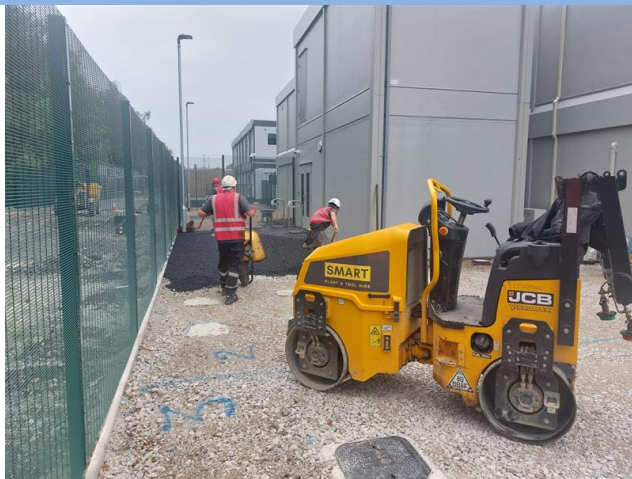
Photograph 3 – Laying of tarmac in progress as of 23.07.25

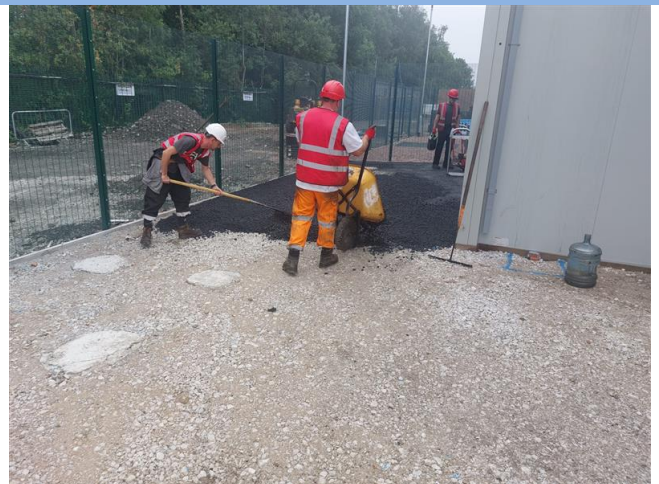
Photograph 4 – Tarmac lay in progress

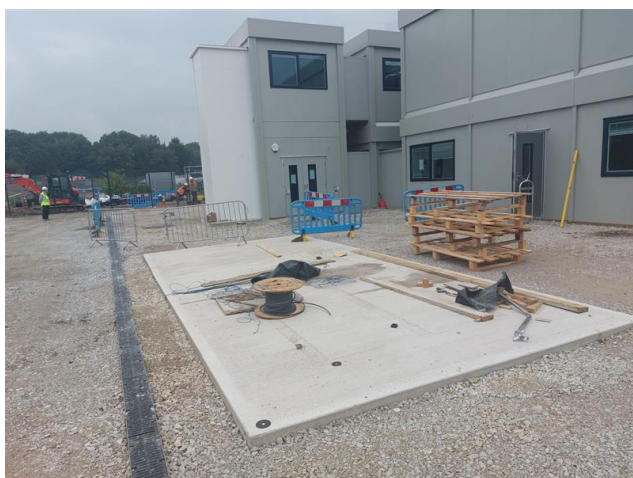
Photograph 5 – Some surfacing is concrete hardstanding

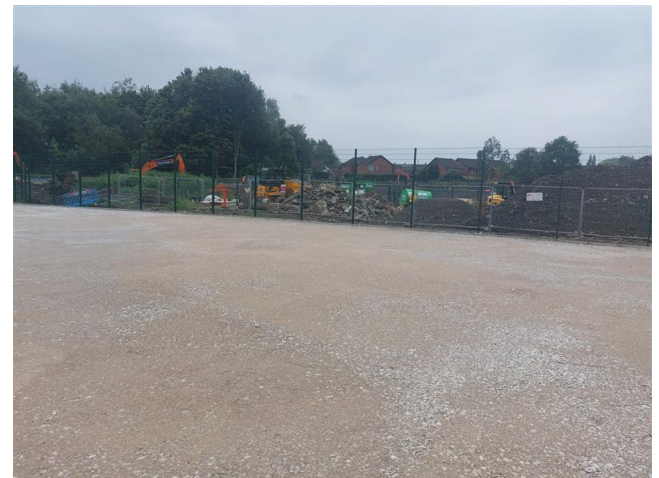
Photograph 6 – View of adjoining stockpiles
