## **Remediation Verification Report for East Lancashire Paper Mill Island Site, Rectory Lane, Radcliffe, M26 2QU**

**Project No: NX418**

**Report Reference: NX418**

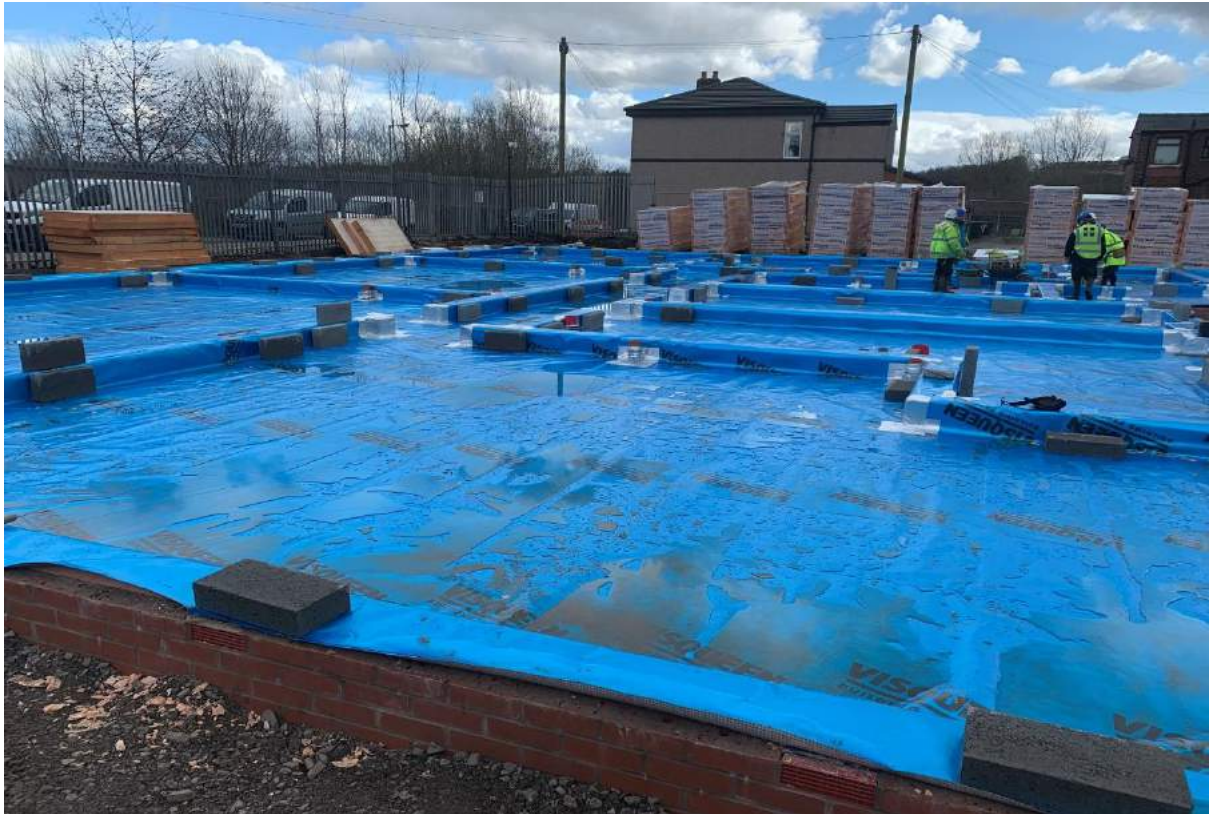
**PLATE 1: Apt 1 to 20 with Full Visqueen Barrier Coverage**

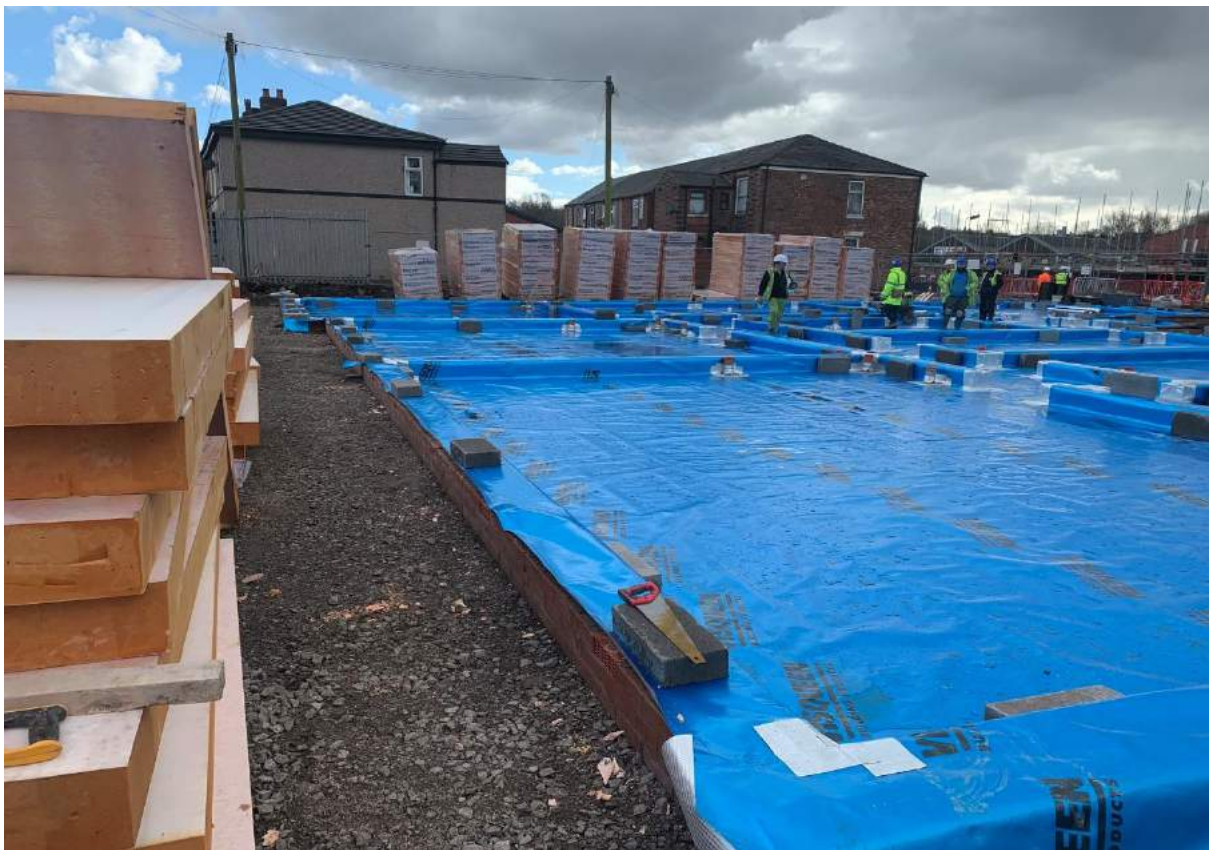
**PLATE 2: Apt 1 to 20 with Full Visqueen Barrier Coverage**

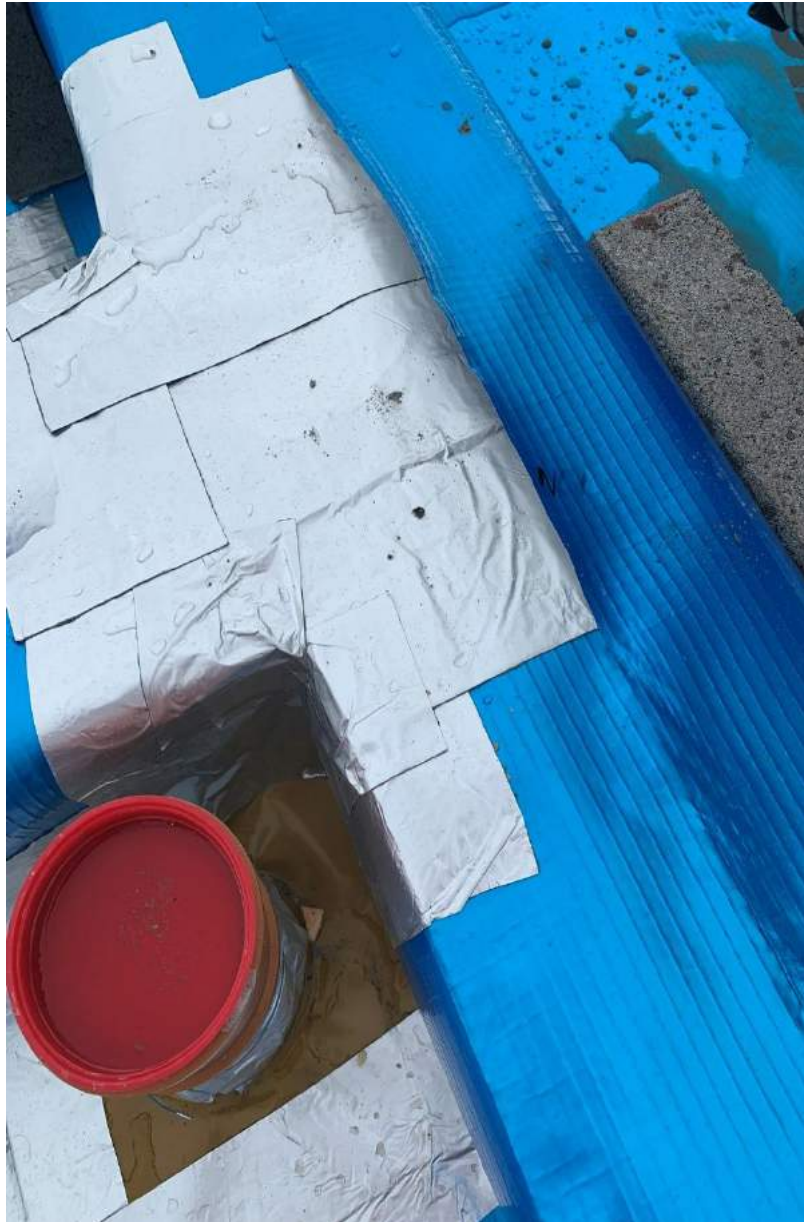
| Non - Conformance Record | | | Repair Record | | | Photo Reference | |
|---|---|---|---|---|---|---|---|
| NC1 | Lapping tape | Tape used as lap on a joint | Patch | ✓ | Repaired on site | NC1 | ✓ |

**PLATE 3: NC1 Patch Repair**

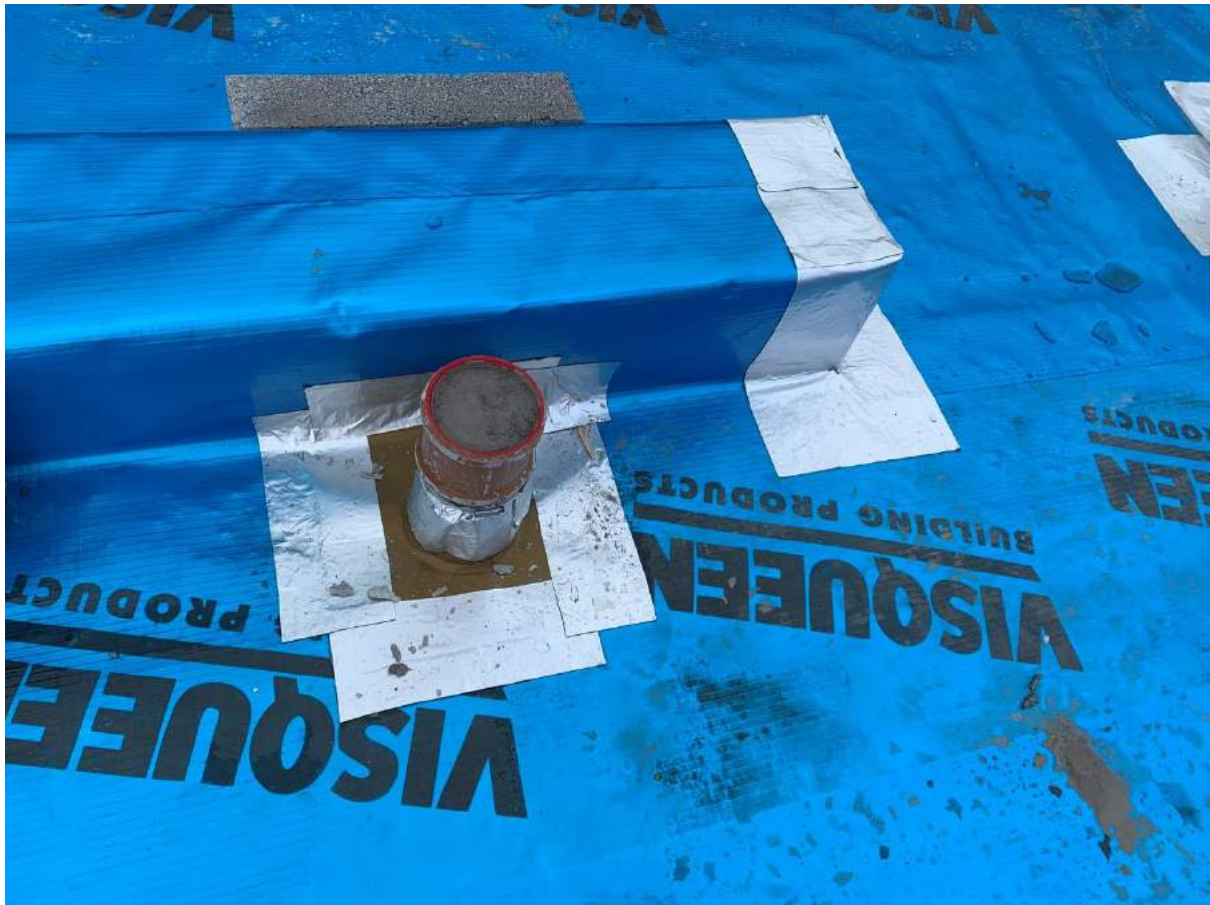
**PLATE 4: Service Entry Detail Example**

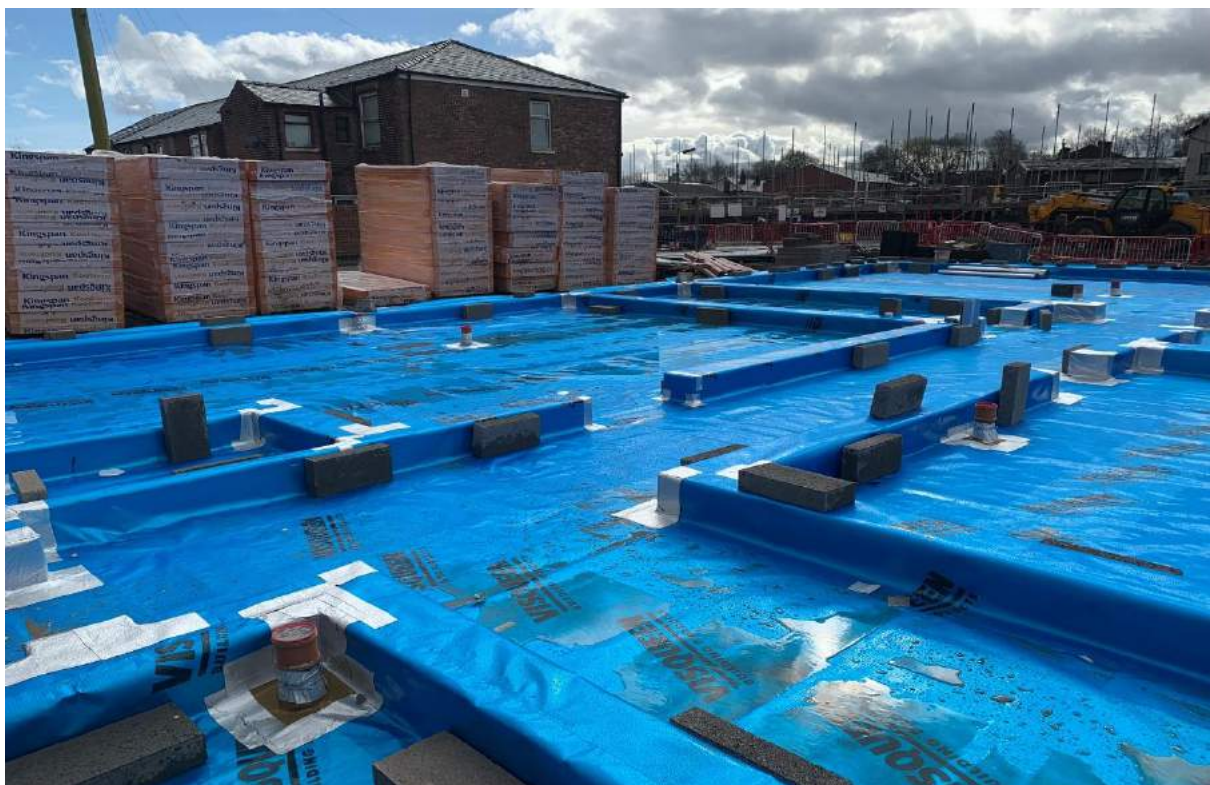
**PLATE 5: Membrane Coverage and internal Wall lapping**

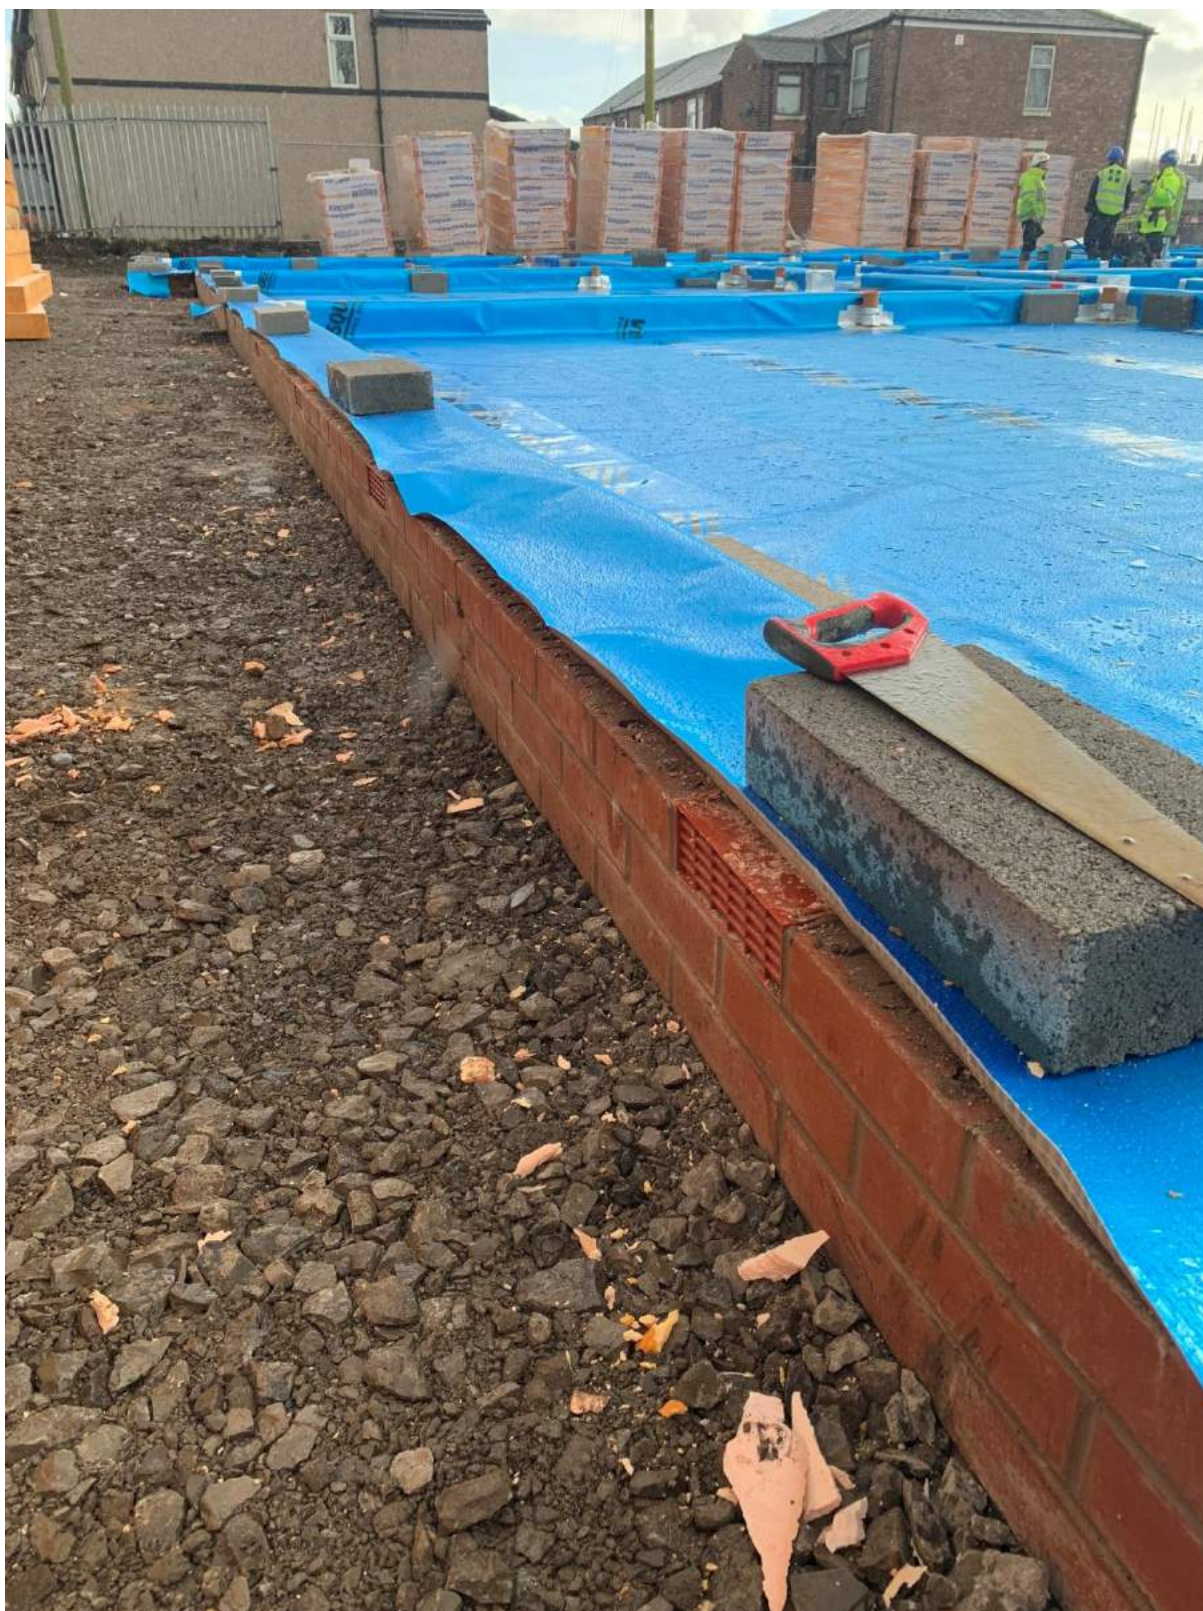
**PLATE 8: Subfloor Venting on 2m to 3m centres**

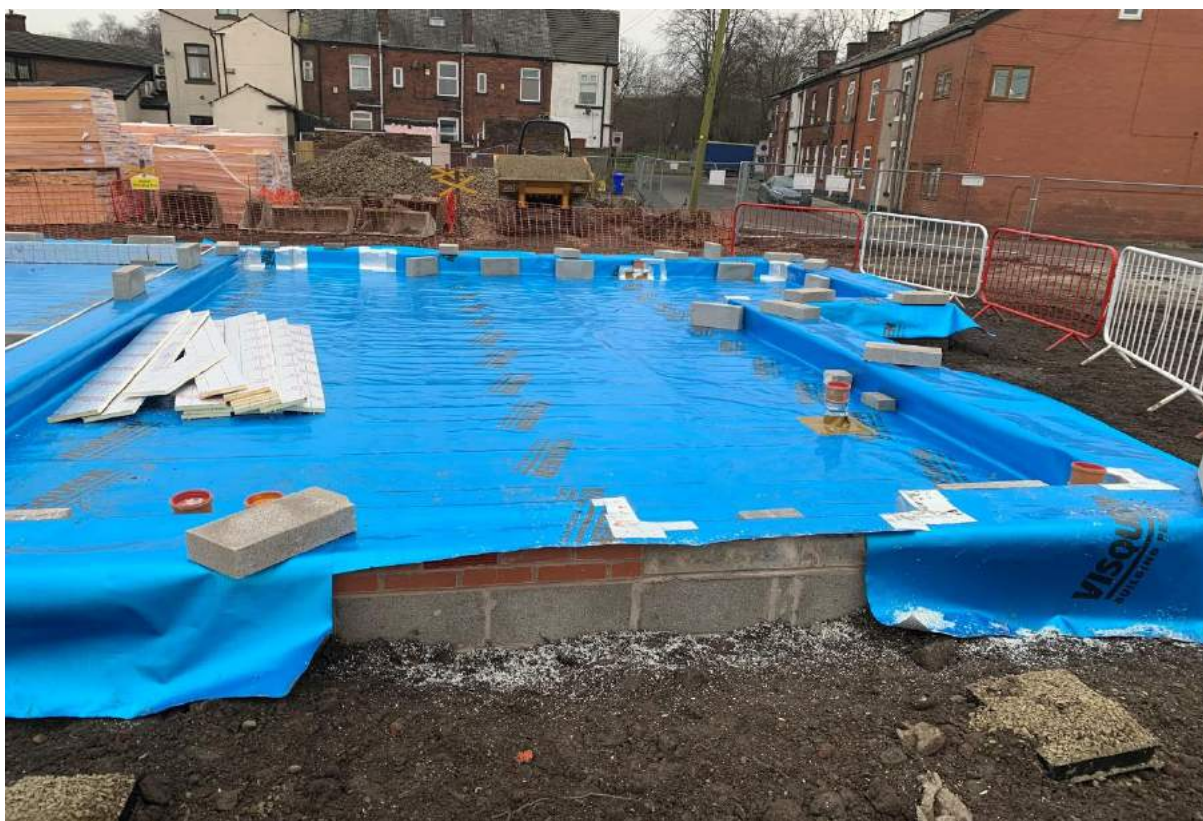
**PLATE 1: Plot 1 with Full Visqueen Barrier Coverage**

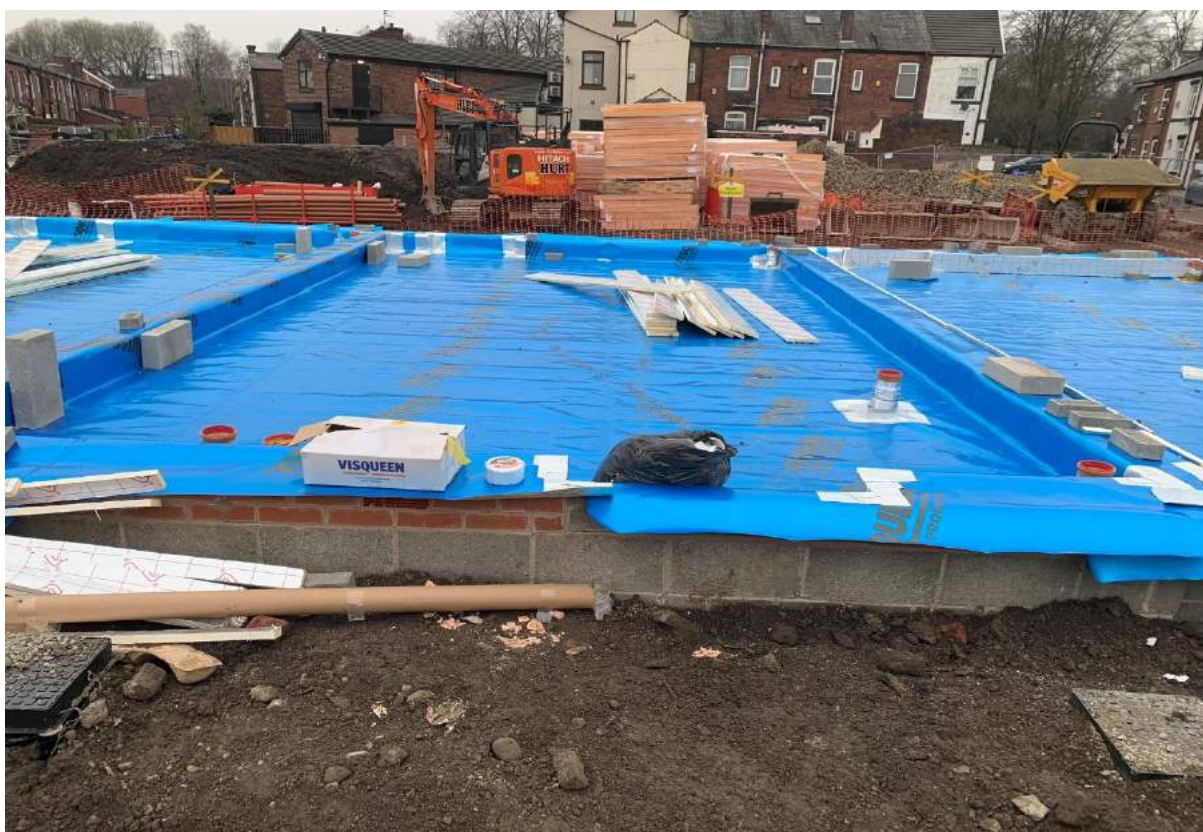
**PLATE 2: Plots 2, 3, 4 with Full Visqueen Barrier Coverage**

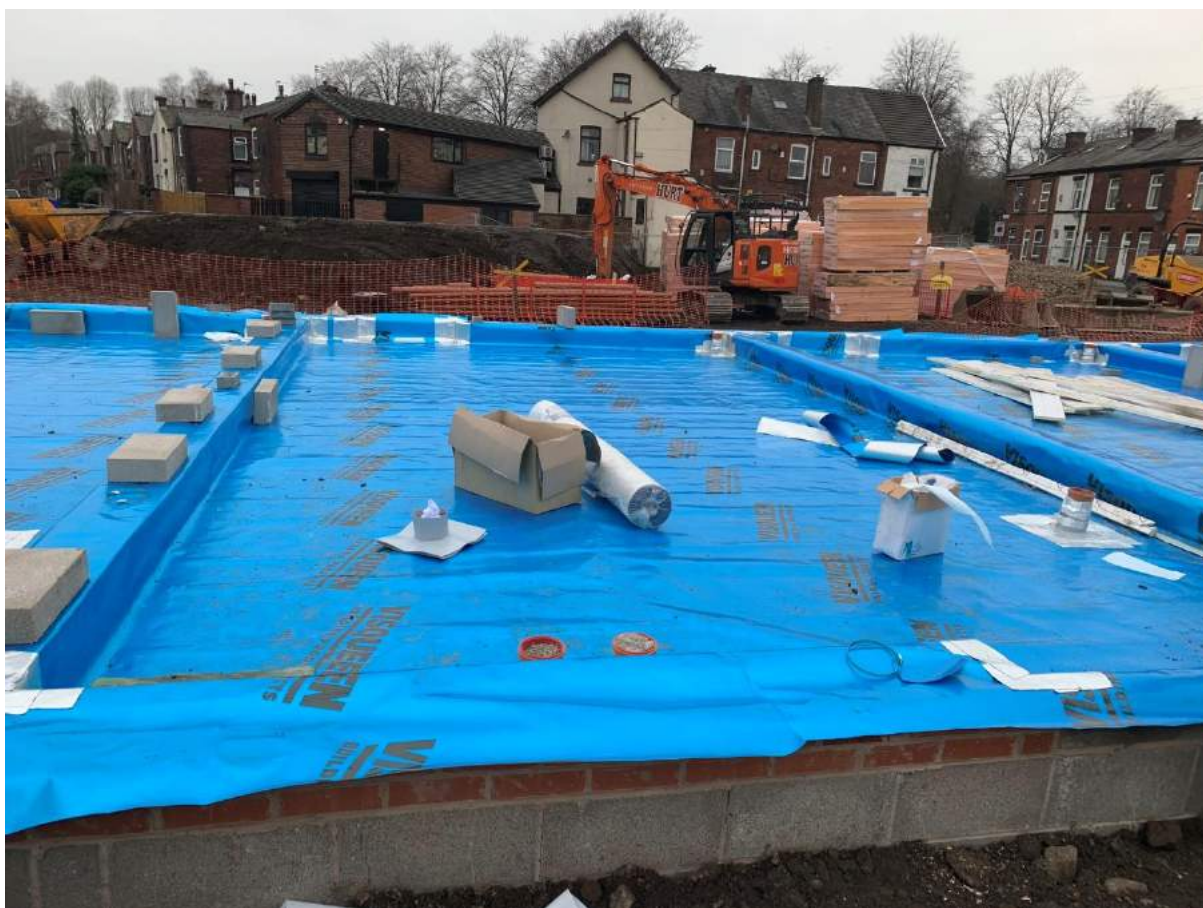
**PLATE 3: Plot 5 with Full Visqueen Barrier Coverage**

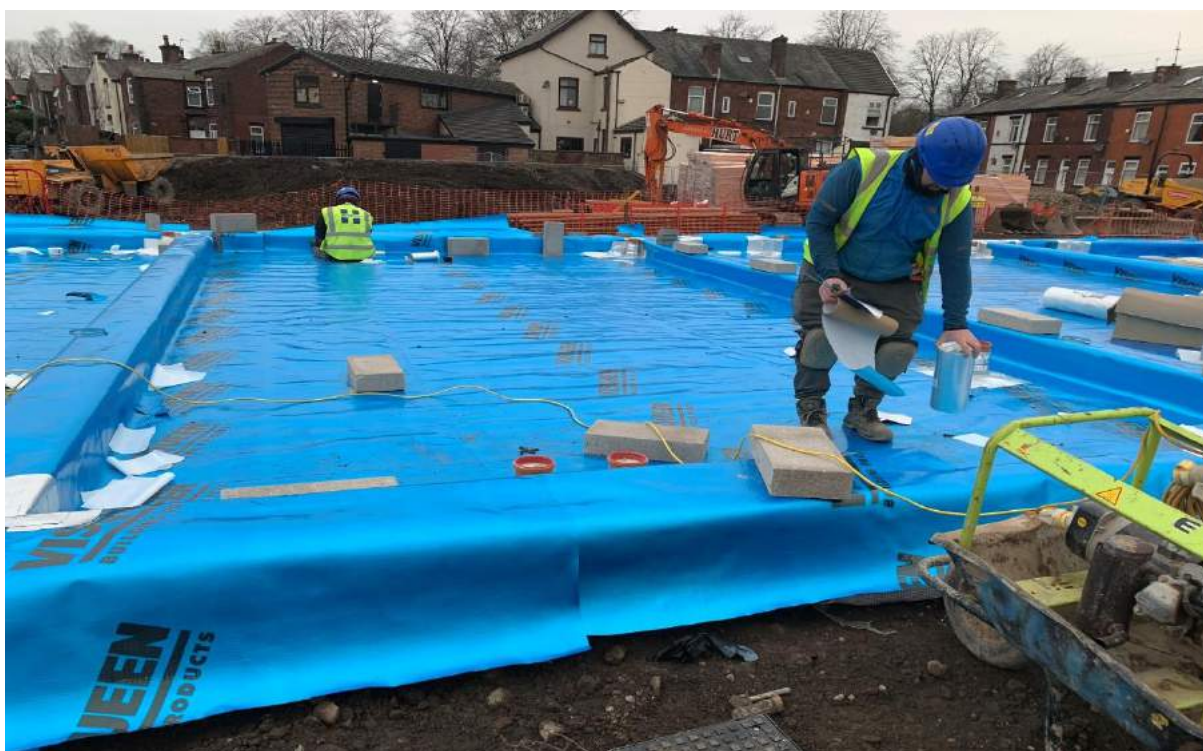
**PLATE 4: Plot 6 with Full Visqueen Barrier Coverage**

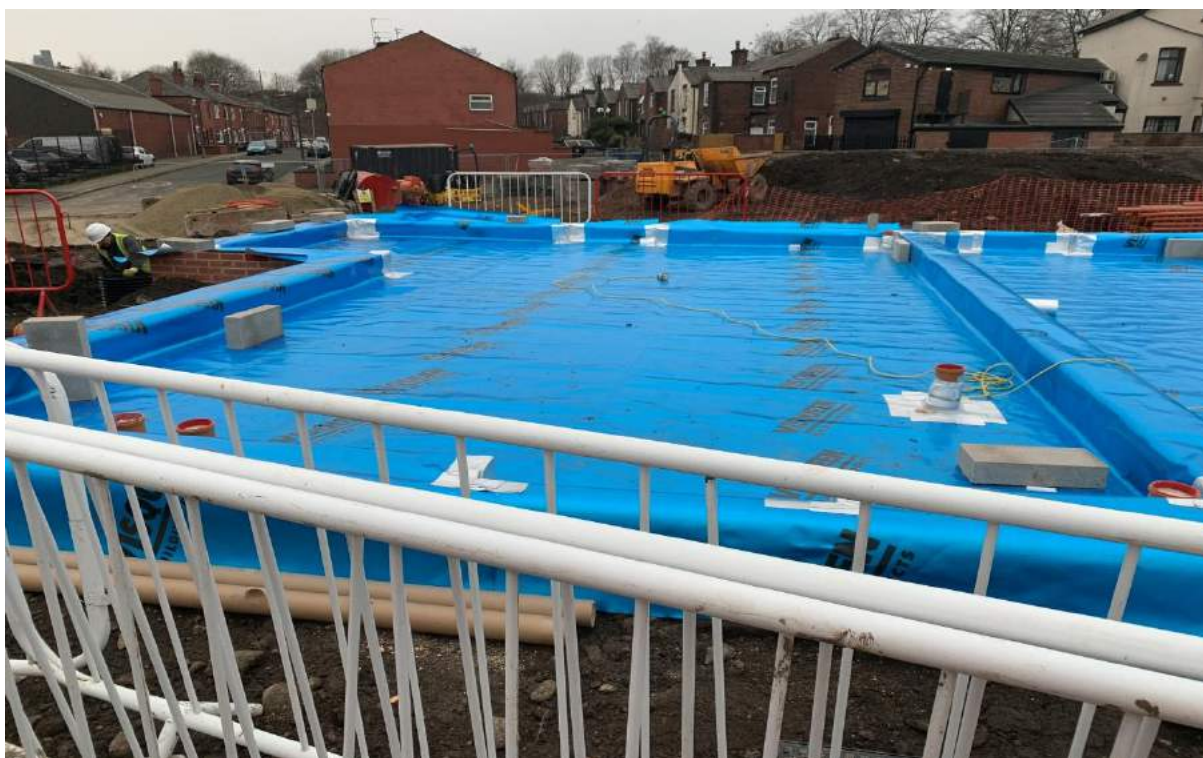
**PLATE 5: Plot 7 with Full Visqueen Barrier Coverage**

| Non - Conformance Record | | | Repair Record | | | Photo Reference | |
|---|---|---|---|---|---|---|---|
| Plot 7 - NC1 | Lapping tape | | Patch | ✓ | Repaired on site | NC1 | ✓ |

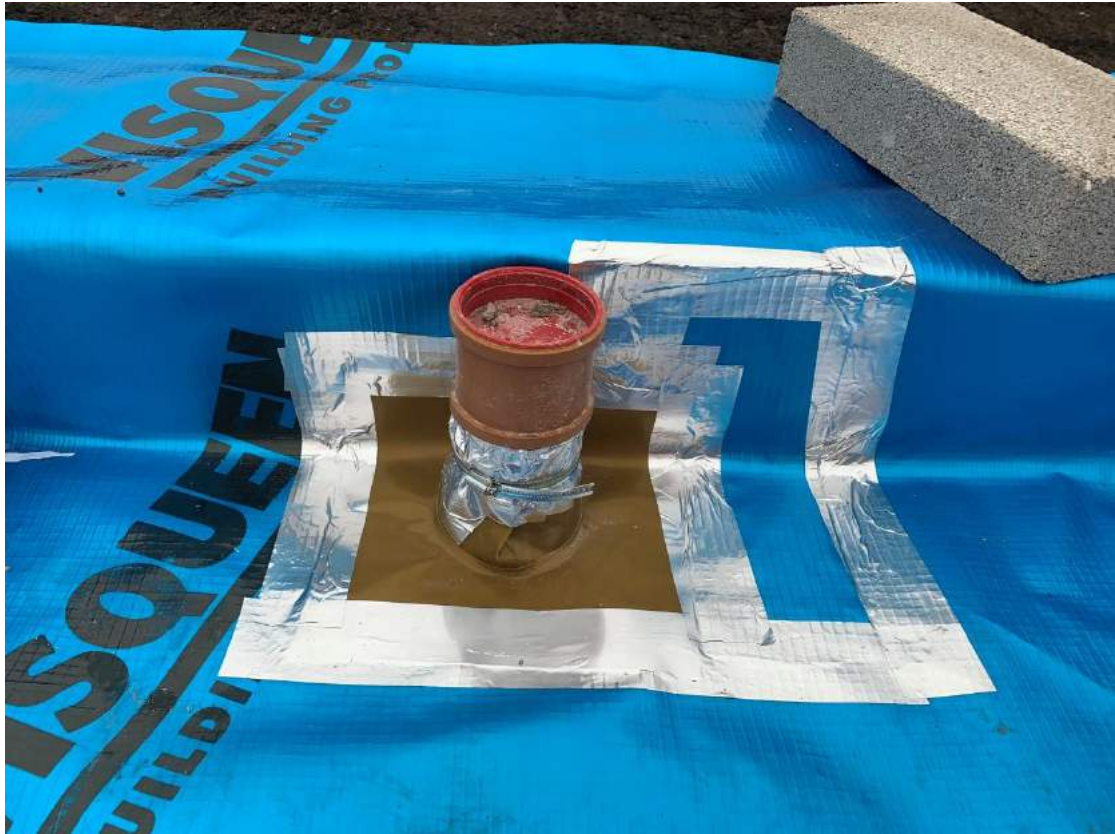
| service entries and seals | Top hats used, sealed in a good order. |

**PLATE 7: Tophat Construction**

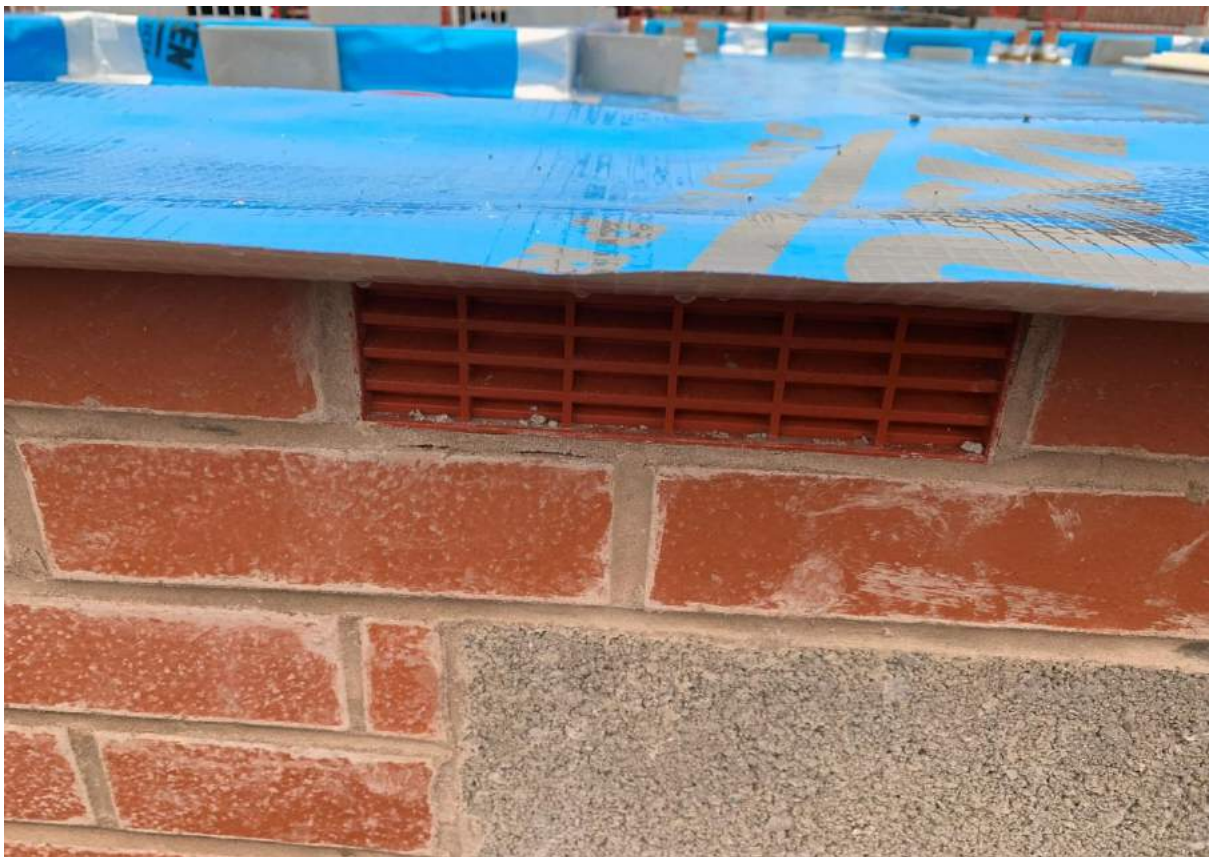
**PLATE 8: Subfloor Venting on 2m centres**

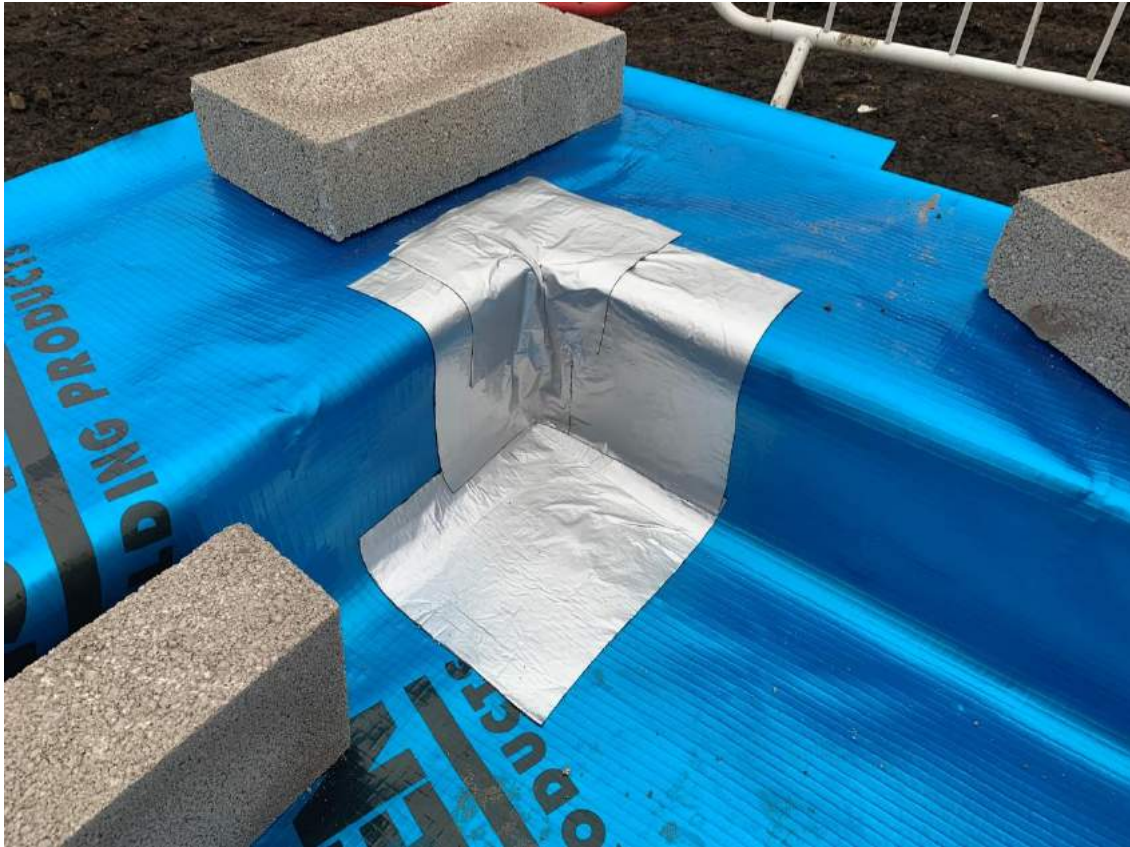
**PLATE 9: Corner Detail**

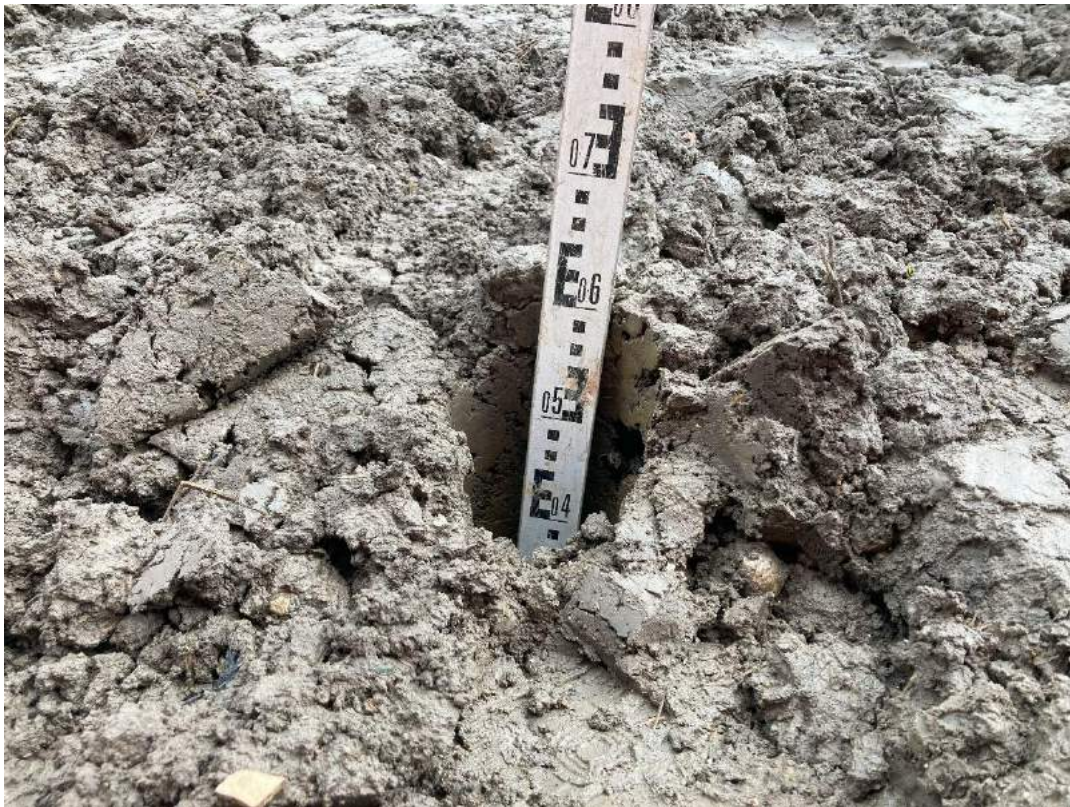
**Plate 3 – Plot 1 front garden cover system GL to 0.60mbgl with 0.15m of topsoil.**

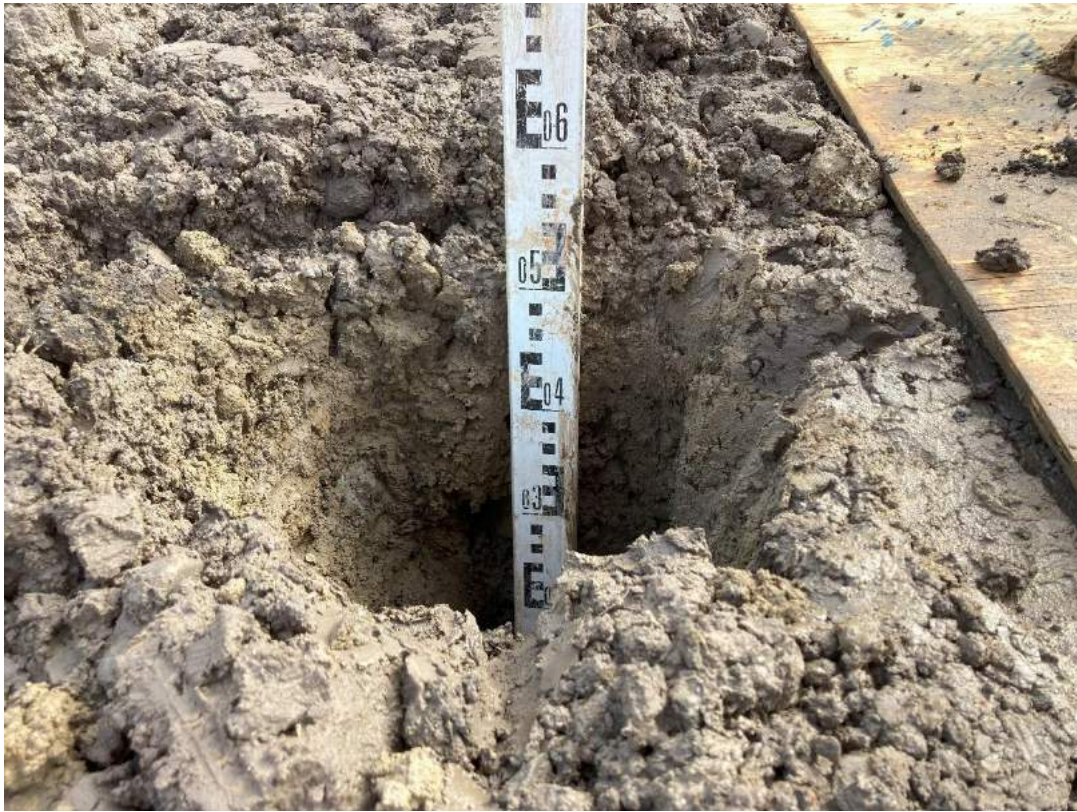
**Plate 5 – Plot 1 rear garden cover system GL to 0.60mbgl with 0.15m of topsoil.**

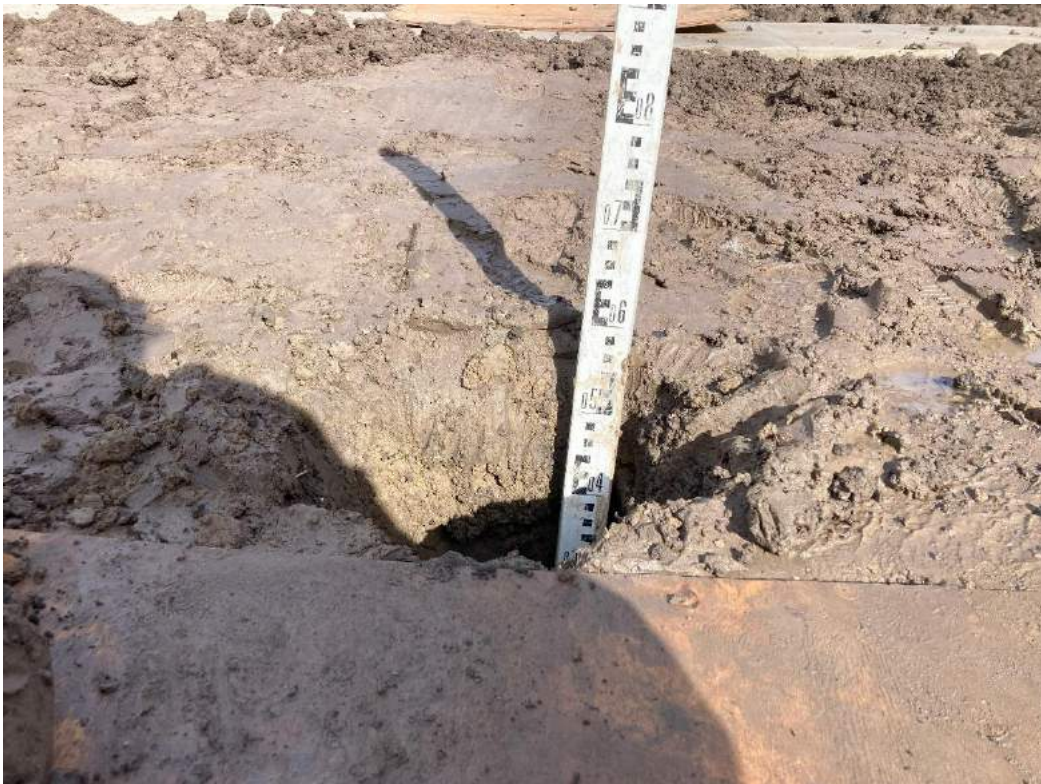
**Plate 10 – Plot 2 rear garden cover system GL to 0.60mbgl with 0.15m of topsoil.**

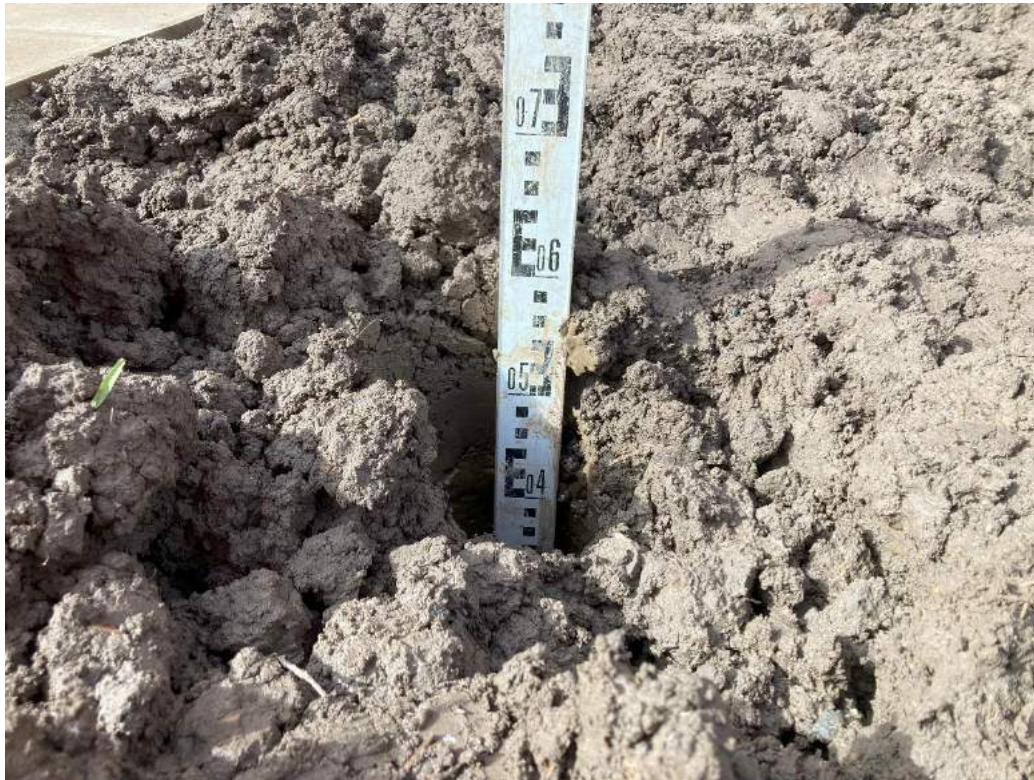
**Plate 13 – Plot 3 front garden cover system GL to 0.60mbgl with 0.15m of topsoil.**

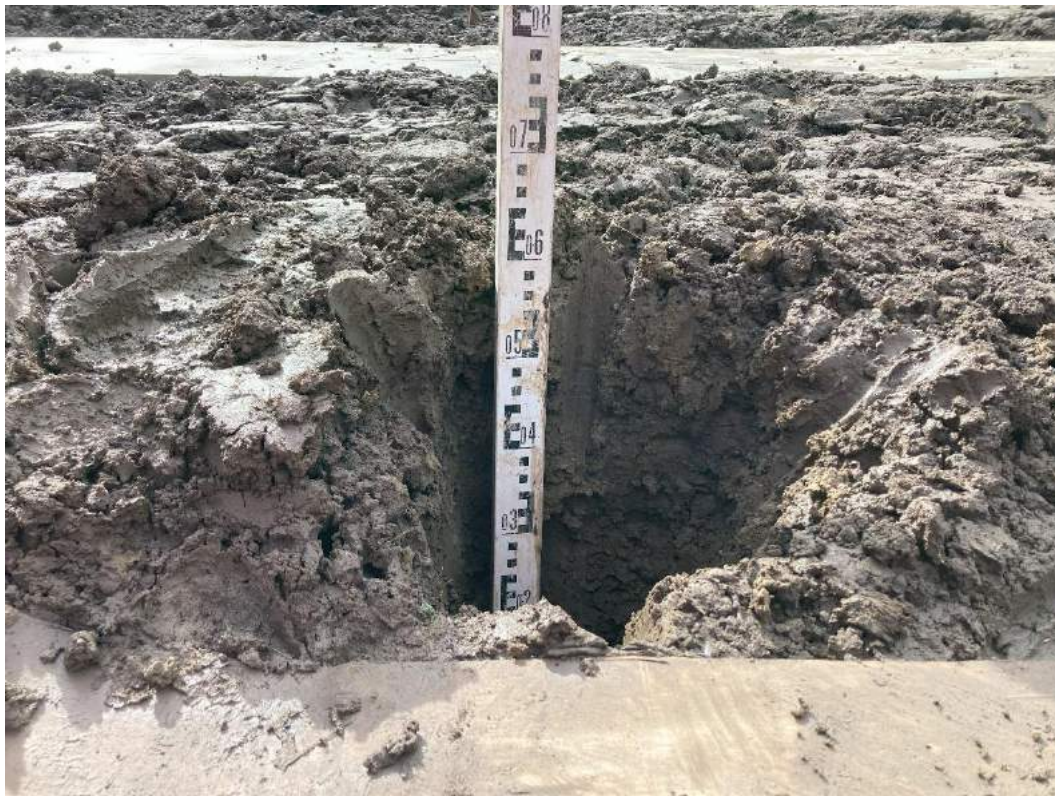
**Plate 15 – Plot 3 rear garden cover system GL to 0.60mbgl with 0.15m of topsoil.**

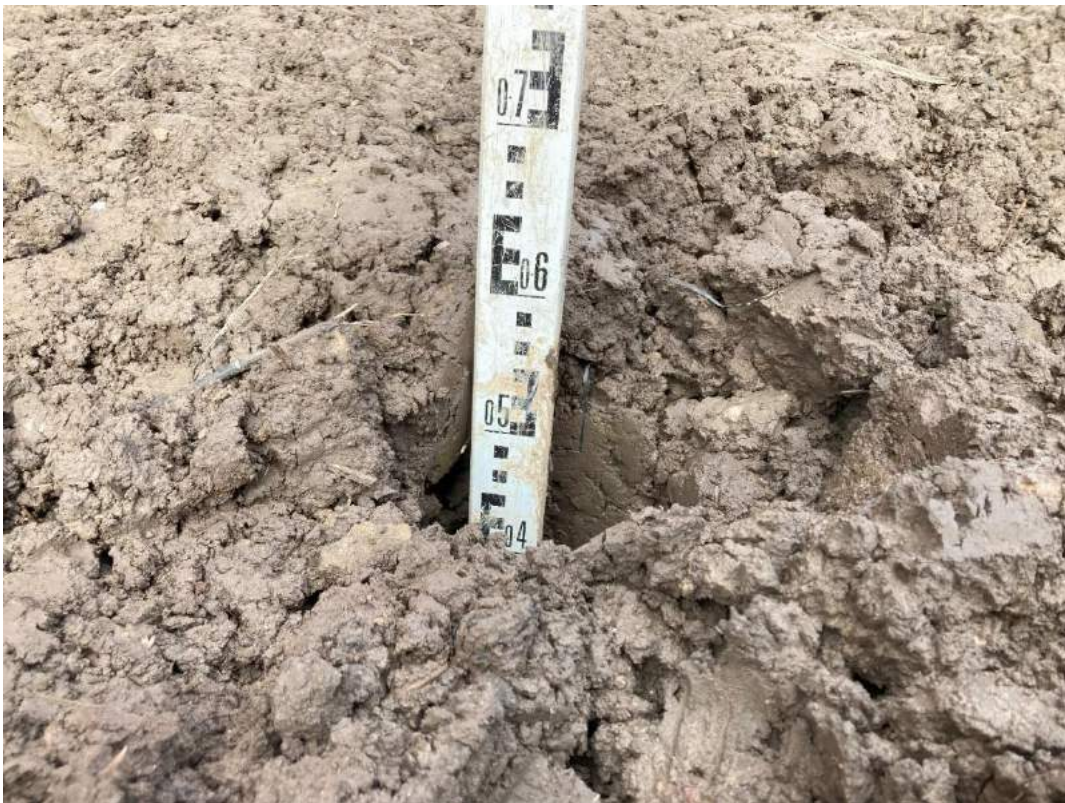
**Plate 18 – Plot 4 front garden cover system GL to 0.60mbgl with 0.15m of topsoil.**

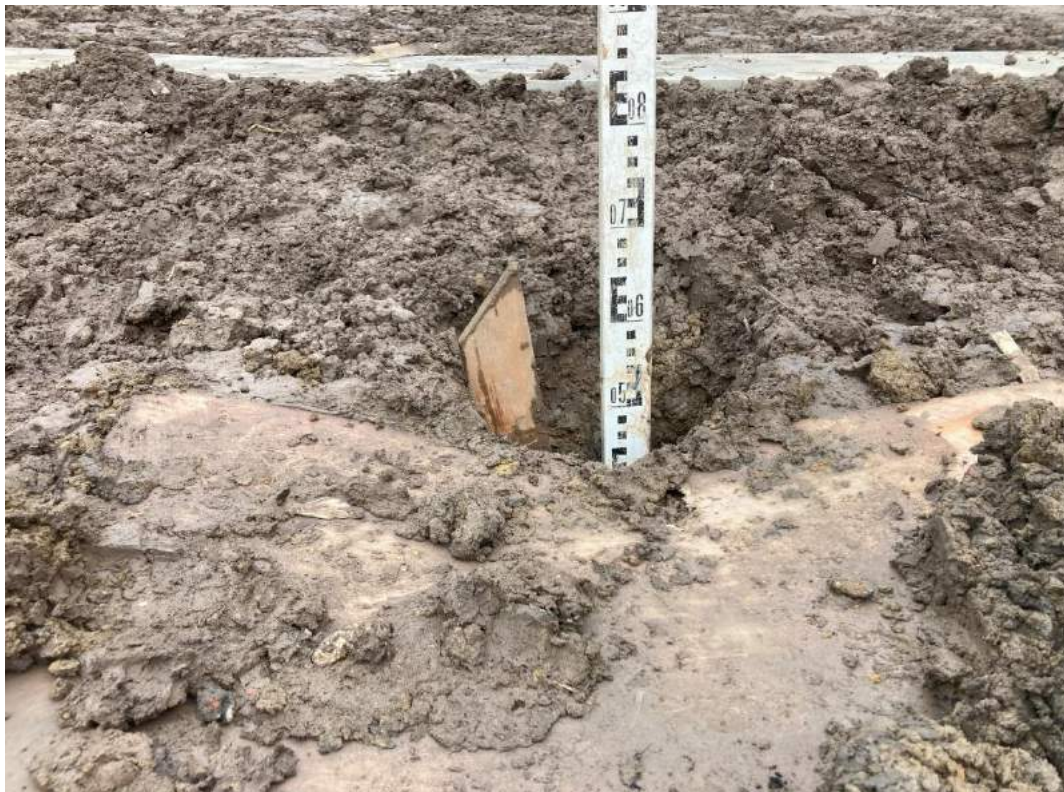
**Plate 20 – Plot 4 rear garden cover system GL to 0.60mbgl with 0.15m of topsoil.**

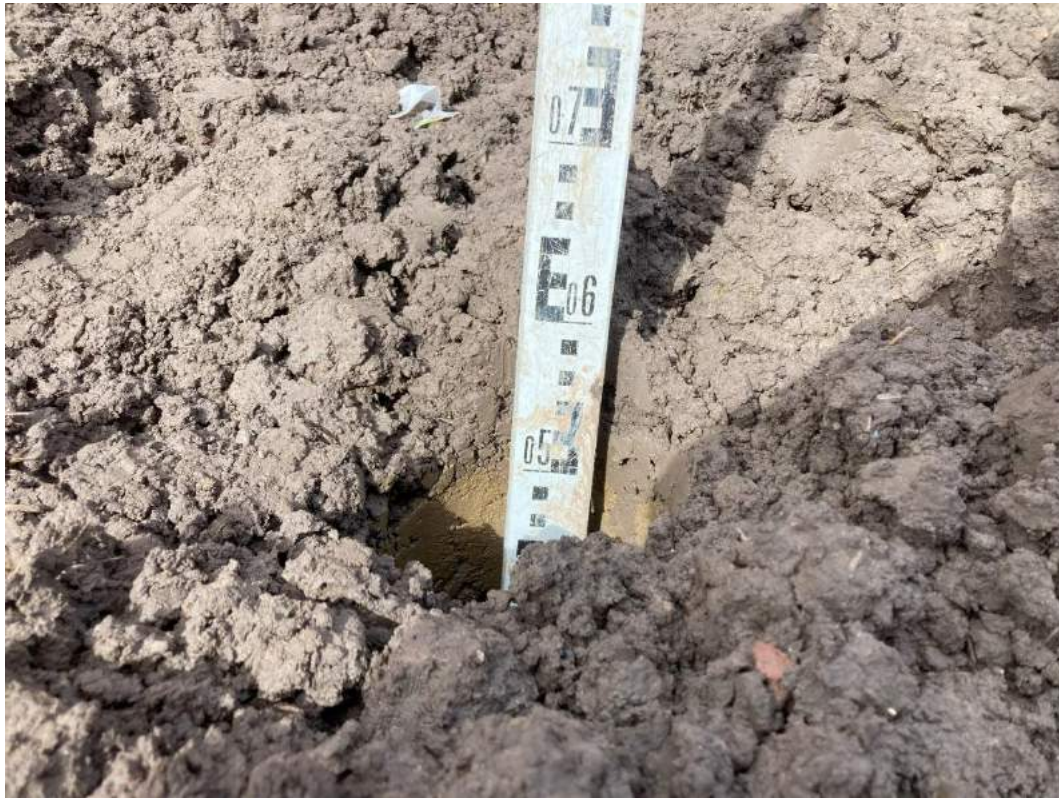
**Plate 23 – Plot 5 front garden cover system GL to 0.60mbgl with 0.15m of topsoil.**

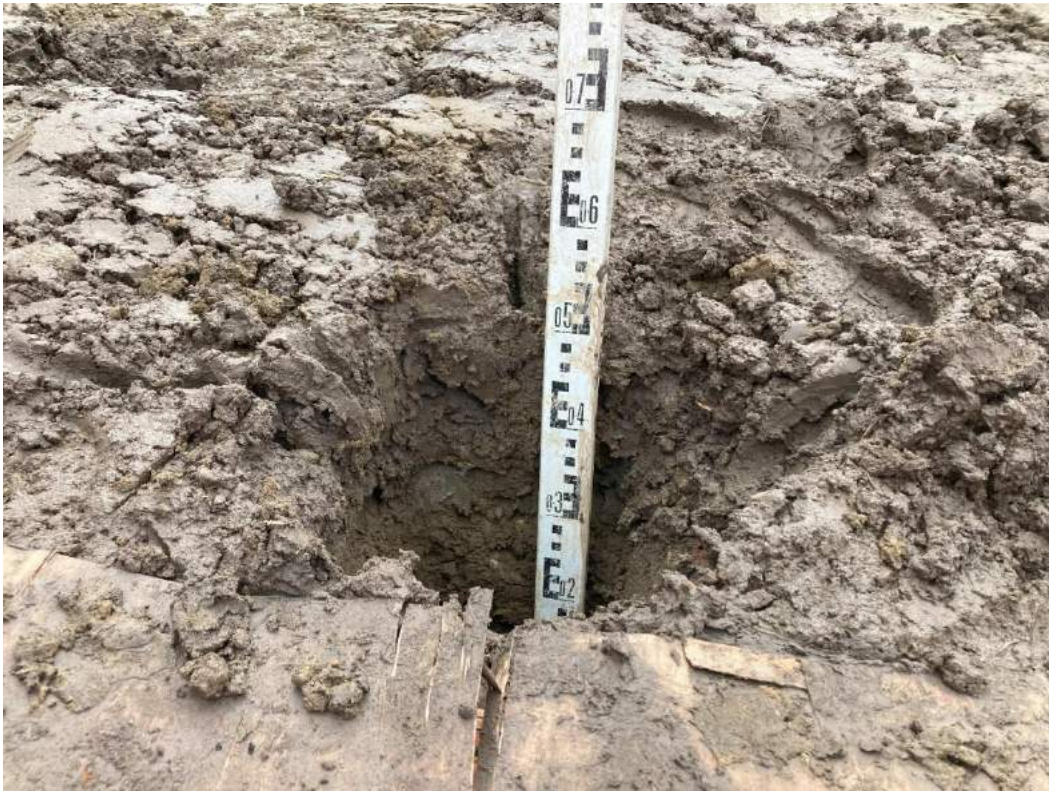
**Plate 25 – Plot 5 rear garden cover system GL to 0.60mbgl with 0.15m of topsoil.**
