## **Remediation Verification Report for East Lancashire Paper Mill Island Site, Rectory Lane, Radcliffe, M26 2QU**

**Project No: NX418**

**Report Reference: NX418**

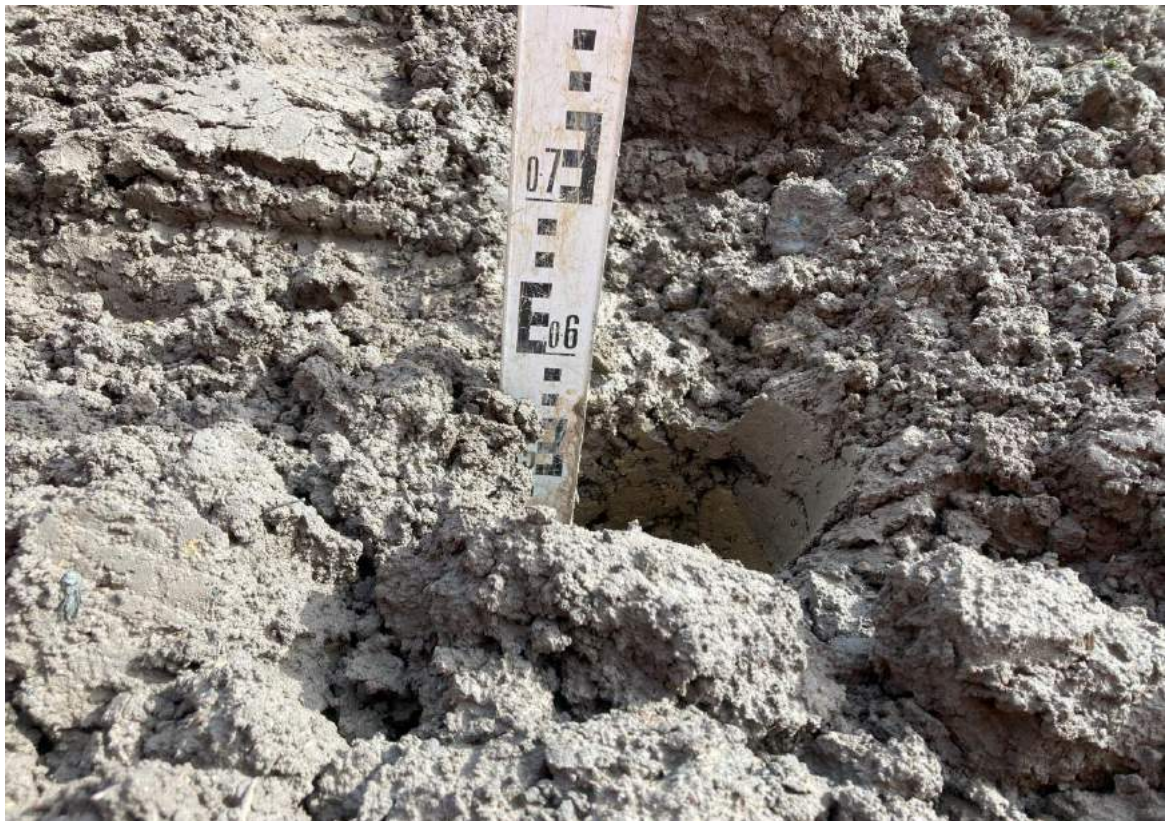
**Plate 28 – Plot 5 front garden cover system GL to 0.60mbgl with 0.15m of topsoil.**

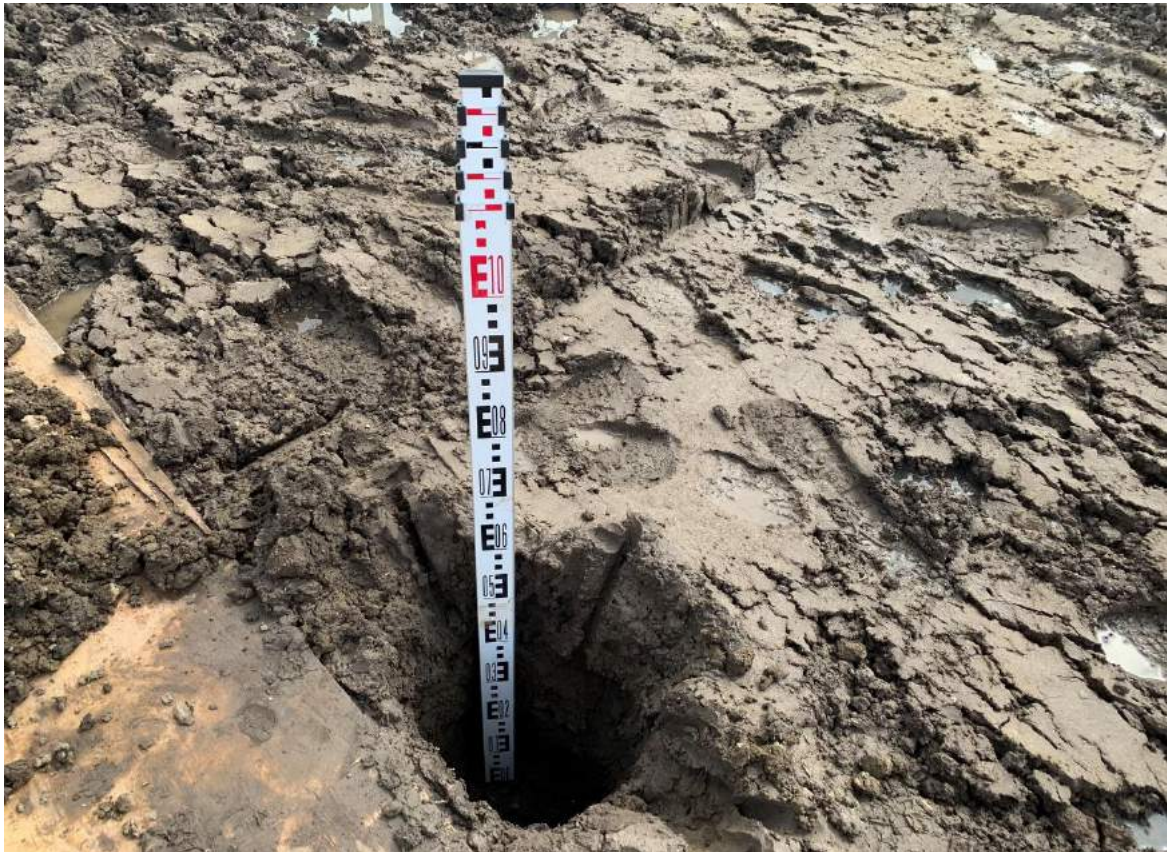
**Plate 31 – Plot 6 & 7 rear garden cover system GL to 0.60mbgl with 0.15m of topsoil.**
