Our Ref: 215/23/GJW

**Re: Barn at Higher Ash Farm, Hawkshaw Lane, Hawkshaw.**

**215/23 – Photograph Schedule for the Barn at Higher Ash Farm, Hawkshaw Lane, Hawkshaw.**

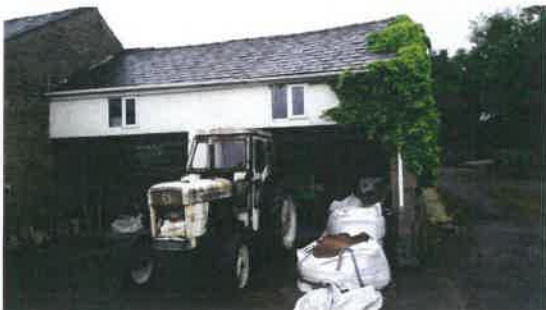
- 2.2 This structure is approximately 8.0 metres long and 6.0 metres wide. The East elevation of this structure is largely open at ground floor level with the exception of a central substantial masonry pier as identified by photograph referenced 1. The masonry pier supports exposed steel beams which are in good condition and the upper floor structure, a rendered masonry wall and roof structure.

| Photograph Reference | Photograph | Comments |
|---|---|---|
| 1 | | Northern open fronted structure – East elevation. |

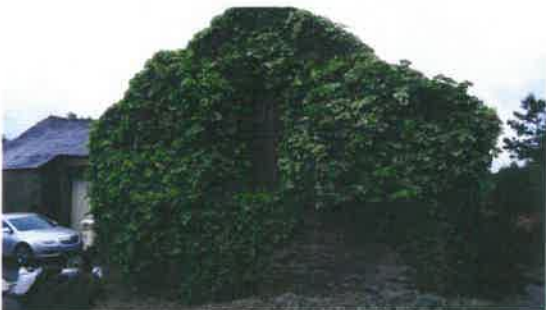
- 2.3 The external masonry walls generally appear to be in sound condition and of reasonable alignment expected for a property of this style and age. The East elevation comprises of rendered blockwork which appears to be a more recent modification and all of which is sound construction. The West elevation which adjoins the Western two-storey barn comprises of substantial coursed stonework which appears to be sound construction that is only in need of re-pointing in localised areas. The North elevation is covered with plant growth which restricted inspection of the substantial coursed stonework – refer to photograph referenced 2. It is likely

that the plant growth will in time, if it has not already, have a detrimental effect upon the masonry, particularly the mortar joints. Although this is unlikely to have any significant structural implications it will result in the requirement to fully re-point the mortar joints to this elevation. It is recommended that this plant growth is removed.

| Photograph Reference | Photograph | Comments |
|---|---|---|
| 2 | | Northern open fronted structure – North elevation. |

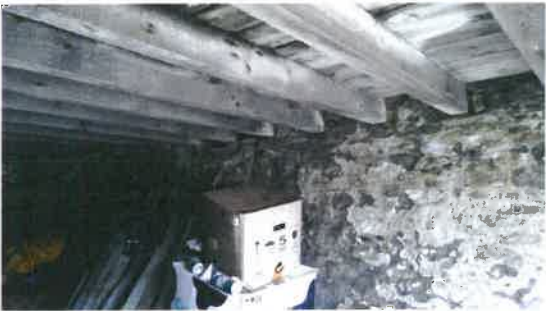
- 2.4 The first floor structure comprises of timber floor boards supported off sawn timber floor joists bearing onto the gable walls – refer to photograph referenced 3 – and a sawn timber beam at mid-span. The structural timber floor members exhibit evidence of biological attack and minor deflections are noted. It would therefore not be appropriate to include this within the conversion.

| Photograph Reference | Photograph | Comments |
|---|---|---|
| 3 | | Northern open fronted structure – first floor joist bearing at gable wall. |

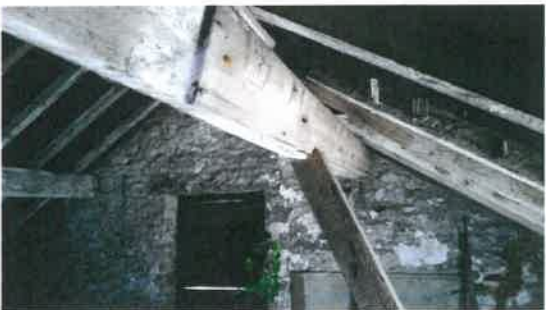
- 2.6 The mid-slope purlin to the East elevation has failed and is currently propped to maintain the integrity of the roof – refer to photograph referenced 4. This purlin will need replacing in full.

| Photograph Reference | Photograph | Comments |
|---|---|---|
| 4 | | Northern open fronted structure – defective timber purlin propped at mid-span. |

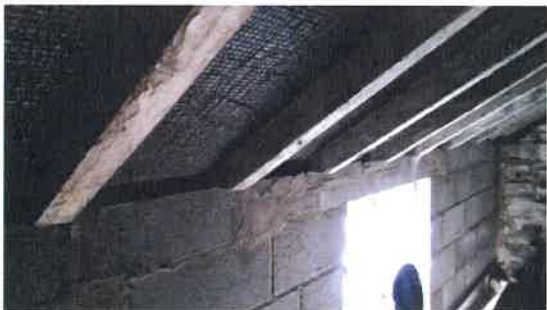
- 2.7 The timber rafter bearings to the East elevation are inadequate and consideration should be given to either improving the bearing of the existing rafters or replacing the rafters to this slope to ensure a full bearing is achieved – refer to photograph referenced 5.

| Photograph Reference | Photograph | Comments |
|---|---|---|
| 5 | | Northern open fronted structure – inadequate timber rafter bearings. |

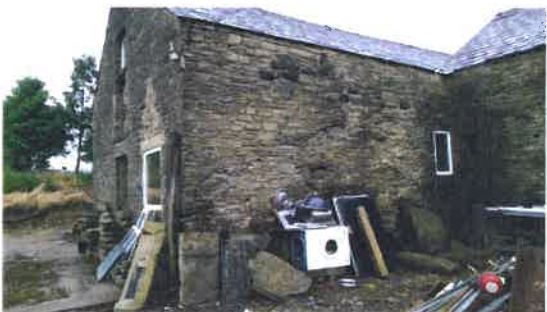
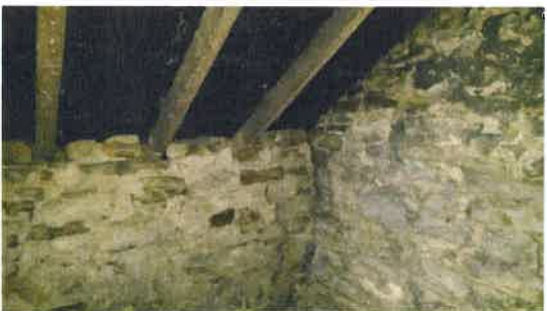
- a. There is a crack and evidence of outward movement to the South-East corner of this structure that has likely been caused over a period of time due to rainwater run-off concentrated at this location and a lack of positive surface water drainage outlet to discharge to – refer to photographs referenced 6 and 7. This corner will require localised underpinning, tying back into the adjacent gable and side walls, the reintroduction of rainwater goods and a ground level surface water outlet in order to remediate this area. This repair equates to approximately 6.0m<sup>2</sup>.

| Photograph Reference | Photograph | Comments |
|---|---|---|
| 6 | | Western two-storey barn – South-East corner – external view. |
| 7 | | Western two-storey barn – South-East corner – internal view. |

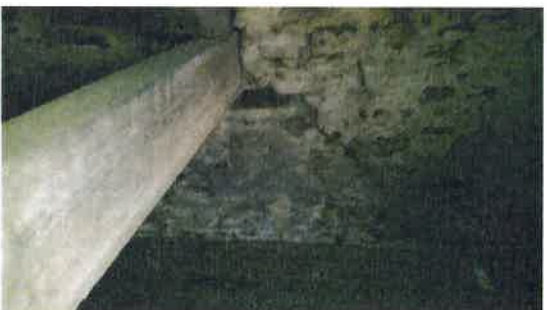
- c. There is an amount of localised cracking internally at the bearing of the trusses and these require a nominal repair – refer to photograph referenced 8. This repair equates to approximately 6.0m<sup>2</sup>.

| Photograph Reference | Photograph | Comments |
|---|---|---|
| 8 | | Western two-storey barn – cracking in stonework at truss end bearing. |

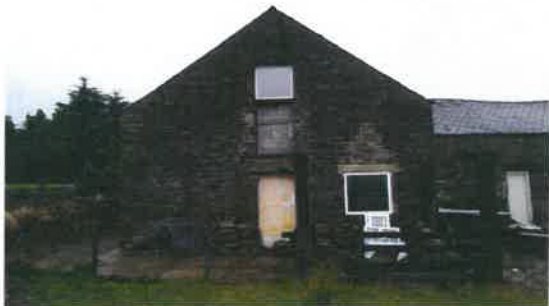
- d. The South elevation;
    - i. The central opening to the elevation at ground floor level needs rebuilding at the reveals and the removal of the existing lintel – refer to photograph referenced 9 – and installation of a new suitably sized lintel, the total area of which is approximately 2.0m<sup>2</sup>.

| Photograph Reference | Photograph | Comments |
|---|---|---|
| 9 | | Western two-storey barn – South elevation. |

- 4.4 Rebuilding work is required to the following areas;
- a. Western two-storey barn;
    - i. To the South elevation central opening at ground floor level which needs rebuilding at the reveals and the replacement of the existing lintel.

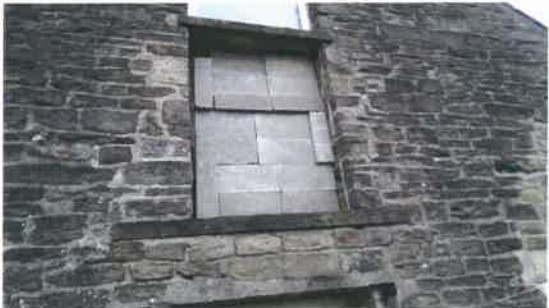
- ii. At first floor level the opening has been infilled with dry jointed blocks – refer to photograph referenced 10. These are unstable and should be removed and re-built in bonded stonework, the total area of which is approximately 1.5m<sup>2</sup>.

| Photograph Reference | Photograph | Comments |
|---|---|---|
| 10 | | Western two-storey barn – South elevation, dry jointed stacked blocks. |

- ii. To the South elevation at first floor level where the opening has been infilled with dry jointed blocks.
  - b. Eastern single-storey barn;
    - i. To the South elevation where the existing lintels are showing signs of corrosion and will require replacing.

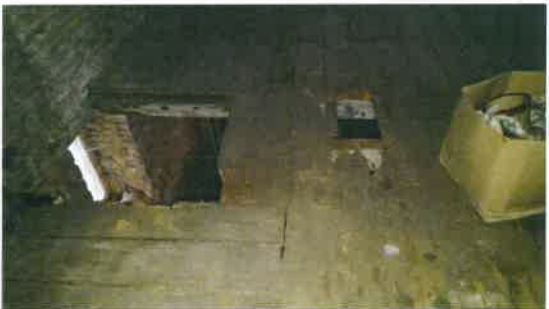
| Photograph Reference | Photograph | Comments |
|---|---|---|
| 11 | | Western two-storey barn – timber floor subject to biological attack. |

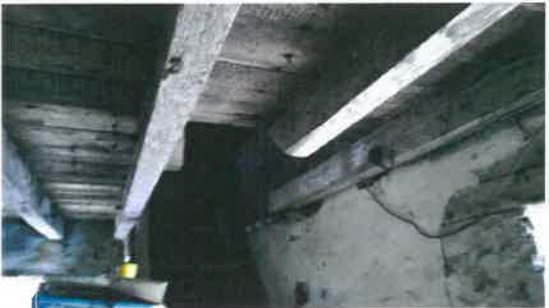
| Photograph Reference | Photograph | Comments |
|---|---|---|
| 12 | | Western two-storey barn – inadequate floor support around staircase. |

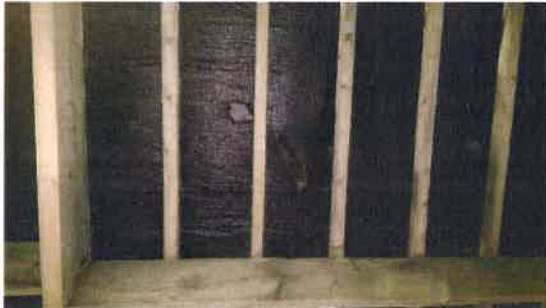
- 2.13 The roof coverings comprise of natural slate over a sarking felt which is torn in a few areas and will therefore require replacing – refer to photograph referenced 13. The roof structure comprises of timber king post trusses at quarter and mid-point of the structure and these in turn support sawn timber purlins and sawn timber rafters. Generally the structural timber members are in good condition with the exception of the following areas;

| Photograph Reference | Photograph | Comments |
|---|---|---|
| 13 | | Western two-storey barn – sarking felt torn. |

- f. The Western two-storey barn roof requires repairs to the sarking felt, therefore it is recommended that the natural slate and sarking felt are stripped off with the sarking felt replaced with new and the slate re-used. Whilst the finishes are removed, remedial work should be undertaken to;

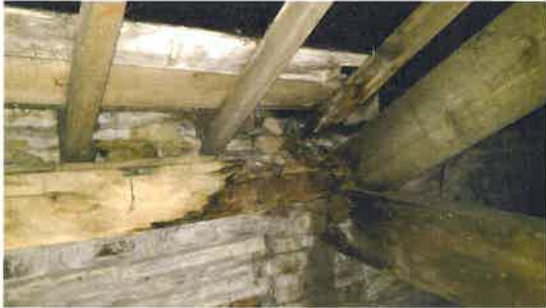
- a. The junction between roofs of the Western and Eastern barns is subject to rainwater ingress which has resulted in wet rot of the rafters, purlin and truss in this area – refer to photograph referenced 14. It will be necessary to repair the roof coverings in order to the let these timbers dry out and further determine whether or not the structural integrity has be compromised. In this area the truss bearing is also poorly constructed and is unlikely to have adequate wall ties between what are apparently two walls constructed at different times.

| Photograph Reference | Photograph | Comments |
|---|---|---|
| 14 | | Western two-storey barn – rainwater ingress at truss bearing. |

- i. The wet rot to the truss, purlin and rafters at the junction between the Western and Eastern barns where water ingress has occurred.
    - ii. All of the truss end bearings into the stonework where waterproofing is required.

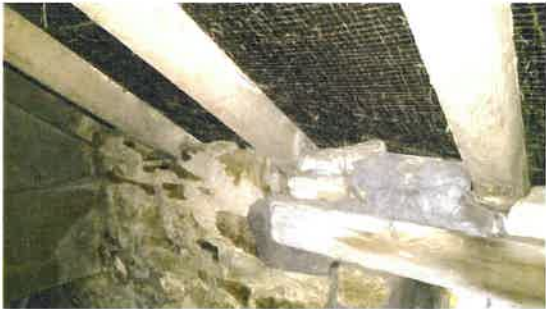
- d. Rafters generally do not appear to be fixed to the wall plate at the eaves therefore skew nail fixings throughout would be recommended. The rafter bearing at timber lintel locations also requires attention where the bearing detail is inadequate – refer to photograph referenced 15.

| Photograph Reference | Photograph | Comments |
|---|---|---|
| 15 | | Western two-storey barn – inadequate timber rafter bearings. |

- iii. The rafter bearings onto the wall plate at the eaves where skew nail fixings are required.
  - g. The Eastern single-storey barn roof is in a state of disrepair and should be removed and replaced in its entirety.

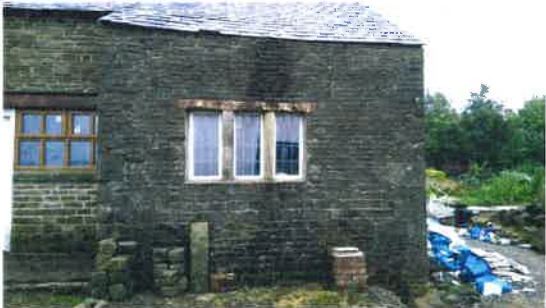
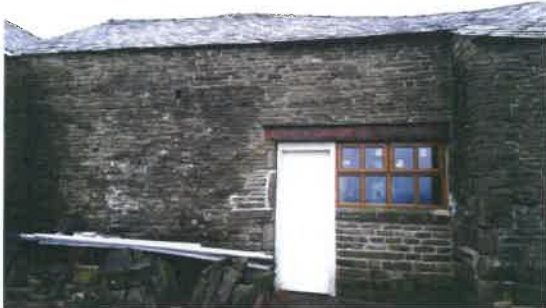
- a. The steel lintels to the South elevation are showing initial signs of corrosion, although they are without significant section size loss and are therefore currently stable – refer to photographs referenced 16 and 17. These should be replaced with an appropriately sized and specified lintel for an external environment and this will require approximately 4.0m<sup>2</sup> of rebuilding.

| Photograph Reference | Photograph | Comments |
|---|---|---|
| 16 | | Eastern single-storey barn – corroding lintel. |

| Photograph Reference | Photograph | Comments |
|---|---|---|
| 17 | | Eastern single-storey barn – corroding lintel. |

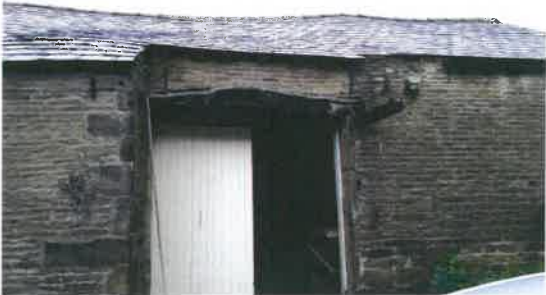
- c. The timber lintel is decaying and its bearings are damaged to the North elevation and need replacing – refer to photograph referenced 18. This will result in approximately 3.0m<sup>2</sup> of rebuilding work.

| Photograph Reference | Photograph | Comments |
|---|---|---|
| 18 | | Eastern single-storey barn – decaying lintel. |

- ii. To the East elevation where the lintels to the infilled openings require replacing.
    - iii. To the North elevation where the existing lintel requires replacing.

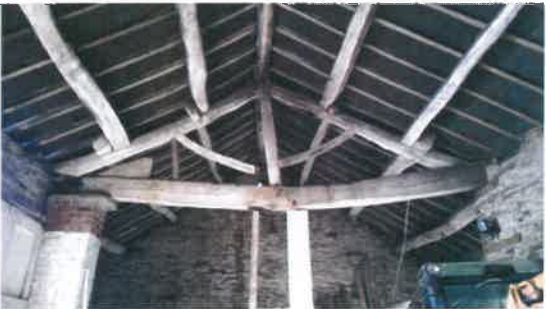
- 2.19 The roof structure shows significant deflection to the natural slate roof finishes when viewed externally, particularly towards the East elevation. The truss closest to the Western barn does not currently show signs of significant deflection although it is noted there is evidence of rot, presumably through rainwater ingress. The second truss is in far worse condition with obvious failure of the internal truss members and joints and evidence of rot. This has caused it to deflect significantly and is only prevented from complete failure by the presence of a prop at mid-span and a brickwork pier added to one end bearing – refer to photograph referenced 19.

| Photograph Reference | Photograph | Comments |
|---|---|---|
| 19 | | Eastern single-storey barn – structural failure of timber king post truss. |

- 2.20 It would be recommended that this roof structure is removed in its entirety and replaced with new trusses, purlins and rafters which are suitable sized and specified for their spans.
