## **Evidence of the Highways Dilapidation**

34 Hillingdon Road,  
Whitefield, Manchester,  
M45 7QN

*Condition 3 of Application Number: 68736/FUL*  
April 2023

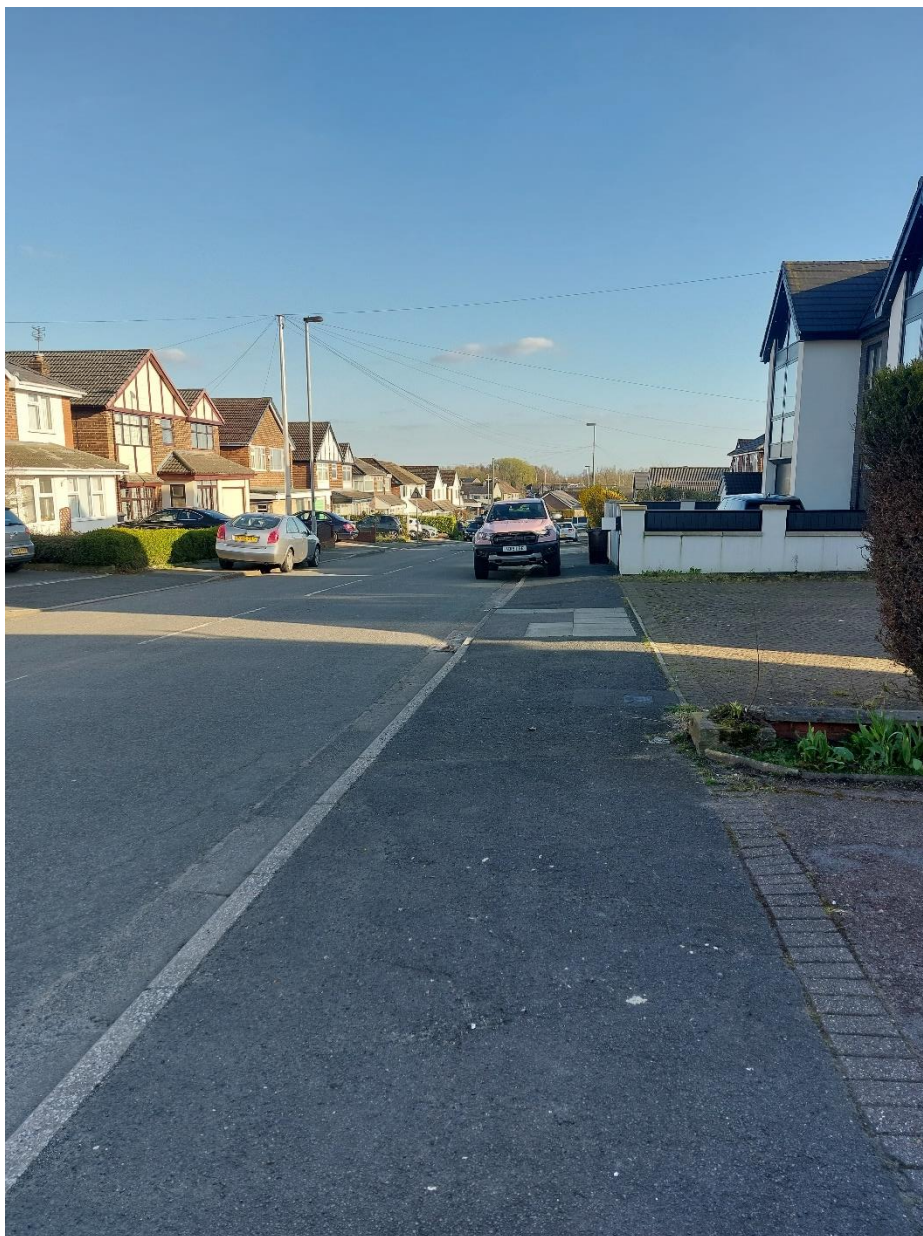
### **Photo 1**

Photo showing Hillingdon Road from the point of the right side of the road viewing from the same side where the property in the enquiry is.

- Dropped down curb majority of the way through apart from further down where the white slabs appear on the path in front of the drive.
- Water source pavement cover with new tarmac around it.
- Small dints and cracks along side of the path before the drive of where No.34 starts.

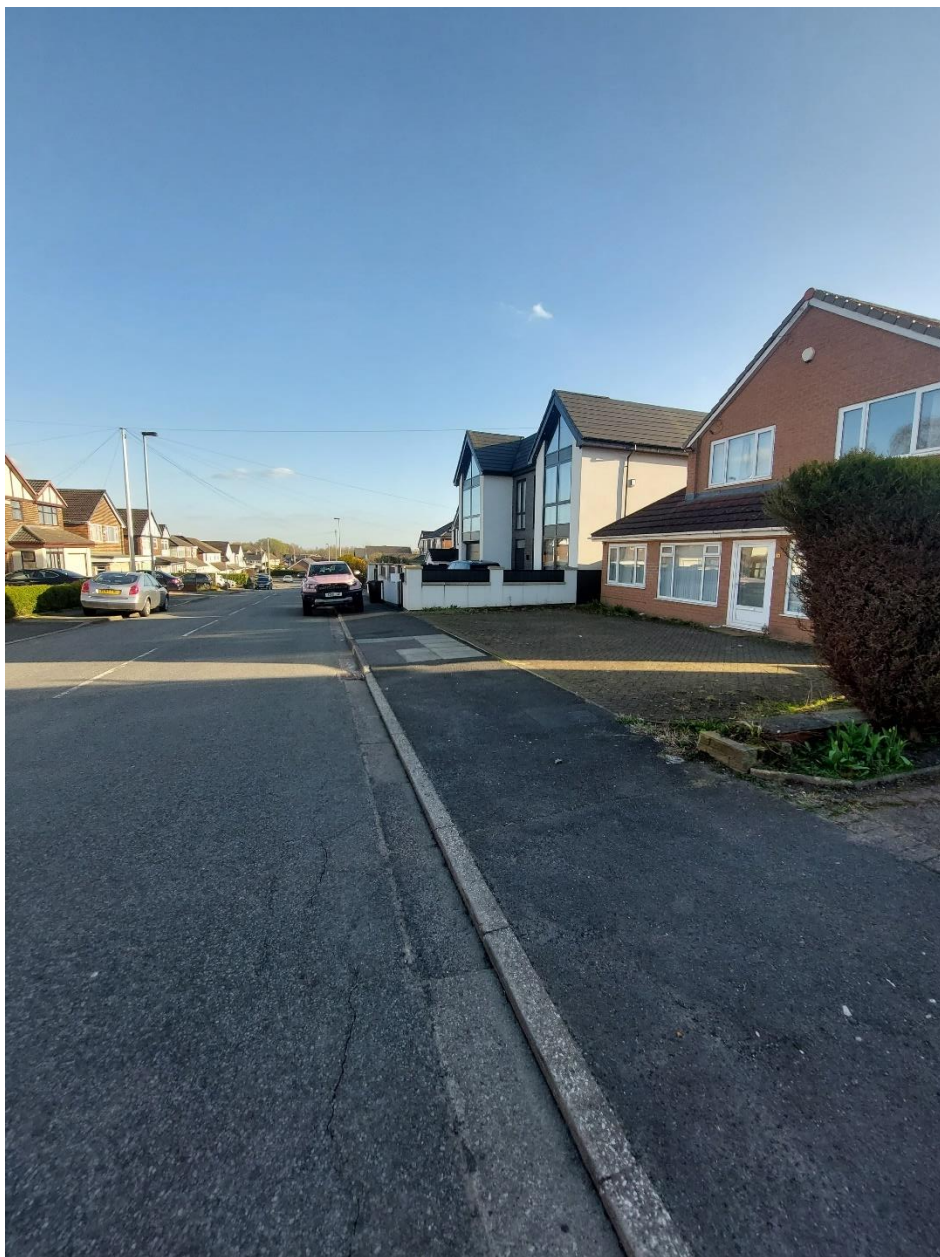
### **Photo 2**

A larger overview of the road, giving a better insight to the area with the property in question included.

- Shows a chipped curb where the white squares are located.
- Near the bottom of the photo, it shows evident cracks in the road leading further into the road.
- The right bottom side of the photo shows dips in the path.

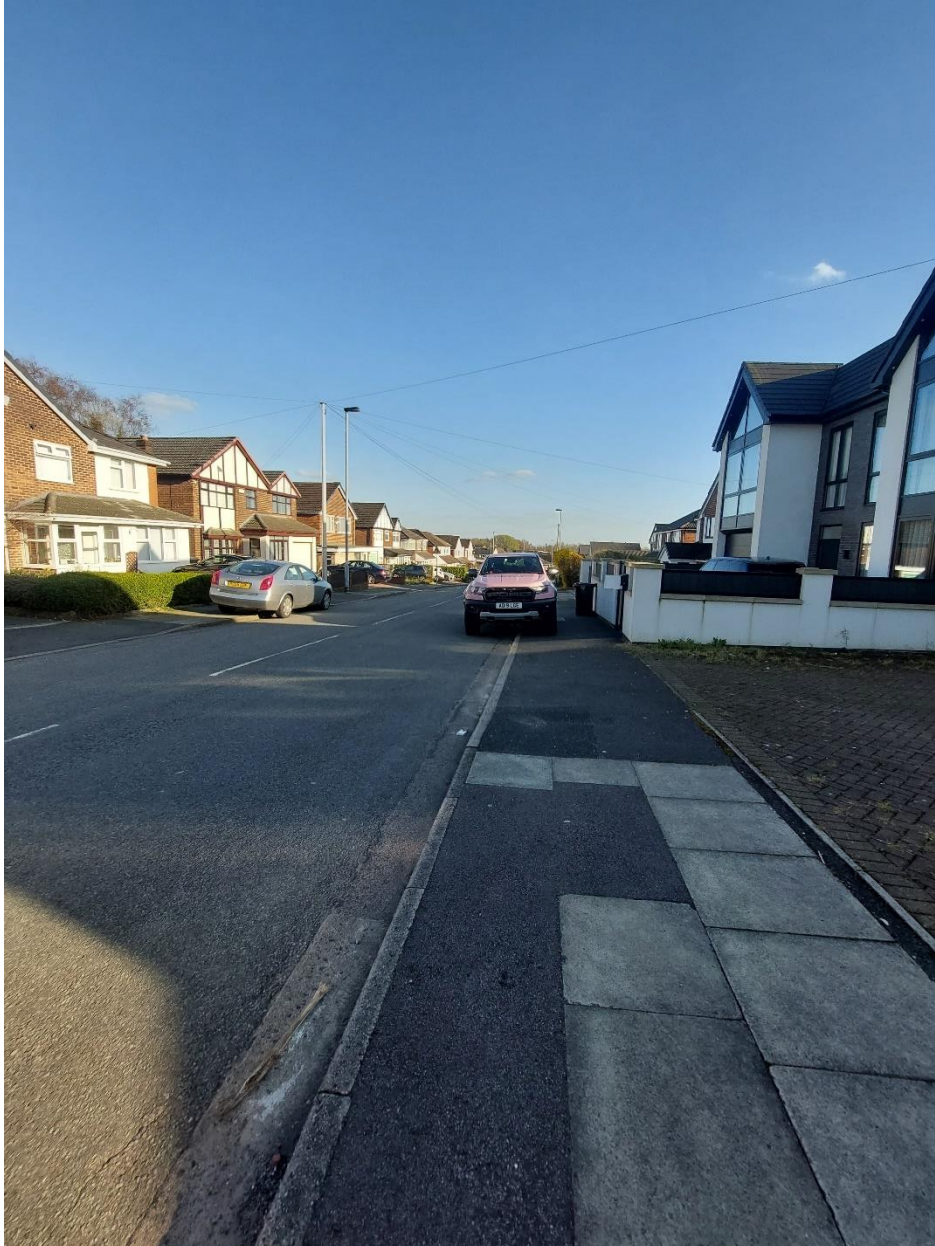
### **Photo 3**

A close up image of the front of the property's drive/path.

- The image is showing exactly how many white concrete slabs there are, which is 9.
- Next to the first two out of three slabs on the left side there is a square of a different colour of tarmac which is covering a slight dip in the path.
- White discolouration right next to the curb.

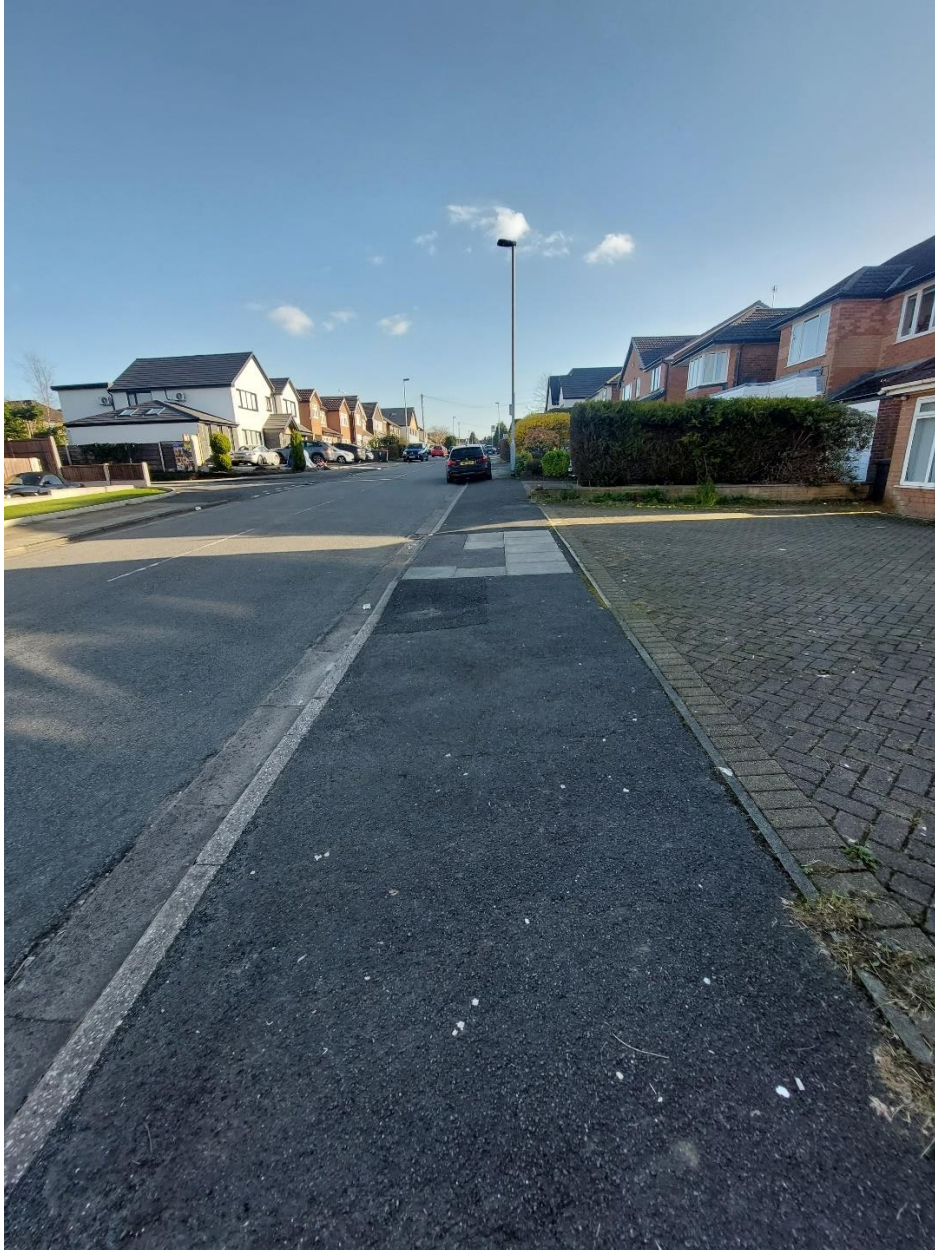
**Photo 4**

The photo has been taken from the opposite traffic side to the ones listed above.

- The photo shows existing cracks and small dints to the pavement on the left hand side.
- The curb is dropped and raised where the white slabs are further up the path.
- The left side, at the bottom of the image, it shows existing cracks on the road where the tarmac and stone meets the curb.

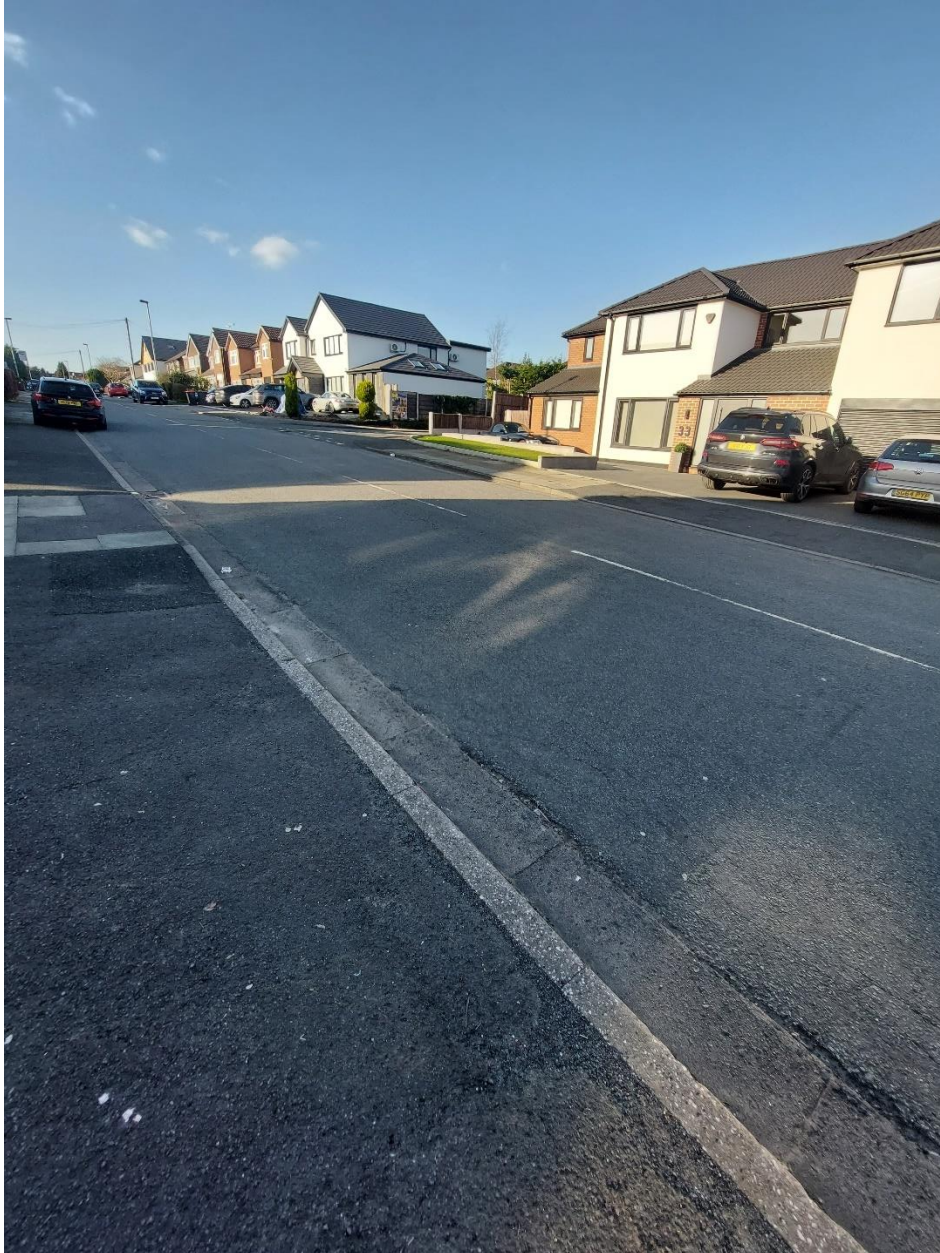
### **Photo 5**

The image is showing the opposite side of the road, facing out from No.34, it is zoomed out and shows a bigger image of the road condition.

- The image shows significant cracks and uneven pavement.
- Next to the curb on the left side, there is cracks lining through the road adjacent to the curb.
- Overall the pavement appears uneven and has a lot of loose tarmac residue on top of it.
