10<sup>th</sup> October 2019

**Our Ref: P.1202.19**

**Re: Tree bat roost potential climbing inspection at Former Mondi Site (Site 1), Holcombe Mill, Bridge Street, Ramsbottom, BL0 0BS**

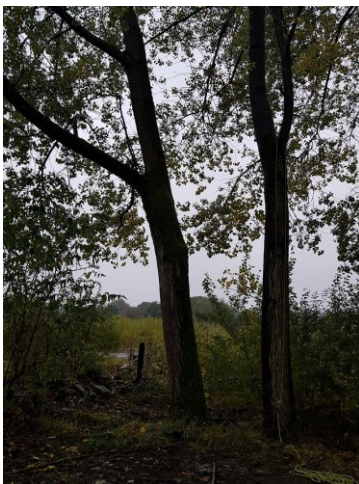
The poplar tree previously assessed as having low bat roost potential located adjacent to the tree with negligible (previously moderate) bat roost potential (Photo 1) was inspecting during the tree climb inspection. There are cracks within a flush cut at approximately 7m height south west facing. The feature was examined during the tree climb and the cracks did not extend deep within the tree. The tree was downgraded from low to **negligible** bat roosting potential.

Photo 1: Tree left (Previously low bat roost potential),  
Tree right (Previously moderate bat roost potential)

Both poplar trees that were subject to a tree climb inspection on 4<sup>th</sup> October 2019 have been downgraded to negligible bat roosting potential following the inspection. Both trees require no further surveys in relation to bats and can be felled without further investigation in relation to bats.

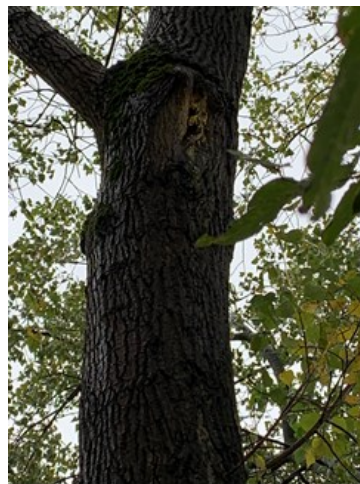
The tree previously assessed as having moderate bat roost potential is a poplar sp. with a callus roll (Photo 2) at approximately 6m height west facing. The feature on this tree were assessed during the tree climb inspection. The callus roll cavity extended within the tree, however, was filled with water, slugs and cobwebs were present within the feature. No bats were present within the feature and the tree bat roost potential has been downgraded to **negligible** bat roost potential following the climb inspection. The cavity has been filled with a piece of foam which was found on site, to reduce the risk of bats using the feature as a roost opportunistically in the future.

Photo 2: Callus roll within tree within moderate bat  
roost potential
