WCS Project Reference: P5090  
Bury MBC Listed Building Consent Reference: 70507

Plant Farm, Cross Lane, Ramsbottom, Bury BL8 4LY

Further submission following application for Listed Building Consent for internal refurbishment works

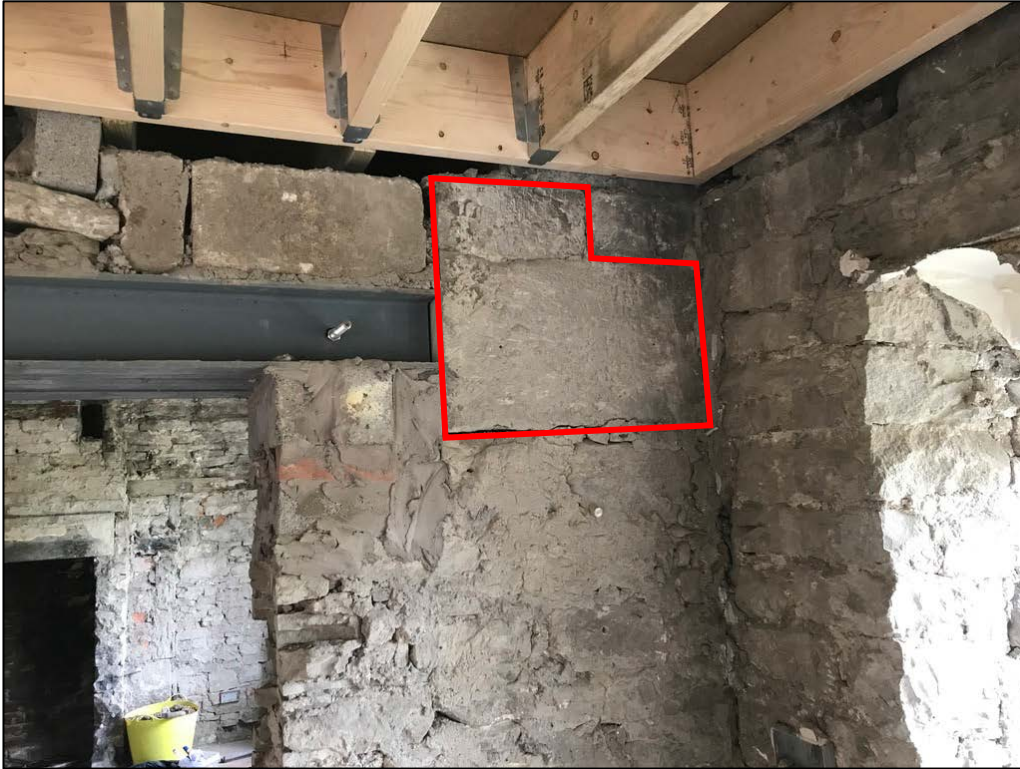
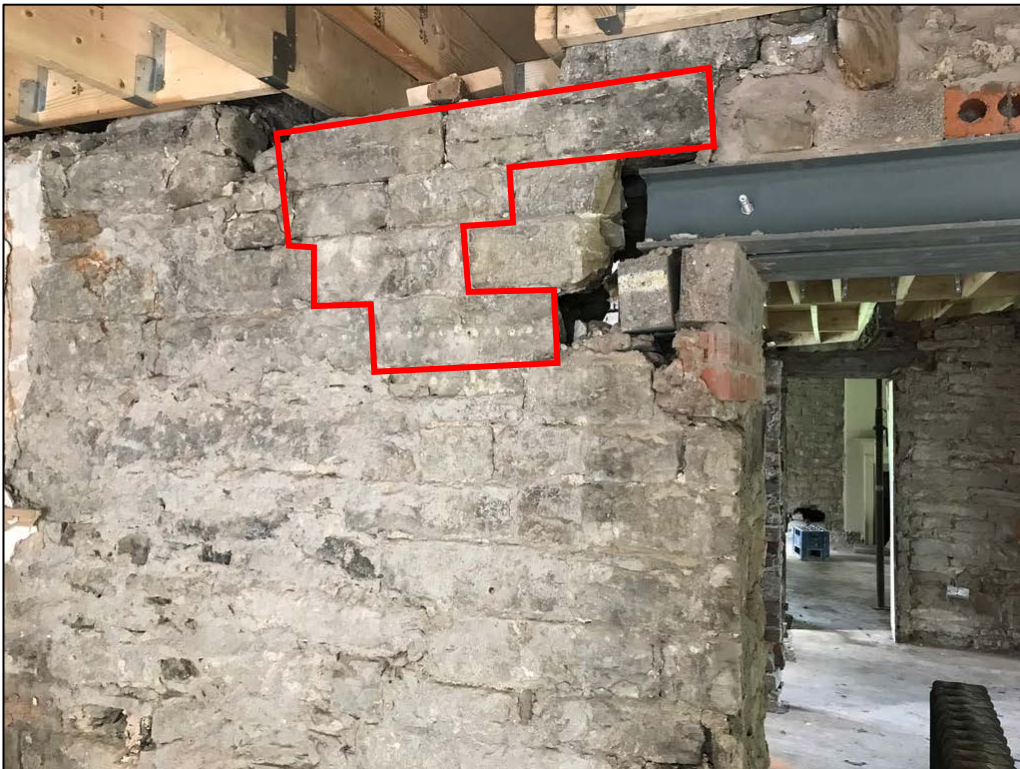
- 3.2 The statutory consultee response from HB&P and the subsequent LPA officer comments indicate a concern regarding the legibility of the remaining sections of the former external wall to either side of the newly formed structural opening. The advice provided encourages the retention of clear visual evidence of the wall's age and previous function following the refurbishment works.

5.6 Proposed exposed stone section to remain visible within former external wall of c. 1739.

5.7 Proposed exposed stone section to remain visible within former external wall of c. 1739.

- 3.3 It is proposed to plaster and redecorate the remaining sections of the wall, using Limelite plaster as set out within the general approach to plastering and damp proofing proposed in Section 4 below. In order to ensure the desired legibility, however, it is proposed that sections of suitably well-dressed stone should be left exposed and visible as shown within the mark up below (Photograph 5.6, 5.7).

- 3.4 The plaster will be finished neatly around the exposed stone sections, with a plain chamfered plaster reveal detail between the plaster surface and recessed stone surfaces.

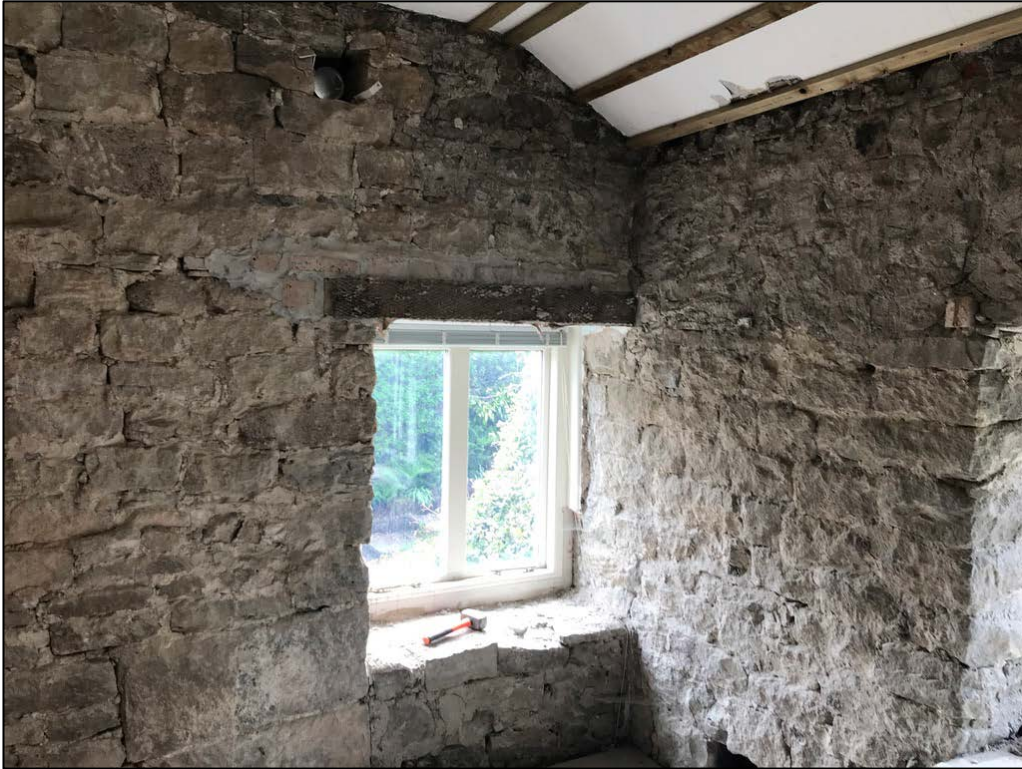
- 4.4 Based upon a visual inspection at the time of the survey, in this case the condition of the above ground external walls following removal of earlier cement-based plaster applications appears to be relatively good for their age and type. There is no significant visual evidence of water ingress through the external walls and the stonework appears to have dried well over time (Photograph 5.8).

5.8 Natural stone faces of external walls generally dry with no major water ingress above ground.

- Plastering internally throughout to the main above ground external walls using Limelite plaster. This is a proprietary lime-based plastering system comprising Easy Bond (primer and keying aid), Limelite Renovating Plaster (undercoat) and Limelite High Impact Finishing Plaster (topcoat). The system provides a suitable level of workability and reliability whilst allowing for breathability to protect the fabric of the building.

- Provision of ongoing maintenance to the main above ground external walls to minimise the risk of water ingress, including but not limited to prompt repair of any defects to rainwater goods and weathering details, removal of moss and algal growth to the main walls, re-pointing as required in lime based mortar and control of ground level vegetation.

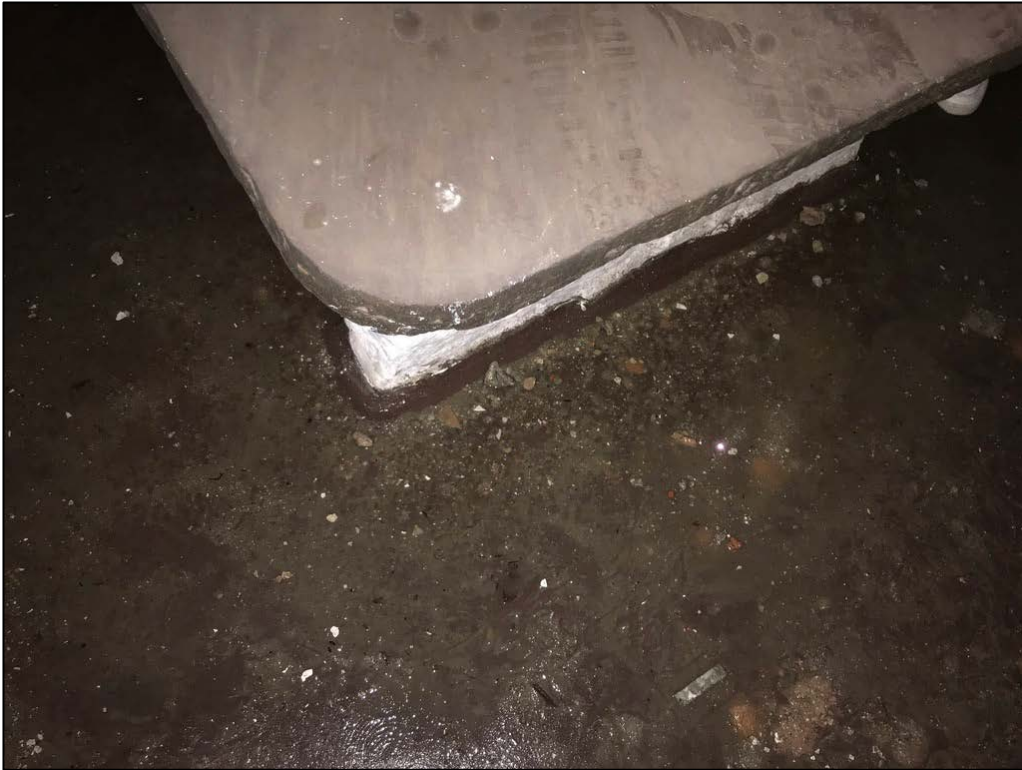
- 4.5 To the partially below-ground walls of the cellar to the rear of the property, there is significant water ingress and the walls are wet to the touch. At ground level within the cellar there is considerable water ingress, and standing water was observed at the time of the survey (Photograph 5.9).

5.9 Significant water ingress to cellar area with standing water visible at ground level.

- Provision of a new sump pump to the cellar to continuously extract standing water from the floor level of the cellar, and provision of continuous mechanical extract ventilation in order to reduce the level of water vapour and condensation within the cellar. It is proposed that the mechanical and electrical equipment required for the sump pump and continuous mechanical extract ventilation may be installed within the modern niche to the north wall of the cellar without causing any damage to the possible historic interest of the area.

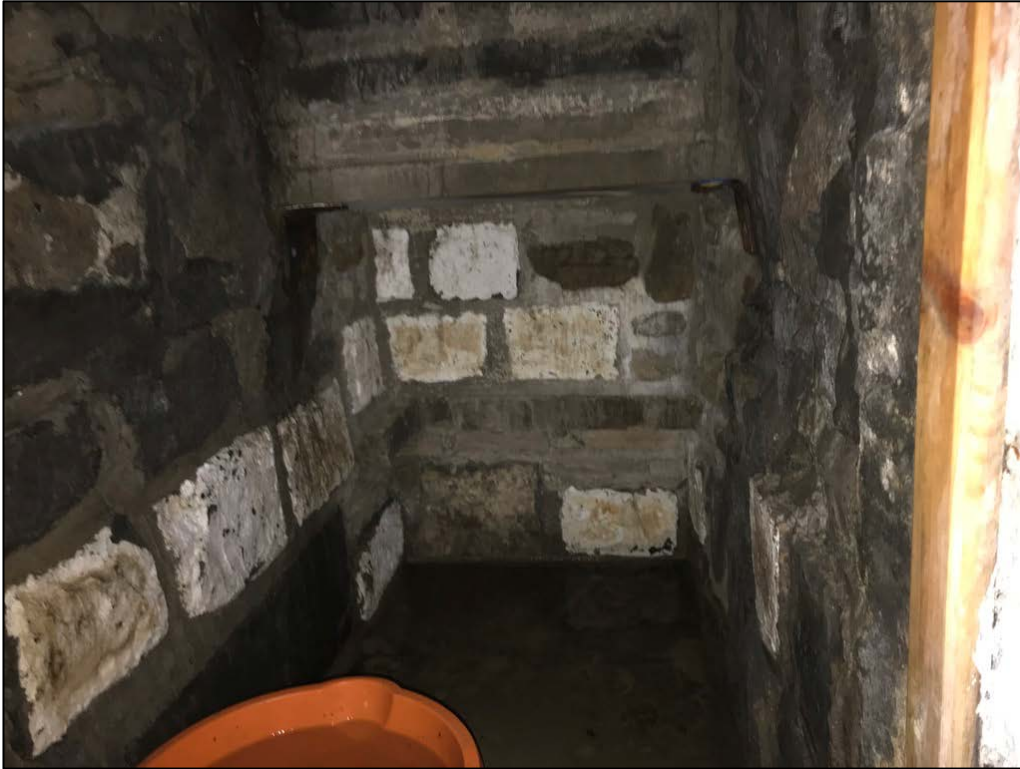
- 4.8 Notwithstanding the modern roof construction of the cellar, the lower parts of the internal walls appear to be of considerable age when viewed internally. The walls have been constructed of hand tooled stonework, although this may be partially reconstructed. The central table to the cellar may also be of historic interest. There is however a further niche to the north cellar wall which is of reclaimed stone and is of modern construction and no historic interest (Photograph 5.12).

5.12 Modern niche within cellar suitable for housing M&E equipment for pump / ventilation.
