MSE – BGH – XX -XX – RP – C-0170 – P1

2128.32  
ISG Construction Ltd

## **Millwood SEN School – New Classroom Block Surface Water Destination Considerations**

**January 2024**

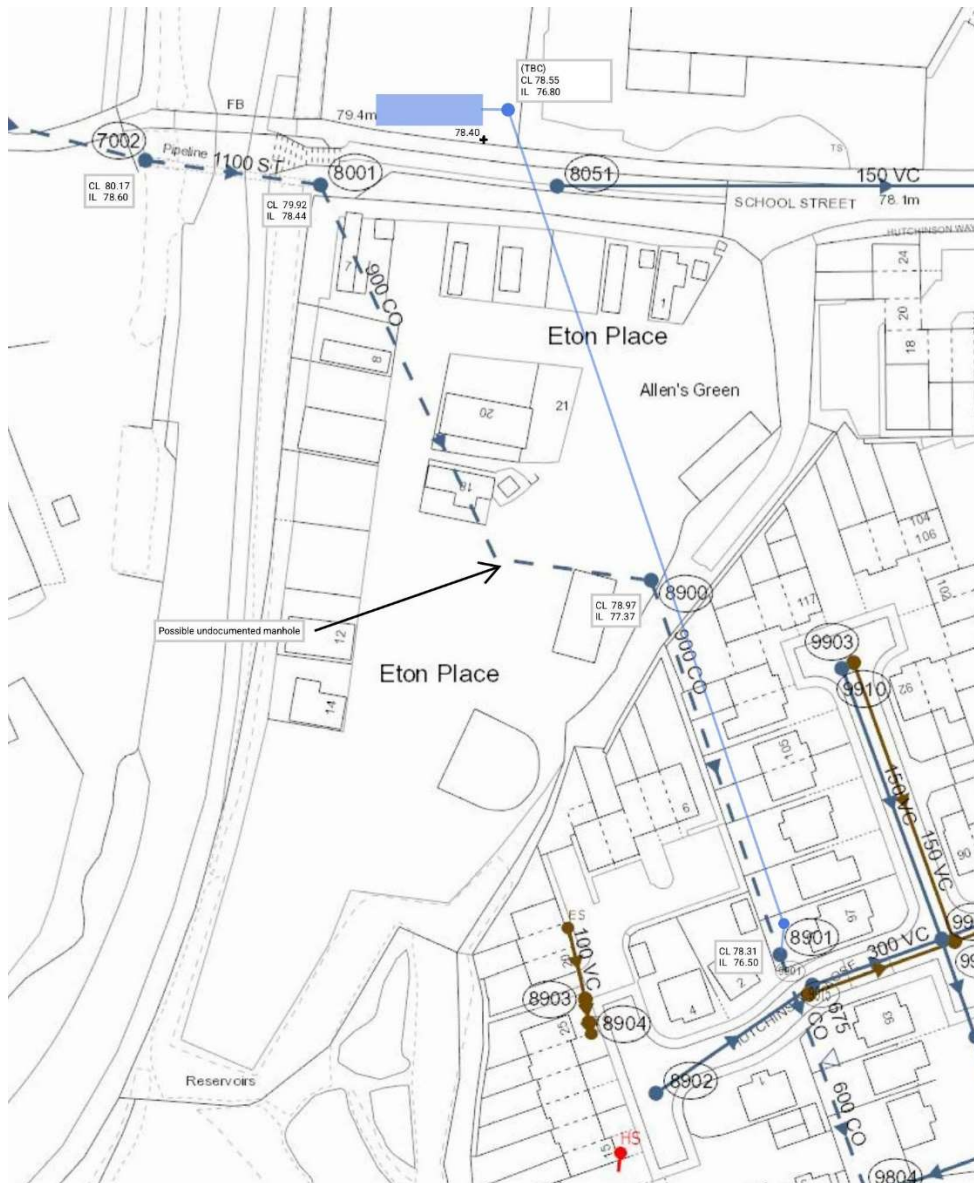
Based on the invert levels shown on the United Utilities Asset plan the connection would need to be approx. 155m to the south-east of the site. The approx. arrangement of this is shown above.

This would require a run circa 155m long, passing through a public footpath, a business yard and the gardens of 8 No private properties.

For a new surface water pipe to cross over numerous land ownerships the network will have to become adopted. For the pipe to be adopted it will have to be in open spaces to allow 24-hour access. This cannot be achieved.

**Given the issues surrounding this we would not consider this to be a suitable option.**

**As such the 150 dia surface water drain (MH 8501) within school street is considered the most suitable connection point.**

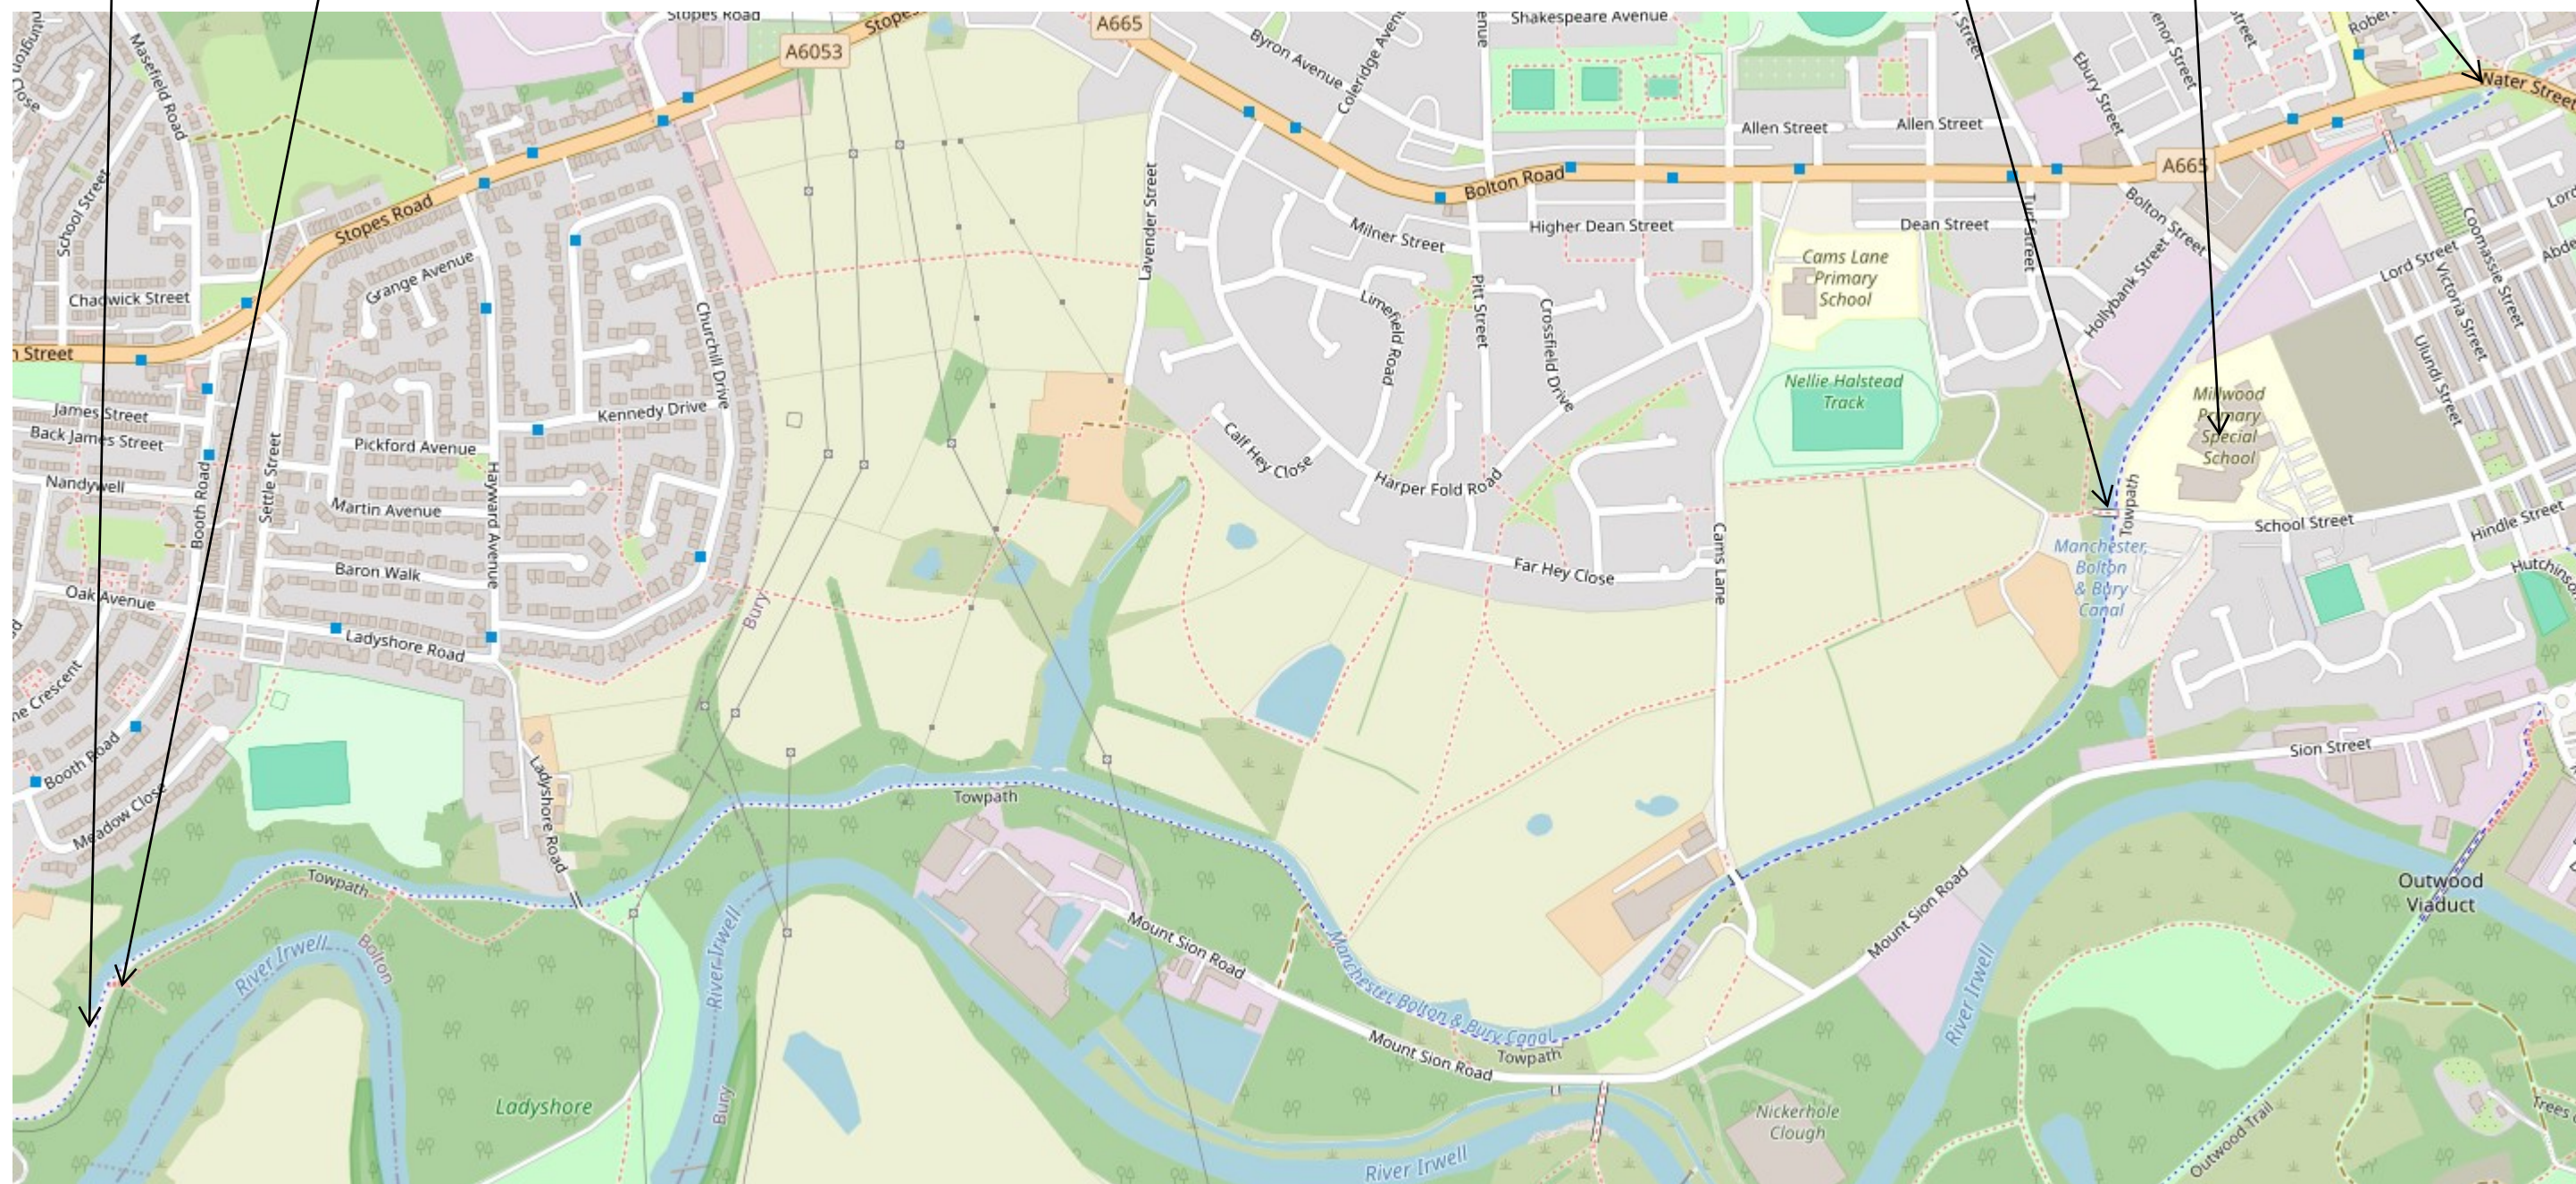
Key Features of Isolated Section of Manchester, Bolton & Bury Canal

"1932 Breach" - Collapse of Bank into Irwell. Approx 600m stretch dry

Overflow to River Irwell

Foot Bridge and Piped Watercourse

Water Street Infill

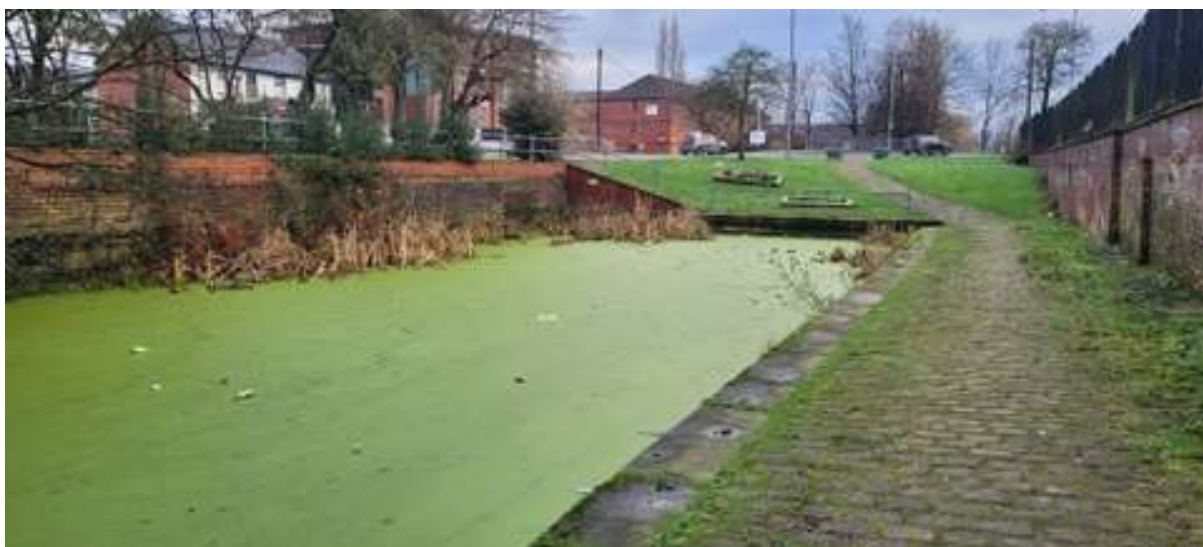
Photo 1 - Water Street Infill

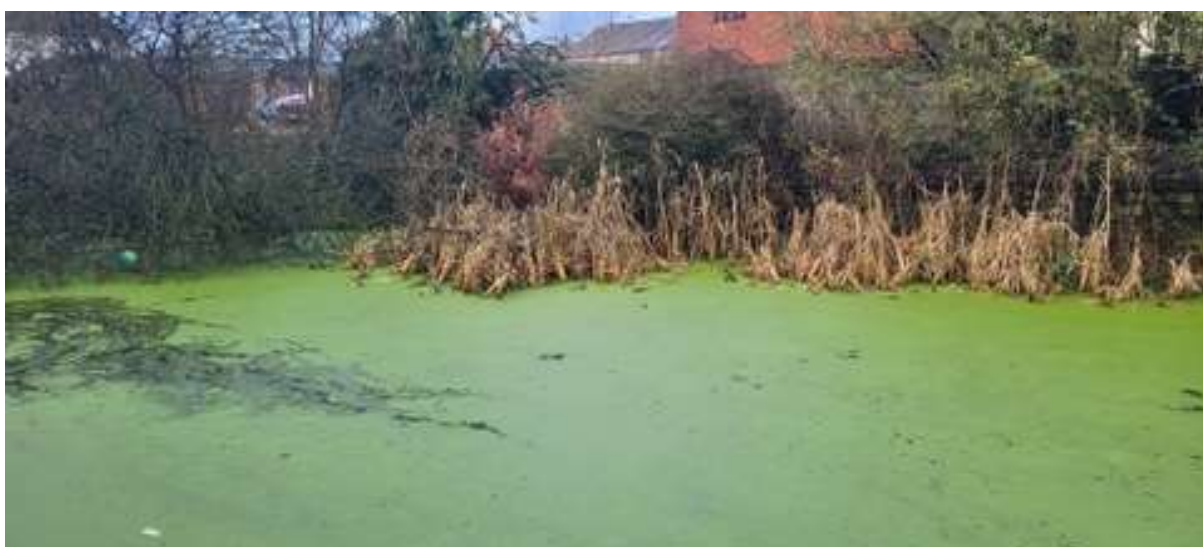
Photo 2 - Site to Water Street

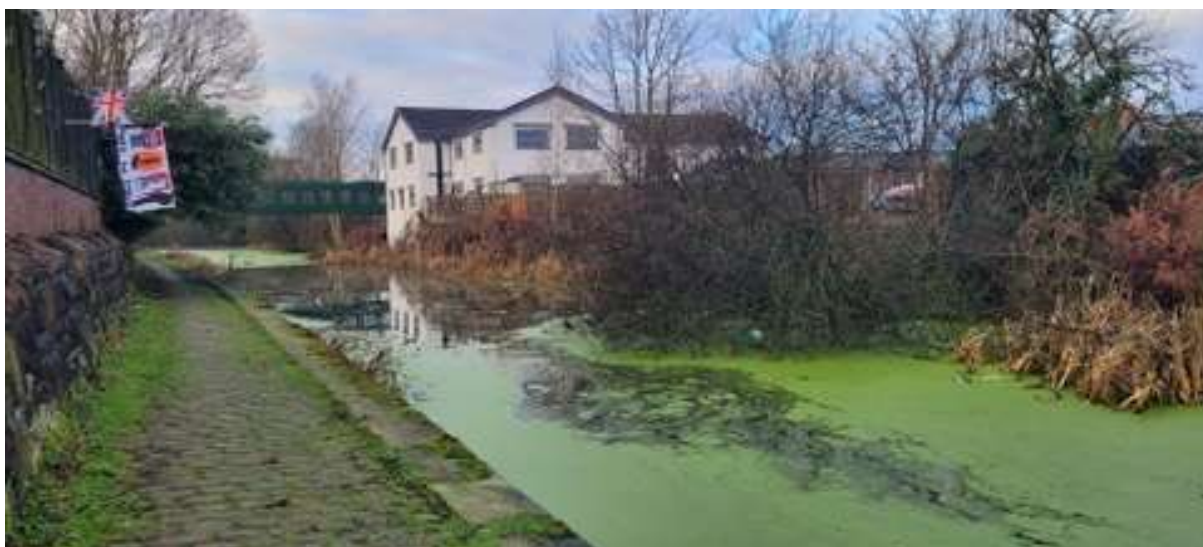
Photo 3 – View Towards bridge from Water Street

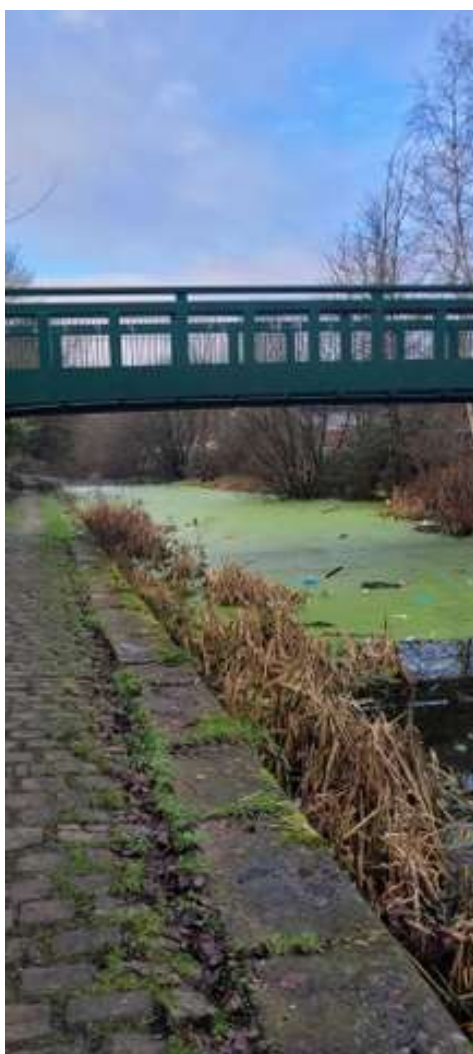
Photo 4 – Canal Bank Adjacent Site and Foot bridge

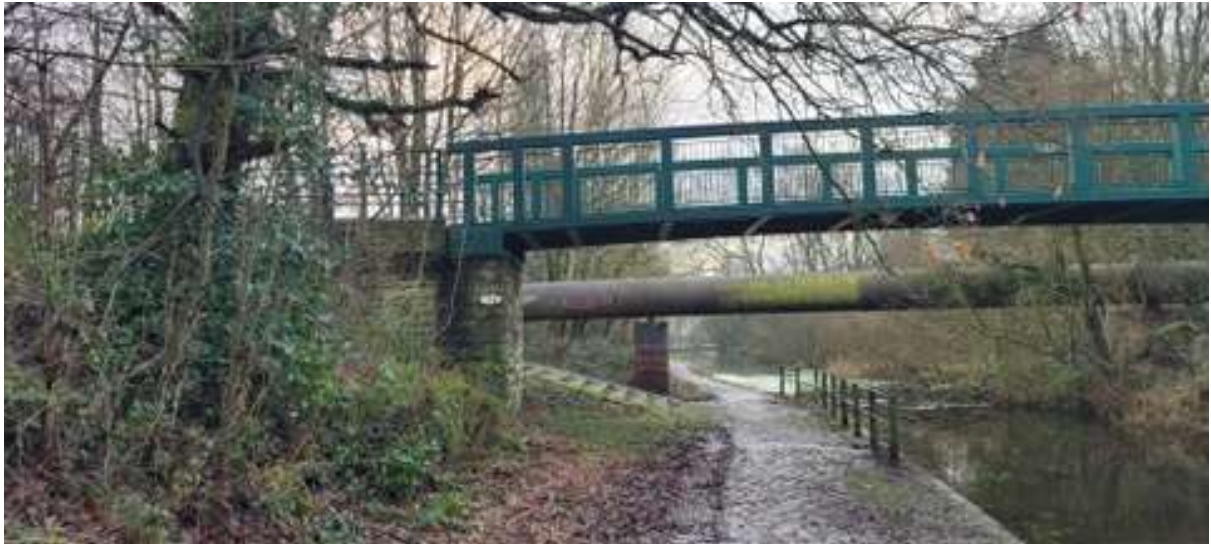
Photo 5 - Adjacent site, Note foot bridge and steel pipe

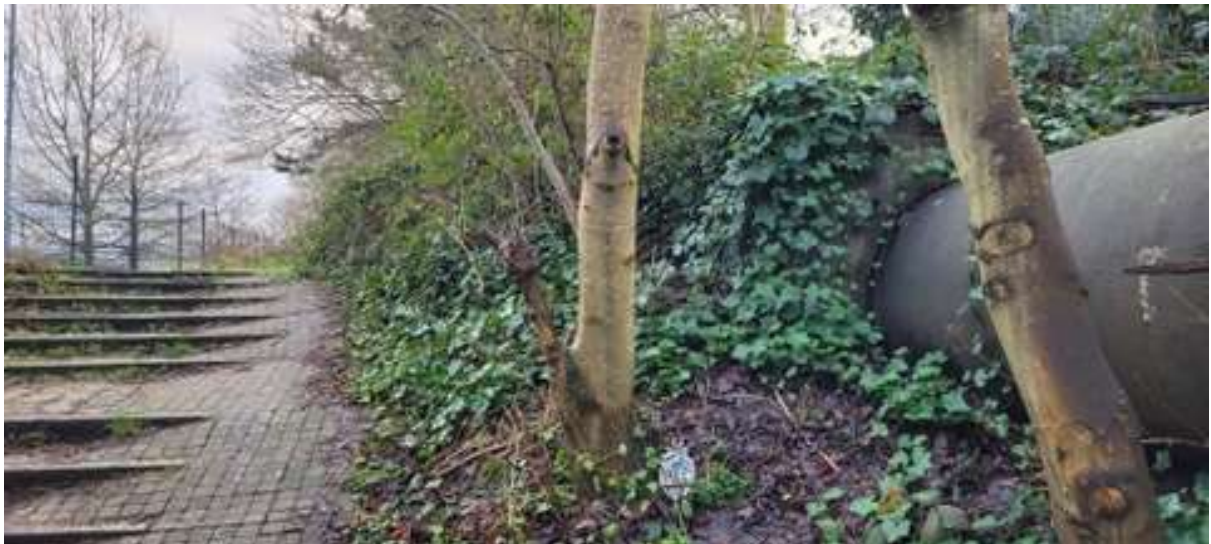
Photo 6 – Pipe interface, note steps and site boundary fence visible to left

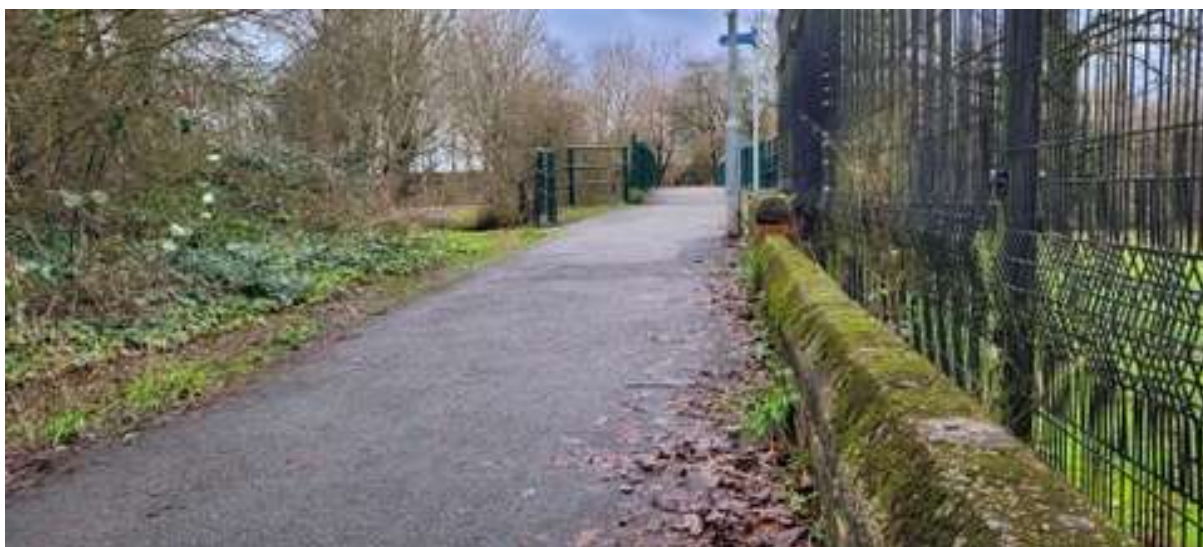
Photo 7 - Raised Footpath adjacent to site boundary, note bridge and pipe crossing canal

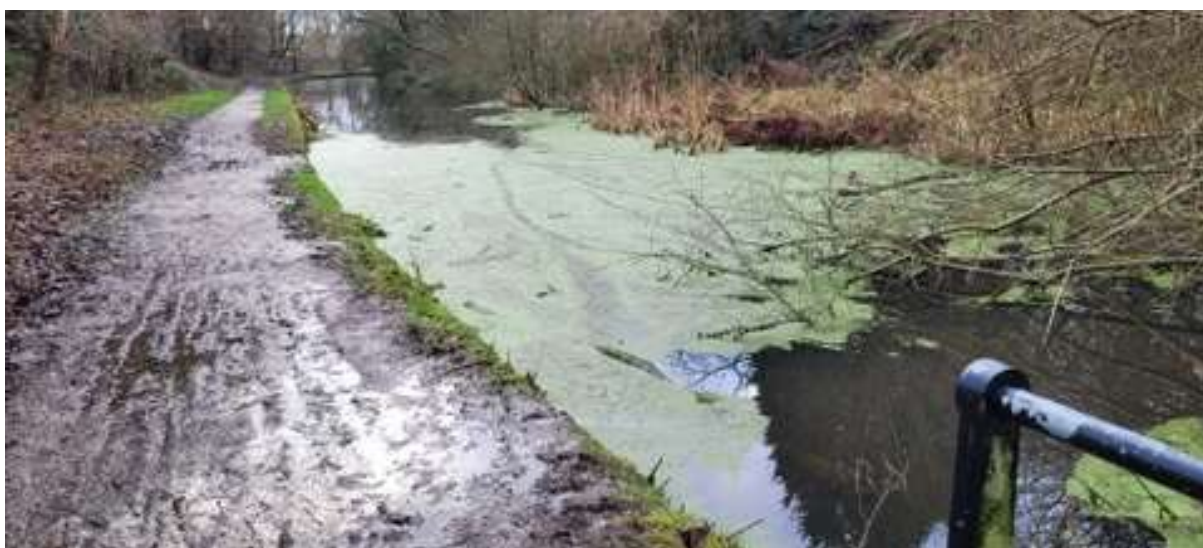
Photo 8 - Canal Bank adjacent to bridge and pipe, note bank lowered to this immediate areas

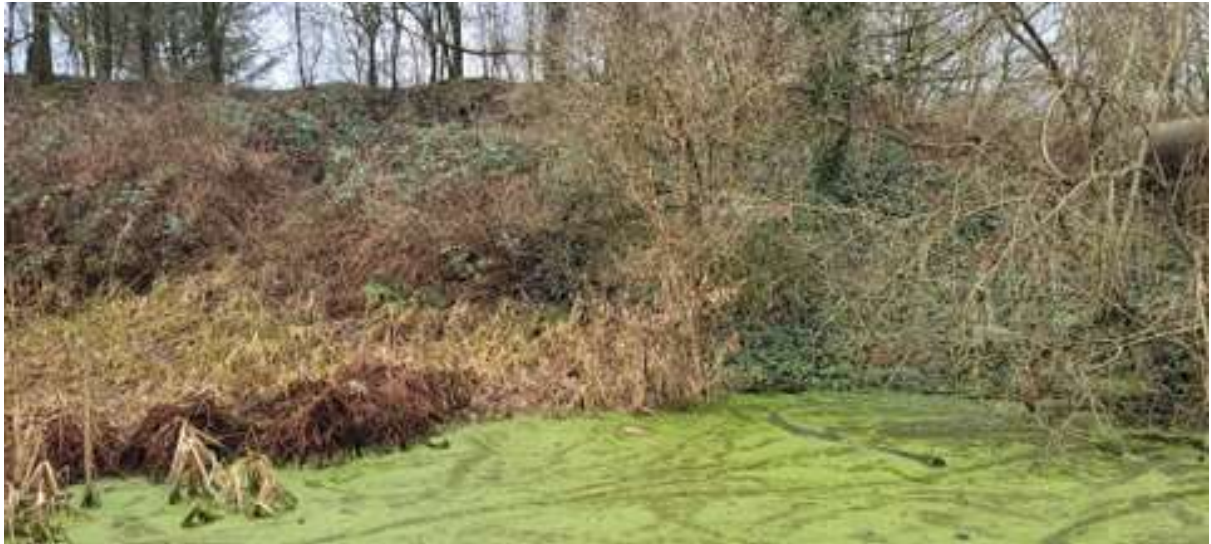
Photo 9 – General photo of Canal Bank

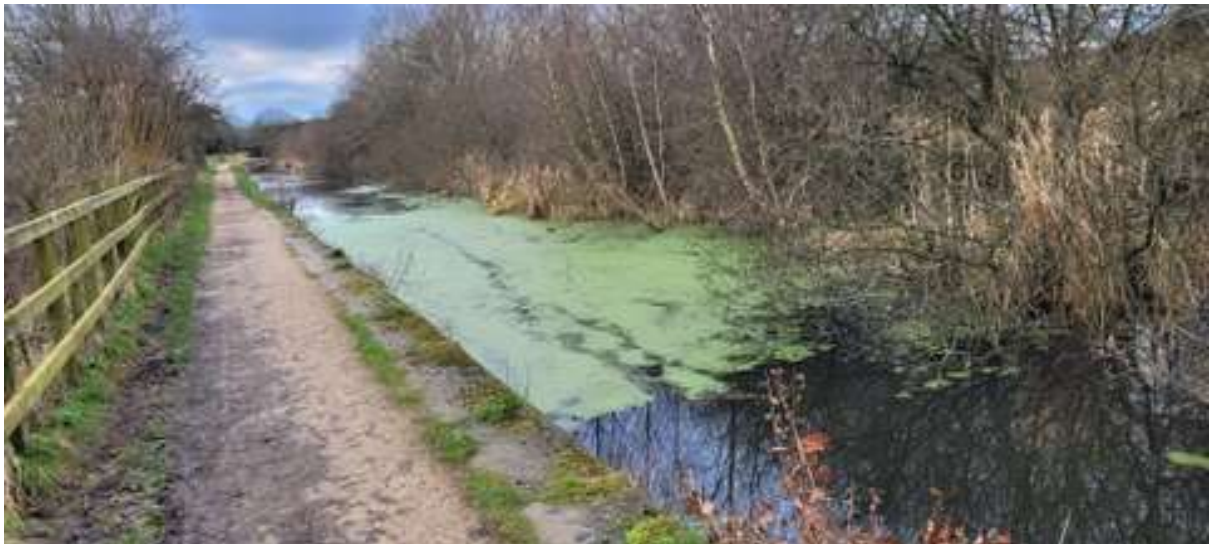
Photo 10 – Typical example of overgrown canal

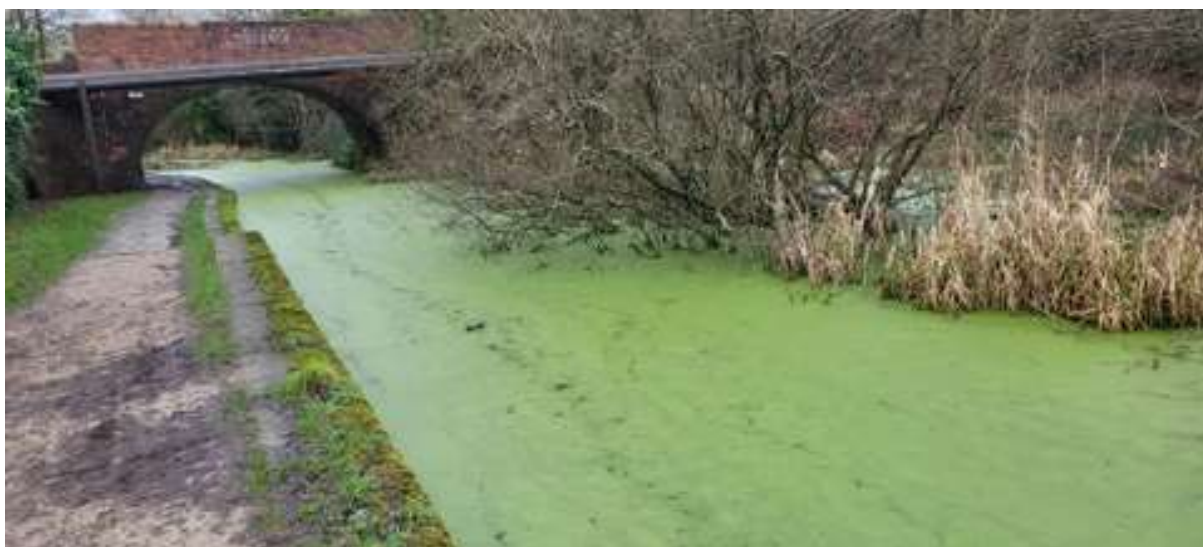
Typically, algae would be expected to die off during colder winter months, however large sections of the Canal display an Algae covering as witnessed in Jan 2024.

Photo 11 – Typical example of algal bloom (photo taken in January)

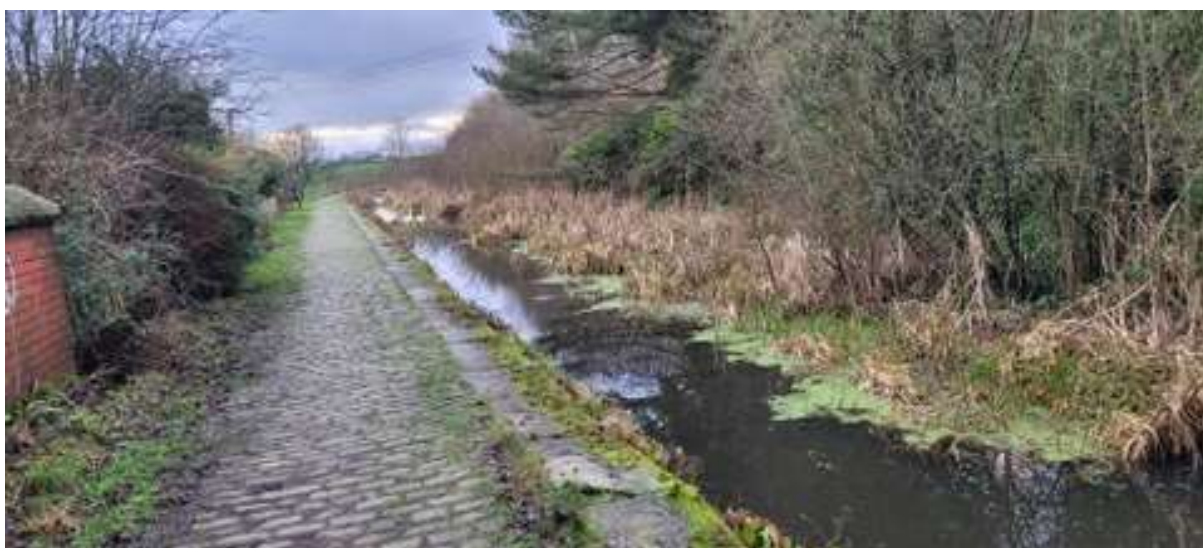
Photo 12 – Example of canal overgrown with weeds

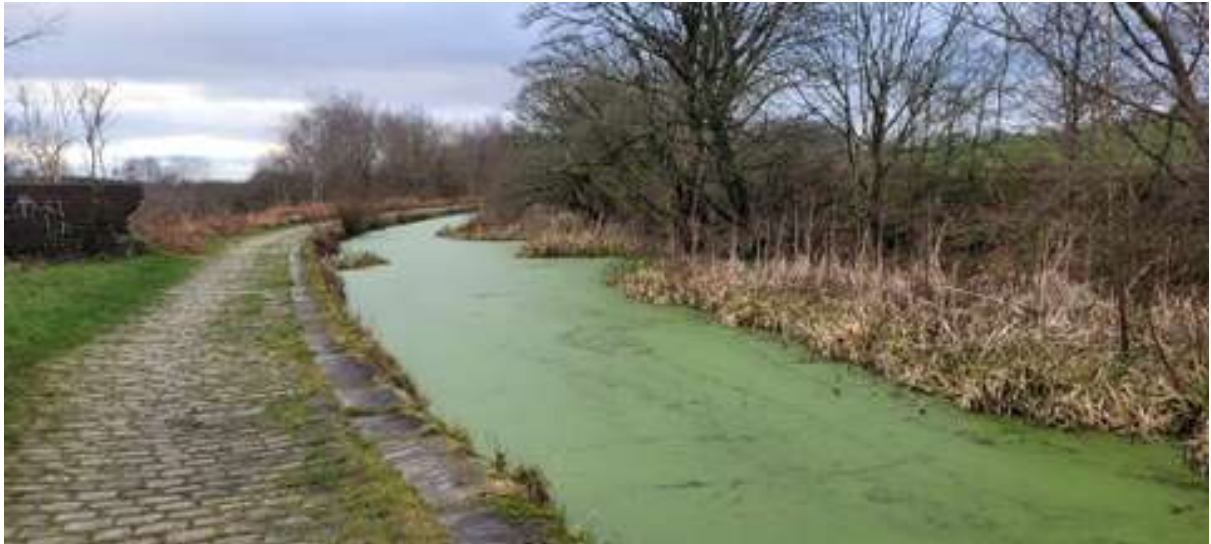
Photo 13 – Further Example of Algal Bloom (during winter months)

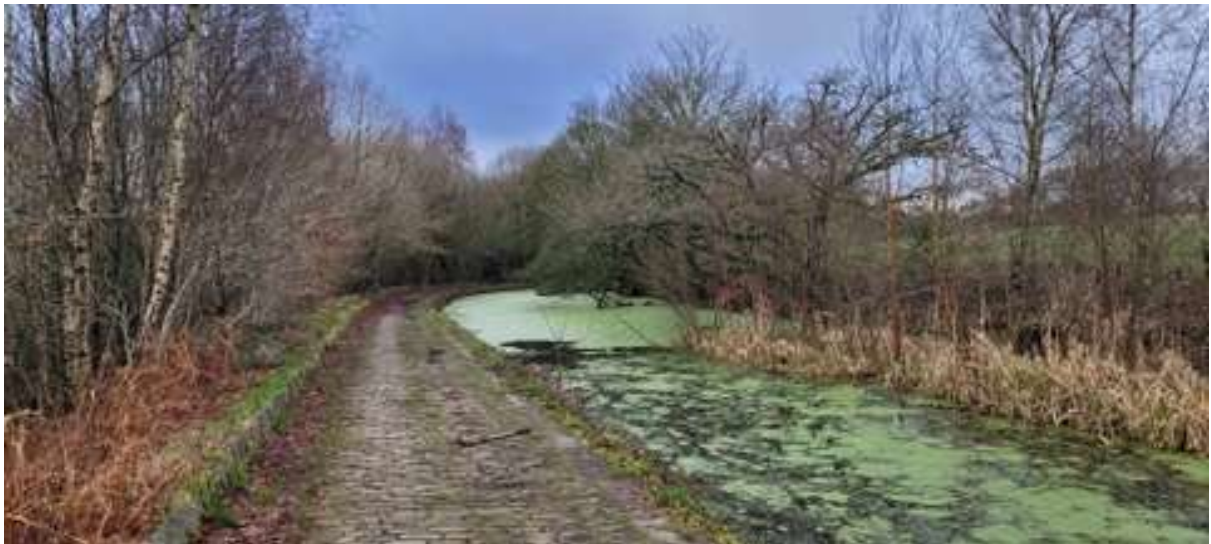
Photo 14 – Further Example of Canal Condition

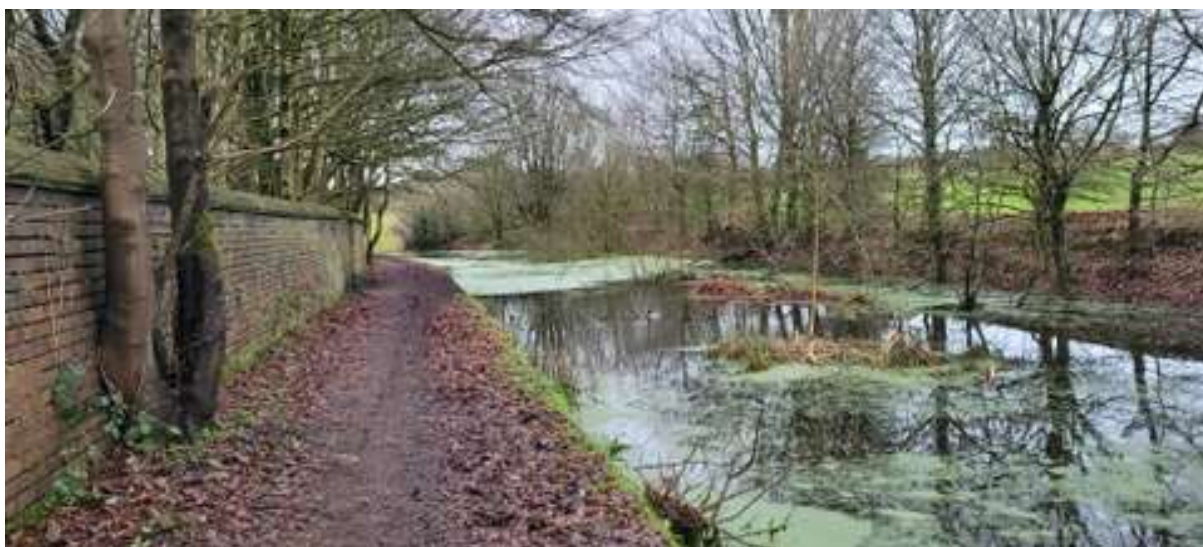
Photo 15 – Further Example of Canal Condition

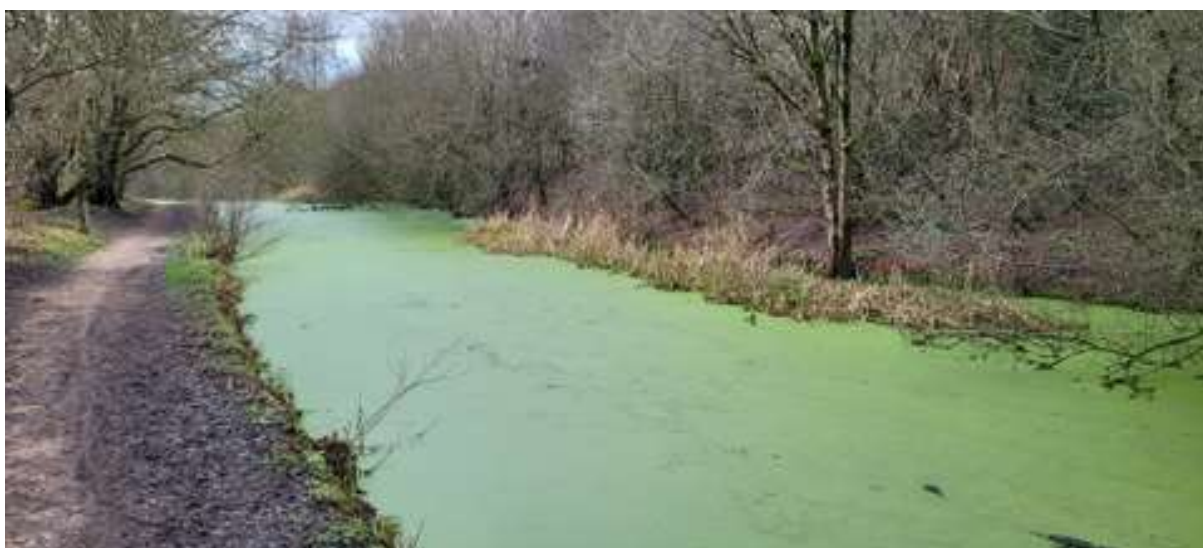
Photo 16 - Further Example of Algal Bloom (during winter months)

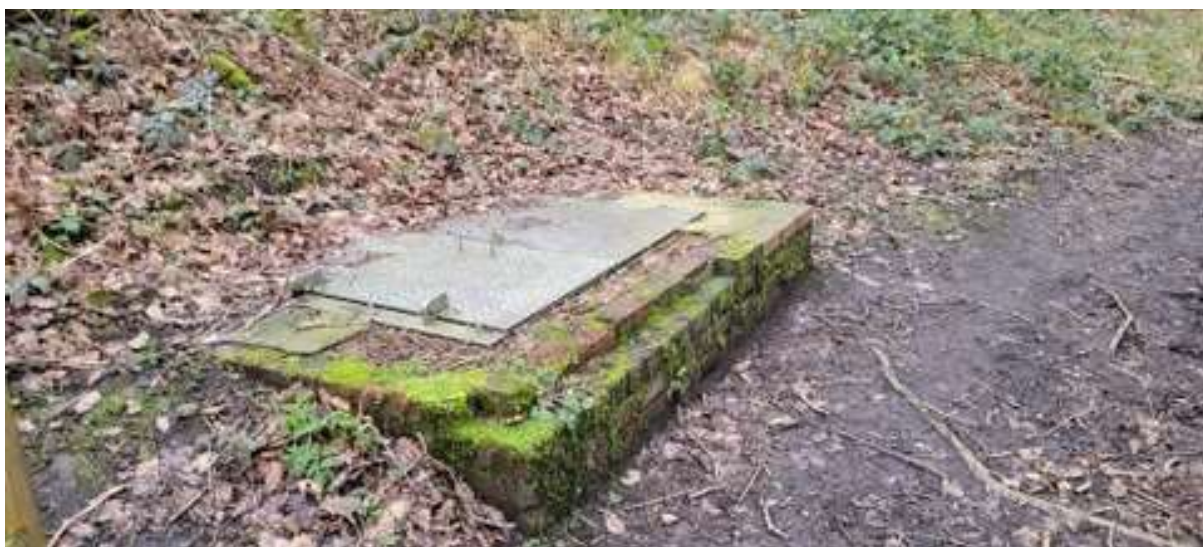
Photo 17 – Manhole Adjacent 1932 Breach, indicates diversion into river Irwell, approx.
