### **EXISTING DRAINAGE SURVEY**

**Project Name:** Huntley Mount Road

**Project Date:** 12/03/2026

**Inspection Standard:** MSCC5 Sewers & Drainage GB (SRM5 Scoring)

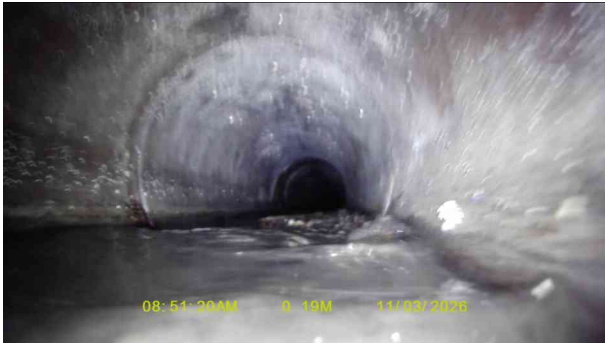
<table><tr><td>MH</td><td>Start node, manhole, reference: MH01</td><td>00:00:00</td><td></td><td></td><td></td></tr><tr><td>S01</td><td>DES</td><td>Settled deposits, fine, 20% cross-sectional area loss, start</td><td>00:00:11</td><td>1</td><td></td></tr></table>

1, 00:00:11, 0.19 m  
 Settled deposits, fine, 20% cross-sectional area loss, start

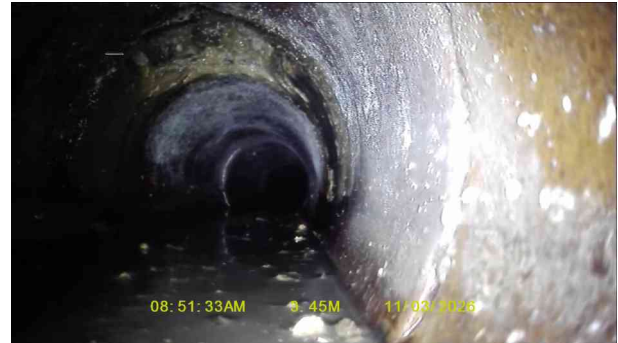
2, 00:00:24, 3.45 m  
 Junction at 12 o'clock, 150mm dia

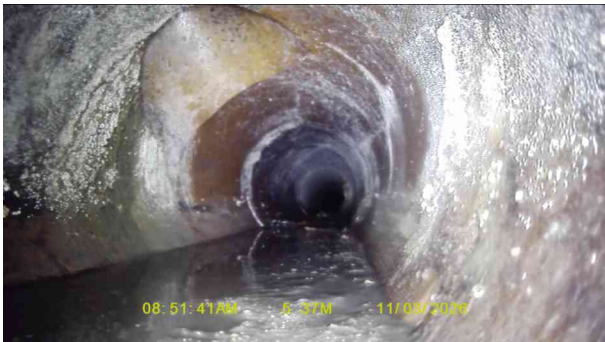
3, 00:00:32, 5.37 m  
 Junction at 10 o'clock, 150mm dia

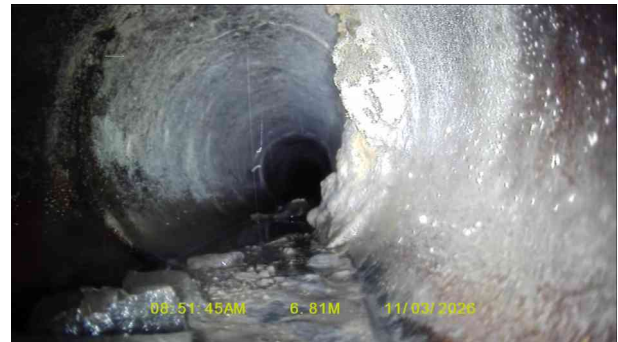
<table><tr><td>MH</td><td>Start node, manhole, reference: MH01</td><td>00:00:00</td><td></td><td></td><td></td></tr><tr><td>OBBJ</td><td>Other obstacles, brick or masonry in invert at joint from 1 o'clock to 5 o'clock, 5% cross-sectional area loss</td><td>00:00:37</td><td>4</td><td></td><td>5</td></tr></table>

4, 00:00:37, 6.81 m  
 Other obstacles, brick or masonry in invert at joint from 1 o'clock to 5 o'clock, 5% cross-sectional area loss

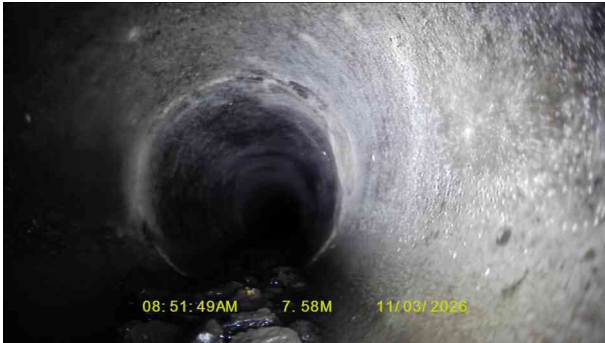
5, 00:00:40, 7.58 m  
 Settled deposits, fine, 10% cross-sectional area loss, change

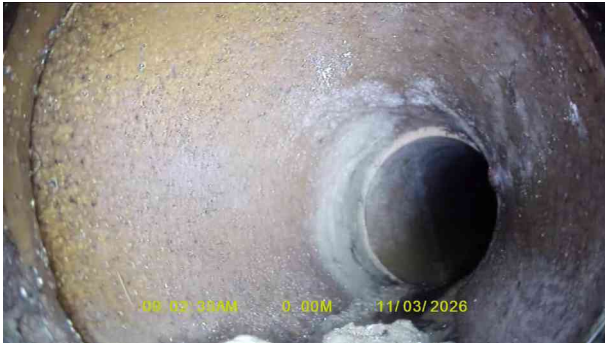
1, 00:00:03, 0.10 m  
Line deviates right

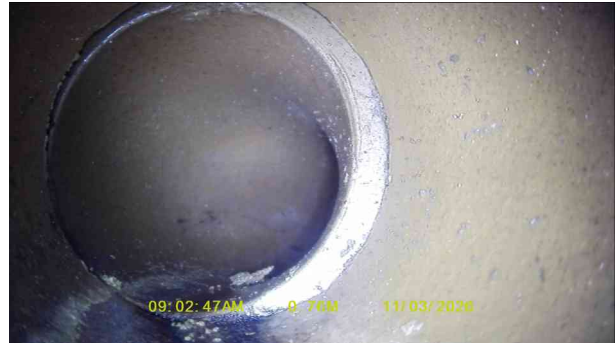
| Scale: 1:50 | Position [m] | Code | Observation | MPEG | Photo | Grade |
|---|---|---|---|---|---|---|
| | 0.76 | JDL | Joint displaced, large | 00:00:16 | 2 | 1 / 4 |

2, 00:00:16, 0.76 m  
Joint displaced, large

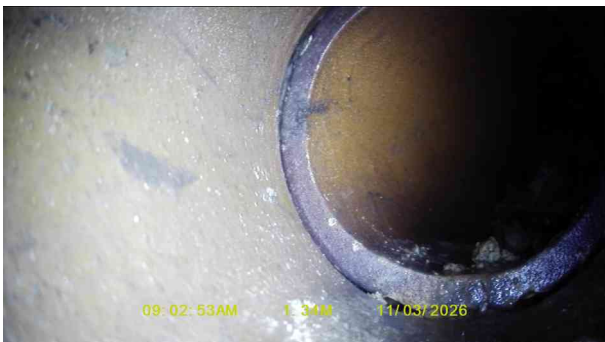
| Scale: 1:50 | Position [m] | Code | Observation | MPEG | Photo | Grade |
|---|---|---|---|---|---|---|
| | 1.34 | JDL | Joint displaced, large | 00:00:22 | 3 | 1 / 4 |

3, 00:00:22, 1.34 m  
Joint displaced, large

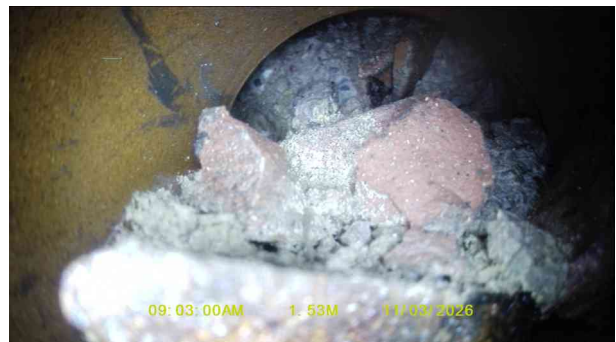
| Scale: 1:50 | Position [m] | Code | Observation | MPEG | Photo | Grade |
|---|---|---|---|---|---|---|
| | 1.53 | OBB | Other obstacles, brick or masonry in invert from 12 o'clock to 12 o'clock, 100% cross-sectional area loss | 00:00:28 | 4 | 5 |

4, 00:00:28, 1.53 m  
Other obstacles, brick or masonry in invert from 12 o'clock to 12 o'clock, 100% cross-sectional area loss

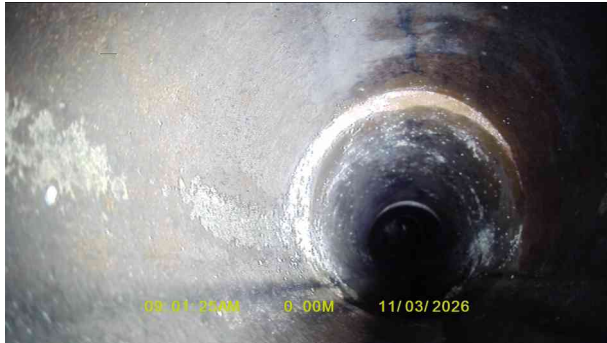
<table><tr><td>MH</td><td>Start node, manhole, reference: MH01</td><td>00:00:00</td><td></td><td></td></tr><tr><td>JDM</td><td>Joint displaced, medium</td><td>00:00:04</td><td>1</td><td>1 / 3</td></tr></table>

1, 00:00:04, 0.10 m  
Joint displaced, medium

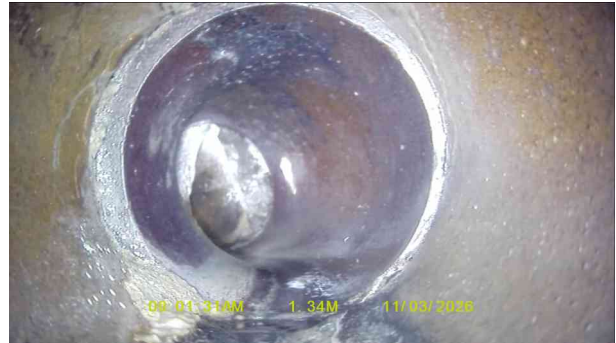
<table><tr><td>MH</td><td>Start node, manhole, reference: MH01</td><td>00:00:00</td><td></td><td></td></tr><tr><td>JDL</td><td>Joint displaced, large</td><td>00:00:09</td><td>2</td><td>1 / 4</td></tr></table>

2, 00:00:09, 1.34 m  
Joint displaced, large

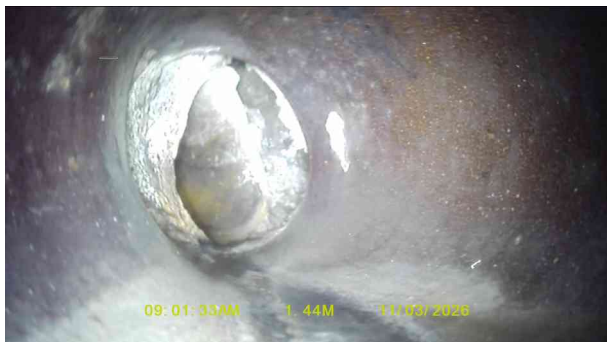
3, 00:00:11, 1.44 m  
Line deviates left

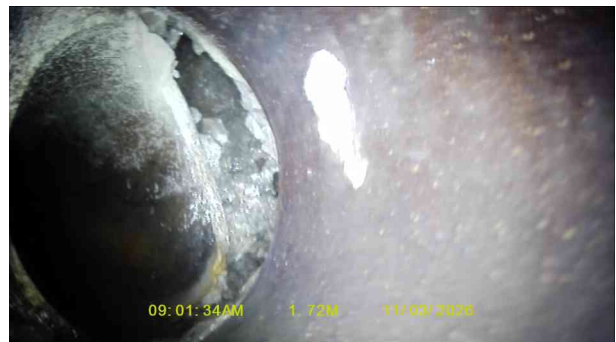
<table><tr><td>MH</td><td>Start node, manhole, reference: MH01</td><td>00:00:00</td><td></td><td></td></tr><tr><td>BJ</td><td>Broken pipe at joint from 12 o'clock to 4 o'clock</td><td>00:00:12</td><td>4</td><td>4</td></tr></table>

4, 00:00:12, 1.72 m  
Broken pipe at joint from 12 o'clock to 4 o'clock

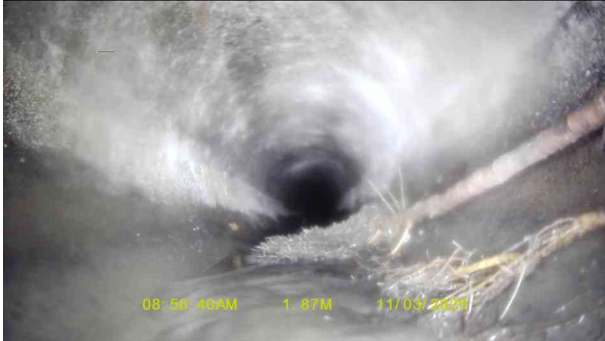
<table><tr><td>MH</td><td>Start node, manhole, reference: MH02</td><td>00:00:00</td><td></td><td></td></tr><tr><td>RM</td><td>Roots, mass, 15% cross-sectional area loss</td><td>00:00:13</td><td>1</td><td>3</td></tr></table>

1, 00:00:13, 1.87 m  
 Roots, mass, 15% cross-sectional area loss

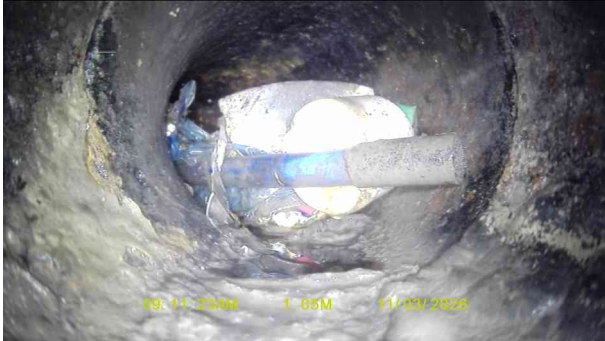
1, 00:00:10, 1.05 m  
 Other obstacles from 12 o'clock to 12 o'clock, 85%  
 cross-sectional area loss, Plastic rubbish

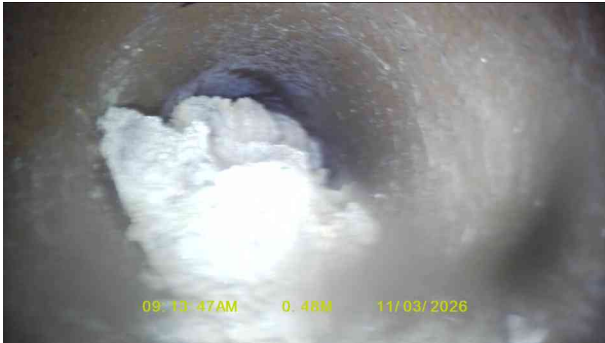
1, 00:00:15, 0.48 m

Other obstacles, brick or masonry in invert from 12 o'clock to  
 12 o'clock, 80% cross-sectional area loss

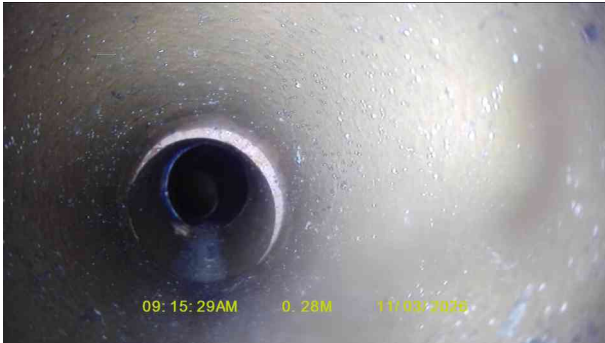
1, 00:00:08, 0.28 m  
Joint displaced, medium

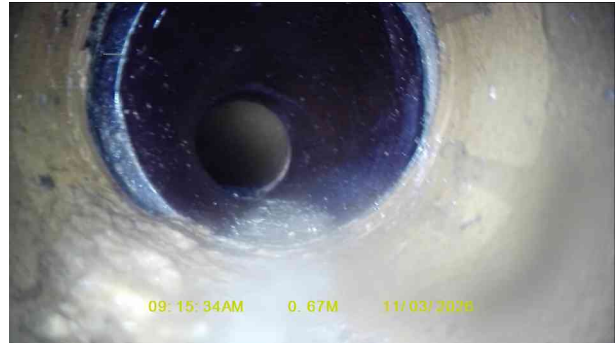
2, 00:00:14, 0.67 m  
Joint displaced, medium

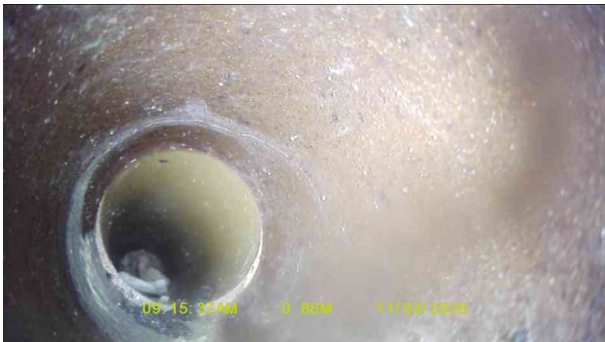
<table><tr><td>0.00</td><td>MH</td><td>Start node, manhole, reference: MH03LAT-C</td><td>00:00:00</td><td></td><td></td></tr><tr><td>0.86</td><td>CC</td><td>Crack, circumferential from 6 o'clock to 2 o'clock</td><td>00:00:17</td><td>3</td><td>2 / 2</td></tr></table>

3, 00:00:17, 0.86 m  
Crack, circumferential from 6 o'clock to 2 o'clock

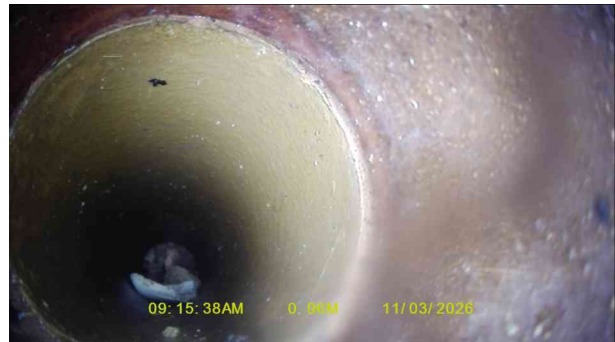
4, 00:00:18, 0.96 m  
Joint displaced, medium

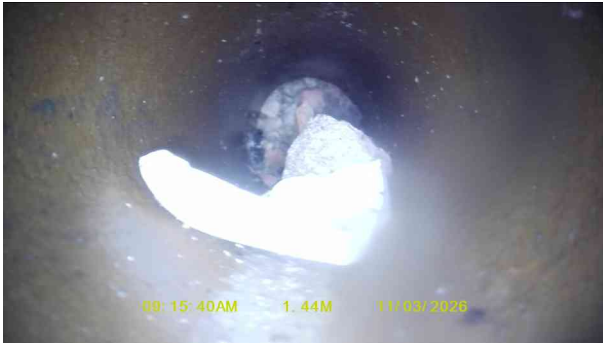
5, 00:00:20, 1.44 m  
 Other obstacles, pipe material in invert at 6 o'clock, 45%  
 cross-sectional area loss

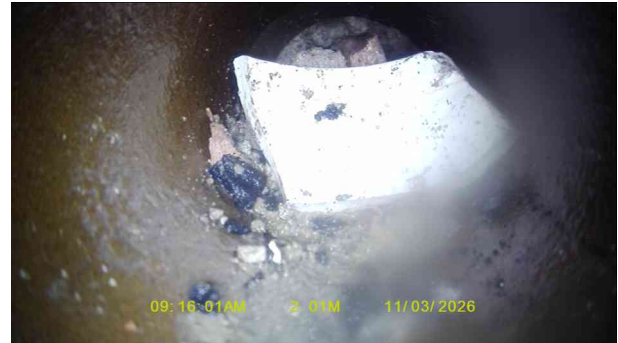
6, 00:00:41, 2.01 m  
 Other obstacles, brick or masonry in invert from 12 o'clock to  
 12 o'clock, 100% cross-sectional area loss

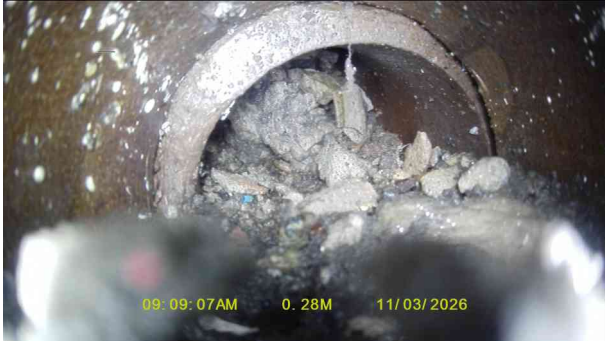
1, 00:00:10, 0.28 m  
Joint displaced, large

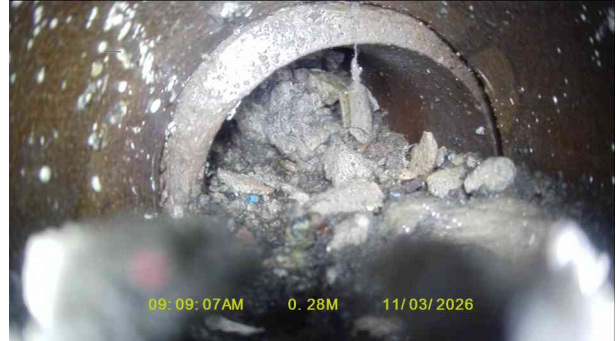
2, 00:00:10, 0.28 m  
Settled deposits, fine, 60% cross-sectional area loss

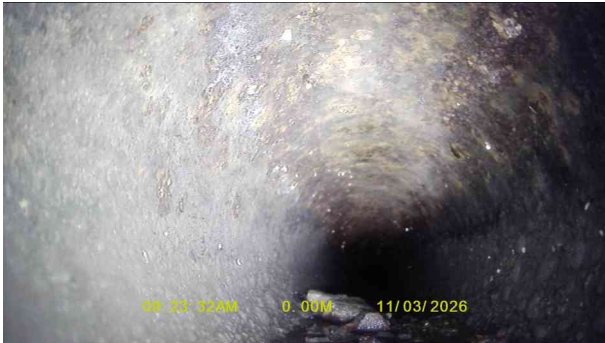
1, 00:00:03, 0.00 m  
 Settled deposits, fine, 10% cross-sectional area loss, start

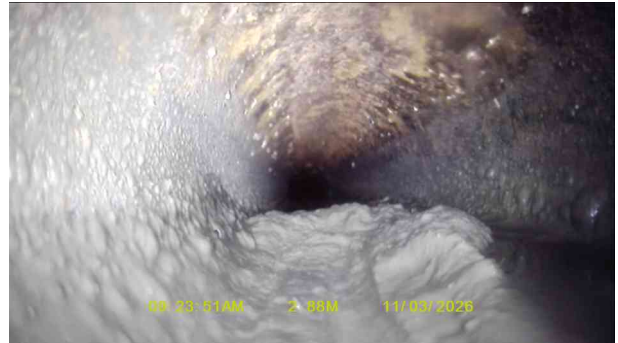
2, 00:00:22, 2.88 m  
 Settled deposits, fine, 20% cross-sectional area loss, change

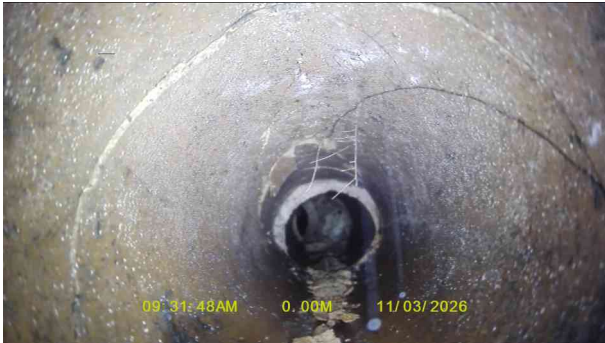
<table><tr><td>0.00</td><td>MH</td><td>Start node, manhole, reference: MH04LAT-A</td><td>00:00:00</td><td></td><td></td></tr><tr><td>0.00</td><td>CC</td><td>Crack, circumferential from 8 o'clock to 4 o'clock</td><td>00:00:03</td><td>1</td><td>2 / 2</td></tr></table>

1, 00:00:03, 0.00 m  
 Crack, circumferential from 8 o'clock to 4 o'clock

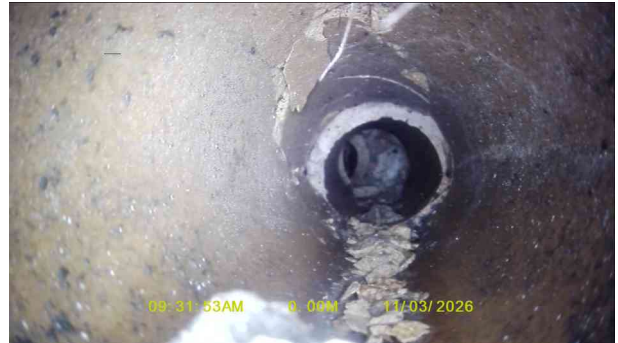
<table><tr><td>0.00</td><td>MH</td><td>Start node, manhole, reference: MH04LAT-A</td><td>00:00:00</td><td></td><td></td></tr><tr><td>0.05</td><td>B</td><td>Broken pipe at 11 o'clock</td><td>00:00:09</td><td>2</td><td>4</td></tr></table>

2, 00:00:09, 0.05 m  
 Broken pipe at 11 o'clock

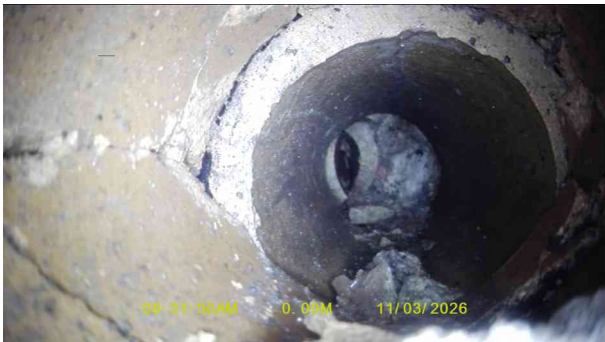
3, 00:00:12, 0.10 m  
 Joint displaced, large

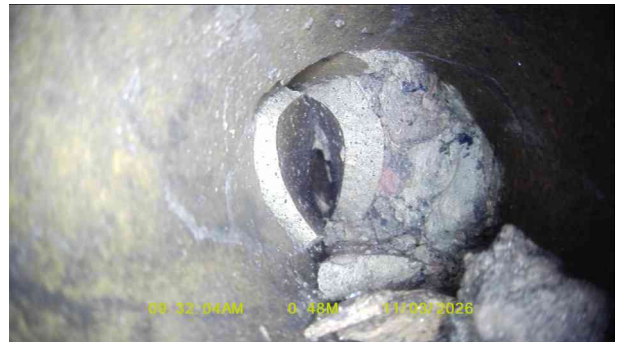
4, 00:00:19, 0.48 m  
 Collapsed drain or sewer, 100% cross-sectional area loss

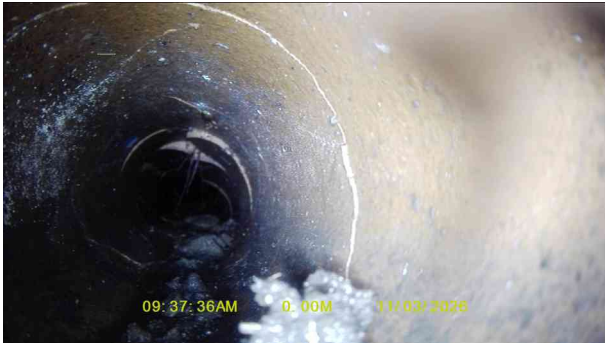
<table><tr><td>0.00</td><td>MH</td><td>Start node, manhole, reference: MH04LAT-C</td><td>00:00:00</td><td></td><td></td></tr><tr><td>0.00</td><td>CC</td><td>Crack, circumferential from 8 o'clock to 4 o'clock</td><td>00:00:04</td><td>1</td><td>2 / 2</td></tr></table>

1, 00:00:04, 0.00 m  
 Crack, circumferential from 8 o'clock to 4 o'clock

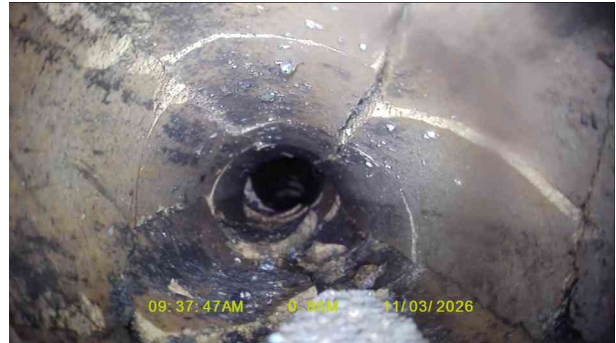
2, 00:00:14, 0.86 m  
 Collapsed drain or sewer, 50% cross-sectional area loss

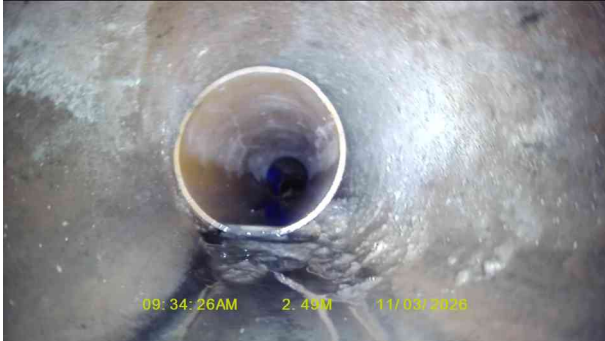
1, 00:00:16, 2.49 m  
 Joint displaced, large
