LIMITED STRUCTURAL REPORT.

**Jackson Fold Farm**  
**Pilsworth Road**  
**Bury**  
**BL9 8QZ**

SURVEY DATE:

Friday 25th August 2023

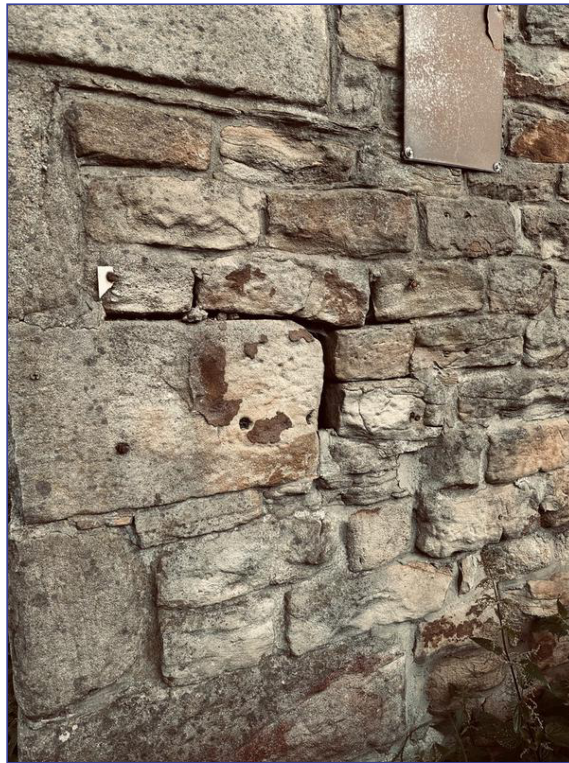
Photo 66 - Cracks to external stone work mortar need pointing
