# DAYTIME BAT SURVEY

121-131 BELL LANE, BURY,  
GREATER MANCHESTER

SEPTEMBER 2021

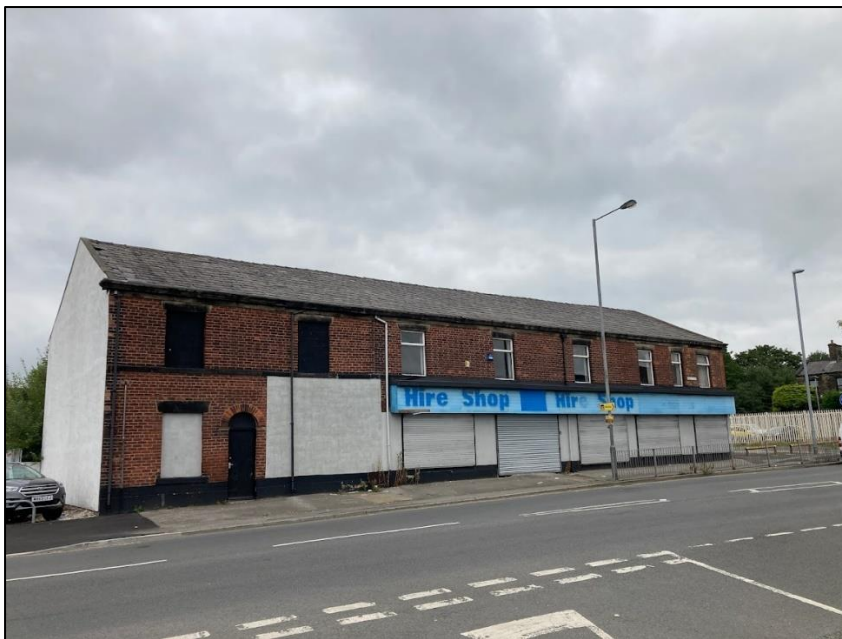
*Photograph 1 showing the building*

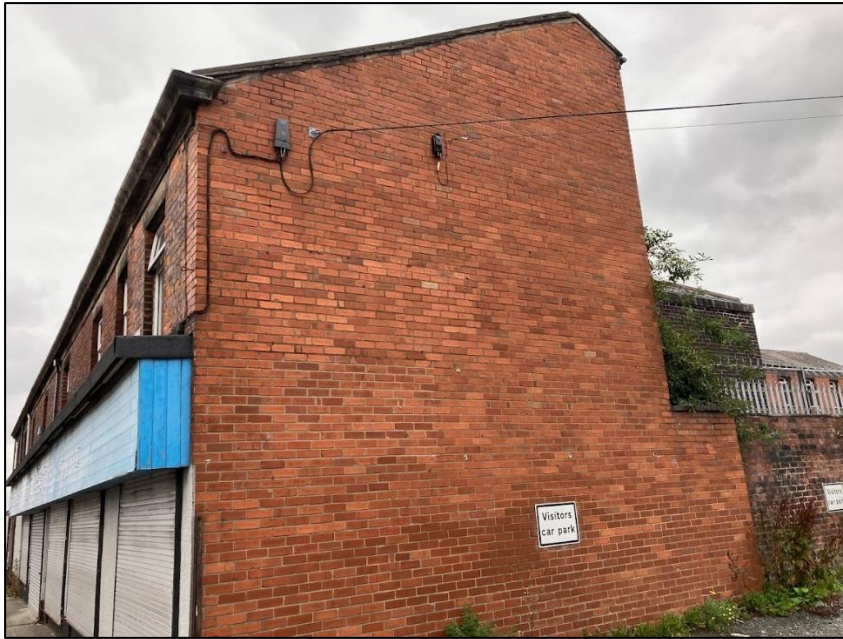
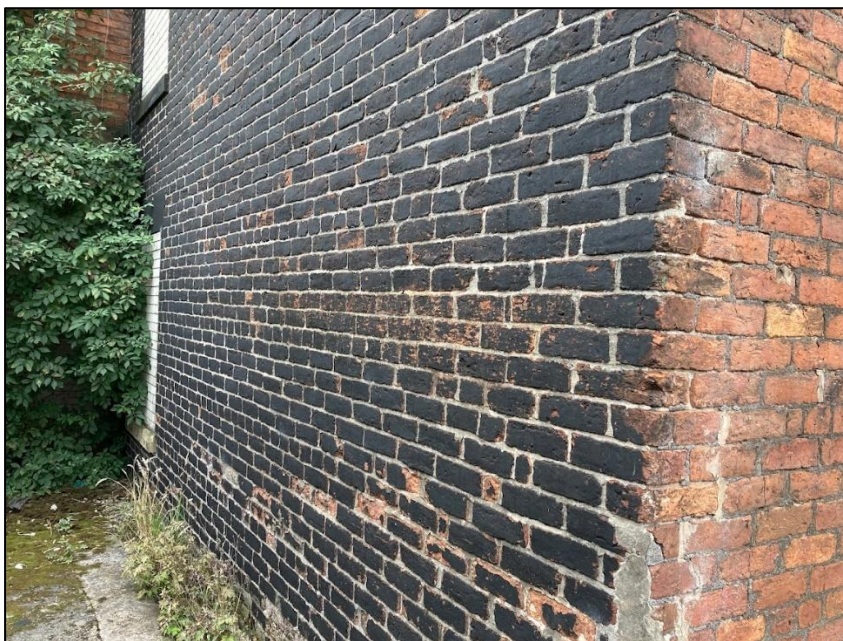
- 3.2 The building is set over two floors and a small basement level, consisting of a former commercial property and an attached dwelling (see Photograph 1). The building is constructed from brick. The brickwork is showing signs of age and weathering, however, is in reasonable condition and sealed with mortar with no missing or damaged sections (see Photographs 2 and 3).

*Photograph 2 showing the exterior of the building*

*Photograph 3 showing the exterior of the building*

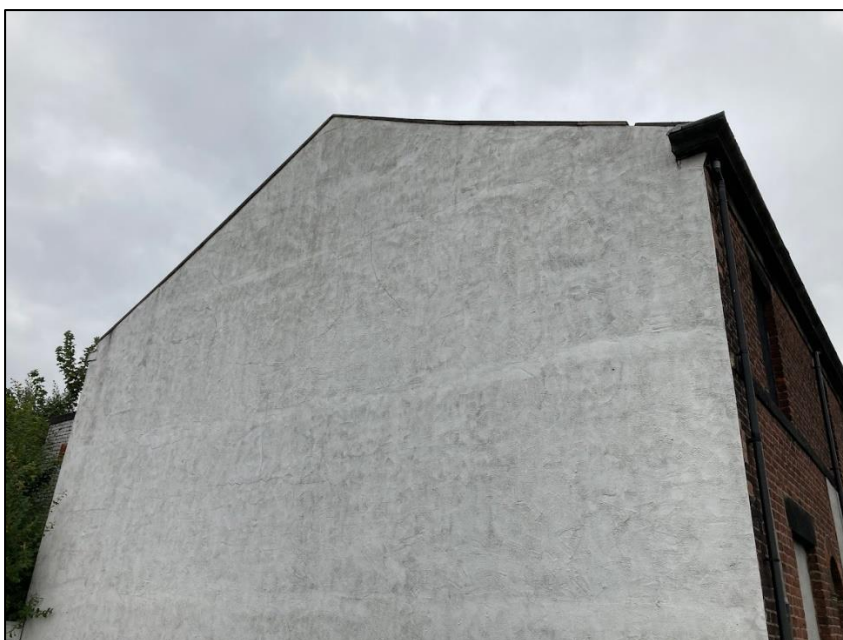
- 3.3 Parts of the buildings external walls have been rendered (see Photographs 4 and 5). The render is in excellent condition, free from cracks, gaps and flaking features bats may exploit.

*Photograph 4 showing the rendered western gable end of the building*

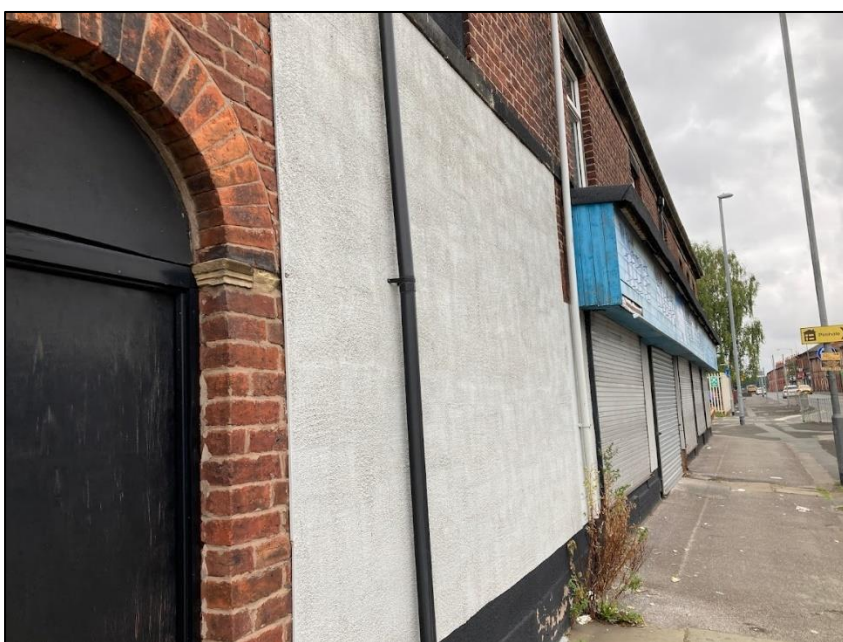
*Photograph 5 showing a rendered section of the building*

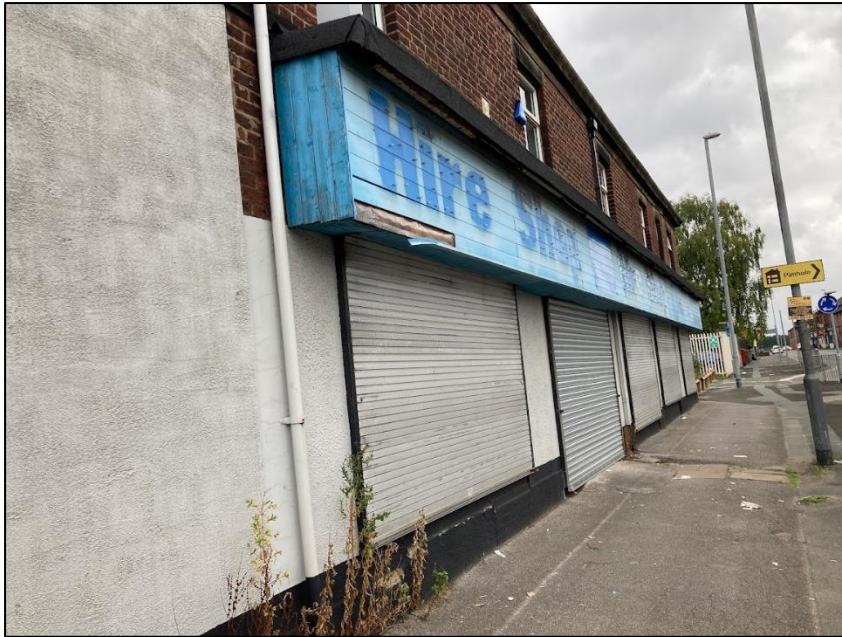
- 3.4 Part of the building's frontage has a timber clad box feature that houses the roller-shutter door motors and top boxes (see Photograph 5 above and 6 below). This is in reasonable condition with one timber board missing. However, this does not provide any entry point into the internal space.

*Photograph 6 showing the timber clad box feature on the building's frontage*

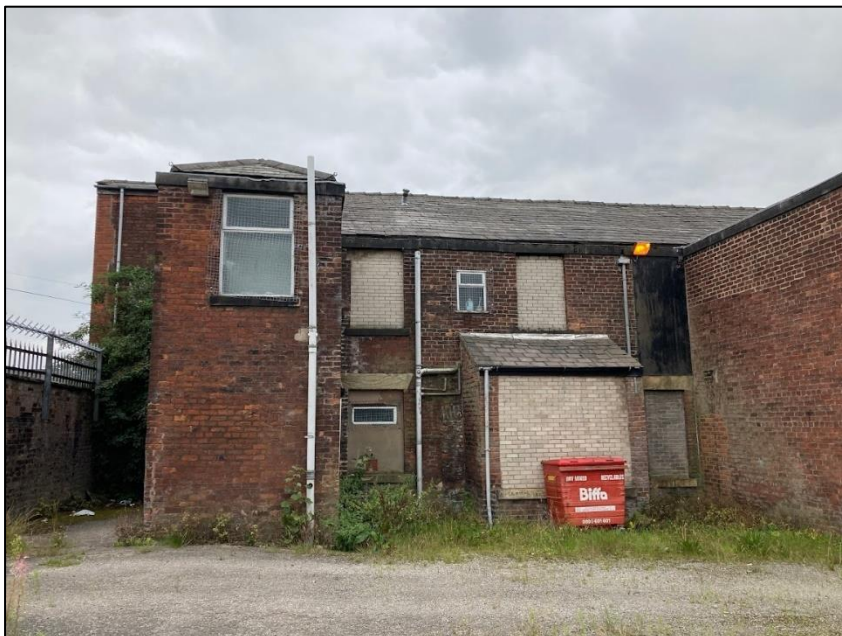
- 3.5 Many of the window spaces have been bricked up, particularly across the rear elevations of the building (see Photograph 7). The timber and uPVC window and door frames, as well as the metal roller-shutters are all in good condition and sealed to the surrounding frames and masonry with no potential entry points found (see Photographs 8 and 9).

*Photograph 7 showing the rear elevation of the building*

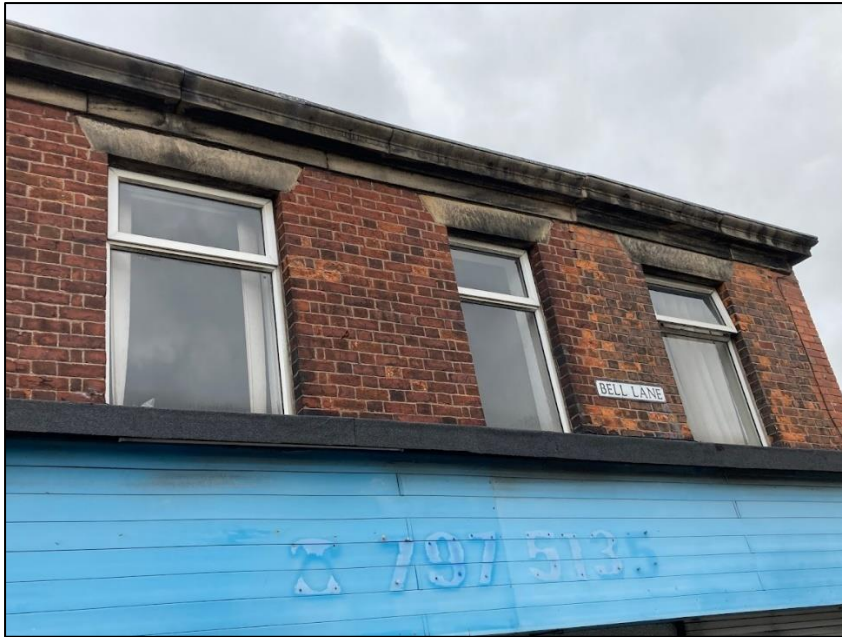
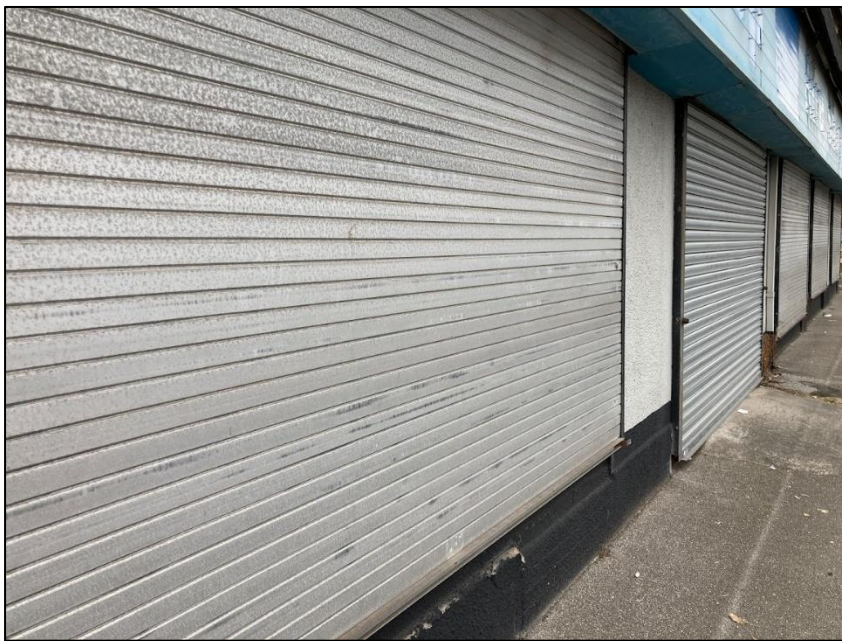
*Photograph 8 showing some of the uPVC window frames*

*Photograph 9 showing the roller-shutters across the building's frontage*

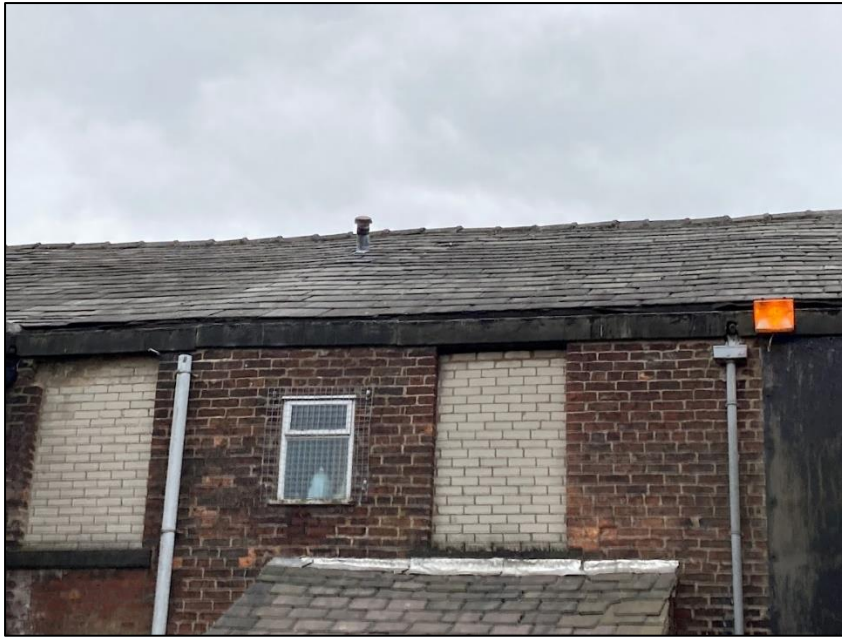
- 3.6 The pitched and hipped roofs are covered with slate roof tiles (see Photograph 10). The tiles are largely intact and fitted flush, as are the ridge tiles. However, a tile is missing along the roof's edge on the western part of the south-facing roof (see Photograph 11). The roof edges are sealed with mortar and topped with coping stones. The mortar is in good condition, sealing the roof edges effectively and the coping stones are in good condition and sealed to the surrounding roof tiles with mortar.

*Photograph 10 showing a section of the roof*

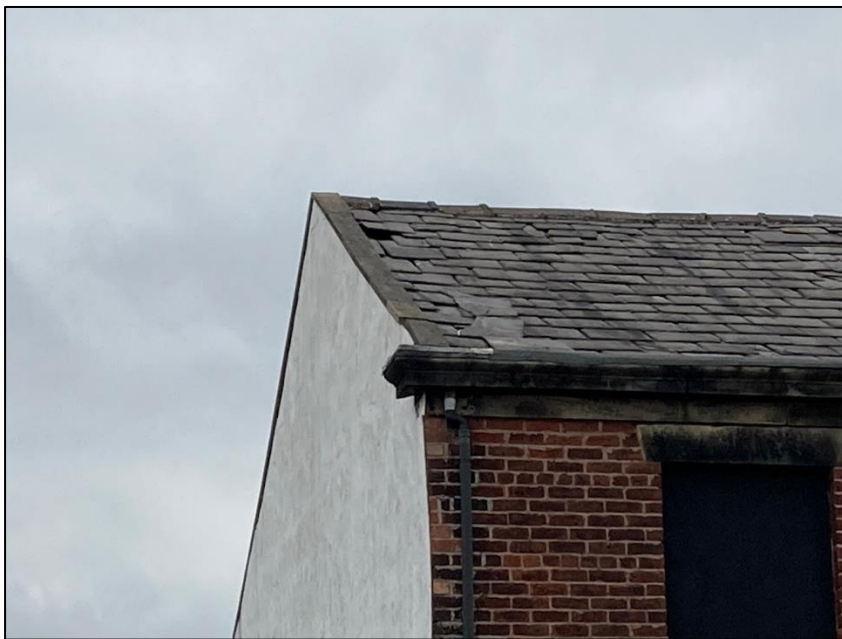
*Photograph 11 showing the missing roof tile*

- 4.1 The building's urban location, next to a well-lit main road and car sales garage provides no-little suitable terrestrial habitat for bats and is arguably located in a hostile habitat for bats. The exterior of the building appears well-sealed, except for the missing roof tile on the western part of the south-facing roof. The buildings internal spaces also appear sealed with no daylight seen during the internal survey, apart from in the roof void space above the dwelling part of the building due to the missing roof tile. No evidence of bat activity or occupancy was found during the external or internal surveys.
- 4.2 Despite the potential entry point provided by the missing roof tile, it is considered the building offers negligible bat roost suitability. This is due to the building location and lack of evidence of bat activity or occupancy.

- 4.8 It is recommended any works to the roof are carried out outside the nesting bird season (generally March – August). If the works need to be carried out within the bird nesting season, then a nesting bird survey will be required immediately prior to work commencing.

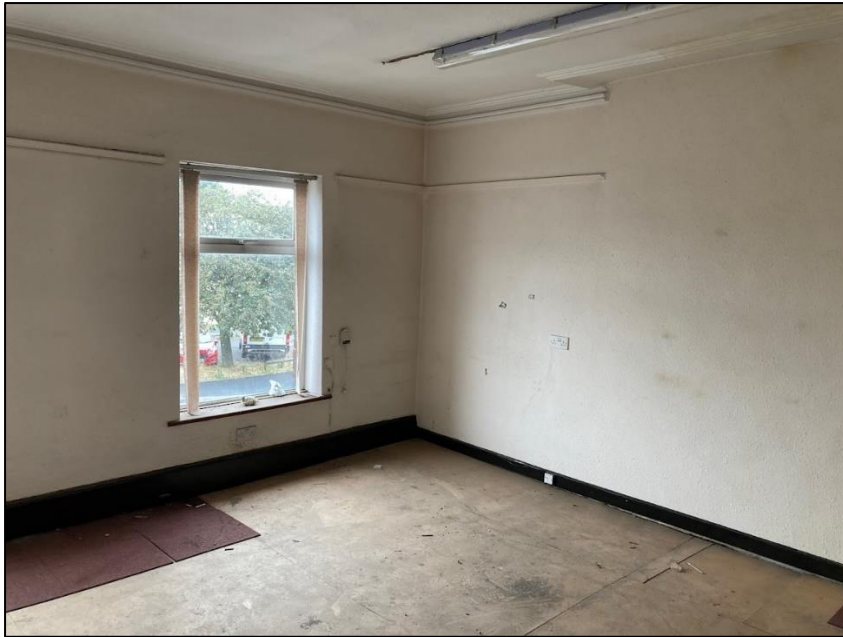
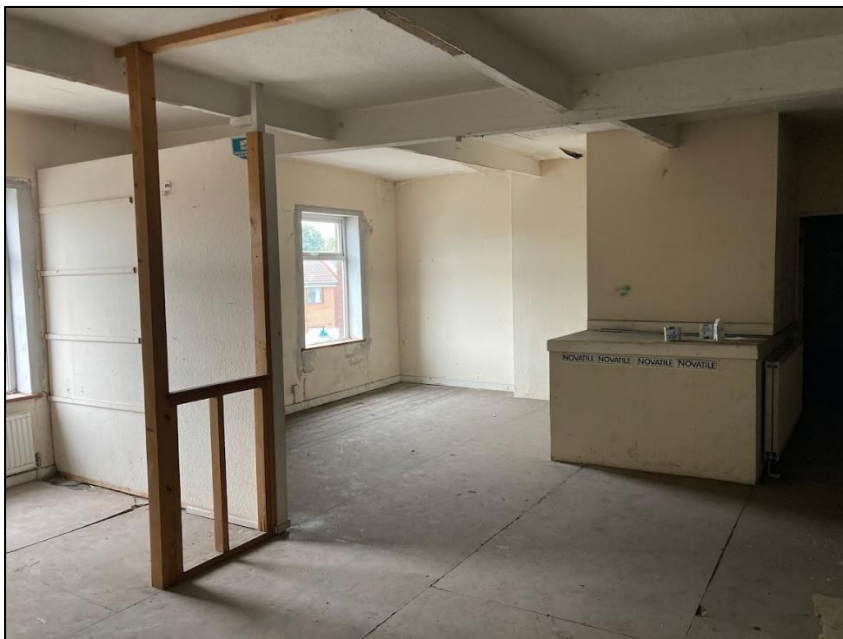
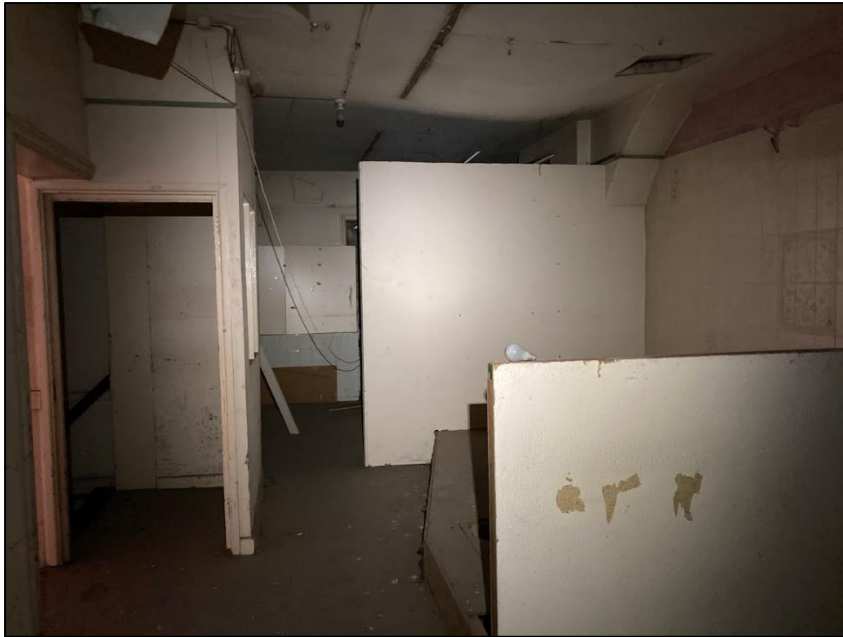
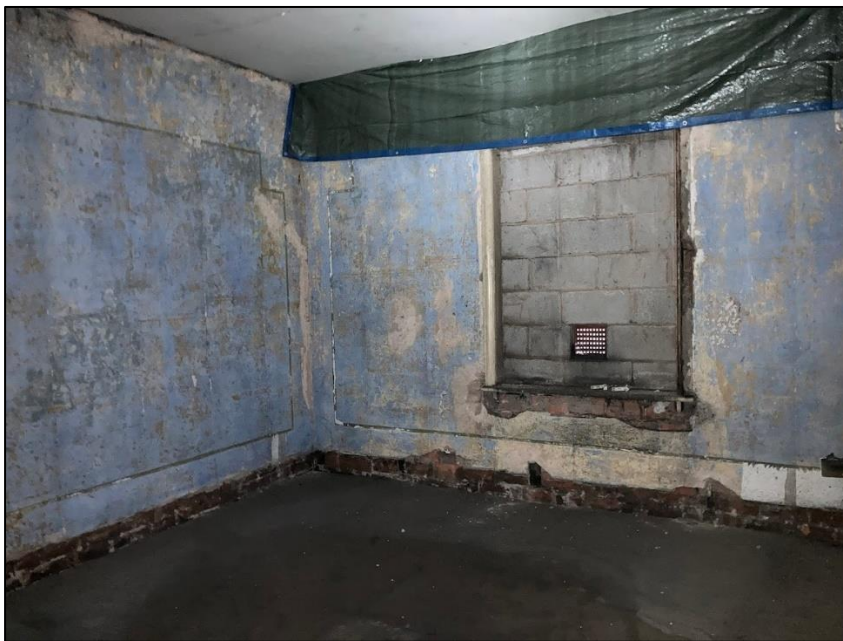
- 3.7 The internal spaces of the commercial property and the dwelling are empty. These spaces are finished and plastered and offer no roosting habitat for bats (see Photographs 12, 13, 14 and 15).

*Photograph 12 showing the interior of the former commercial part of the building*

*Photograph 13 showing the interior of the former commercial part of the building*

*Photograph 14 showing the interior of the former commercial part of the building*

*Photograph 15 showing the interior of the dwelling*

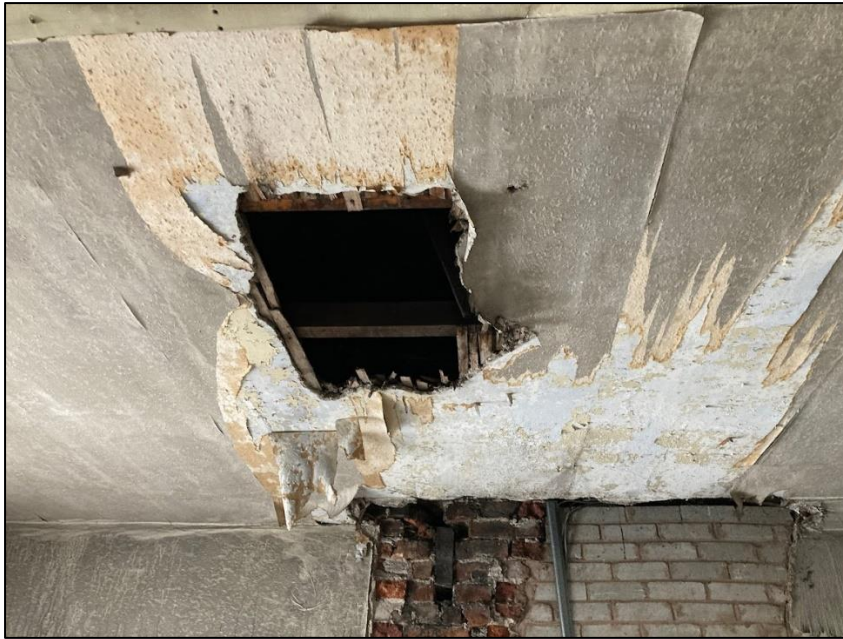
- 3.8 Access holes into the roof void spaces of both the former commercial part and the dwelling part of the building have been made in the ceilings of the first-floor rooms (see Photograph 16). These gave easy access into the roof void spaces above via a ladder.

*Photograph 16 showing on of the access holes in the former commercial part of the building*

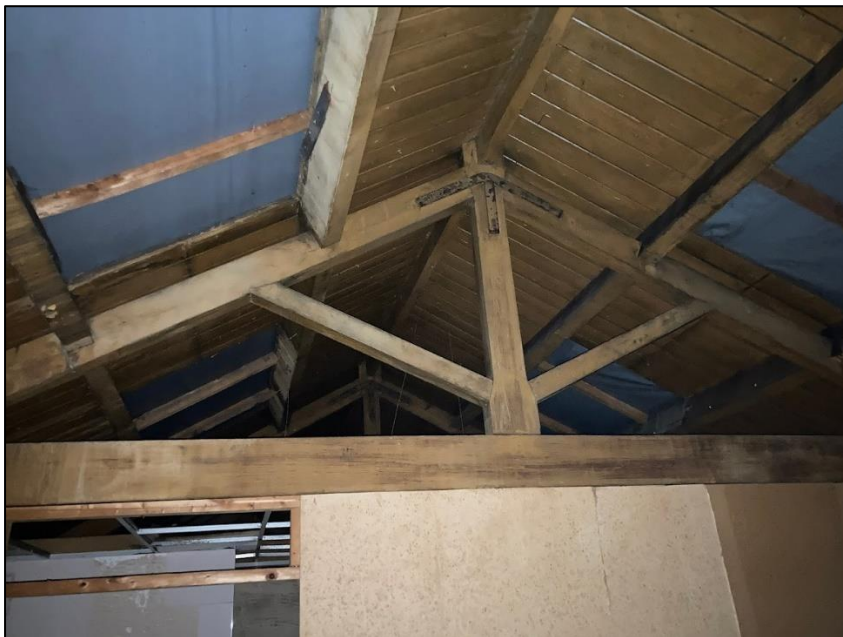
- 3.9 The extended parts of the former commercial building are open to the underside of the roof with no roof void spaces present (see Photograph 17).

*Photograph 17 showing on of the extended section of the former commercial part of the building*

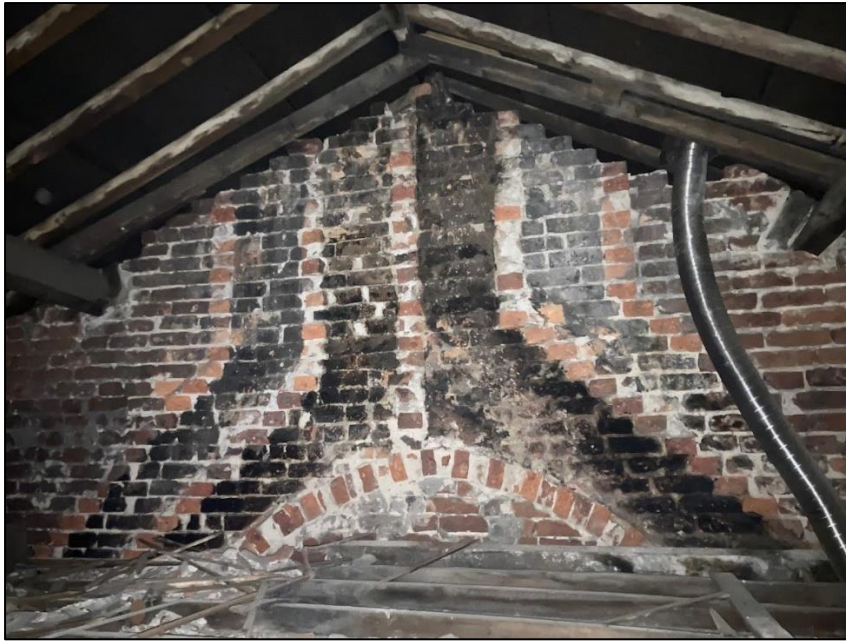
- 3.10 The roof void space of the former commercial part of the building is split into separate spaces with brick partition walls. Each space was accessed via the holes made in the ceilings or by holes in the partition walls. The gable and partition walls are in good condition and sealed with mortar and the spaces are very dusty and cobwebbed (see Photograph 18).

*Photograph 18 showing one of the gable walls*

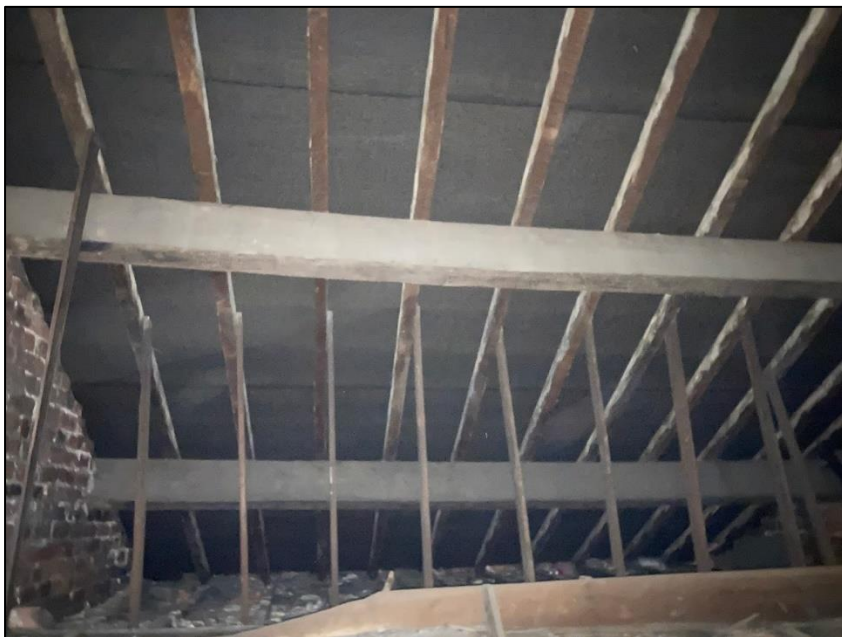
- 3.11 The roof space has no insulation, and the underside of the roof is lined with roofing felt (see Photograph 19). The felt is in good condition, free from rips, tears, and folds. The roof timbers are in good condition with no roosting habitat located. The roof void appears sealed as no daylight could be seen at any point.

*Photograph 19 showing the underside of the roof*

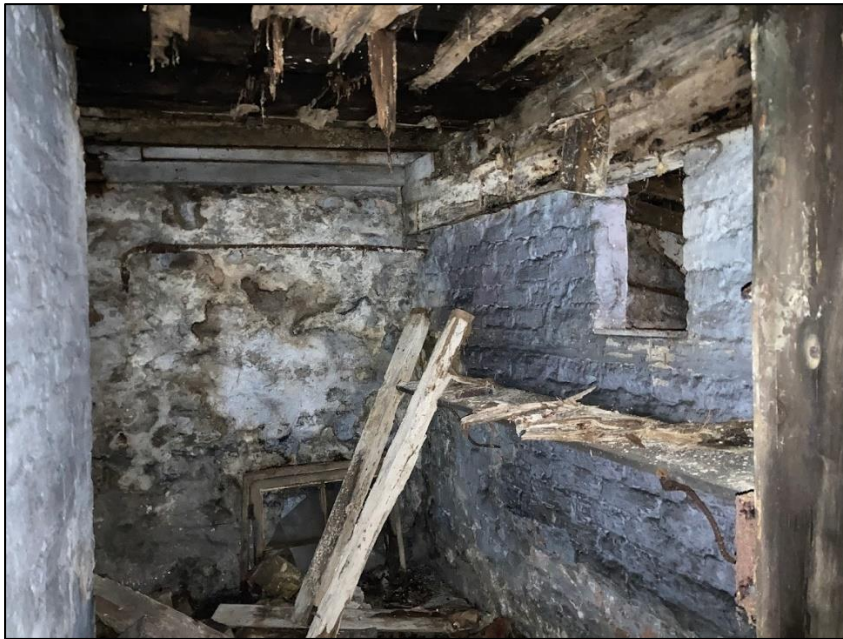
- 3.12 The basement level, located in the former commercial part of the building only, is in poor condition with part of the ceiling collapsed in (see Photograph 20). The basement has no access points located across the external walls and it is considered to offer no entry points for bats. Therefore, this space is discounted as offering potential hibernation or summer roost habitat.

*Photograph 20 showing part of the basement level*

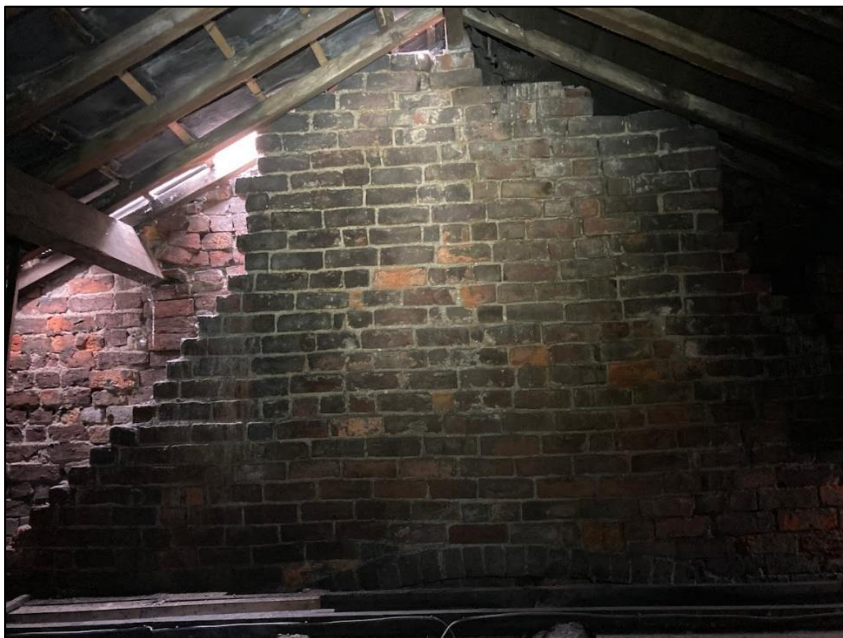
- 3.13 The roof void space above the dwelling part of the building consists of one space. The gable walls are in good condition and sealed with mortar (see Photograph 21). The western part of the roof void is partially lit due to the missing roof tile. Evidence of historic use of Pigeon is located across the roof void space.

*Photograph 21 showing the gable wall of the dwelling part of the building*

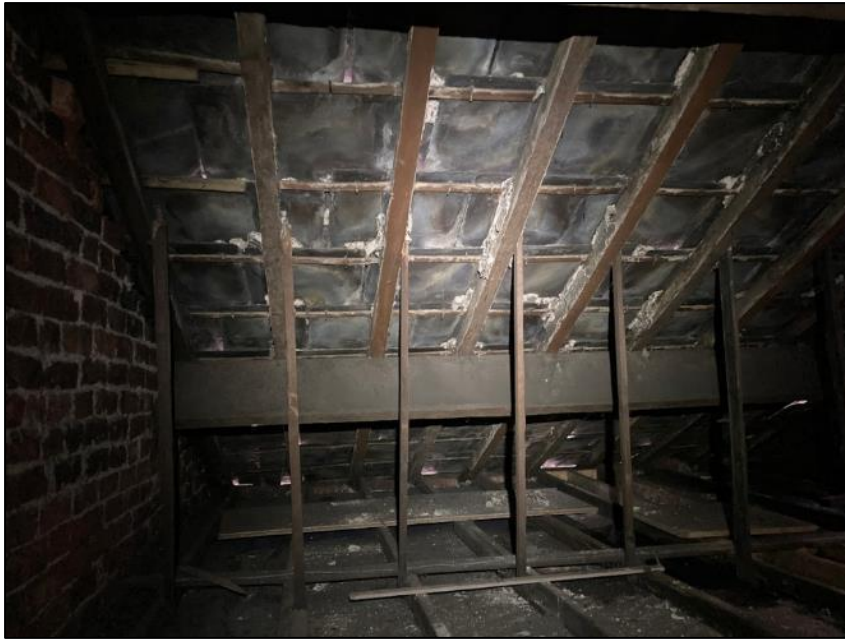
- 3.14 The underside of the roof is partially lined with roofing felt with the other part leaving the underside of the roof tiles exposed (see Photograph 22). The roof timbers are in good condition and free for cracks, crevices and gaps.

*Photograph 22 showing the underside of the roof tiles*
