# Condition Report and Proposals on the roof at 6-8 Manchester Rd, Bury, BL9 0ED

For Horsfield Insolvency Practitioners

Dated: August 2020

Ref: C-0447

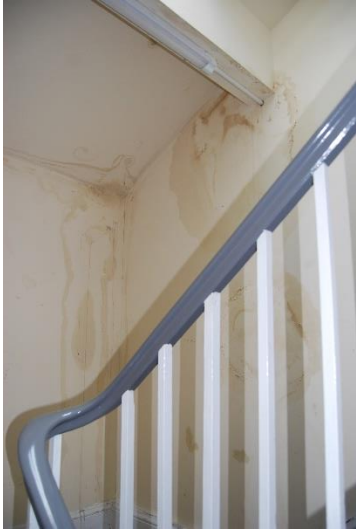
Dampness to stairwells

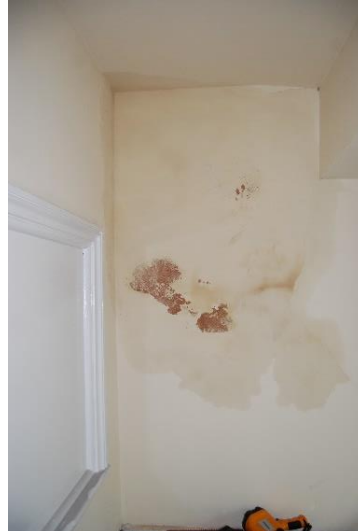
Damaged plaster to landing area

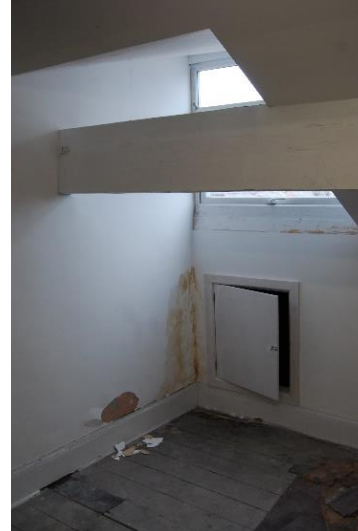
Damp from Dormers

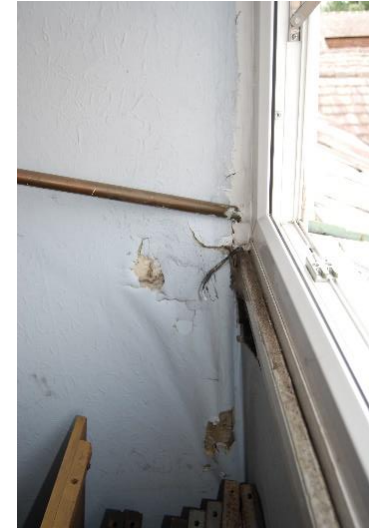
Damp from Dormers

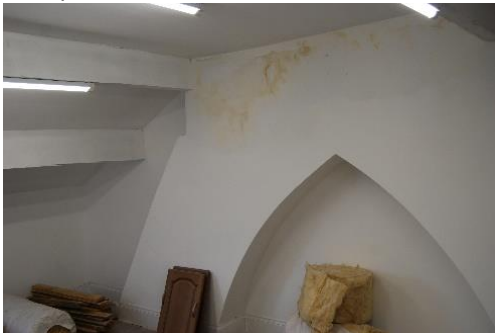
Damp from Chimney

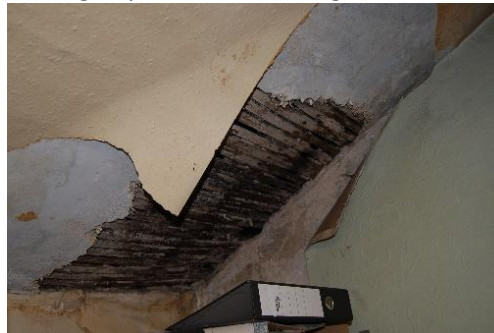
Dampness affecting ceilings

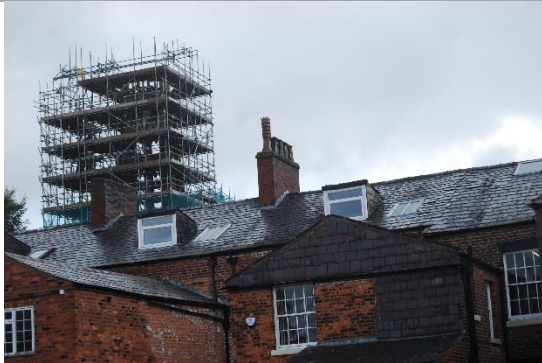
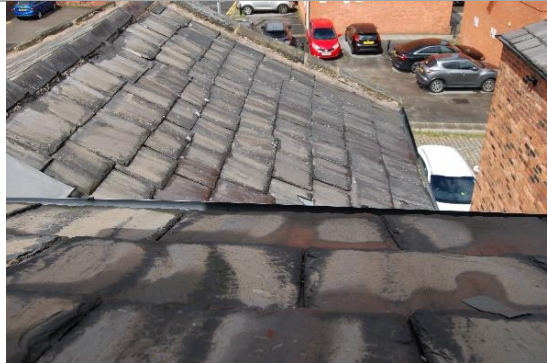
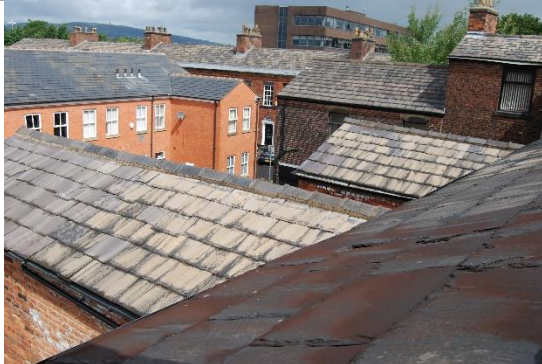
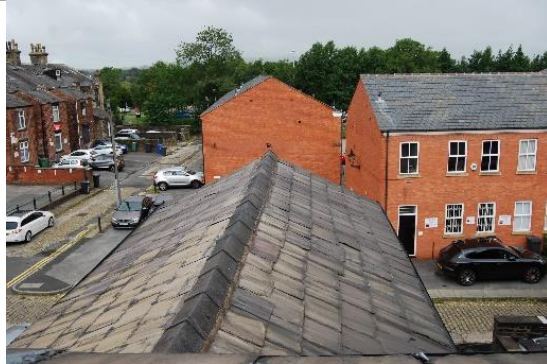
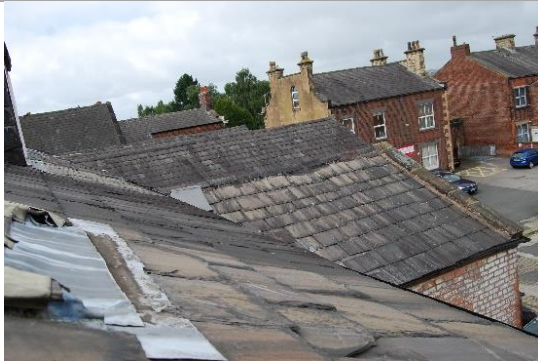
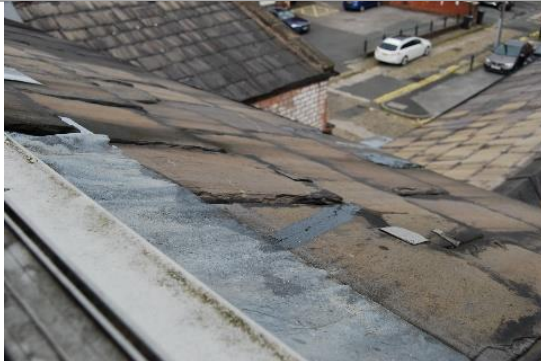
| Building Element | | | |
|---|---|---|---|
| Slating and Ridges | Rear and front roofs including outriggers exhibit broken, slipped and missing slates.<br>A number of slates have been bitumen repaired/sealed<br>Significant number of tabbed slates | | |

- a. General slate coverings: carefully the remove the existing slates and recover using new tantalisated battens to match the existing batten profile (75x13mm). Lay on a new breathable felt

- b. Clay ridges. Rebed on new lime mortar
- c. Abutment Flashings to outrigger roofs. Renew with lead soakers and cover flashings.
- d. Dormers D1 and D2. Slate hanging – carefully remove and recover using existing slates and make good to match existing. Inspect lead valley at intersection and renew if required.

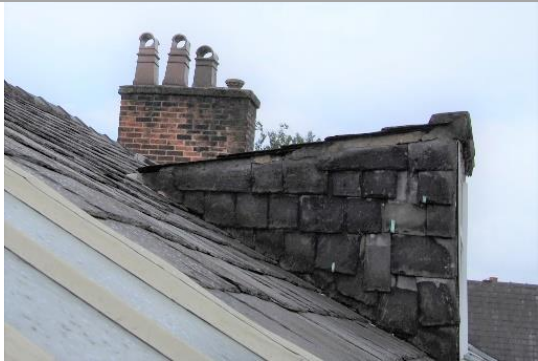
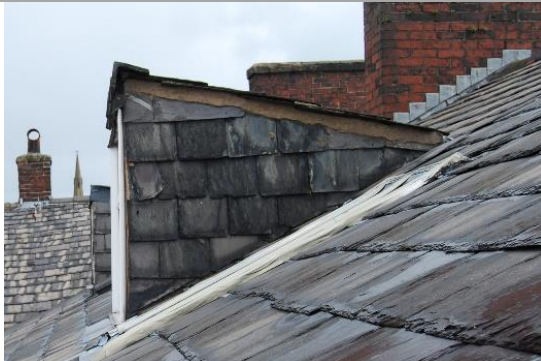
| Dormers D1 and D2 | Timber framed constructions with reversed sloping slate covered roofs, slate hanging to cheeks and Upvc windows. Slate hanging is failing and verge pointing fractured | | |

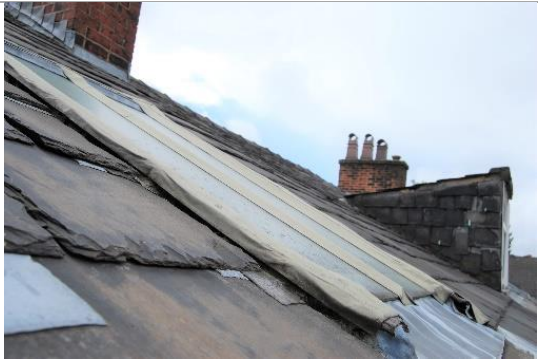
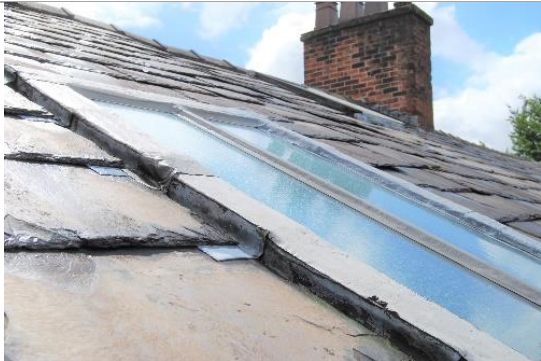
| Rooflights RL1 and RL2 | Traditional timber rooflights with glazing bar. Single glazed. Externally repaired with bituminous felt. Perished timber noted internally. | | |

- CH4 – Rake out and repoint with a new NHL 5 lime mortar. New lead soakers and cover flashings. Replace/repair flaunching.
- h. Rooflights.
  - RL1 and RL2: Carefully remove existing single glazed rooflight and reform the opening to suit a new Velux Conservation Rooflight Ref GGLSD5N2 (78x118) MK08

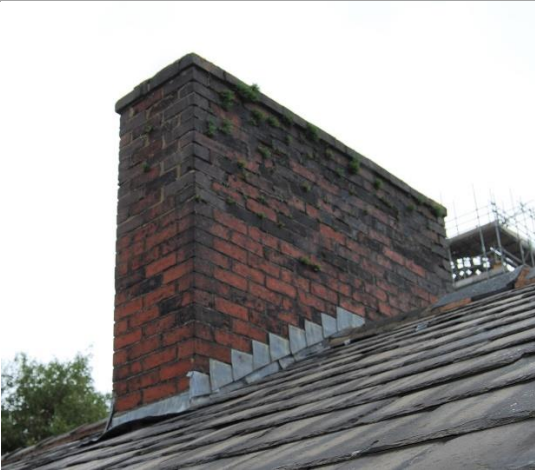
| CH1 | Brick with capped top. Fractured pointing and defective/lifting flashings. Perished bricks noted. Fractured cement capping. | | |

- f. Allow for redressing the inner lead-lined face of the stone parapet.
- g. Chimneys:
  - CH1 – Rake out and repoint with a new NHL 5 lime mortar. New lead soakers and cover flashings. Replace/repair flaunching.

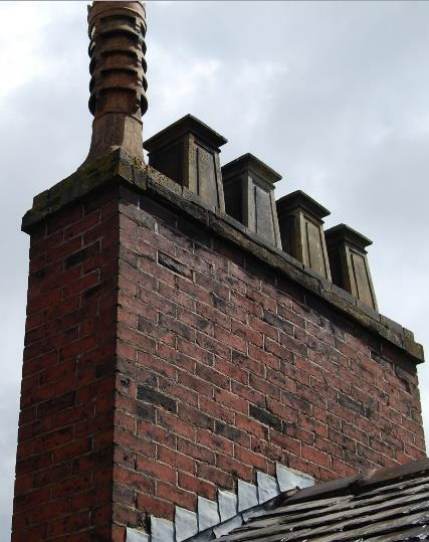
| CH2 | Brick stack with 5 clay pots. Stone sailing course with brick edge over. Fractured pointing and erosion to stone sailing course. Flashings require close inspection. | | |

- CH2 – Rake out and repoint with a new NHL 5 lime mortar. New lead soakers and cover flashings. Replace/repair flaunching.
  - CH3 – Rake out and repoint with a new NHL 5 lime mortar. New lead soakers and cover flashings. Replace/repair flaunching.

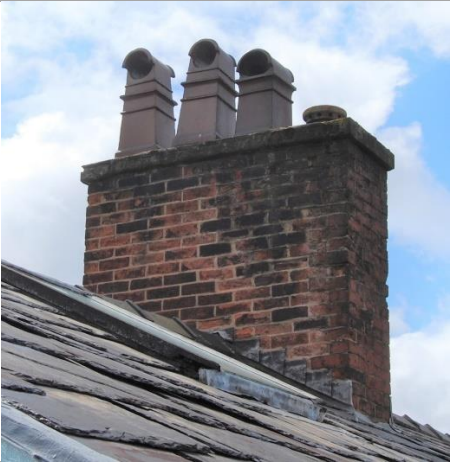
| CH3 | Brick stack 3 clay pots and flue terminal. Stone sailing course. Fractured jointing and perished brickwork evident. | | |

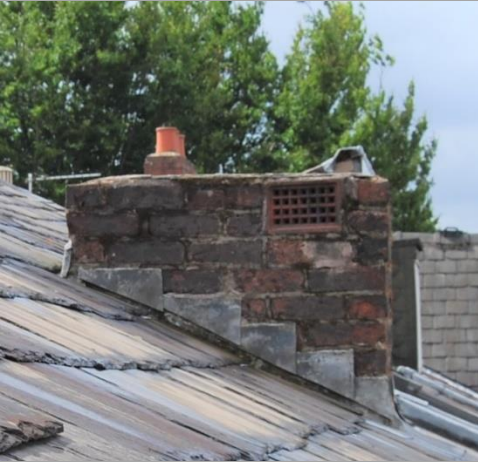
| CH4 | Brick stack which is capped and vented by terracotta air brick. Fractured pointing and vegetation noted. Lifting flashings. | | |

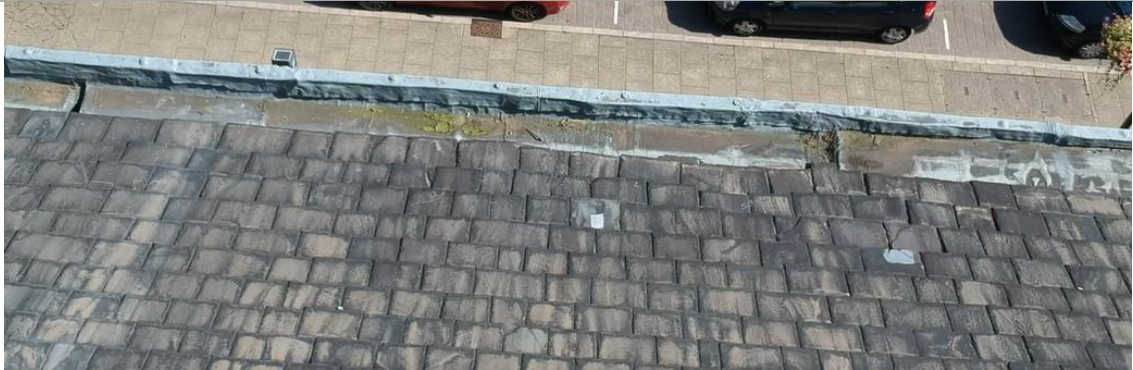
| <p>Abutment Gutter<br/>East elevation</p> <p>When viewed<br/>from the drone<br/>footage (next<br/>section)</p> | <p>It is quite clear that the abutment lead gutter is suffering from age. The drone footage shows a lead lining to the gutter with steps. There is evidence of regular horizontal creasing which is usually brought about by expansion and contraction of the lead over a long period of time. This provides inherent weakness especially of lead of this age.</p> <p>Flashings appear deformed.</p> | | |

- e. Abutment Gutter to east elevation. Carefully take up the existing lead gutter and boarding and replace with a new WPB ply lining to fall on new battens, with Code 6 lead on felt and T-Pren (or similar) neoprene expansion joints all fixed in accordance with manufacturer’s instructions.

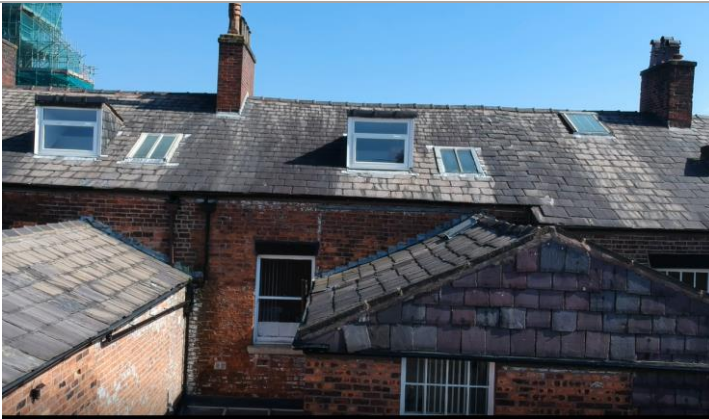
| Video Time | Comment | |
|---|---|---|
| 0.00 | View from the west.<br>Uneven slates generally.<br>Extensive number of slipped and broken slates | |

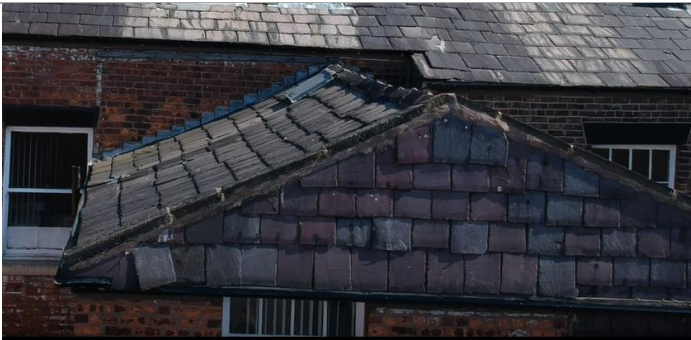
| Video Time | Comment | |
|---|---|---|
| 00.25 | Outrigger gable<br>Slipped slates to slate hanging | |

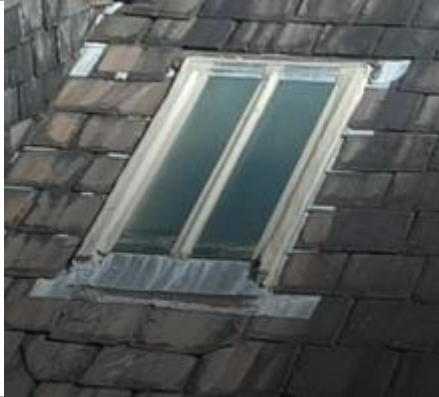
| 00.54 | Flashband (bituminous felt) repairs to Rooflight 1 | | |

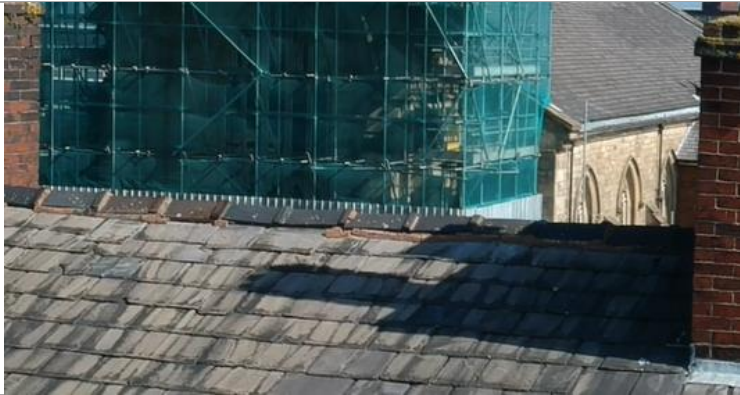
| 01.00 | Fractured ridge pointing | | |

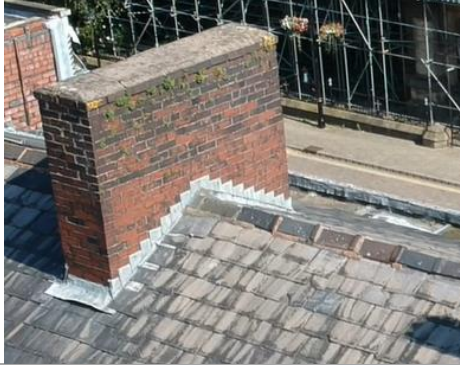
| 01.30 | <p>Chimney 1</p> <p>Fractured flaunching</p> <p>Lifting flashings</p> <p>Vegetation growth (suggesting water ingress)</p> | | |

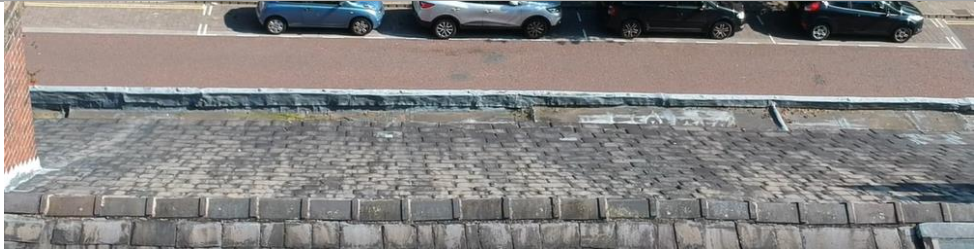
| 02.01 | <p>East parapet</p> <p>Uneven flashings</p> <p>View of concealed gutter with stepped lead finish partly silted</p> | | |

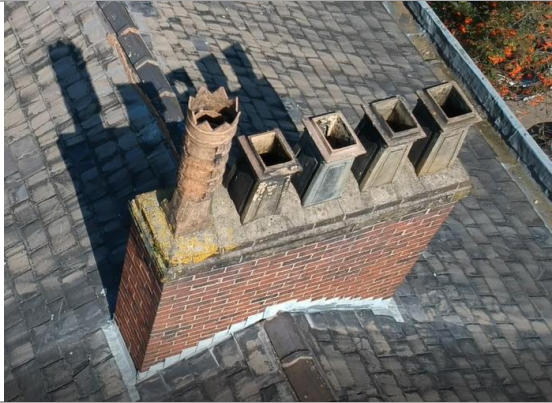
| 02.26 | <p>Chimney 2 - Fractured flaunching</p> <p>Fractured ridge pointing</p> <p>Creased lead to abutment gutter</p> | | |

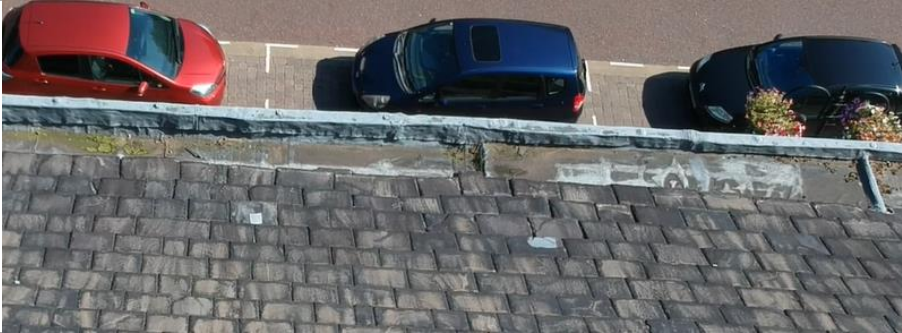
| <p>02.37<br/>02.58</p> | <p>Creased lead to abutment gutter and deformed flashings<br/>Note lead covering to stone parapet fixings covered with lead buttons</p> | | |

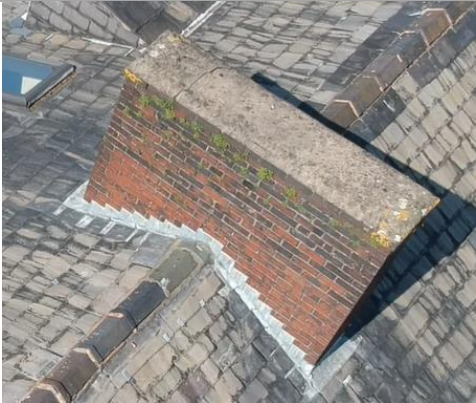
| <p>03.09</p> | <p>Fractured flaunching to Chimney 1 and vegetation</p> | | |

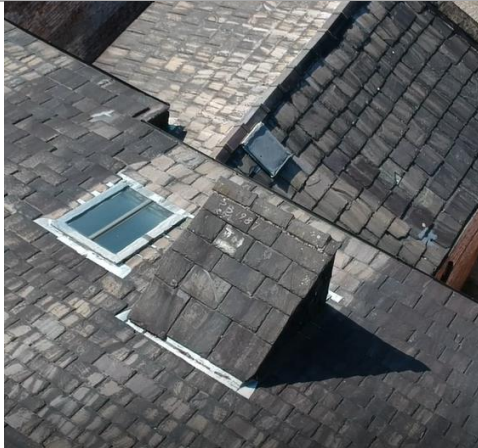
| 03.12 | Slipped slates to Dormer 2 and outrigger<br>Flashband repairs to Rooflight RL1 | | |

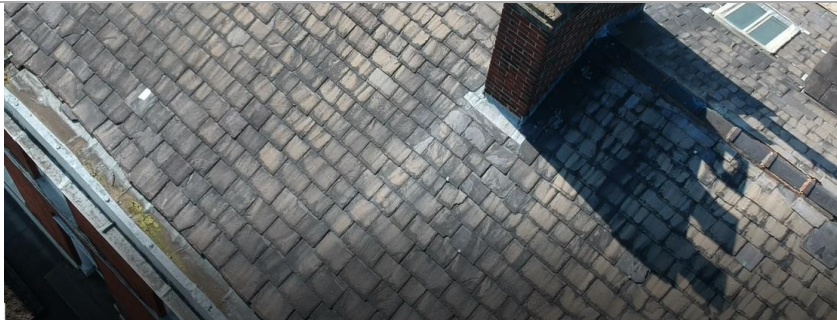
| 03.19 | Creased lead to main abutment gutter<br>Slipped slates below main ridge (east slope) | | |

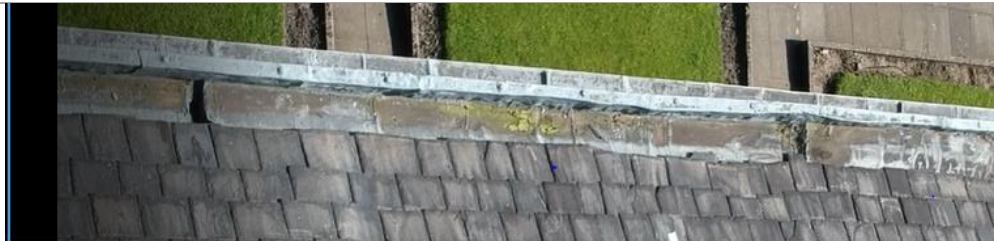
| 04.13 | Parapet gutter<br>Extensive lengths of lead with creasing<br>Uneven stone to parapet | | |

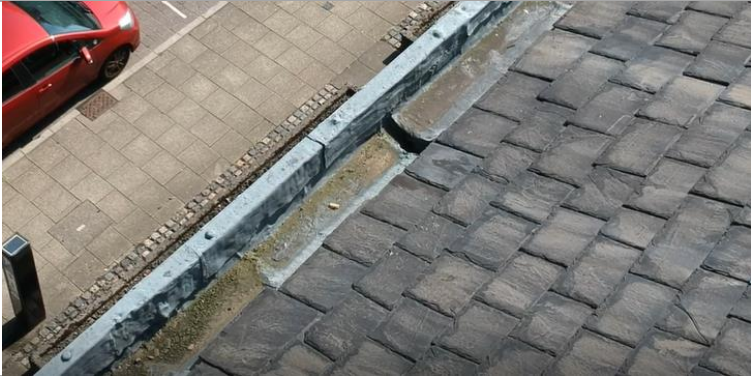
| 05.12 | Deformed flashings to parapet | | |

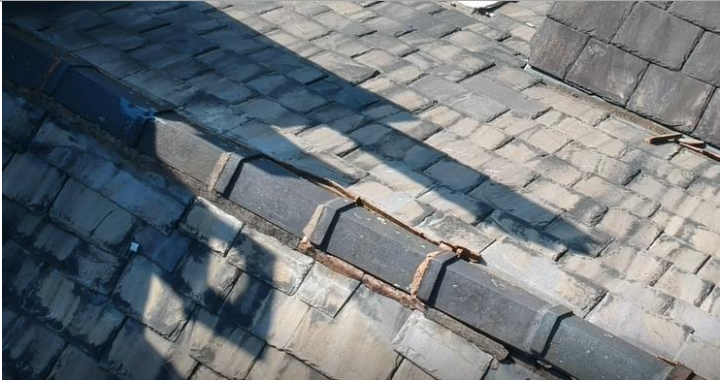
| 05.18 | Fractured ridge pointing | | |

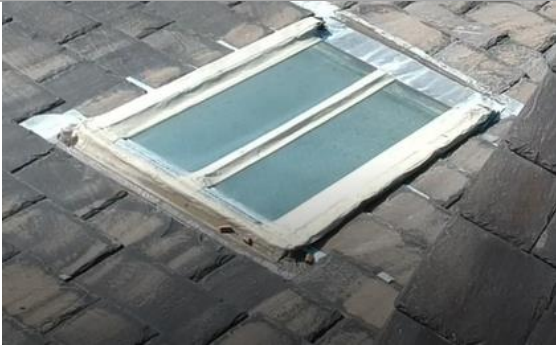
| 05.23 | Flashband repairs to Rooflight RL1 | | |

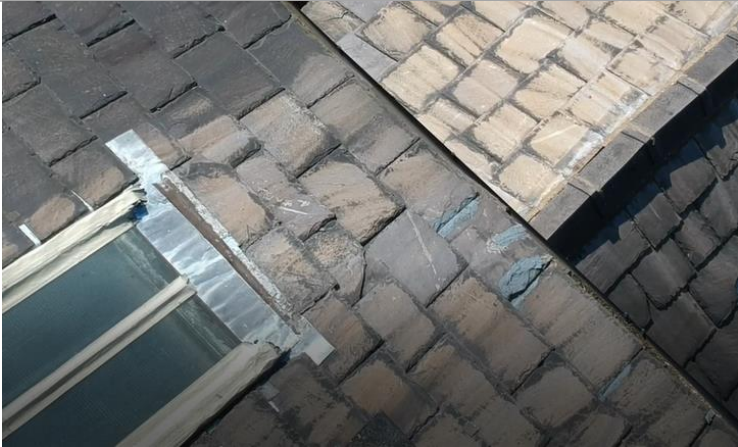
| 05.34 | Broken slates and bitumen repairs to slates | | |

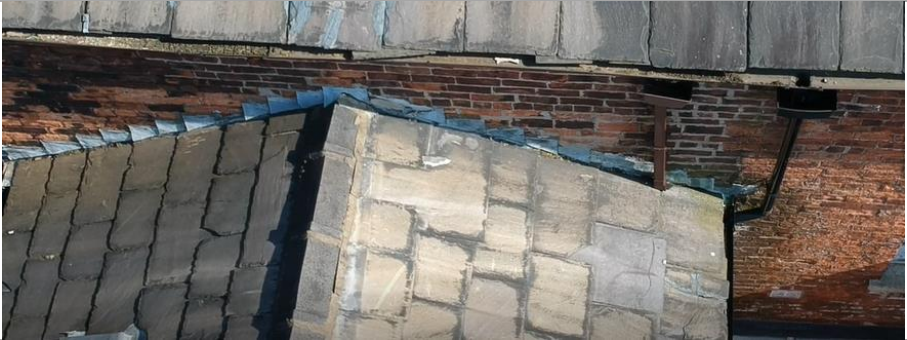
| 06.38 | Defective abutment flashings to outrigger | |

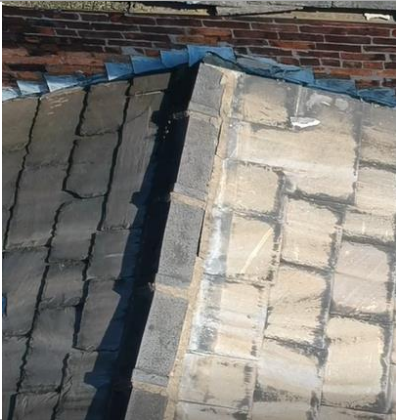
| 06.46 | Fractured pointing to outrigger | |

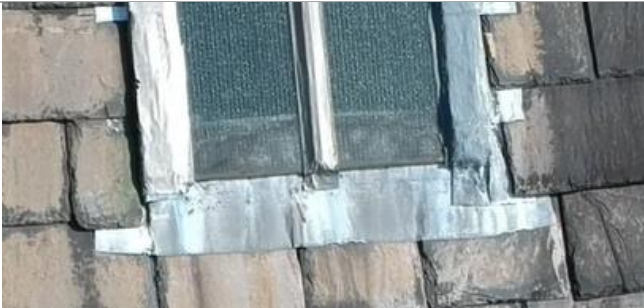
| 07.09 | Flashband repairs to Rooflight RL2 | |

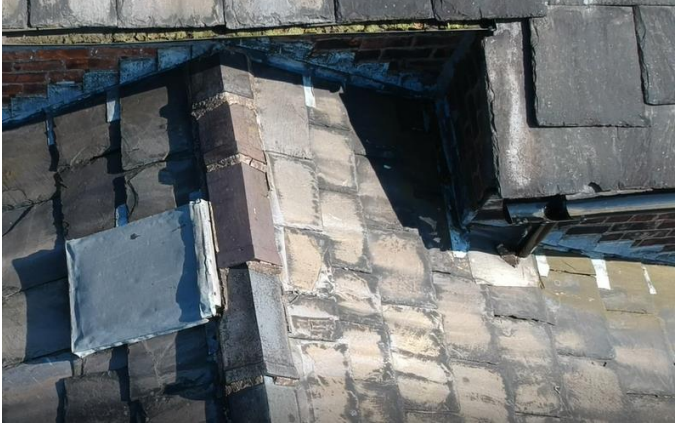
| 07.23 | Slipped slates and fractured ridge pointing to outrigger | | |

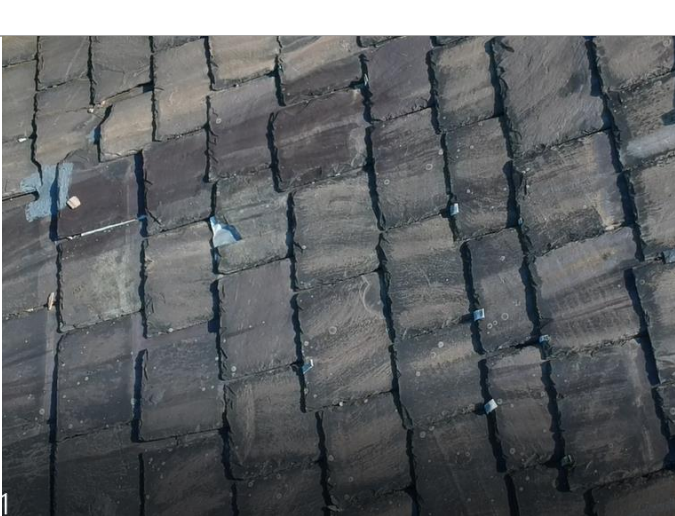
| 07.48 | Defective and tabbed slates | | |
