P. Keeling  
M. Crompton  
25 November 2021  
CH.21.12.030.LW  
13 December 2021

## Report on Survey of Asbestos Materials at

**Radcliffe Market Chambers**  
**Blackburn Street**  
**Radcliffe**  
**Gtr. Manchester**  
**M26 1NN**

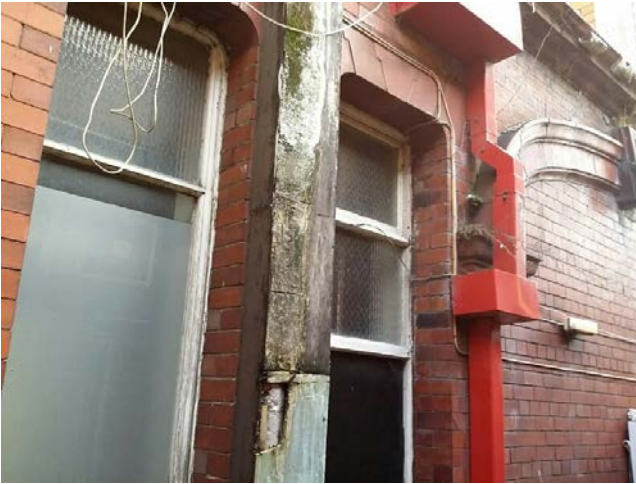
Sample No: 21/11/B/25/PK16  
External  
Court yard  
Insulation to pipe in boxing  
**No Asbestos Detected**

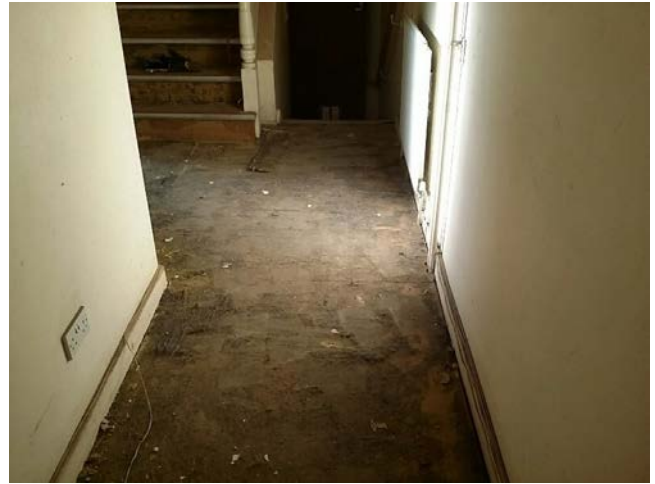
Sample No: Refer to Sample 21/11/B/25/PK1  
G.01 Circulation  
Floor  
Sheet vinyl flooring  
**No Asbestos Detected**

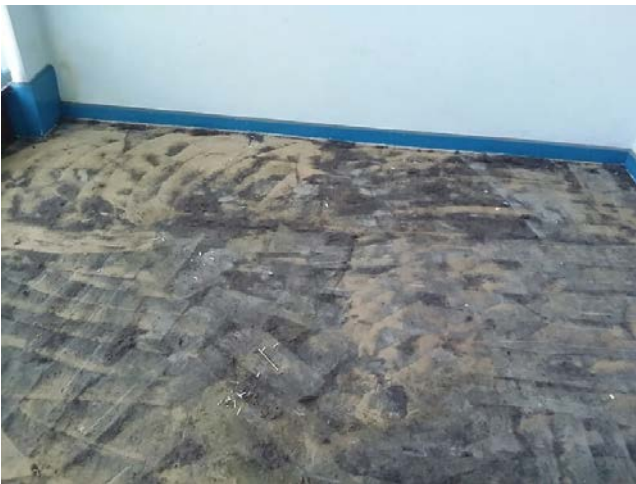
Sample No: 21/11/B/25/PK1  
G.02 Office  
Floor  
Sheet vinyl flooring  
**No Asbestos Detected**

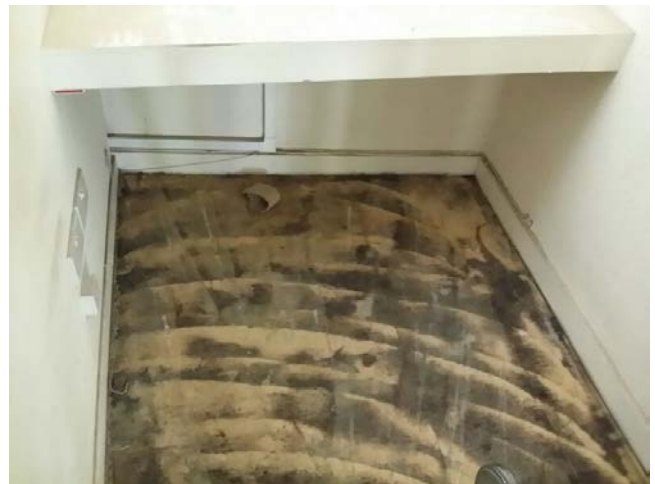
Sample No: Refer to Sample 21/11/B/25/PK1  
G.03 Office  
Floor  
Sheet vinyl flooring  
**No Asbestos Detected**

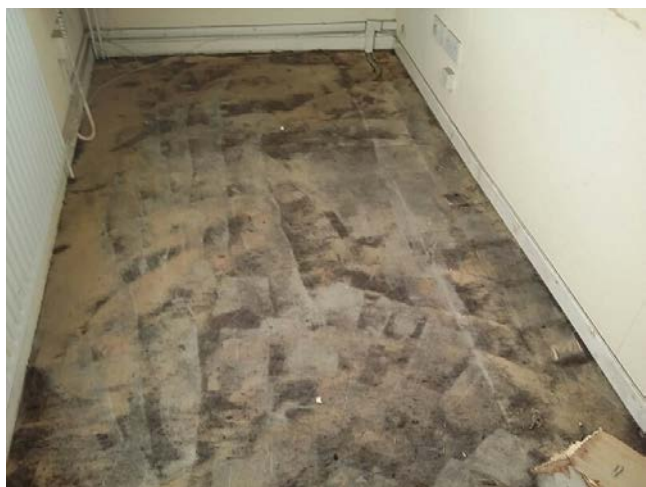
Sample No: Refer to Sample 21/11/B/25/PK1  
G.04 WC  
Floor  
Sheet vinyl flooring  
**No Asbestos Detected**

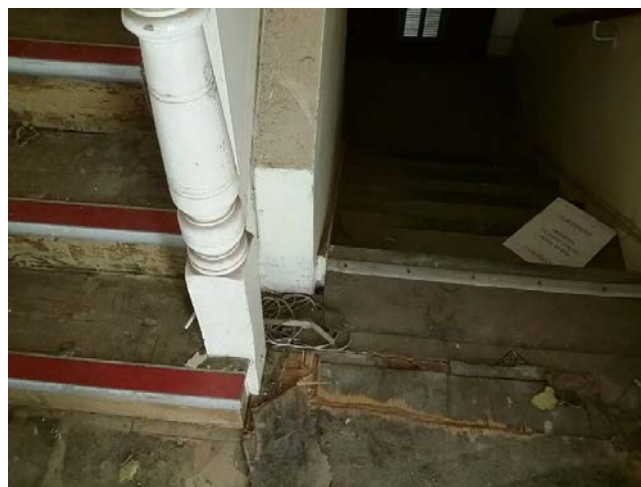
Sample No: 21/11/B/25/PK2  
G.05 Stairwell  
Stairs  
Vinyl nosings  
**No Asbestos Detected**

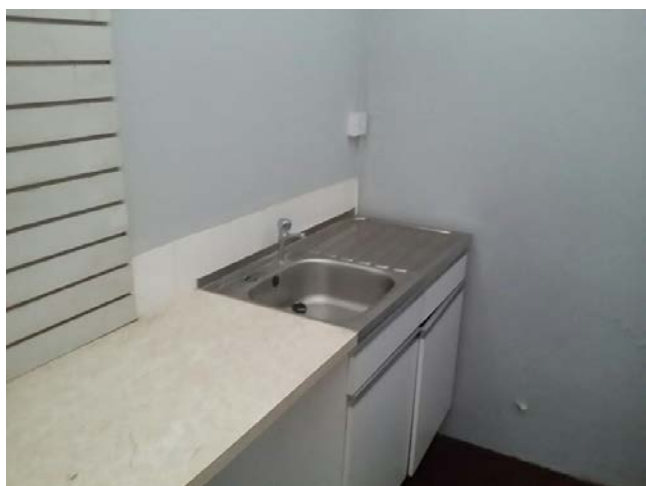
Sample No: 21/11/B/25/PK17  
G.06 Shop unit  
Sink  
Bitumen pad  
**No Asbestos Detected**

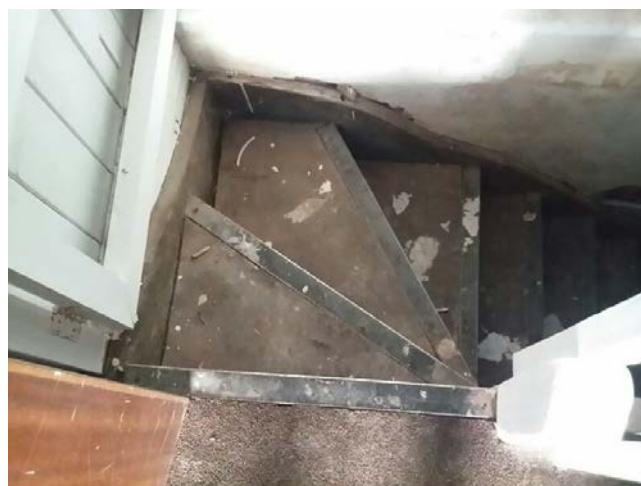
Sample No: 21/11/B/25/PK18  
G.07 Basement stairwell  
Stairs  
Vinyl nosing  
**No Asbestos Detected**

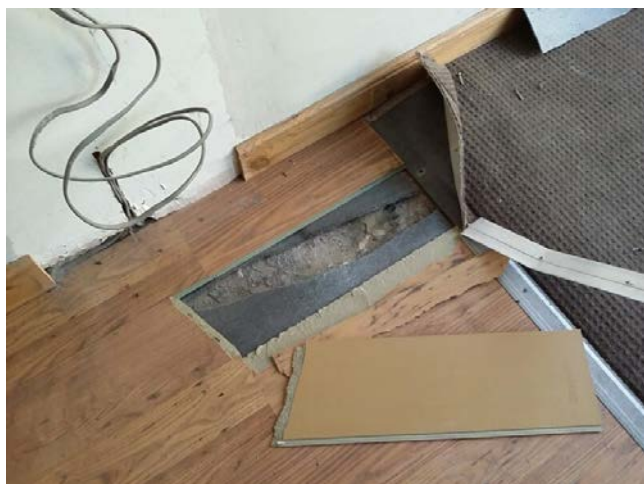
Sample No: 21/11/B/25/PK19  
G.08 Shop unit  
Floor  
Bitumen adhesive  
**No Asbestos Detected**

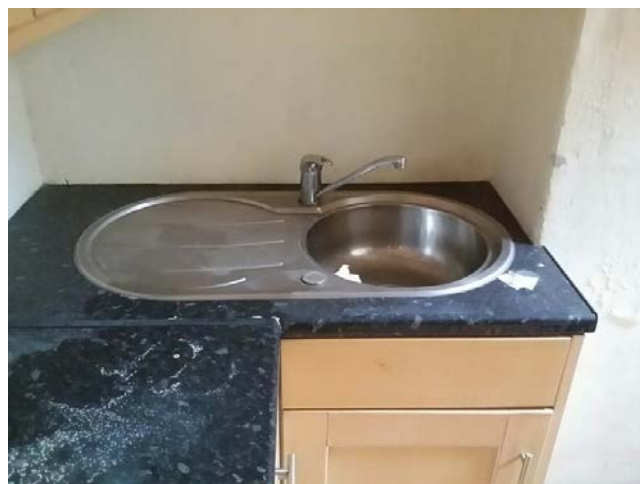
Sample No: 21/11/B/25/PK20  
G.09 Kitchen area  
Sink  
Bitumen pad  
**No Asbestos Detected**

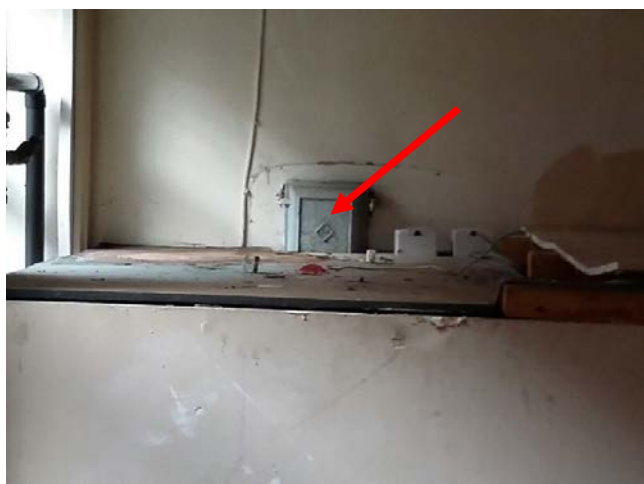
| Sample Number | Location | ACM Type | Condition | Recommendation |
|---|---|---|---|---|
| No Sample | G.09 - Kitchen area - Old fuse box above WC | Flash guards | Fair | Remove |

Sample No: No Sample  
G.09 Kitchen area  
Old fuse box above WC  
Flash guards containing:  
**Chrysotile**

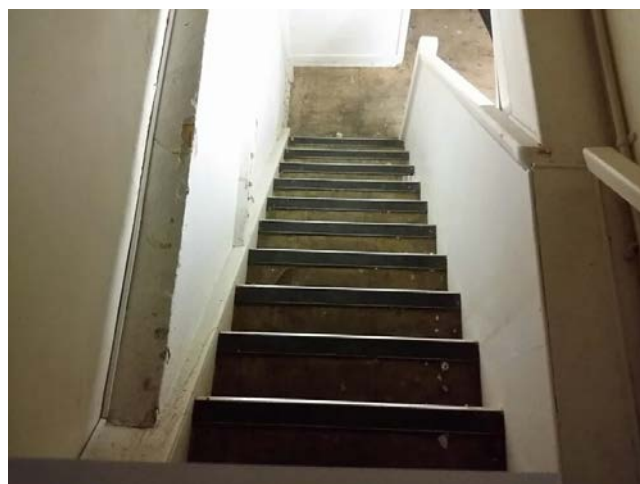
Sample No: 21/11/B/25/PK21  
G.13 Stairwell  
Stairs  
Vinyl covering  
**No Asbestos Detected**

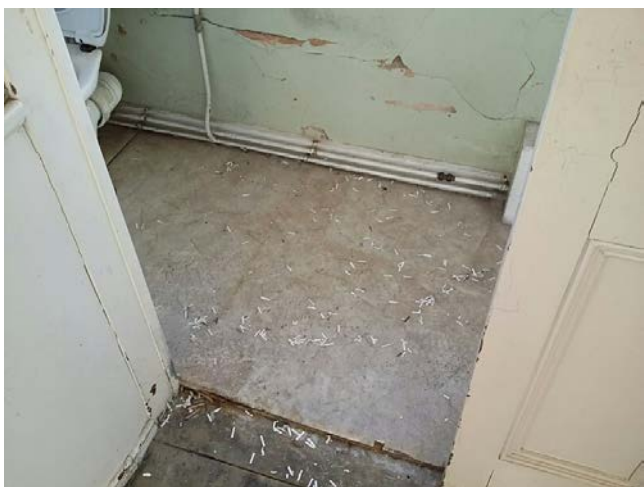
Sample No: 21/11/B/25/PK3  
1.09 WC  
Floor  
WC  
**No Asbestos Detected**

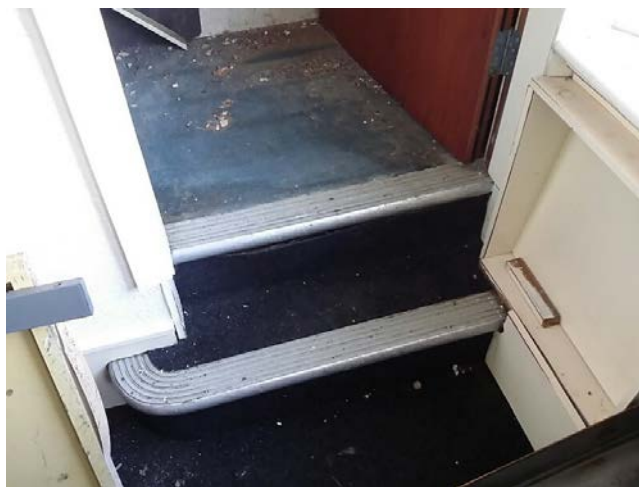
Sample No: 21/11/B/25/PK10  
1.10 Stairwell  
Stairs  
Vinyl nosings  
**No Asbestos Detected**

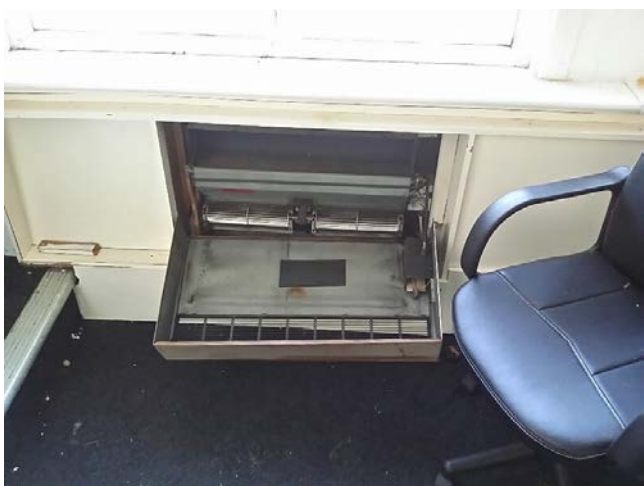
Sample No: 21/11/B/25/PK11  
1.11 Store  
Wall behind radiator  
Insulation board  
**No Asbestos Detected**

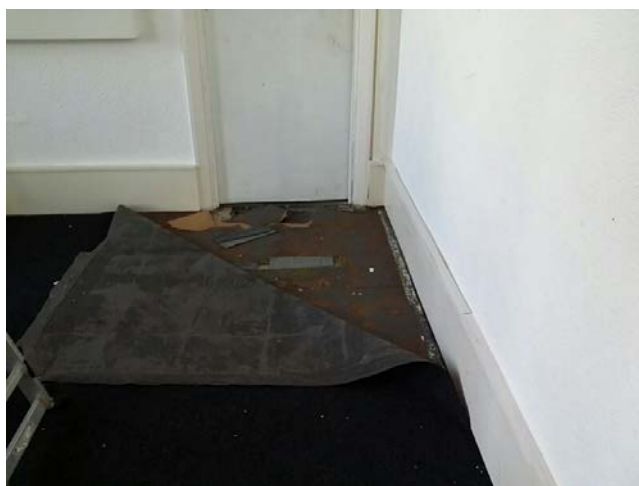
Sample No: 21/11/B/25/PK12  
1.11 Store  
Floor below carpet  
Vinyl floor tiles  
**No Asbestos Detected**

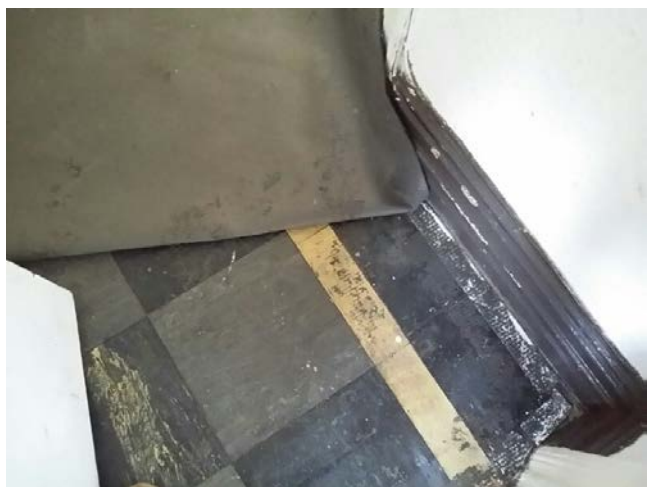
Sample No: Refer to Sample 21/11/B/25/PK12  
1.13 Circulation  
Floor below carpet  
Vinyl floor tiles  
**No Asbestos Detected**

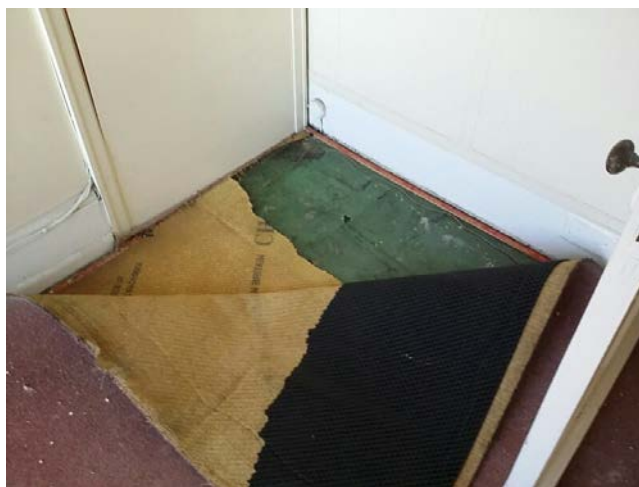
| Sample Number | Location | ACM Type | Condition | Recommendation |
|---|---|---|---|---|
| 21/11/B/25/PK13 | 1.14 - Office - Floor | Vinyl tiles below carpet | Fair | Remove |

Sample No: 21/11/B/25/PK13  
1.14 Office  
Floor  
Vinyl tiles below carpet containing:  
**Chrysotile (In bitumen only)**

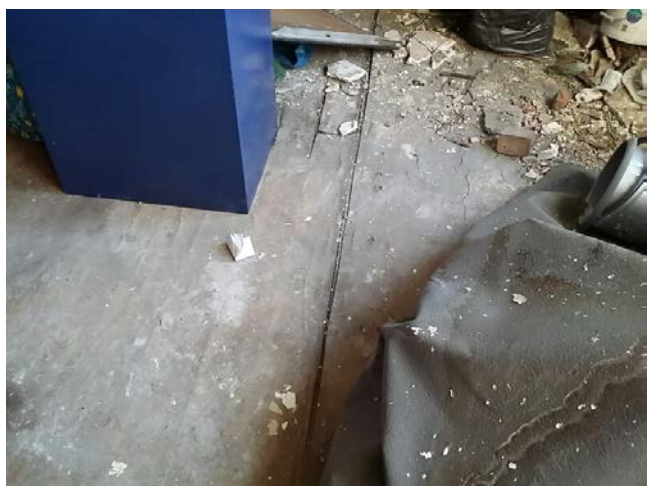
Sample No: 21/11/B/25/PK14  
1.16 Office  
Floor  
VFC  
**No Asbestos Detected**

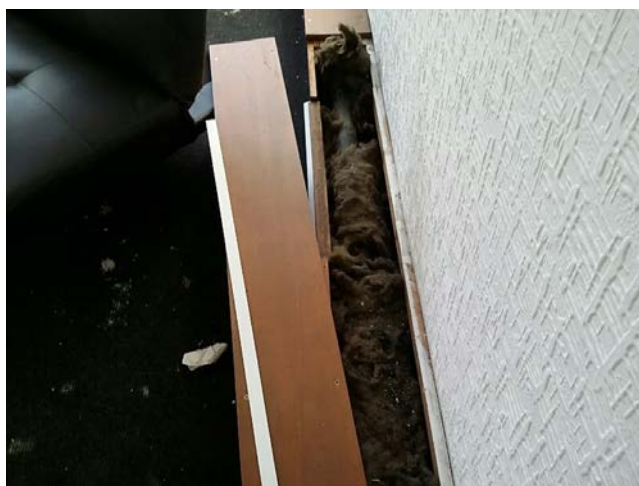
Sample No: 21/11/B/25/PK15  
1.18 Office  
Pipe boxing  
Insulation to pipework  
**No Asbestos Detected**

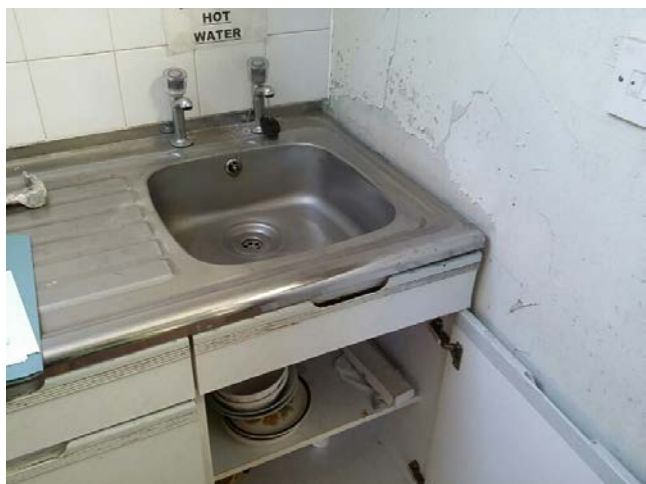
Sample No: 21/11/B/25/PK4  
2.01 Kitchen  
Sink  
Bitumen pad  
**No Asbestos Detected**

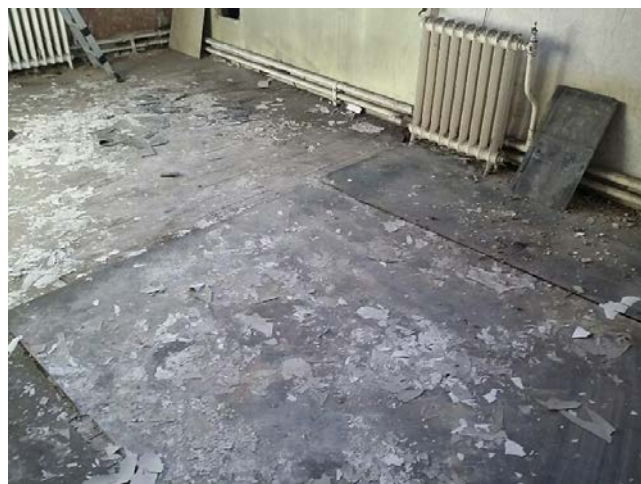
Sample No: 21/11/B/25/PK5  
2.02 Store  
Floor  
VFC  
**No Asbestos Detected**

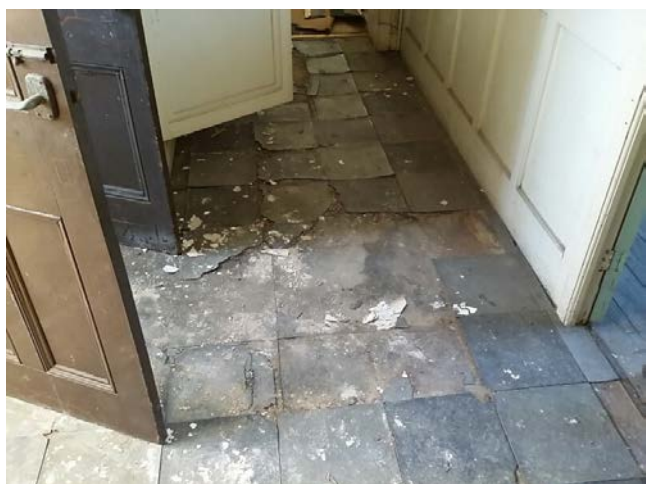
Sample No: 21/11/B/25/PK6  
2.04 Circulation  
Floor  
Vinyl floor tiles  
**No Asbestos Detected**

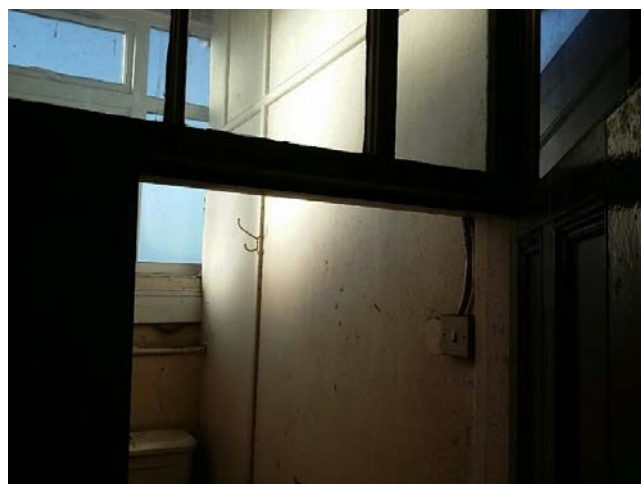
Sample No: 21/11/B/25/PK7  
2.06 WC  
Wall  
Wall panels  
**No Asbestos Detected**

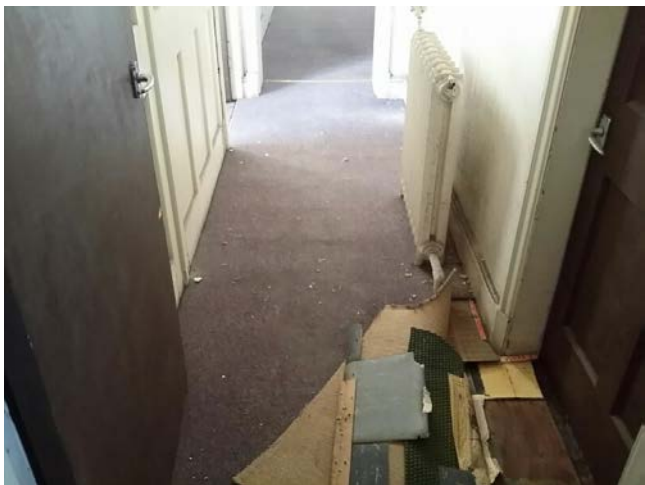
Sample No: 21/11/B/25/PK8  
2.08 Corridor  
Floor  
Core sample (various floor coverings)  
**No Asbestos Detected**

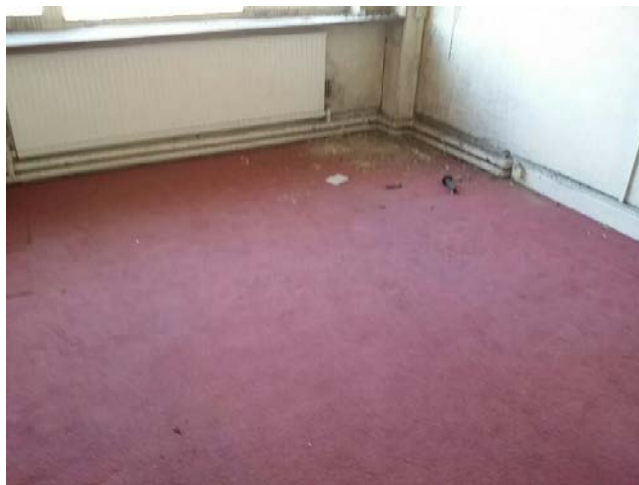
Sample No: 21/11/B/25/PK9  
2.09 Office  
Floor  
VFC below carpet  
**No Asbestos Detected**

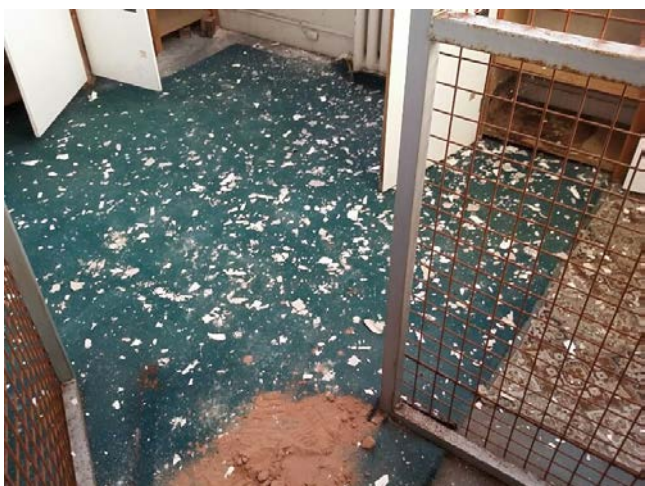
Sample No: Refer to Sample 21/11/B/25/PK5  
2.10 Store  
Floor  
VFC  
**No Asbestos Detected**

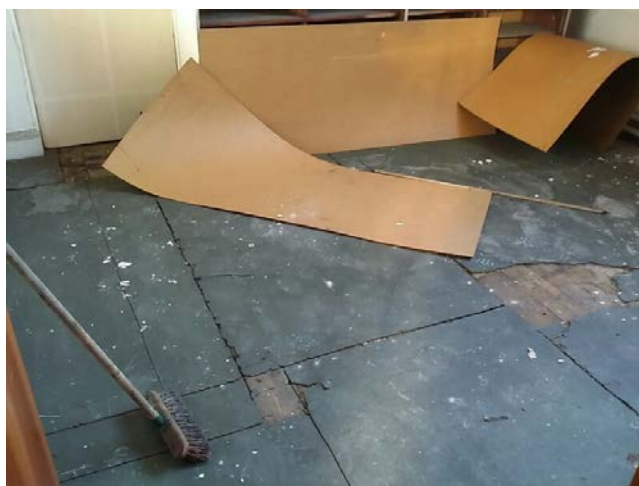
Sample No: Refer to Sample 21/11/B/25/PK5  
2.11 Store  
Floor  
VFC  
**No Asbestos Detected**

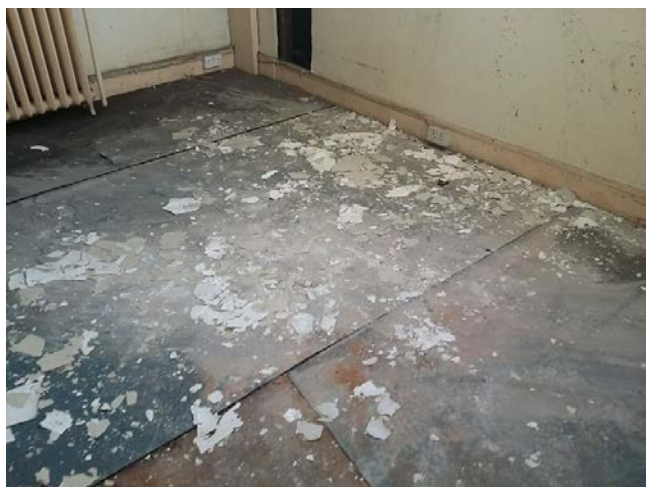
Sample No: Refer to Sample 21/11/B/25/PK5  
2.12 Store  
Floor  
VFC  
**No Asbestos Detected**

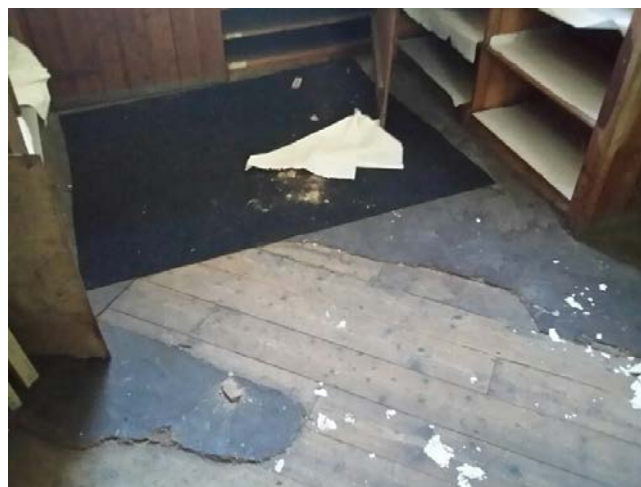
Sample No: Refer to Sample 21/11/B/25/PK5  
2.14 Store  
Floor  
VFC  
**No Asbestos Detected**

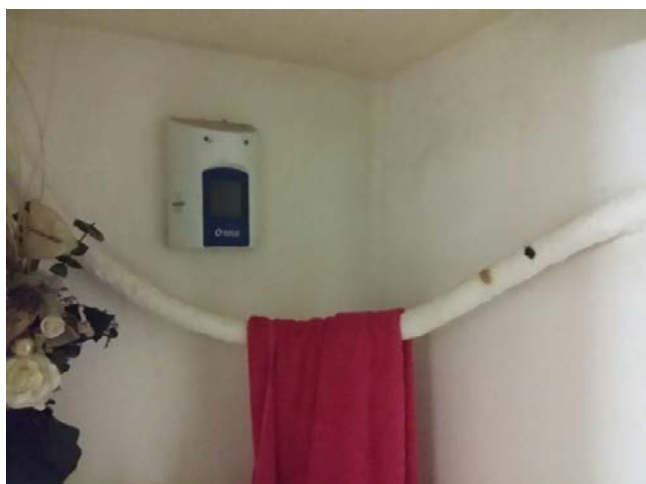
Sample No: 21/11/B/25/PK22  
B.05 WC  
Electrical cable  
Woven wrap  
**No Asbestos Detected**

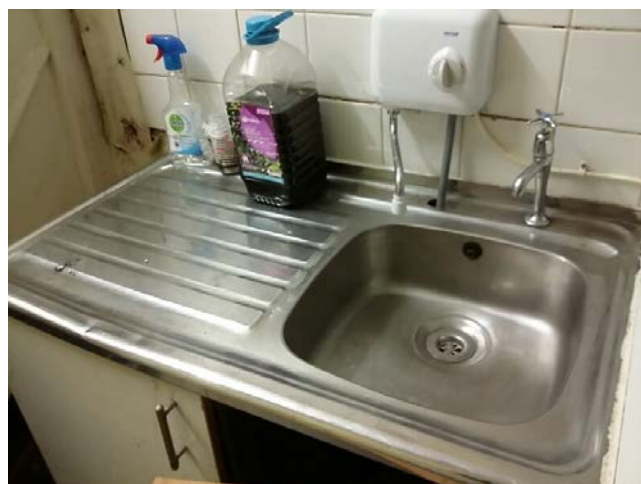
Sample No: 21/11/B/25/PK23  
B.08 Store  
Sink  
Bitumen pad  
**No Asbestos Detected**

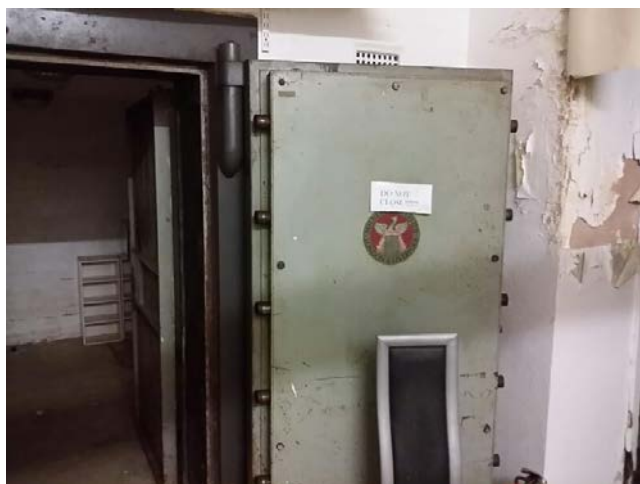
| Location/Item | Reason for non-access | Client Agreed (Y/N) |
|---|---|---|
| Internals to safe door in B.09 | No physical means of access | Yes |

Safe door to B.09 (may have ACMs internally)
