# Preliminary Roost Assessment

Davenport Farm Annex  
Arthur lane  
Ainsworth  
BL2 5PW

For  
Jenkins Design Services Ltd

# Gritstone Ecology

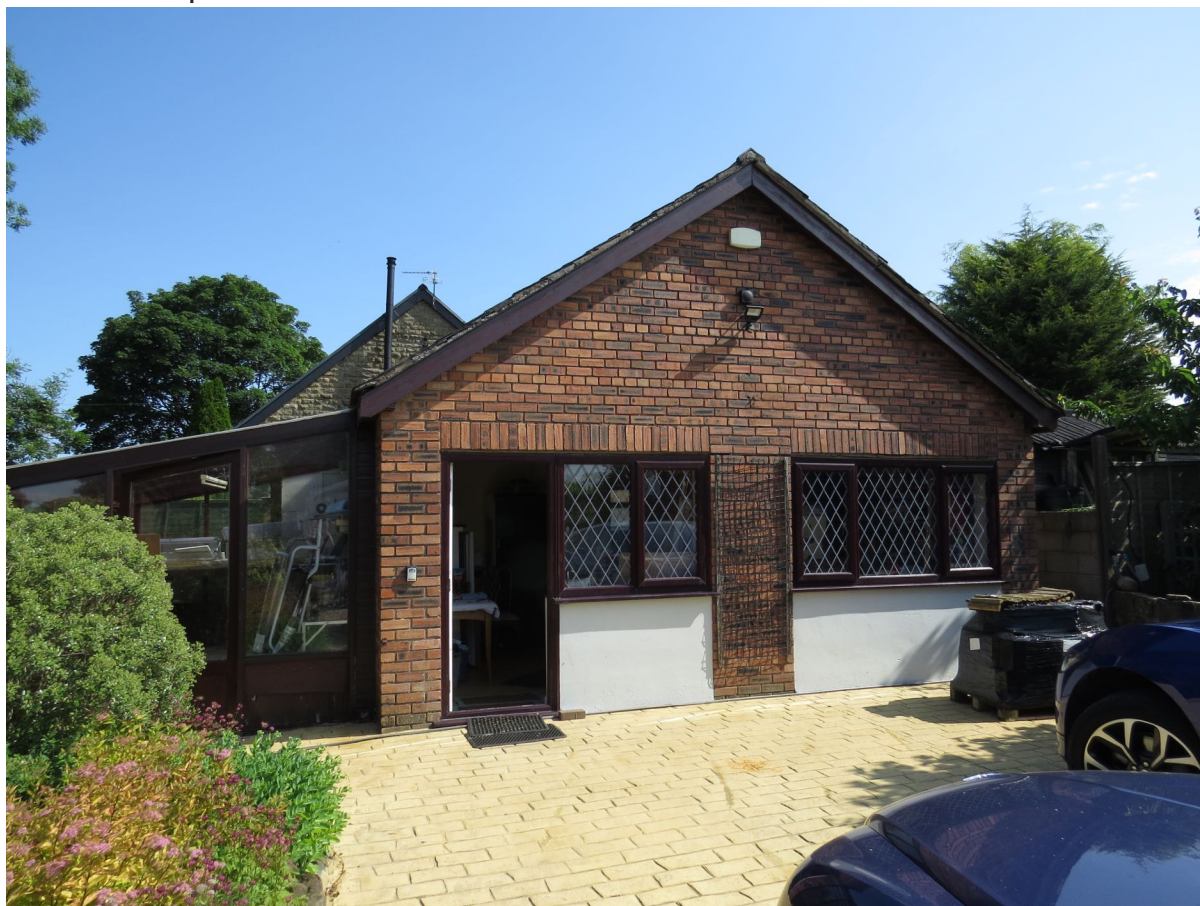
3.1a – The front of the annex.

The building is relatively modern, it is well maintained, and in good condition. Ridge tiles are fixed tightly, there are no damaged or missing ridge tiles. There are no damaged, slipped, or missing roof tiles. Roof tiles are tightly fitted, with no gaps between tiles.

There are no features externally which are likely be used by roosting bats, and no evidence of use by bats was present during the inspection.

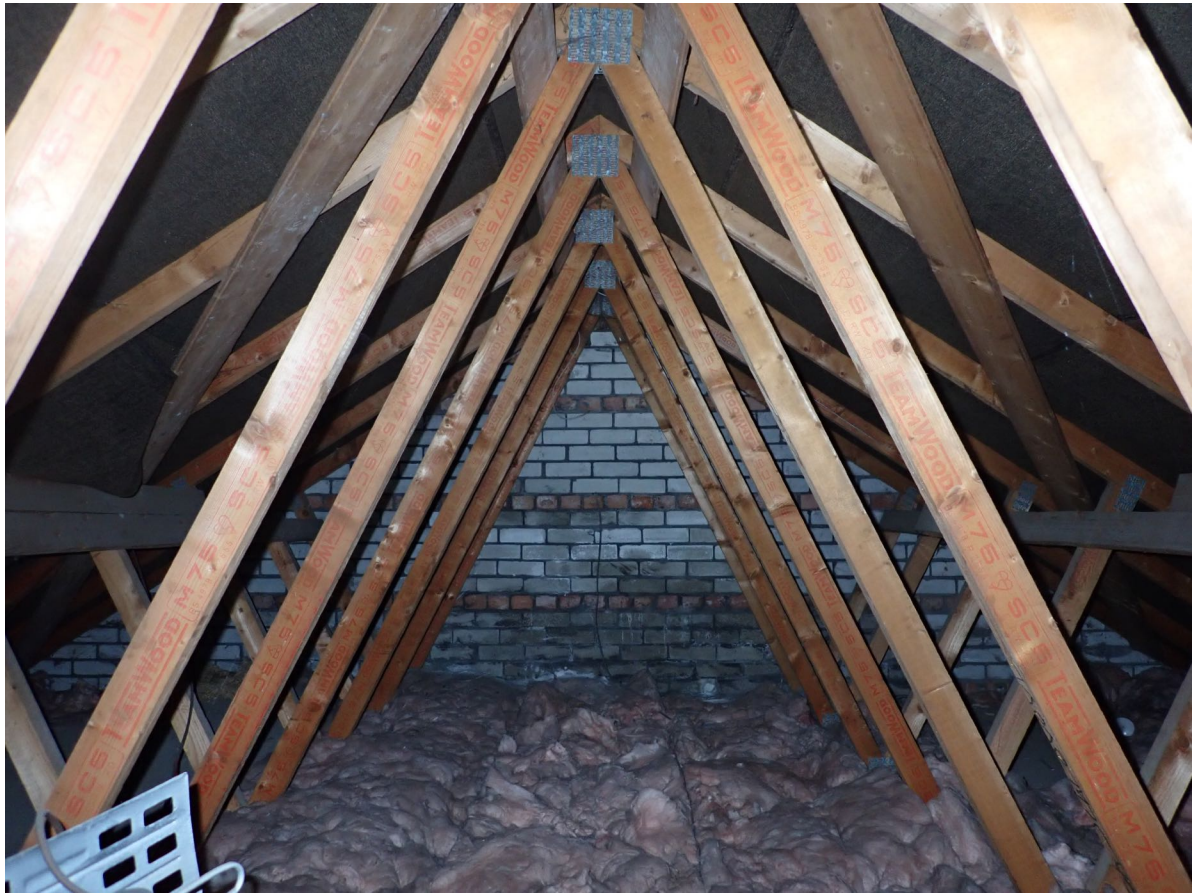
3.2a – The roof void.

The roof has a timber trussed structure, lined with bitumen felt, and insulated with mineral wool between the ceiling joists. The roof lining is in good condition with no tears, or gaps.

The wall cavity has been filled with insulation and was inspected at the wall plate using an endoscope. There are no gaps at the wall-plate; and there are no gaps which give direct access to the roof void from the outside. Boxed soffits open into the roof void and were inspected from above.

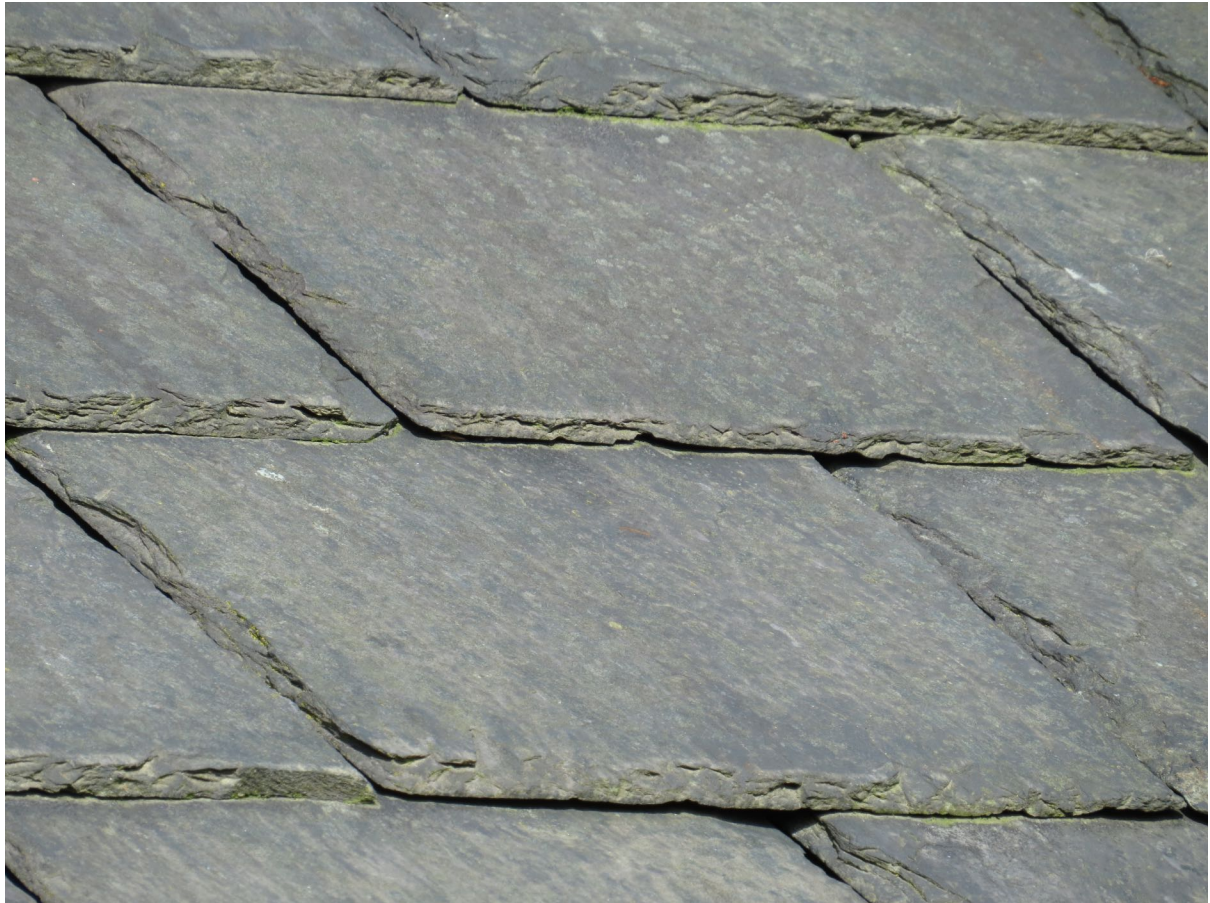
Roof and ridge tiles are in good condition; ridge tiles are sealed with cement. There are no gaps between roofing materials which are likely to be used by roosting bats.

3 – Roof tiles are in good condition with no suitable gaps.

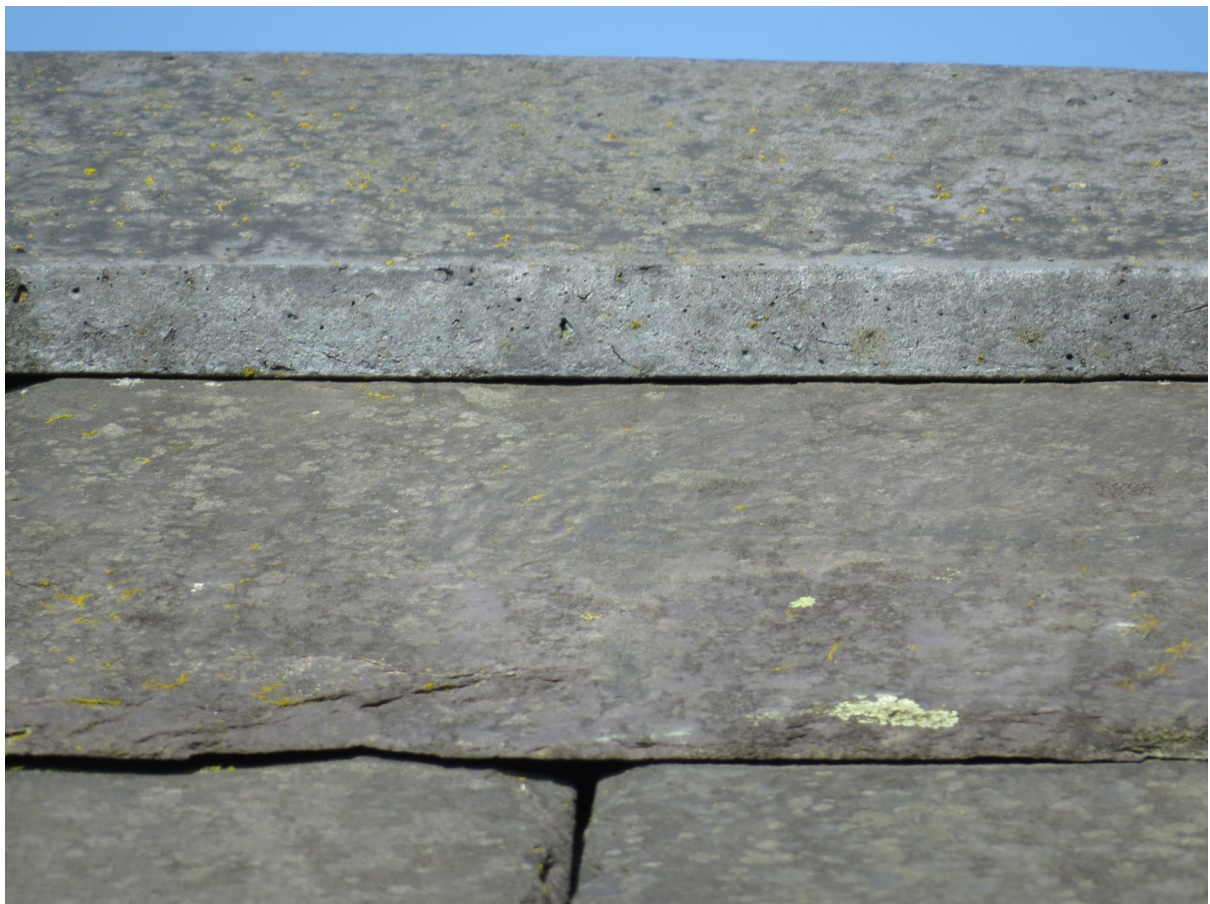
4 – Ridge tiles are laid tightly against roof tiles.

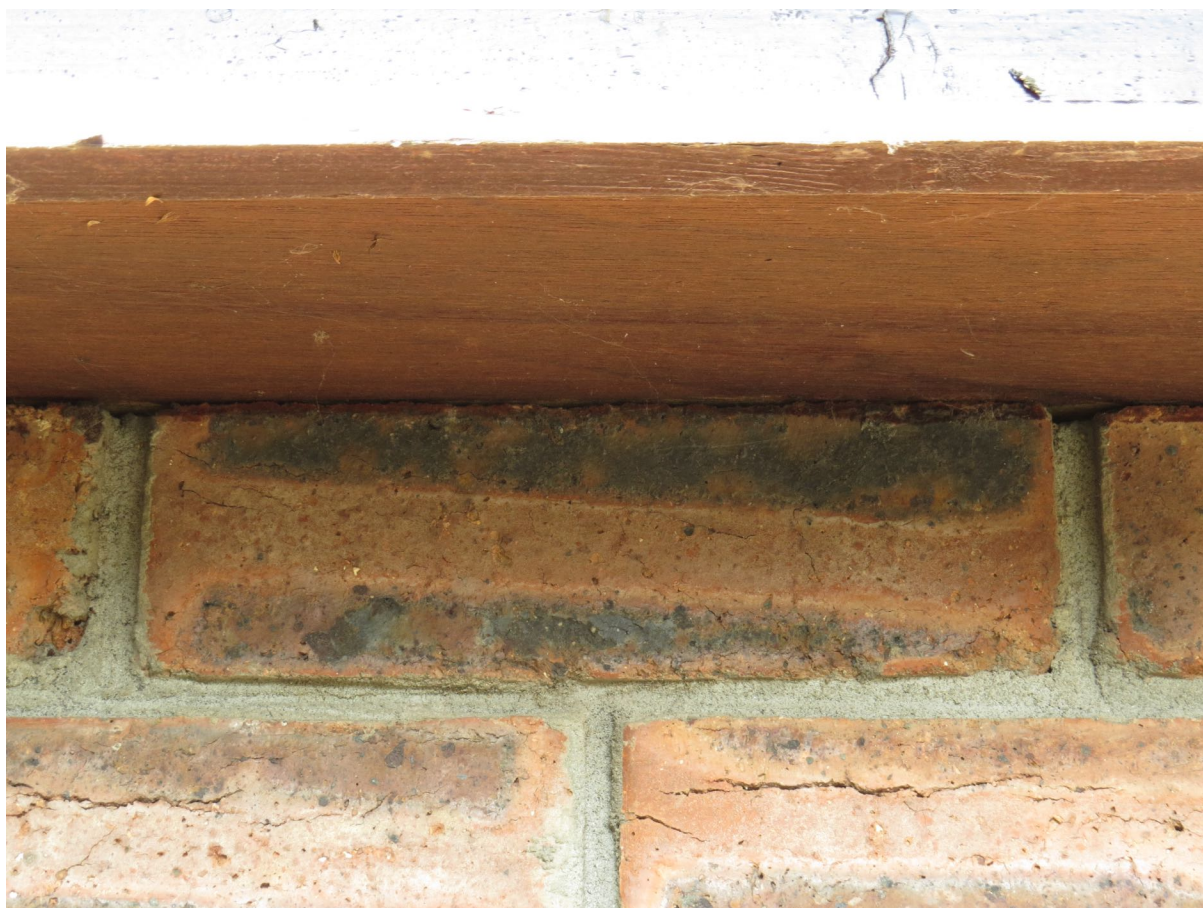
Timber fascia boards and boxed soffits at the eaves are fixed tightly against brickwork, with no suitable gaps; wall cavities and boxed soffits open into the roof void, and were inspected from above.

5 – Timber soffits and fascia are fixed tightly against brickwork.

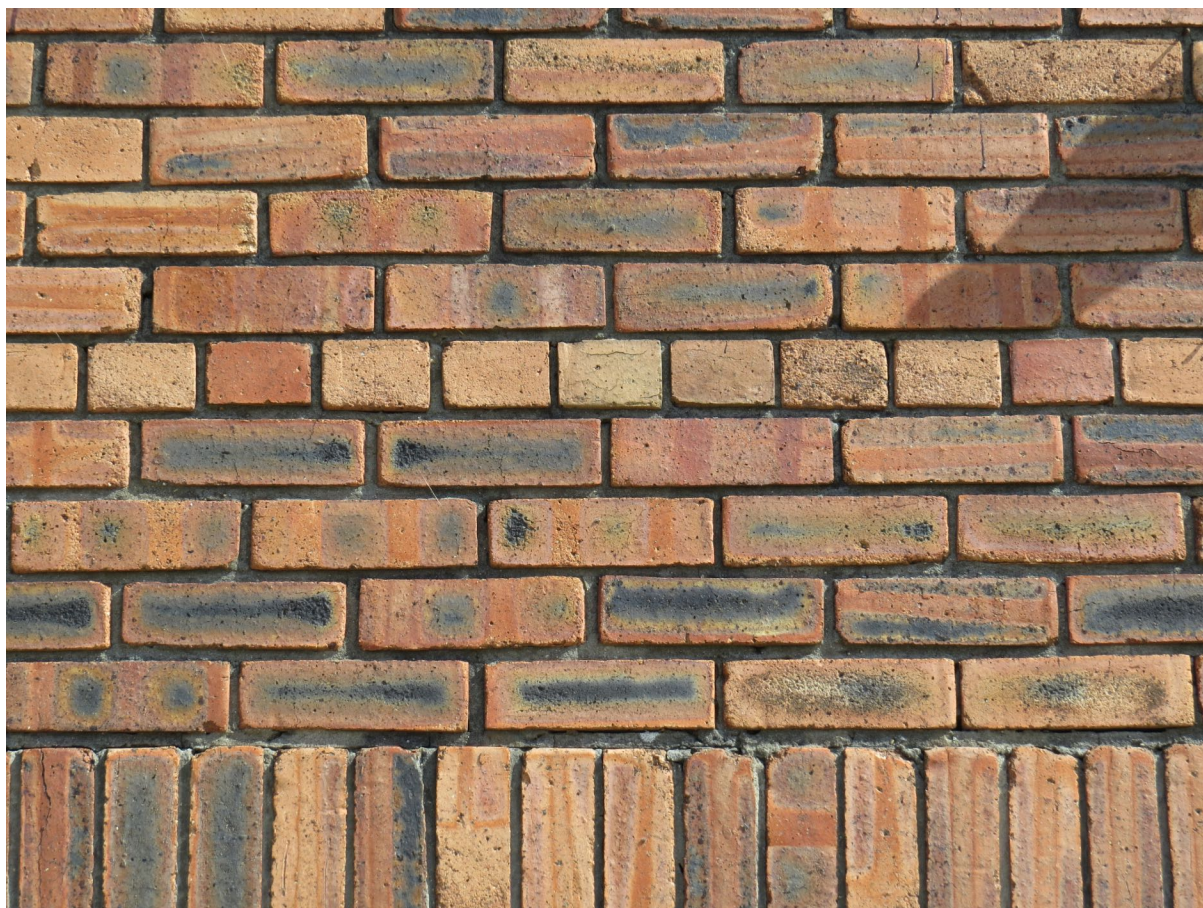
Walls are brick with an insulating cavity. The wall cavity has been filled with insulation. Walls are in good condition, with no cracks, or missing mortar which could be used by crevice dwelling bats.

6 – Brickwork and mortar are in good condition with no suitable gaps.

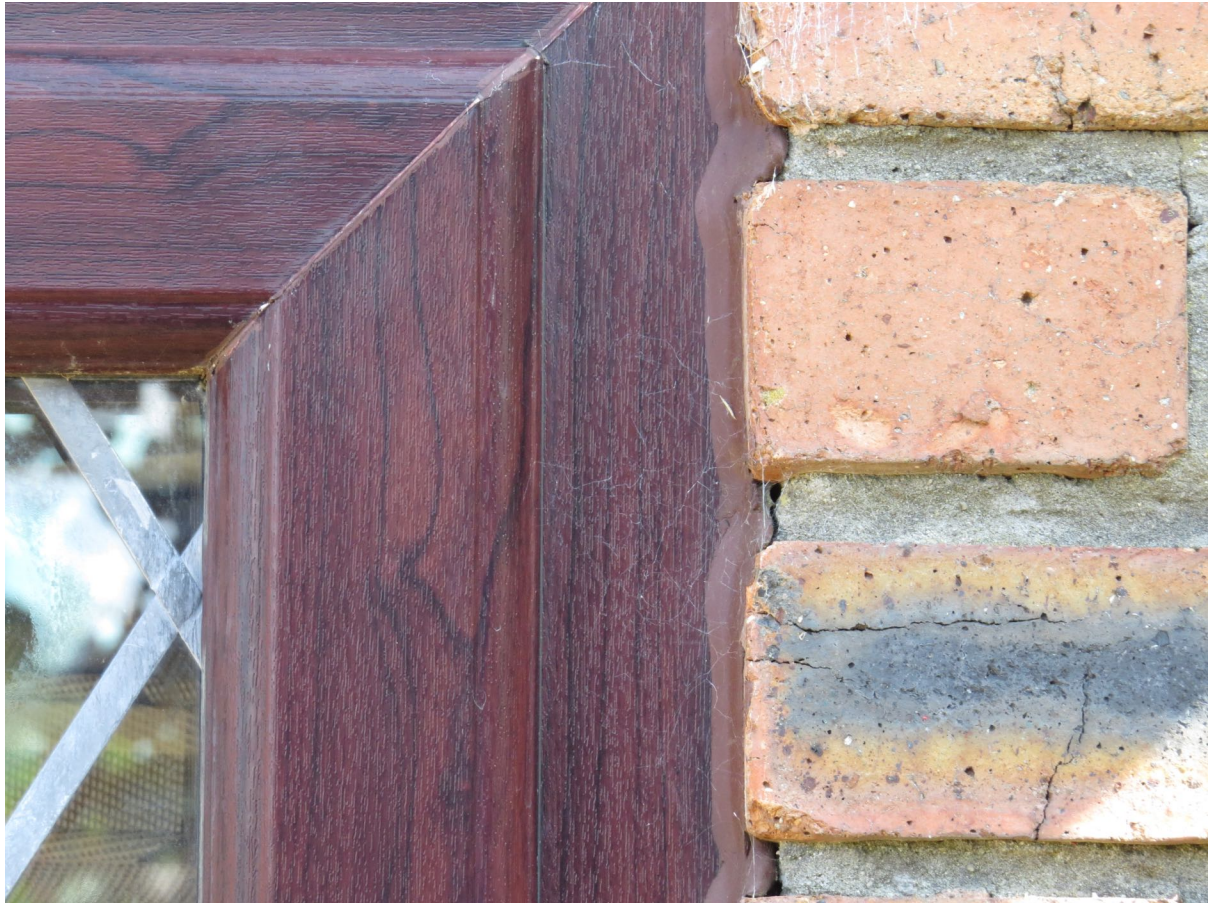
Window and door frames are fixed into the brickwork, gaps are filled with sealant, and offer no suitable roosting opportunities.

7 – Window and door frames are tightly sealed into brickwork with no suitable gaps.

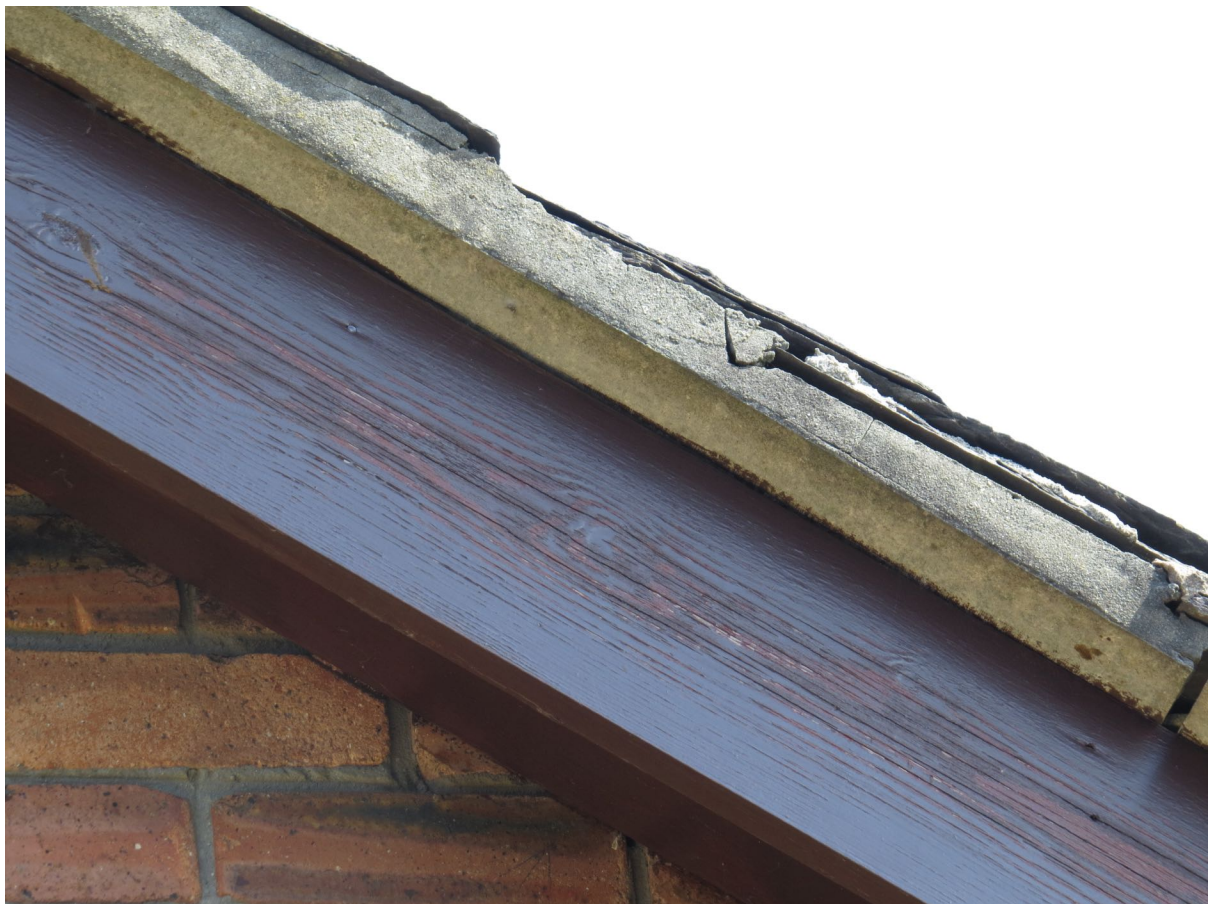
Minor areas of missing cement at the verges were inspected in detail using an endoscope. These areas are filled with dust and cobwebs, and no indications of use by bats were present.

8 – Verges are sealed with cement minor gaps were checked using an endoscope.

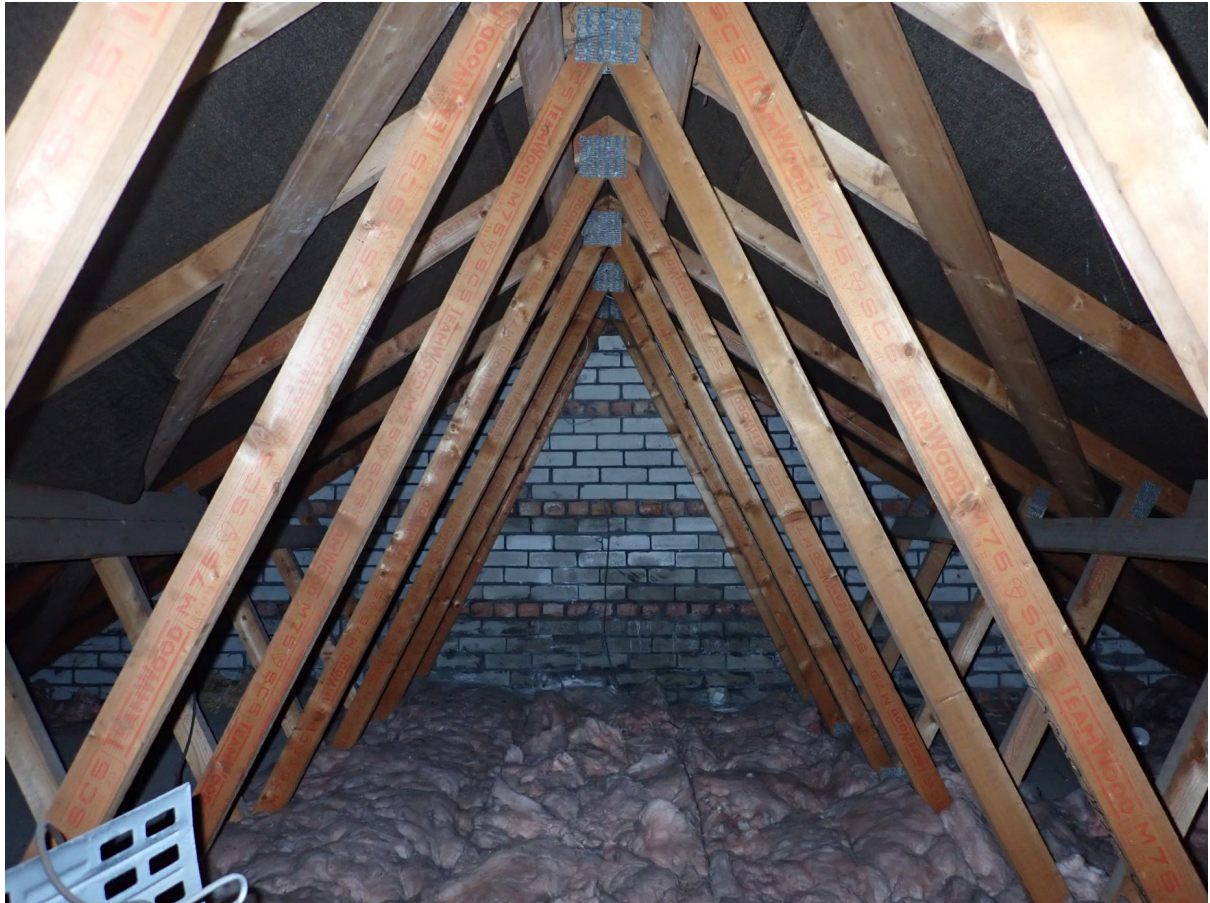
The building has a single roof void, which is not used for storage, and accessed infrequently for essential maintenance.

9 – The annex has a single roof void which is not used for storage.

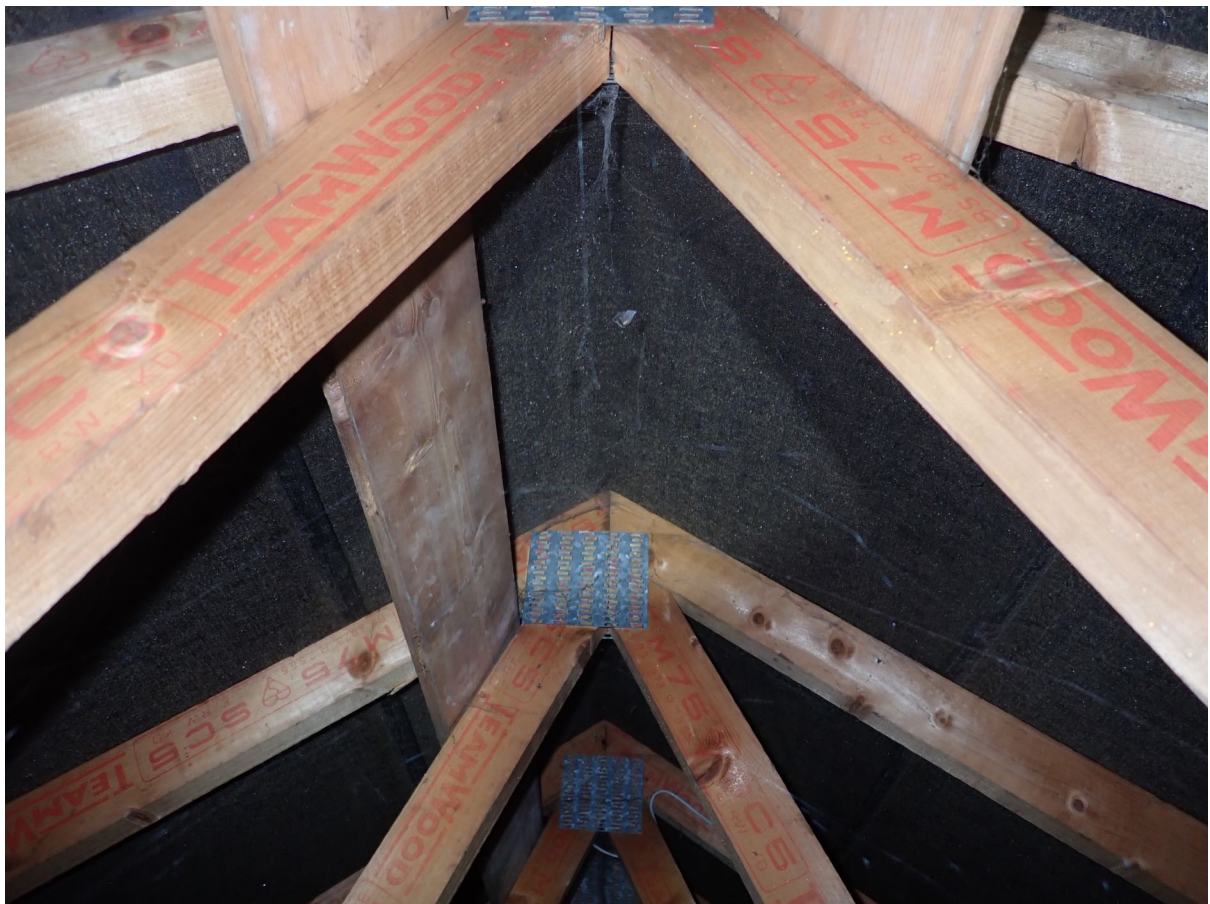
10 – Roof lining is in good condition with no gaps or tears.

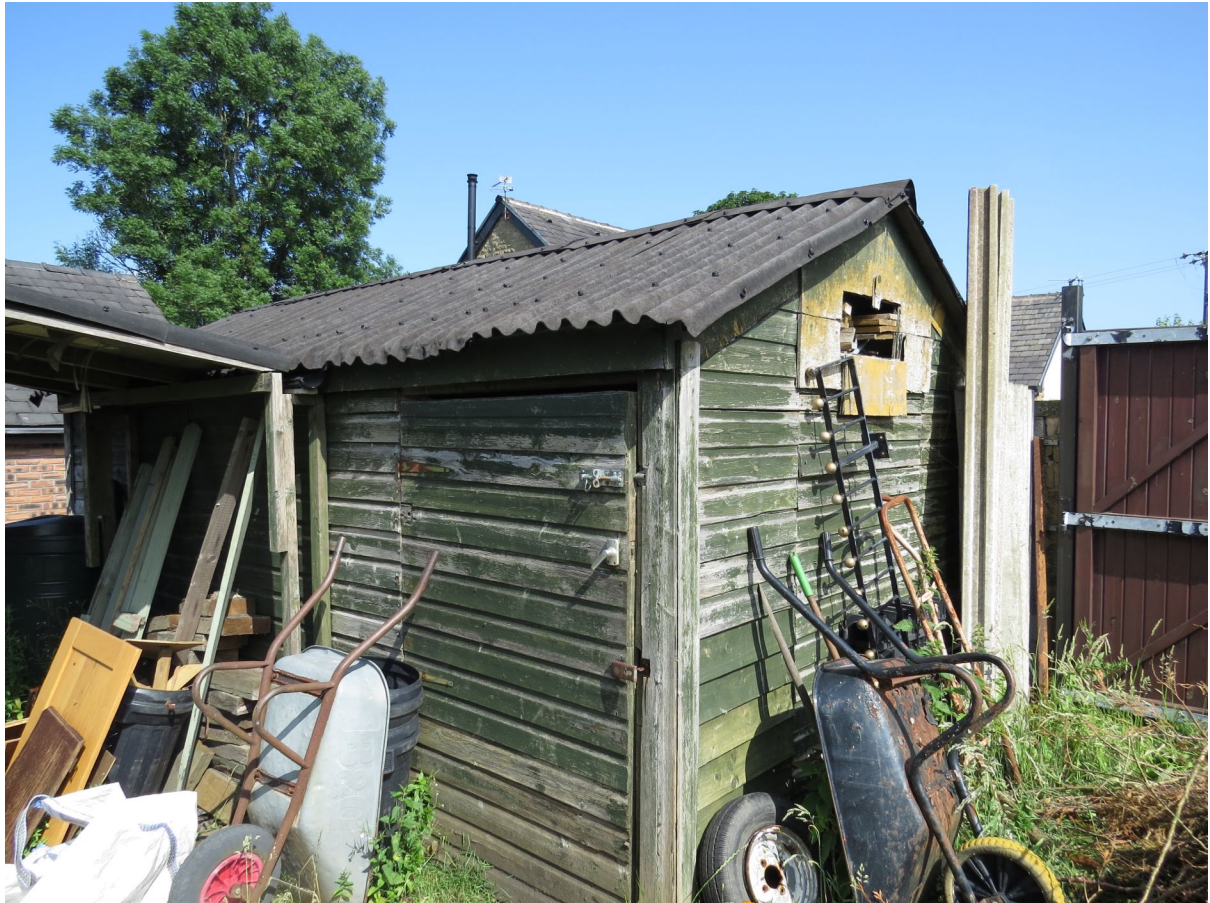
The timber outbuilding has a pitched roof covered with corrugated bitumen roof sheets. Walls are a single layer of shiplap boards, around a simple timber frame. The building is in daily use as a store for garden tools, and has no internal voids or crevices which are likely to be used by roosting bats.

11 – The timber outbuilding has a bitumen sheet roof and single layer boarded walls.

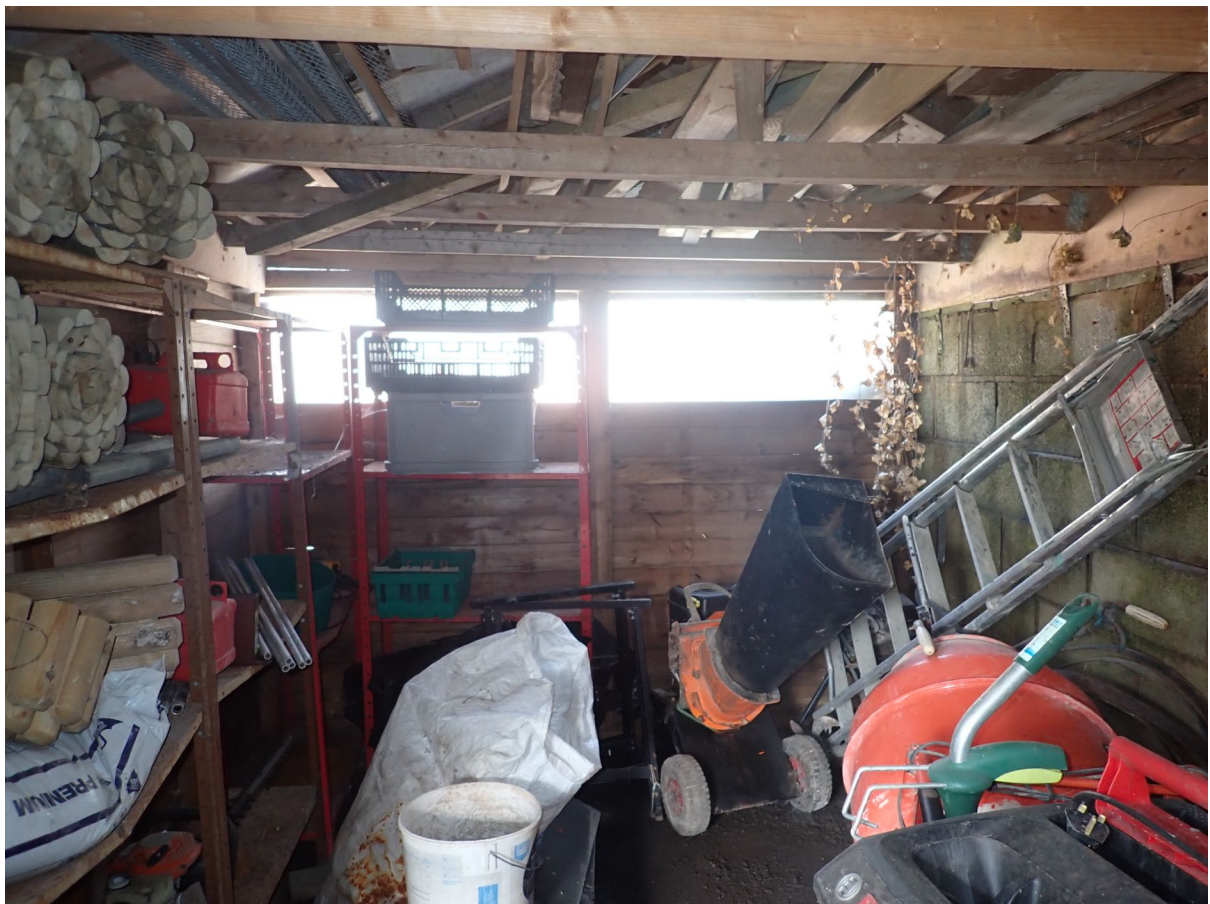
12 – The building has no internal voids, or crevices which could be used by roosting bats.
