# **Site Tree Appraisal**

***Former Texaco Garage, Bury Old Road, Prestwich M25 0EY***

**‘BS 5837 2012: Trees in Relation to Design, Demolition and Construction – Recommendations’**

Date: 24<sup>th</sup> July 2023  
Ref: RTS/24072023 002  
Revision: 002

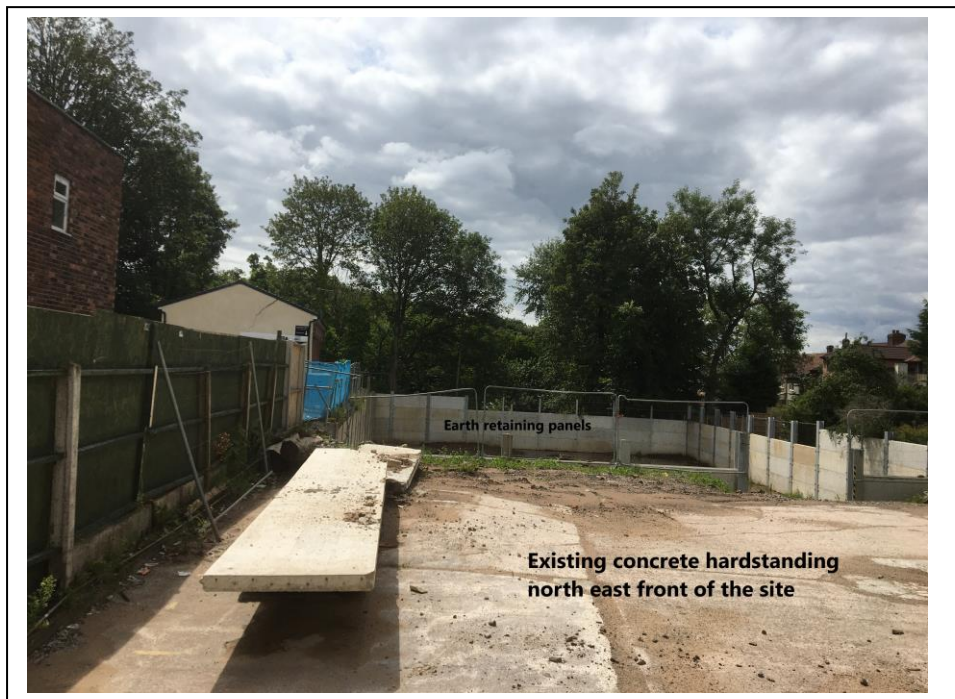
Photo 01:

- 2.1 Site visit:** I carried out an unaccompanied site visit on 24<sup>th</sup> July 2023. All my observations were from ground level without detailed investigations and I estimated all dimensions unless otherwise indicated. The weather at the time of inspection was dry and clear with good visibility.
- 2.2 Brief site description:** The site is the location of the former Texaco Garage on Bury Old Road. The garage has long since been demolished and the site is now derelict. The north east side of the site, frontage adjacent to Bury Old Road, is existing hardstanding covering an area of approximately 650 square metres. The rear south west half of the site has a significant level drop of approximately 2 metres. The rear of the site has recently been surfaced skimmed and had concrete earth retaining panels installed along three sides, (photo 01).
