**Highway**  
**Dilapidation Survey**  
**East Lancs Papermill, Radcliffe**

Location: ELPM, Radcliffe, M26 2PS

A road condition survey was carried out on the adopted roads surrounding the proposed site on Pollitt St, Howard St, Cross Lane and Rectory Lane. The purpose of the inspection is to provide a report on the current condition of the highway prior to construction work commencing on the adjacent land.

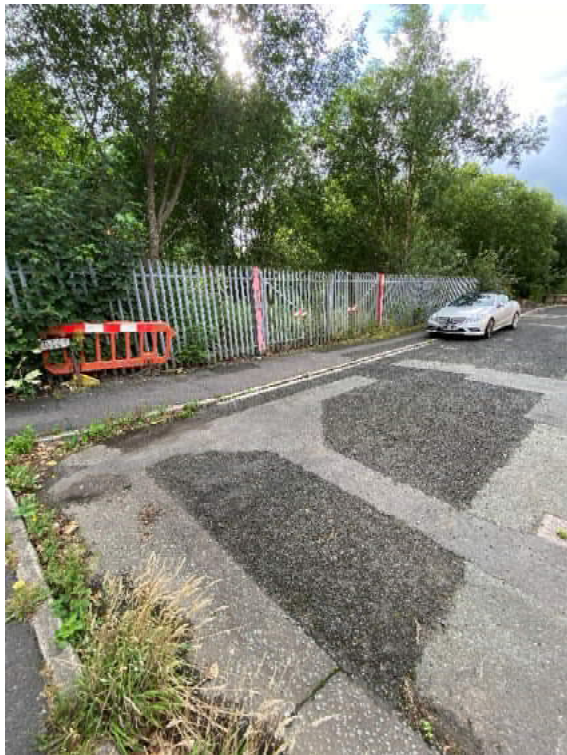
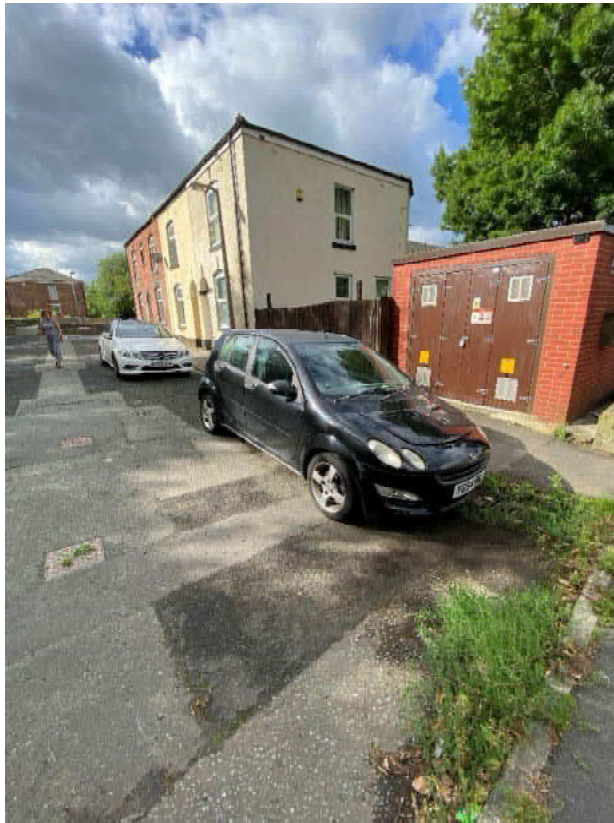
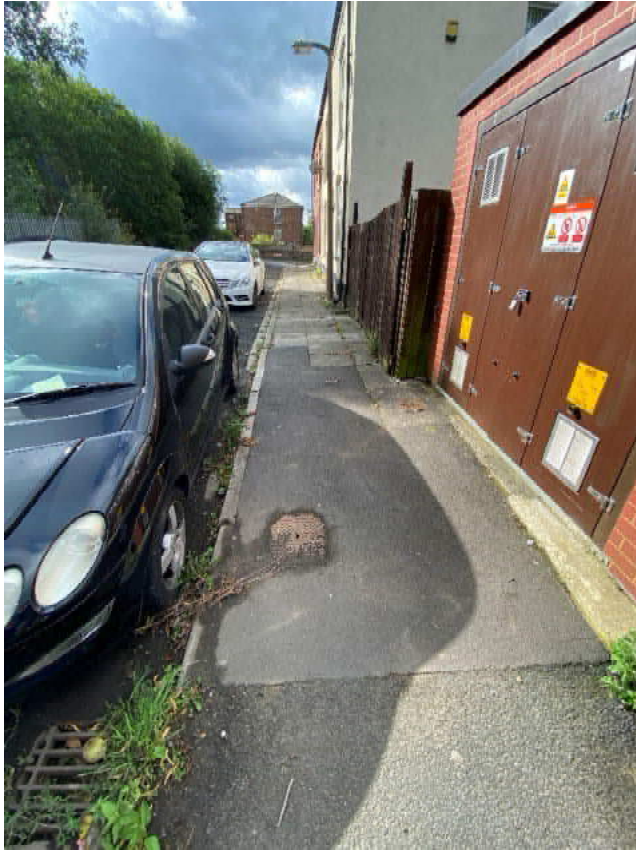
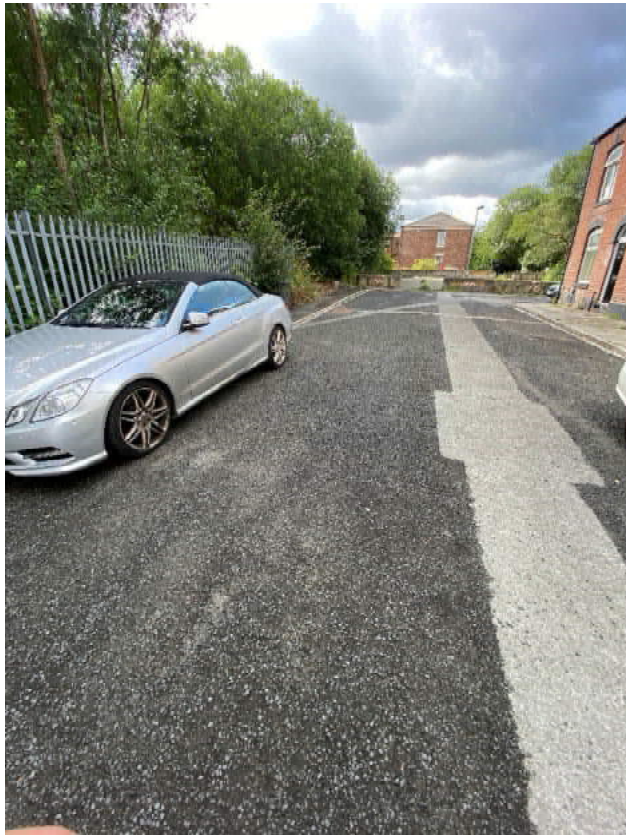
### **Pollitt Street**

Both tarmac & concrete flagged surfaces throughout uneven, both roads & footpaths in very poor state of repair, numerous road opening scaring, kerbs in poor repair, vegetation growing in numerous locations including gullies, gullies full of debris. Ironworks dropped, vegetation growing & server surface wear & tear.

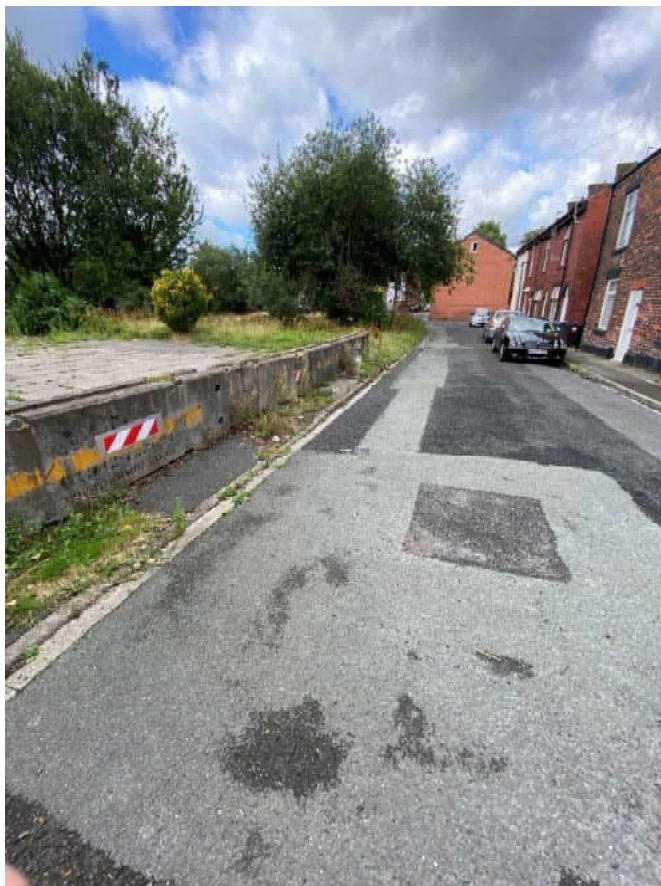
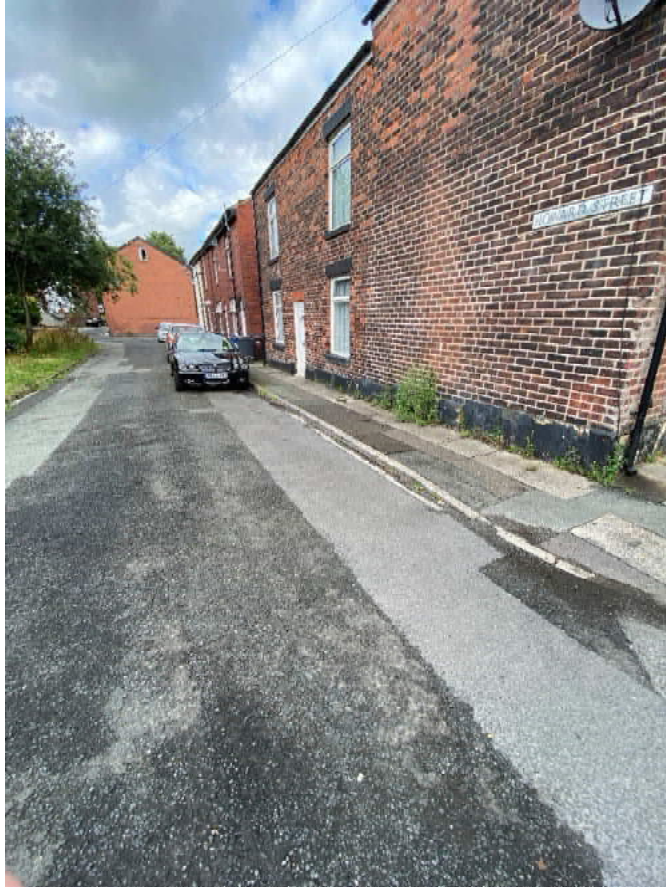
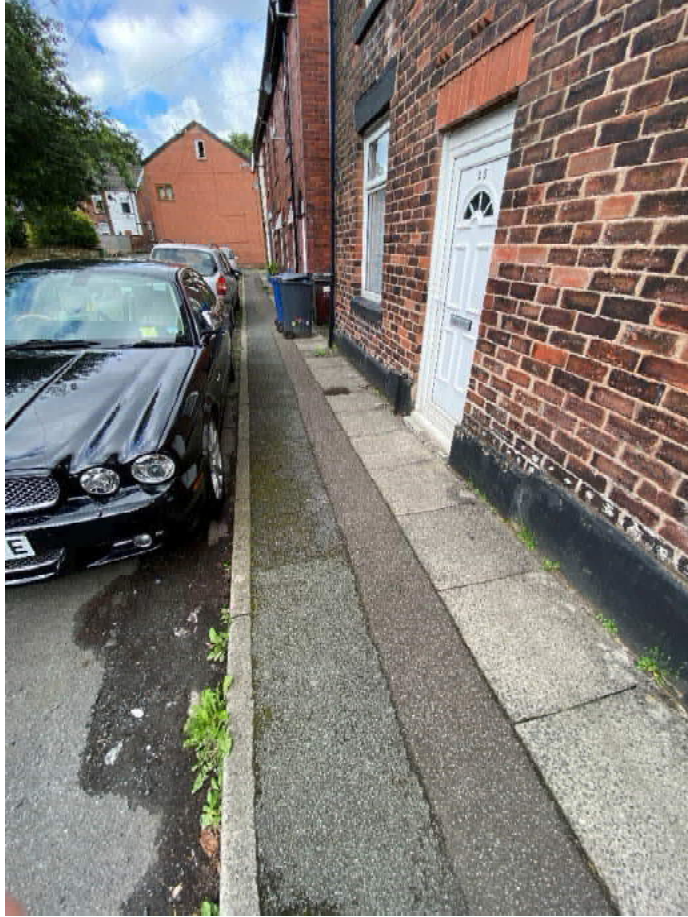
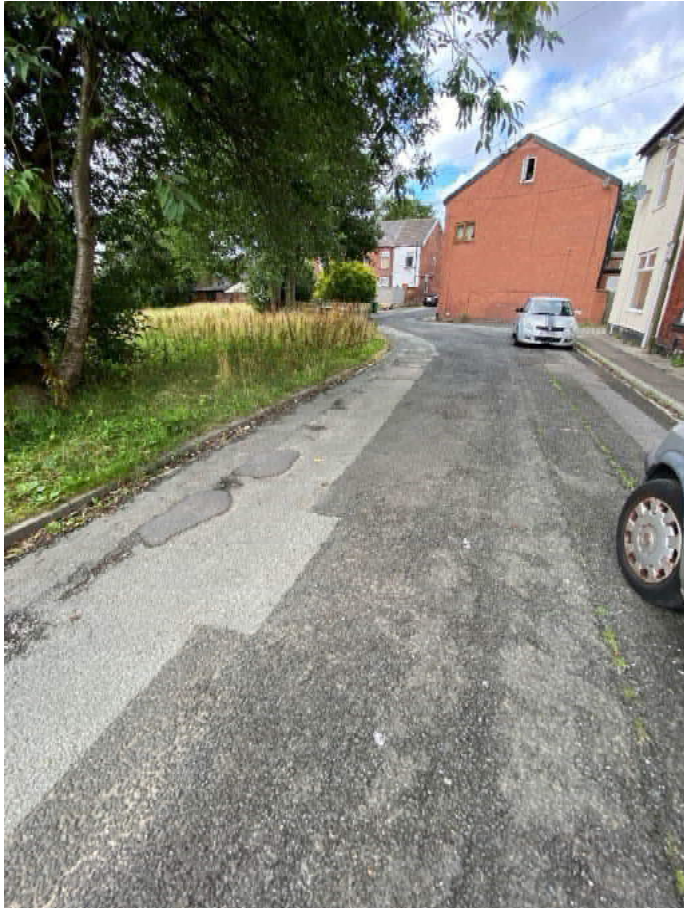
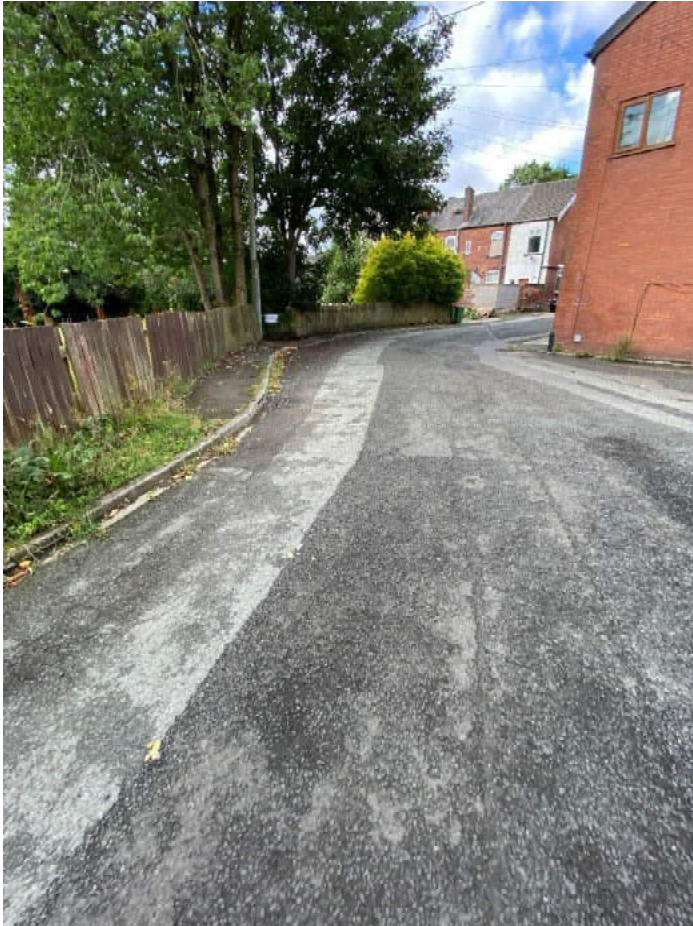
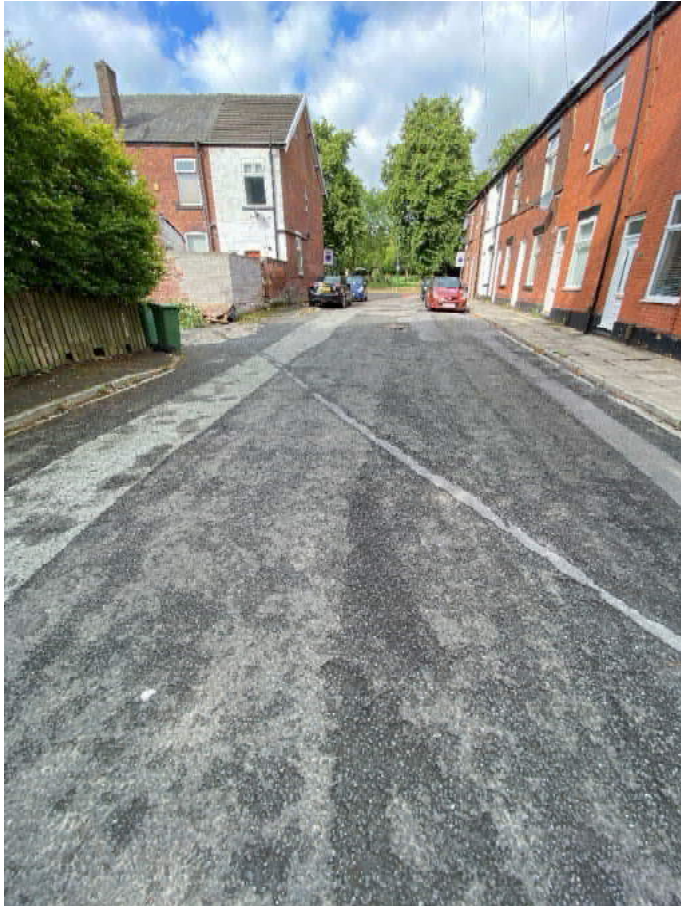
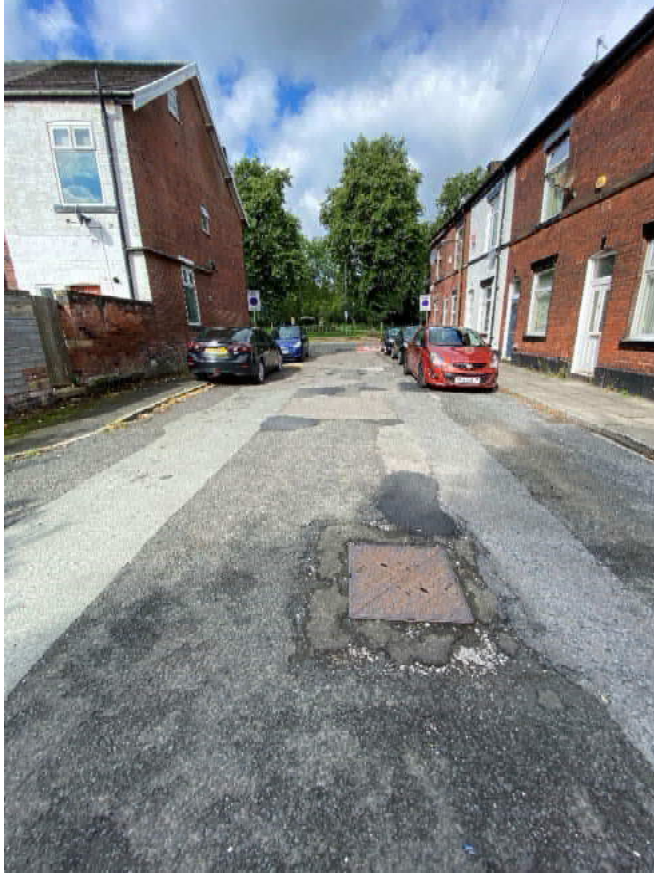
## Howard Street

Both tarmac & concrete flagged surfaces throughout uneven, both roads & footpaths in very poor state of repair, numerous road opening scaring, surface thinning in various locations, surface worn down to cobbles, kerbs in poor repair, vegetation growing in numerous locations including gullies, gullies full of debris. Ironworks dropped, vegetation growing & server surface wear & tear around manholes.

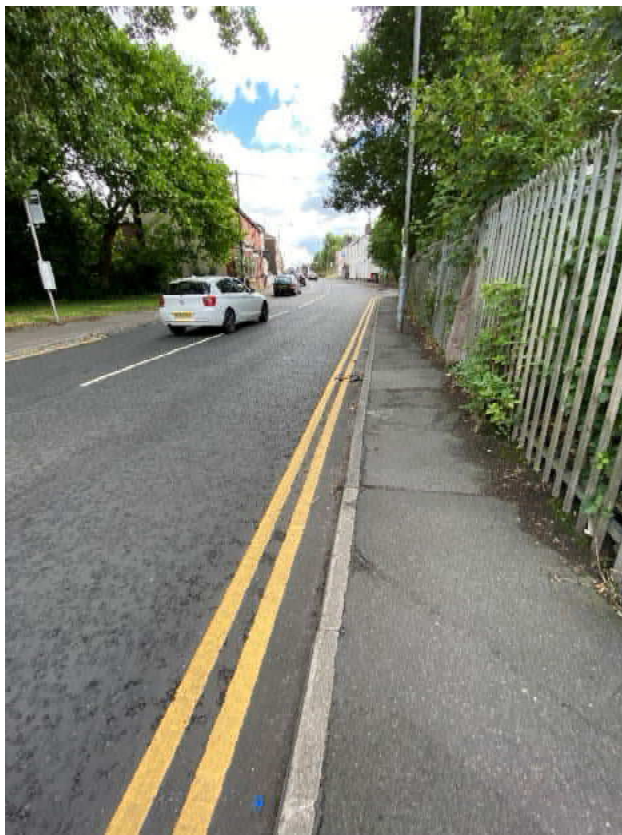
### **Cross Lane**

Road surface in fair condition. Footpath surface uneven and in poor state of repair. Various repair scars & damage. Kerbs generally in good repair although worn with damage. Vegetation growth to edge of footpaths.

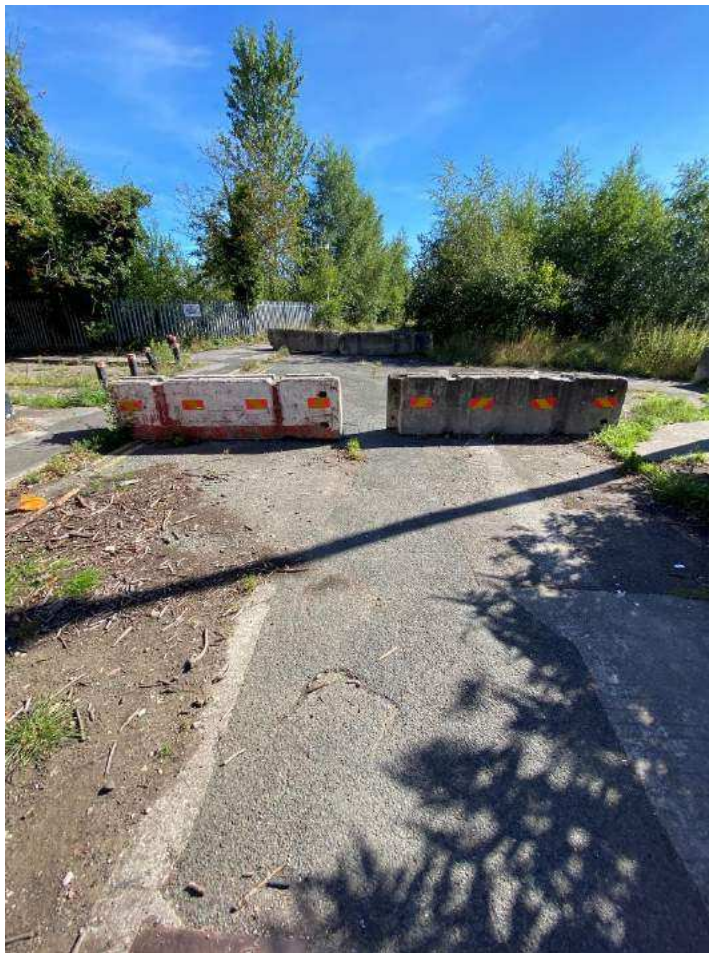
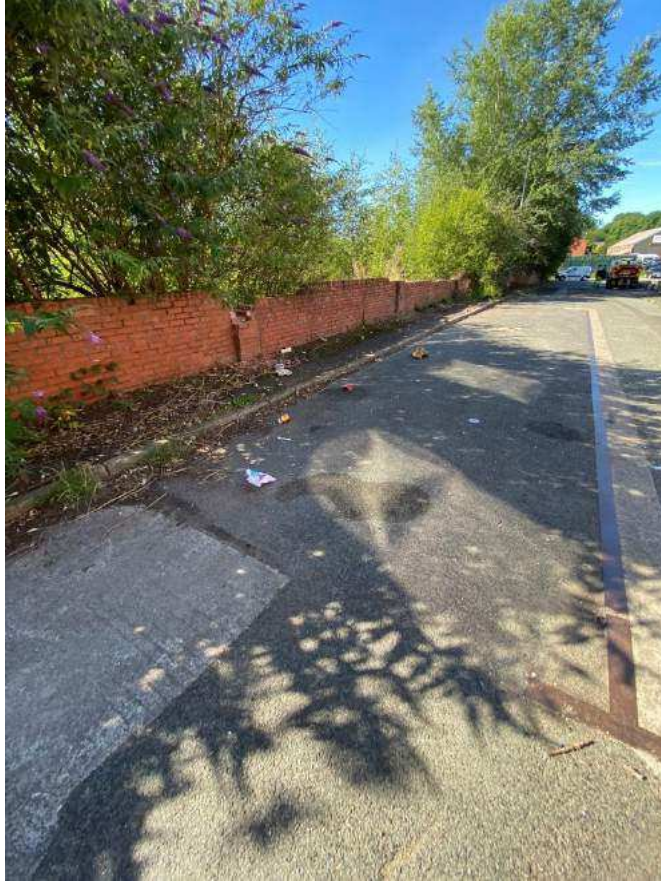
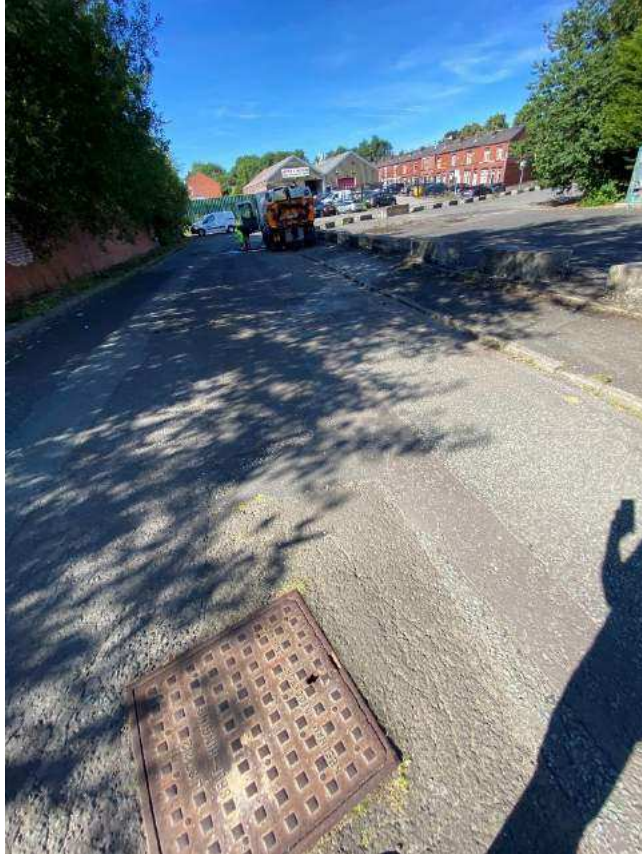
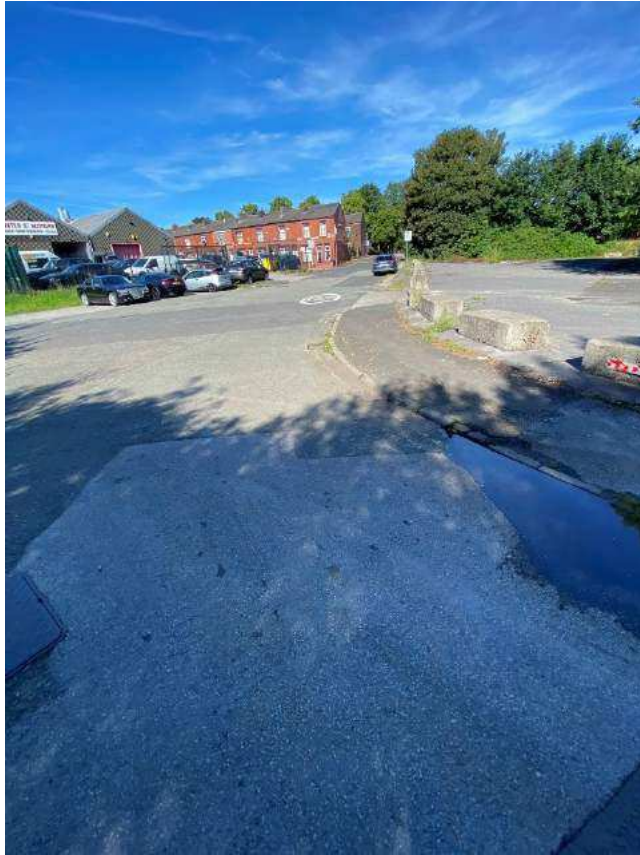
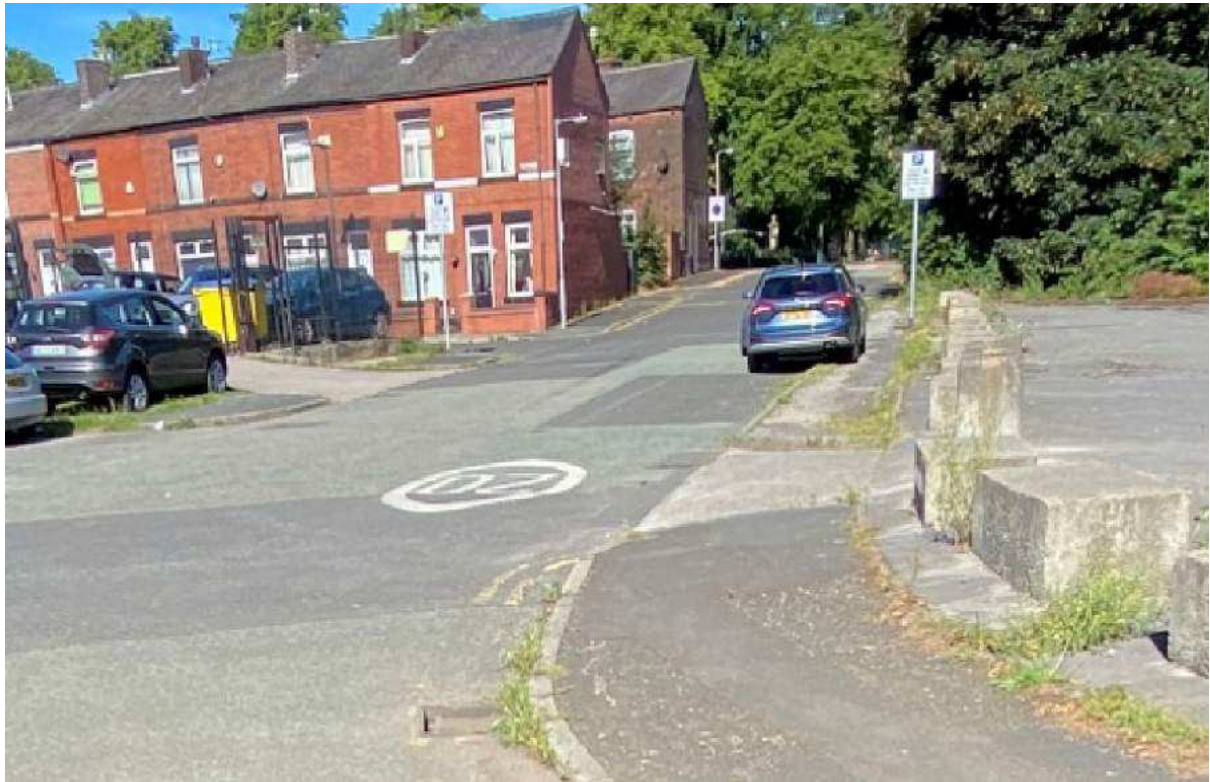
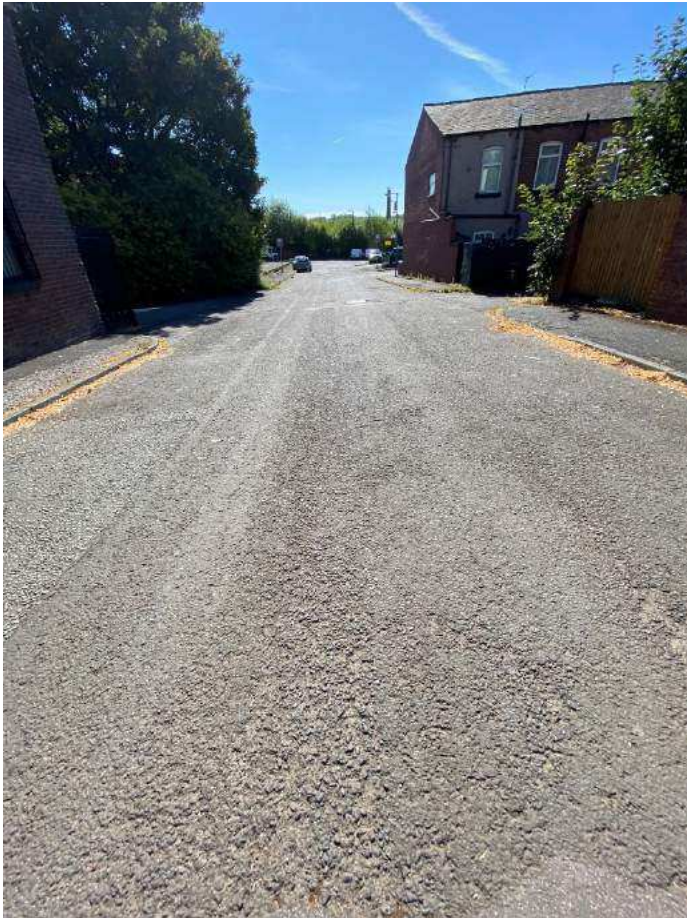
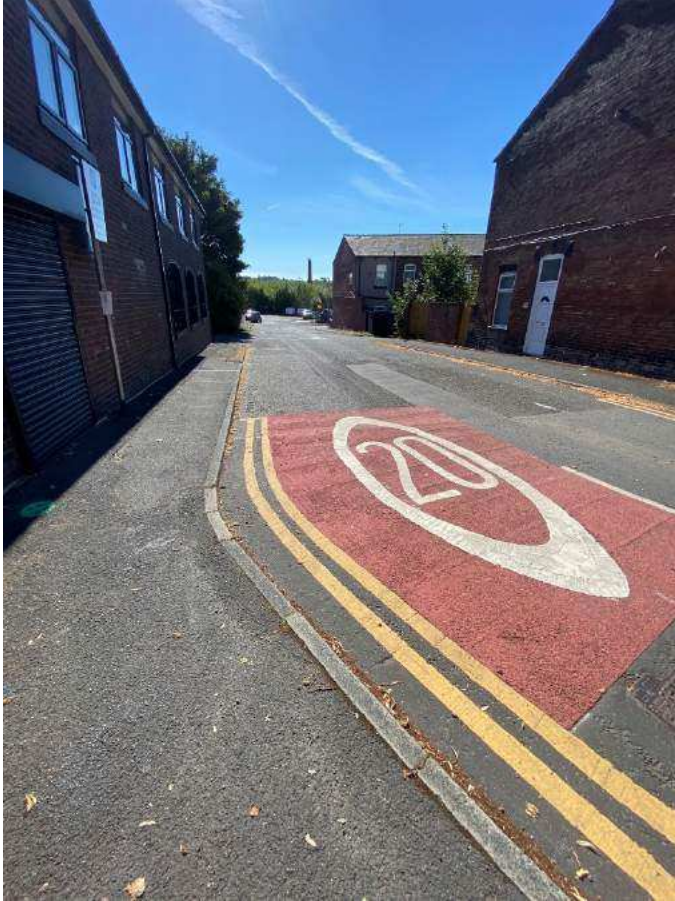
## **Rectory Lane**

Multiple road surfaces consisting tarmac & concrete throughout in very poor state of repair, numerous road opening scares, surface thinning in various locations, surface worn down to cobbles, kerbs in poor repair, large amounts of vegetation growing throughout on footpaths and in the road including gullies, gullies full of debris. Ironworks dropped, vegetation growing & server surface wear & tear around manholes. Yellow lines barely identifiable and in poor state. Pooling water located outside UUs land and road severely damaged.
