## 2.0 Inspection

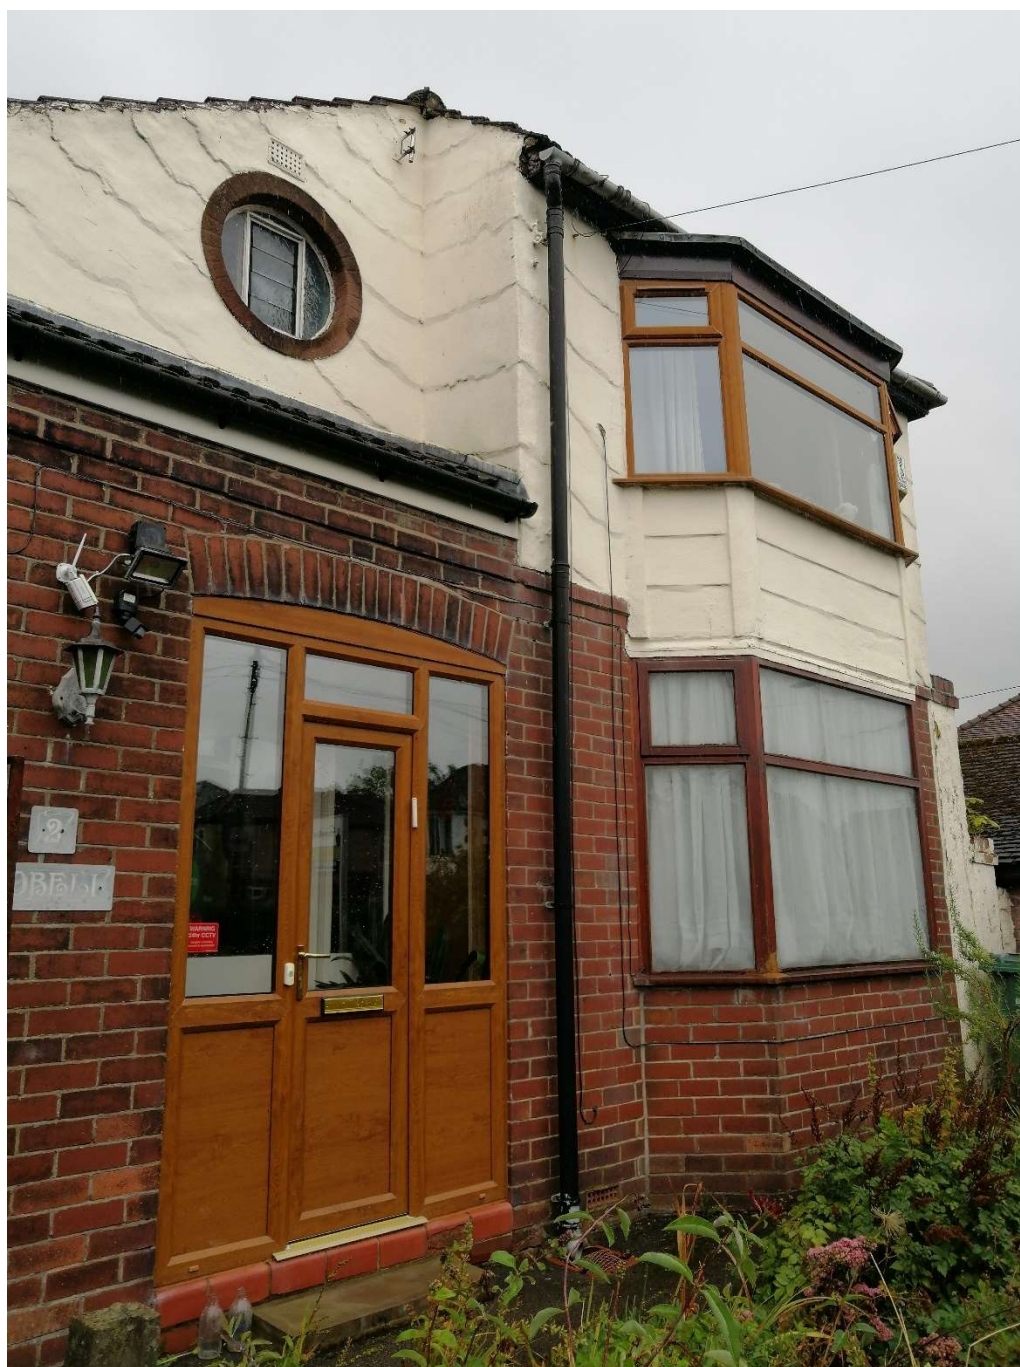
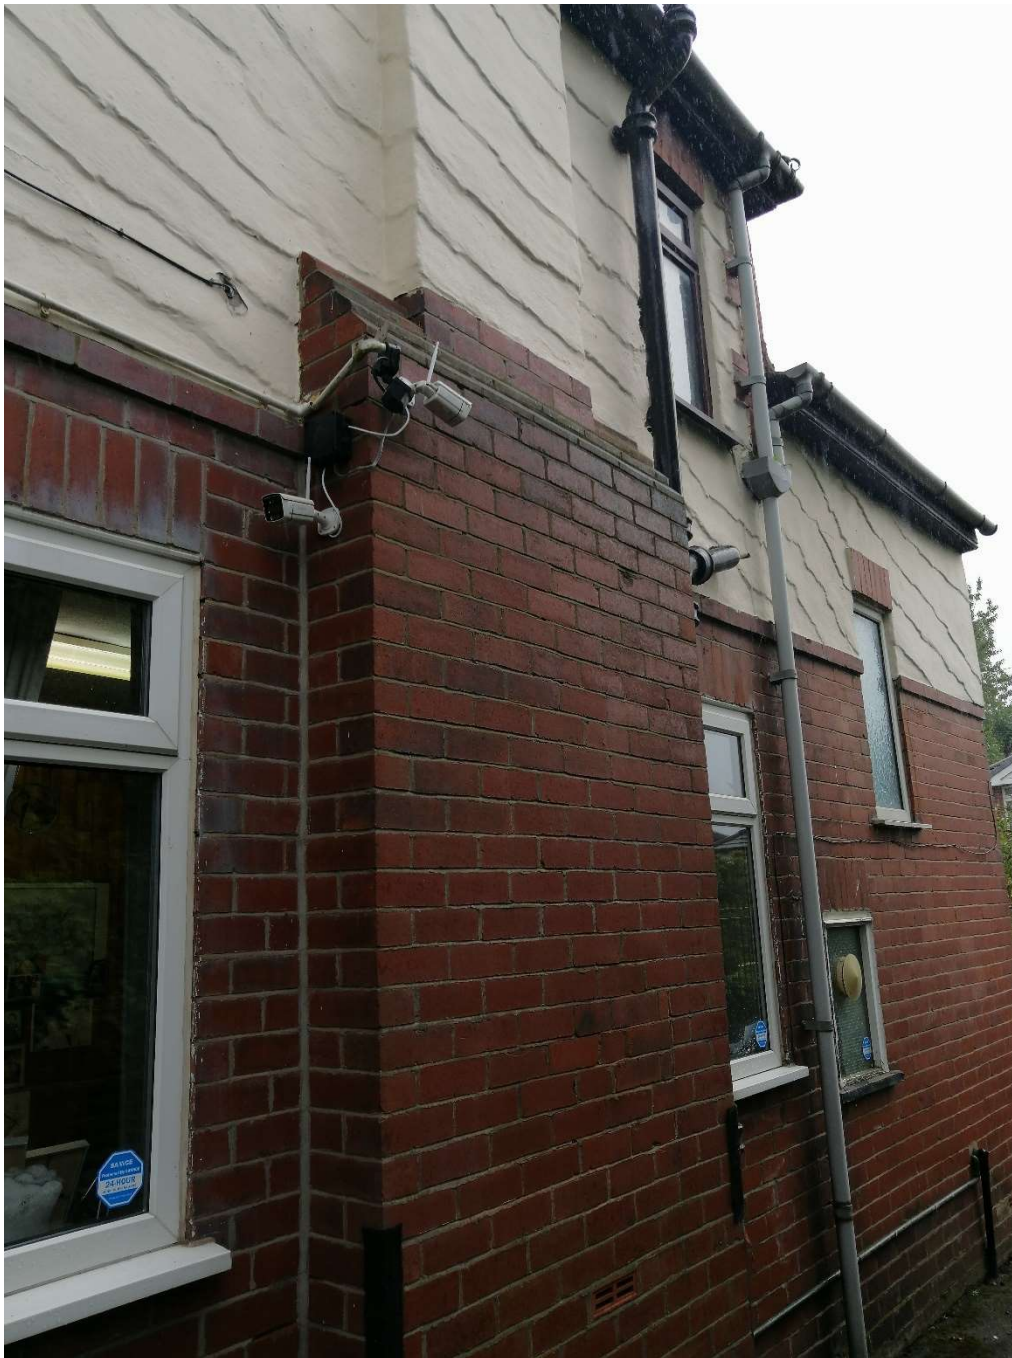
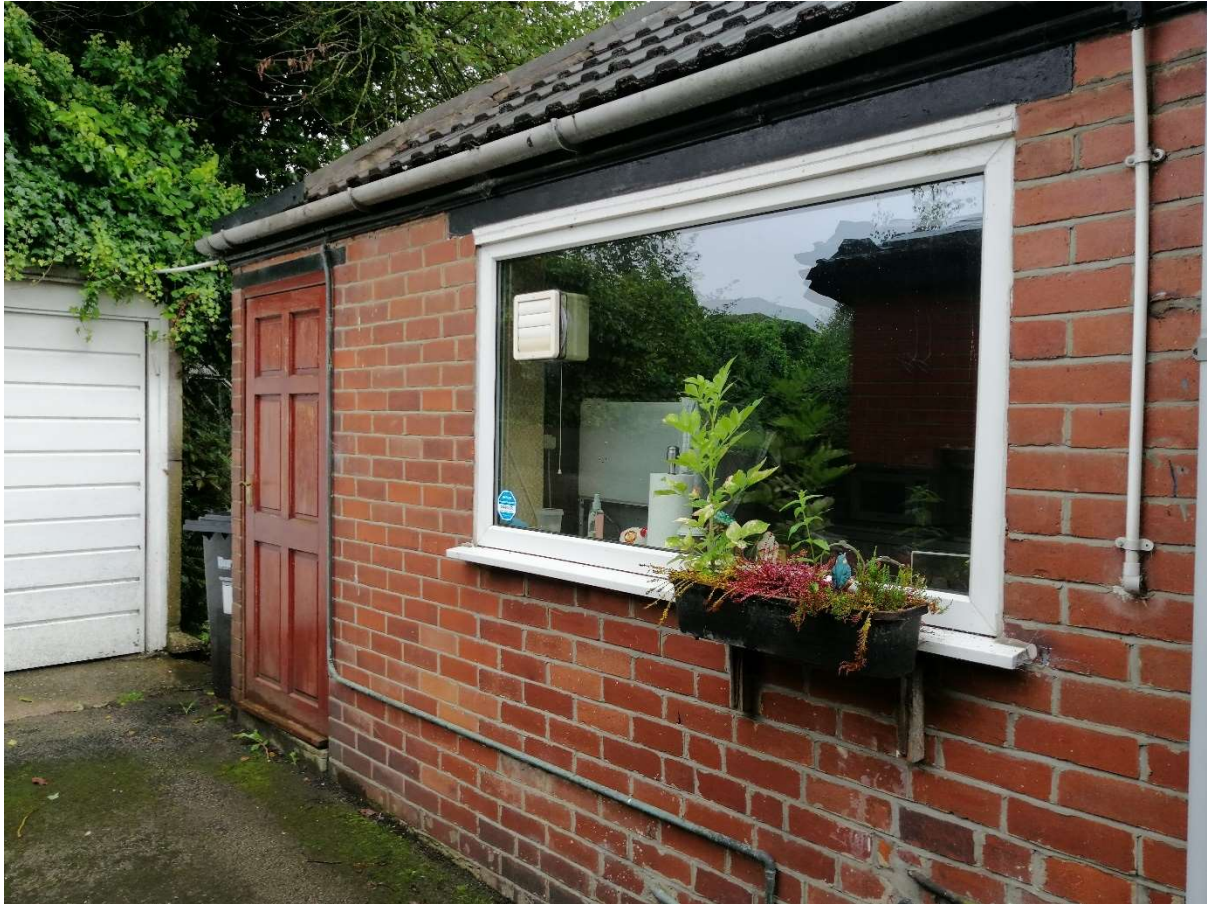
The front and Northeast elevations were in exposed brickwork at ground-floor and rendered on the top floor and no issues were observed in terms of cracking or movement (Photos 1, 2 & 3).

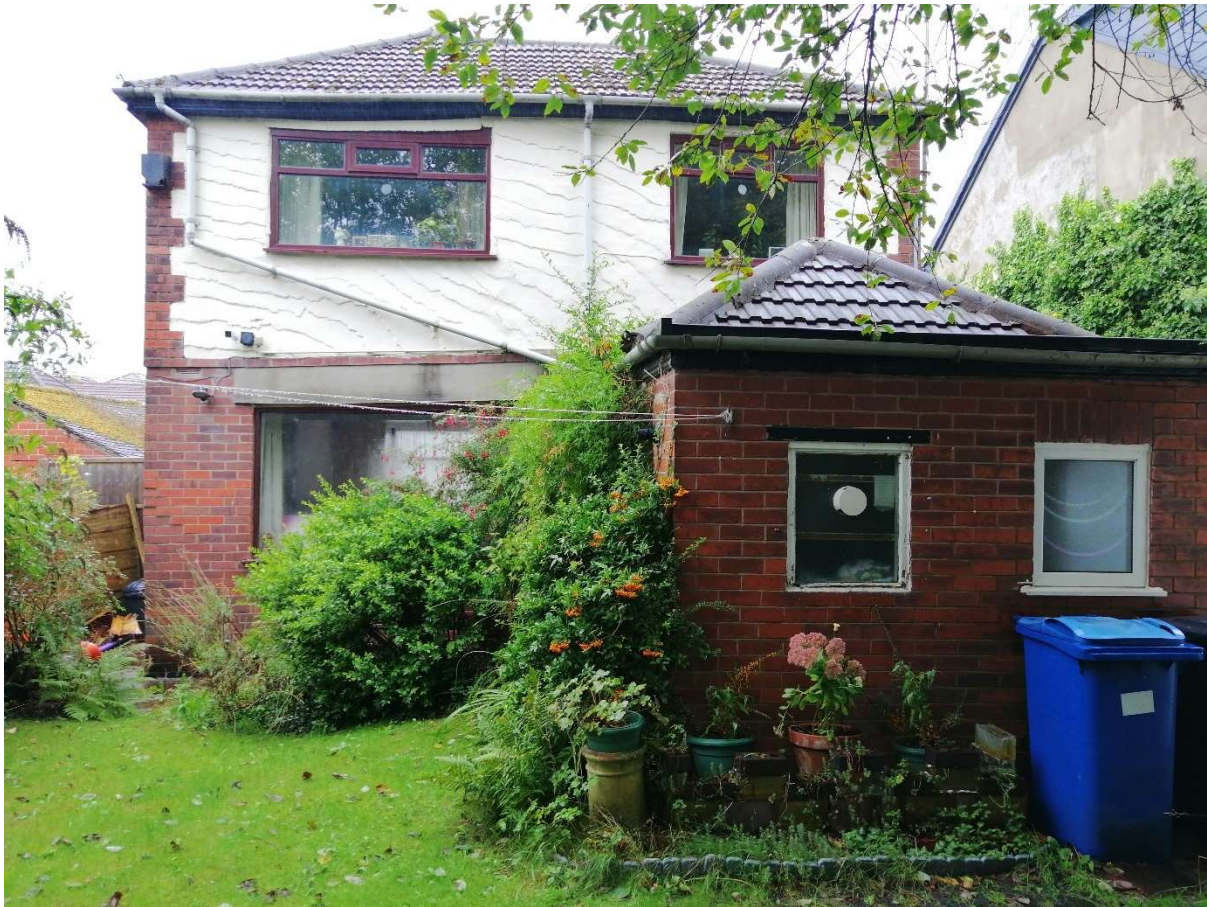
Photo 4

The rear elevation of the property consists of the rear of the main structure and the rear and side of the outrigger (Photo 4).

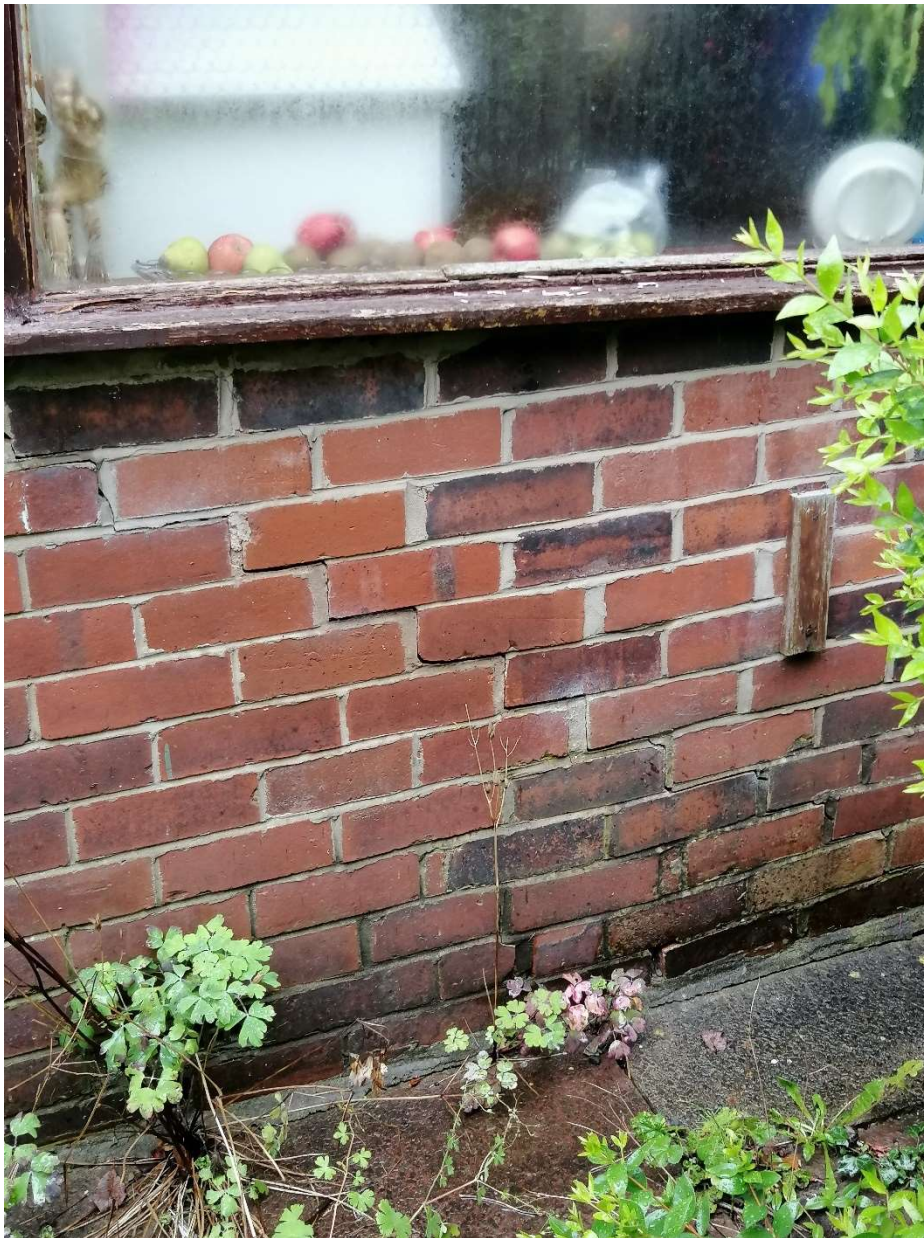
Photo 5

Stepped cracking was observed below the opening at ground-floor (Photo 5), which suggests movement to the corner of the property. It was noted some previous repair works to pointing on the rear elevation have been carried out, which have opened up slightly since then. To the left of the opening and the corner of the property, a few bricks appeared to be bulging out and further repair works have been carried out, with some masonry replaced.

There is a considerable drop in level to both the ground floor and first floor at 2 Windsor Road and the inspection suggests the rear elevation may have rotated out of plumb and the ground has settled under the foundations to the rear. However, it is difficult to confirm if this is now historic or potentially ongoing.

The fact that cracking is visible on the external walls after repairs to the masonry were carried out, suggests that the settlement may still be ongoing, although we have no information when such repairs were made. The cracking to the external walls should be monitored in the future.

It will not be possible to reinstate any previous movement or settlement to the walls and these should be made good as required.

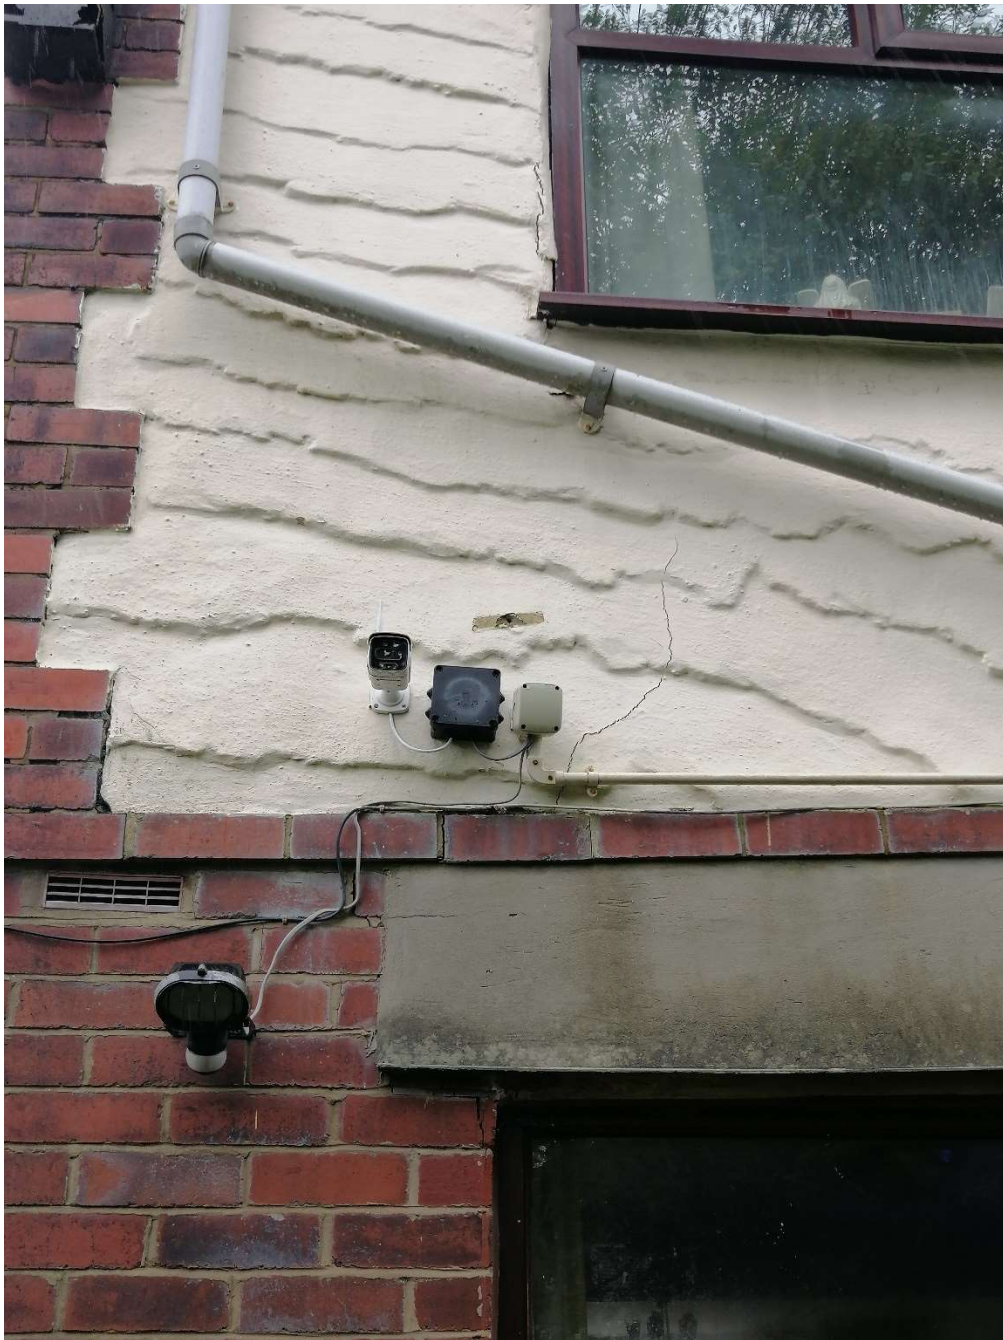
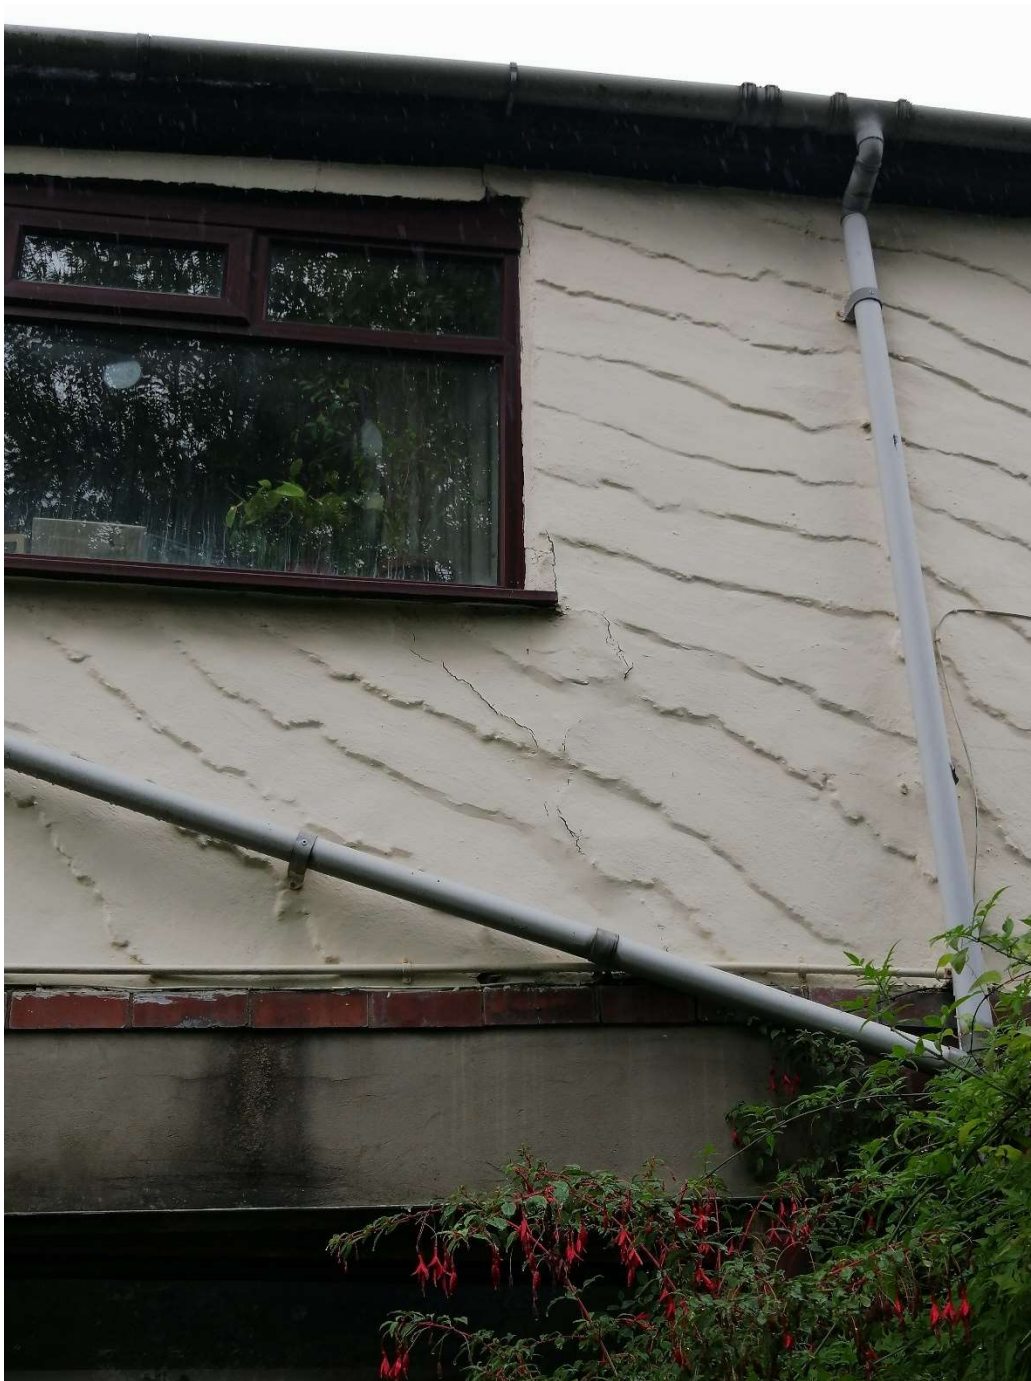
Above the opening, the concrete lintel looked to be leaning towards the corner of the property and cracking to the render was visible to both sides of the lintel (Photos 6 & 7).

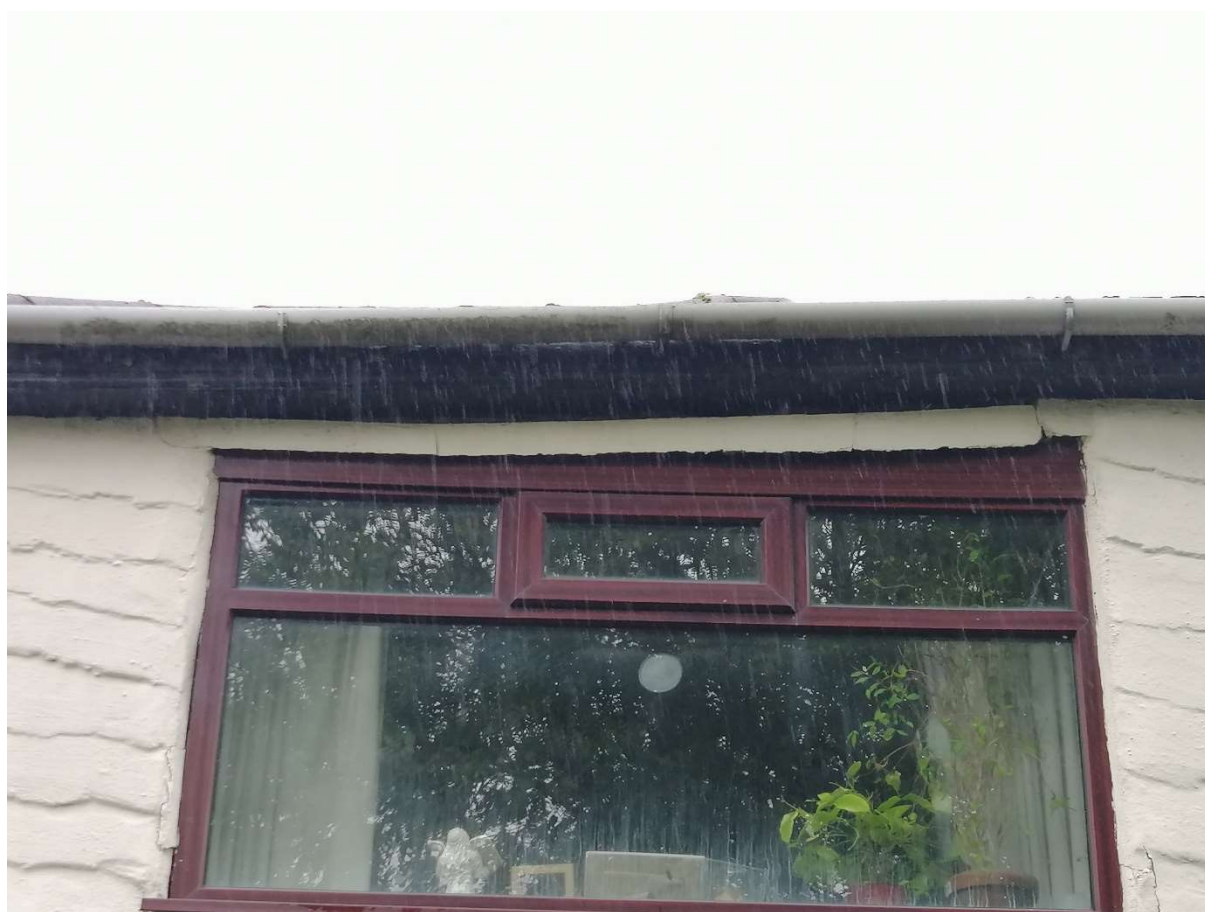
Photo 8

It was also observed cracking to the render above the first-floor window in various locations (Photo 8).

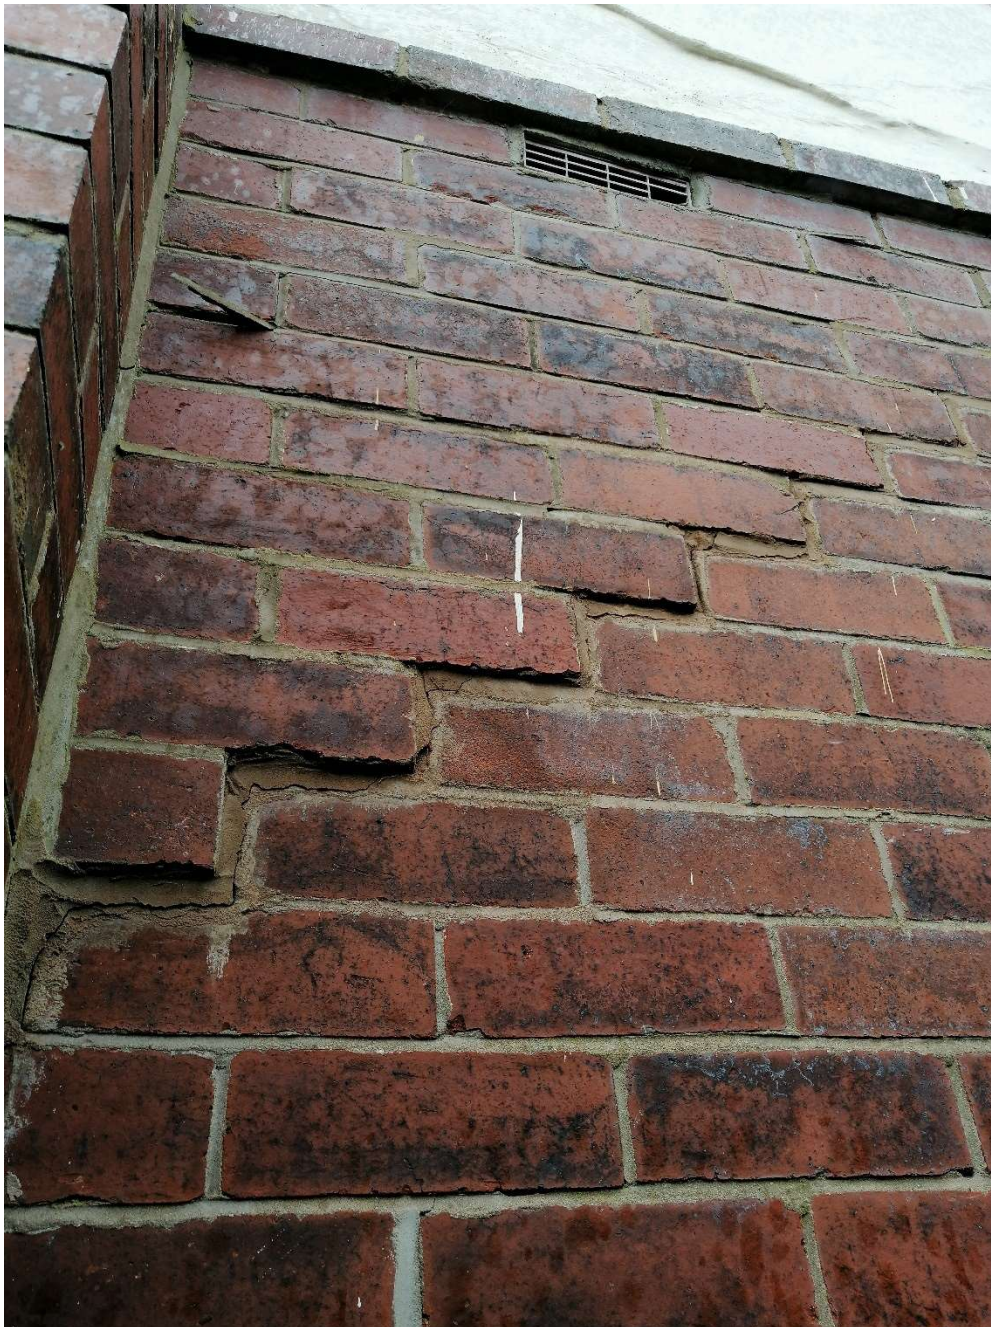
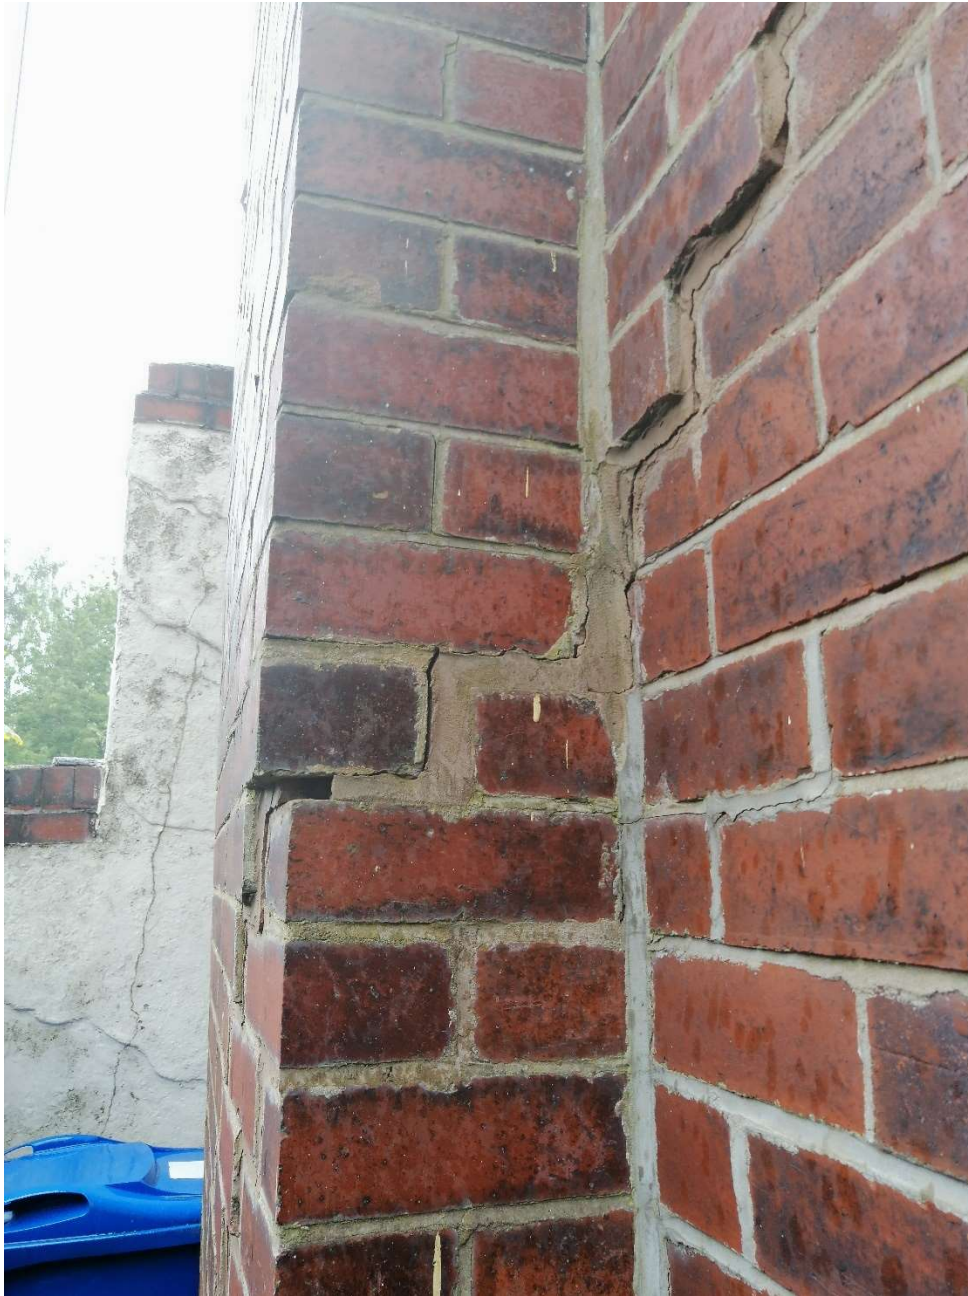
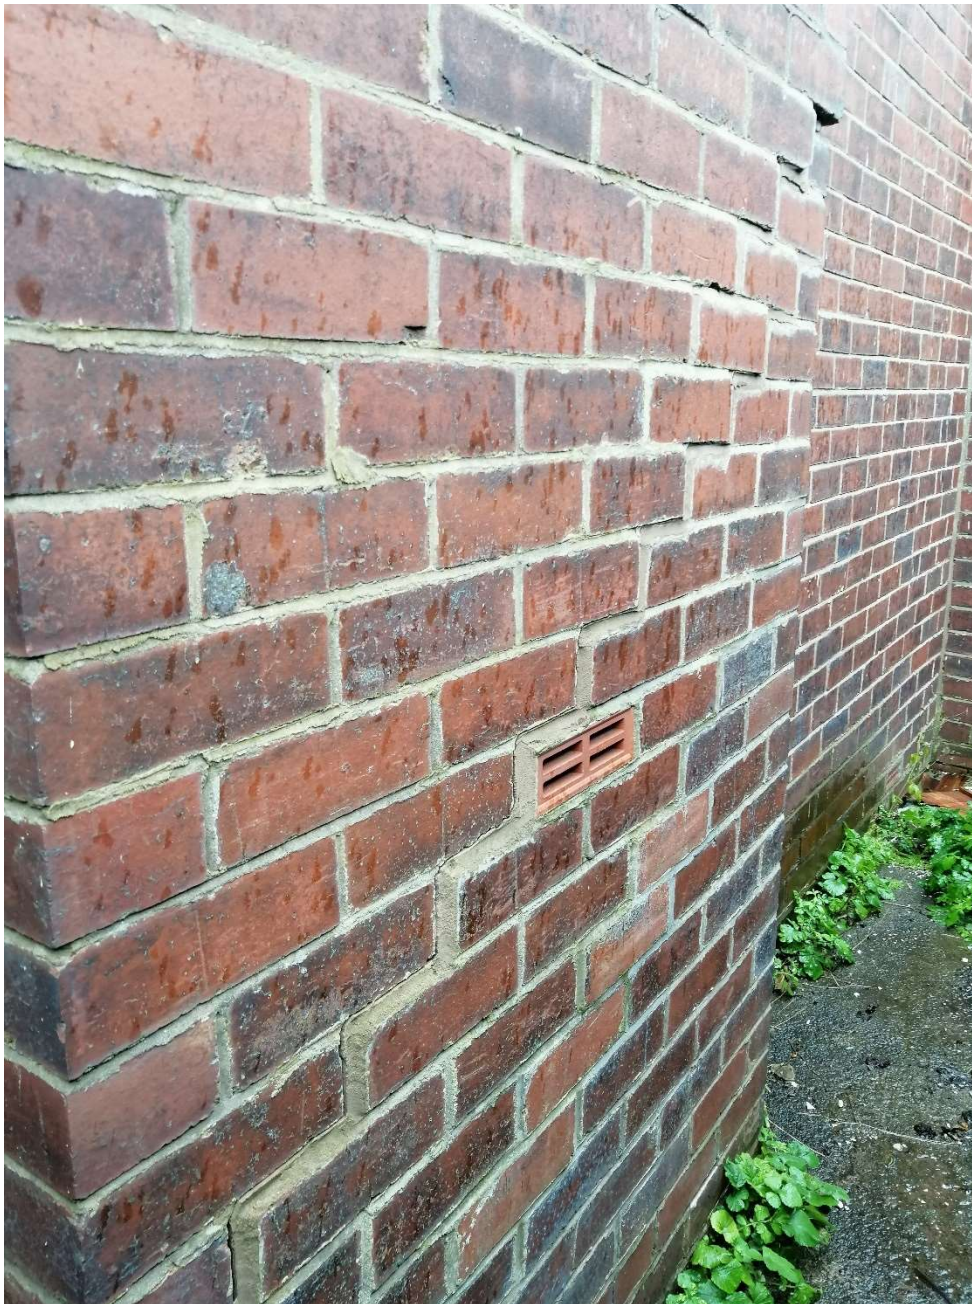
Photos 9, 10 and 11 show further stepped cracking in the Southwest elevation, suggesting rotation of the wall towards the rear corner of the property. Again, some repair works to pointing have been carried out.

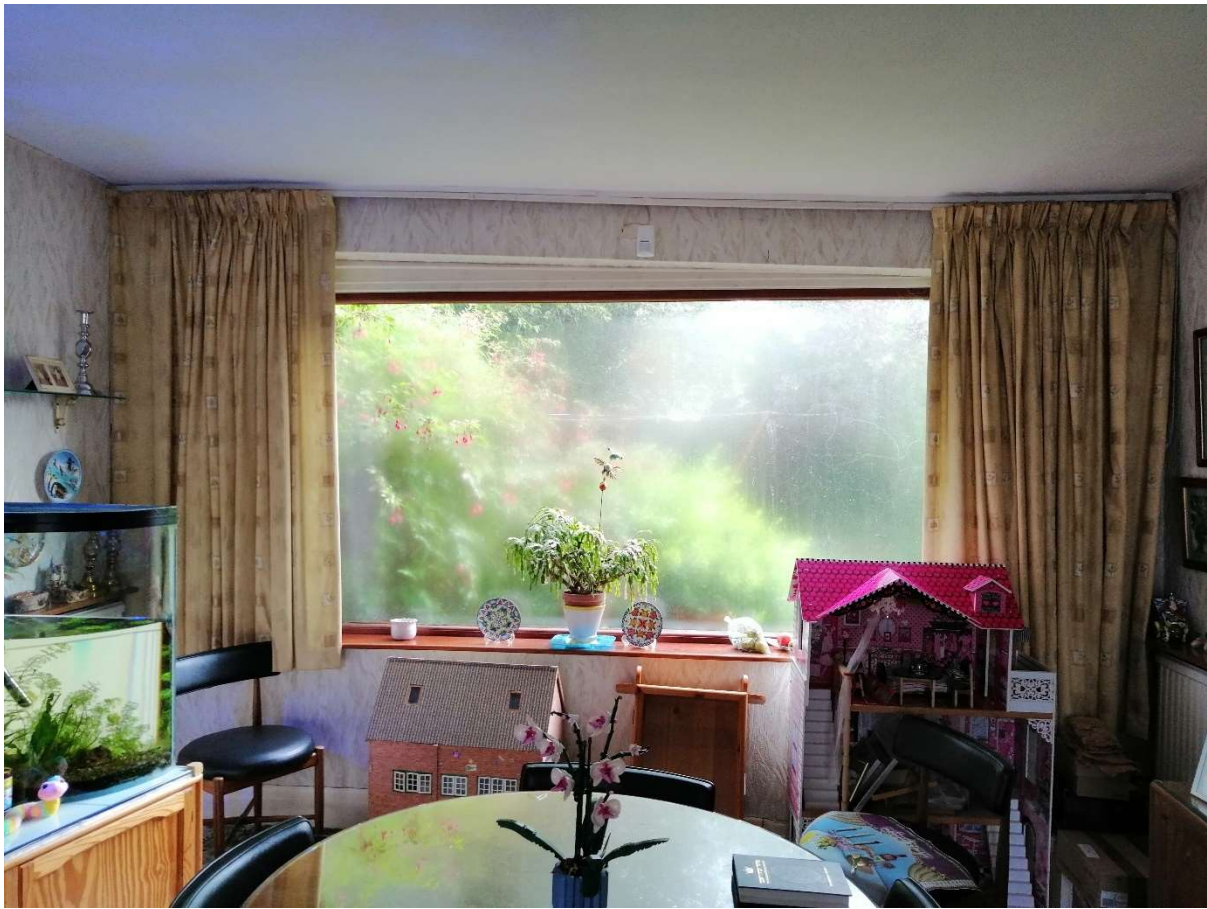
Photo 12

The lintel above rear window was noted to be sloping towards the external wall (Photo 12), similar to what was observed from the outside.

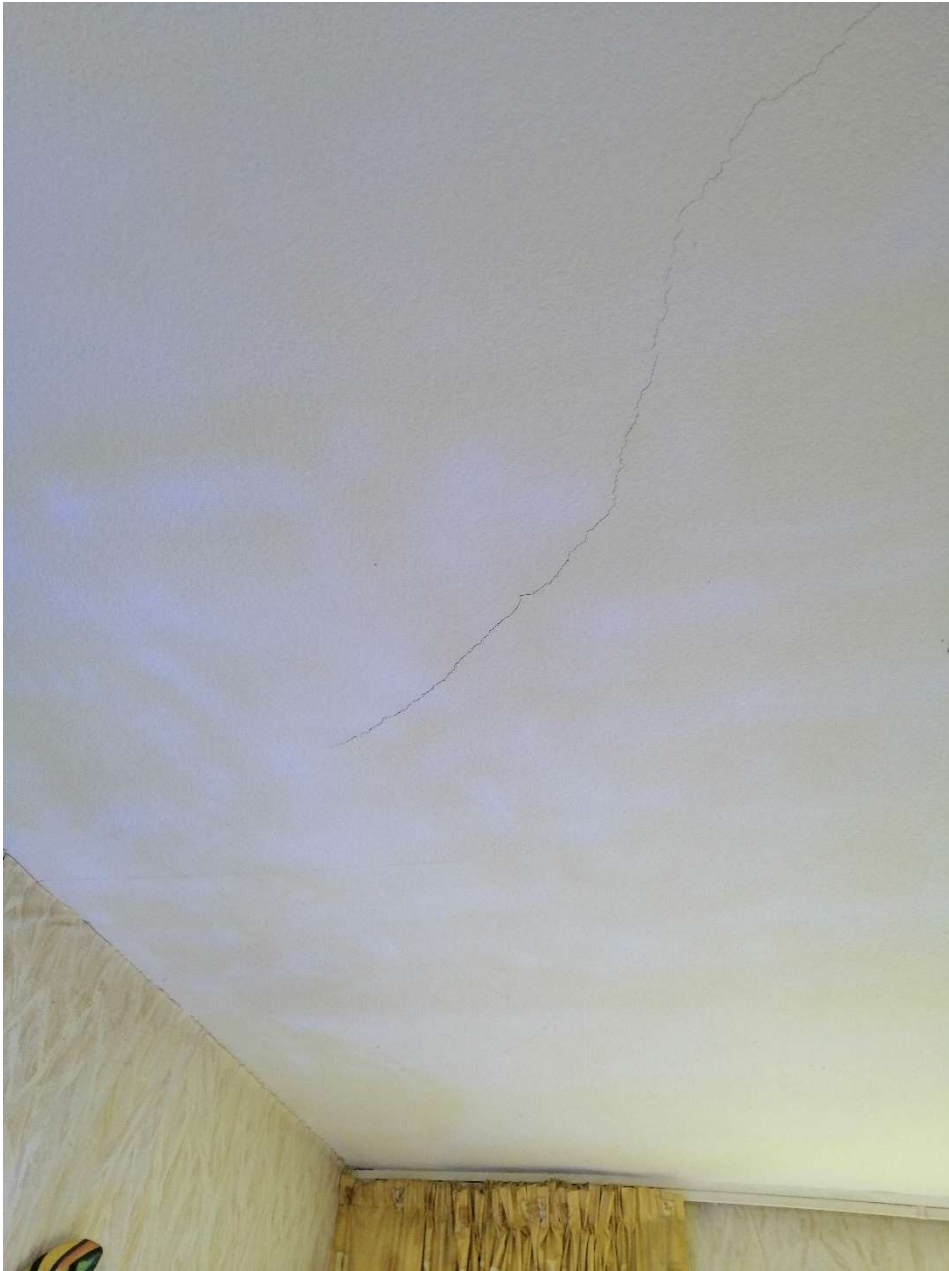
Photo 13

Diagonal cracking was observed to the ceiling of the dining area (Photo 13), and although it appeared to be minor cracking, could also be related to the movement noted to the corner of the property.

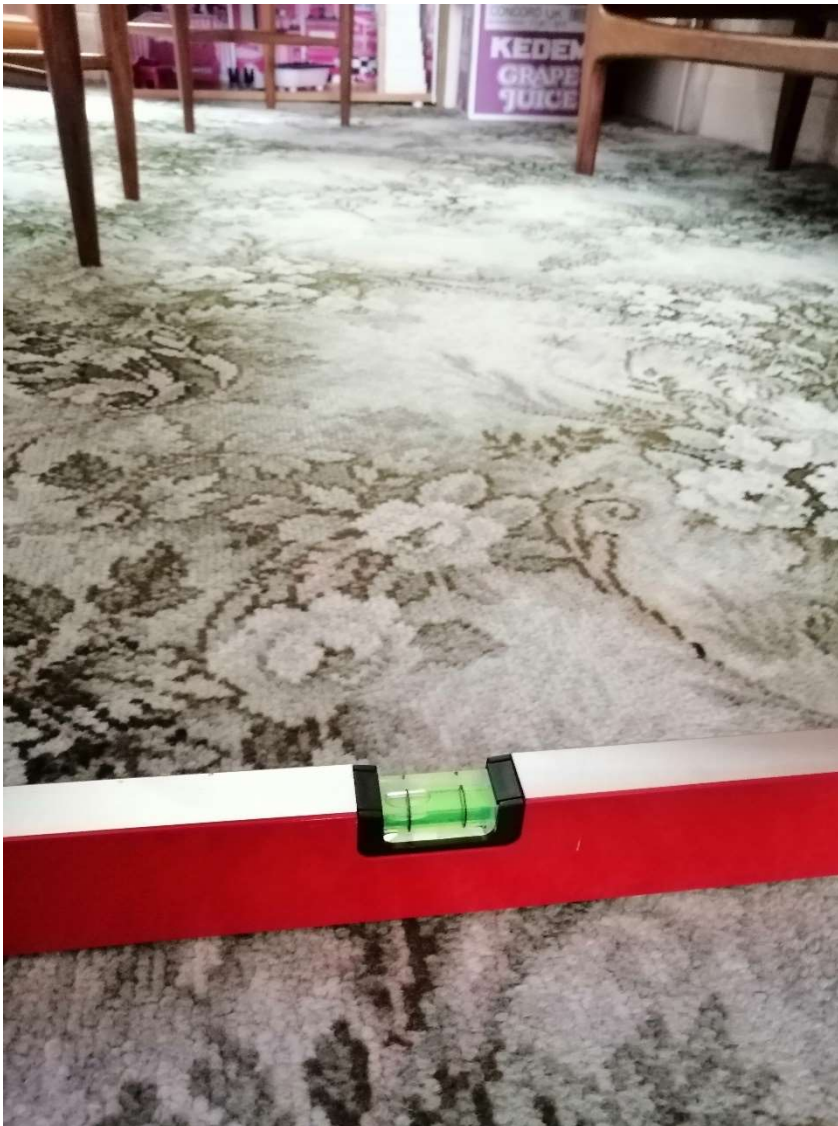
Photo 14

It was noted a clear slope of the floor towards the side elevation, confirmed to be out of level when checked by spirit (Photo 14). The vendor mentioned the floor had been like this since the time the house was bought, around 50 years ago.

If the floors are to be made level, it would be worth investigating the current floor build up and construction under further. Depending on the outcome of this it may be possible to just level the floors to make good. If not, replacement of the floors with new may provide a more permanent solution.

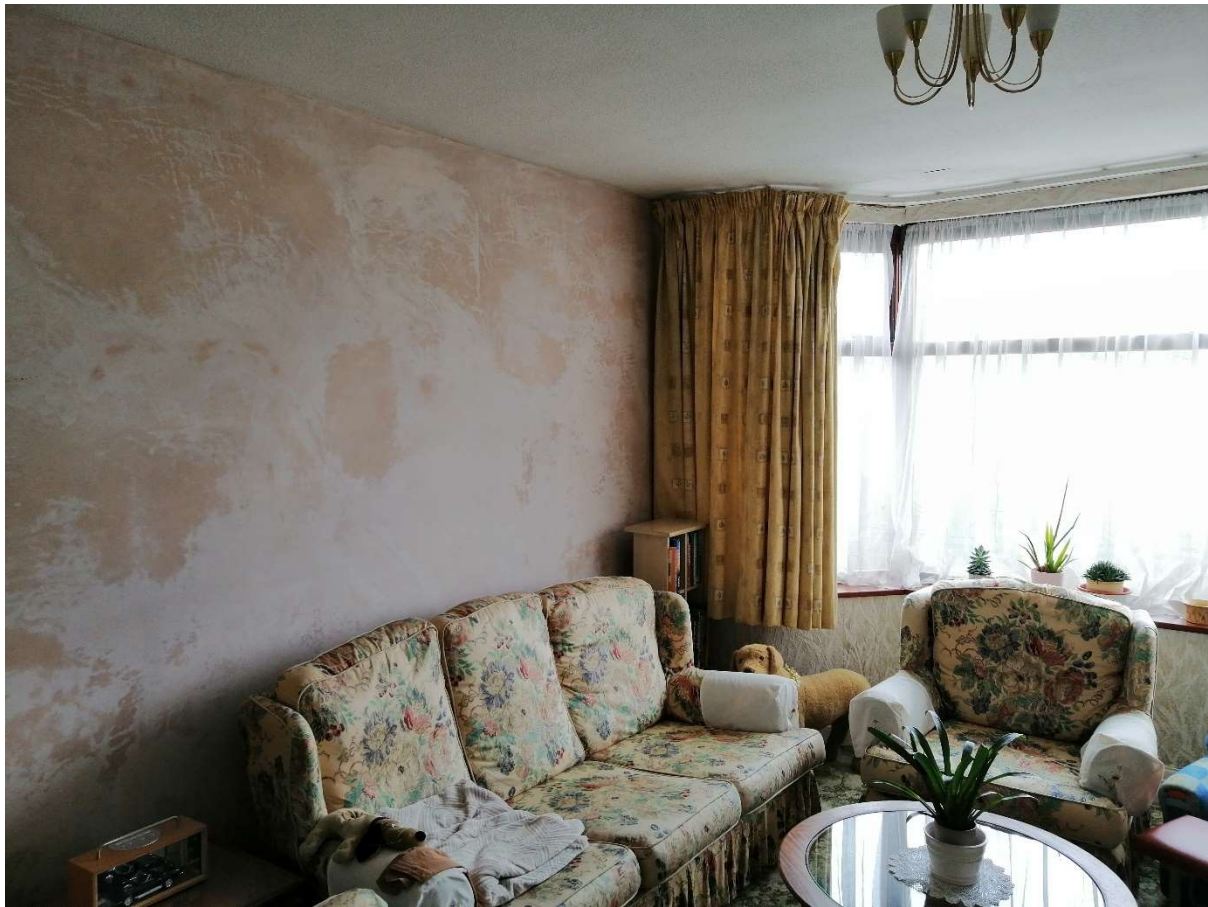
Photo 15

The side wall had been replastered recently (Photo 15) due to cracking noted, as mentioned by the current owner.

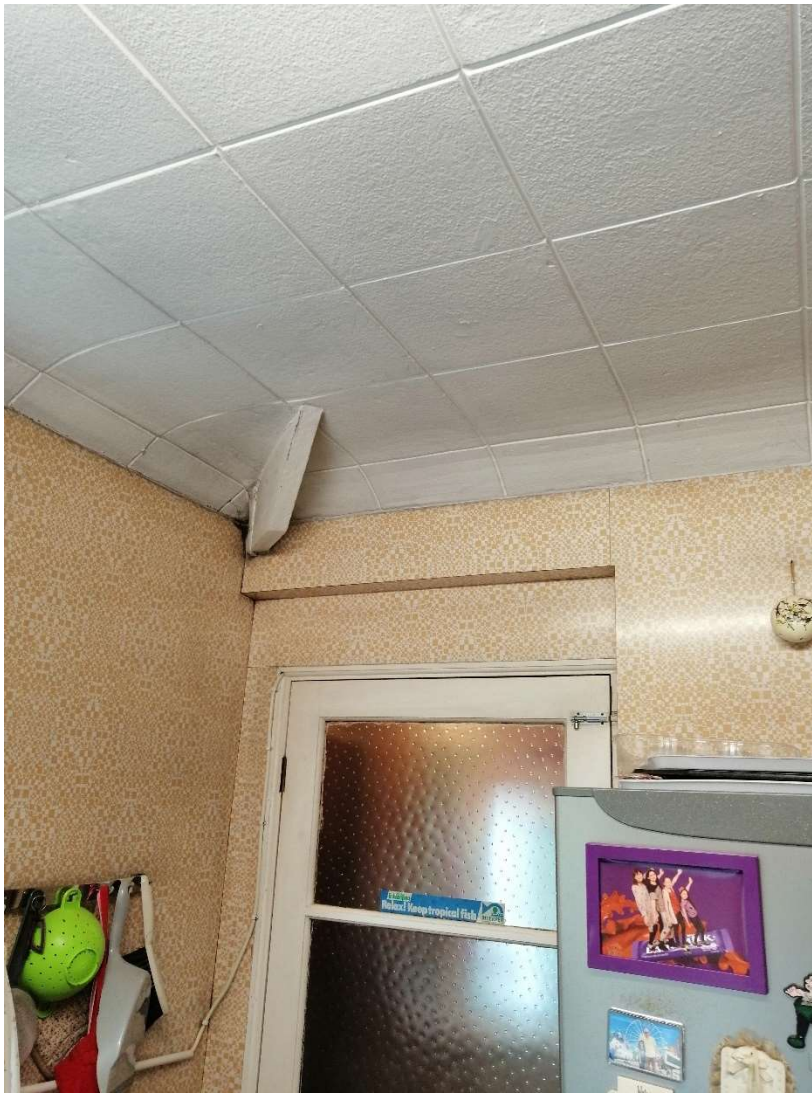
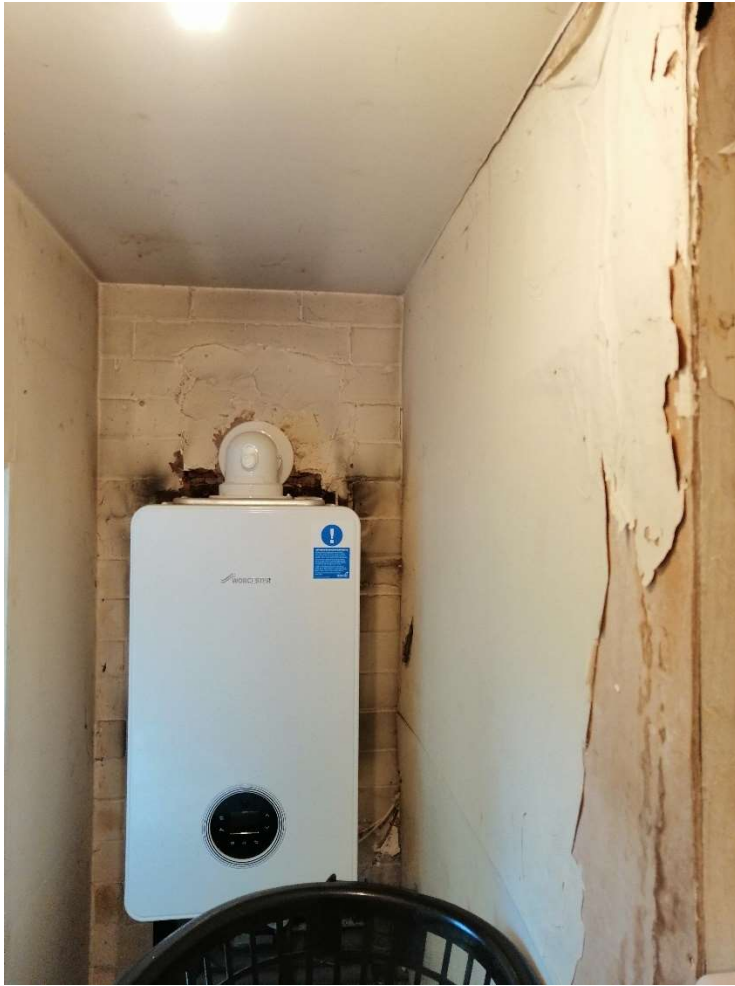
No obvious structural issues were observed within the kitchen (Photo 16) and the small utility room (Photo 17) in the outrigger of the property.

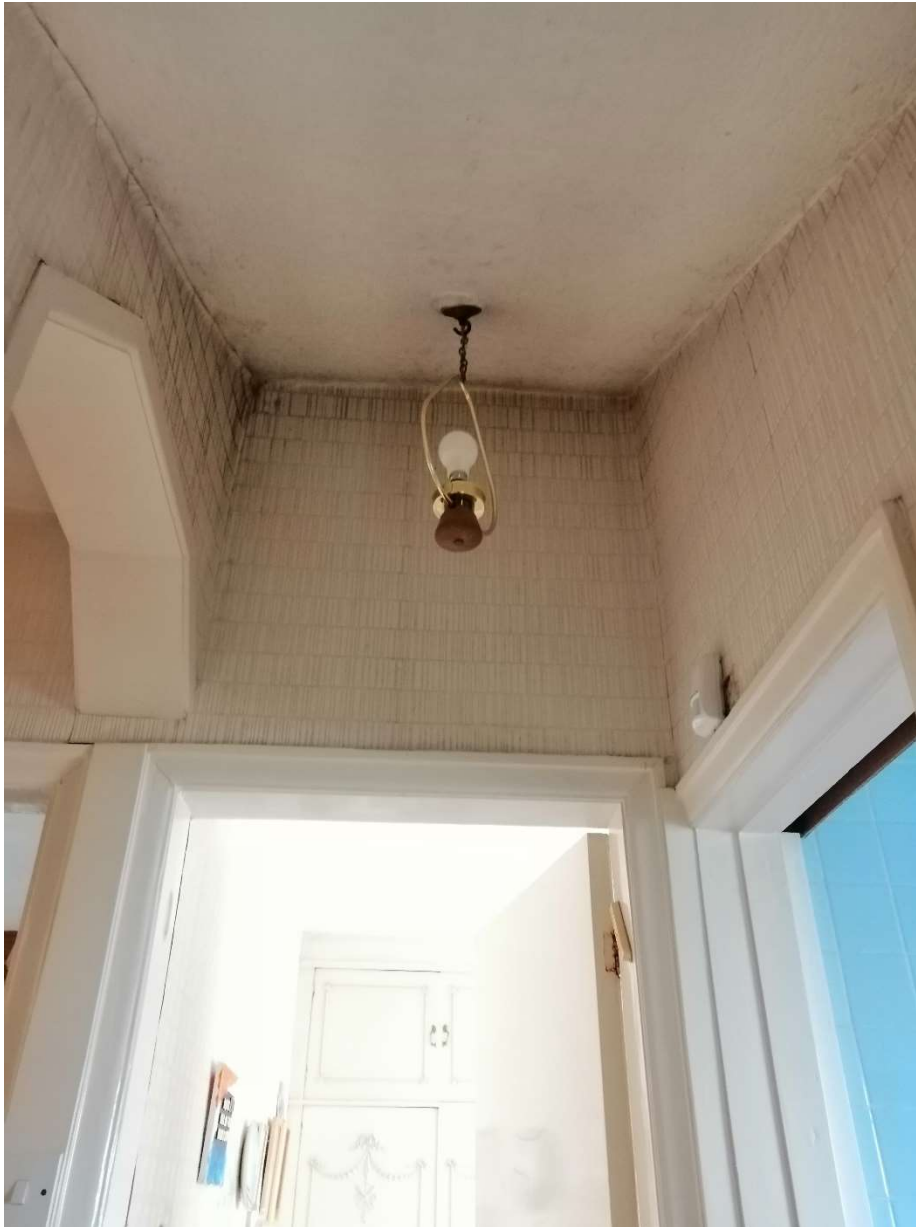
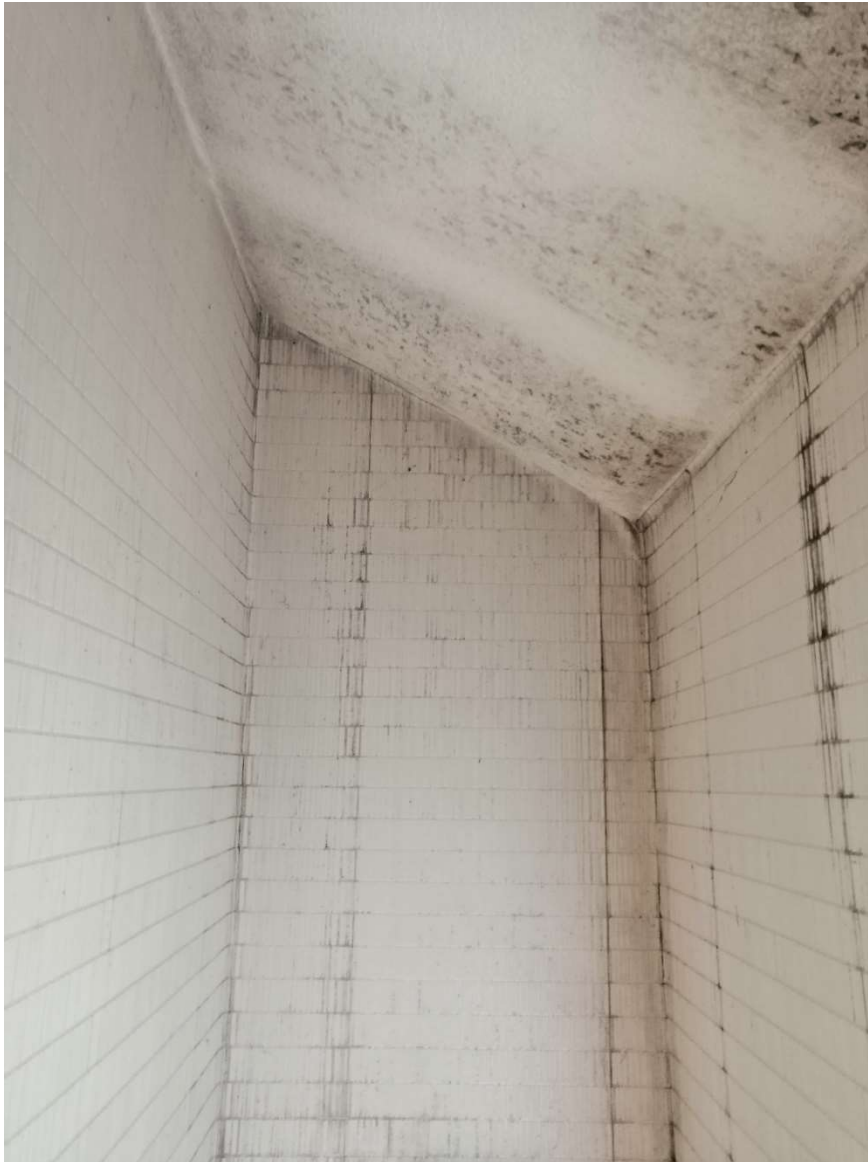
Damp was observed in the ceiling finishes of the hallway and staircase (Photos 18 and 19). Although it doesn't seem to have had any impact on the structure, the roof should be inspected to confirm there are no leaks.
