## 2.0 Inspection

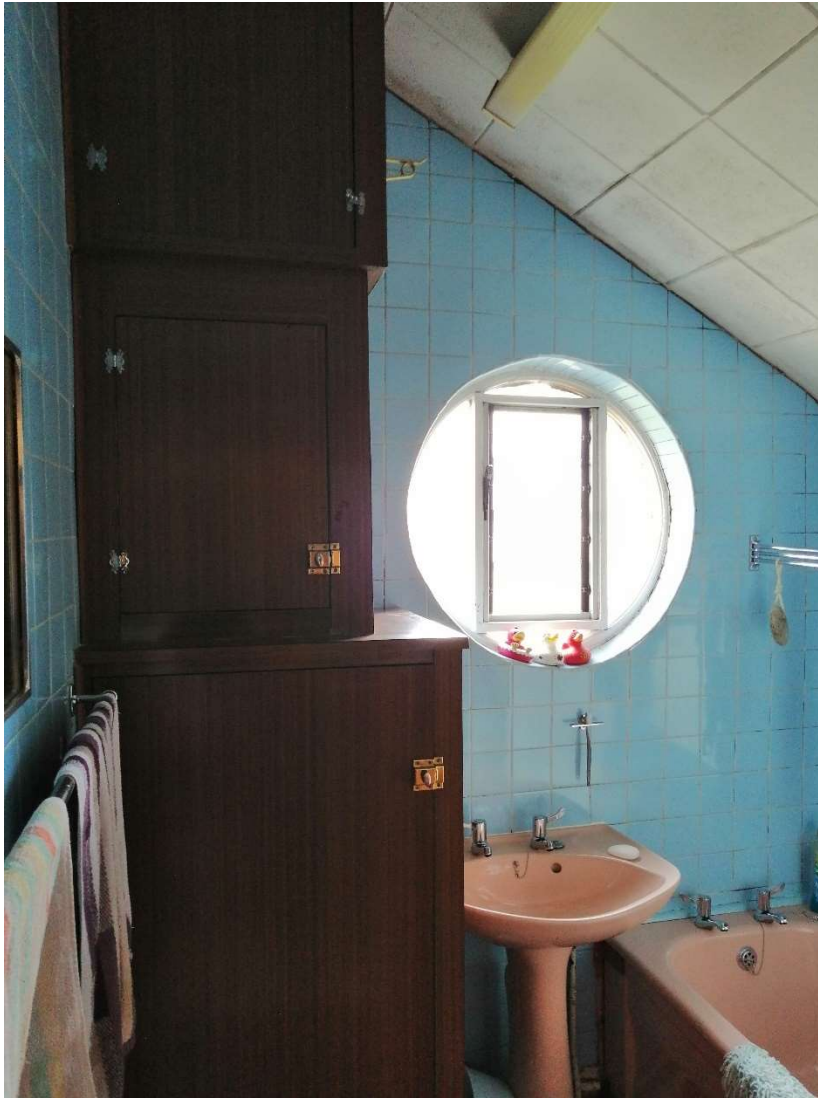
Photo 20

Tiled finishes were present to the front bathroom walls and there were no obvious signs of structural movement to the finishes (Photo 20).

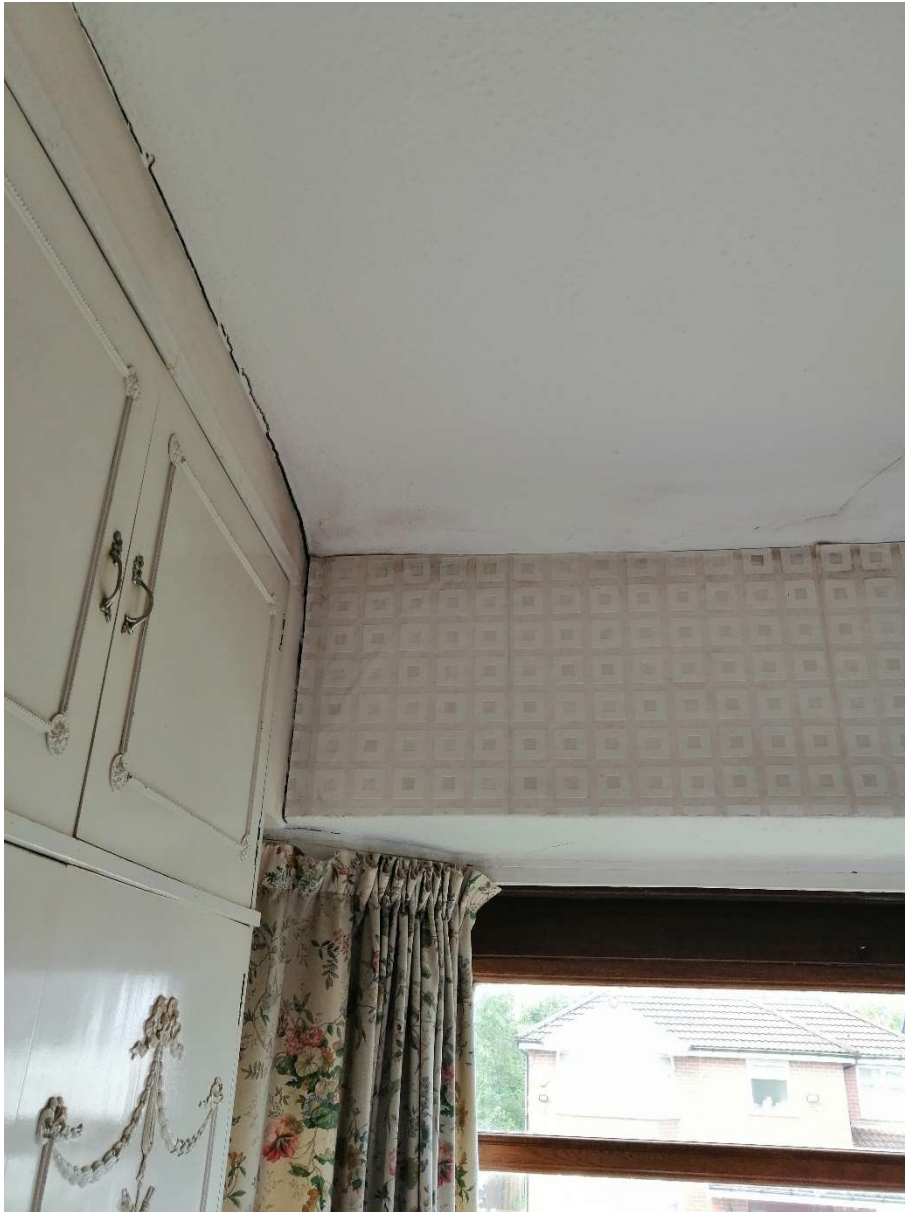
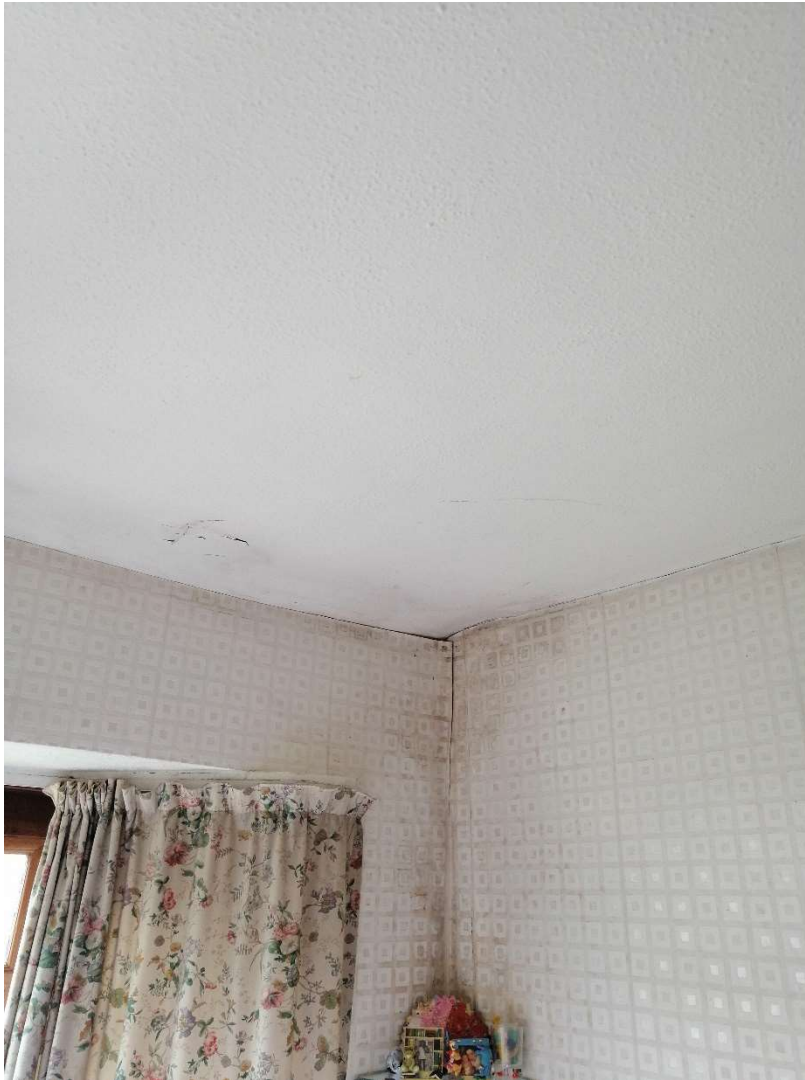
Cracking was observed in the ceiling finishes (Photos 21 & 22) but seemed minor and could be mended with the normal redecorating process.

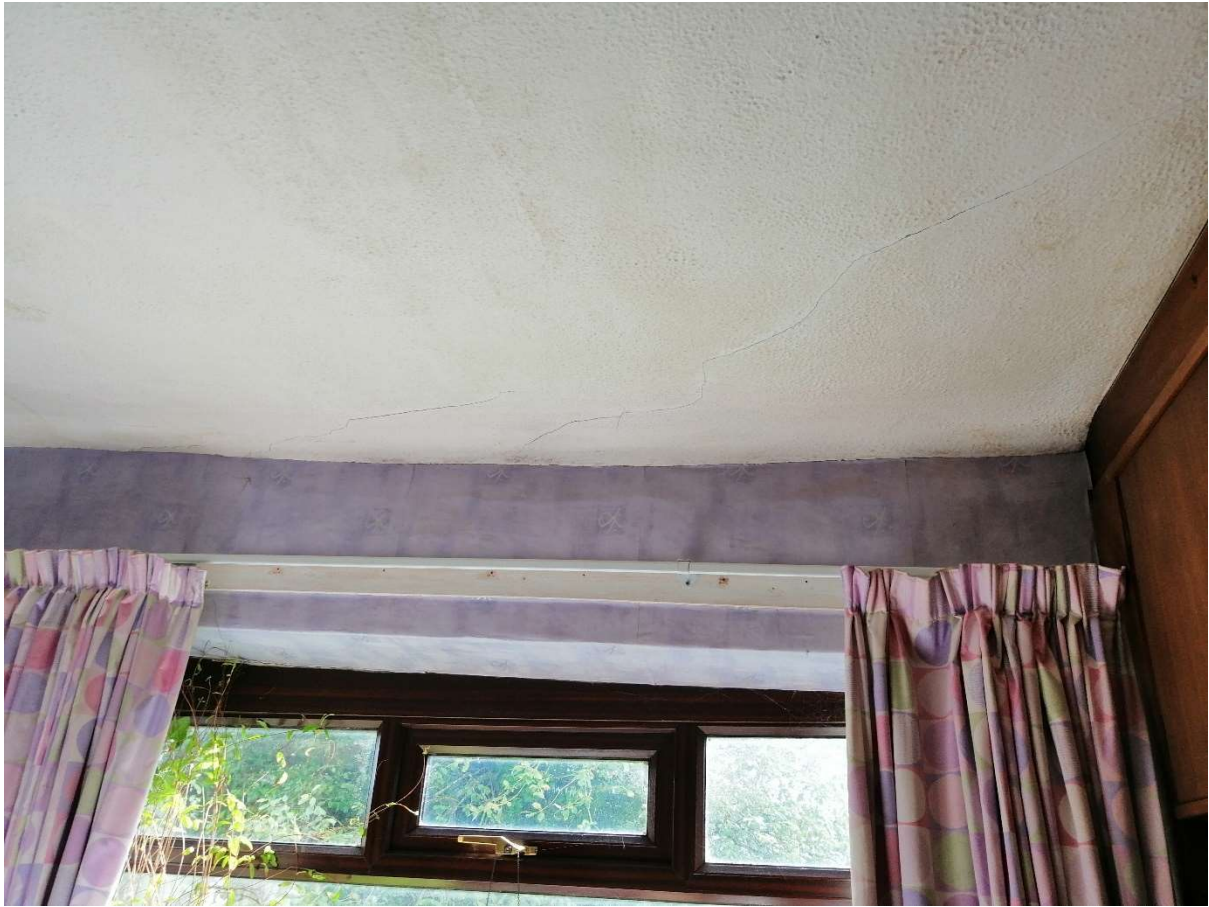
Photo 23

Similar to what was observed in the dining area, the lintel above opening was sloping towards the side external wall, confirming movement to the corner of the house. Further cracking was also noted to the ceiling (Photo 23)

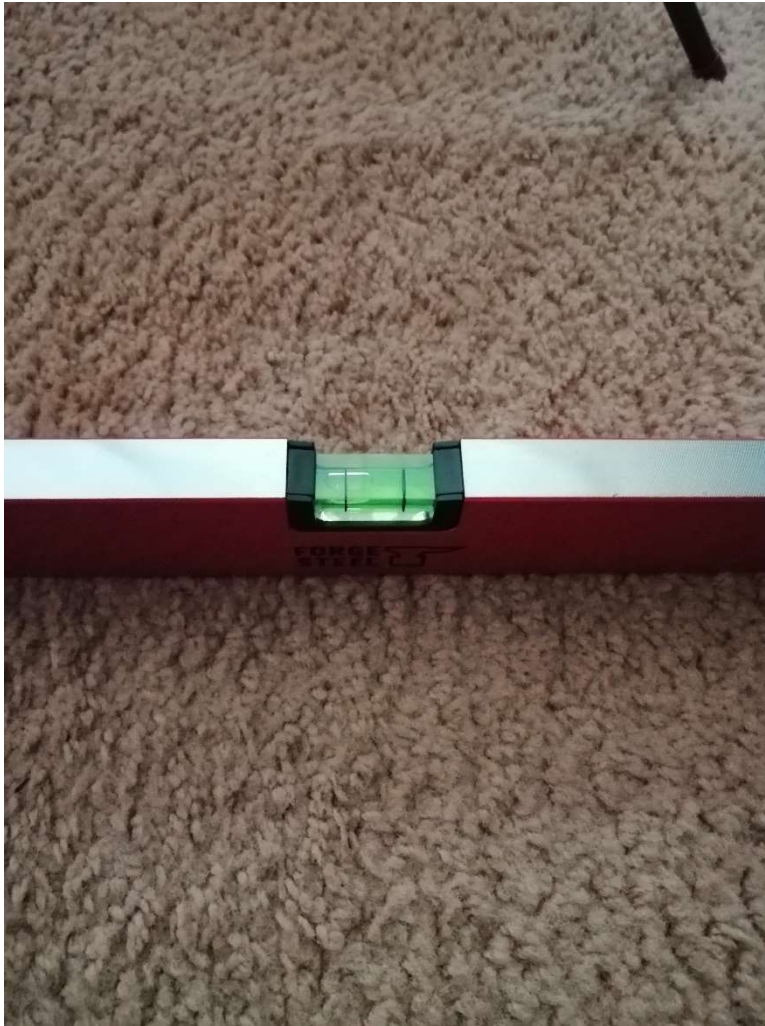
Photo 24

The floor felt to be out of level when walked across and confirmed with a level (Photo 24).

If the floors are to be made level, it would be worth investigating the current floor build up and construction under further. Depending on the outcome of this it may be possible to just level the floors to make good. If not, replacement of the floors with new may provide a more permanent solution.

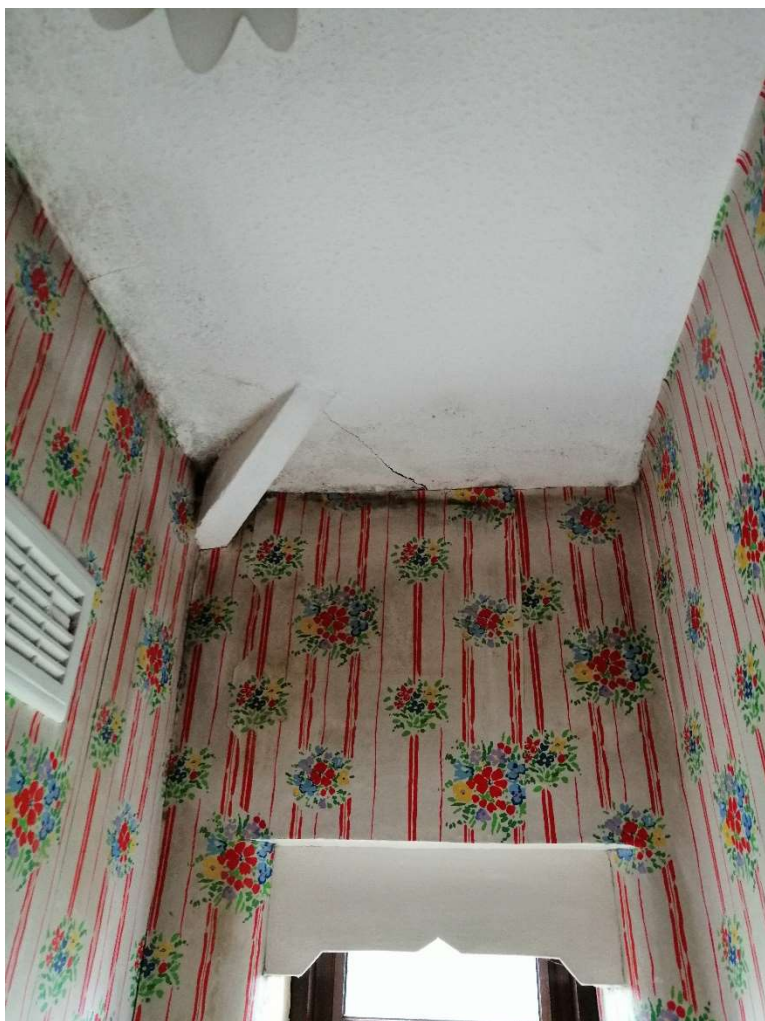
Photo 25

Wallpaper was present within the bathroom walls and hairline cracks were observed to the ceiling (Photo 25). These appeared to be minor and merely cosmetic.
