## **Brookhouse Barn, 218 Holcombe Road, Tottington BL8 4BQ**

### **Proposed Works Schedule for Brookhouse Barn**

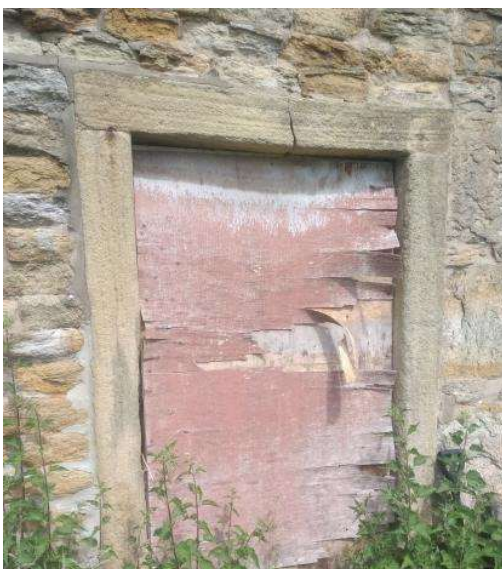
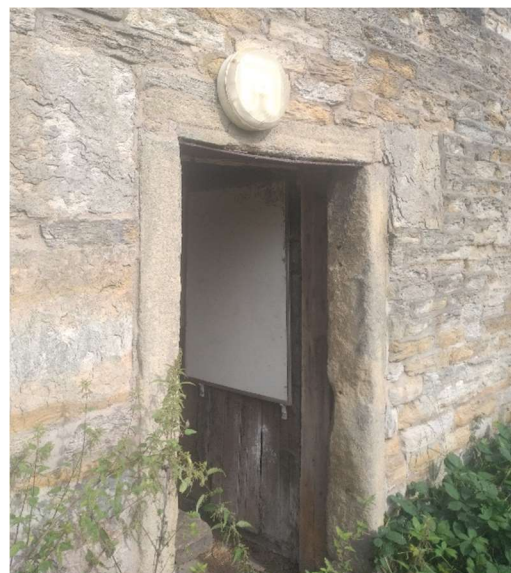
- 2) As damage to stone lintels is long standing and non-progressive, recess fill crack with an appropriate epoxy mortar and point with colour matched NHL 3.5 RG lime mortar. Products details as follows:

Appropriate method statement from Helifix and SPAB / Historic England would be followed and works undertaken in a professional manner.
