## Survey Report & Proposal

Property:  
Buckley Wells  
Carriage Shed  
Locomotive Works  
Bury  
BL9 0TY

Our Reference: G62753-GF-CRW

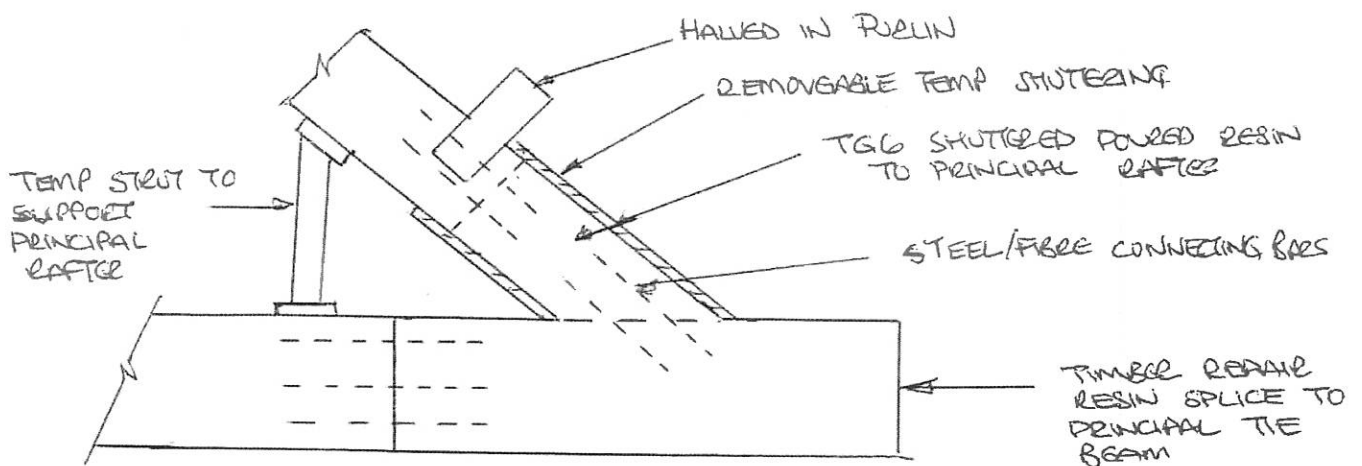
## 14 NO REPAIRS

**Truss Numbers 2, 3, 5, 9, 15, 18, 22, 23, 24, 25, 26, 27, 28, 29**

- Insert temporary strut to re-support principal rafter off the principal tie beam.
- Following safe and adequate structural support by others, cut the principal rafter and tie beam clear of decay (approximately 500mm)
- Provide and fit a TRS repair splice to the beam in accordance with Rotafix specifications.
- Provide and fix temp shuttering to principal rafter, inserting connecting bars from rafter to the newly installed TRS tie beam
- Pour TG6 resin into shuttering to form new principal rafter
- Following full cure remove shuttering
- Make good and sand down repair if required
- Replace the timber bearer underneath the truss tie beam with new concrete bearer pads.

1. PROP TRUSS SECURELY
2. INSERT TEMP STUPT TO RESUPPORT PRINCIPAL RAFTER
3. CUT PRINCIPAL TIE BEAM & RAFTER CLEAR OF DECAY (APPROX MAX) 500mm
4. PROVIDE + FIT A TRS REPAIR SPLICE TO TIE BEAM
5. PROVIDE + FIX TEMP SHUTTERING TO PRINCIPAL RAFTER INCLUDING CONNECTING BARS FROM RAFTER TO TIE BEAM
6. POUR T&G RESIN INTO SHUTTER TO FORM NEW PRINCIPAL RAFTER
7. FOLLOWING FULL CURE STRIP SHUTTER

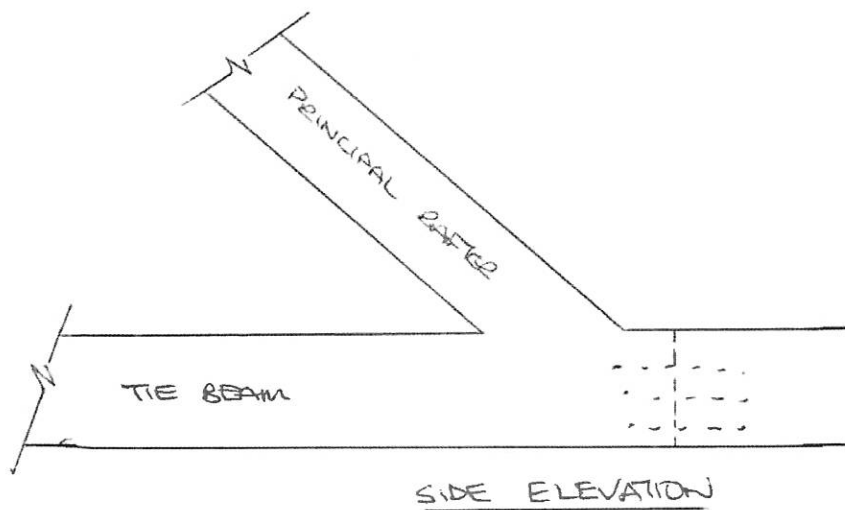
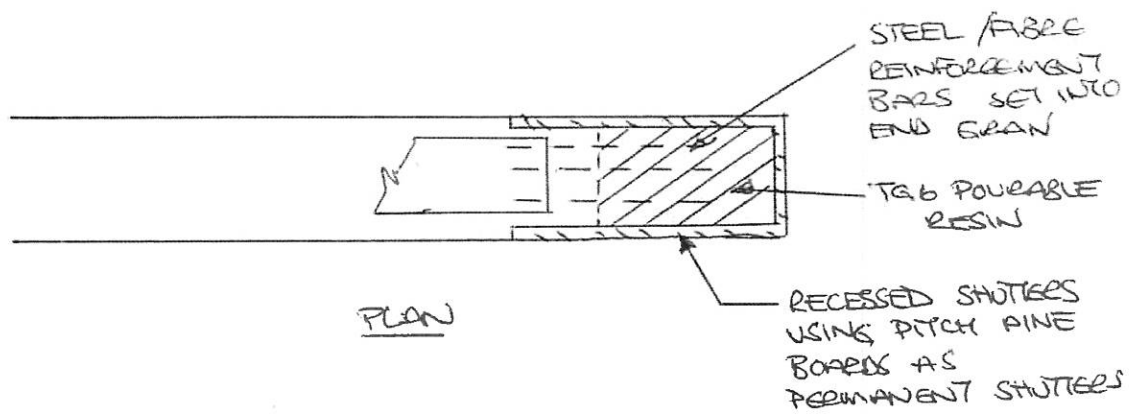
16 NO LEAKS

**Tie beams 31, 32, 33, 34, 35, 36, 37, 38, 39, 43, 45, 51, 52, 55, 56, 57**

- Cut tie beam clear of decay (approximately 500mm)
- Create a 25mm rebate into each side of the tie beam to accommodate the permanent pitch pine shutter boards.
- Drill into end of Tie beam and insert 6 no fibre bars and fix with Rotafix Timber Set Resin.
- Install recessed shutters using pitch pine boards 25mm thick as permanent shutters to the tie beam
- Pour TG6 to form permanent repair to the tie beam.
