**ENGINEERING REPORT 9622**

**THE ENGINE SHED  
ROWLANDS ROAD  
SUMMERSEAT**

**CLIENT: MR MIAH**

**02.07.2024 / 04.07.2024 MP/CH**

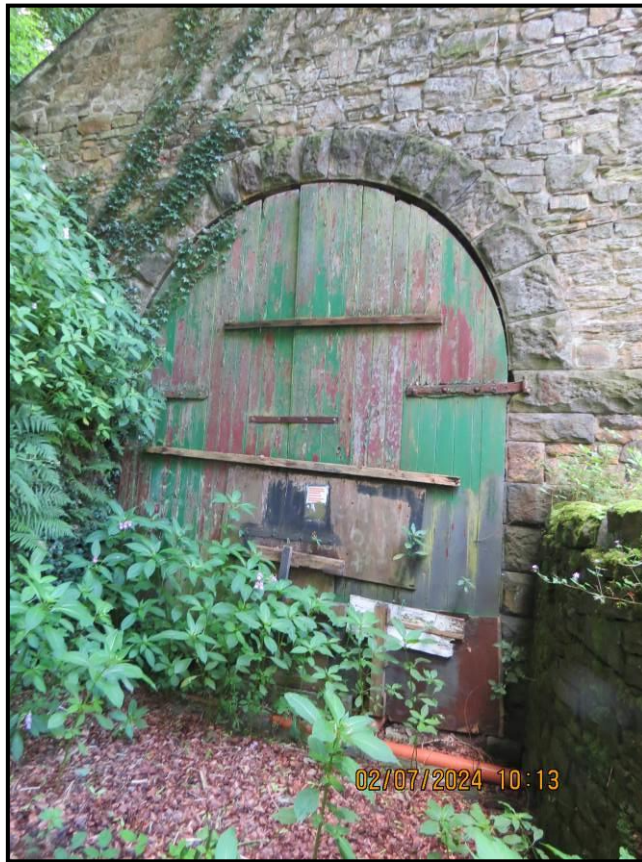
**Photograph 004 North Eastern arch**

- 3.1 The Eastern flank wall is constructed against a 5 metres high retaining wall on a Western facing slope incorporating the original flank wall and the return Northern gable to the Engine Shed, the gable approximately 3.5 metres wide x 4.5 metres high completed with a single natural stone archway of dressed stone in the order of 450mm deep. (Photographs 003, 004).

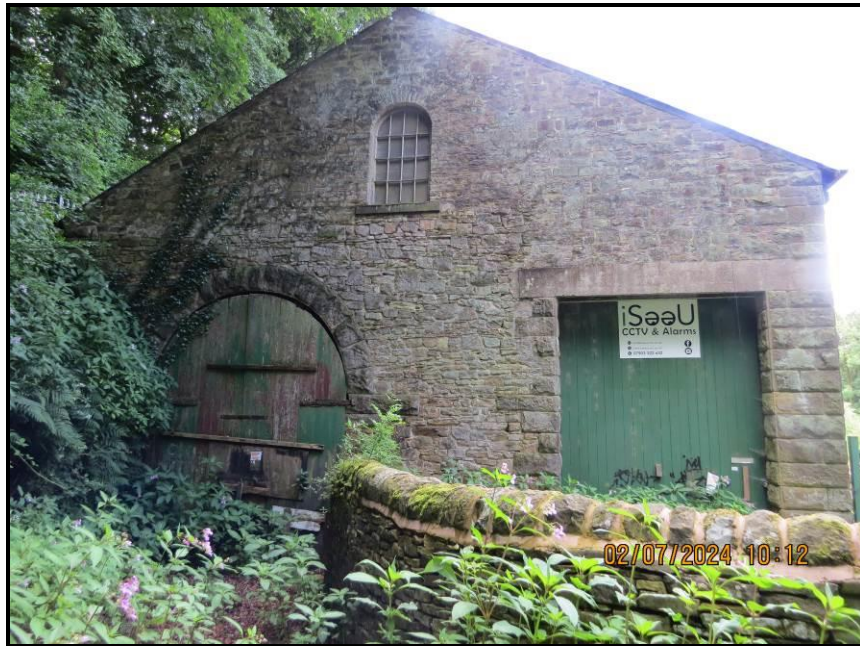
**Photograph 003 Northern gable**

- 4.1 The Northern gable extends for a width in the order 14 metres, a height at eaves level circa 6 metres completed with a pitched roof laid to a 30° slope. (Photograph 003).

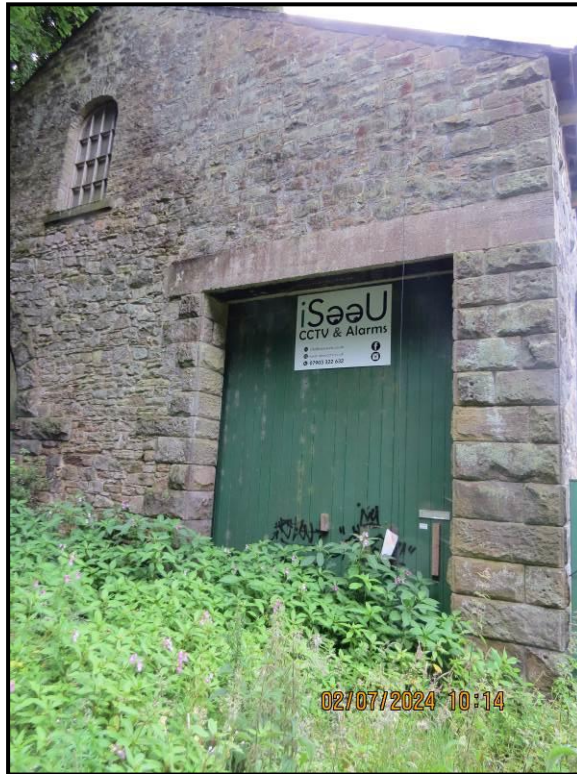
Photograph 007 North Western doorway

- 4.6 The right hand rectangular opening is completed with natural stone quoins to the door reveals. The door jambs and reveals follow a satisfactory vertical alignment, and the overall vertical profile to the Northern gable is good. (Photograph 007).

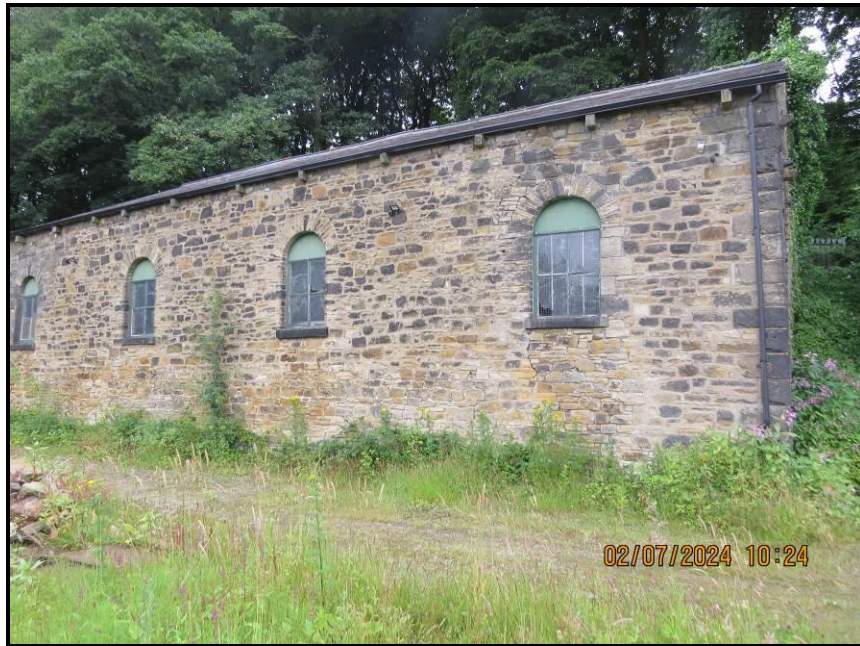
**Photograph 012 Western flank, 0 – 20 metres**

- 5.1 The Western flank wall extends for a length in the order of 20 metres incorporating four number radial headed windows completed with stone lintels and semi-circular arch. The windows are located at approximate chainages 3, 8, 12 and 17 metres (North – South). (Photograph 012).

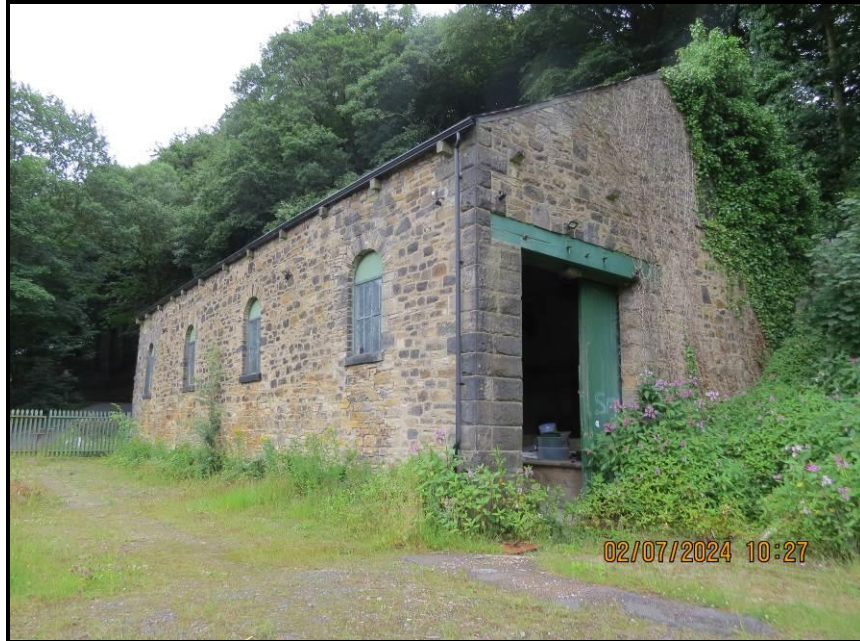
**Photograph 014 Western flank and Southern gable**

- 6.1 The Southern gable replicates the opposite Northern gable with a rectangular door opening on the left hand, South Western corner completed with large section stone quoins and a timber lintel. (Photograph 014).

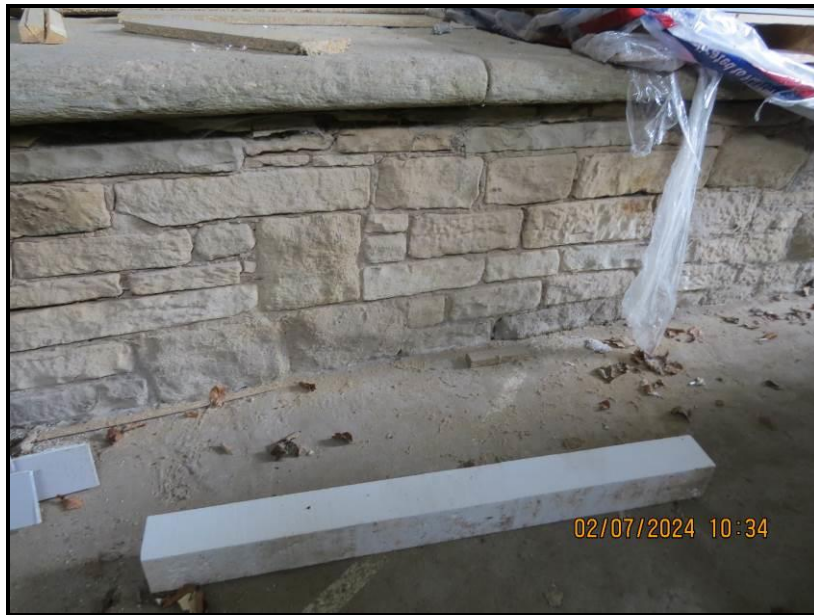
Photograph 027 Typical plinth construction

- 7.1 Internally the building retains a natural stone plinth platform occupying a footprint in the order of 90 square metres with a lifting derrick located towards the Northern aspect. (Photographs 027, 028, 030).

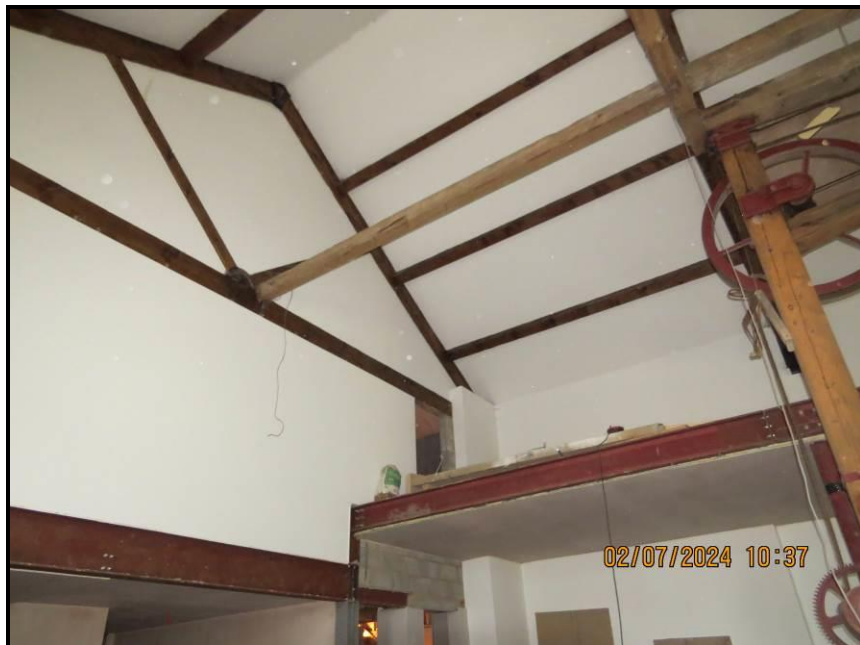
**Photograph 031 North Eastern Trusses 1 - 2**

- 7.10 The roof incorporates three exposed purlins, sized in the order of 200mm x 150mm, purlins following a satisfactory line and level. (Photographs 031, 032).
- 7.11 All the timberwork, trusses, purlins and longitudinal tie are in good order.

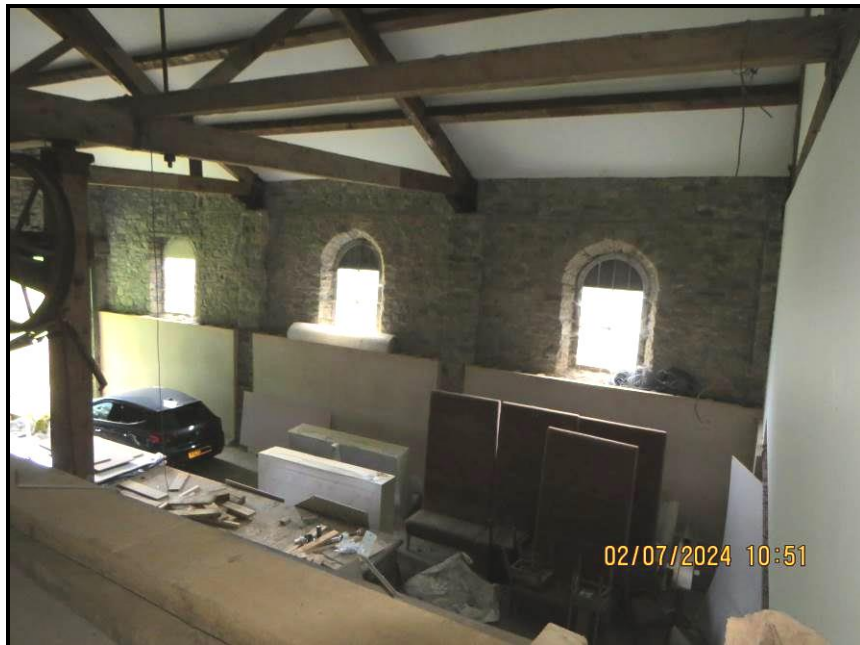
**Photograph 056 Western elevation, windows 4 - 2**

- 7.17 Viewing from the second floor level, confirms good overall horizontal alignment to the main purlins and a satisfactory vertical profile to the trusses. (Photographs 056, 057, 058).

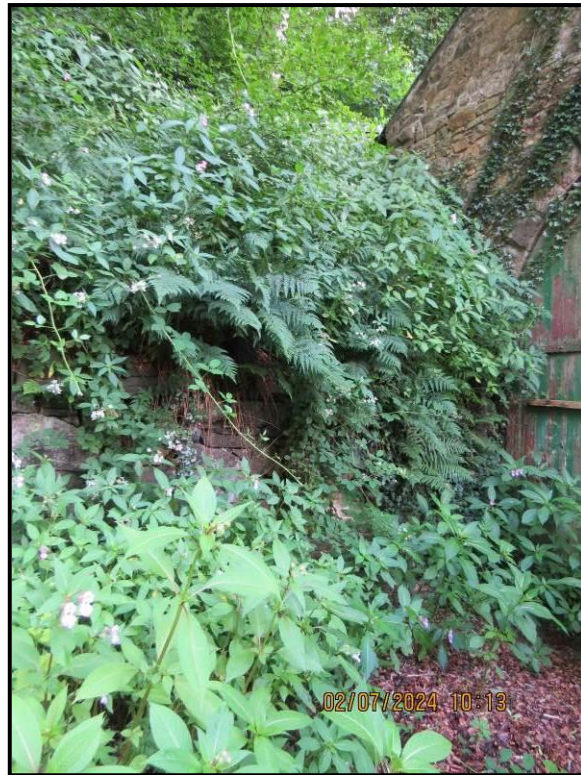
005 Eastern boundary wall (vegetation)

- 3.2 Vegetation growth from the plinth retaining wall on the left hand Eastern side precludes a detailed inspection but the overall profile of the exposed wall appears reasonable. (Photograph 005).

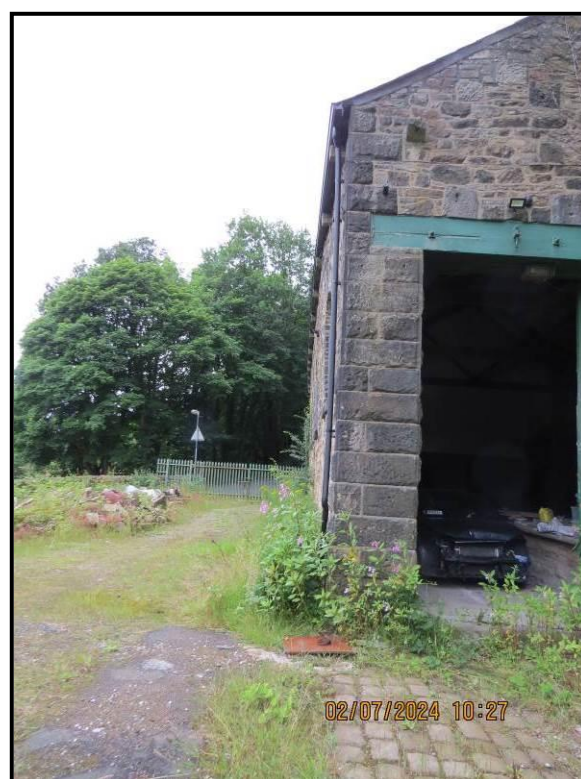
015 Good vertical alignment to Western flank

- 5.2 Minor variations are evident in the weathering to the stonework along the elevation probably occasioned by former Ivy growth or similar (not of any structural consequence). (Photographs 009, 010, 011, 012, 013).
- 5.3 The eaves gutters are supported on stone corbels at approximately 1.5 metre centres.
- 5.4 The random stonework coursing is well maintained and in good order, the profile of all four window openings is good, and the vertical alignment along the elevation is good. (Photographs 014, 015).

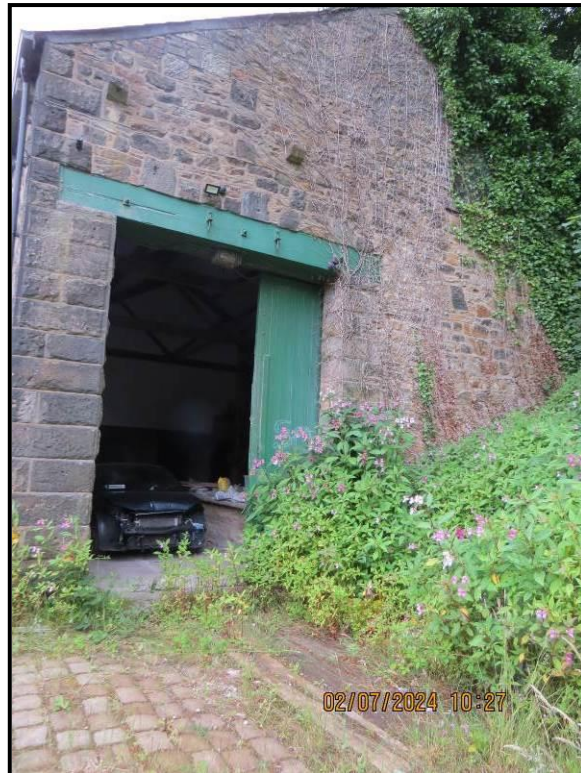
016 Southern gable

- 6.2 Very mature Ivy growth extending from the Eastern hillside onto the upper and lower faces of the right hand gable section. (Photograph 016).
- 6.3 No access was available to the back-to-earth retaining wall on the Eastern flank. (Photograph 016).

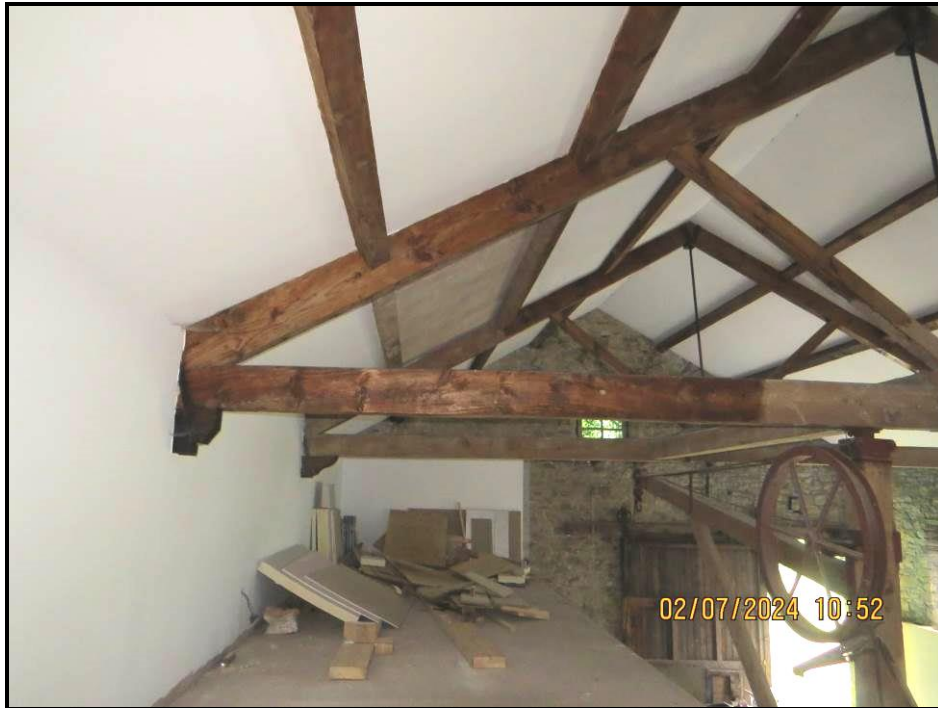
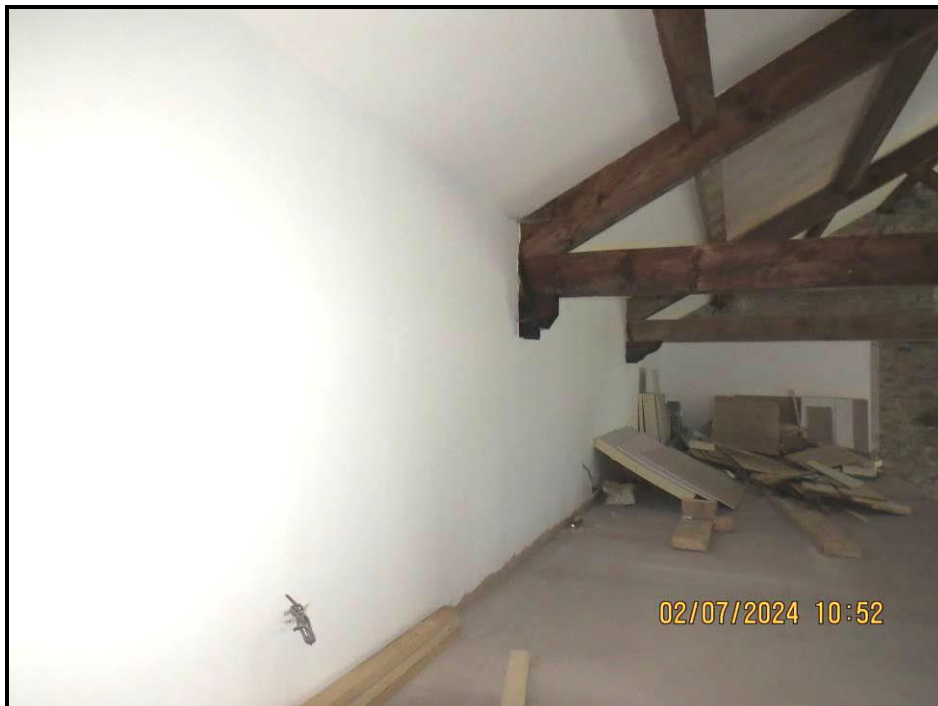
- 7.18 On the second floor of the Eastern flank wall the seating of the trusses on the stone corbels is good. (Photographs 059, 060).
