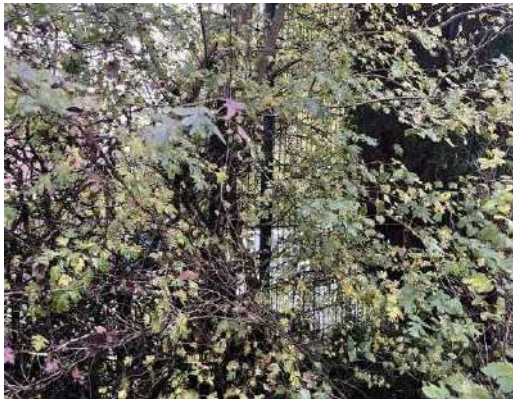
Photo 1 - Gap between chain-link and newer mesh fencing creating a breach in the perimeter and an unauthorised access point.

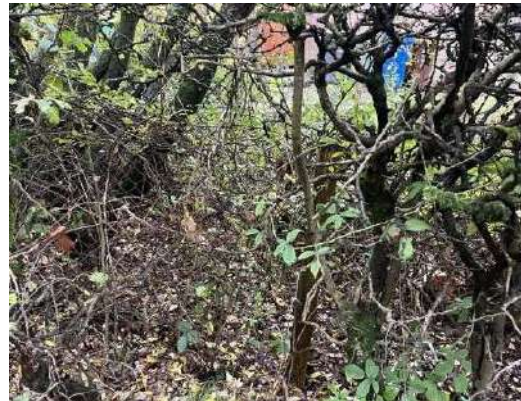
Photo 2 - Full opening in perimeter fencing to the south-west boundary, creating unrestricted public access and a critical safeguarding risk

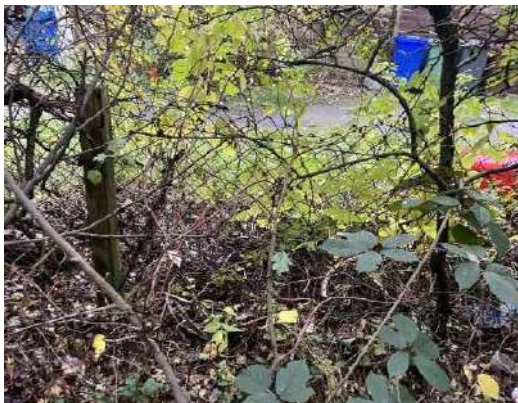
Photo 3 - Low level chain link fencing Low-level, life-expired chain-link boundary fencing providing ineffective safeguarding and unrestricted access to the school site

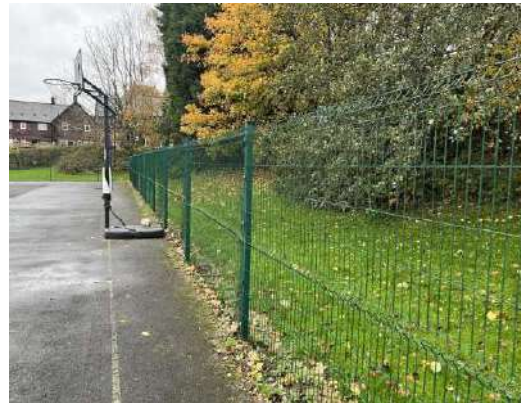
Photo 4 - 1.8m perimeter fencing that does not meet DfE minimum height requirements for safeguarding boundaries.

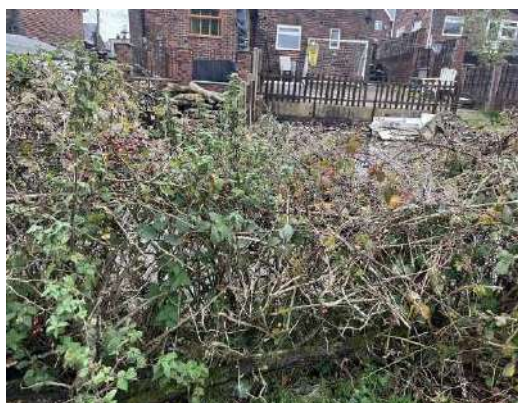
Photo 5 - Vegetation growth provides climbing assistance, enabling unauthorised access over the boundary and undermining perimeter security on the north boundary.

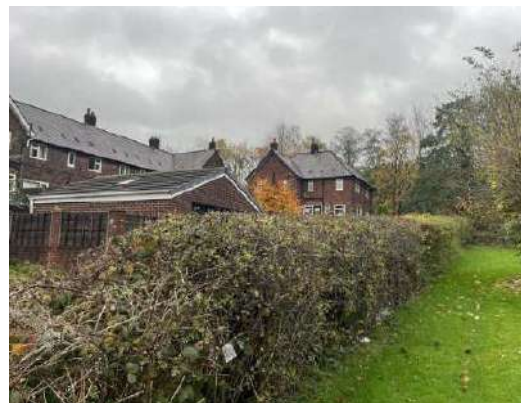
Photo 6 - Unmanaged vegetation obscuring boundary fencing, concealing access points and compromising safeguarding and visibility on the north boundary.

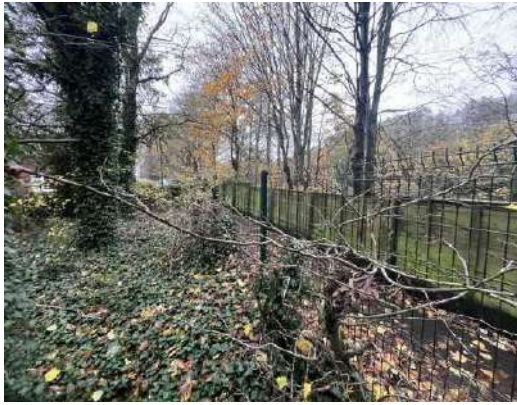
Photo 7 - 1.8m perimeter fencing that does not meet DfE minimum height requirements for safeguarding boundaries.

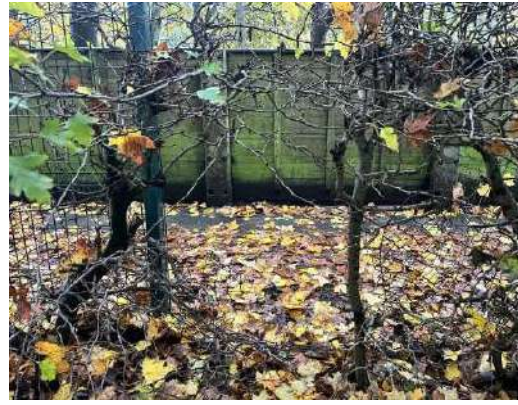
Photo 8 - Complete collapse of boundary fencing allowing unrestricted access to a public footpath adjacent to a motorway, representing an extreme safeguarding risk.

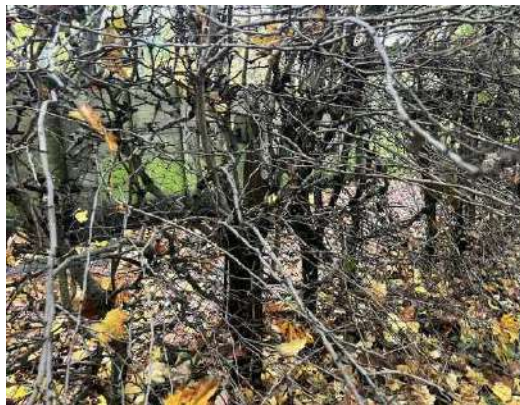
Photo 9 - Low level chain link fencing Low-level, life-expired chain-link boundary fencing providing ineffective safeguarding and unrestricted access to the school site

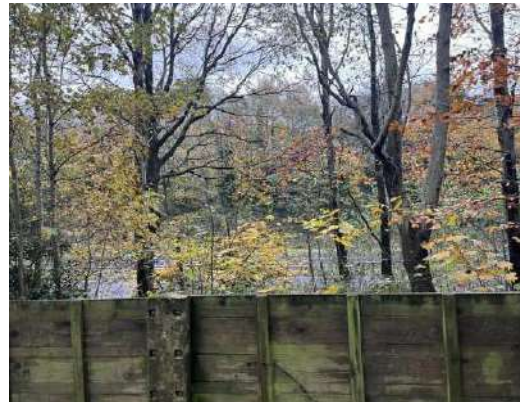
Photo 10 - Motorway located directly beyond the school perimeter, highlighting the severe external hazard present where fencing failures allow unrestricted access from the school grounds.

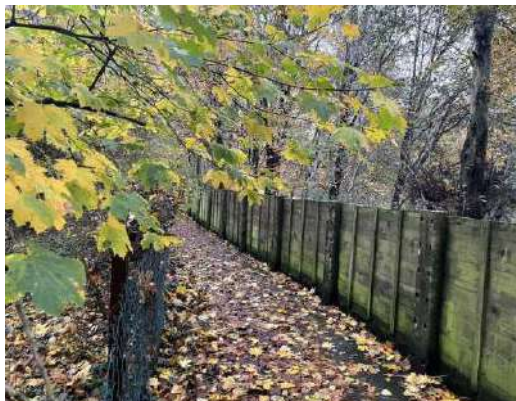
Photo 11 - Public footpath directly adjoining the school perimeter, where low and deteriorated chain-link fencing provides inadequate separation between members of the public and the school grounds.

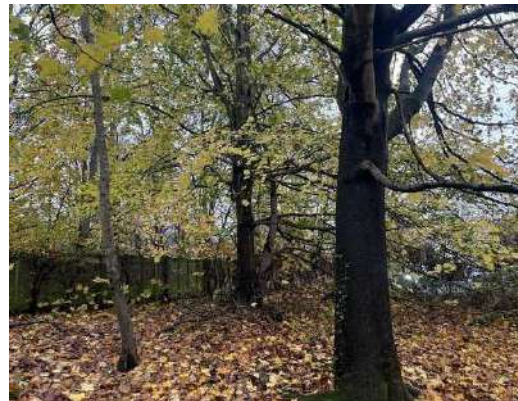
Photo 12 - Dense tree cover obscuring sightlines and reducing supervision of boundary areas, increasing safeguarding risk.

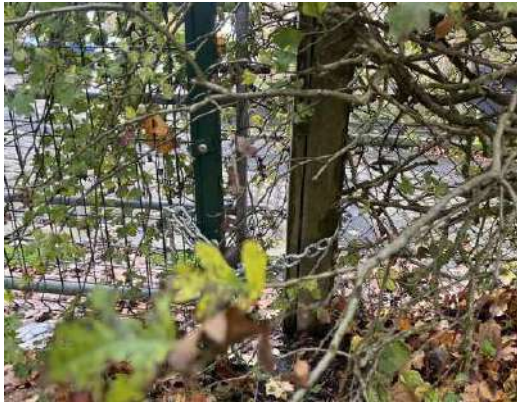
Photo 13 - Unsecured gap between legacy chain-link fencing and newer mesh fencing to the roadside boundary, resulting in a breach of the secure line and enabling unauthorised access on the south boundary

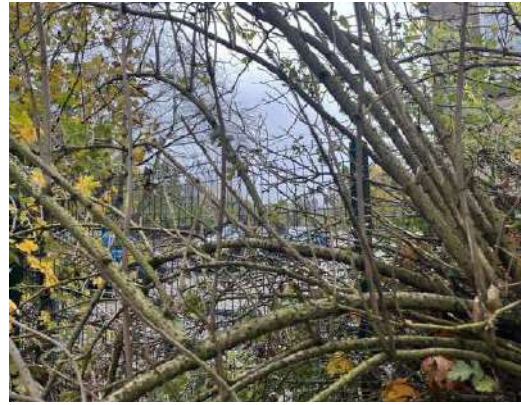
Photo 14 - 1.8m perimeter fencing that does not meet DfE minimum height requirements for safeguarding boundaries

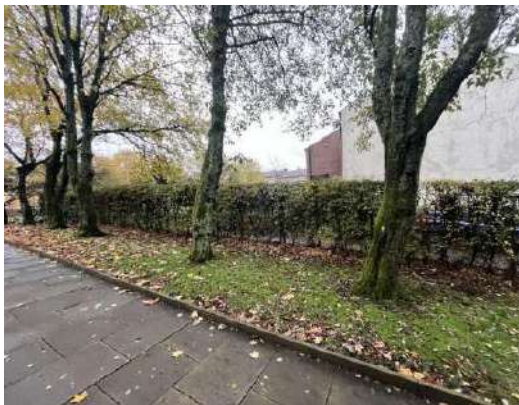
Photo 15 - Front boundary reliant solely on hedging, with no physical fencing and unrestricted public access to the school site.

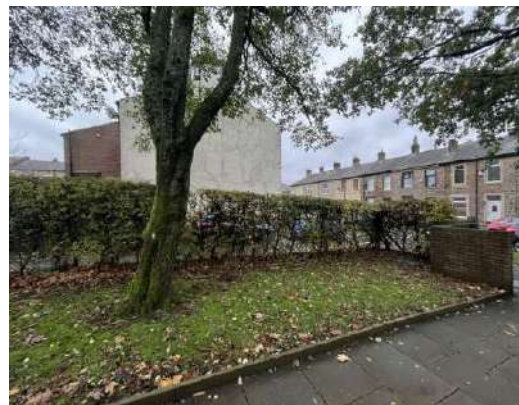
Photo 16 - Front boundary reliant solely on hedging, with no physical fencing and unrestricted public access to the school site.

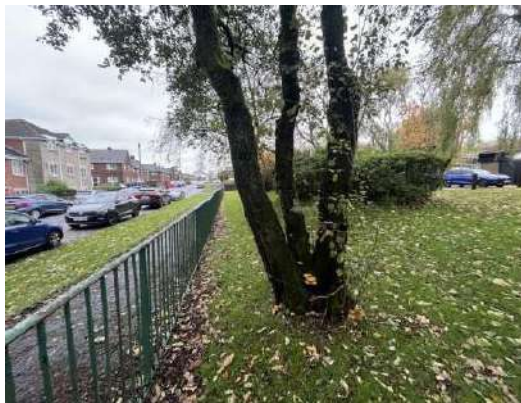
Photo 17 - Low-level iron railings to the front boundary adjacent to the main road, which do not provide an effective safeguarding barrier or meet current DfE requirements for secure school perimeters.
