# **Whitefield Fire Station, Whitefield**

## **Phase 1 Geo-Environmental Investigation**

For: Greater Manchester Combined Authority (GMCA)

Ref: 3866a-01  
Job: 3866a  
Rev: A  
By: LM

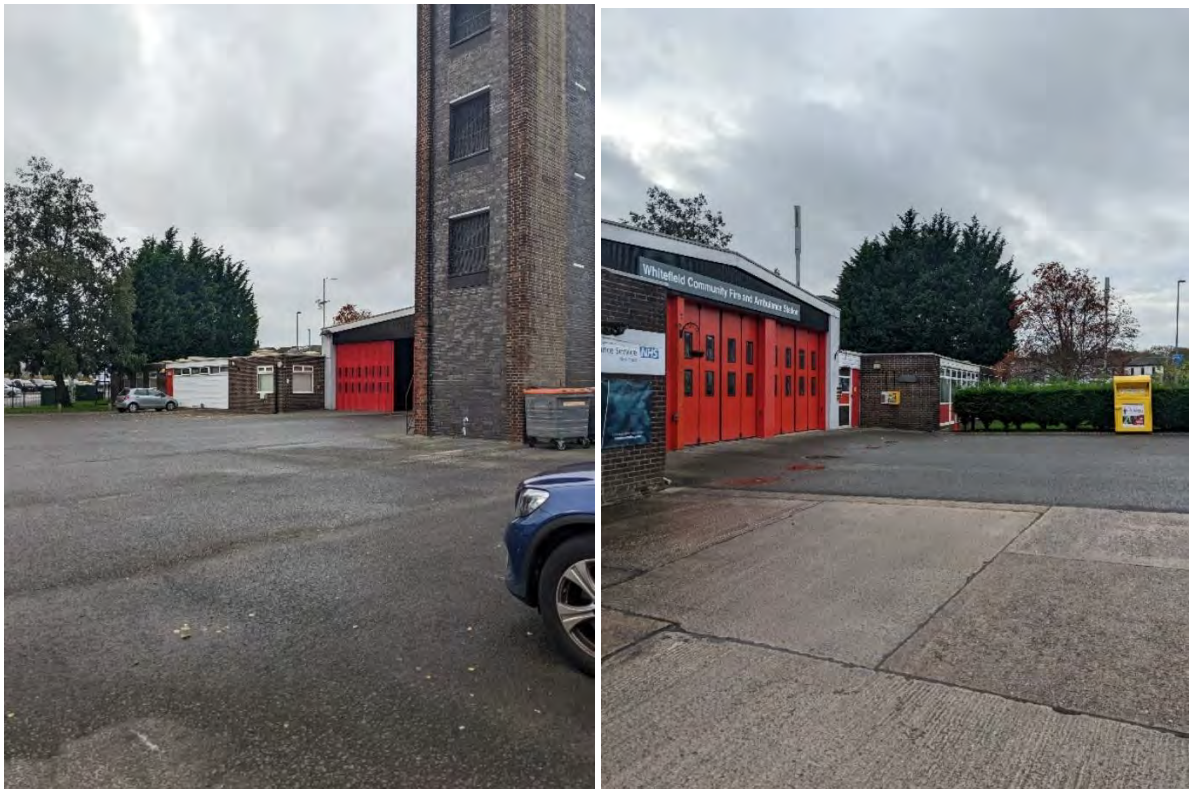
Figure 2: Photographs of the rear and front of the fire station

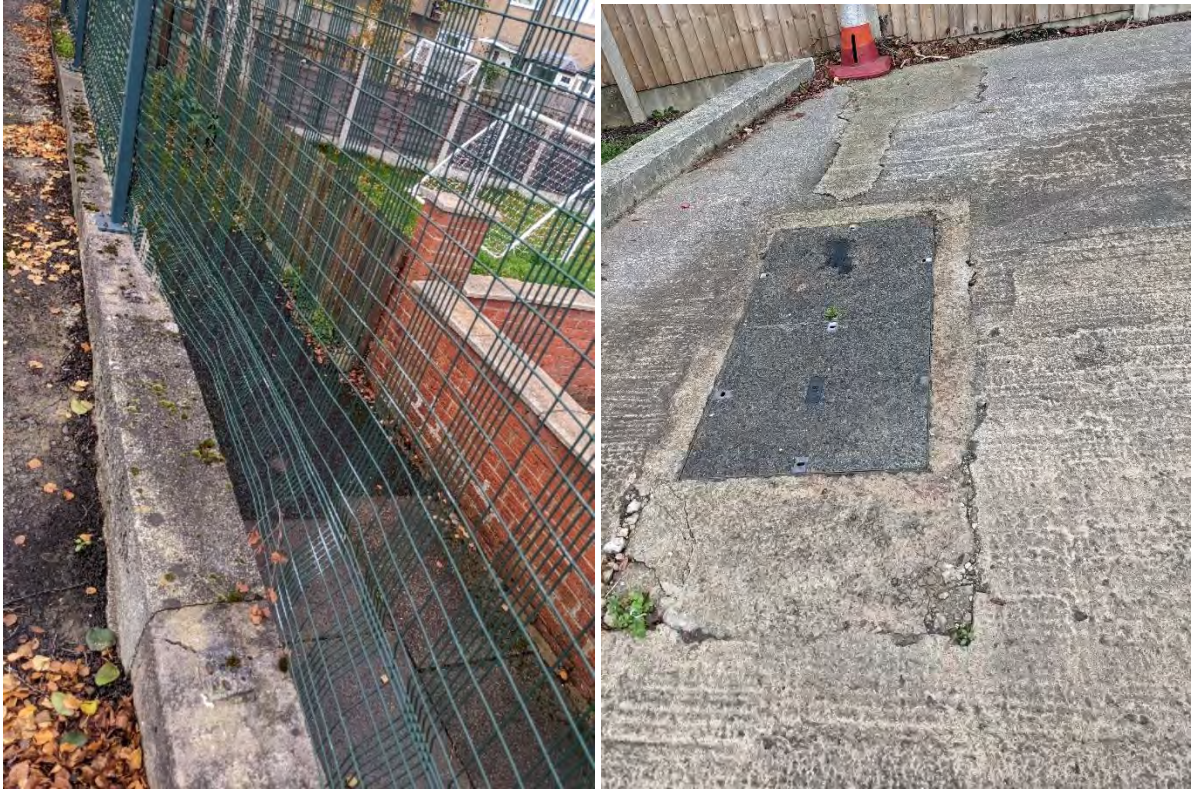
Figure 3: Photograph of the retaining wall (left) and service manholes (right)

| <b>Retaining Wall</b> | A c. 0.50m - 1.00m retaining wall is present along the eastern extent of the northern boundary of the site. The retaining wall was noted to be in good condition. | The retaining wall will need to be inspected and remedial measures undertaken prior to development, subject to an assessment of the impact upon Third Party assets. | <b>Low</b> |

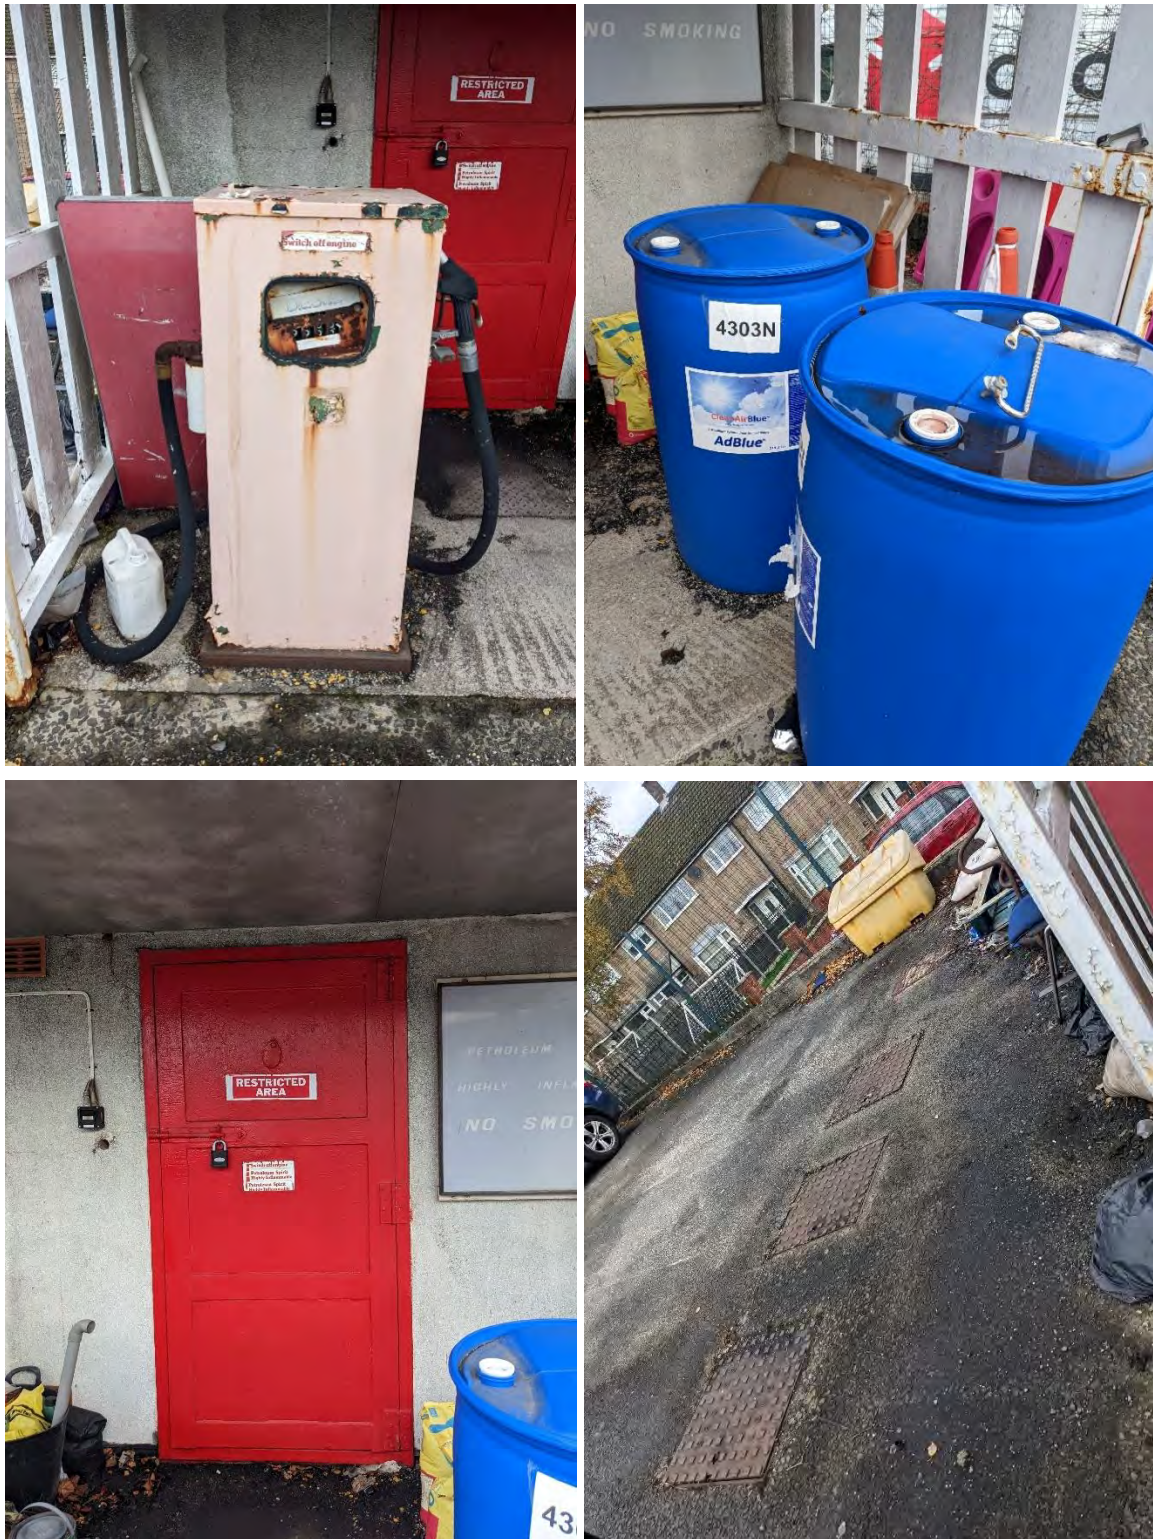
Possible contaminative sources were identified during the site walkover, including a disused diesel pump and suspected associated underground storage tank, drums of AdBlue and a hydrocarbon spirit storage room in the north eastern corner of the site. A suspected interceptor was recorded adjacent the aforementioned features. No information was available regarding the size of the tank or whether it has been decommissioned.

Figure 4: Photographs of the diesel pump, AdBlue, petroleum spirit storage and interceptor

| <b>Obstructions</b> | An underground storage tank is anticipated to be present in the north eastern site section. Additional obstructions associated with the current and historical site buildings may also be present on-site. | May act as obstructions to excavations and / or the chosen foundation solution or act as 'hard spots' within the ground if left in-situ. | <b>Low to Moderate</b> |

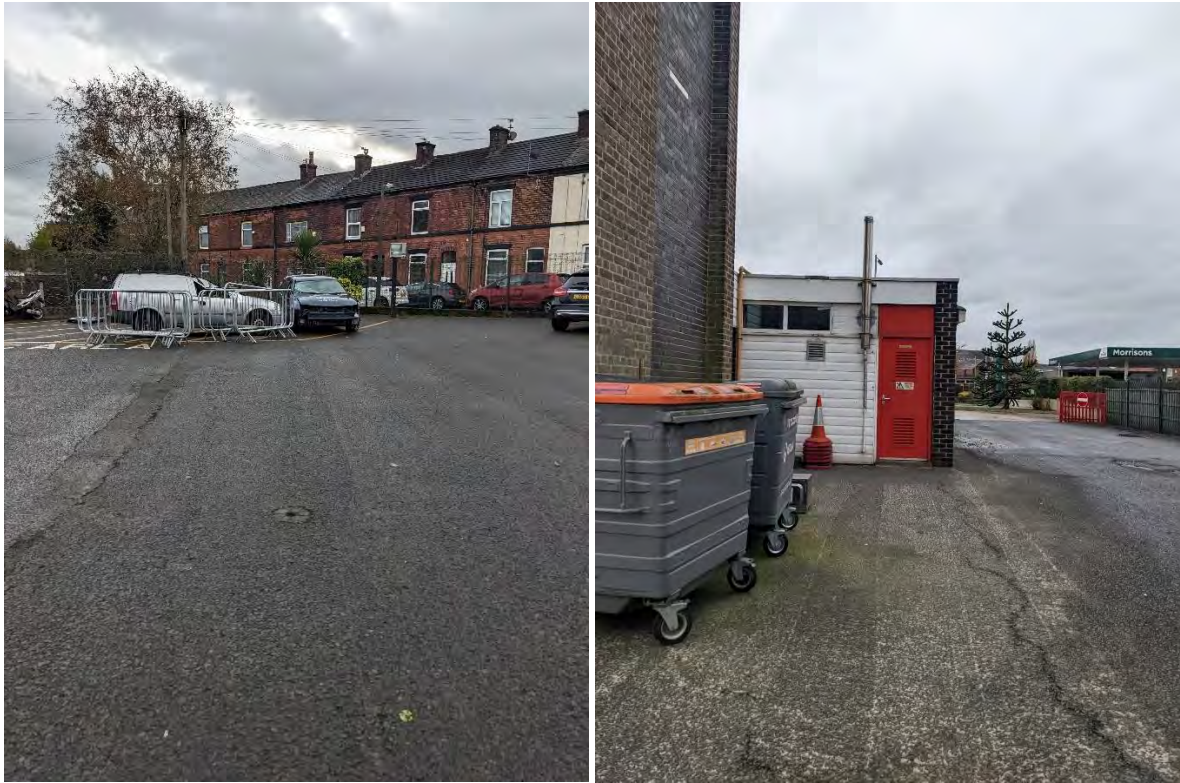
A boiler room was also noted in the main building in the central site section. Disused vehicles used for training were also noted in the eastern site section which are considered a potentially contaminative source.

Figure 5: Photographs of the vehicles and boiler room
