# 1 THE ROCK, BURY

POST FIRE DECONSTRUCTION - SITE VISIT 1

Friday, 16 January 2026

Prepared For Broad Property Ltd

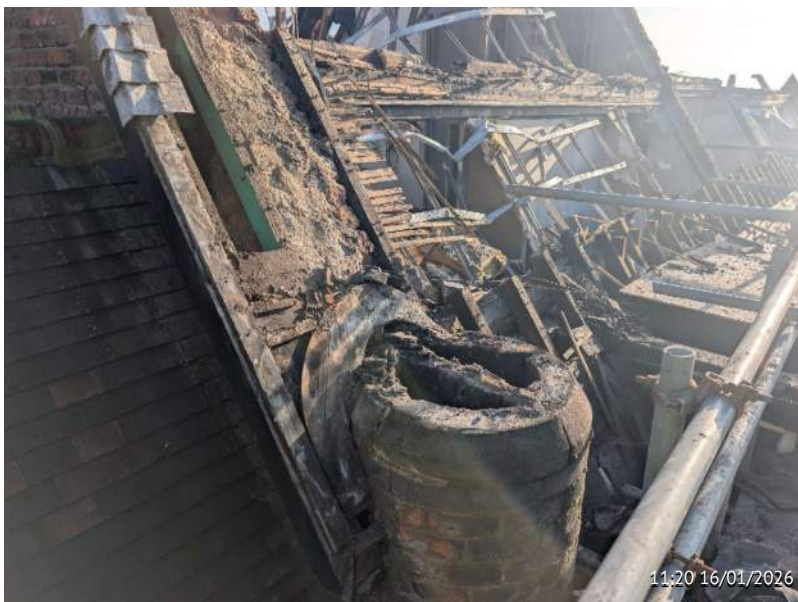
### Observation 2

View On Rear Left

Lower sections of rafters yet to be removed.

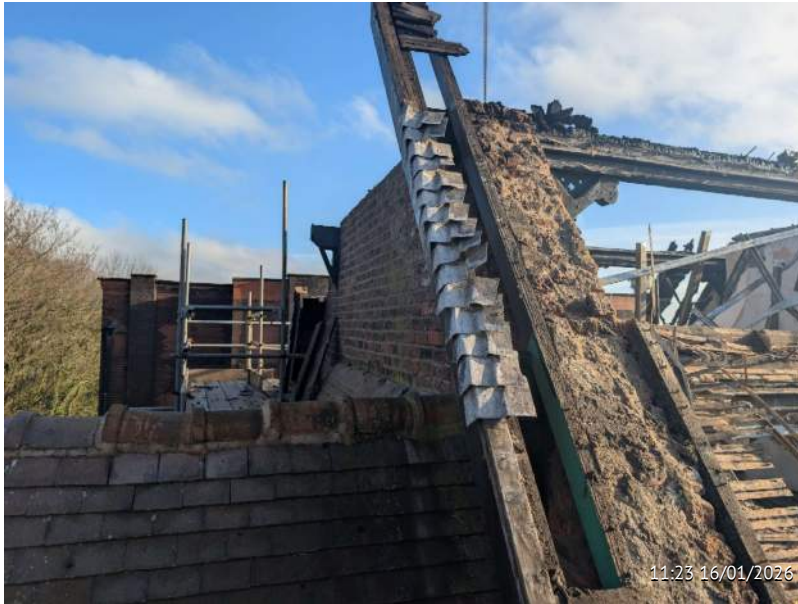
### Observation 7

View On Rear Gable

To be taken down to just above  
outrigger roof level.

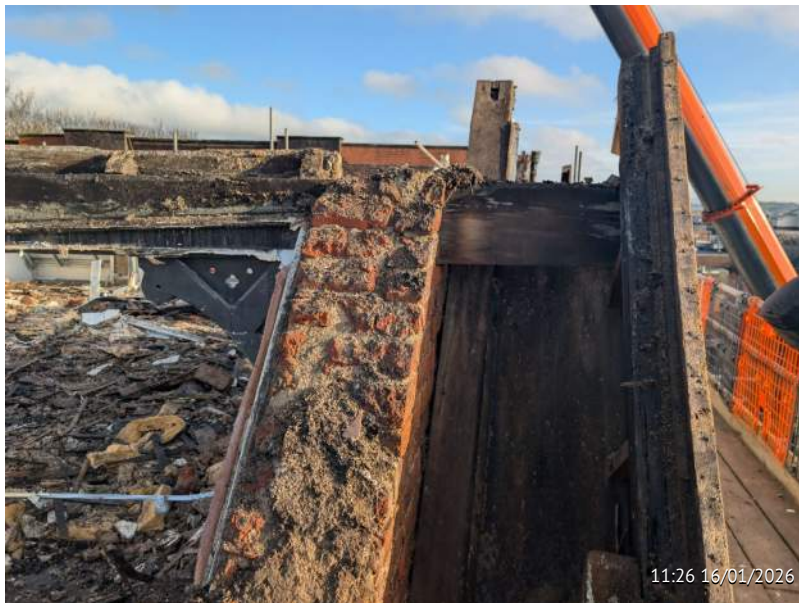
### Observation 14

View On Front Gable

Purlin extends through gable wall to support timber panelling on front elevation.

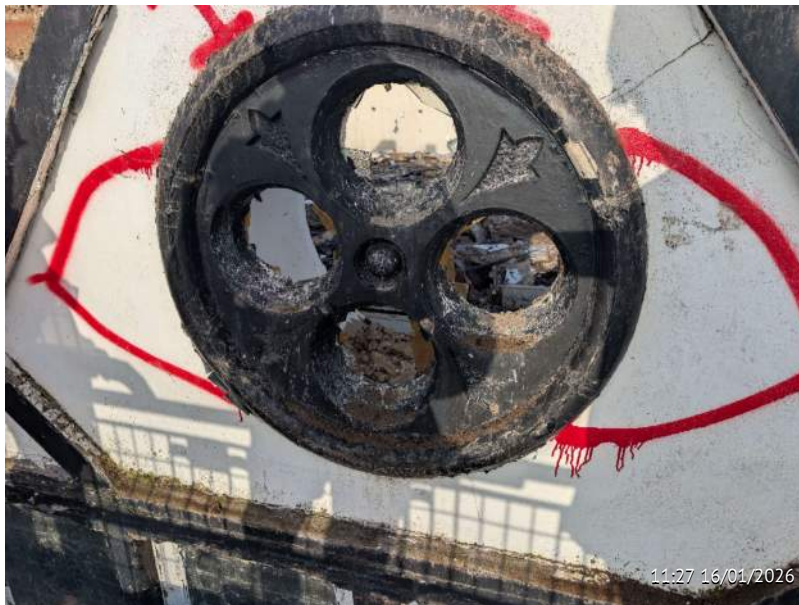
### Observation 18

Oculus Window On Front  
Elevation

Appears to be segmental.

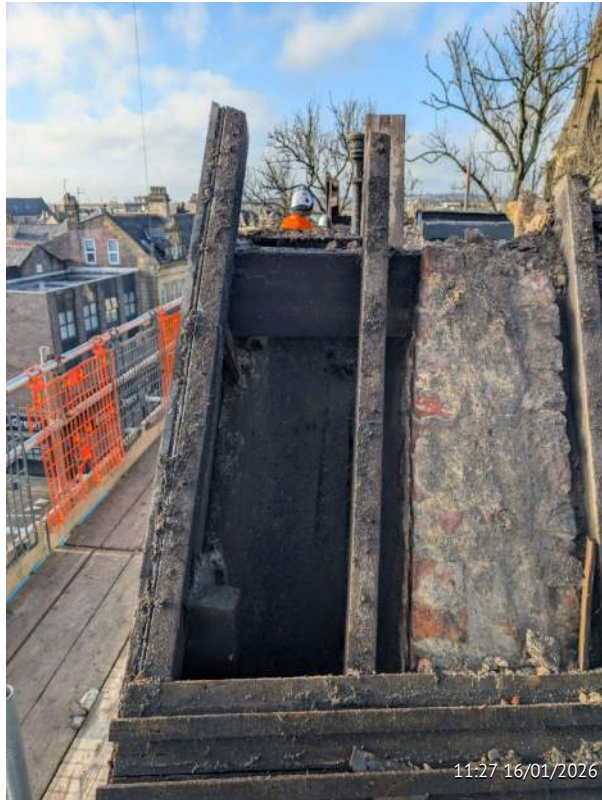
### Observation 21

View On Front Gable Wall

Purlin extends through gable wall to support timber panelling on front elevation.

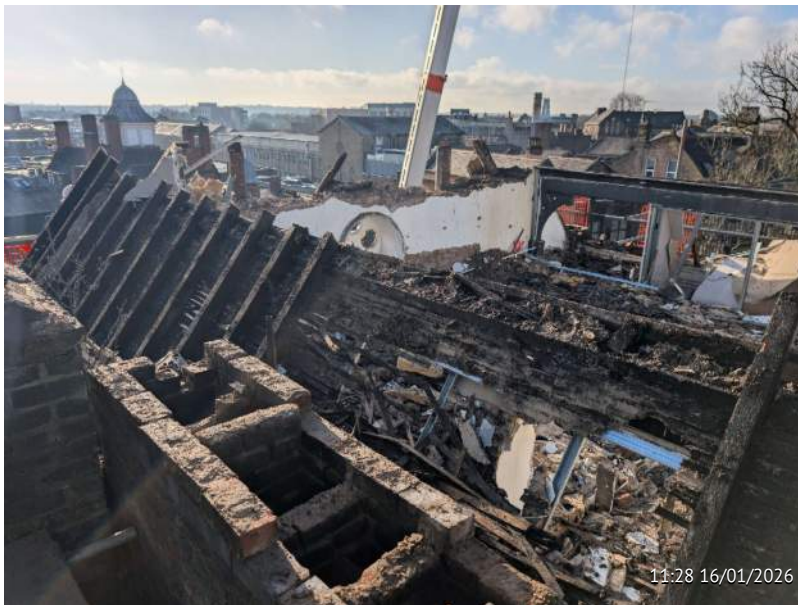
### Observation 26

View On Front Section

Several loose bricks at bottom of chimney stack.

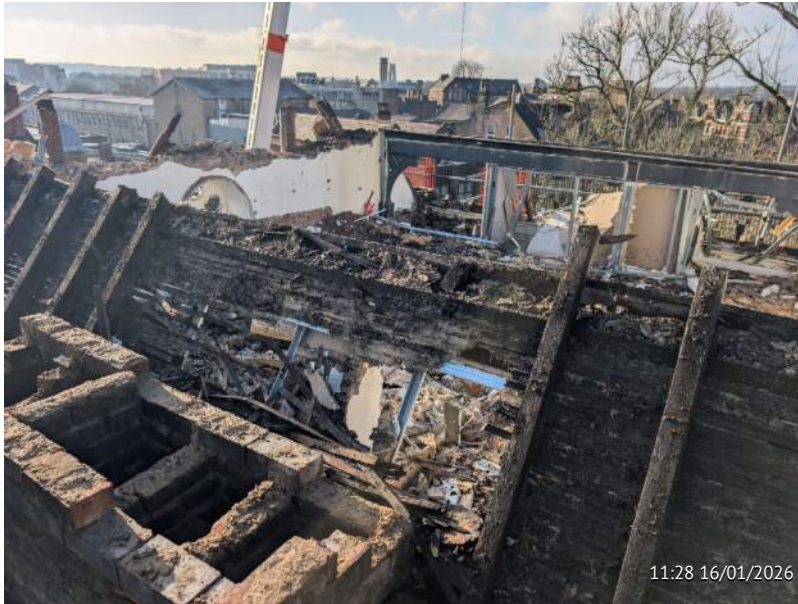
### Observation 27

View On Front Section

Floor boarding may now be unsafe to walk on due to exposure to the elements and previous fire fighting activities - Contractor to consider in floor debris removal methodology.

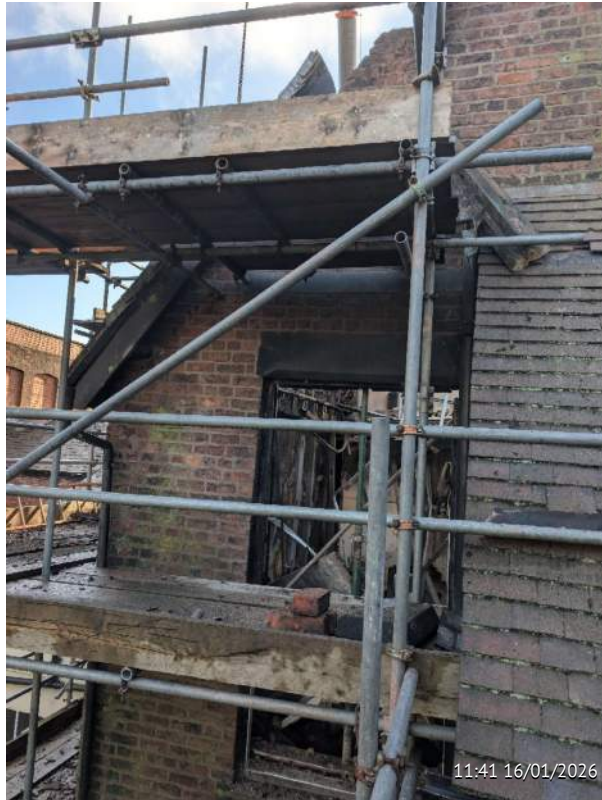
### Observation 33

View On Rear Right Corner Of Building

Stability of corner to be monitored and assessed when safe to do so.

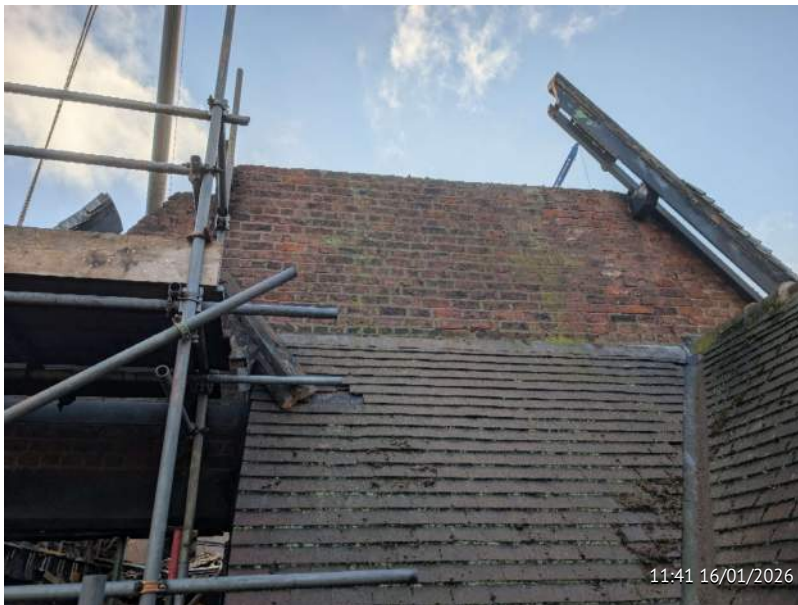
### Observation 34

View On Rear Gable

To be taken down to just above outrigger ridge line.

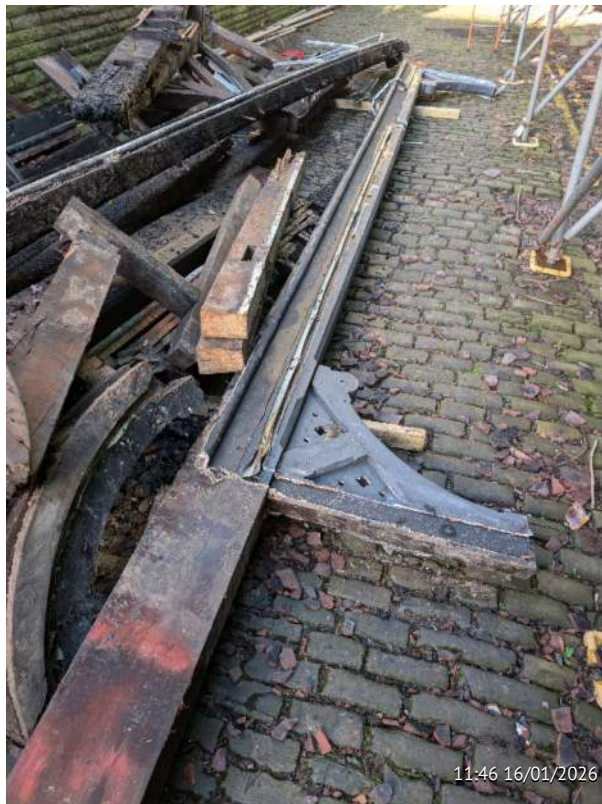
### Observation 36

Salvaged Purlin  
Gallows brackets appear to be non-structural.

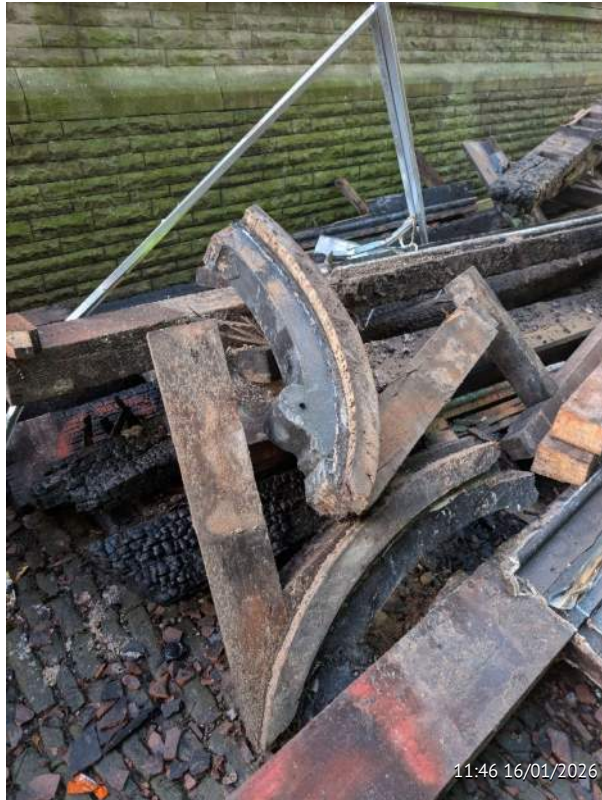
### Observation 37

#### Salvaged Timber Elements

All timber elements will require inspection by a rot and infestation specialist before re-use.

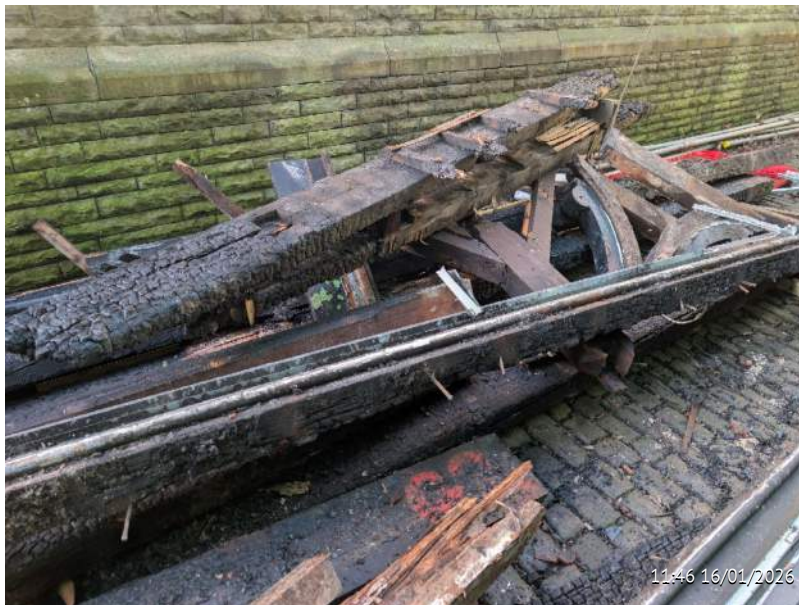
### Observation 38

#### Salvaged Timber Elements

Some are heavily charred and may be unsuitable for reuse in current form.

Undamaged timber beneath the charring may be salvageable and re-used elsewhere in the reconstruction.

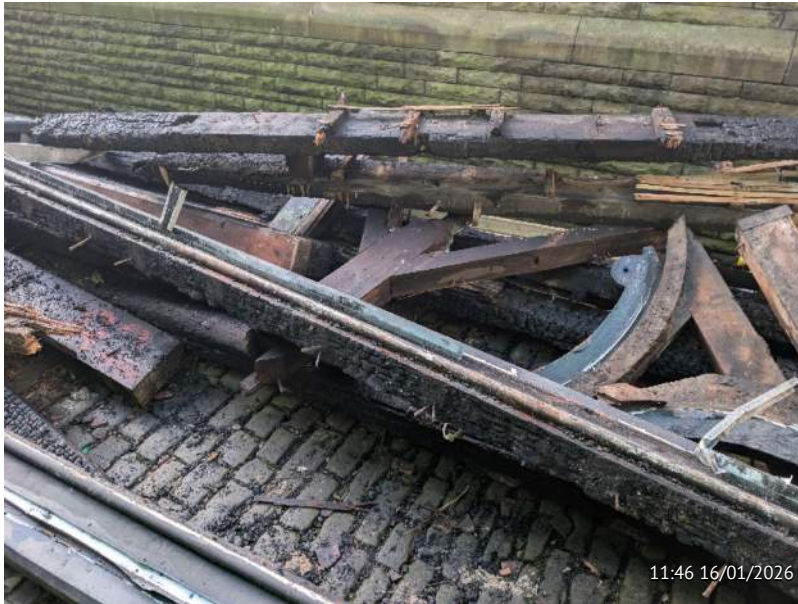
### Observation 39

Salvaged Timbers

See previous comments.

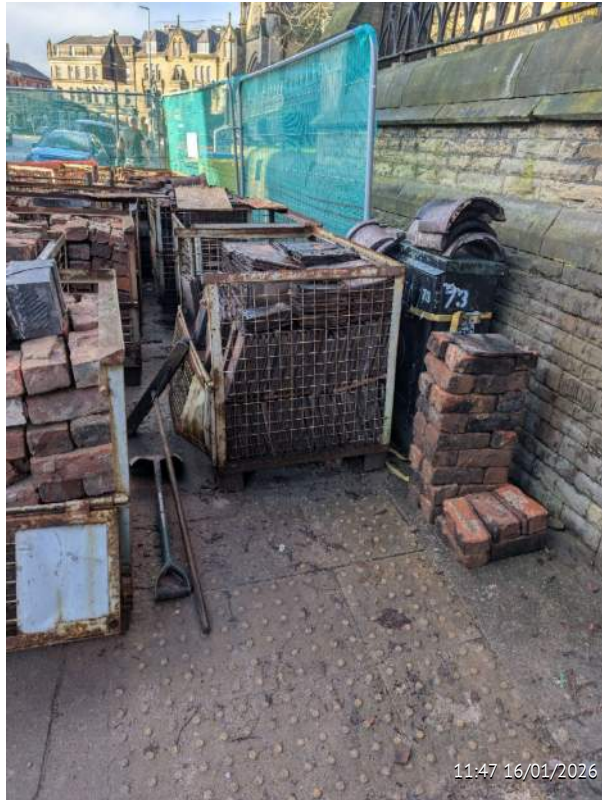
#### Observation 41

Reclaimed Tiles And Bricks

Further consideration required by M&G of the next stages of selection of suitable bricks for reuse.

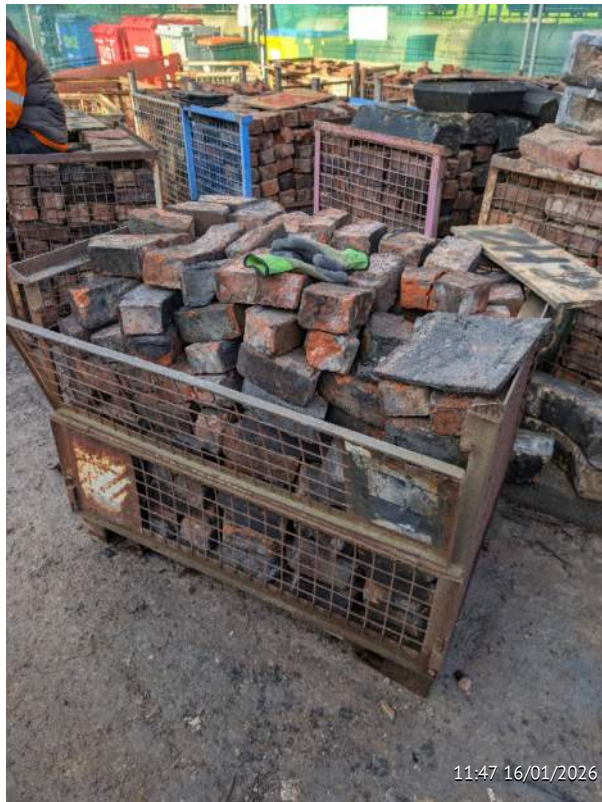
### Observation 44

Reclaimed Bricks

Sorted into areas that they were reclaimed from and recorded by Contractor.

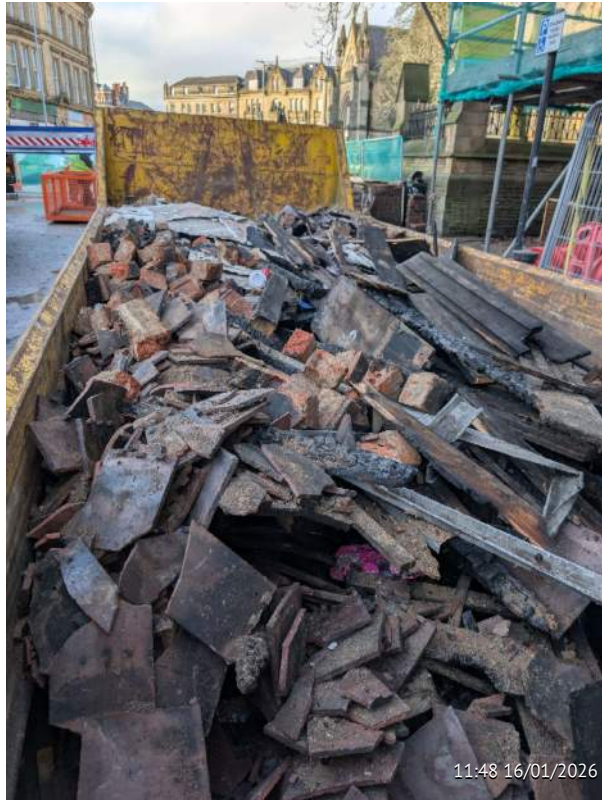
#### Observation 47

Damaged Elements Not Salvageable
